**BEFORE THE HON'BLE NATIONAL GREEN TRIBUNAL
PRINCIPAL BENCH AT NEW DELHI**

ORIGINAL APPLICATION NO. 288/2019

**COMPLIANCE REPORT OF THE HON'BLE TRIBUNAL
ORDER DATED 19.06.2020, ON BEHALF OF
RAJASTHAN STATE POLLUTION CONTROL BOARD.**

Scientific studies on blast induced ground vibration and air overpressure and investigation on its damage potential vis-à-vis housing structures in Pur village, Bhilwara Distt., Rajasthan

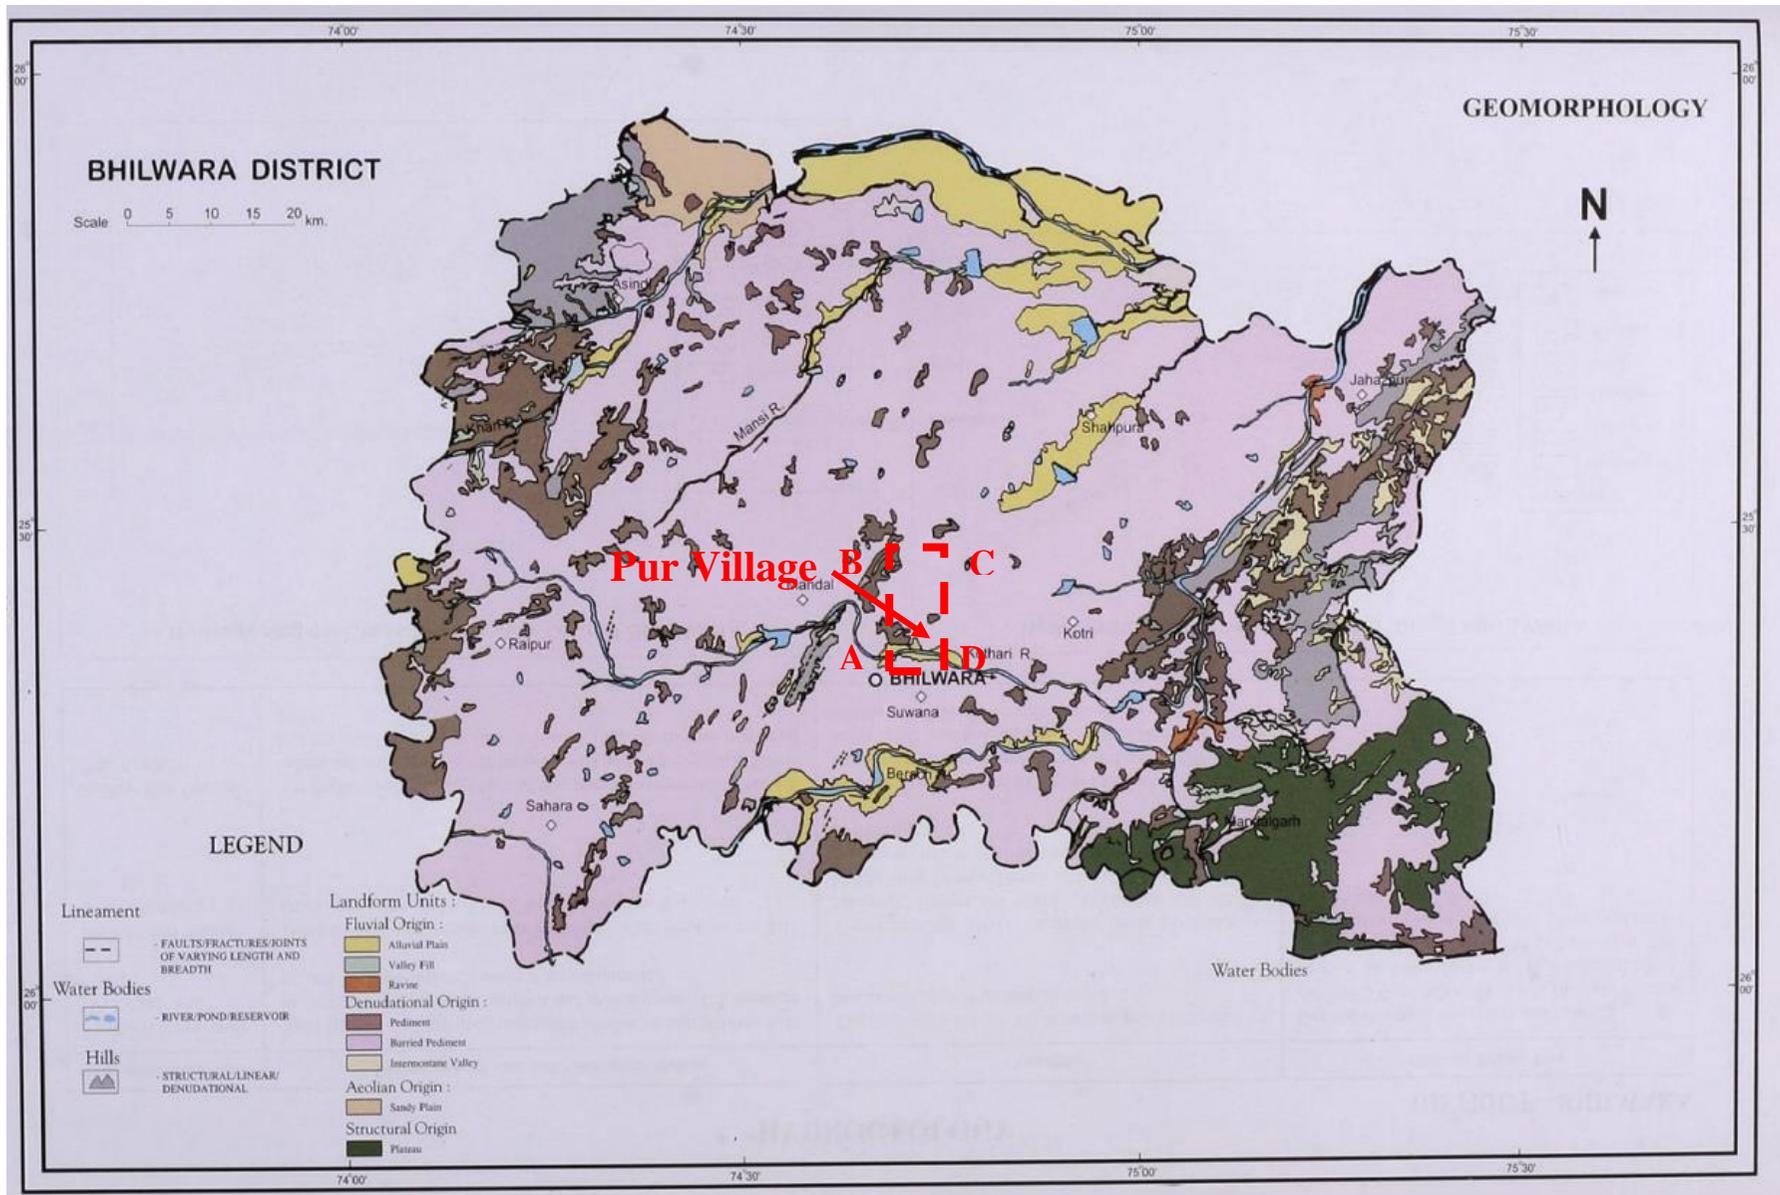
Figure 3: Geological map of the Bhilwara District, with marking of the target area (adopted from Indianwaterportal.org)

The project area contains gneiss and schist (Bhilwara Super group); gneiss, schist, phyllite, slate and limestone (Aravalli Supergroup); sandstone, shale and limestone (Vindhyan Supergroup) and alluvium as major water bearing formations. The aquifers formed are localized within the weathered, fractured and jointed hard rock areas zones. The geomorphological map of the area is shown in figure 3.

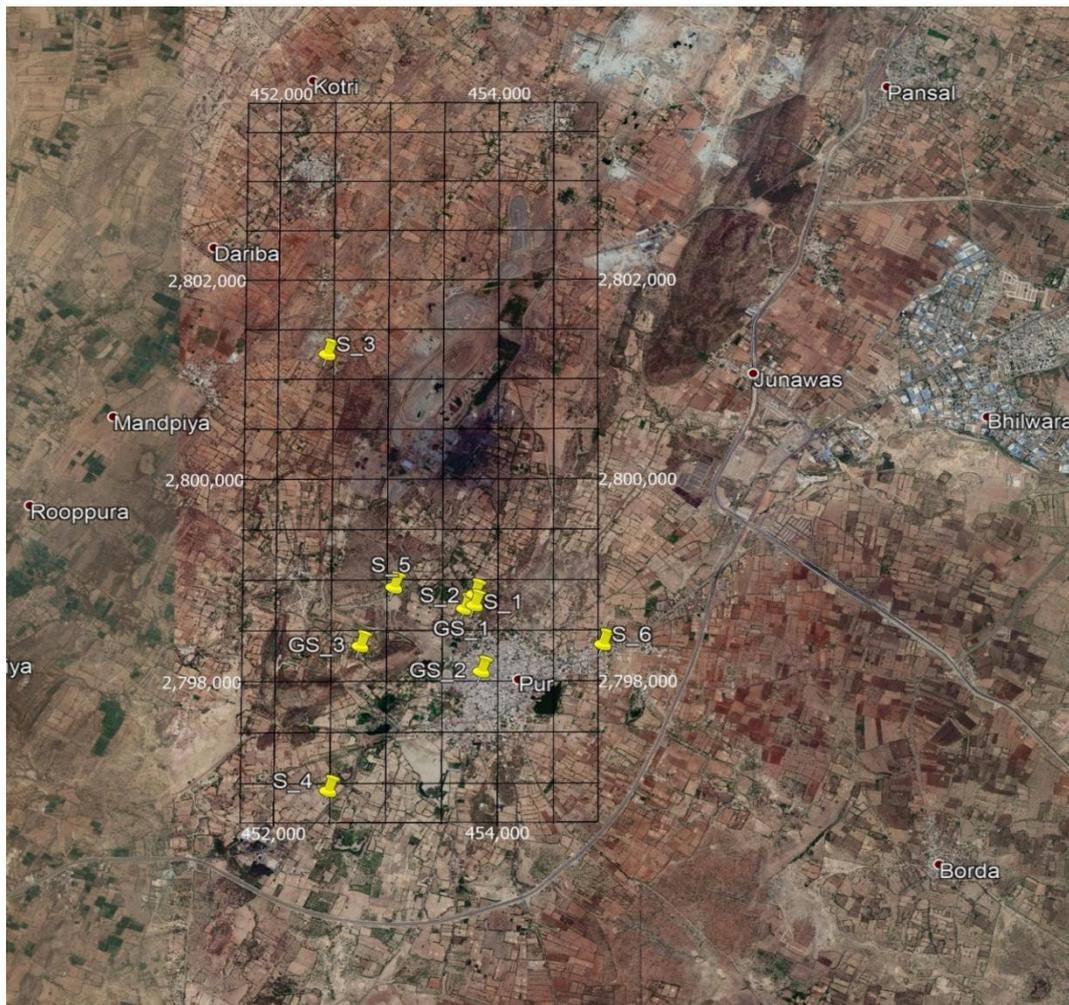
Figure 4: Locations of all survey sites used for resistivity and tomography surveys.

Three main equipment setups comprising 1) sounding terrameter for 1-D VES 2), Earth resistivity meter for 2-D ERT and 3) Ground magnetic resonance (GMR) were used for this study along with the dip-meter, water quality probe and other relevant accessories. Six locations were selected for performing VES, ERT, and GMR soundings during the first field visit based on the topography and area availability. Three more locations were selected for ERT during the second field visit. The locations and elevation above msl of sites is listed in table 2 and marked in figure 4. A total of 17 resistivity (6 VES and 11 ERT) soundings and 2 GMR surveys were conducted. In-situ water quality analysis were conducted at 4 different locations during the first visit while 9 water samples were collected during the second field visit for analysis of isotopic and other physio-chemical water quality parameters. It is to be noted that most of the soundings were performed at the periphery of the Pur village facing towards the mining site to map the existing hydrogeological profile of the severely affected area.

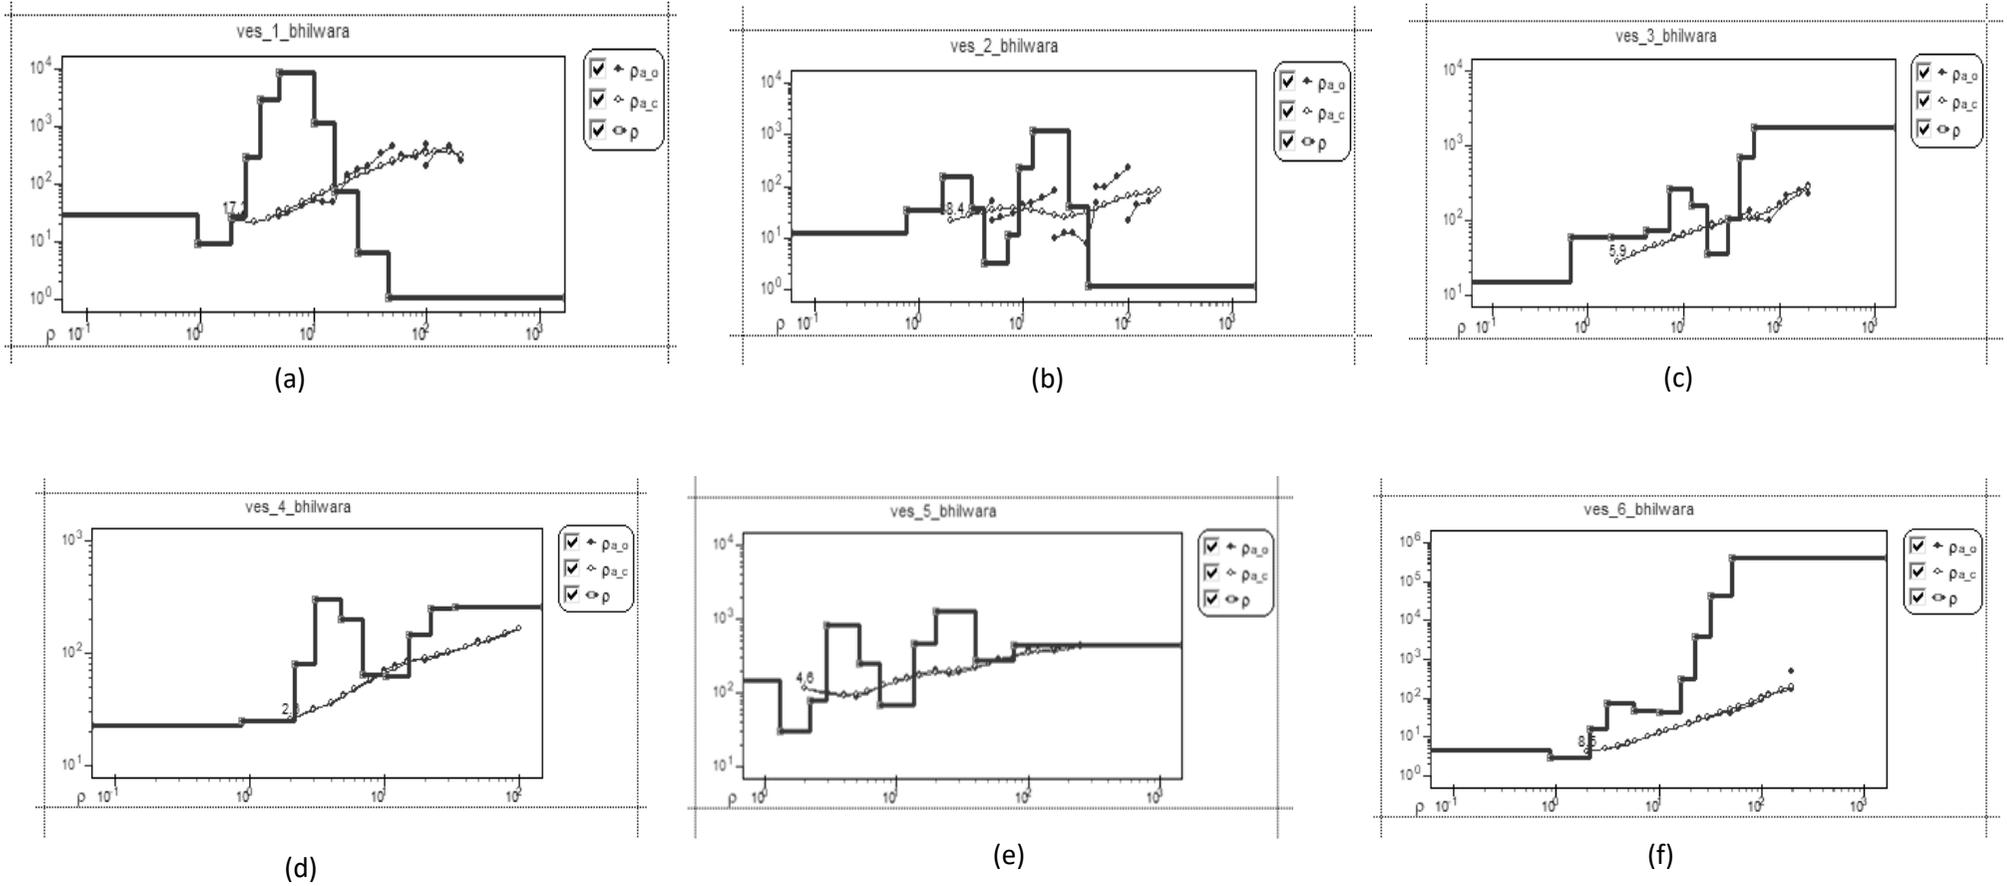
Figure 6. Field resistivity curves plotted by the Zondip 1D for the site: (a) S_1, (b) S_6. (c) S_5 parallel to dip, (d) S_5 perpendicular to strike direction, (e) S_3, and (f) S_4.

Soundings are carried out using Schlumberger configuration with maximum current electrode spacing (AB) of 400 m to delineate the subsurface. The field data (Apparent resistivity and half current electrode separation, $AB/2$) along with the spatial coordinates of VES locations are interpreted using Masters Curves and also by using a geophysical exploration software (Zondip 1D). The resistivity data is analyzed and depth to resistivity models are prepared using forward modelling followed by inverse modeling for more accurate results. The plots of field apparent resistivity versus $AB/2$ on log-log graph are given in figure 6 (a-f). The results of the interpretation of the field data in terms of layer thicknesses and true resistivity are shown in figure 7 (a-f). Along with the software interpretation, all the VES performed in the field are also interpreted manually. A perusal of the interpreted results indicates that each VES location is comprised of 4-5 layers and showing possibility of cracks, fissures, and fractures in the subsurface. In general, the topsoil layer in the Project area is found to be composed of grey black schist and quartzite often overlain by thin top layer of alluvial soil with sand and clay mixture.

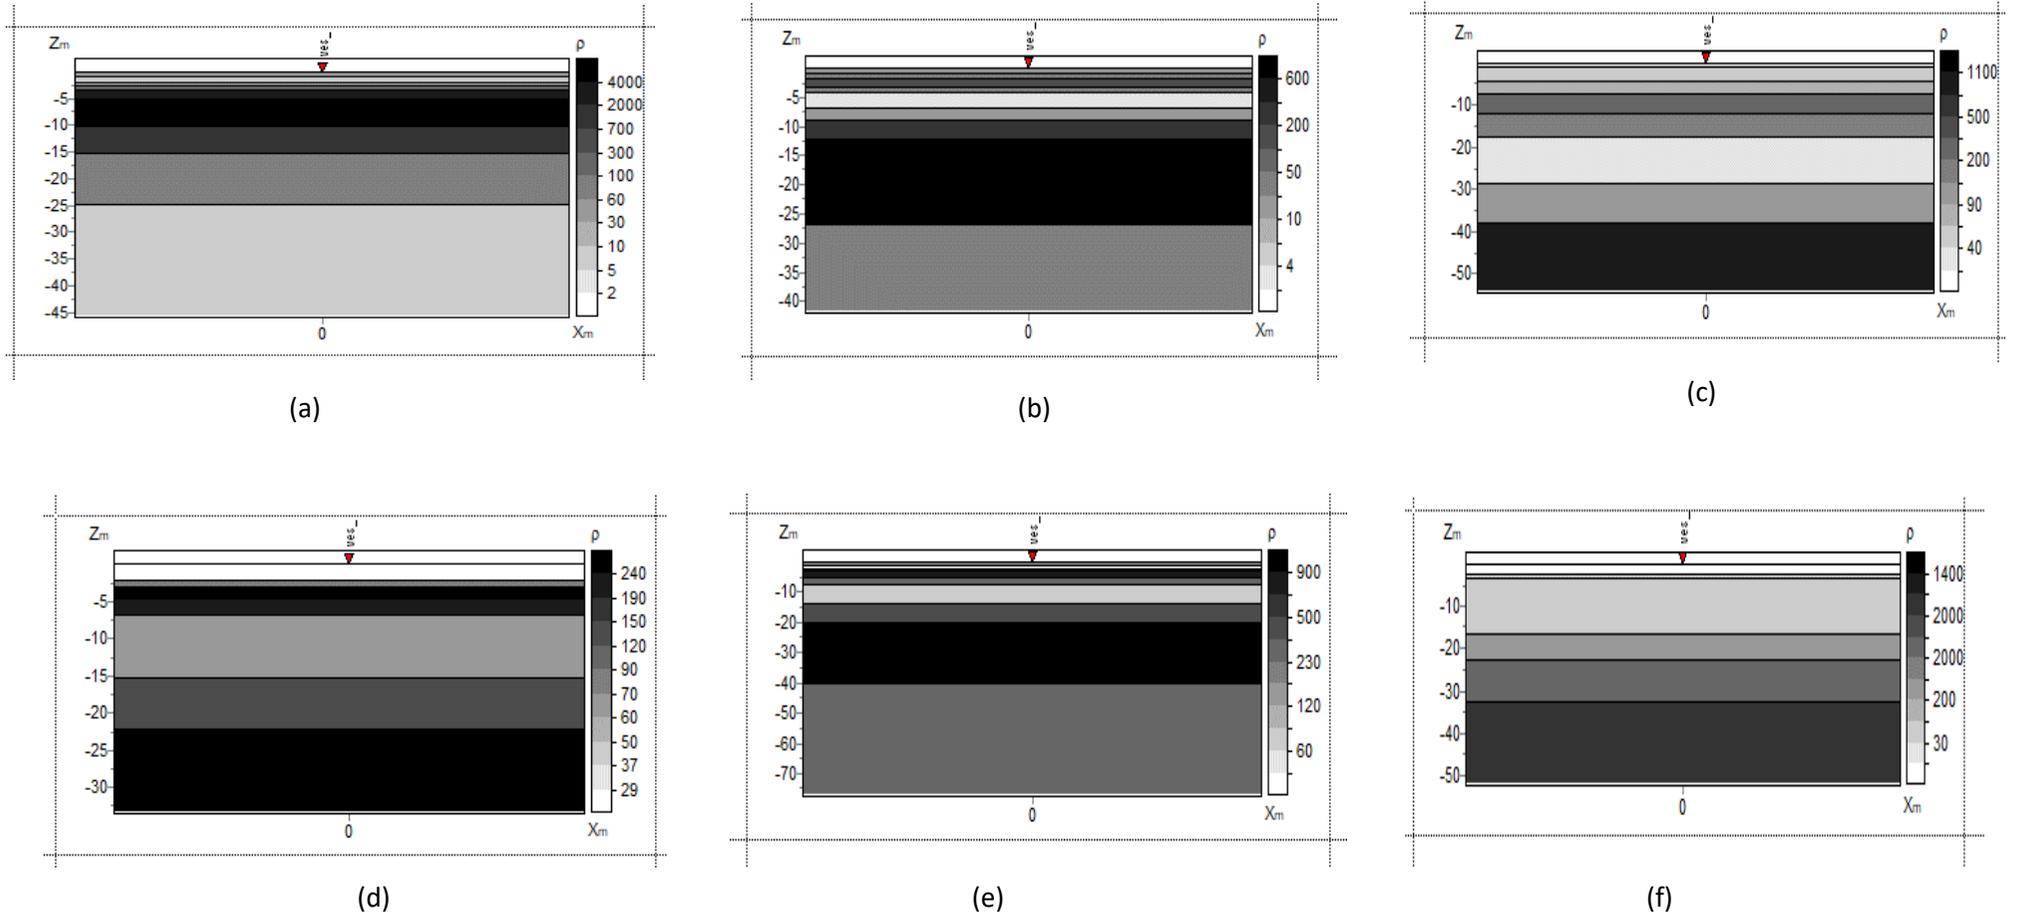
Figure 7: Depth-Resistivity models for the sites: (a) S_1, (b) S_6. (c) S_5 parallel to dip, (d) S_5 perpendicular to strike direction, (e) S_3, and (f) S_4. The depth (Z_m) is shown in meters and resistivity (ρ) is in Ohm-meters ($\Omega\text{-m}$).

A perusal of the table 4 generally indicates presence of a thin top soil/alluvium, having resistivity of 2 to 20 ohm-m, of thickness varying between 1m to 5 m. The top soil/alluvium is underlain by weathered hard rock, schistose quartzite, having resistivity in the range 76 to 161 ohm-m and thickness ranging from 2 m to 7 m, with a maximum thickness of 34 m at Sukhadia stadium observed in VES-3. However, at VES-5 location nearby to Jindal Mata Mandir, the top veneer is directly comprised of weathered hard rock as seen from the high resistivity of 100 ohm-m. The above interpretation is corroborated by the presence of isolated outcrops of schistose quartzite dotting the area. The rocks in these outcrops show steep dips towards SE, with presence of slicken sides in Sukhadia stadium, at sites VES-3 and VES-4, pointing to the incidence of displacement of rocks in the geological past. The weathered schist/quartzite is indicated to be underlain by hard/compact Schist/quartzite having resistivity of 440-9900 ohm-m at depths varying between 5 m below the surface at Pathwari and 36m bgl at Sukhadia stadium.

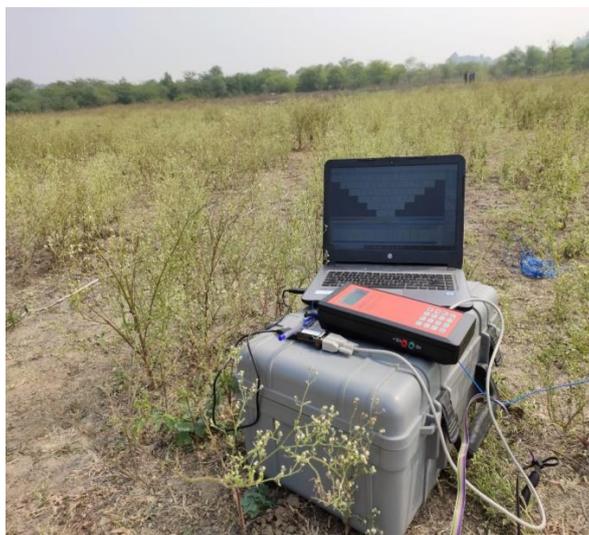
Figure 9: Earth Resistivity Meter installed in the field

The earth resistivity meter shown in figure 9 is a 4-point light 10W high precision instrument for determination of soil resistivity. The electrical resistivity allows determination of the water content in the soil and of the types of soils and rock. It can be applicable to groundwater prospecting, mining, and other environmental investigations. The phase shift between output current and voltage provides information about the induced polarization (IP). The accuracy of the instrument is about 0.1 % with a resolution of max. 100 nV. From the current I , the voltage U and a geometric configuration factor the specific electrical resistivity ρ (Ohm-m) is calculated. The receiver of the instrument is highly selective and only records voltages at the set frequency. However, noise at the measurement frequency degrades the quality of the measurement and should be suppressed. Major reasons for noise may include Mains (electric) interferences, magnetic interferences, wind, rain, and mechanical instability of the electrodes. The ERT is performed over sites S_1, S_2, S_3, S_4, S_5, GS_1, GS_2, and GS_3 in this study.

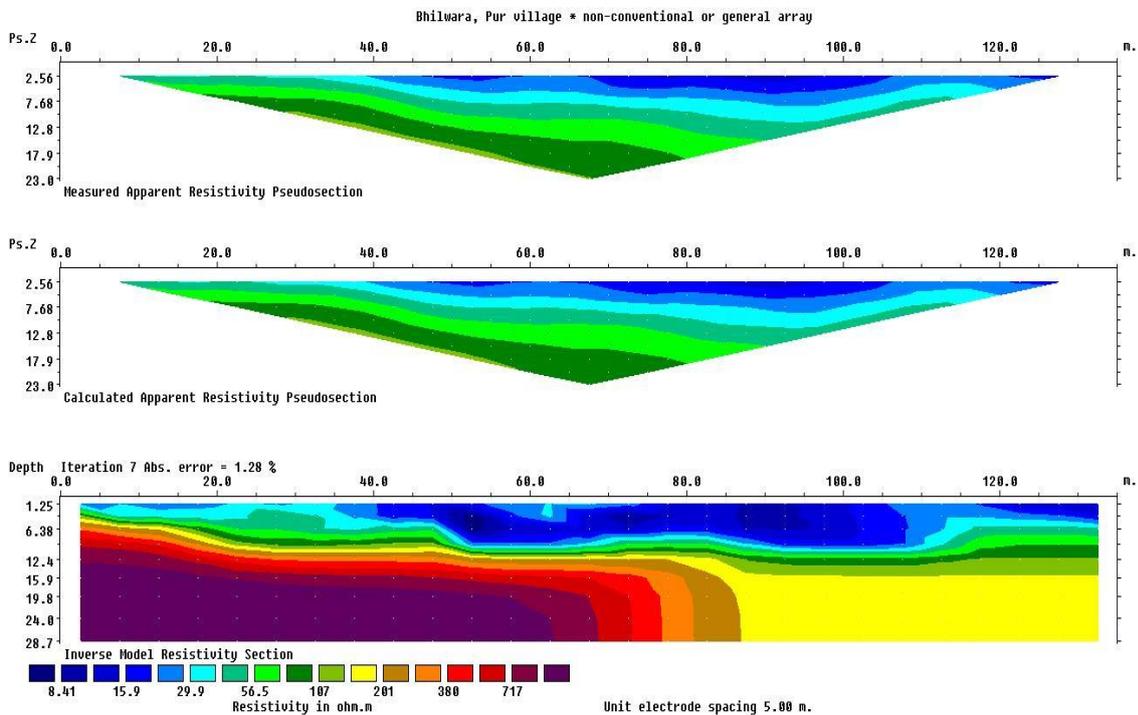
Figure 10: 2D resistivity inverse model by Wenner method at S_1.

Depth of Investigation (meter)	ERT test	
	Resistivity (Ohm-m)	Probable lithologs
0-4	8.74-42.8	Sandy Soil
4-12	42.8-463	saturated sand and clay, sandstone, lignite, coal
12-22	463-1024	Gravel and Sand, garnetiferous Quartzite
22-26	463-2266	Metamorphic Quartzite

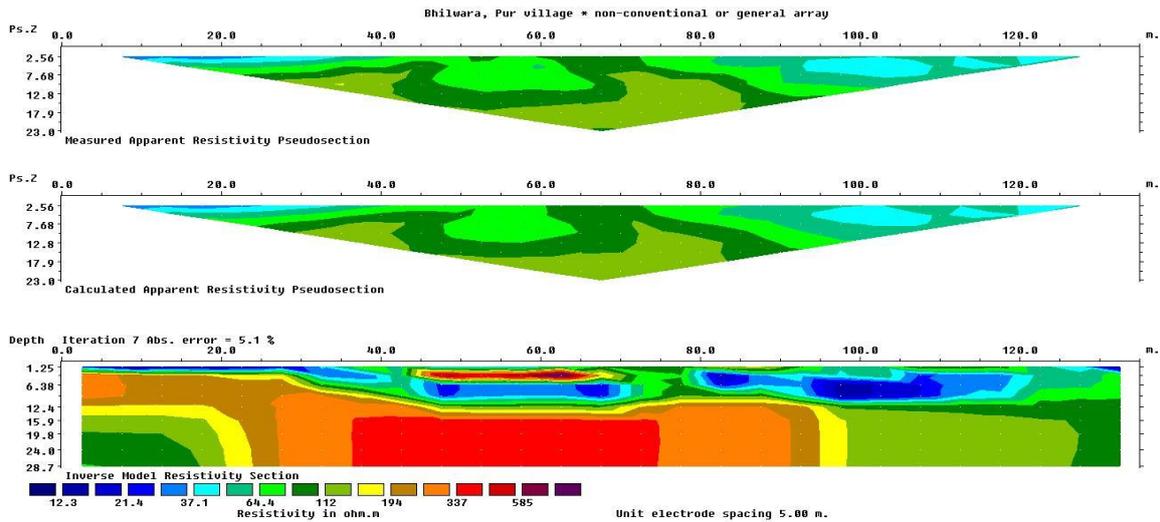
Figure 11: 2D resistivity inverse model by Wenner method at site S_2.

Depth of Investigation (meter)	ERT test	
	Resistivity (Ohm-m)	Probable lithologs
0-7	11.5-472	Clayey soil
7-26.2	137-877	Schistose Quartzite/gneiss with water in fractures

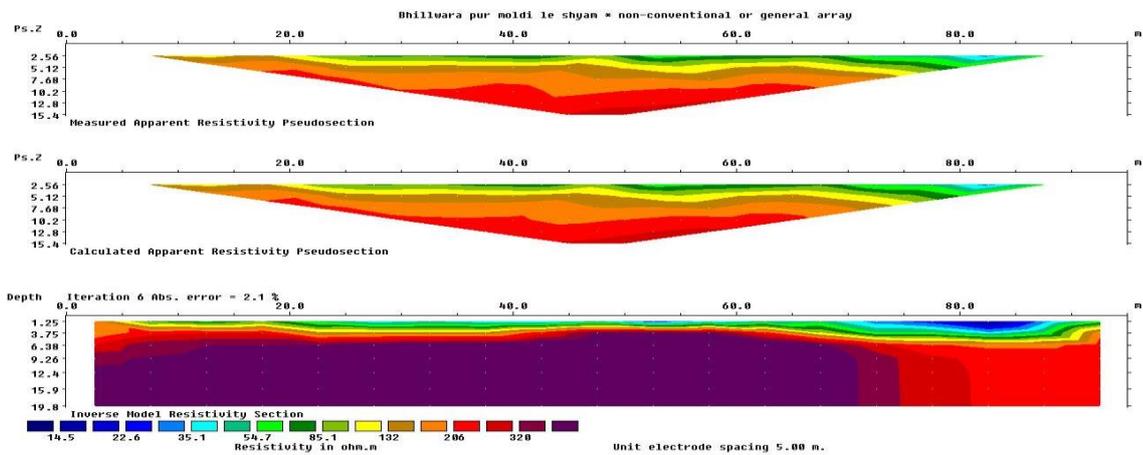
Figure 12: 2D resistivity inverse model by Wenner method at S_3.

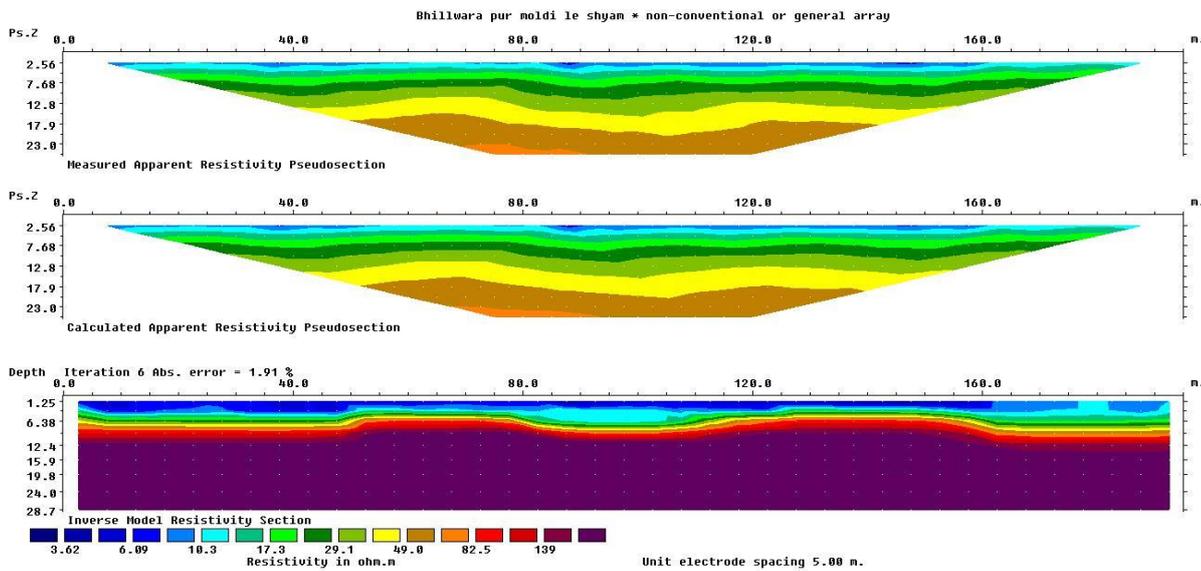
**Figure 13:** 2D resistivity inverse model by Wenner method at S_4.**Table 7:** 2D resistivity inverse model by Wenner method at east direction of S_4

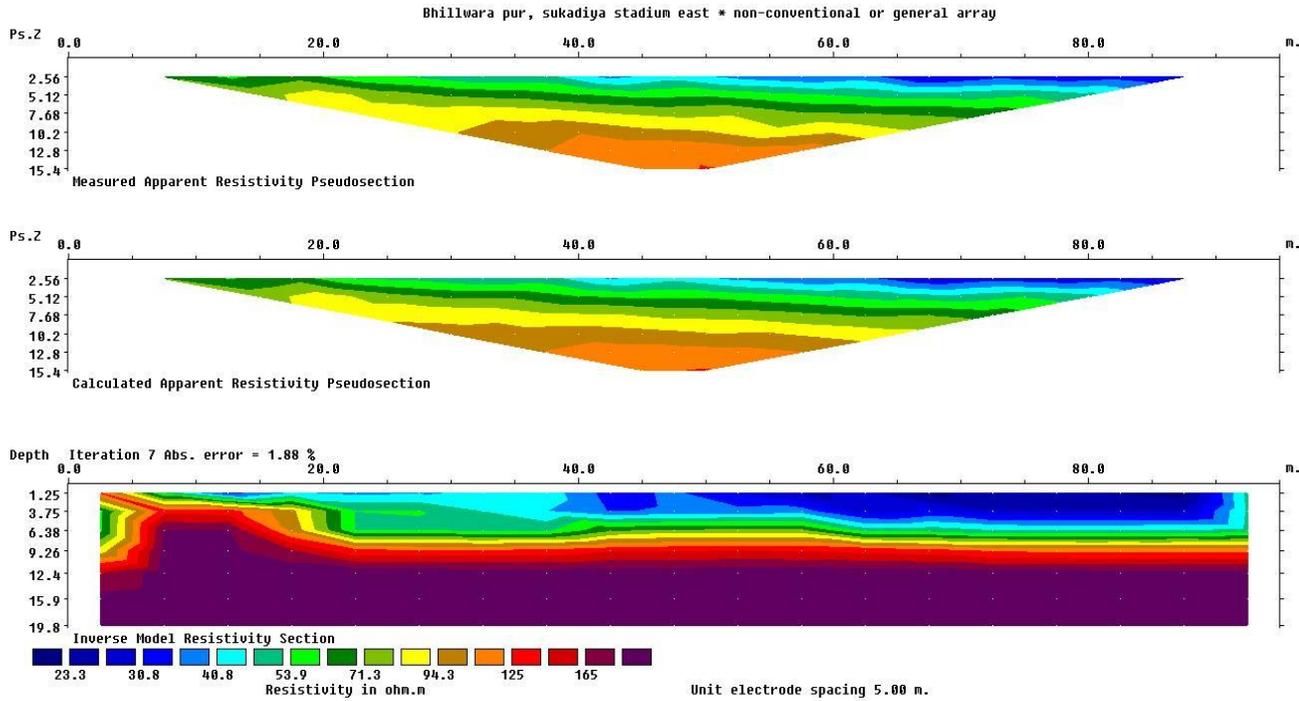
Figure 14: 2D resistivity model by Wenner method at east direction of Sukadiya stadium.

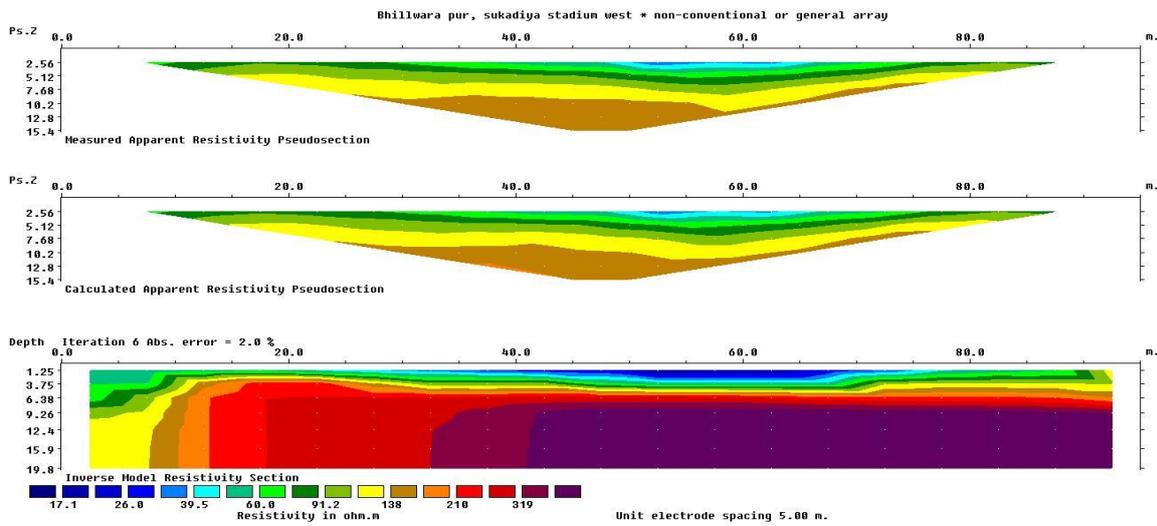
Figure 15: 2D resistivity model by Wenner method at West direction of Sukadiya stadium

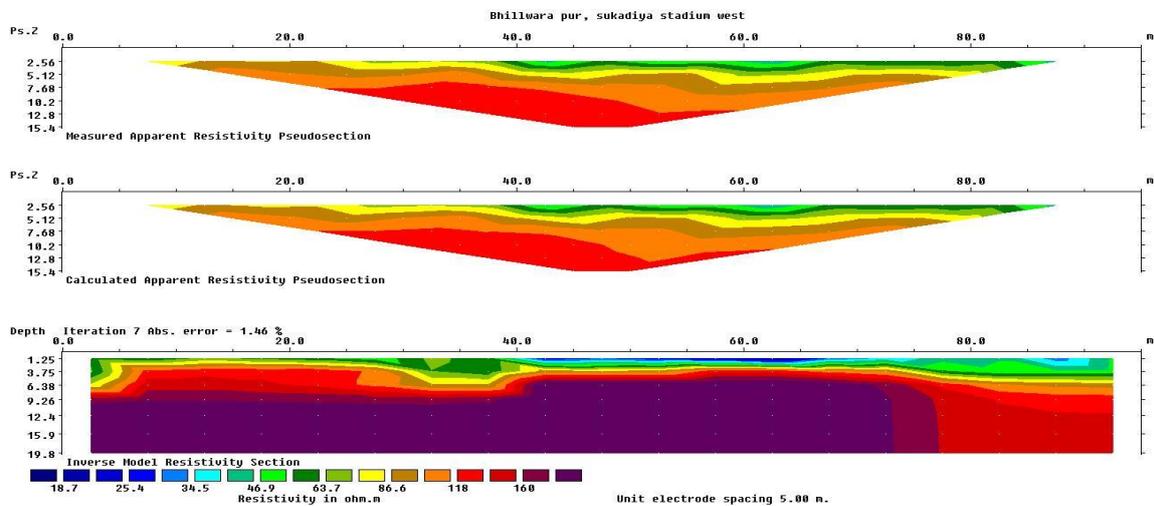
Figure 16: 2D resistivity model by Wenner method at north direction of Sukadiya stadium

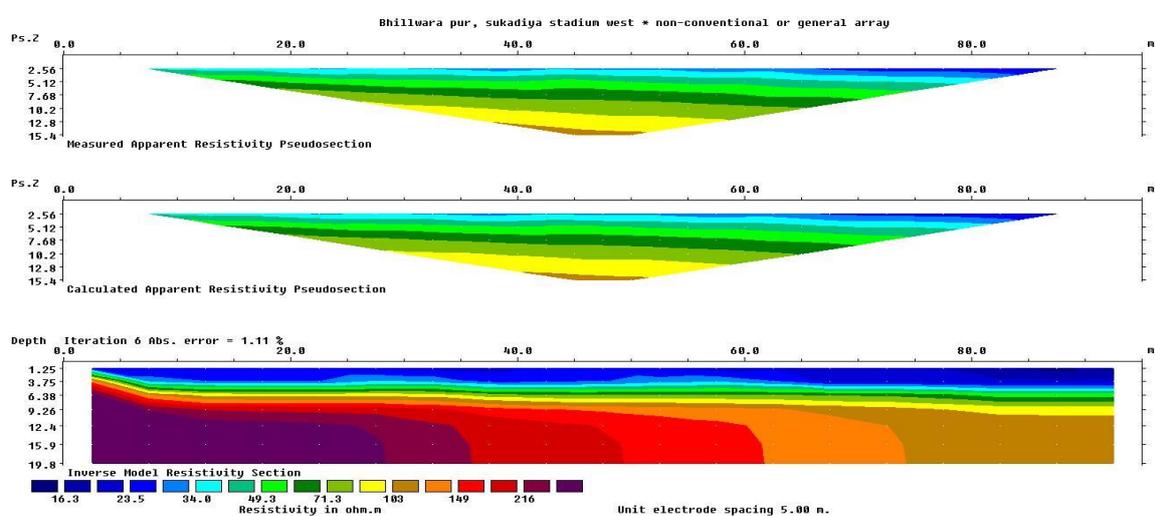
Figure 17: 2D resistivity model by Wenner method at south direction of Sukadiya stadium

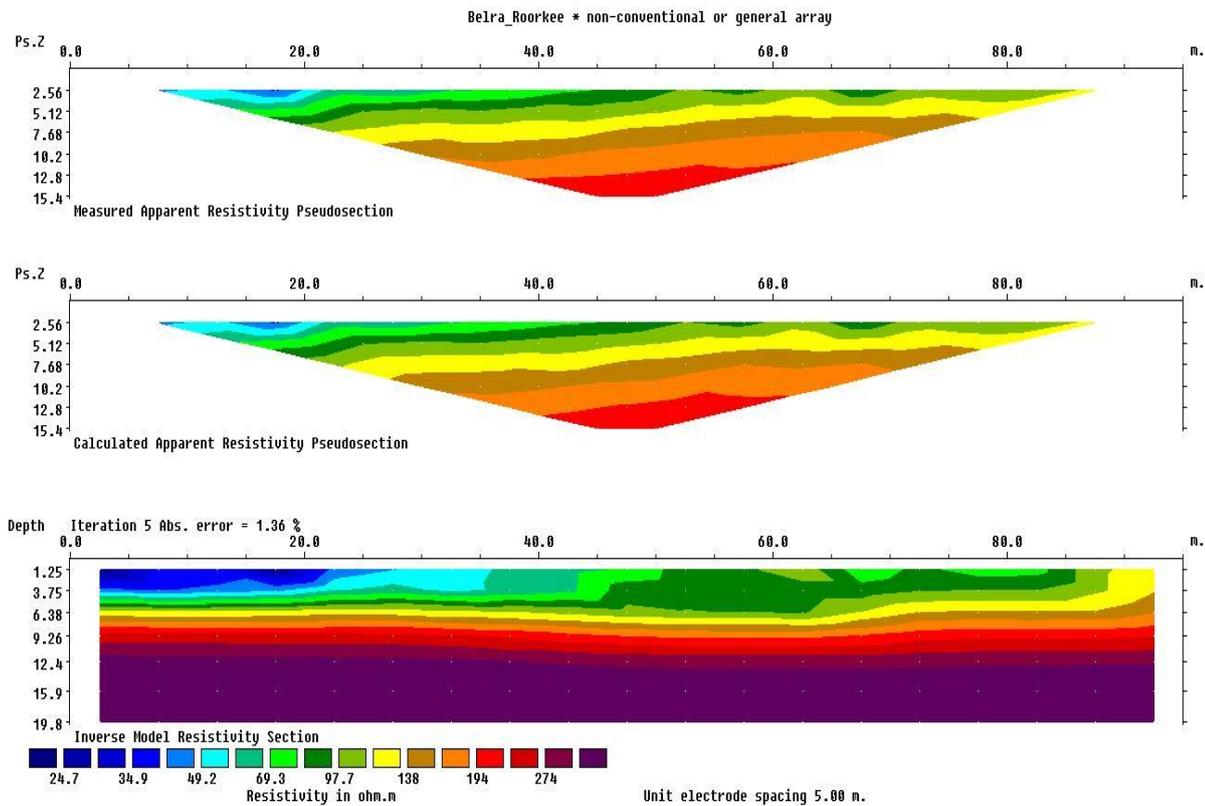
Figure 18: 2D resistivity inverse model by Wenner method near old masjid beside the pond

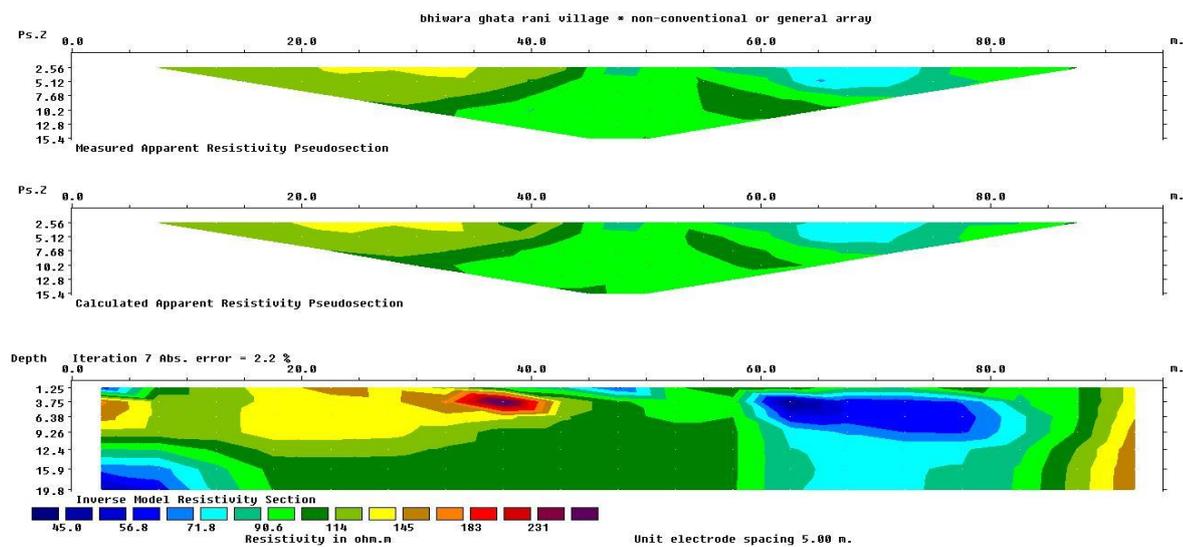
Figure 19: 2D resistivity inverse model by Wenner method near Bada Mandir

Depth of Investigation (meter)	ERT test	
	Avg. Resistivity (Ohm-m)	Probable litho log
0-5	50	Top Soil
5-10	85	Fractured Schistose
10-15	228	Weathered schist
15-20	243	Weathered schist

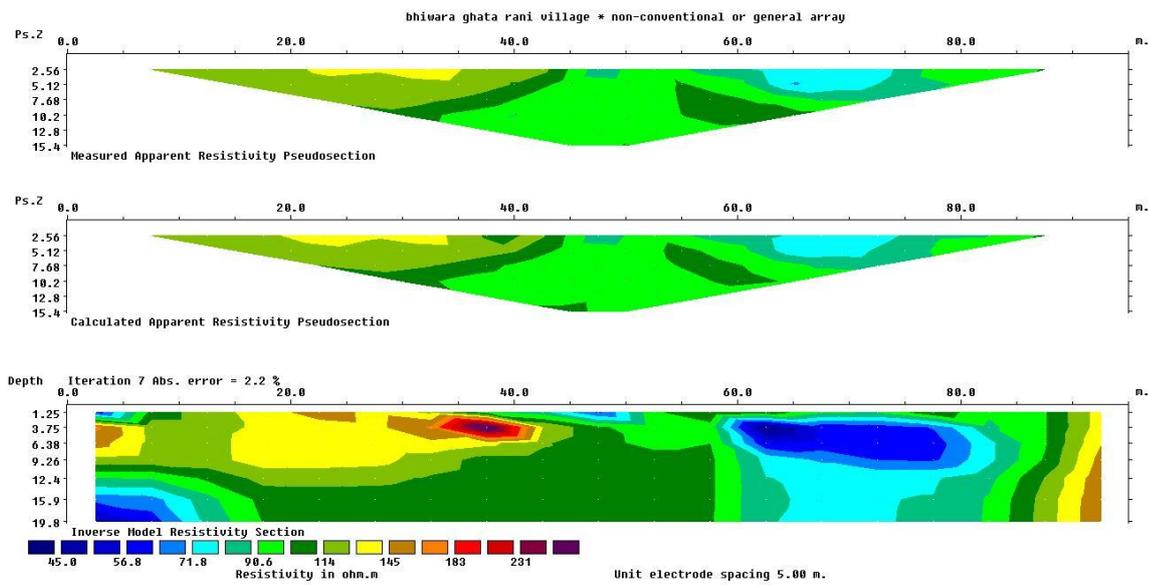
Figure 20: 2D resistivity inverse model by Wenner method near Bada Mandir.

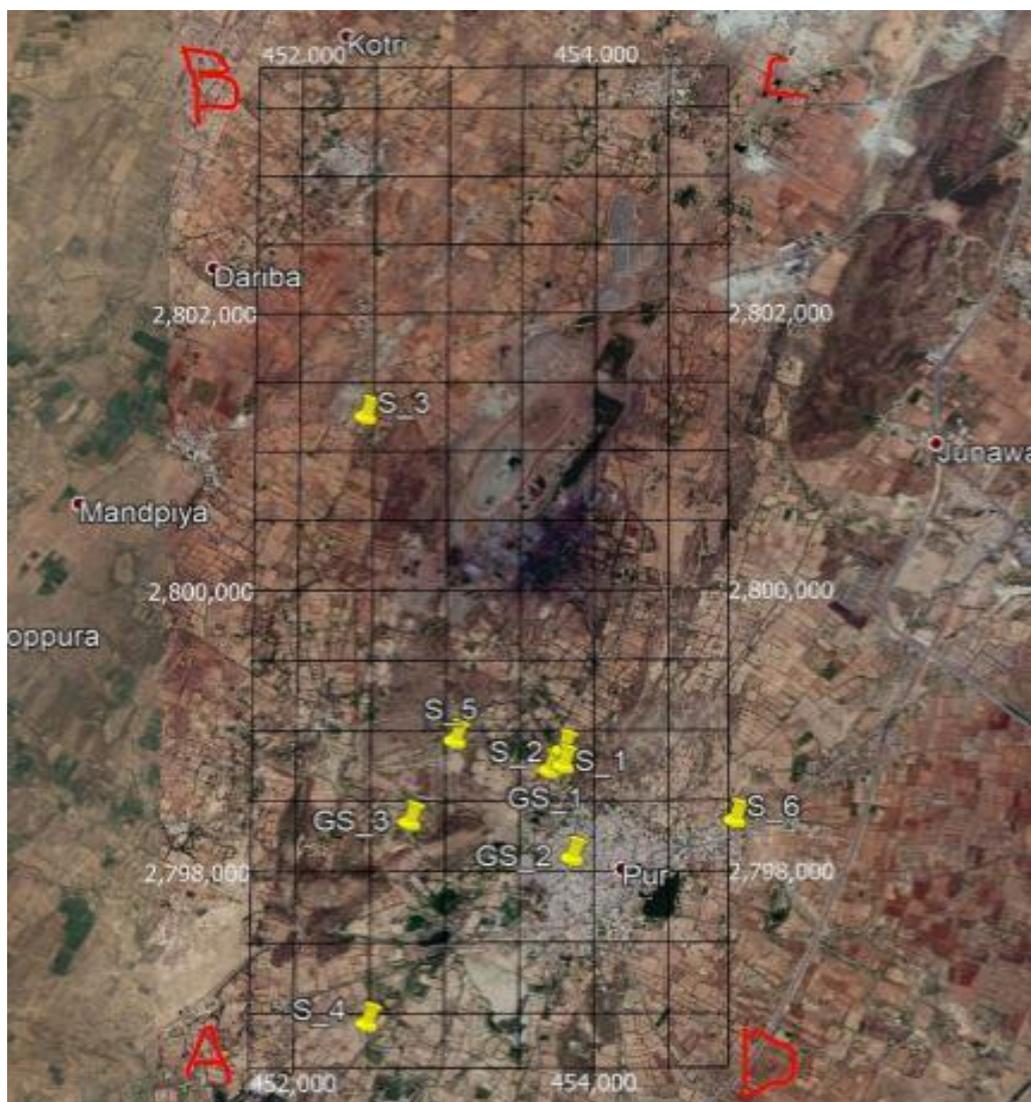
Figure 21: Google map of study area with marking for testing sites and grid ABCD used in lithological modelling.

The existing geological picture of the study area obtained by performing various VES and ERT can be understood by a professional hydro-geologist but may not be easy to conclude by others. In order to clearly explain the current geological scenario in the area, results of both these tests are clubbed together and 3-dimensional solid model, strip log diagrams, and fence diagrams are developed using ROCKWARE modelling software. The grid network used as base for 3-D lithological modelling is shown in figure 21. The problematic area i.e., in and around Pur village is situated near to edge AD of grid whereas mining site is located near the BC edge of this grid.

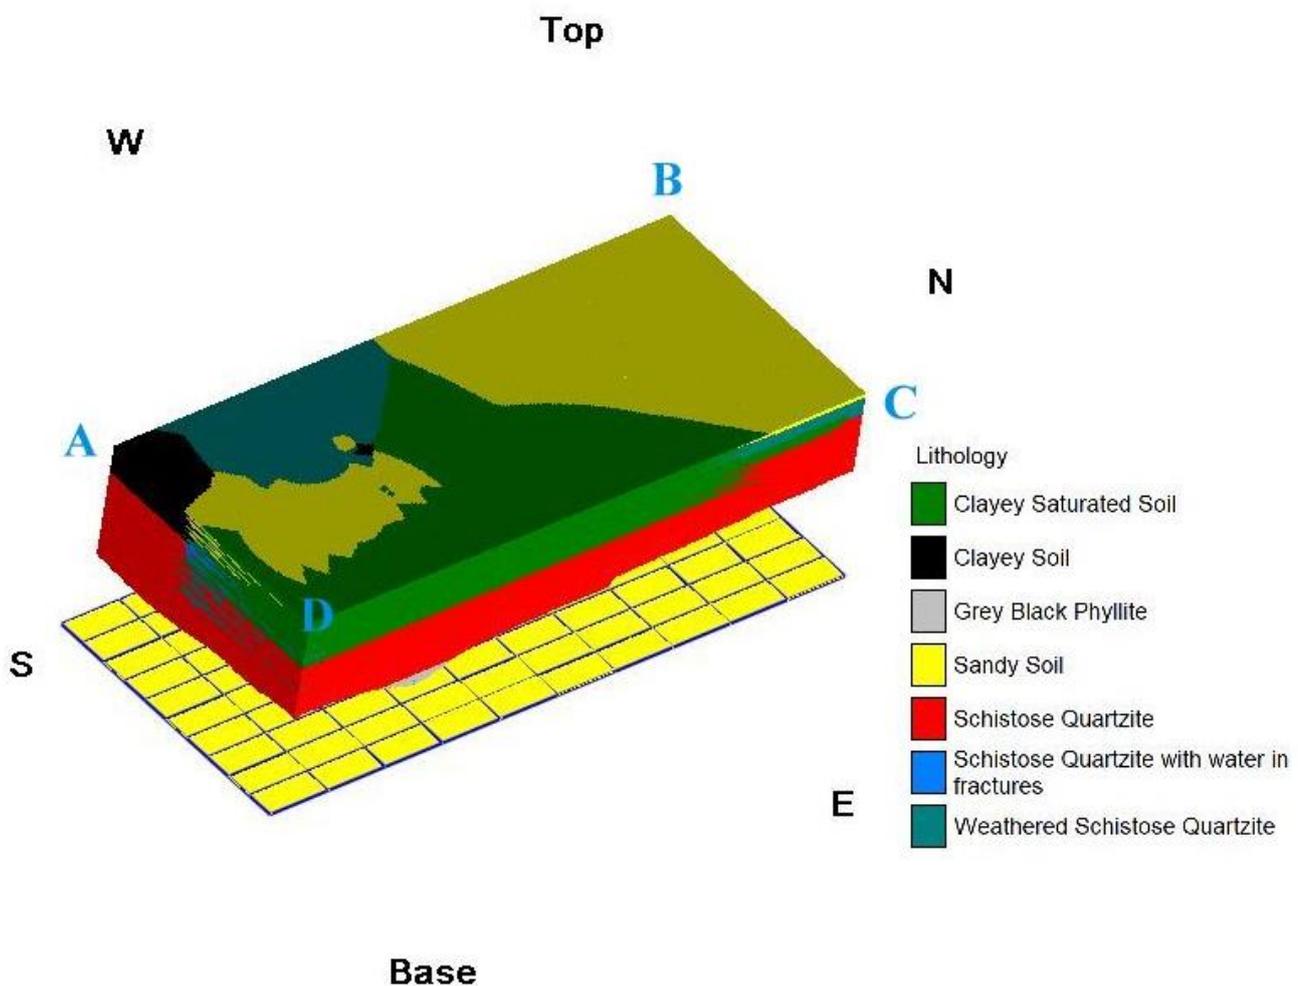
Figure 22: Three dimensional solid geological model of the study area with direction and grid marking for better understanding.

A three dimensional geological model of the study area is shown in figure 22. This model gives the overall picture of the existing subsurface conditions in the area. As single view side of this complex model seems insufficient to deliver the whole information, an animated GIF depicting this 3-D model from 360⁰ angle is also prepared with this report. This 3-D solid model is the interpolation of well lithologs obtained from different VES and ERT field tests. The strip log diagram for these well logs is also shown in figures 23 and 24 with the South-East and South-West face forward. GIF of strip log diagram is also developed.

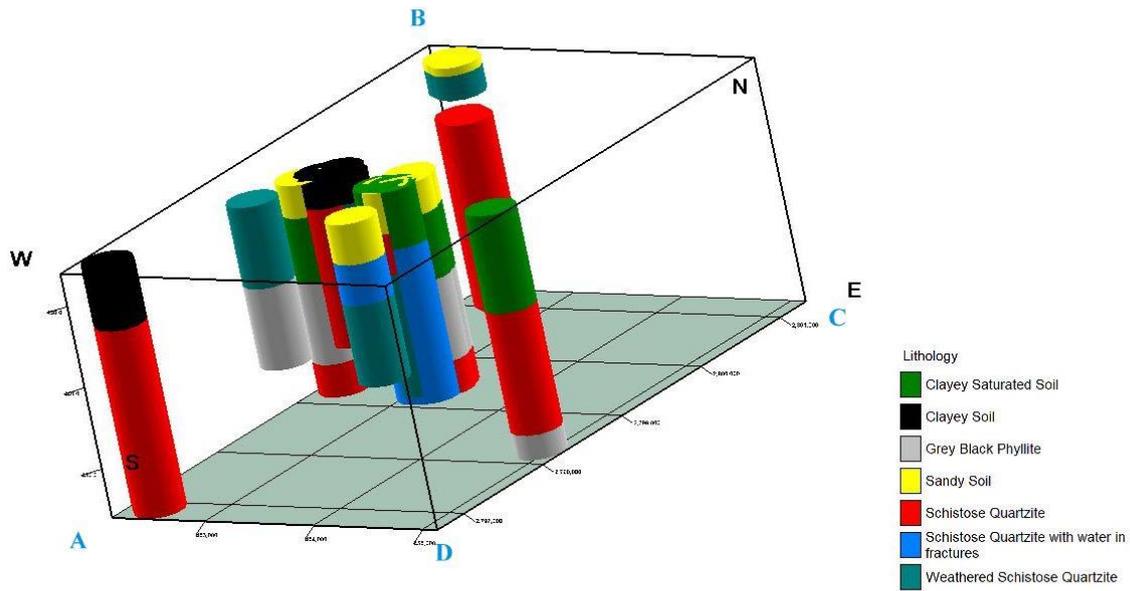
Figure 22: Three-D strip log model of the study area with South-East face forward.

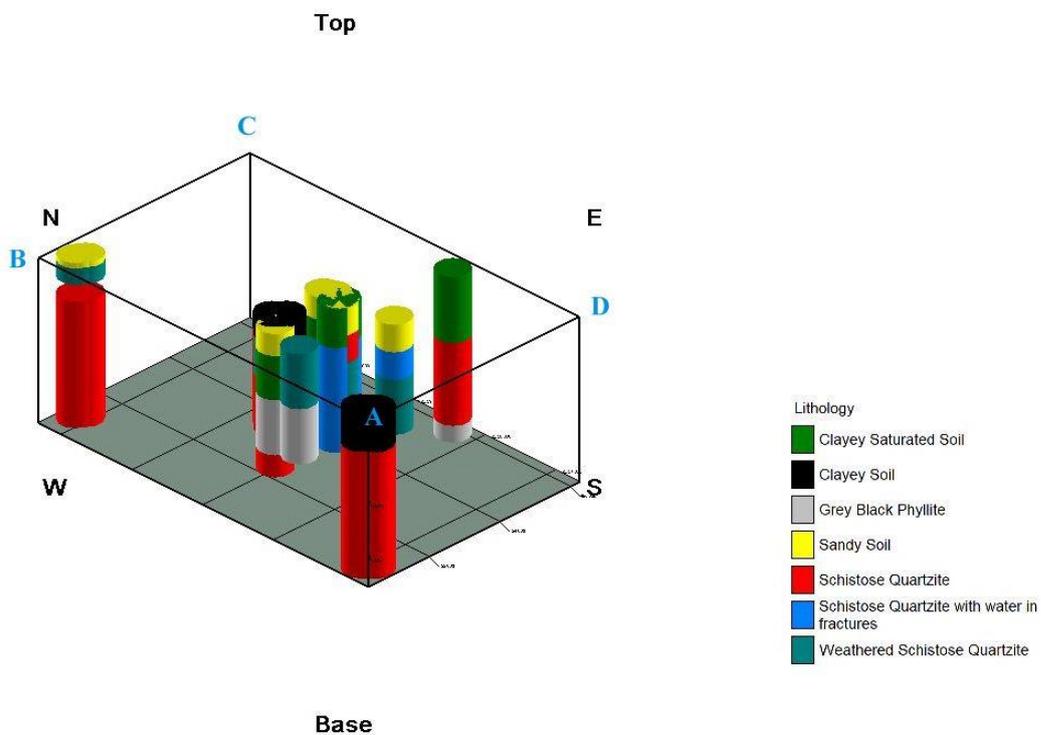
Figure 23: Three-D strip log model of the study area with South-West face forward.

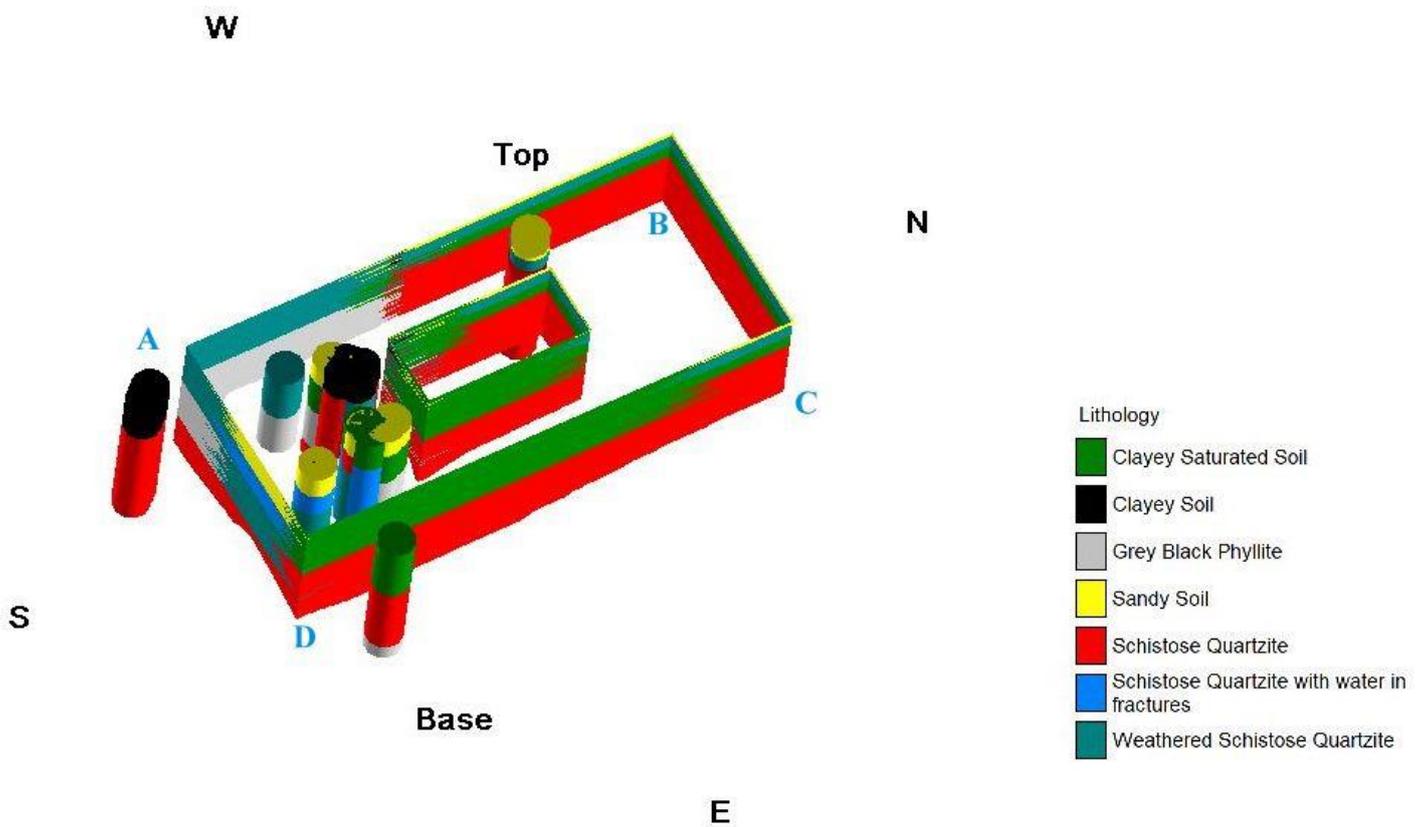
(a) Fence consisting of Collinear Rectangles

Apart from solid 3-D model and strip log diagrams, fence diagram is useful to depict the geological condition more clearly. Fence diagram refer to three or more geologic sections showing the relationship of wells to subsurface formations. The scales diminish with distance from the foreground to give a proper perspective of the whole area. Similar in some respect to a block diagram, fence diagram has the advantage of transparency, which is not possible in a block diagram. The fence diagrams for the study area are shown in figure 24 (a) and (b).
