**BEFORE THE HON'BLE NATIONAL GREEN TRIBUNAL
PRINCIPAL BENCH AT NEW DELHI**

ORIGINAL APPLICATION NO. 288/2019

**COMPLIANCE REPORT OF THE HON'BLE TRIBUNAL
ORDER DATED 19.06.2020, ON BEHALF OF
RAJASTHAN STATE POLLUTION CONTROL BOARD.**

Scientific studies on blast induced ground vibration and air overpressure and investigation on its damage potential vis-à-vis housing structures in Pur village, Bhilwara Distt., Rajasthan

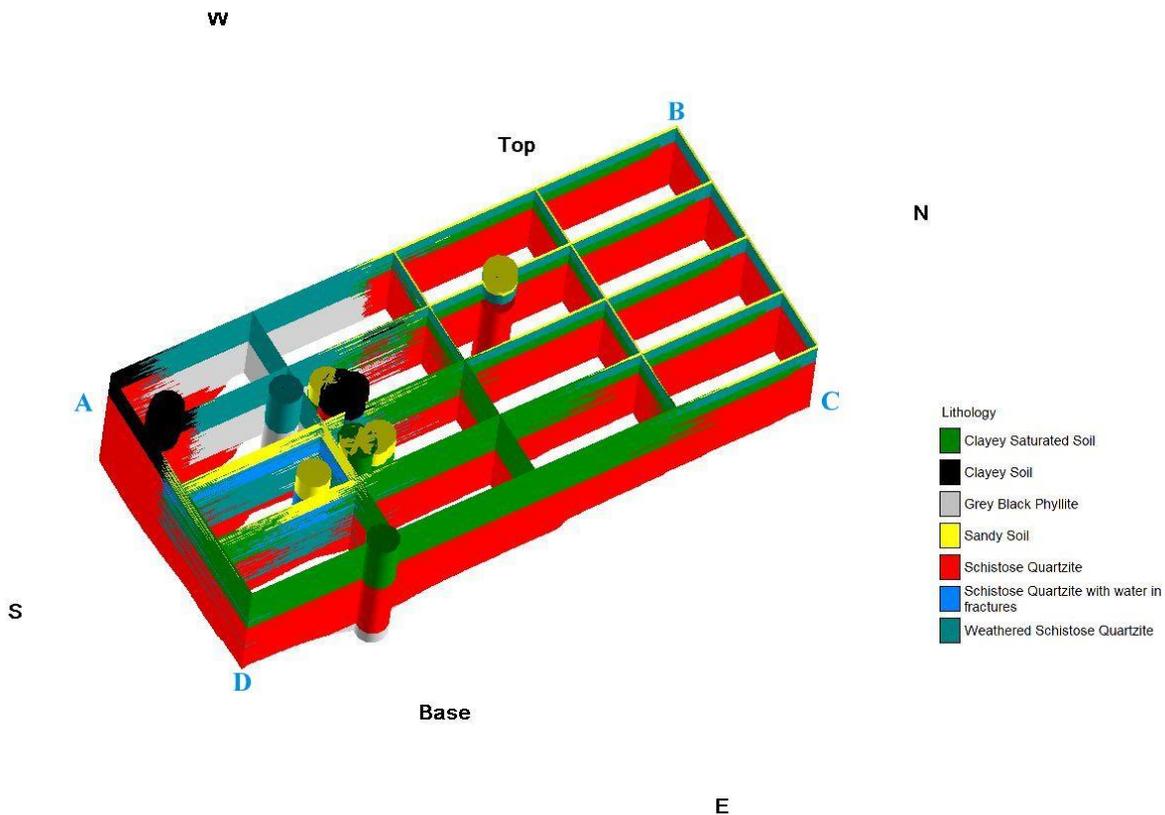
(b) Fence consisting of Collinear Grids

Apart from solid 3-D model and strip log diagrams, fence diagram is useful to depict the geological condition more clearly. Fence diagram refer to three or more geologic sections showing the relationship of wells to subsurface formations. The scales diminish with distance from the foreground to give a proper perspective of the whole area. Similar in some respect to a block diagram, fence diagram has the advantage of transparency, which is not possible in a block diagram. The fence diagrams for the study area are shown in figure 24 (a) and (b).

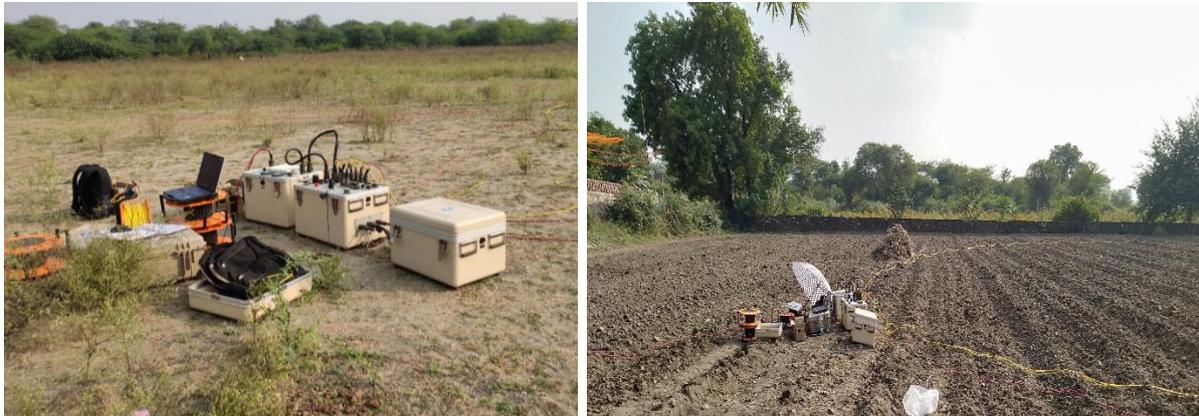
Figure 25: Field setup of ground magnetic resonance (GMR)

The GMR system directly detects the presence of soil water utilizing a phenomenon known as proton nuclear magnetic resonance (NMR). Proton NMR observed when proton spins associated with hydrogen atoms in groundwater are subjected to perturbation in the background magnetic field. In the static magnetic field, the proton spins will preferentially align in the same direction as the field and so form a small magnetic moment. The GMR system provides unambiguous detection of soil water because the measured signal is generated by hydrogen in fluids. By measuring the NMR properties of the subsurface, GMR provides quantitative images of moisture content as along with estimation of hydro-geologic parameters, including specific yield and permeability. Using GMR, it is possible to obtain detailed aquifer characterization before ever drilling a well. The field setup of GMR is shown in figure 16. GMR applications include direct detection of groundwater, non-invasive imaging of groundwater to depths of 100m (Approx.), quantitative determination of water

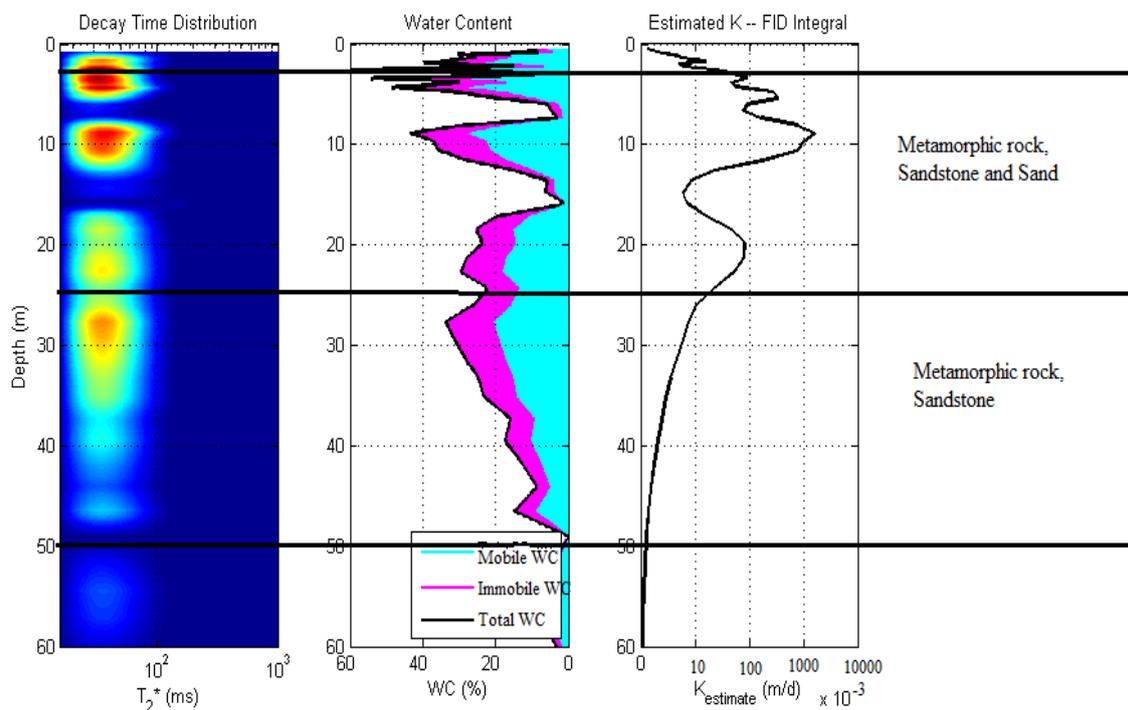
Figure 26. Distribution of water content, hydraulic conductivity and soil strata at site of Sukhadia stadium at Pur-Village

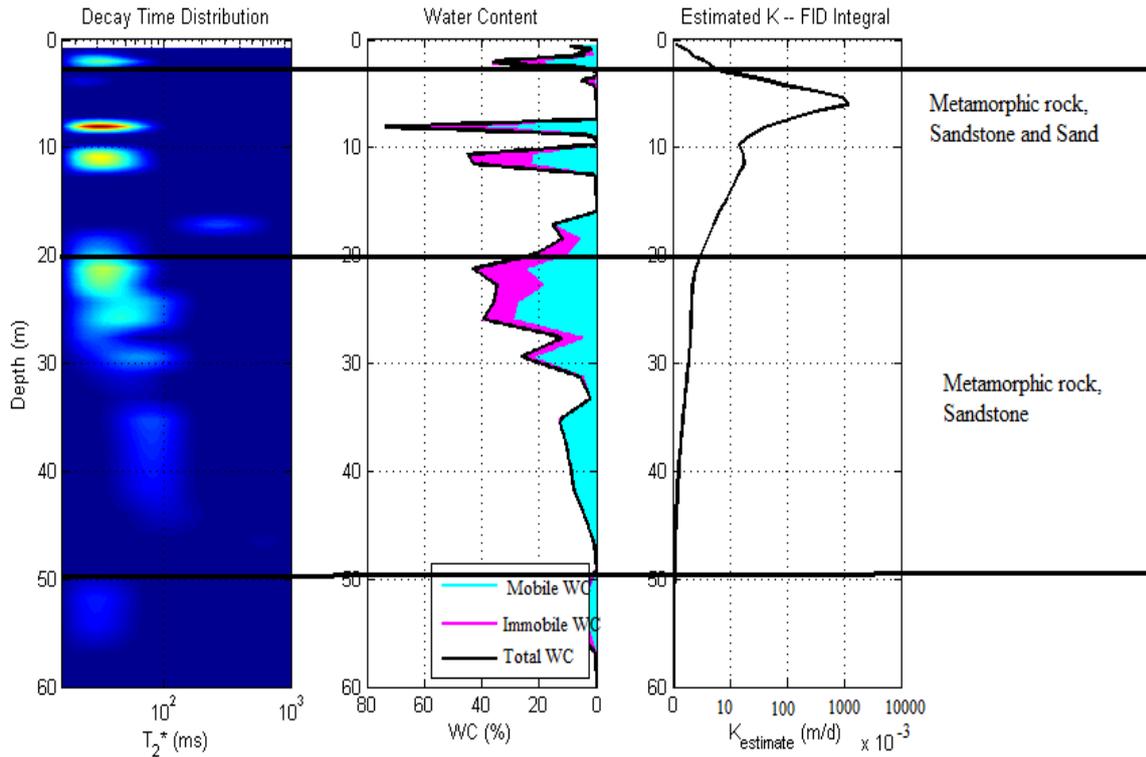
Figure 27. Distribution of water content, hydraulic conductivity and soil strata at site of Moldyka Shyam at Pur-Village

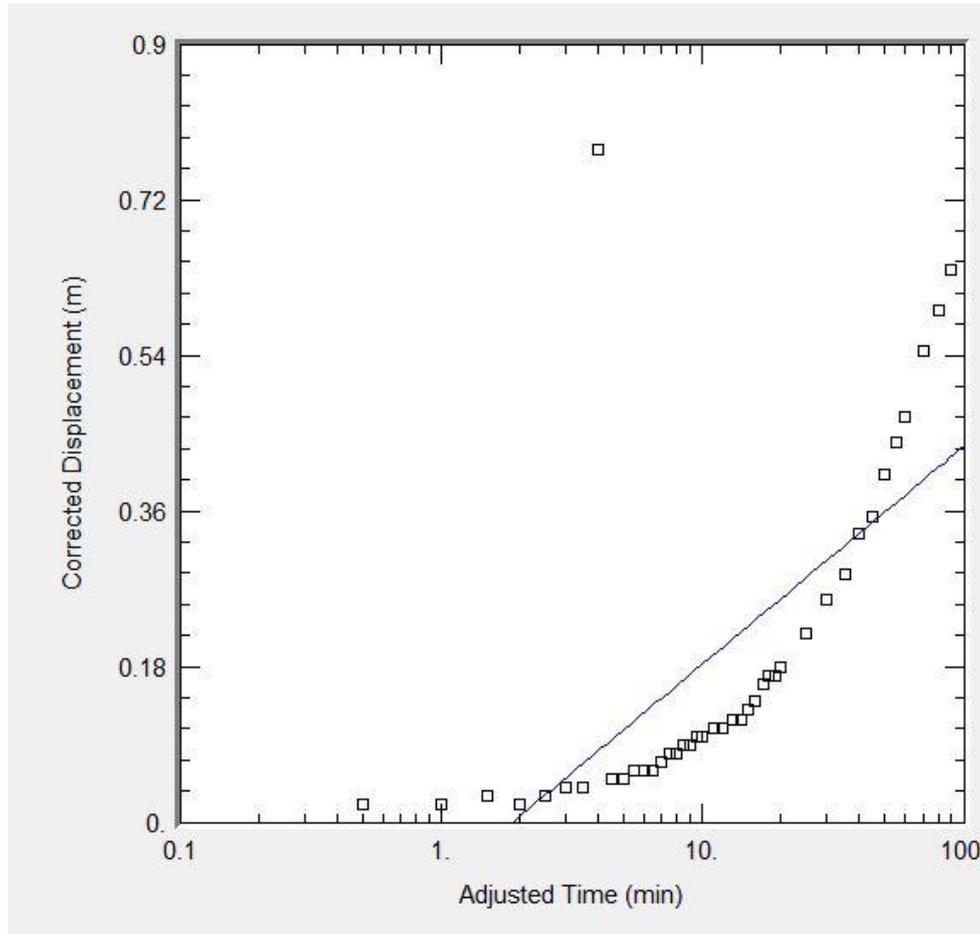
Figure 28: Data curve obtained after plotting the corrected drawdown recorded in the observation well against adjusted time since pumping start.

test is shown in figure 28. This Data Curve is then matched with the Theis type curve with the help of software AQTESOLV 4.5. Transmissivity (T) and Storativity (S) of the aquifer system is calculated using Cooper Jacob equation and were found as 501.90 m²/day and 3.00% respectively. A plot of residual drawdown s' vs. $\log(t/t')$ is plotted (figure 29) and slope of best fit straight line is obtained (figure 10) as, $\Delta s = 0.2554$ from which,

$$T = \frac{2.303Q}{4\pi\Delta s} = 499.96 \text{ m}^2/\text{day}$$

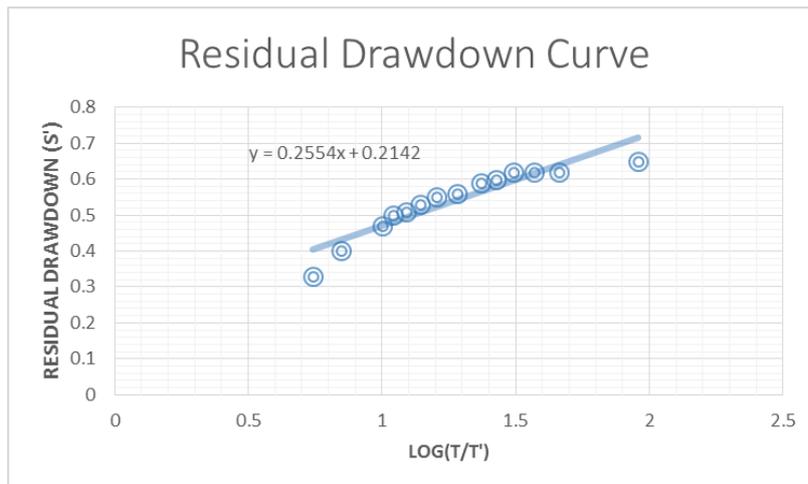
Figure 29: Recovery test plot of the observation well obtained after plotting the residual drawdown per log cycle of time.

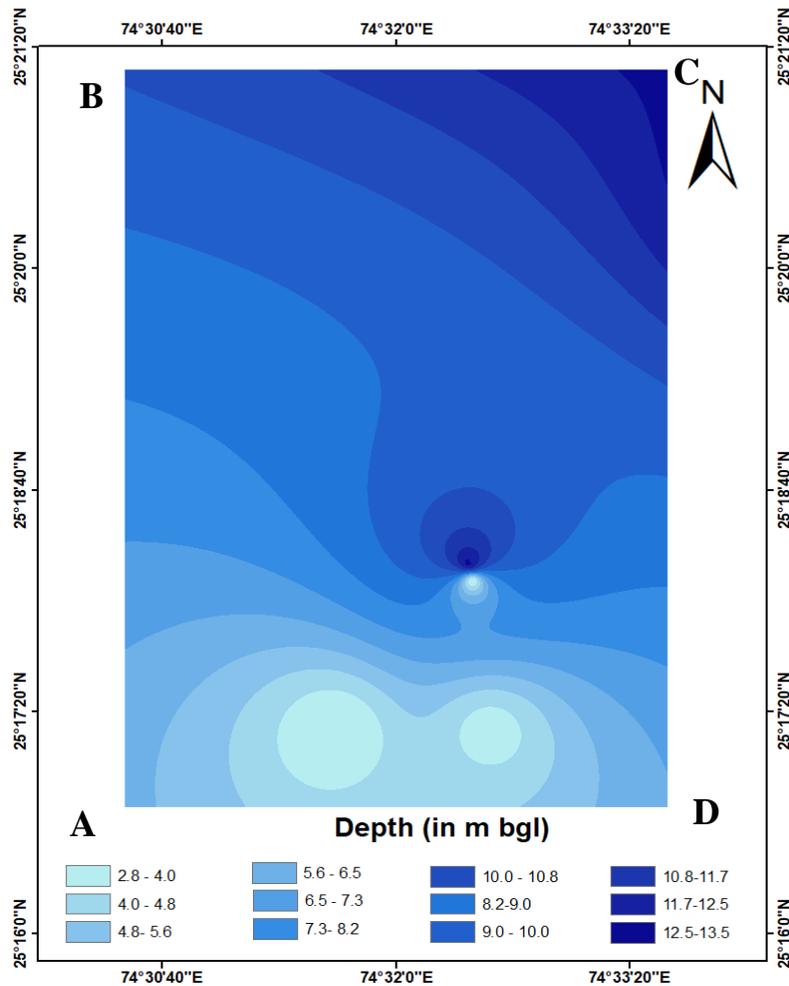
Figure 30: Variation of Groundwater table (Hydraulic head) in and around the study area with grid mark ABCD for better understanding.
