**ORIGINAL APPLICATION NO. 418 OF 2025**

**Submission by Applicant**

## Flash Flood Damage Assessment at Dharali, Uttarkashi: 05 August, 2025

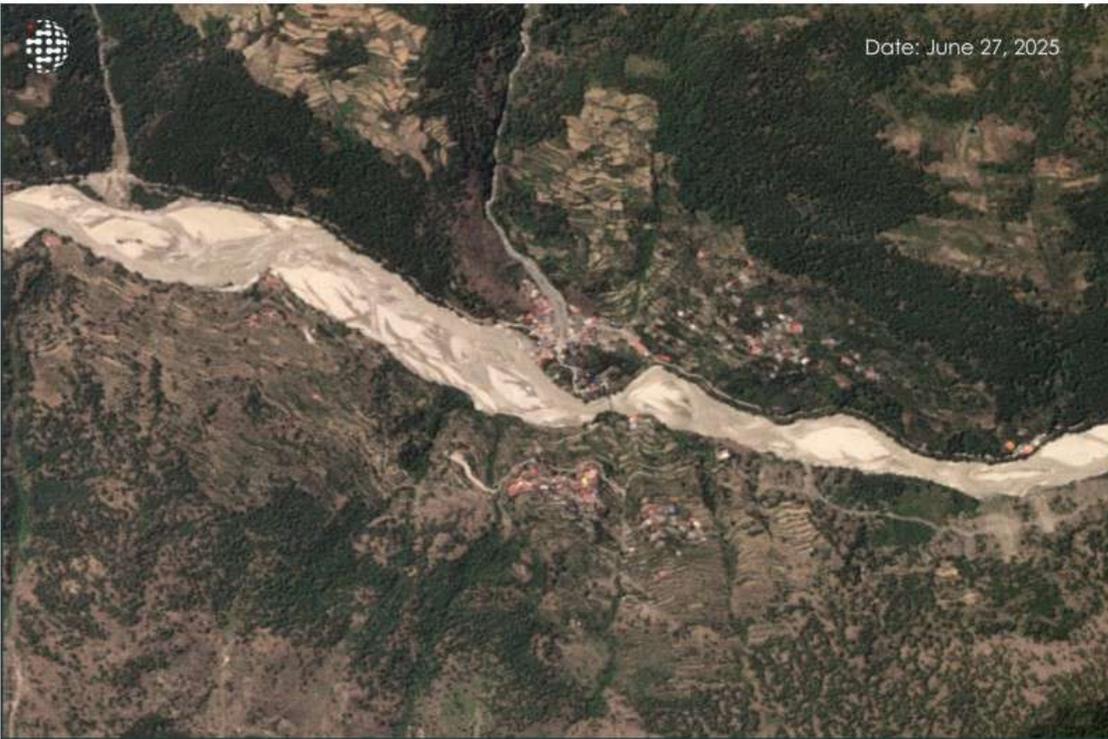
Image before the devastating flash flood at Dharali

(PlanetScope - 3m)

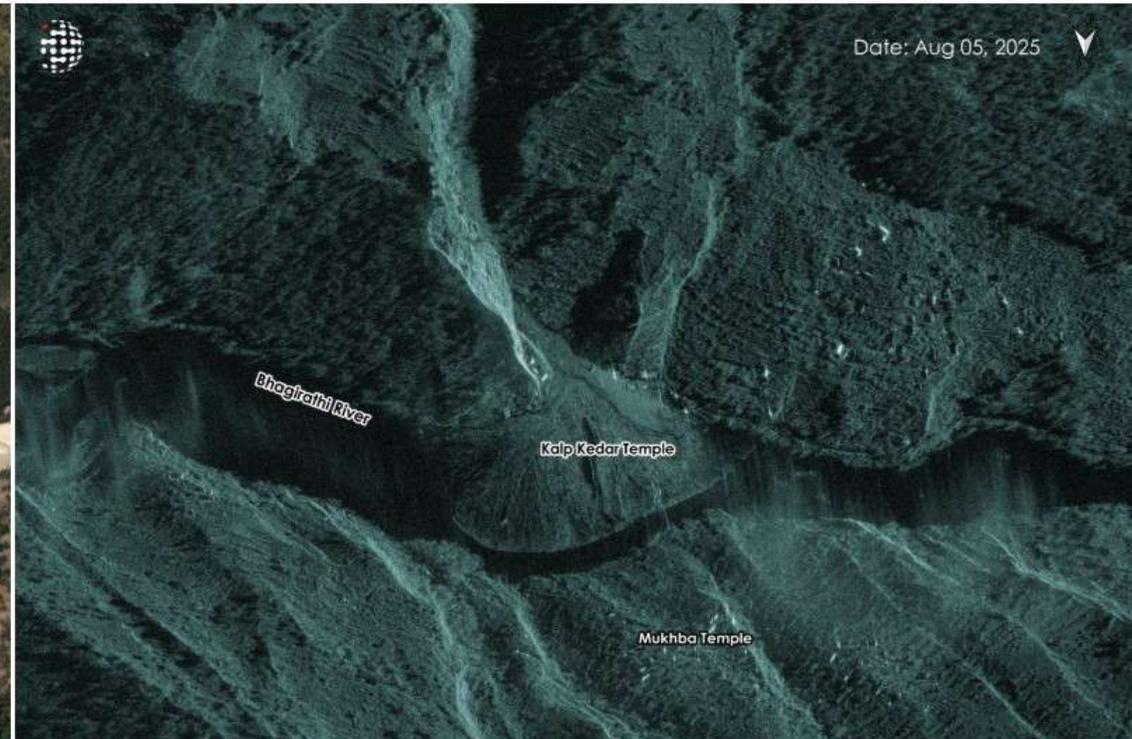
Post Flash Flood Image at Dharali, Uttarkashi

(ICEYE - 1m)

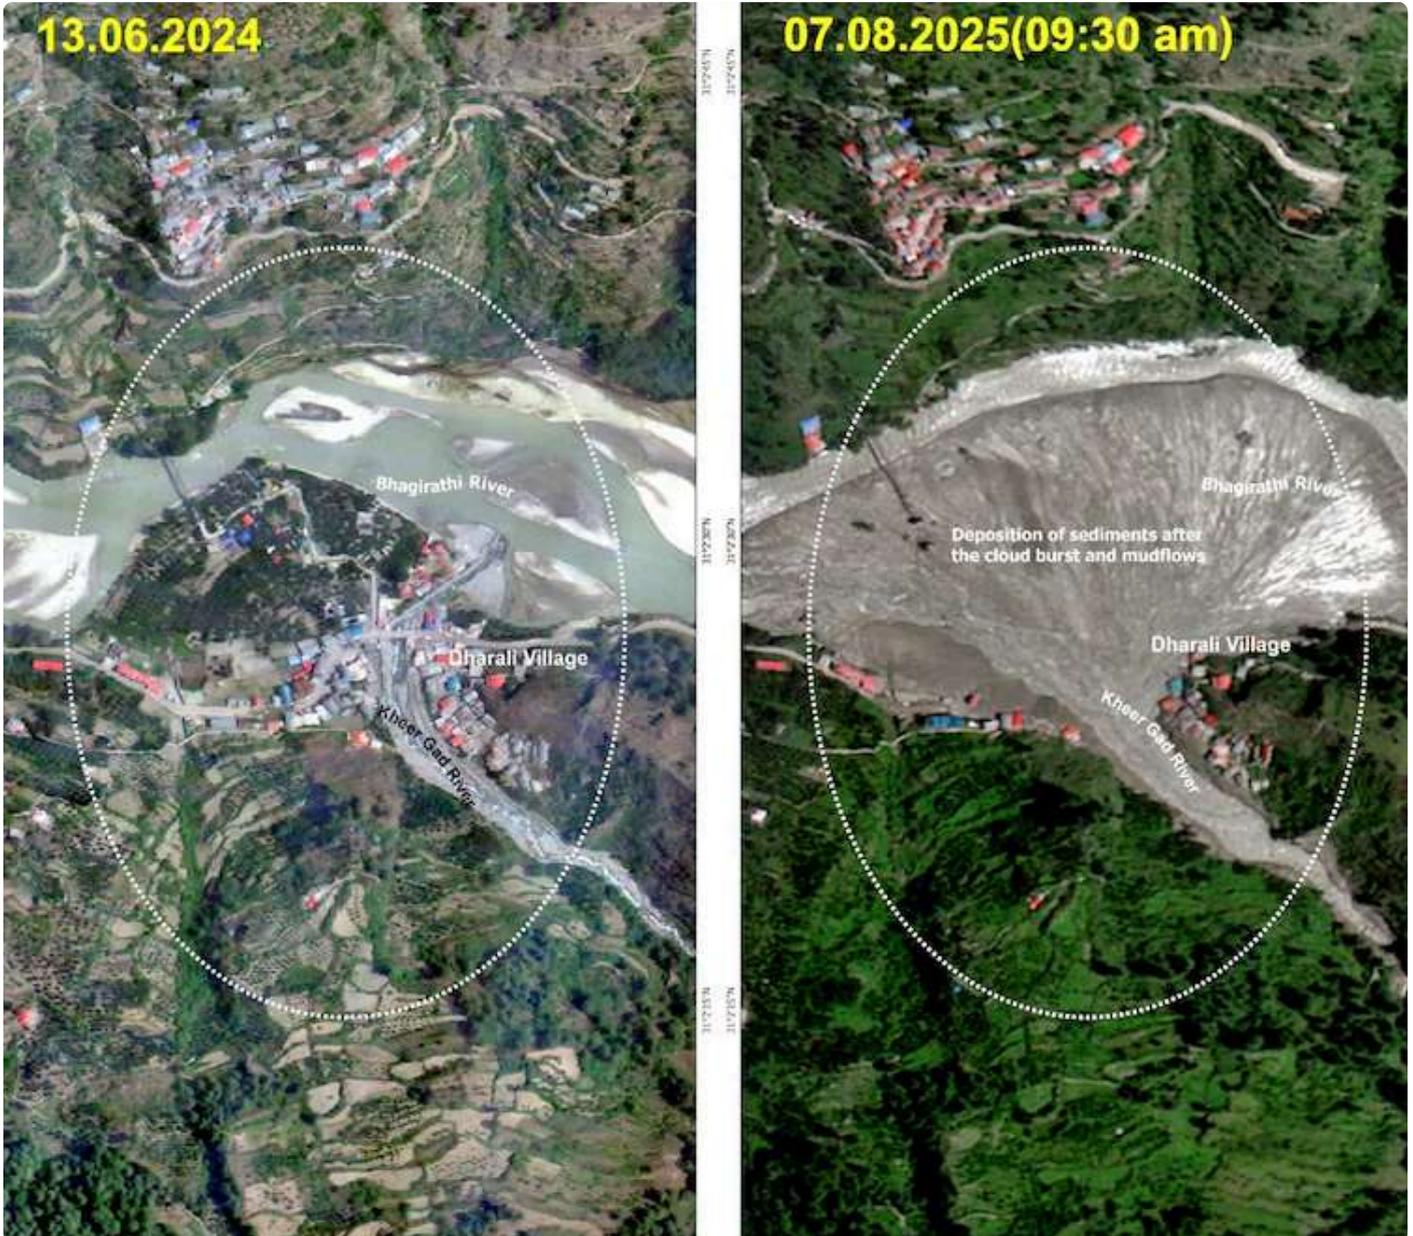
Before and after pictures of Dharali village show how the riverbed was encroached that led to massive destruction. (Photo: Isro)

While mountainous regions often face natural hazards such as cloudbursts, glacier lake outburst floods (GLOFs), and monsoonal mudflows, he emphasised that the scale of destruction seen in Dharali was amplified due to human intervention in the river's natural course.

The width needed for the mudflow to pass was missing due to construction in and [around it, which worsened the disaster.](#)

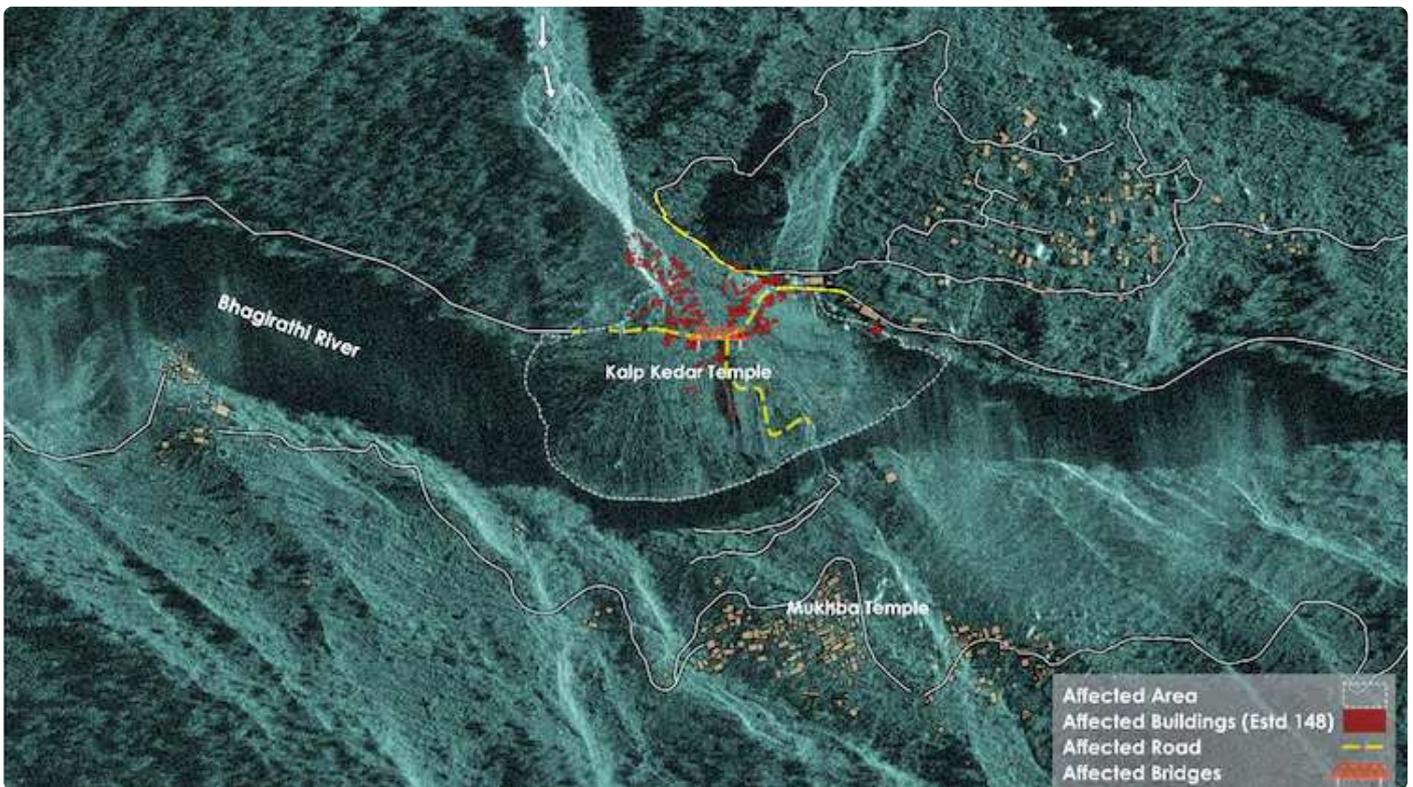
Flash flood damage assessment map. (Photo: Suhora Technologies)

The data, captured at 11:01 PM on August 5, [showed approximately 148 buildings damaged](#) and an area of about 16 hectares affected. The imaging also highlighted damage to critical infrastructure, including one bridge and nearly 0.95 km of roadway, leading to significant disruptions in connectivity and emergency response.
