IN THE NATIONAL GREEN TRIBUNAL, EASTERN ZONE ENCH

ORIGINAL APPLICATION NO. 26 OF 2023

A. WHETHER RESPONDENT NO. 3 HAS DULY MANAGED THE MUCK DISPOSAL AND PREVENTED ENVIRONMENTAL DEGRADATION?

PHOTOS SHOWING VIOLATION OF MUCK DISPOSAL PLAN BY NHIDCL IN NH-54 ROAD (PACKAGE-2)

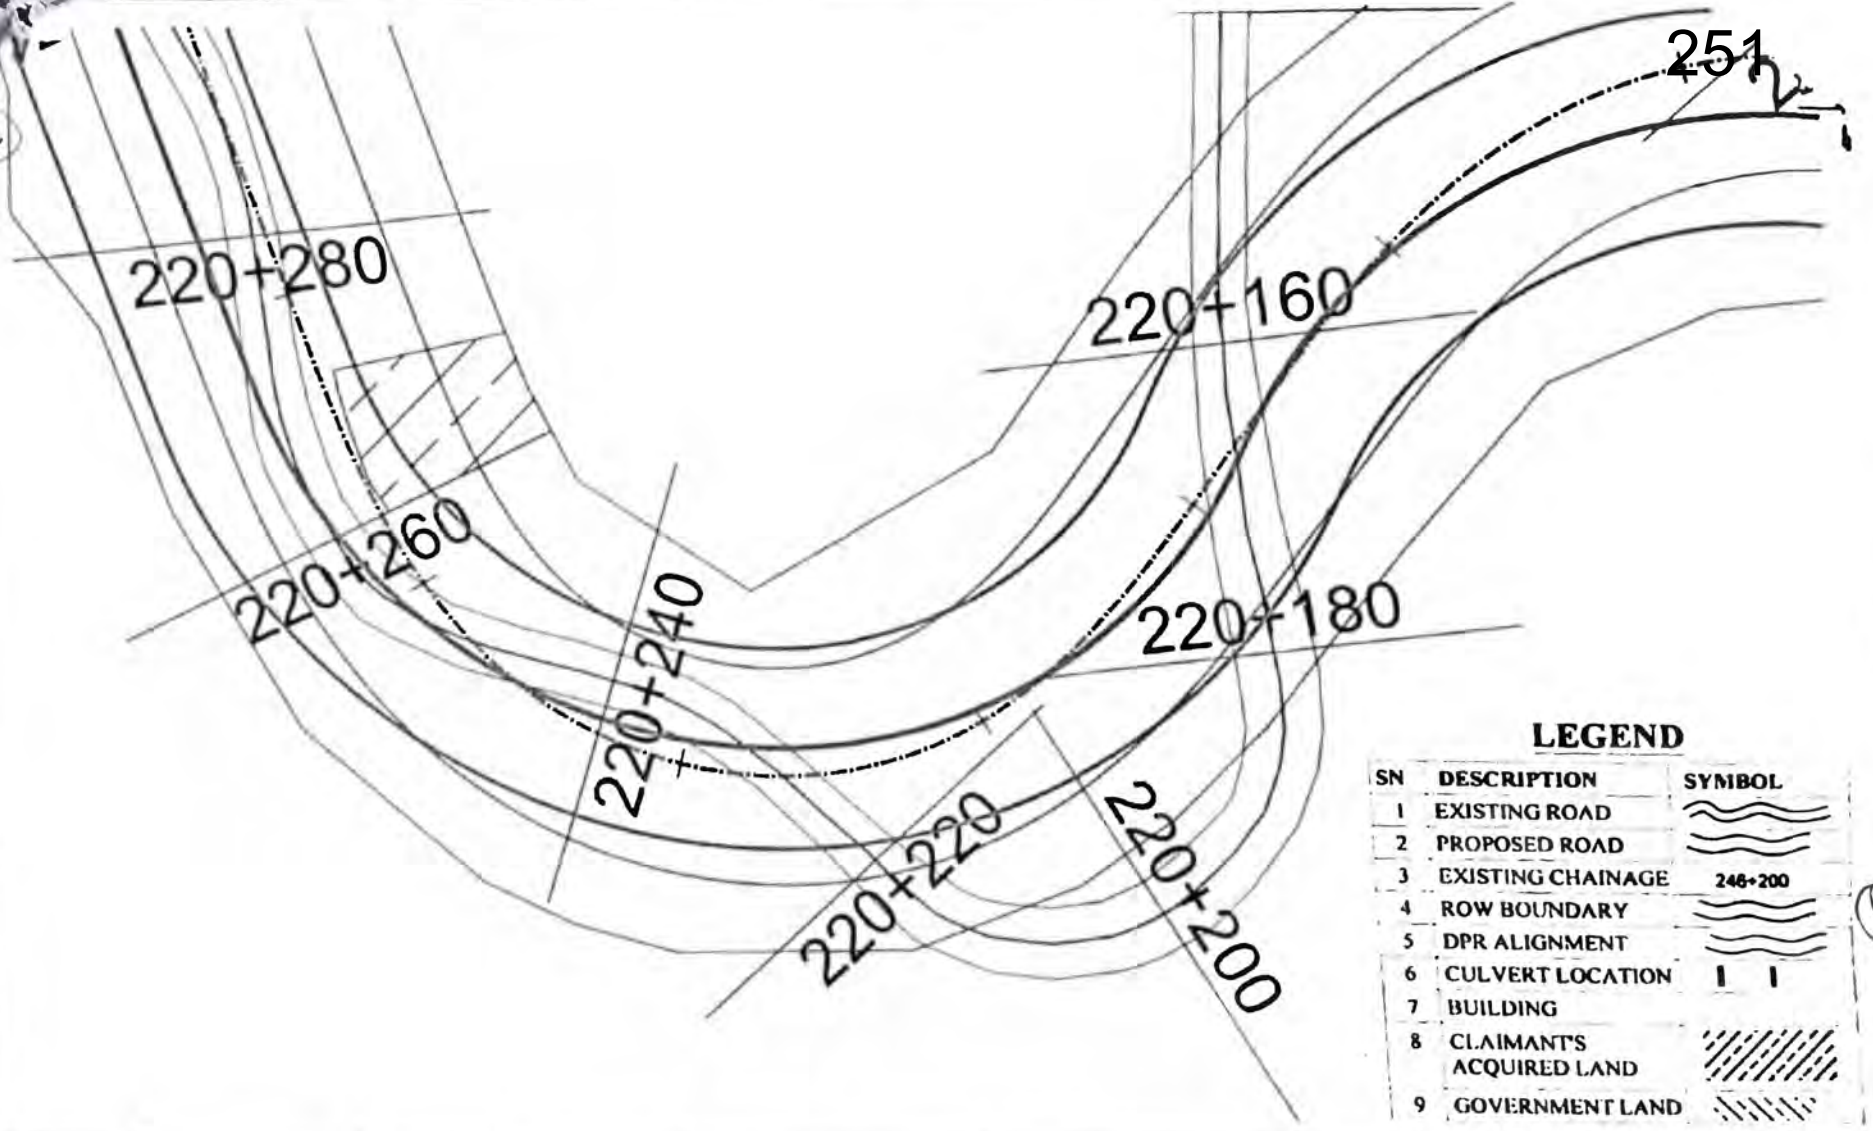
Sr. No.	Name	Village	Chainage		Reason of complaint	Finding of Verification Team	Action Taken/ Action to be taken
10	Thangmawii C/o Ralliantawna	Thualthu	240+620	240+810	His complaint is that due to disposal of muck and waste beyond ROW damage his additional assets.	This has been verified on the site and surveyor's report states that due to heavy muck and waste have been disposal on his land beyond ROW results to additional damage of trees and crops.	1. We have verified at site with in the given stretch. 2. No muck and waste was found out of ROW. 3. The complaint is already compensated with Rs. 482537/- through CALA for NHIDCL, which is much more than the actual damage. 4. The verification report is at an early stage. 5. The location map is attached for reference. 6. Therefore complaint may be closed.
11	ZD Lalfinpuia	Thualthu	238+330	238+480	His complaint is that his land was safe and was not compensated for his land. But contractor had cut off his land without his consent.	This has been verified on the site and Surveyor's report states that contractors had cut off his land beyond ROW. It had been already verified, but after verification already done, landslide had occurred on his due to NH-54 construction resulting to damage of additional trees and	1. Pu Lalfinpuia's land is claimed from Km 238+330 to Km 238+480 on LHS 2. We have verified that his land falls within ROW. 3. Location map is attached for reference. **4. His land needs to be acquired by CALA Land & Renenue department on behalf NHIDCL.**

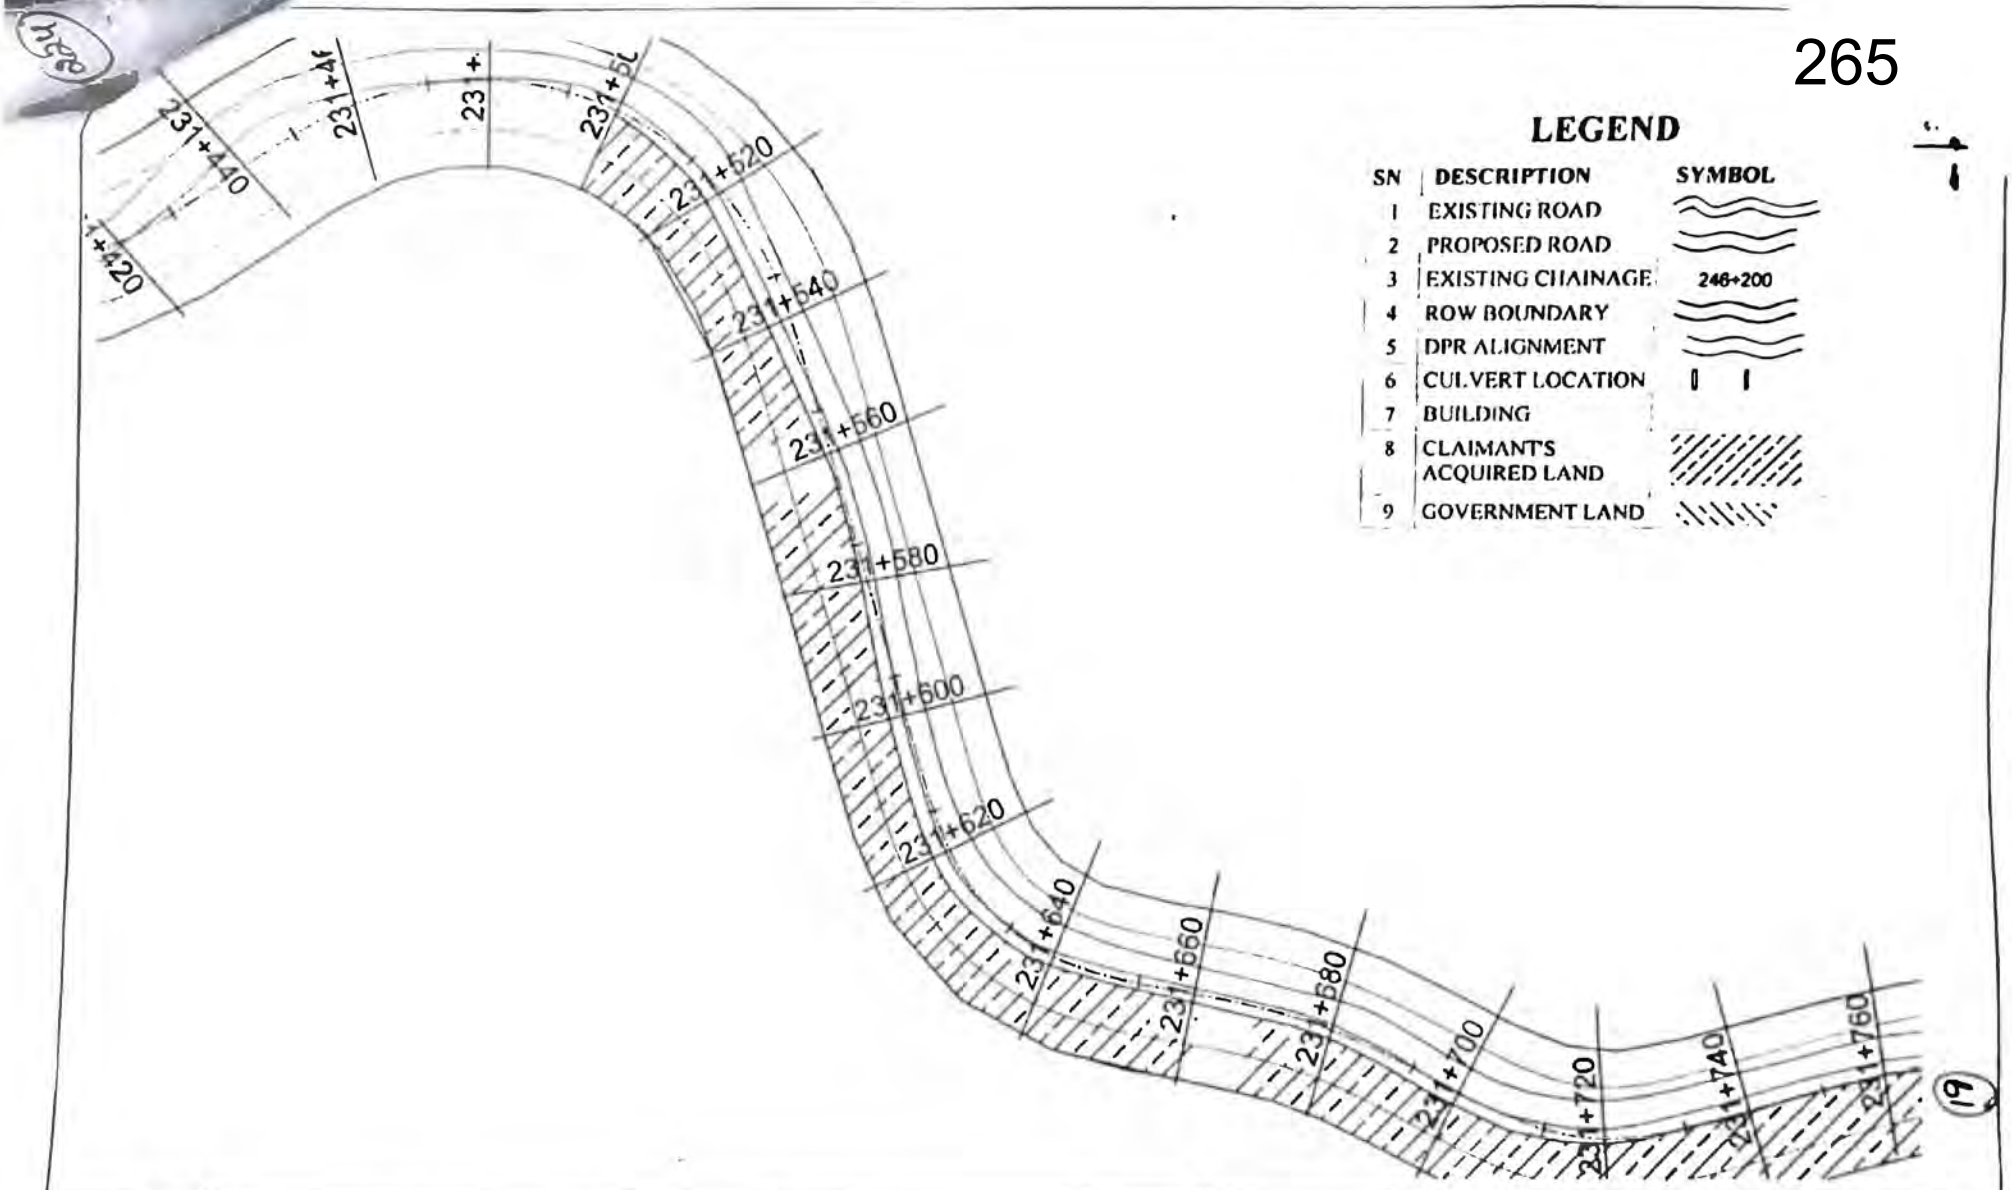
NHIDCL BUILDING INFRASTRUCTURE - BUILDING THE NATION	JICA JAPAN INTERNATIONAL COOPERATION AGENCY	TPF - RODIC (JV) in association with Anandjiwala Infra Advisory	ABCI Infrastructures Pvt. Ltd Club Road Silchar - 788001	AIZAWL-TUIPANG NH-54, PKG-5 (KM 208+00 TO 250+00)	LOCATION PLAN 231+500-231+680

SN	Name	Village	Compensation Amount	Reason of Complaint	Findings of Verification Team	Action Taken /Action to be taken
13	Rohlupuia	Bualte	116000	Pu Rohlupuia lodged a complaint stating that heavy muck and waste have been disposed on his land without his consent which results to damaged of his assets (tanky,crops etc.)	This has been verified on the site and Surveyor's report states that his land situated beyond ROW (Right of Way) and due to heavy muck and waste has been disposed on K. Tlangliansanga's site ;lots of trees and crops have been damaged.	1. Pu Rokhara's land is part of ROW from 233+249 to 233+320 (RHS) 2. This part of the land is acquired for developemnt of Highway with filling., Location map attached for reference. 3. We have worked with in ROW and still we have 7 to 8m wide ROW outside the formation of Highway. 4. The findings of verification team are at early stage. 5. Therefore the complaint may be closed.

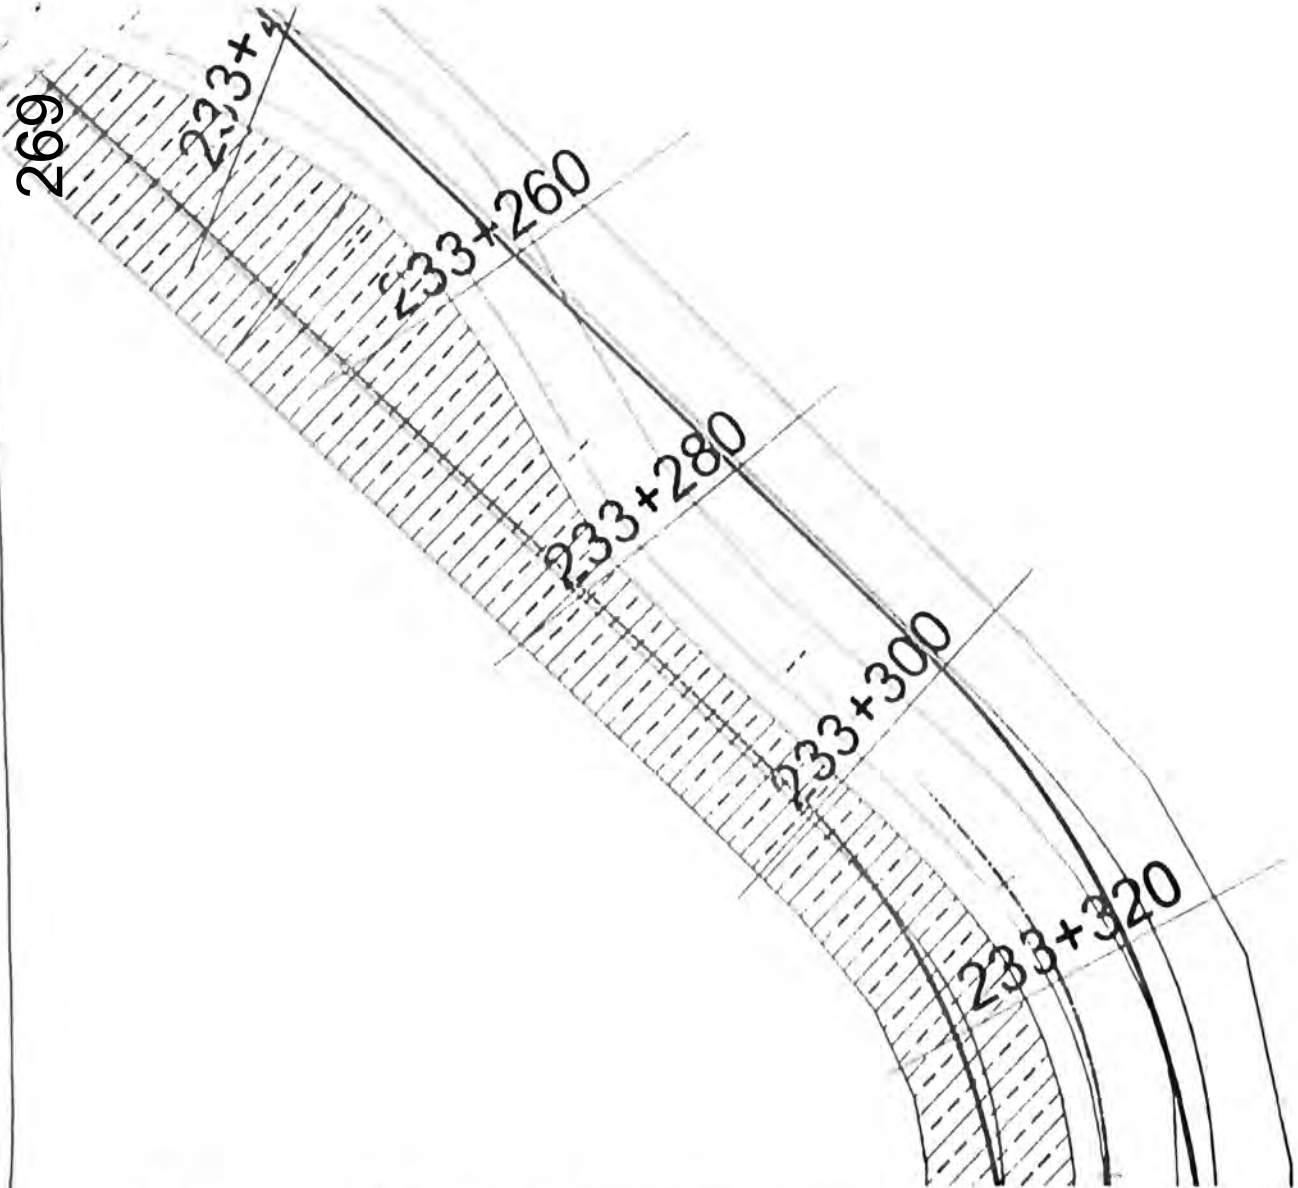
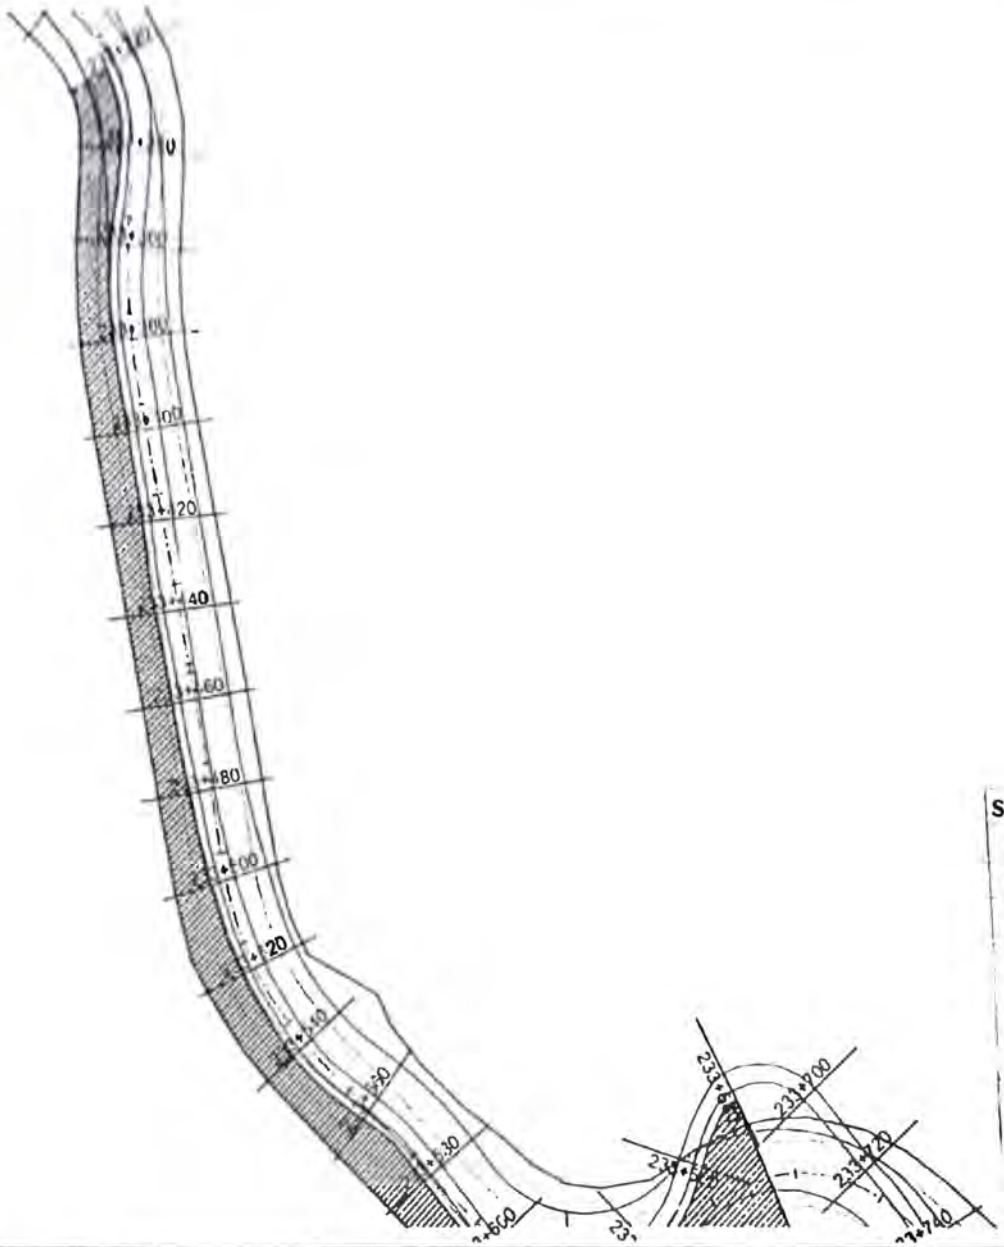
SN	Name	Village	Compensation Amount	Reason of Complaint	Findings of Verification Team	Action Taken /Action to be taken
4	Agriculture Dept (Additional)	Bualte	1114503.85	Their complaint is that due to heavy disposal of much and waste beyond ROW (Right of Way), their additional assets was damaged .	This has been verified on the site and surveyor's report state that due to heavy muck and waste being disposed on their lands affected damage of their crops on Agriculture Dept.'s site	1. The land of Agriculture Departemnt wasacquired from Km 233+330 to 233+570.

2. The road construction line in the portion was limited to Shoulder line of existing road. Location map attached for reference.
						3. The Agriculture Departemnt is already compensated for Rs.1114504/- against **0.0 %** actual damage to the trees and assets of department.

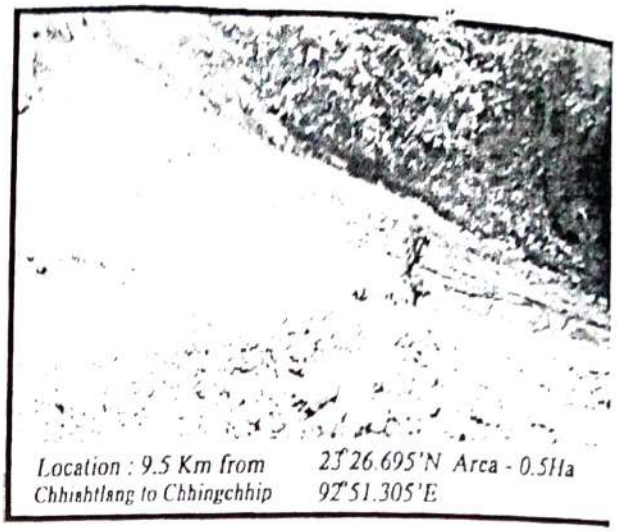
Location-2:

Location : 9.5 Km from Chhiahtlang to Chhingchhip — 23°26.695'N 92°51.305'E Area - 0.5Ha

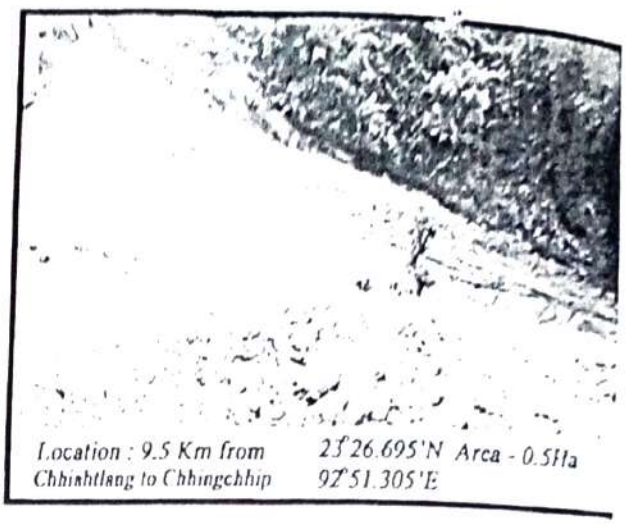
Location-2:

Location : 9.5 Km from Chhiahtlang to Chhingchhip — 23°26.695'N 92°51.305'E Area - 0.5Ha

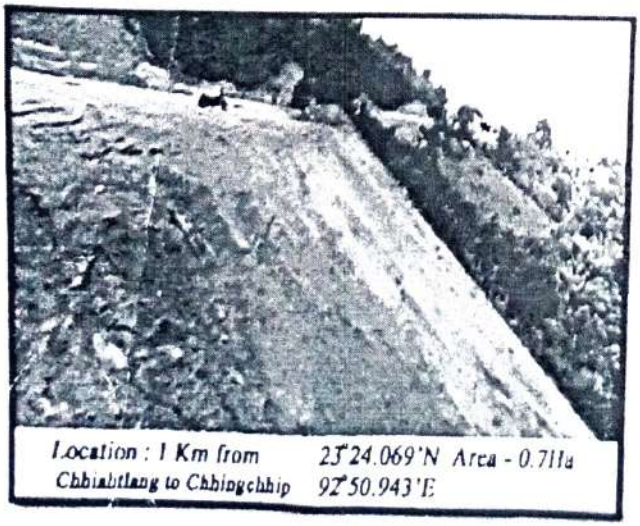
Location-5:

Location : 1 Km from Chhiahtlang to Chhingchhip — 23°24.069'N 92°50.943'E Area - 0.7Ha

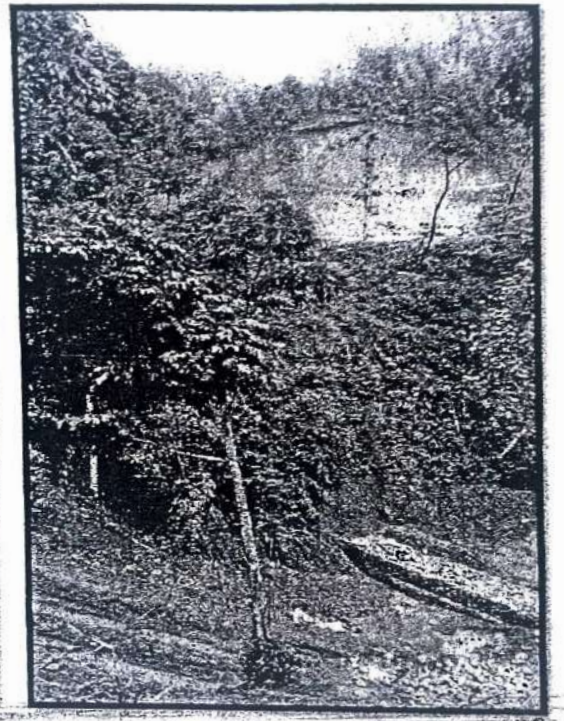
Location-1:

PHOTOS SHOWING VIOLATION OF MUCK DISPOSAL PLAN BY NHIDCL IN NH-54 ROAD (PACKAGE-3)

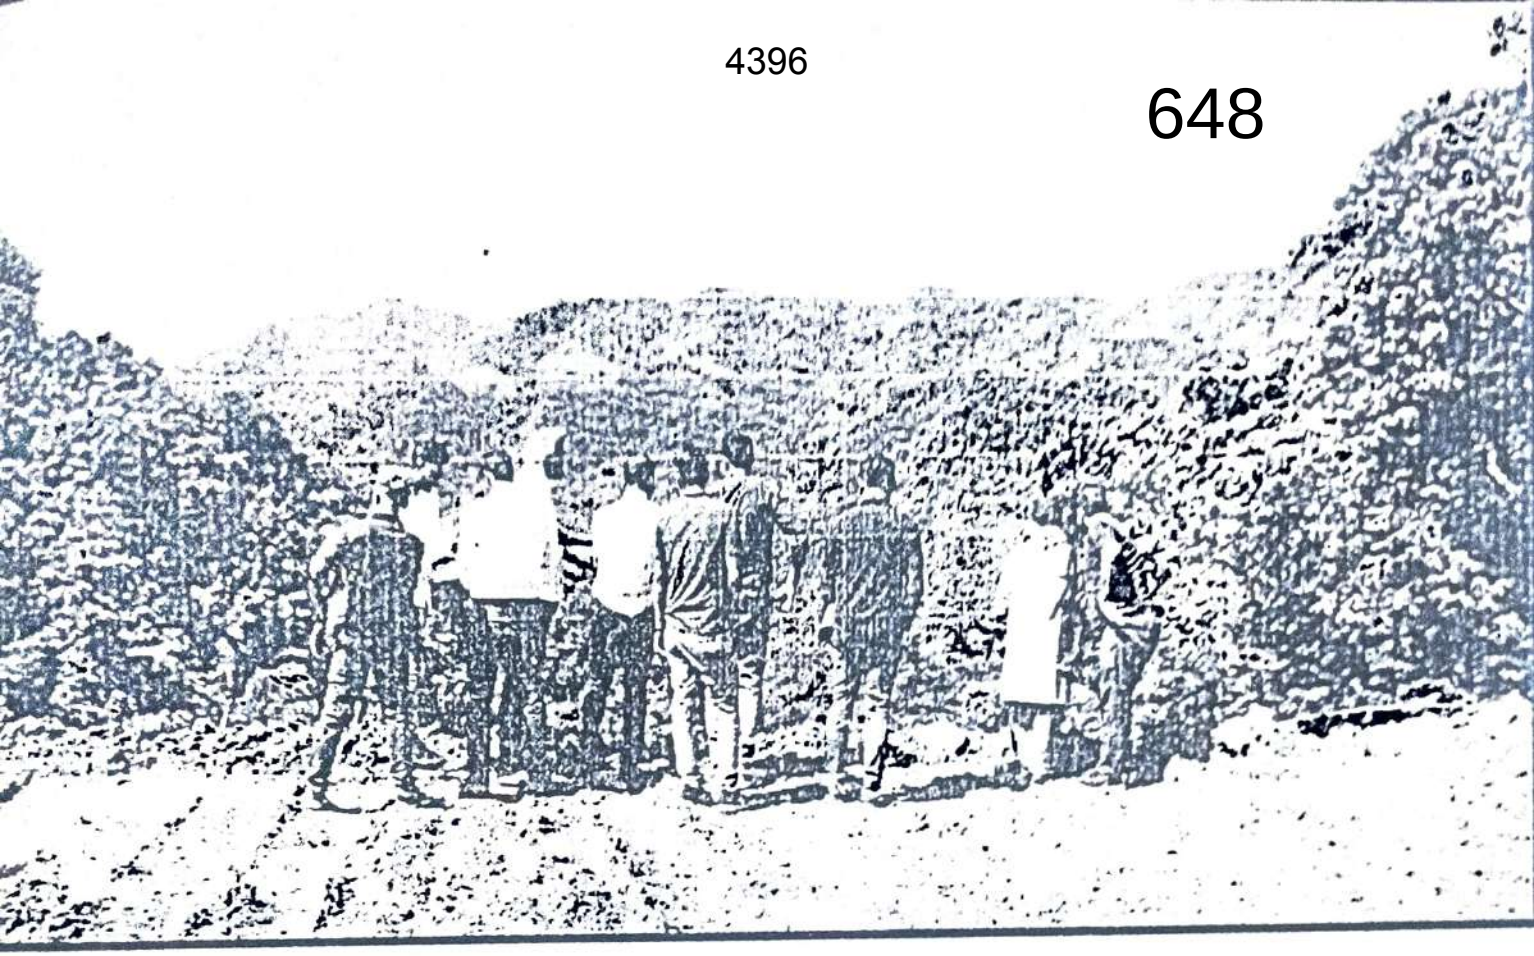
2. A meeting will be called to try and resolve issue due to accident of Tripper/Truck at Thualthu at Ralliantawna's land (RHS 240+620 – 240+810) where the landowner has demanded compensation for the damaged caused at his land due to this accident.

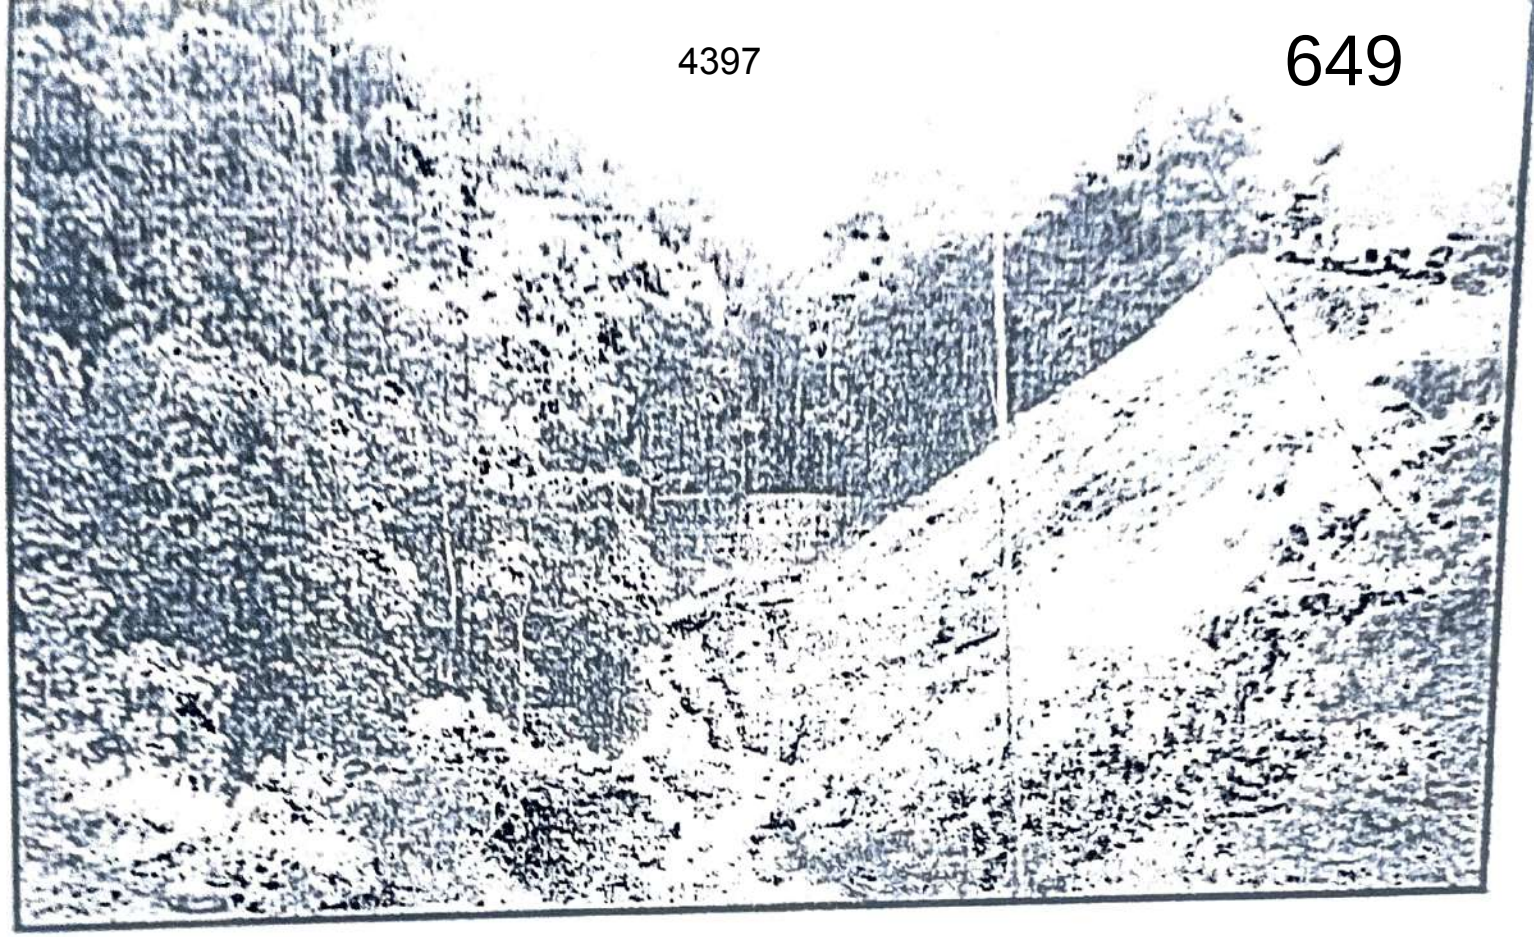
3. Complaint by Pu Laltlanthanga & Pu Lalhluta at RHS 240+870 – 241+010 and other verbal complaints made to verification team will be further examined for quick and collective action.

4. The team also observed that many of the instruction given by DC to ABCI & NHIDCL on the previous verification dated 12th January, 2022 were still not complied by the contractors. They were instructed to assiduously comply to the previous verification.

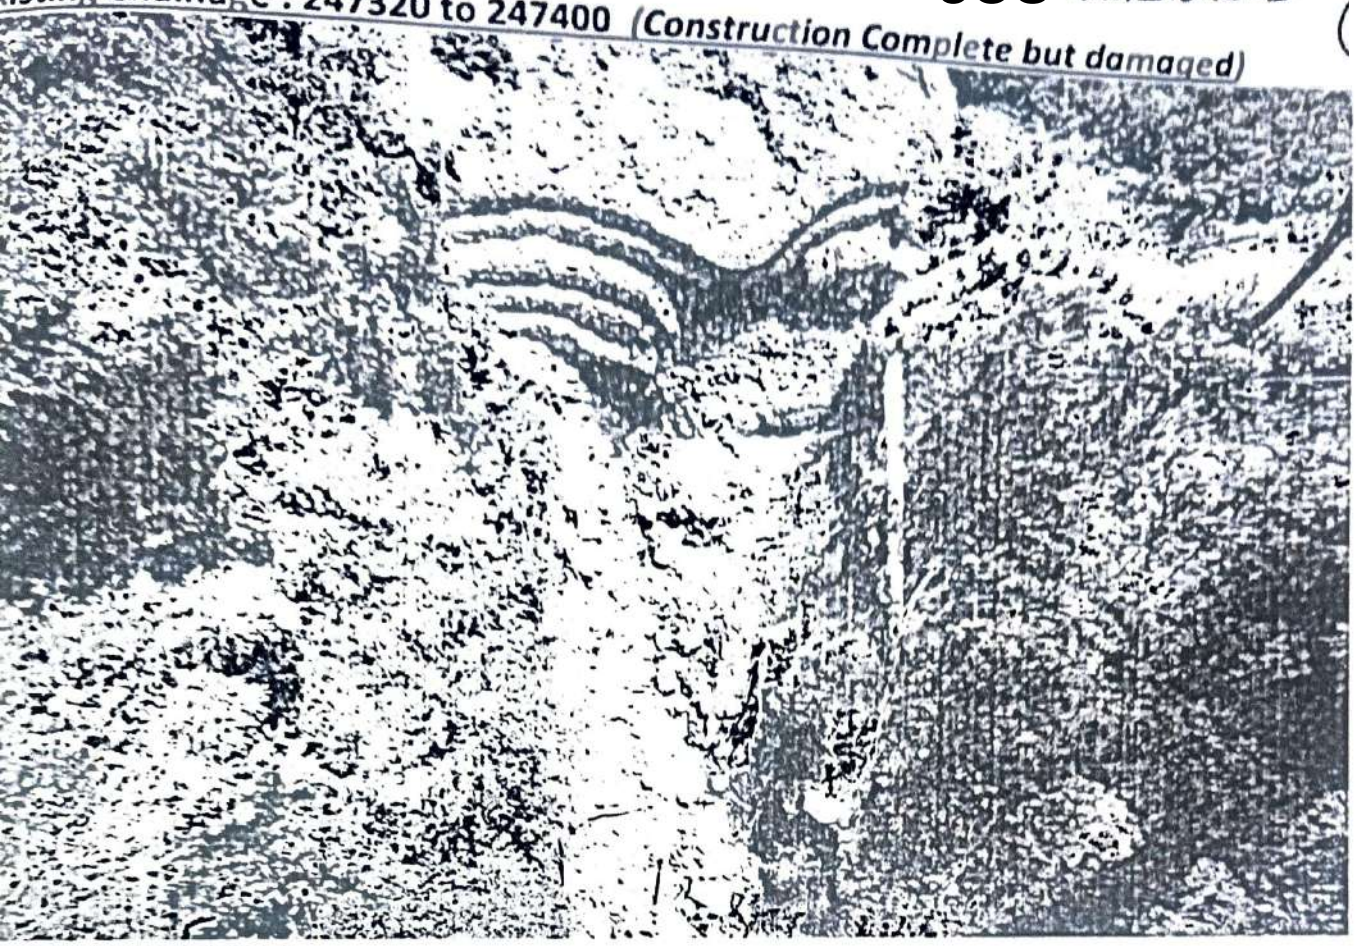
Existing Chainage : 247320 to 247400 *(Construction Complete but damaged)*

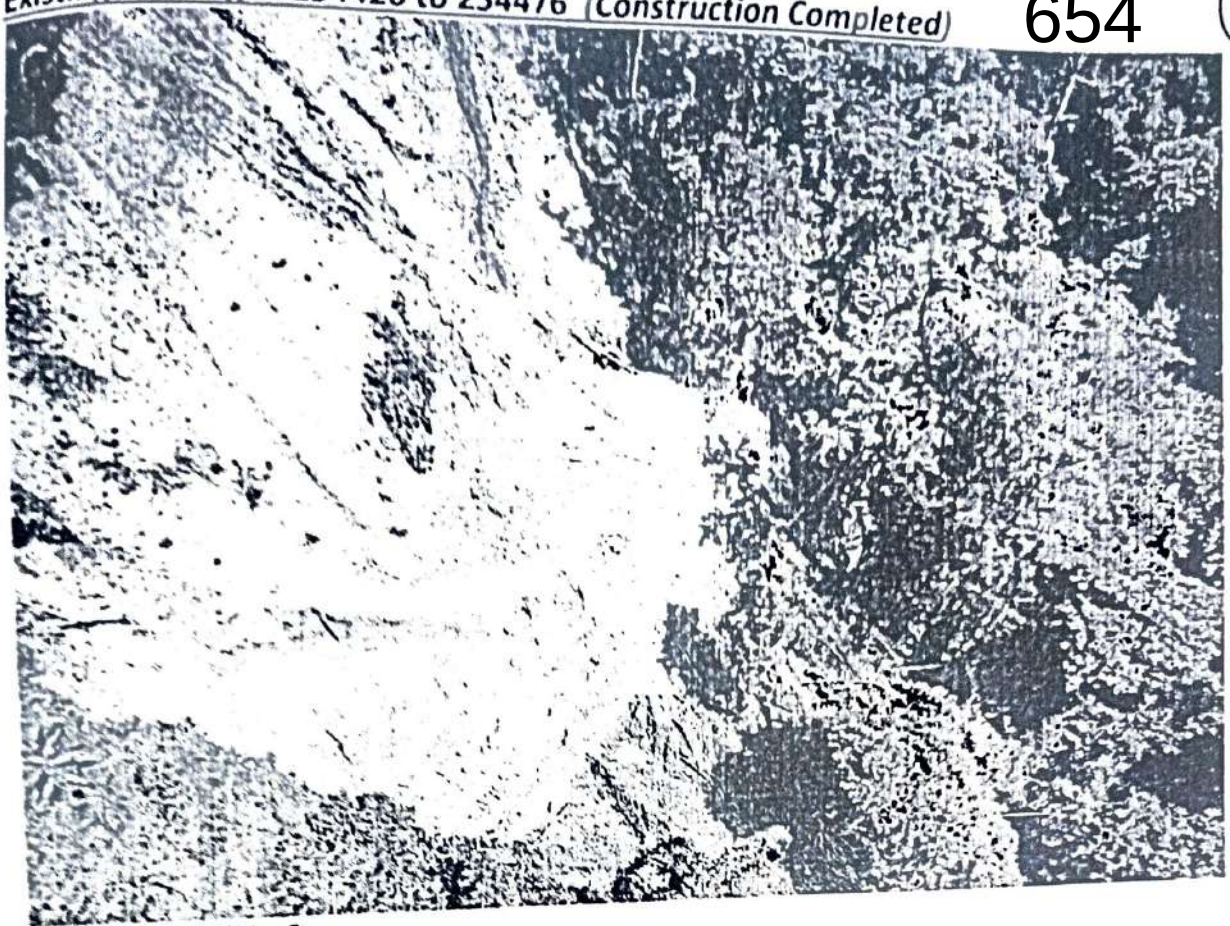
Existing Chainage : 250180 to 250260 *(Construction Complete but damaged)*

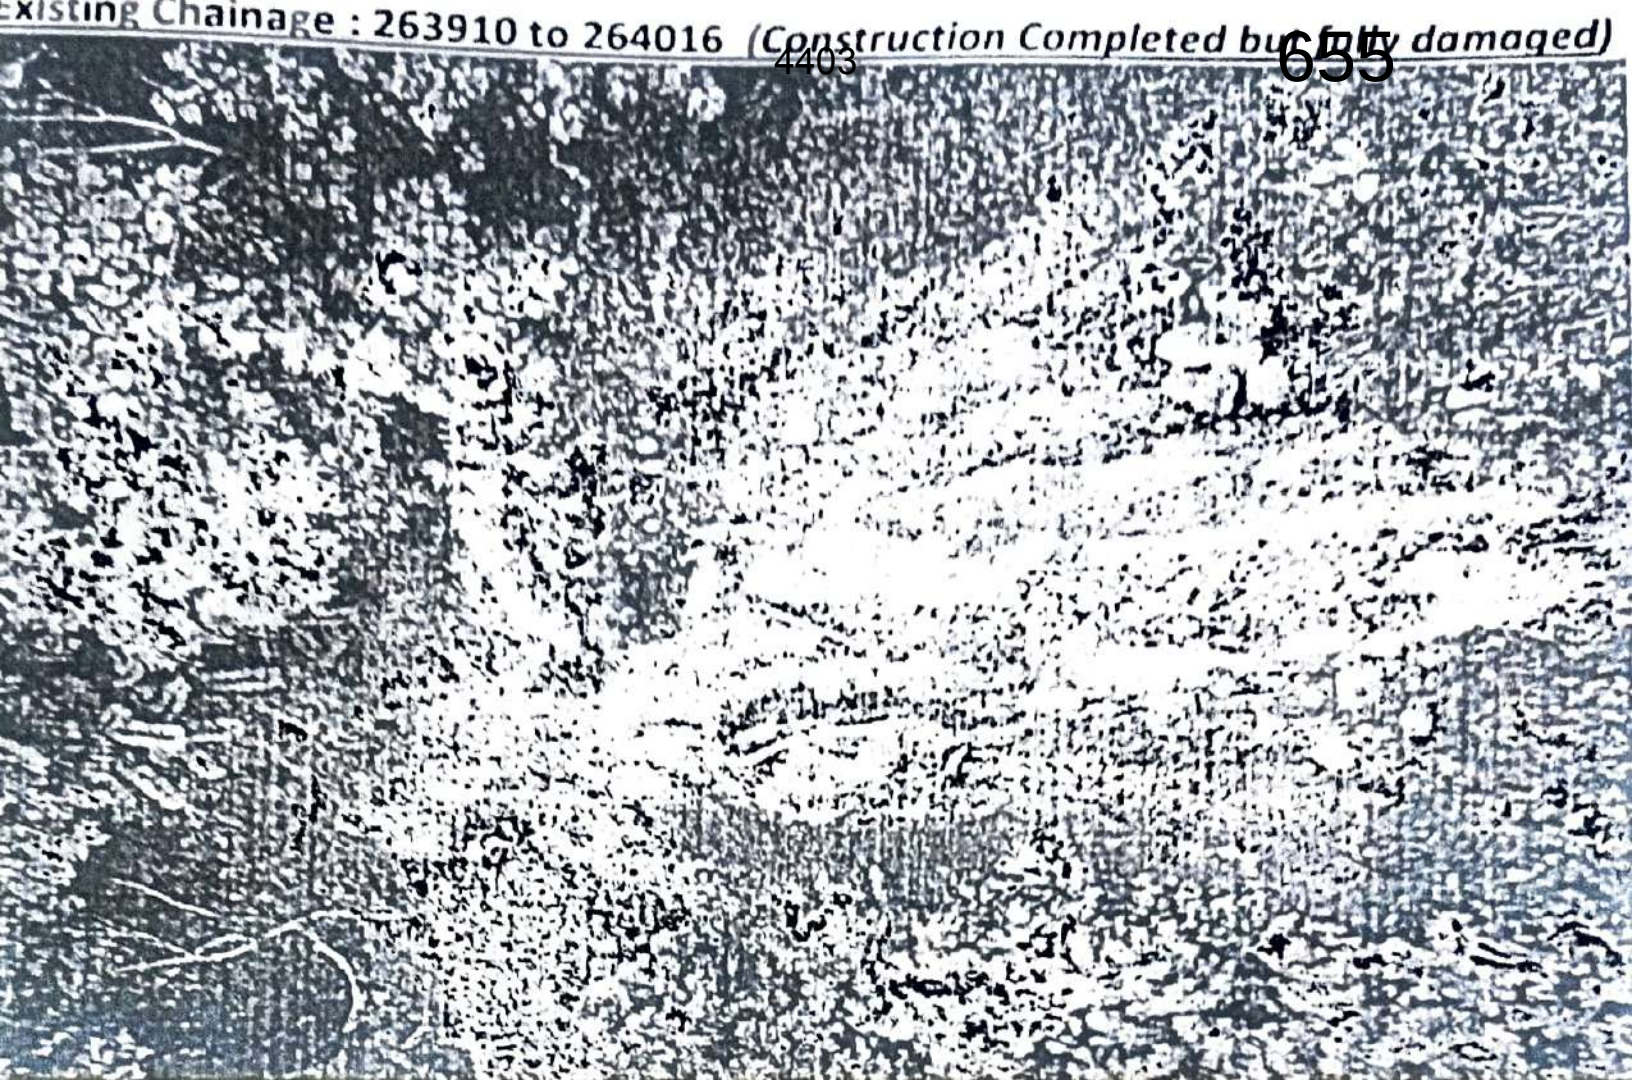
Aerial Photo of Sl No. 8

Existing Chainage : 263910 to 264016 *(Construction Completed but fully damaged)*

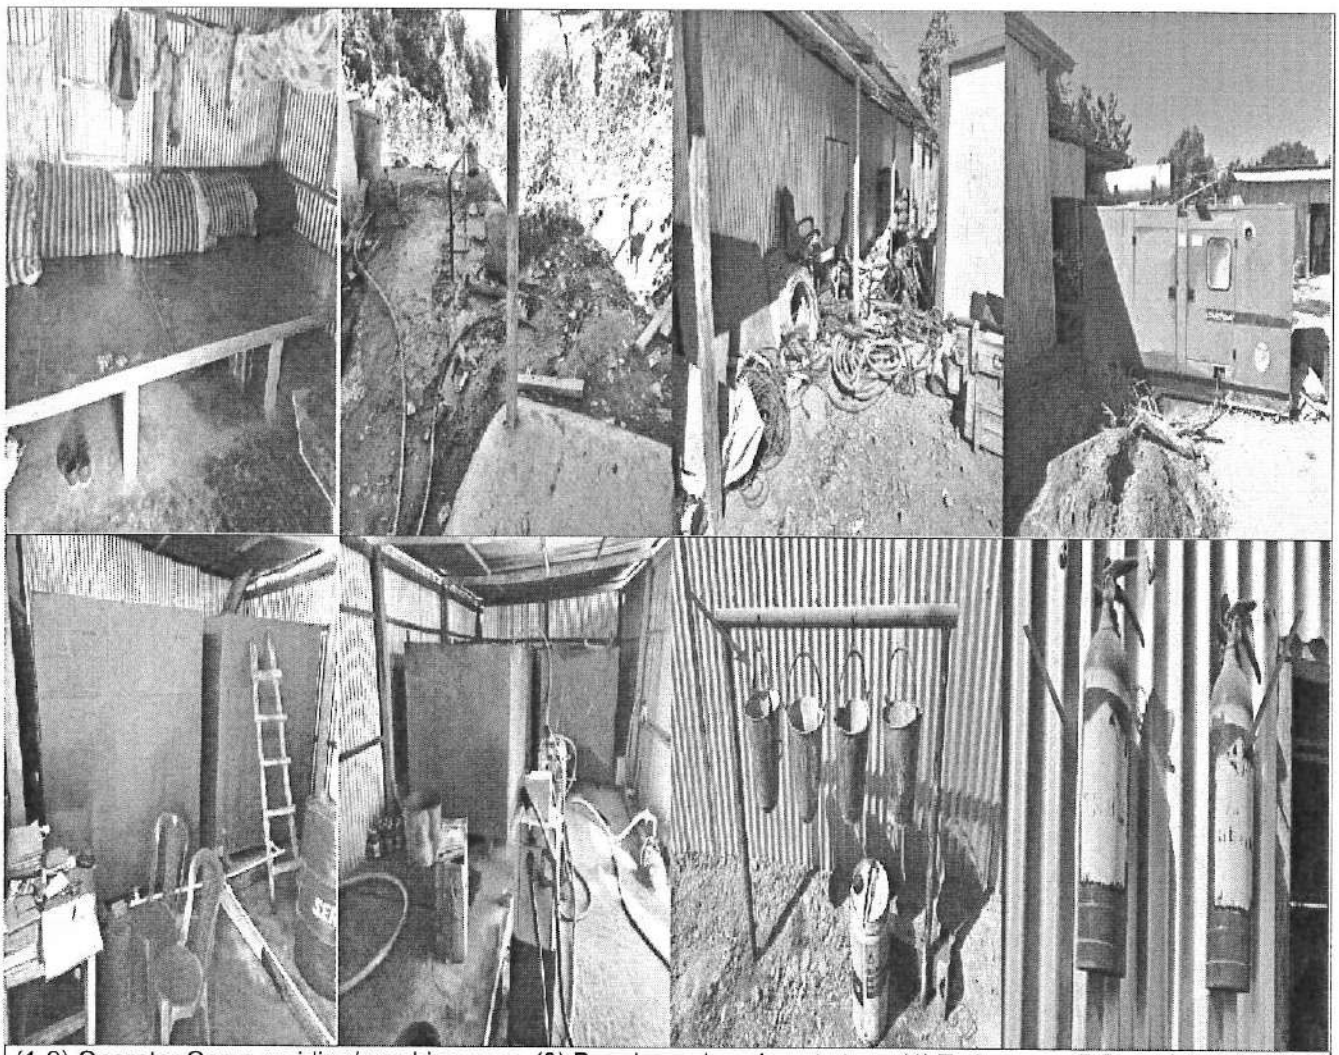
BASE CAMP

(1-2) DG set stack height, electrical hazard, (3-4) Hazard prone locaitons, (5) First aid centre, (6) Water facilitation at Staff's camp

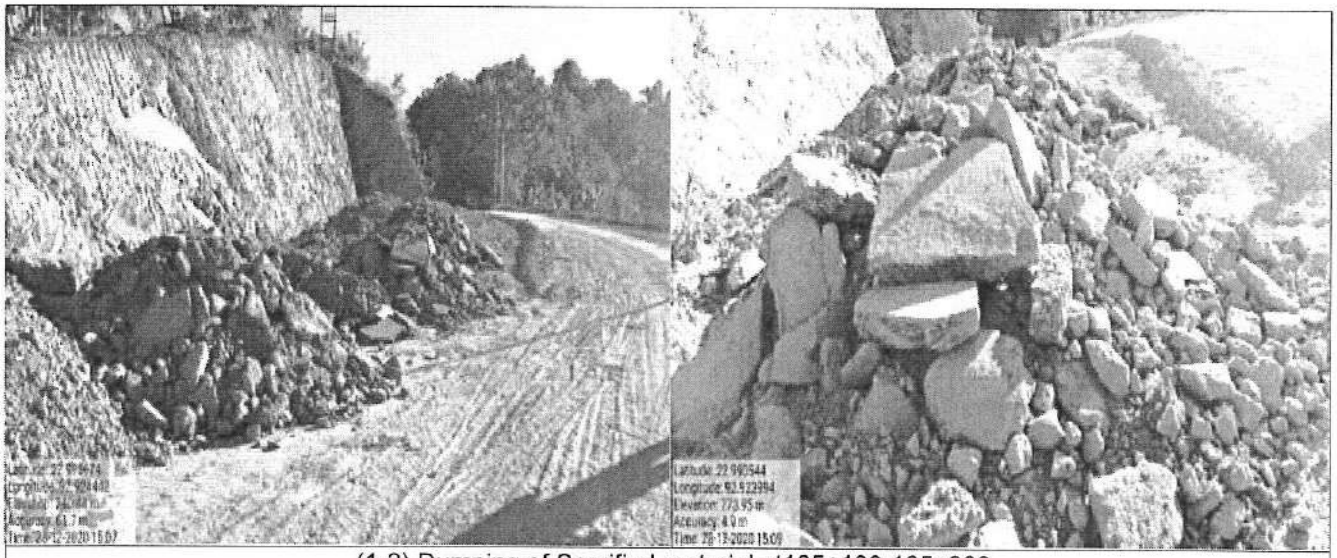
(1-2) Operator Camp residing/ washing area, (3) Poor housekeeping at store, (4) To increase DG stack height, (5-8) Fuel storage tank, Empty fire bucket & unspecified fire extinguisher
