IN THE NATIONAL GREEN TRIBUNAL, EASTERN ZONE ENCH

ORIGINAL APPLICATION NO. 26 OF 2023

PI VANRAMCHHUANGI … APPELLANT

UNION OF INDIA & ORS. … RESPONDENTS

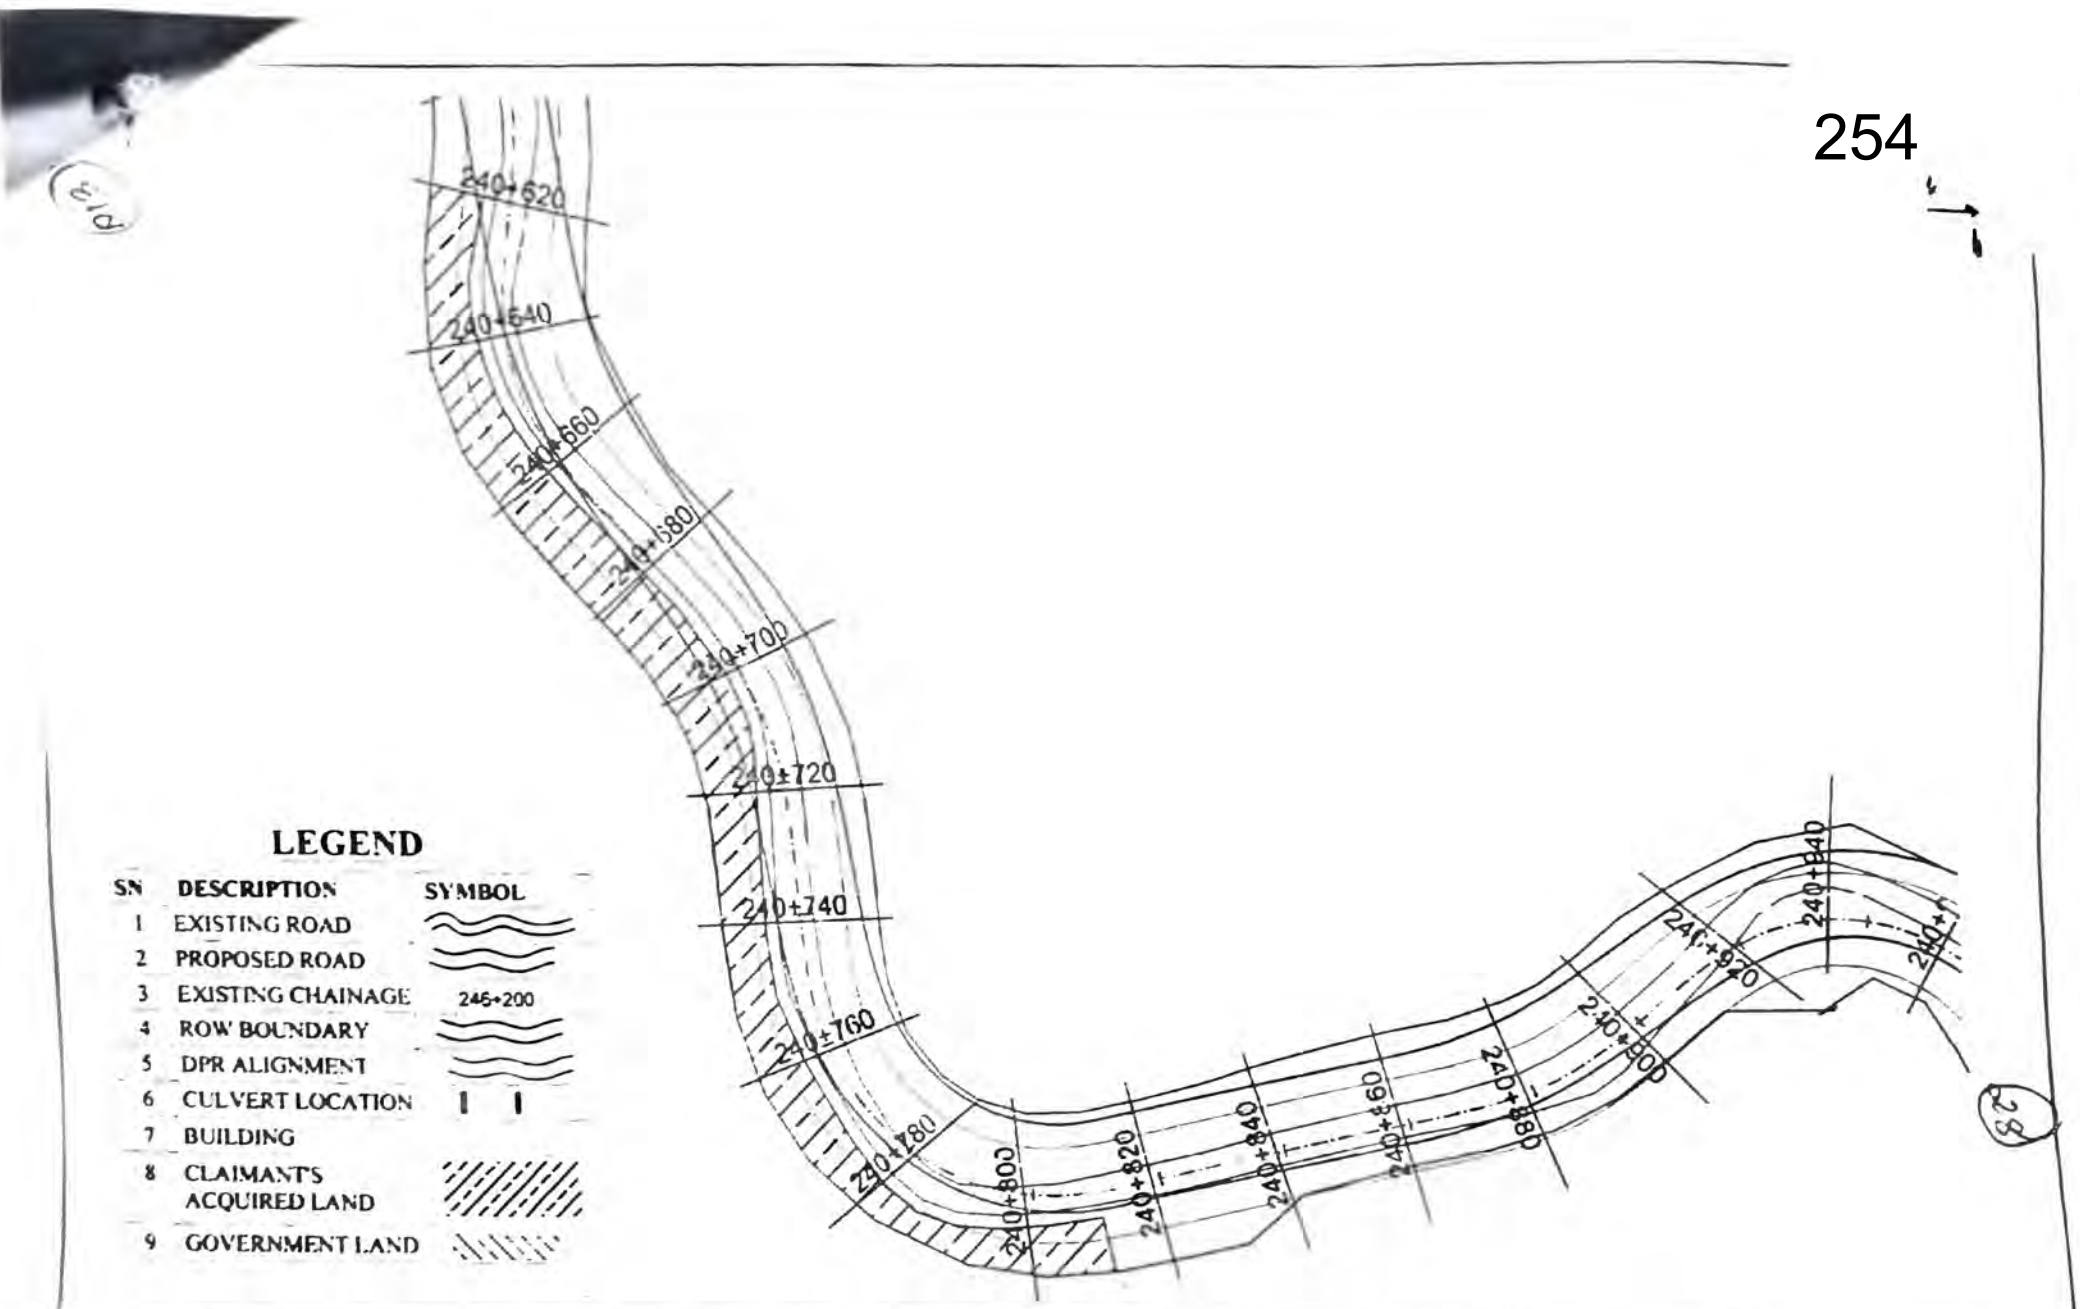
Sr. No.	Name	Village	Chainage		Reason of complaint	Finding of Verification Team	Action Taken/ Action to be taken
10	Thangmawii C/o Ralliantawna	Thualthu	240+620	240+810	His complaint is that due to disposal of muck and waste beyond ROW damage his additional assets.	This has been verified on the site and surveyor's report states that due to heavy muck and waste have been disposal on his land beyond ROW results to additional damage of trees and crops.	1. We have verified at site with in the given stretch. 2. No muck and waste was found out of ROW. 3. The complaint is already compensated with Rs. 482537/- through CALA for NHIDCL, which is much more than the actual damage. 4. The verification report is at an early stage. 5. The location map is attached for reference. 6. Therefore complaint may be closed.
11	ZD Lalfinpuia	Thualthu	238+330	238+480	His complaint is that his land was safe and was not compensated for his land. But contractor had cut off his land without his consent.	This has been verified on the site and Surveyor's report states that contractors had cut off his land beyond ROW. It had been already verified, but after verification already done, landslide had occurred on his due to NH-54 construction resulting to damage of additional trees and	1. Pu Lalfinpuia's land is claimed from Km 238+330 to Km 238+480 on LHS 2. We have verified that his land falls within ROW. 3. Location map is attached for reference. **4. His land needs to be acquired by CALA Land & Renenue department on behalf NHIDCL.**

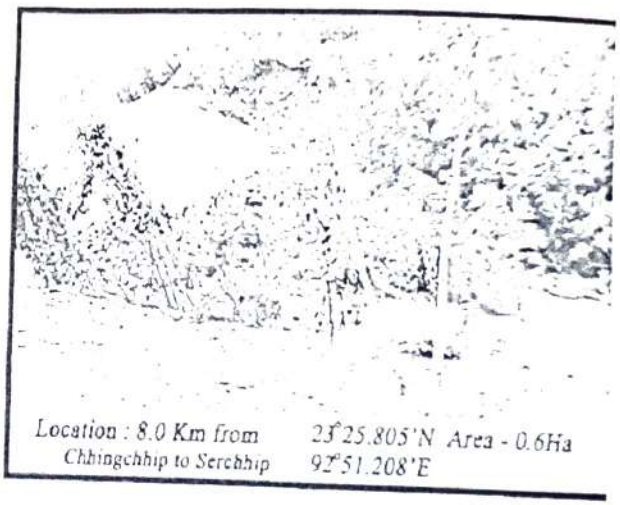
Location-4:

Location : 8.0 Km from Chhingchhip to Serchhip — 23°25.805'N 92°51.208'E Area - 0.6Ha

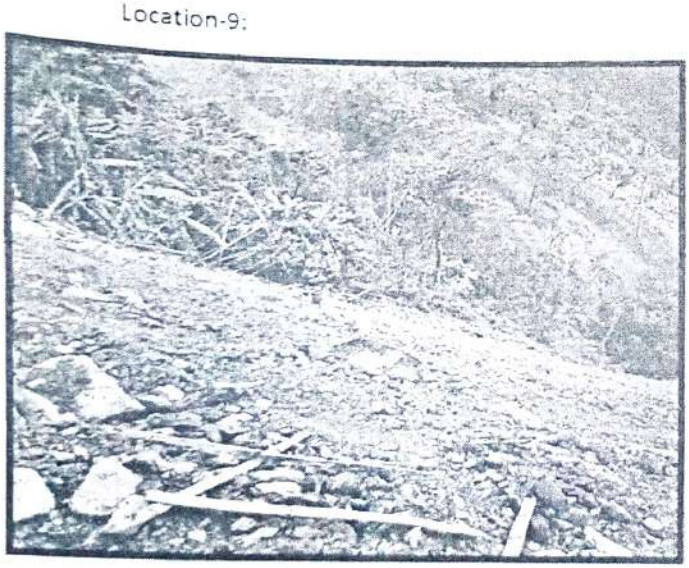
Location-9:

Location : 0.5 Km from Chhiahtlang to Chhingchhip — 23°23.873'N 92°50.955'E Area - 0.6Ha

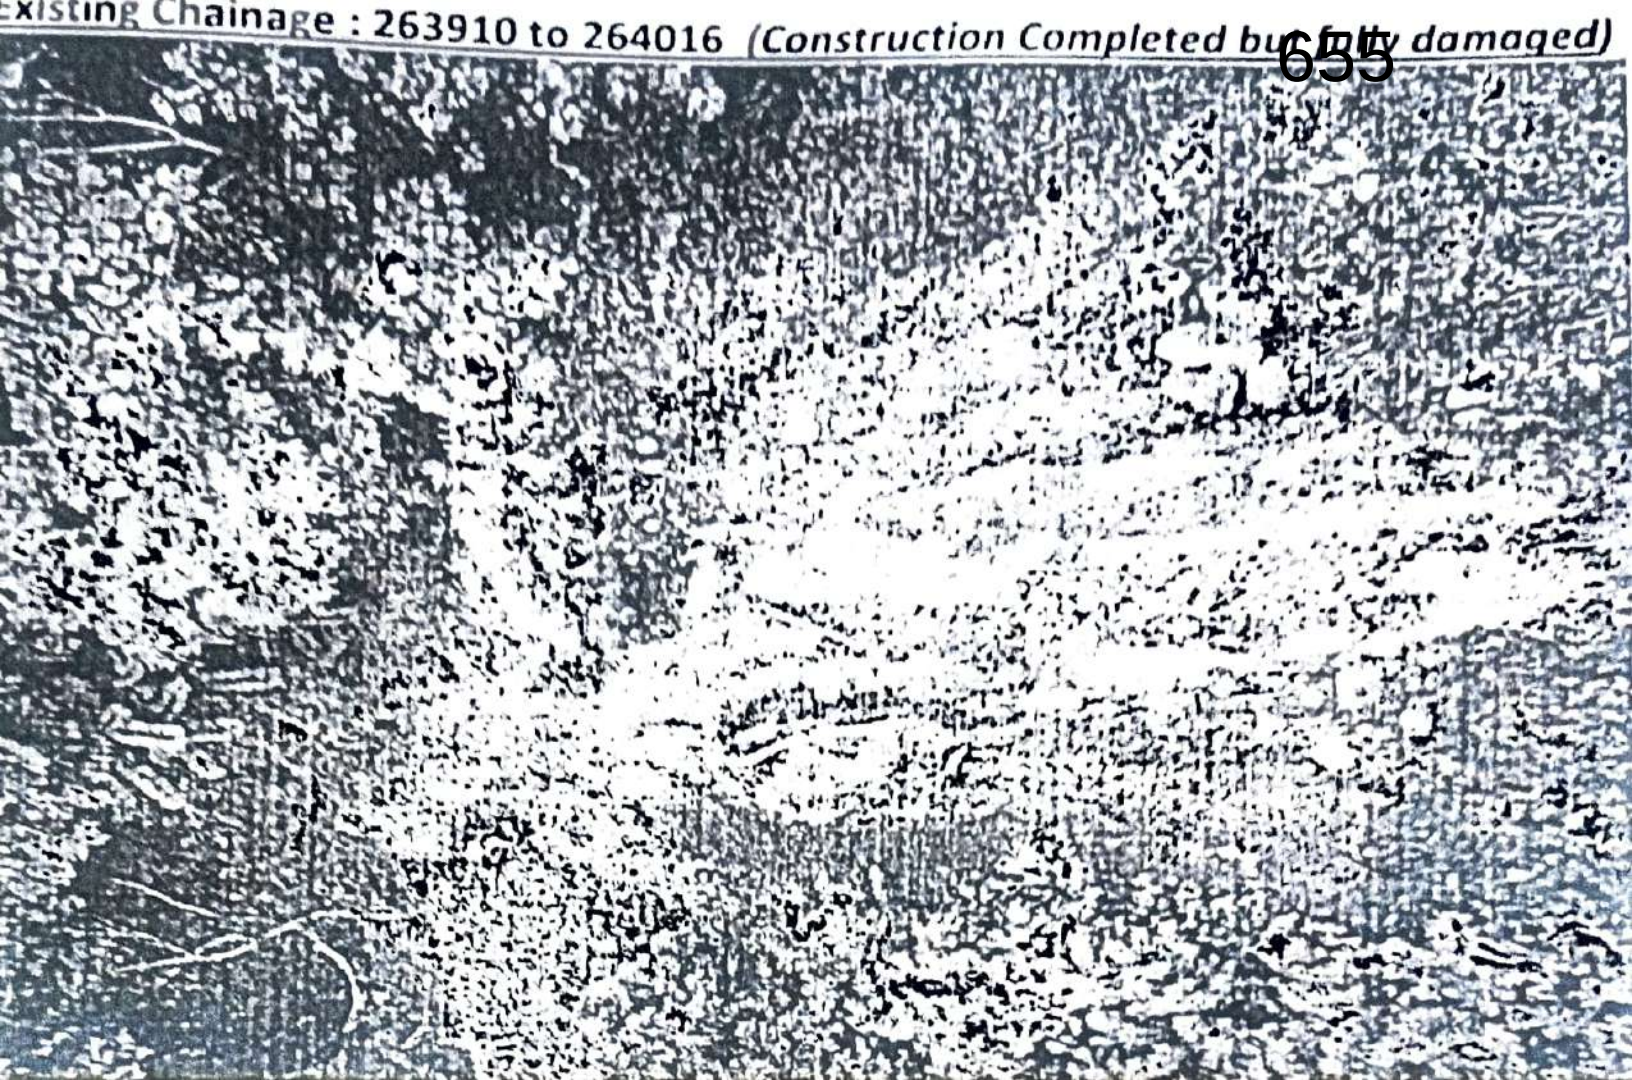
Existing Chainage : 263910 to 264016 *(Construction Completed but fully damaged)*

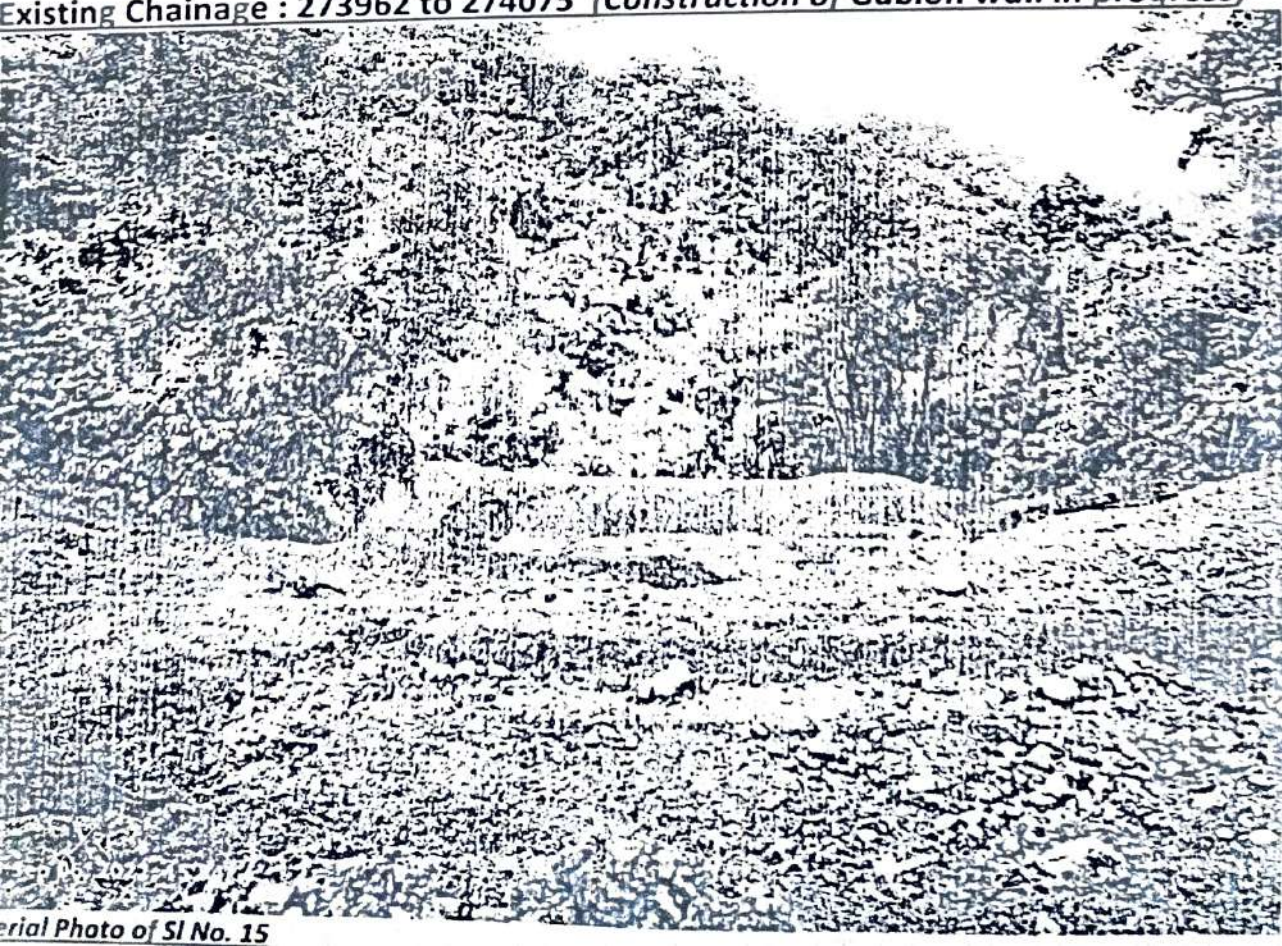
erial Photo of Sl No. 15

Existing Chainage : 273962 to 274075 *(Construction of Gabion wall in progress)*

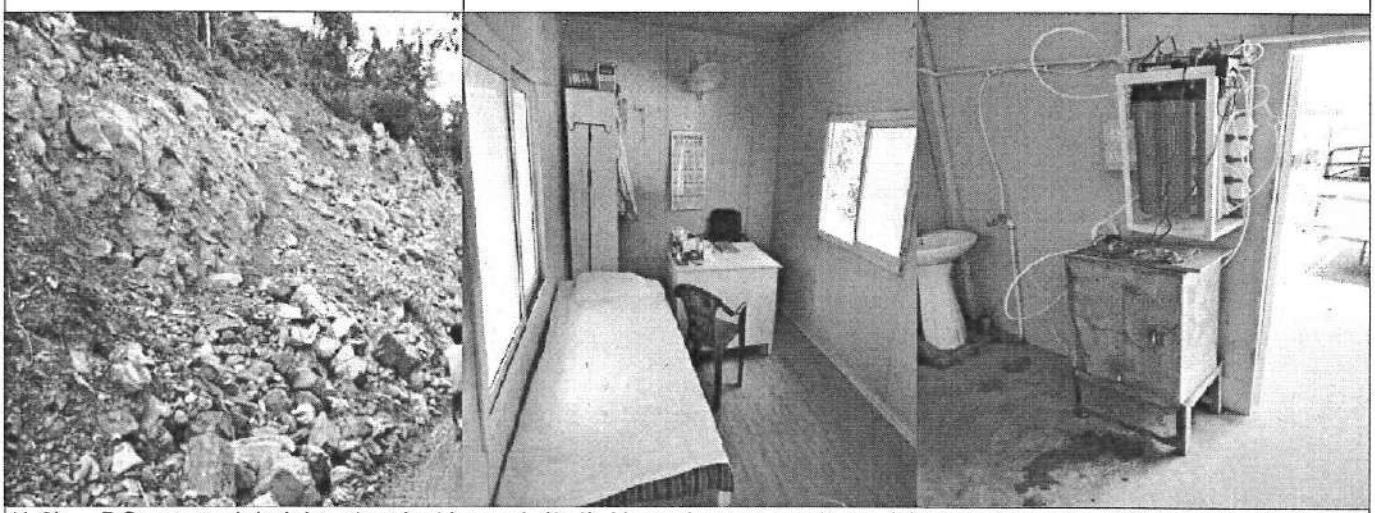
(1-4) Overcrowing at labour residing area, cooking facilitation, poor housekeeping & to improve waste management

(1-2) DG set stack height, electrical hazard, (3-4) Hazard prone locaitons, (5) First aid centre, (6) Water facilitation at Staff's camp
