BEFORE THE HON'BLE NATIONAL GREEN TRIBUNAL
PRINCIPAL BENCH, NEW DELHI

Original Application No. 109/2024

ADDITIONAL REPORT OF THE JOINT COMMITTEE ON REQUISITE INFORMATION AS PER ORDER DATED 08.07.2024 of HON'BLE NATIONAL GREEN TRIBUNAL, PRINCIPAL BENCH IN ORIGINAL APPLICATION NO. 109/2024 IN THE MATTER OF AKASH DUBEY VS. UNION OF INDIA & ORS

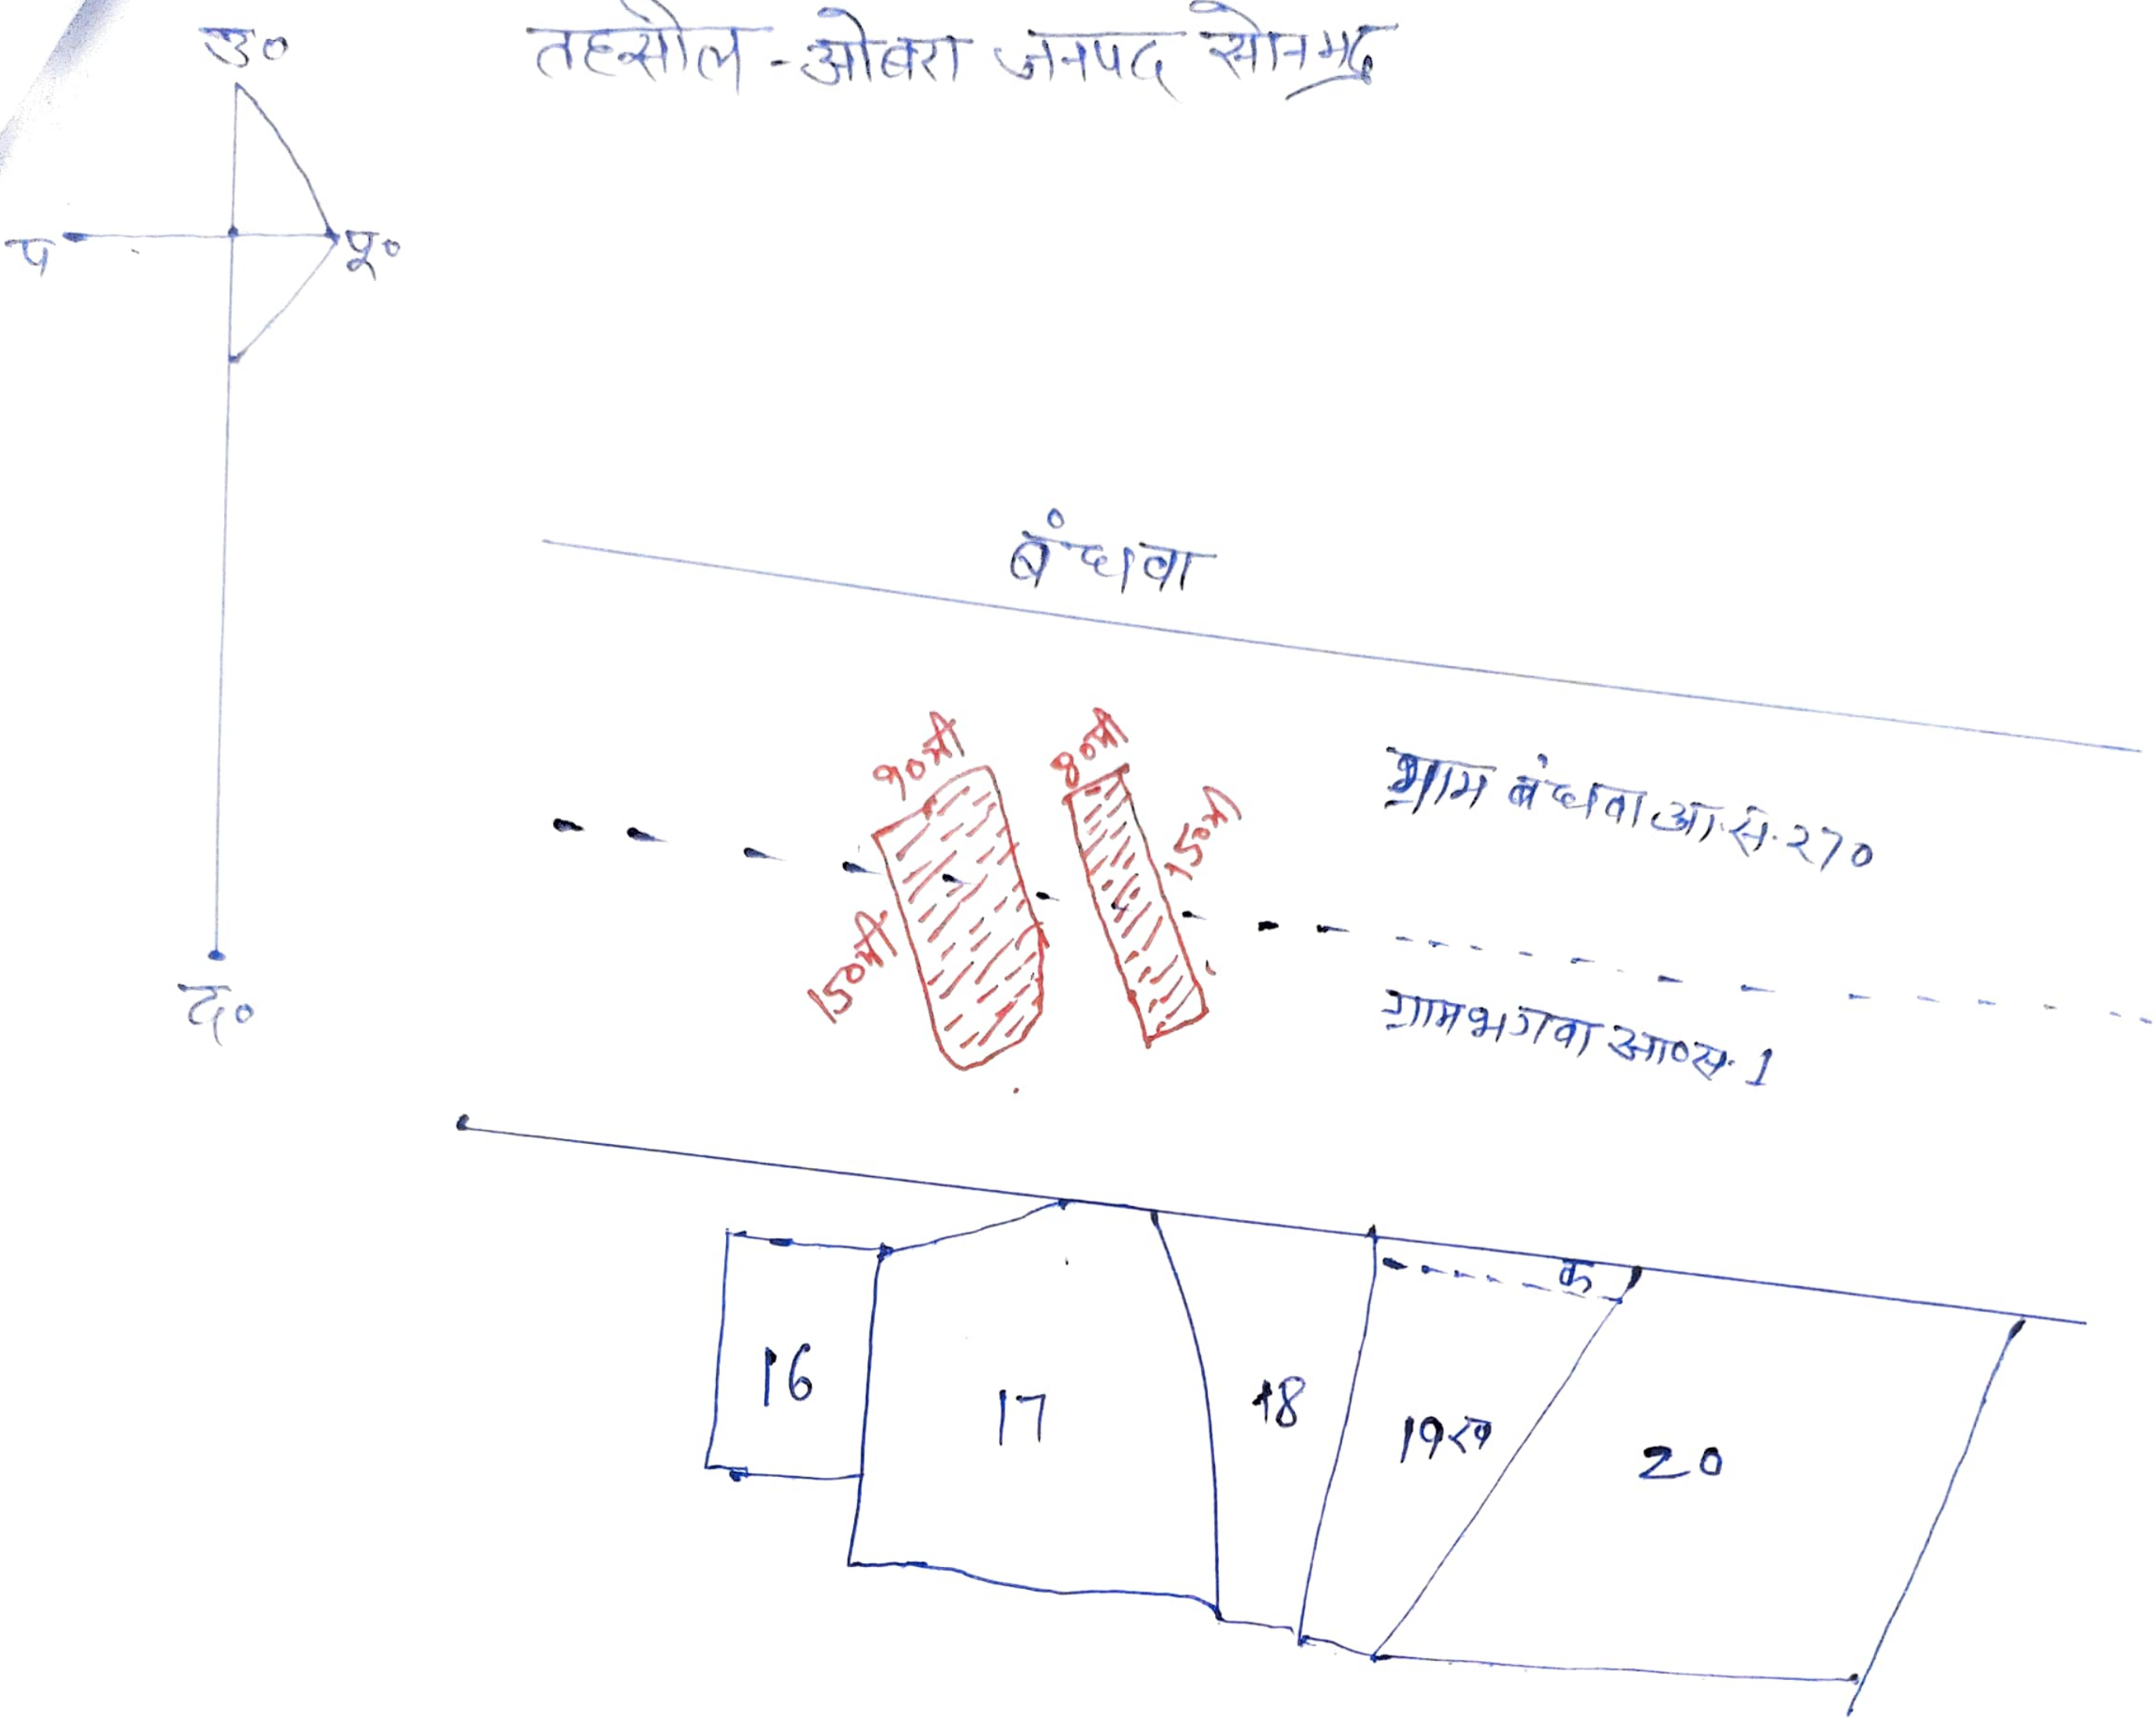
आंशिक नजरी नक्शा - ग्राम भगवा व बंधवा प० अगोरी
तहसील - ओबरा जनपद सोनभद्र

1. 150(L) मी0×90(B) मी0 ×2(H) मी0 = 27000 घन मी0
2. 150(L) मी0×80(B) मी0 ×2(H) मी0 =24000 घन मी0

कुल मात्रा = **51000** घन मी0

इस प्रकार अनुज्ञा धारक व उनके प्रतिनिधि अजय कुमार सिंह पुत्र बसन्त राम सिंह ग्राम–रामपुर, सक्तेशगढ़, चुनार, मीरजापुर द्वारा अपने स्वीकृत खनन पट्टा क्षेत्र के बाहर 51000 घन मी0 बालू/मौरम का खनन ग्राम–भगवा की आराजी संख्या– 1 जो नदी खाते की भूमि है व ग्राम–बंधवा की आराजी संख्या– 270 जो सुरक्षित वन व नदी के खाते में अंकित है से अवैध खनन/परिवहन किया गया है। खनन अनुज्ञा क्षेत्र में अब तक बालू/मौरम का खनन कार्य नहीं किया गया है। खनन अनुज्ञा क्षेत्र में सीमा स्तम्भ व साइन बोर्ड लगे हुए नहीं पाये गये। उपरोक्त के दृष्टिगत खनन अनुज्ञाधारक

संकेत - अवैध खननक्षेत्र

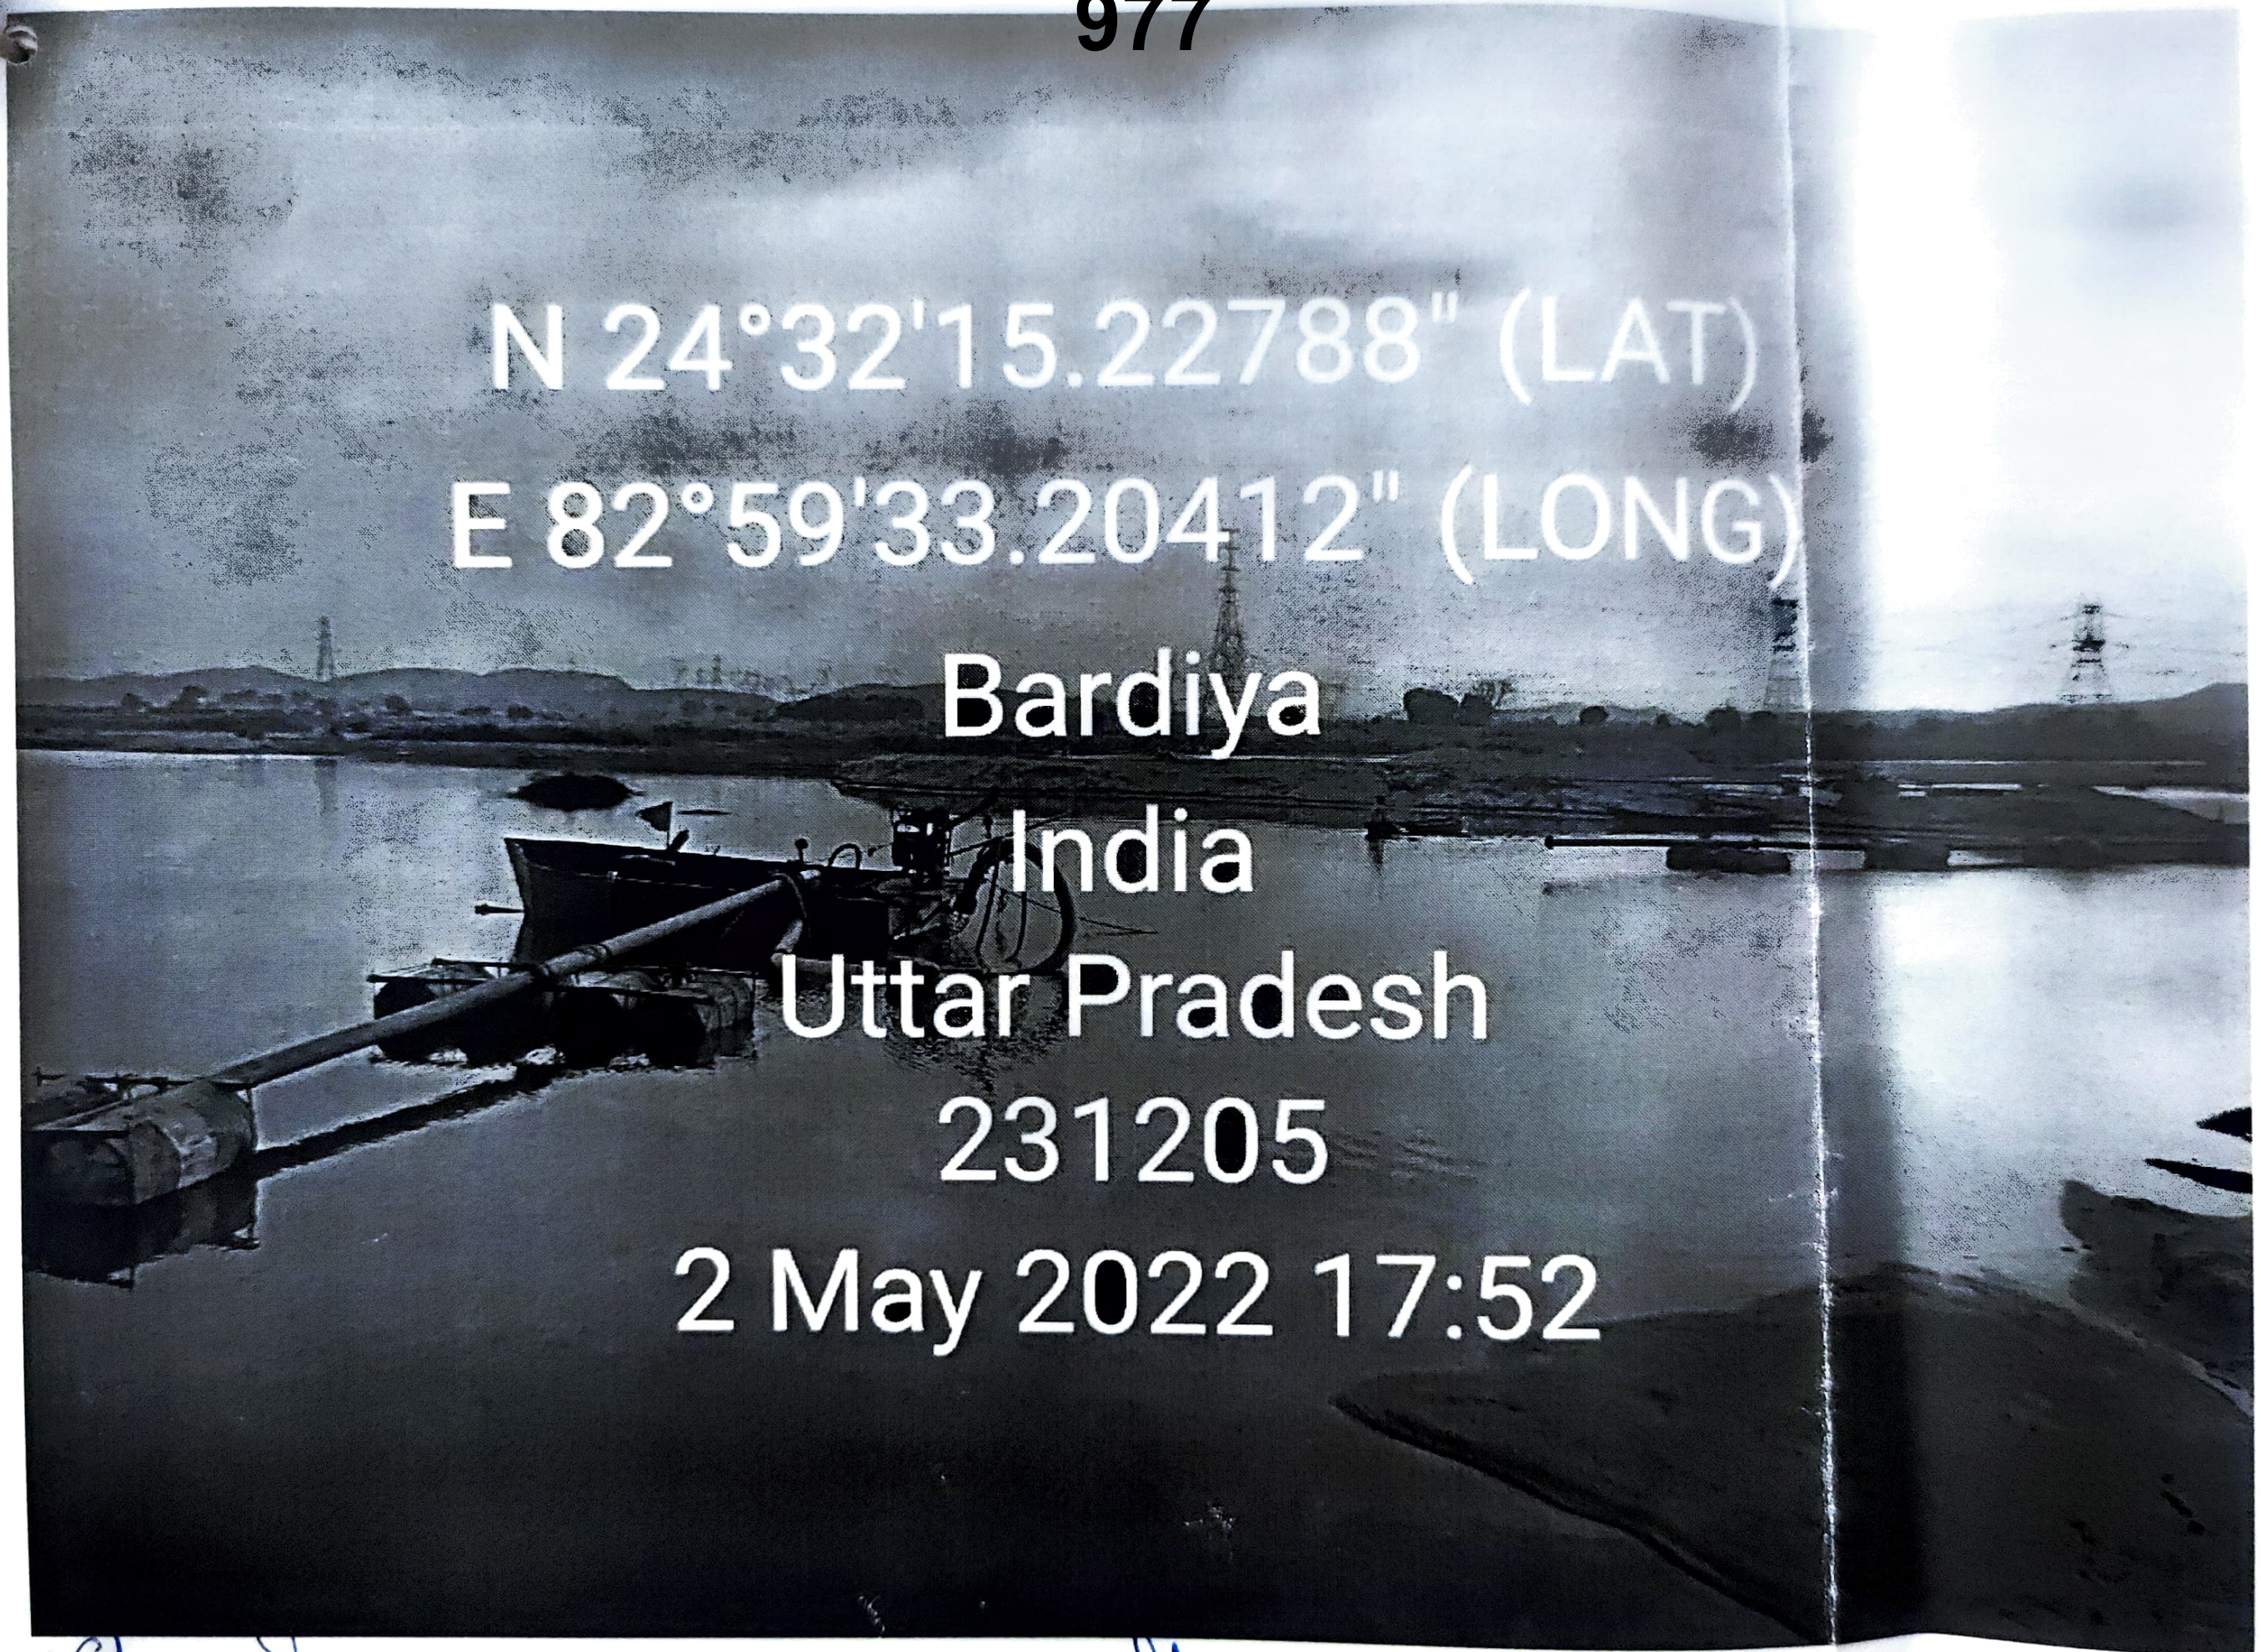
N 24°32'14.06868" (LAT)
E 82°59'41.54136" (LONG)
Bardiya
India
Uttar Pradesh
231205
2 May 2022 17:58

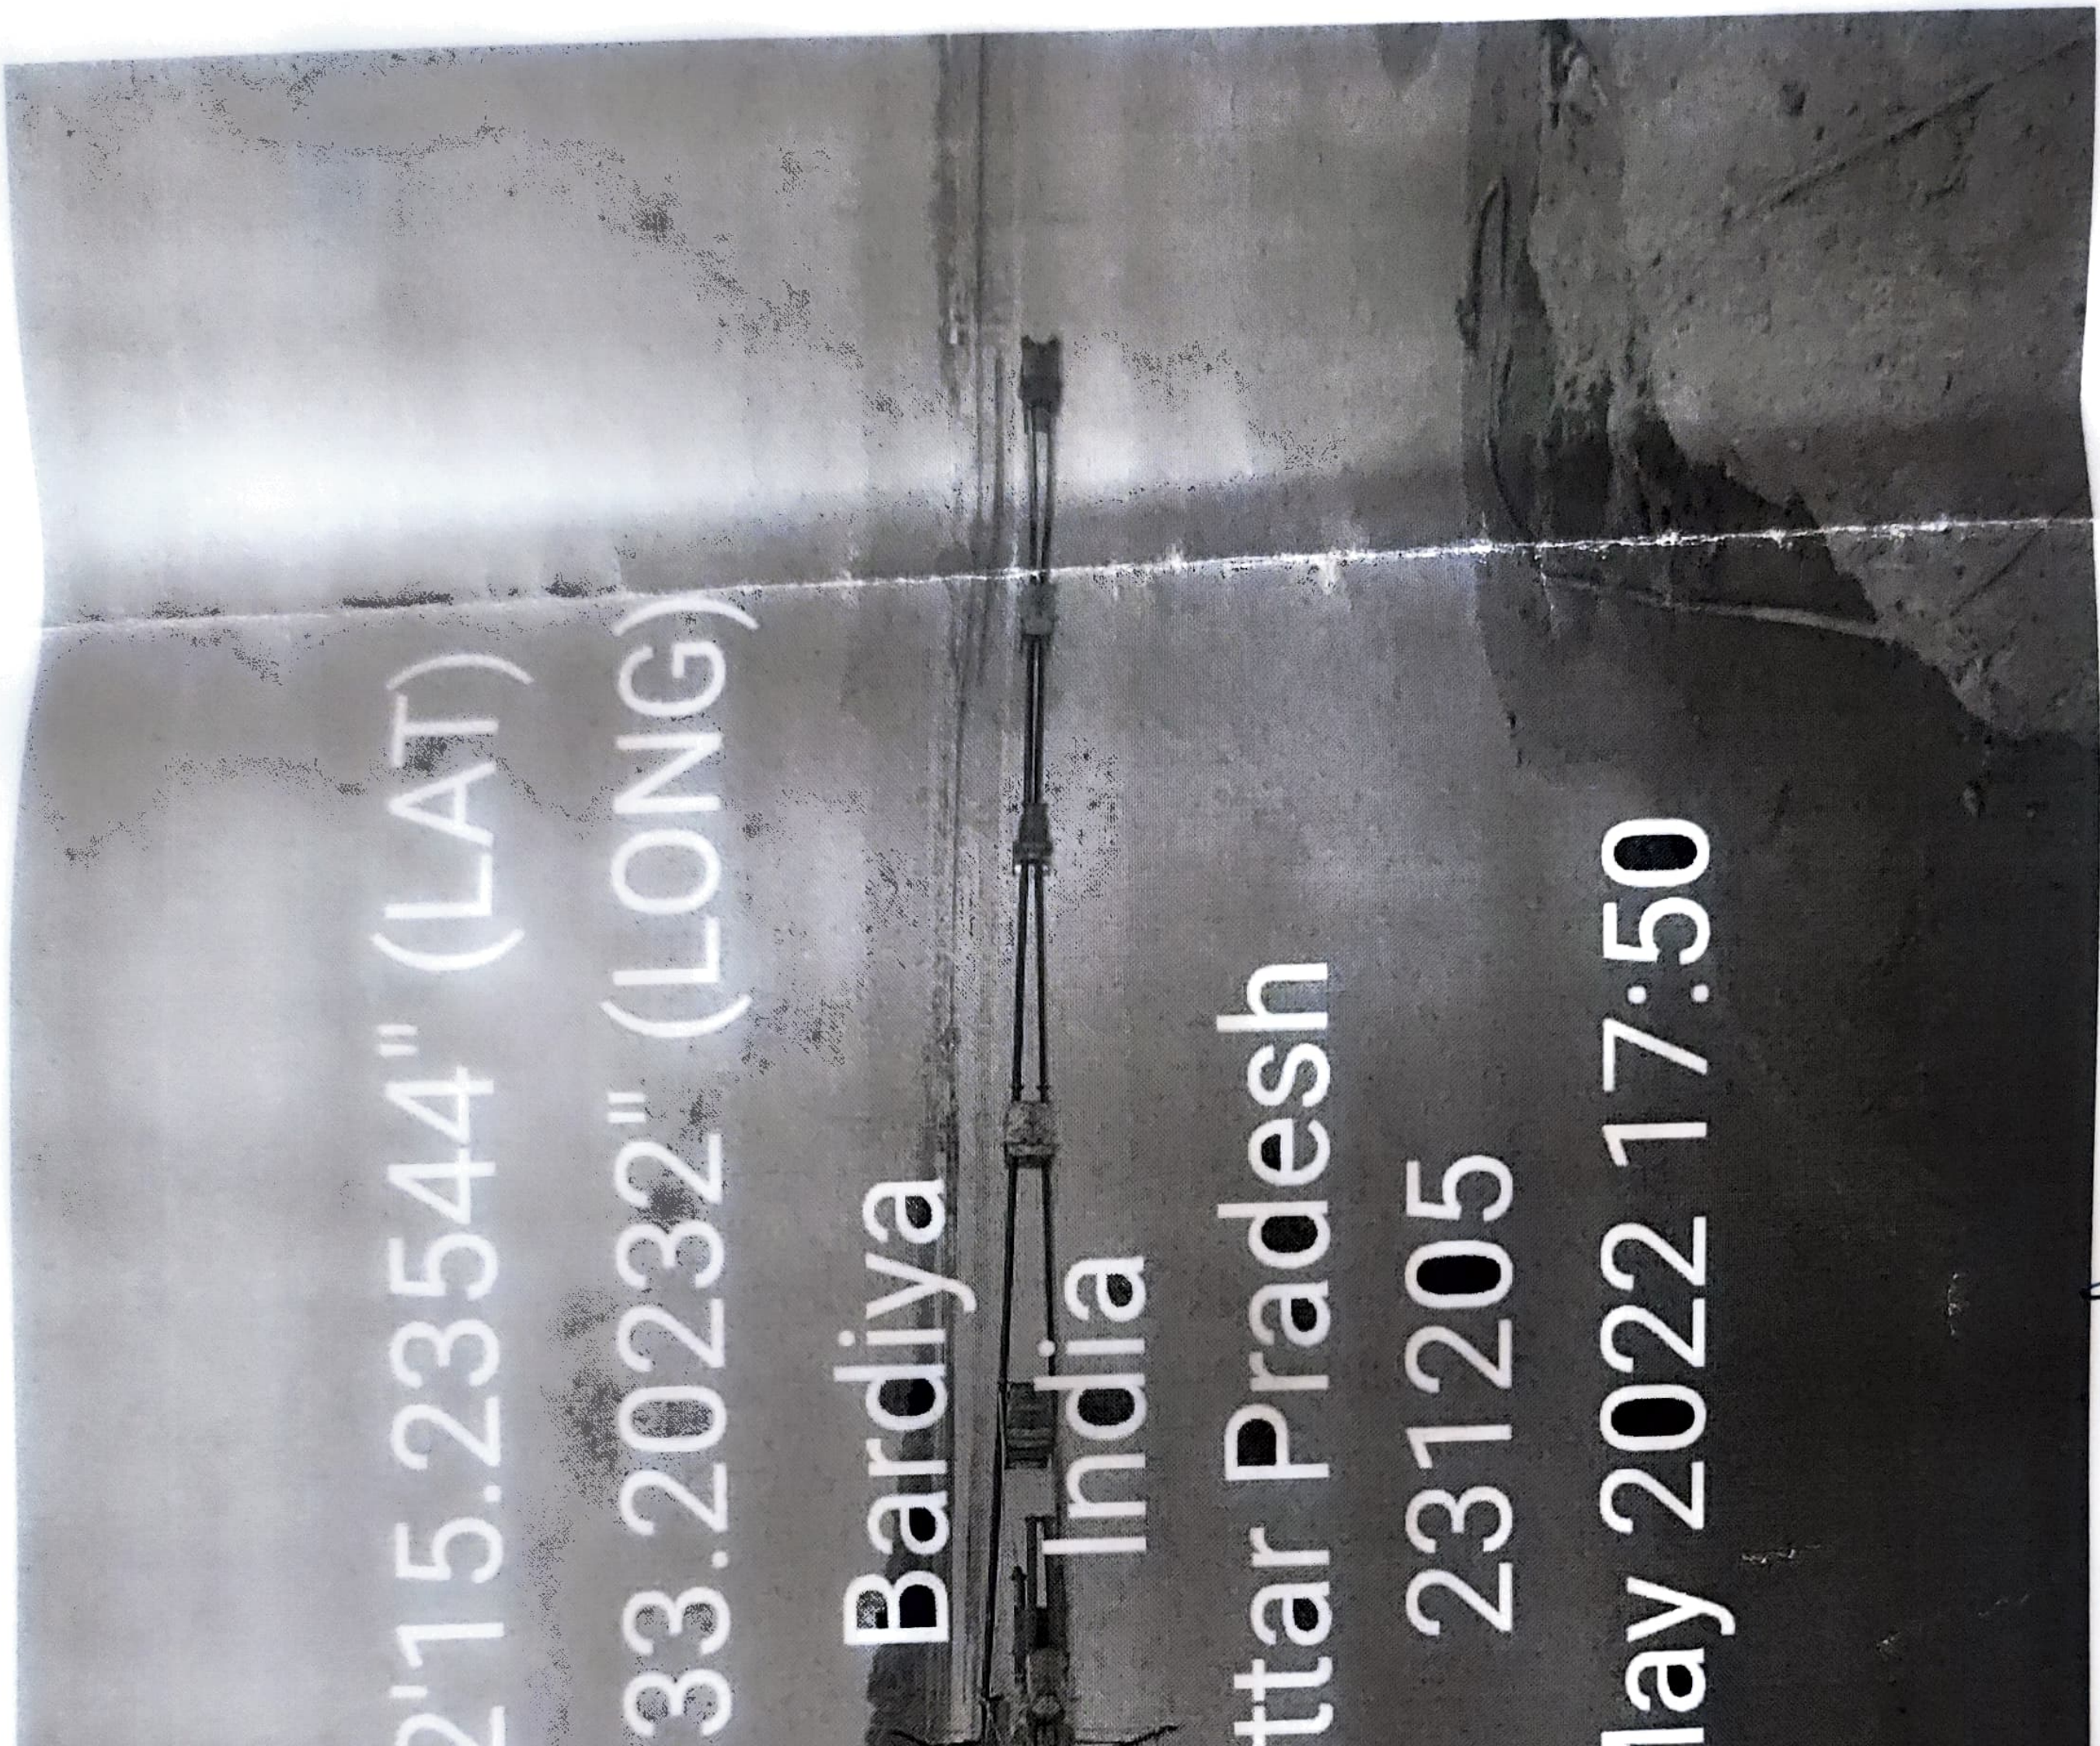
N 24°32'15.22788" (LAT)
E 82°59'33.20412" (LONG)
Bardiya
India
Uttar Pradesh
231205
2 May 2022 17:52

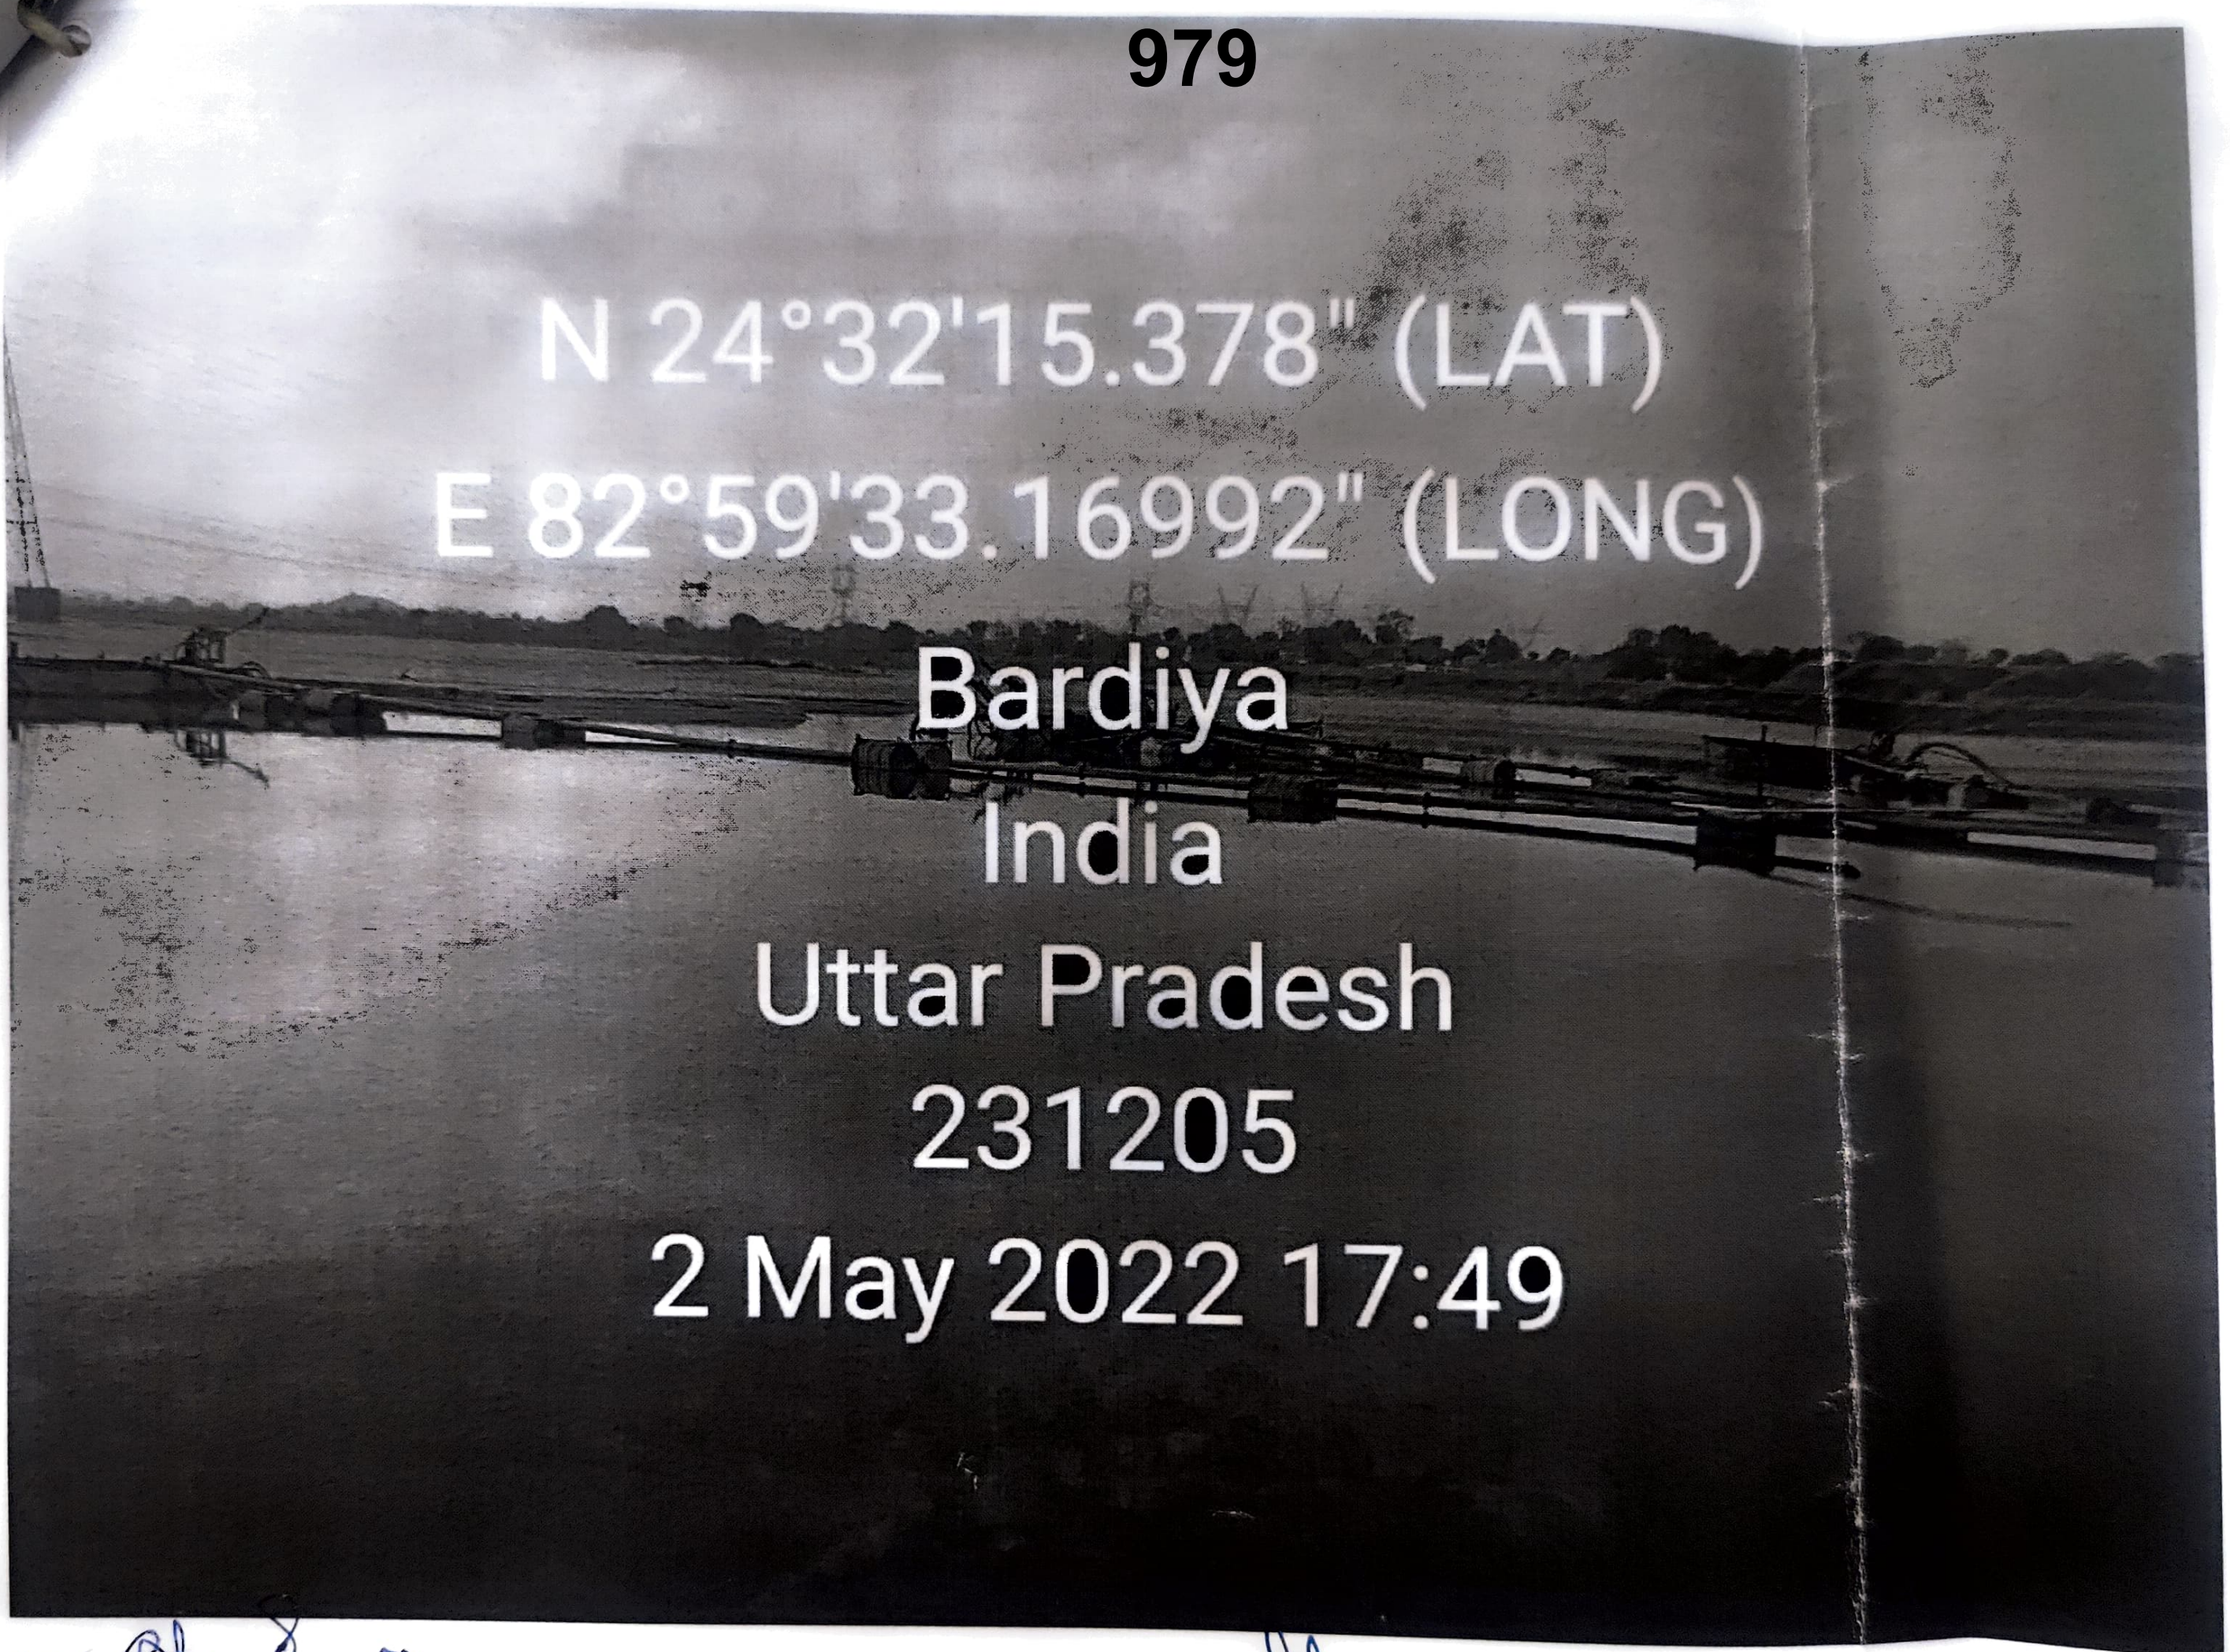
N 24°32'15.23544" (LAT)
E 82°59'33.20232" (LONG)
Bardiya
India
Uttar Pradesh
231205
2 May 2022 17:50

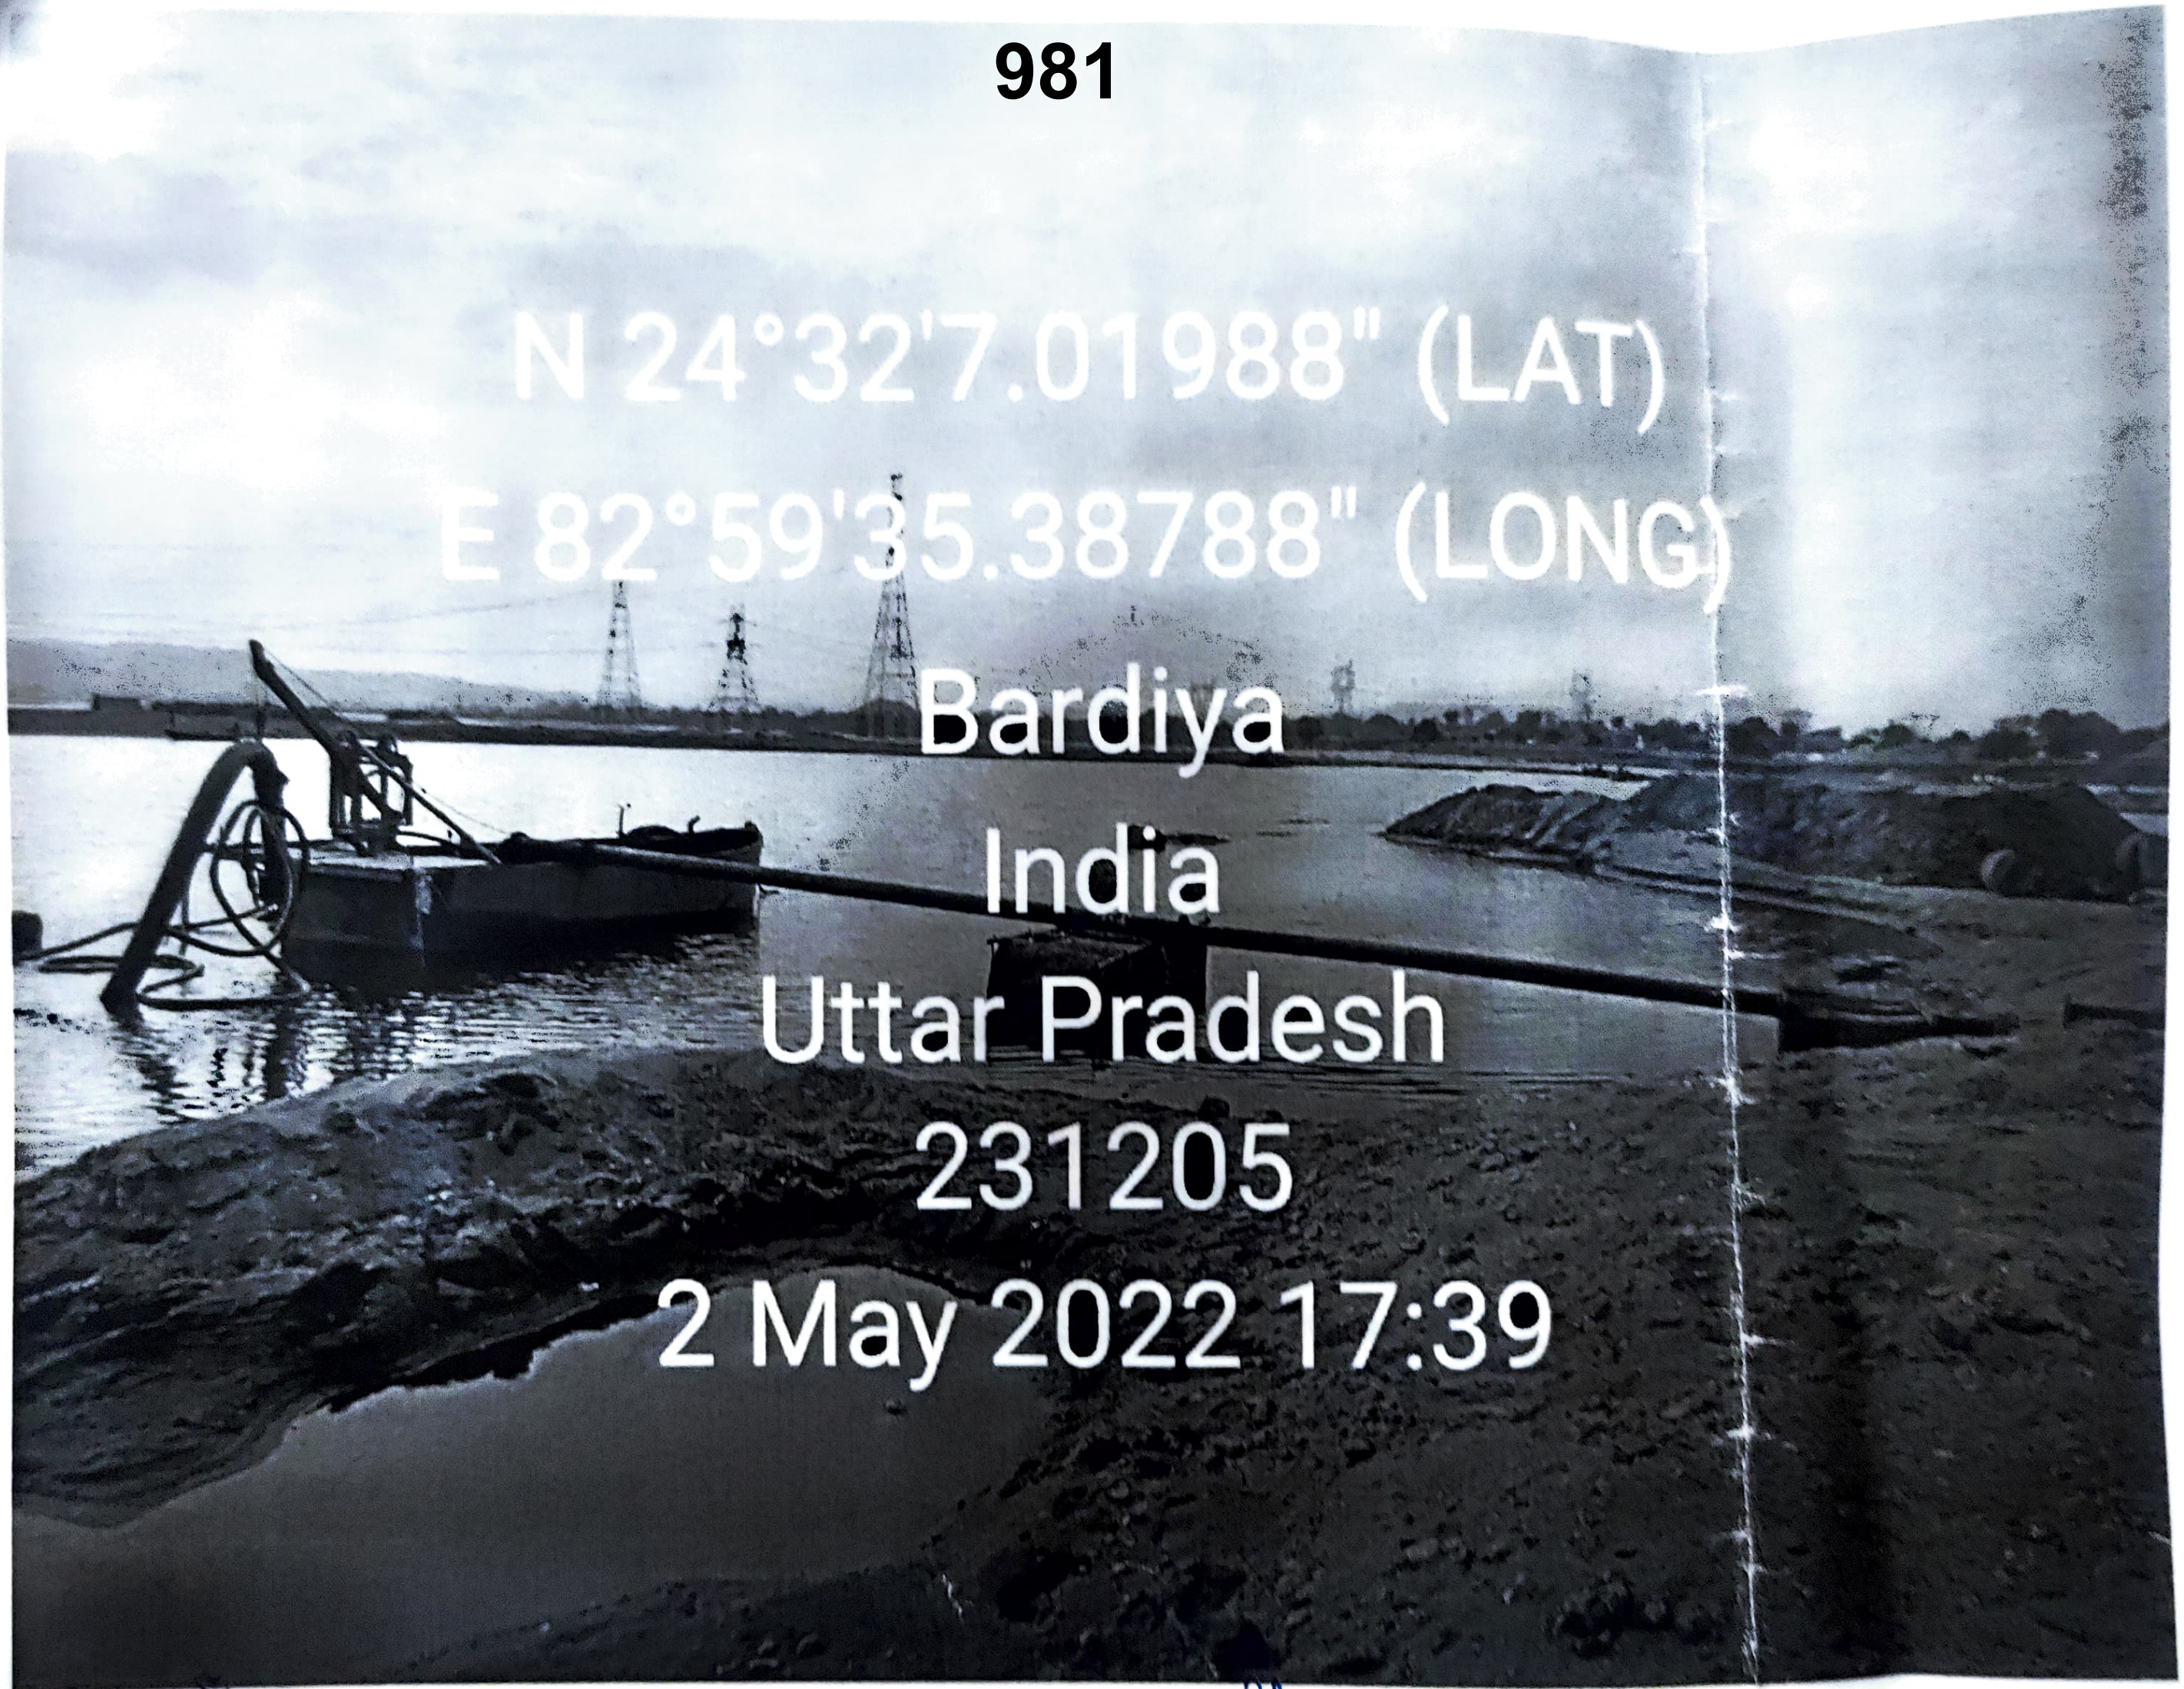
N 24°32'8.754" (LAT)
E 82°59'34.28412" (LONG)
Bardiya
India
Uttar Pradesh
231205
2 May 2022 17:41

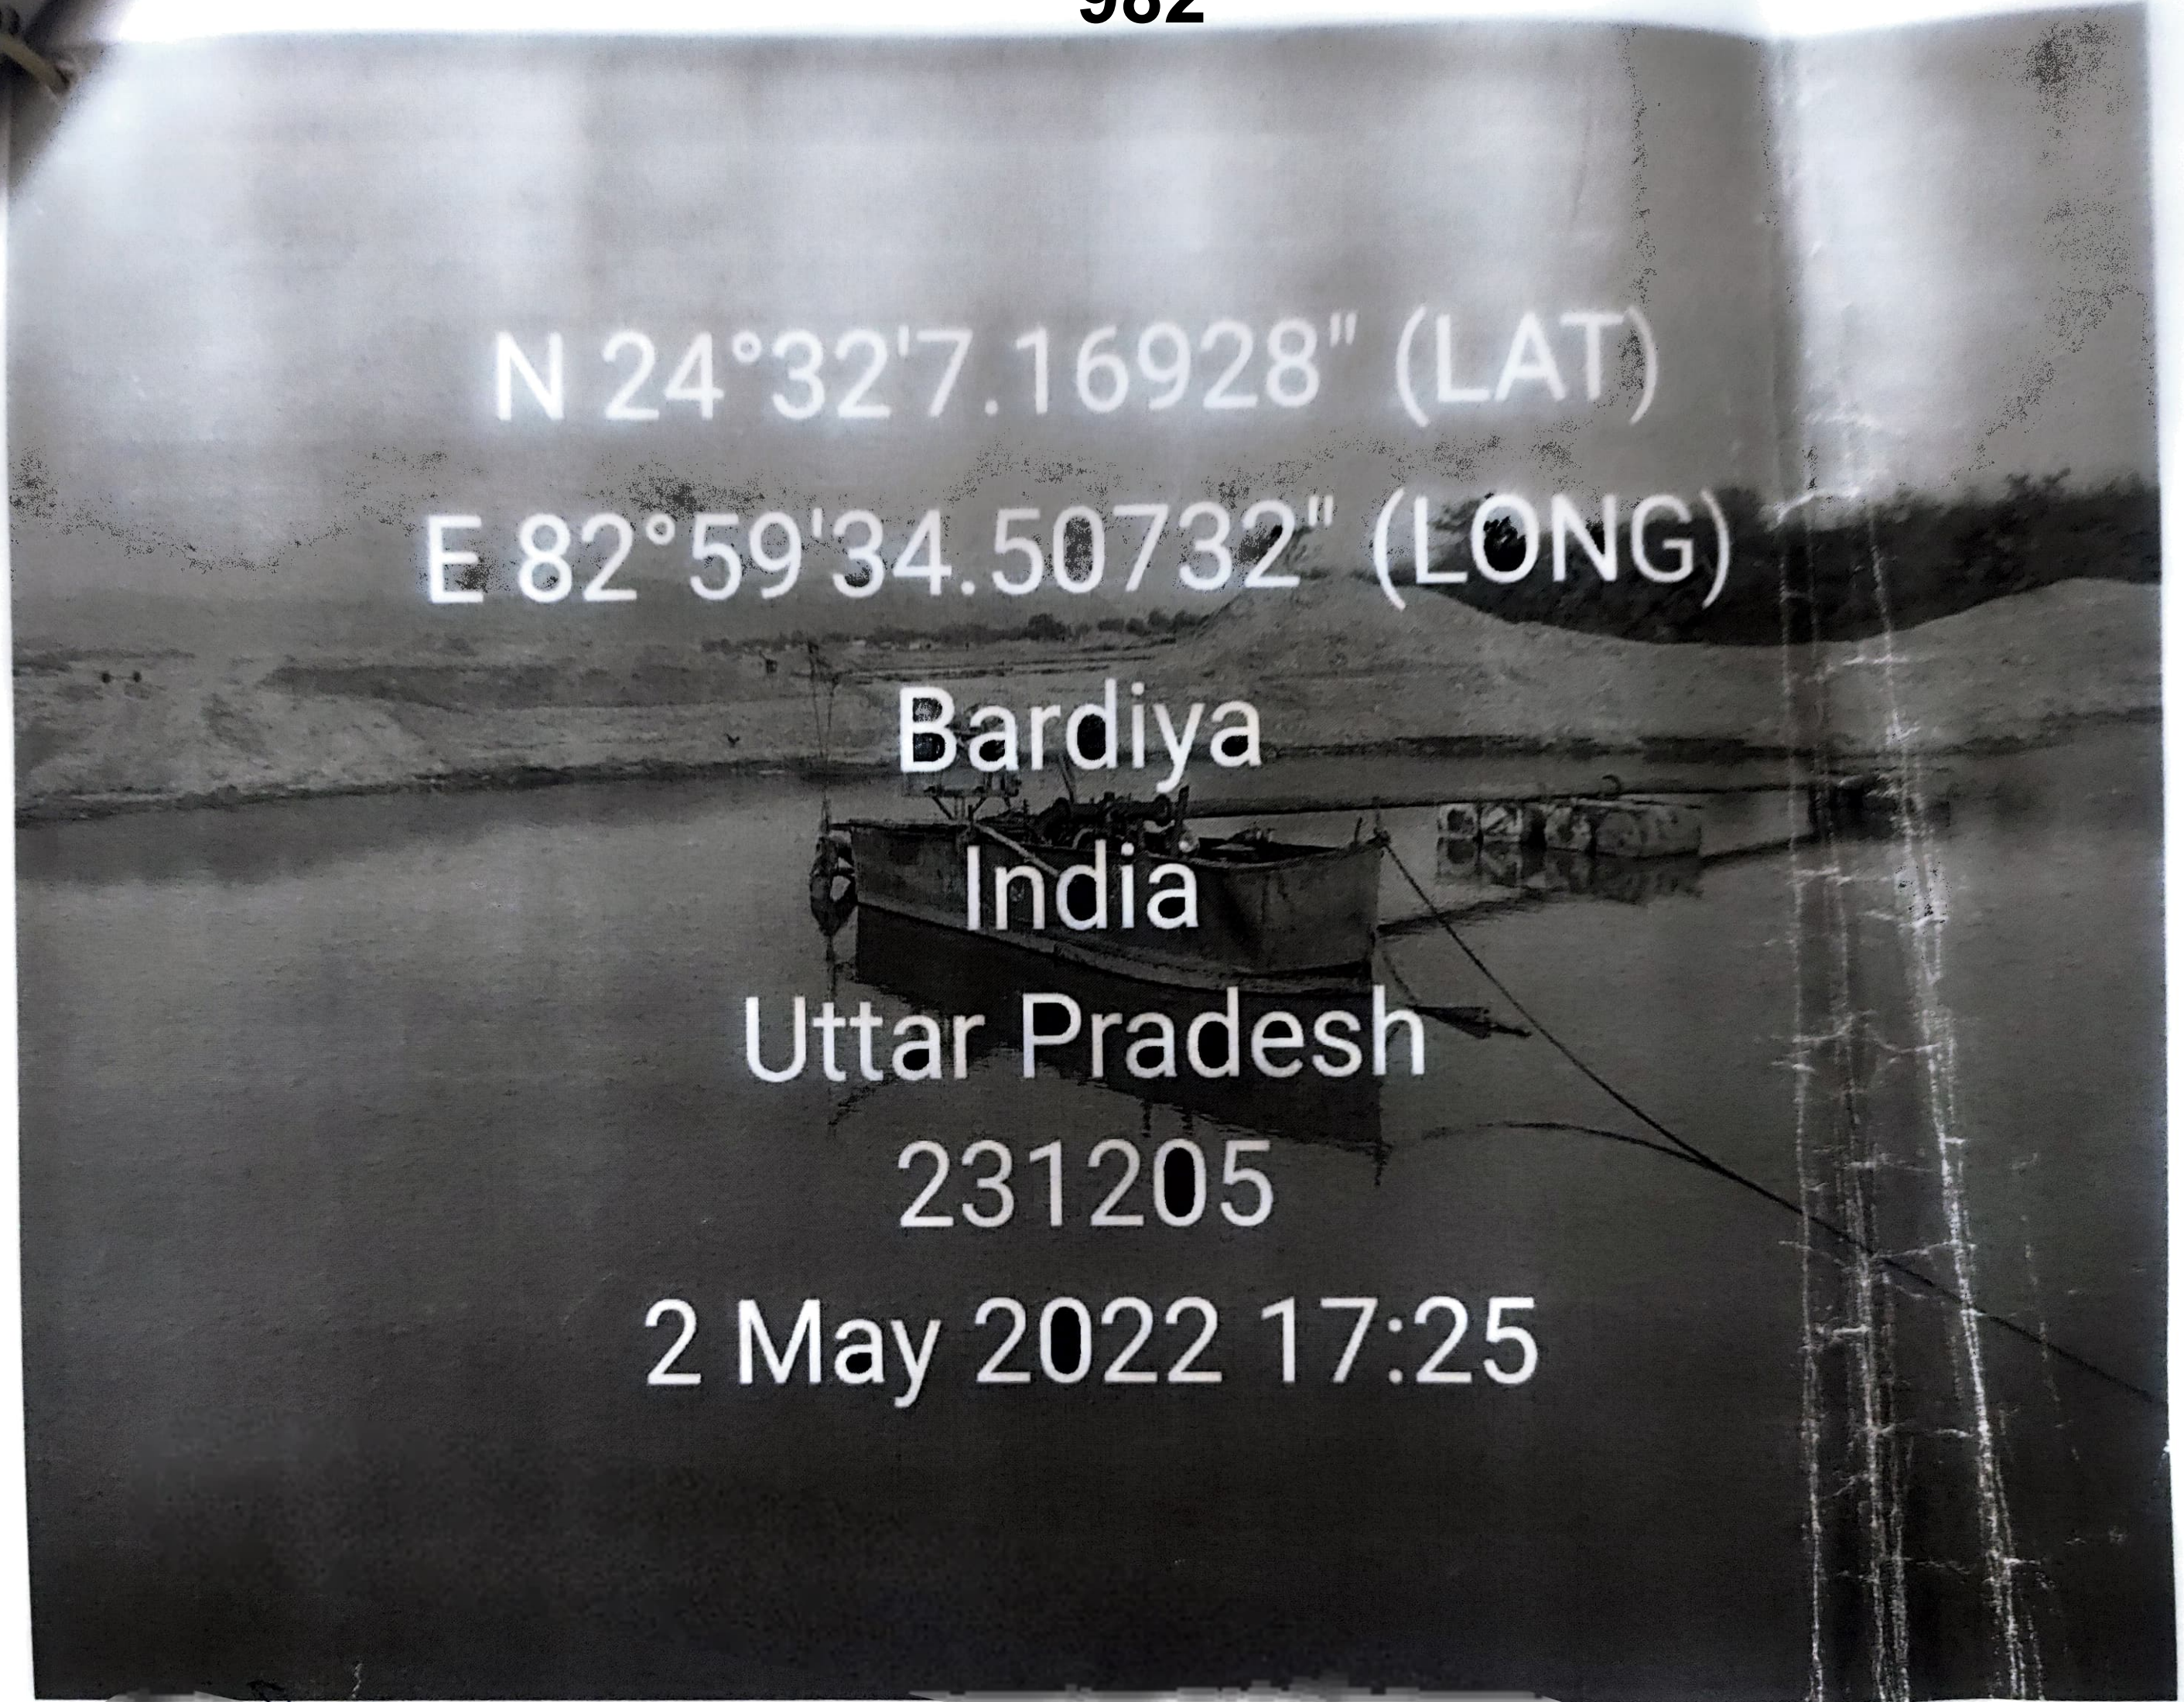
N 24°32'7.01988" (LAT)
E 82°59'35.38788" (LONG)
Bardiya
India
Uttar Pradesh
231205
2 May 2022 17:39
