Action Taken Report in the Original Application No: 128/2025(WZ) of Hon'ble National Green Tribunal (NGT), Western Zone Bench (WZ), Pune

Gujarat Pollution Control Board

Date of Visit : **18/12/2025**

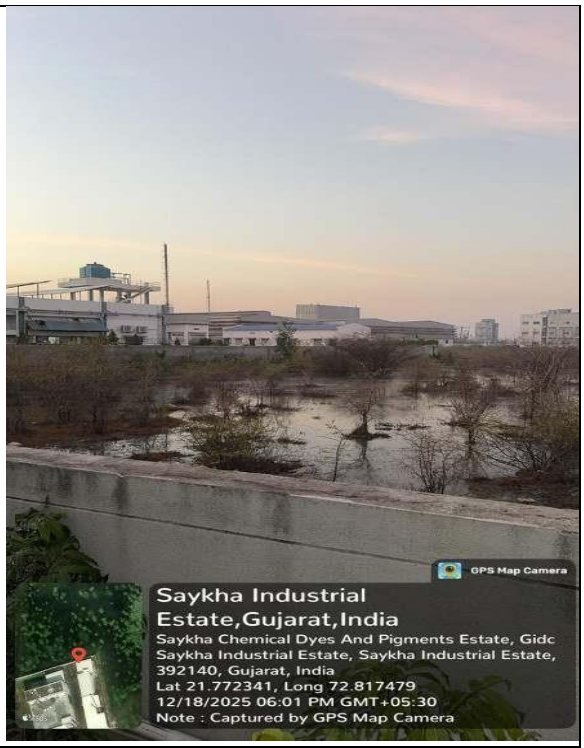
ETP area of the unit

⇒ During inspection, ETP units are found not in operation except aeration tank.
⇒ During inspection, construction work of additional ETP tanks is found under construction stage, so written instruction is given for the same.
⇒ During visit, two water samples are collected from ETP inlet (collection tank) and ETP outlet (treated w/w holding tank) for analysis purpose.
⇒ Treated wastewater is being discharged in to CETP Saykha through above ground pipeline (recently done) though GIDC sub-pumping station S-4C and PS-4. During visit, discharge is not observed.
⇒ Unit is not maintaining the record for logbook of ETP operation, so written instruction is given for the same.

2.11	Any bypass/ponding/accumulation of wastewater inside or outside the premises observed	⇒ During visit, no live discharge observed from this unit to outside premises. ⇒ During visit, it is observed that contaminated water ponding observed on open GIDC plot adjacent to boundary wall. Unit is asked to clarify the same. However, one water sample is collected from the same accumulated wastewater ponding for fingerprint analysis.

Construction activity observed going on in ETP for additional tank	Contaminated water found accumulated in open plot located back and sadjacent of the unit

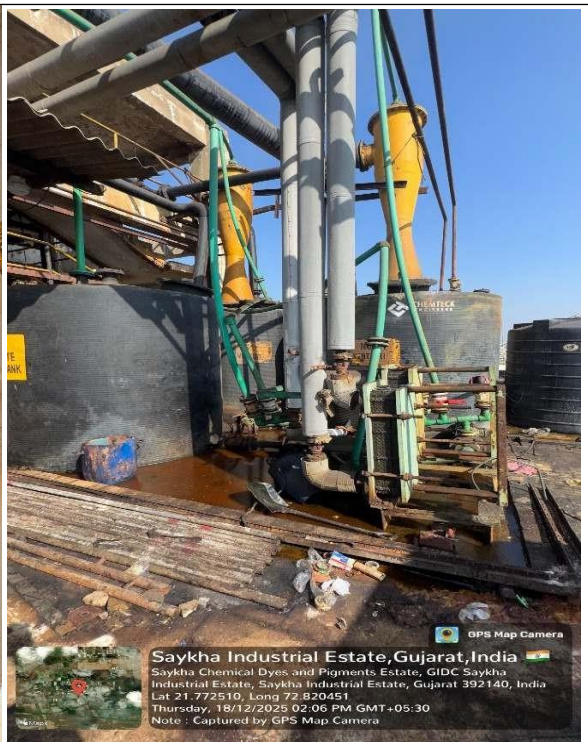
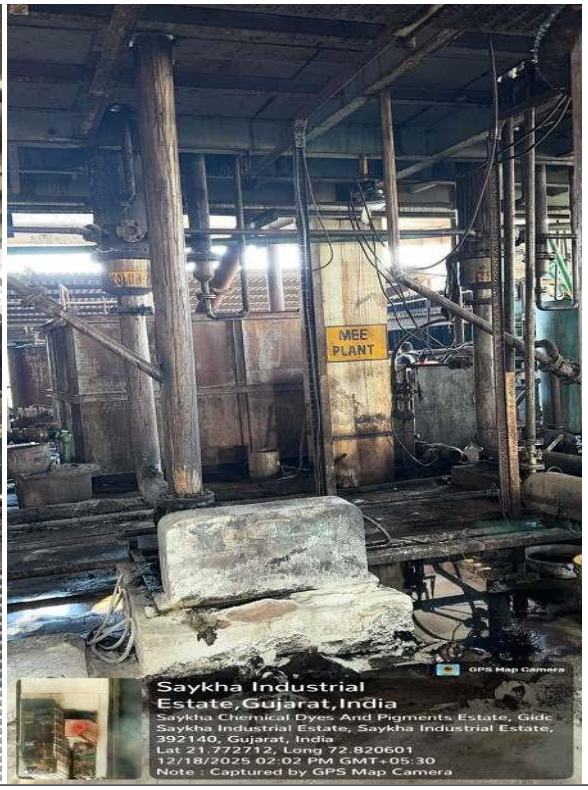
⇒ All over housekeeping in manufacturing plant area, ETP area, scrubber area, hazardous waste storage area are found poor due to leakages/ spillages which need to improve.

Leakages/ Spillages are found in Plant premises and in production plant, ETP/MEE area, scrubber area

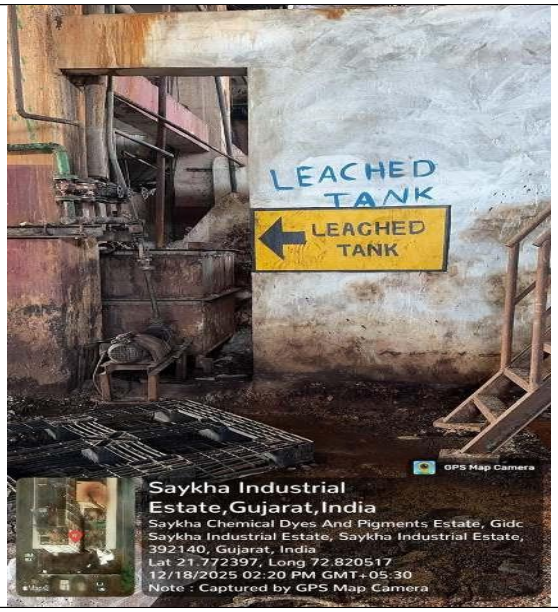
Pump provided in leachate collection tank was found non operational

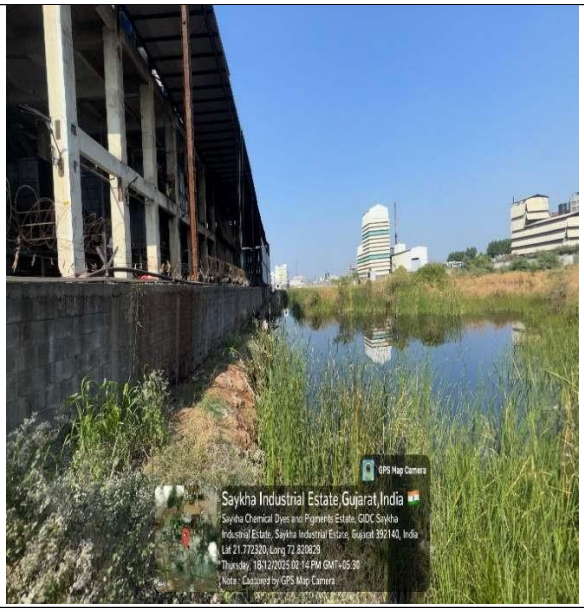
2.11	Any bypass/ponding/accumulation of wastewater inside or outside the premises observed	⇒ During visit, it is observed that contaminated water ponding (total area @ 4800 sq.mt, @ 1.5 to 2 ft uneven depth) on GIDC open plot adjacent to boundary wall of the unit. However, one water sample is collected from the same pond for fingerprint analysis. ⇒ During visit, no live discharge observed from this unit to outside premises.

Contaminated water found accumulated in open plot located at adjacent to unit in East direction.

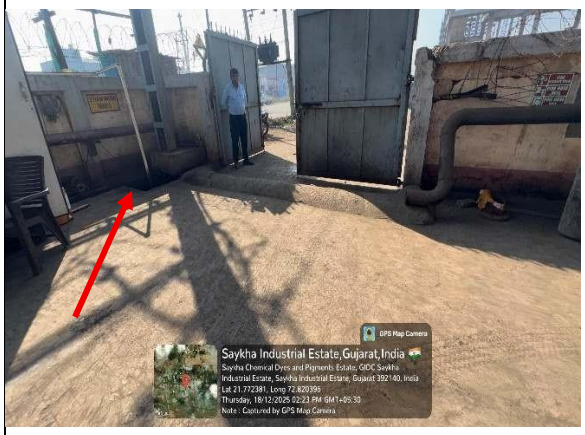
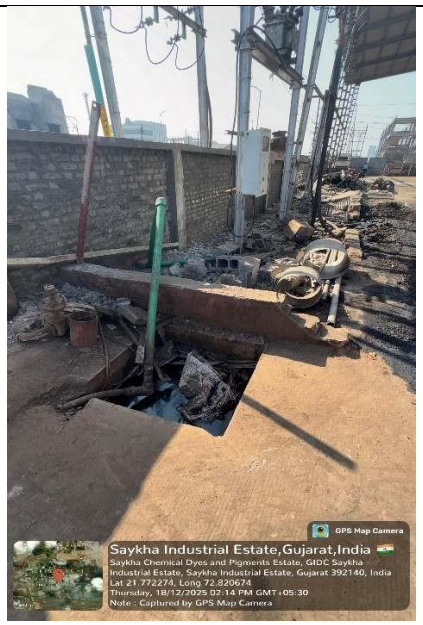
Gypsum, iron sludge stored in Hazardous waste storage area.

Collection pit provided near main gate and gate no.2

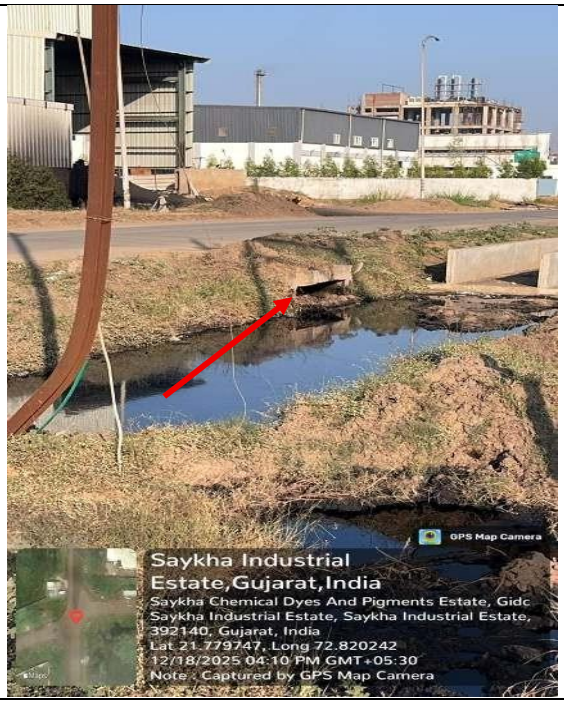
5. Other Observations		
⇒ During inspection, behind boiler area live discharge of untreated wastewater (dark blue colored) flow falling from roof top (drain provided for rain water disposal in roof top) which is directly enter in to GIDC kachha SWD drain outside the premises and going towards south direction (after GIDC road crossing) in to open GIDC plot/ land and spread up to 250 m area where dark blue colored wastewater ponding/ puddle observed (approx. area of w/w puddle is @ 12000 sq.mt having @ 0.5 to 1 ft uneven depth) and also top soil is found contaminated. Upon asking and verified, this wastewater is generated from washing activity of SFD feed tank. Hence, unit is discharging untreated washing wastewater without any treatment to directly GIDC open kachha drain and plot/ land and violates consent condition instead taking it to ETP. Looking to site condition inside and outside premises it seems that unit may regularly discharge this washing wastewater to outside premises.

SFD feed tank from which dark blue coloured washing wastewater generated which was going outside premises through live discharged

Live discharge of dark blue coloured wastewater by free fall from roof top drain provided in shed

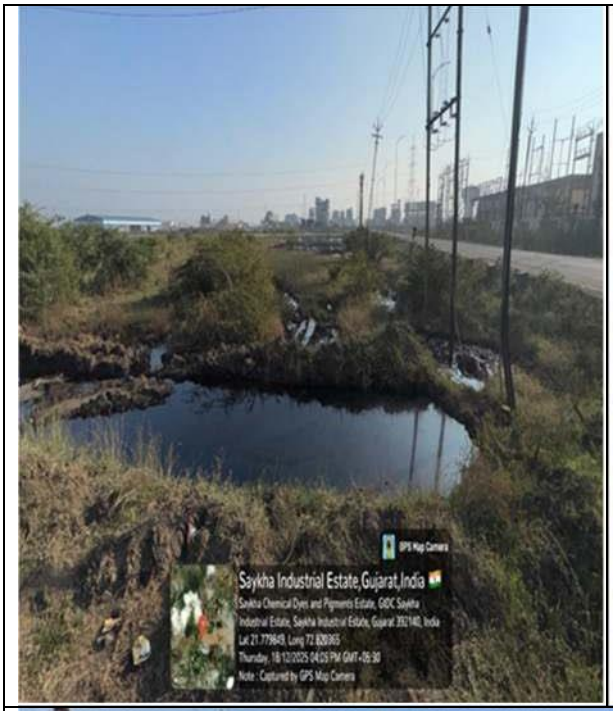
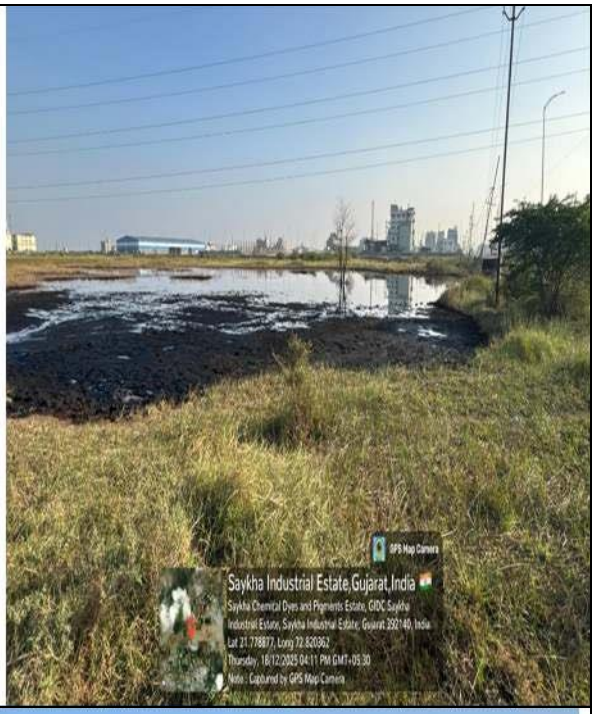
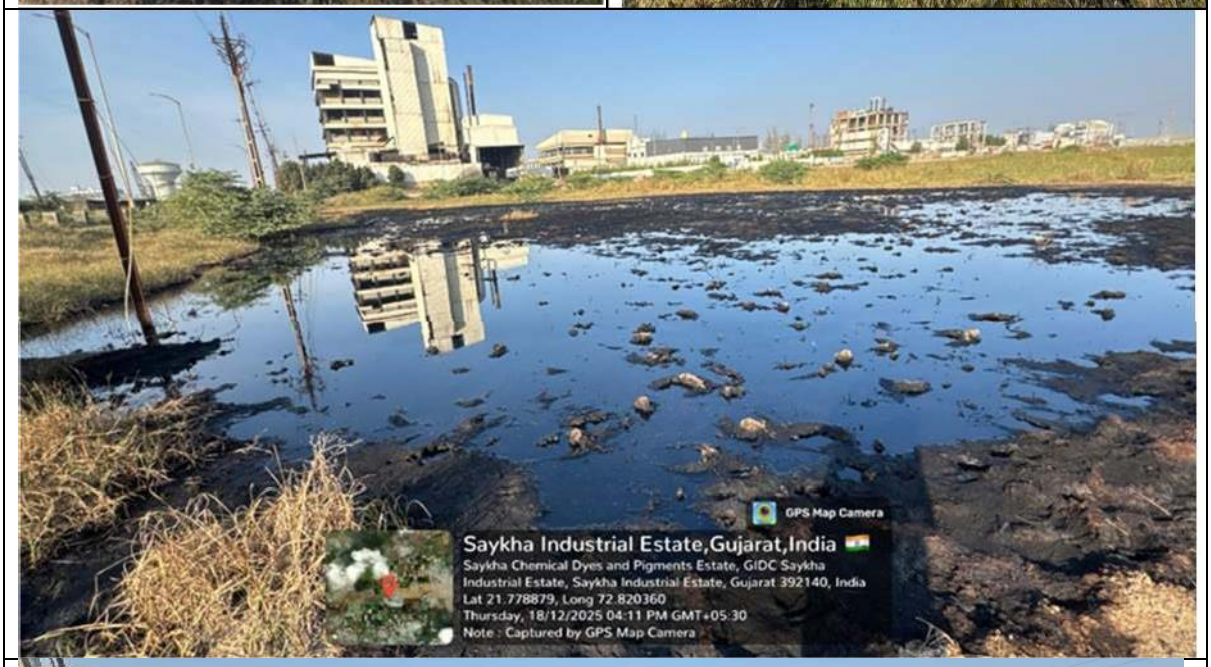
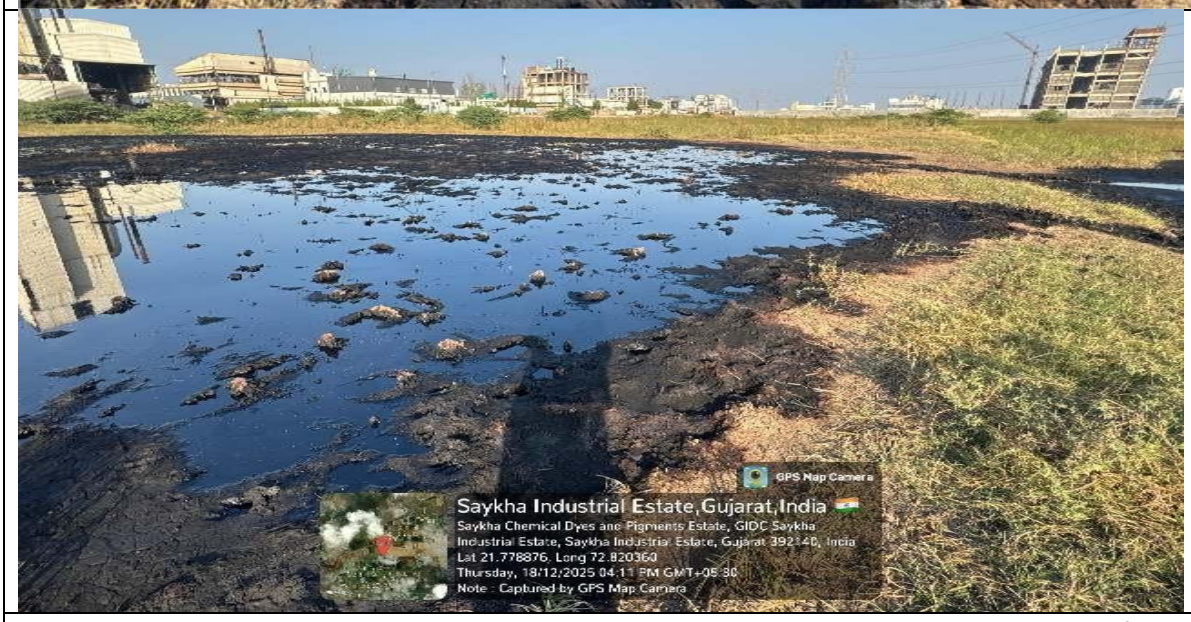
connectivity to CPCB/GPCB server	
2.11	Any bypass/ponding/accumulation of wastewater inside or outside the premises observed	⇒ Yes, live discharge of untreated wastewater is observed from unit premises and going outside on open GIDC plot/ land. Details mentioned in general observation part.

Live discharge of dark blue coloured wastewater by free fall from roof top drain provided in shed is going to GIDC kachha SWD adjacent to boundary of the unit which is further leading towards South direction of open GIDC plot/land through road crossing

Accumulated dark blue coloured wastewater in open GIDC plot located at South direction of the unit and top soil is also found contaminated up to 250 m strech

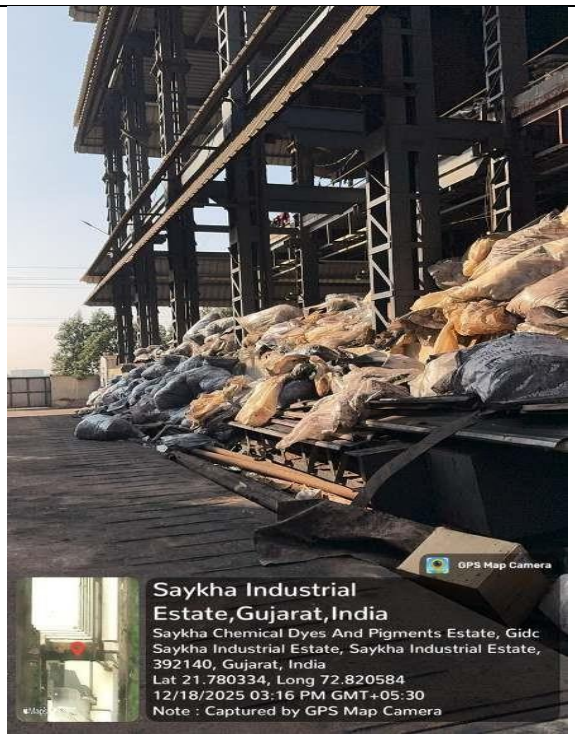
4.3	Membership certificate of common hazardous waste facility	Unit has obtained BEIL TSDF NOC for dispose of 30 MTA landfilling hazardous waste
4.4	**Non-compliance observed under Hazardous waste management**	
	Contaminated bags/liners/ carboys/barrels are found stored hap-hazard manner in covered shed in one portion of production plant and some quantity also in hazardous waste storage area besides ETP which is found full and some portion is lying down outside the shed. Unit need to dispose it as per consent condition on regular basis and provide adequate hazardous waste storage area.

Hap hazard manner storage of contaminated bags/ liners

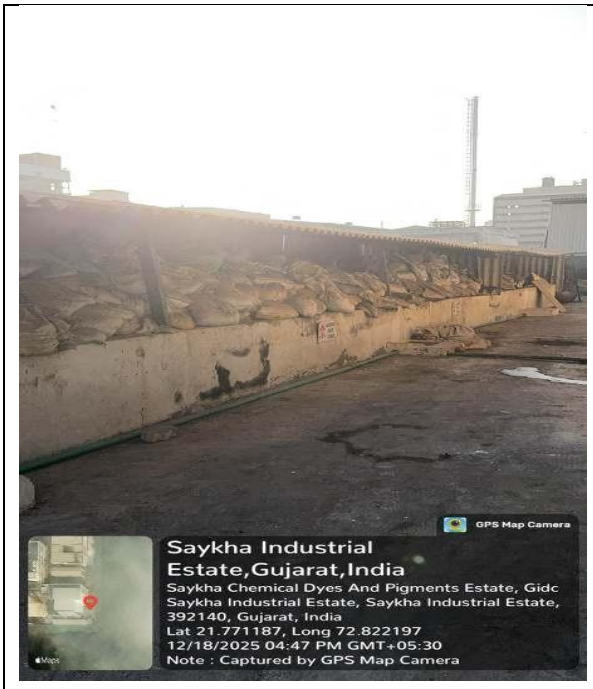
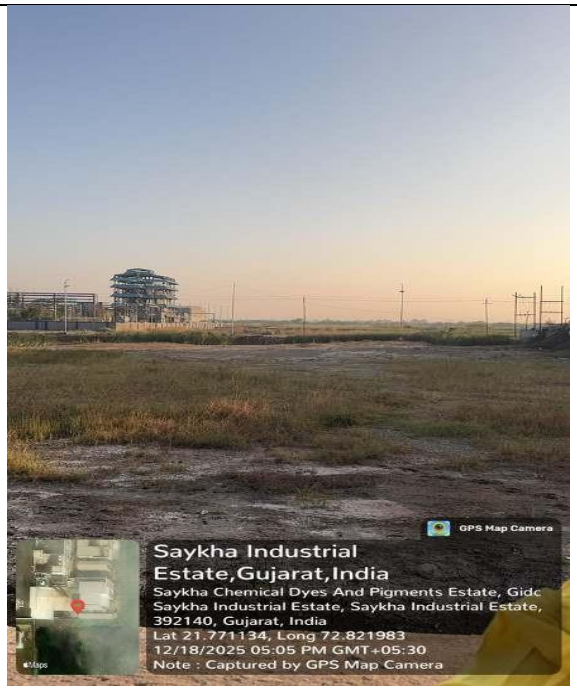
⇒ Earlier Boad had issued NOD for wastewater going outside premises through boundary wall seepage which is found concreting / sealed by the unit and back side area found dry. (photograph attached)

Wastewater discharge was not observed from the boundary wall of the unit.

Housekeeping found good within plant premises

Hazardous waste storage area	Wastewater discharge was not observed in open located at back side of the unit and found dry during inspection

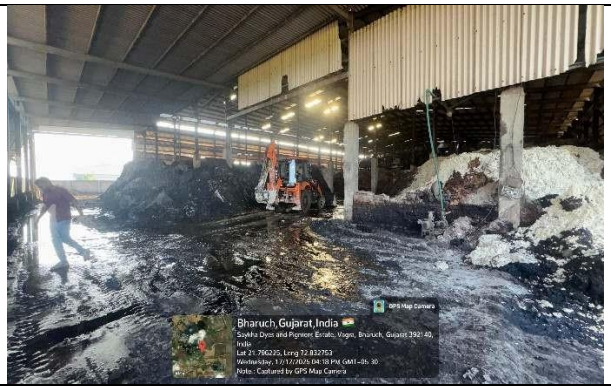
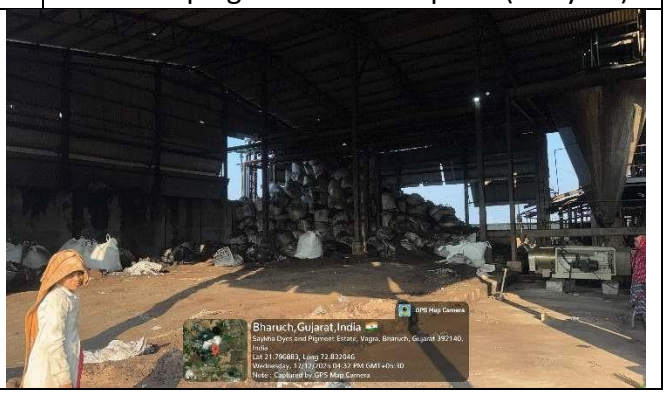
2.11	Any bypass/ponding/accumulation of wastewater inside or outside the premises observed	⇒ During inspection, no any bypass or illegal wastewater discharge observed from this unit. ⇒ In plant area, scrubber area leakages of pumps are observed and due to this these area housekeeping was found poor. Unit is instructed to do regular maintenance to avoid such situation. However, provided area is acid brick lining and the leakage area was limited for respective plant and no spilled material was released outside the plant.

Leakages in production plant area

Housekeeping behind H acid plant (LSP yard)

Huge quantity of gypsum and iron sludge, SD/ MEE salt fund stored in covered shed
