## [NATIONAL] GREEN TRIBUNAL

**O.A No. 437/2023** (O.A No. 68/2023/EZ)

## AFFIDAVIT OF COMPLIANCE FILED BY DEPUTY COMMISSIONER / DISTRICT MAGISTRATE, DHANBAD, JHARKHAND.

विषयः– भारत कोकिंग कोल लिमिटेड के अंतर्गत ईस्ट झरिया क्षेत्र के भौंरा में दिनांक 09.06.2023 को चाल धँसने की घटना के संबंध में।

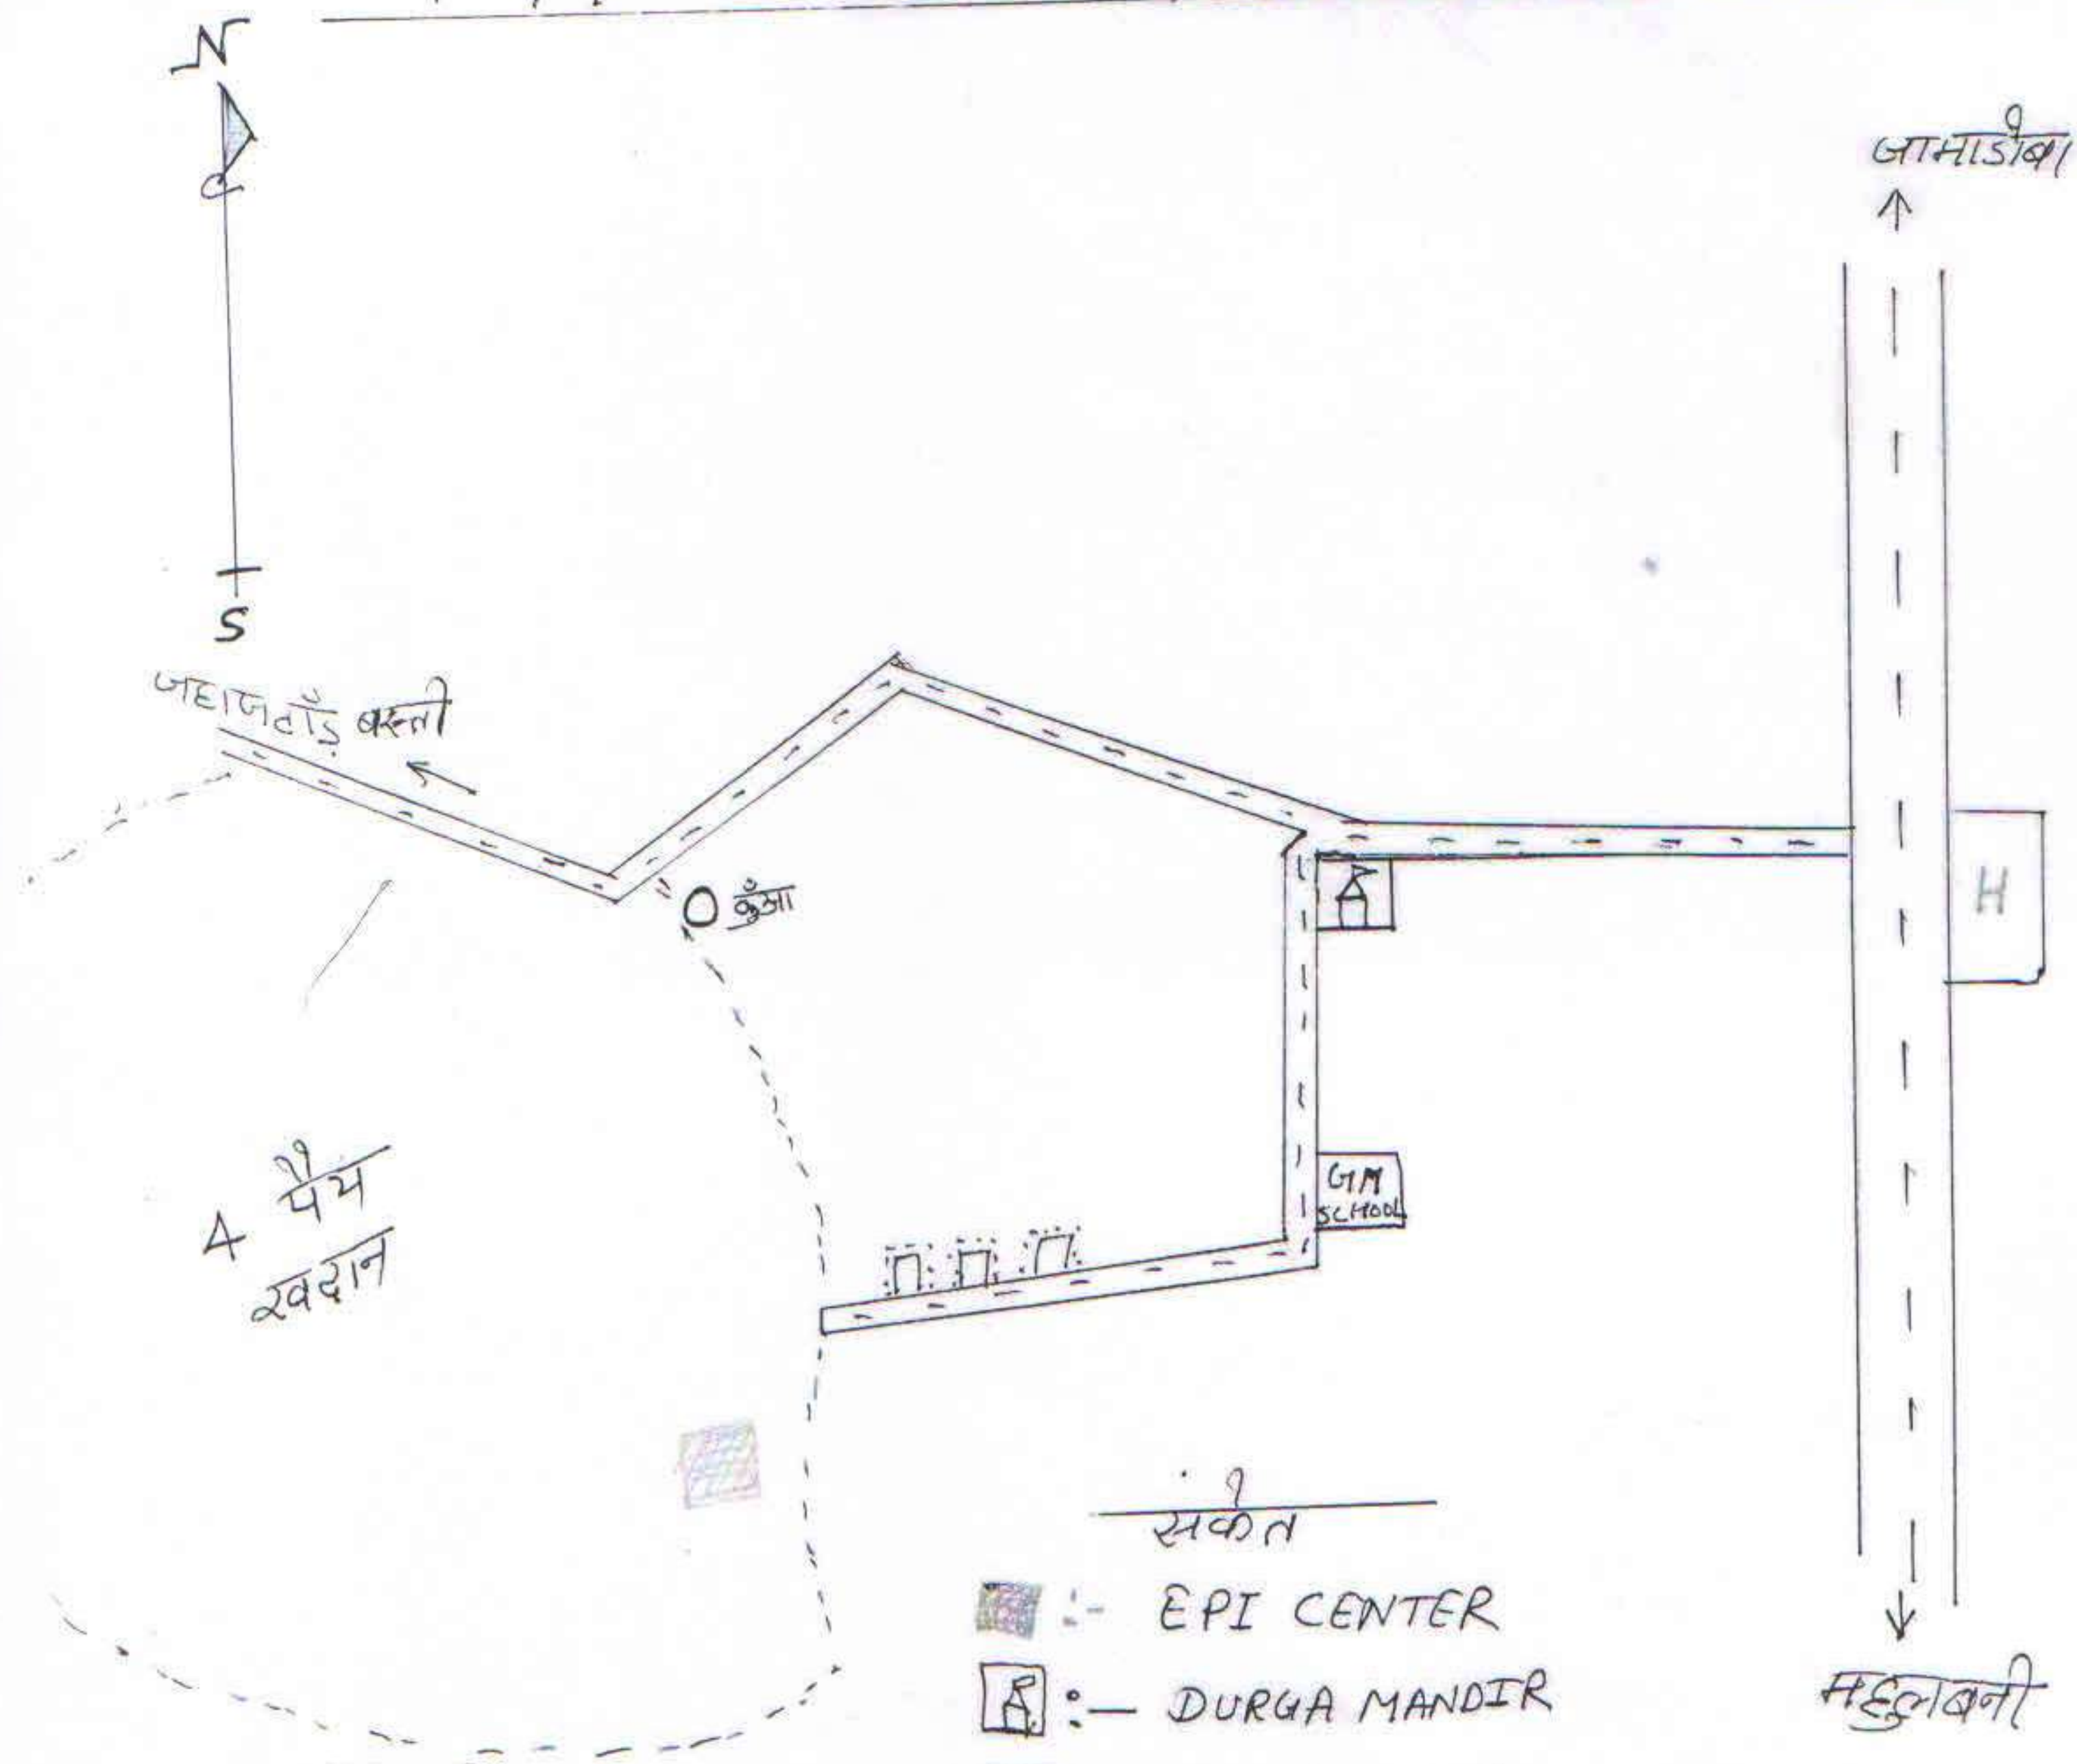
# नजरी नक्शा

यह घटना दिनांक–09.06.2023 को पूर्वाहन लगभग 09:00 बजे की है। घटना स्थल भौंरा 12 नं0 बस्ती के पास 3 पीट और 4-A पैच के पास का Open Cast Mining परिसर के अंदर का क्षेत्र है। जिसकी नजरी नक्शा संलग्न है।
