IN THE NATIONAL GREEN TRIBUNAL, EASTERN ZONE ENCH

ORIGINAL APPLICATION NO. 26 OF 2023

PI VANRAMCHHUANGI … APPELLANT

UNION OF INDIA & ORS. … RESPONDENTS

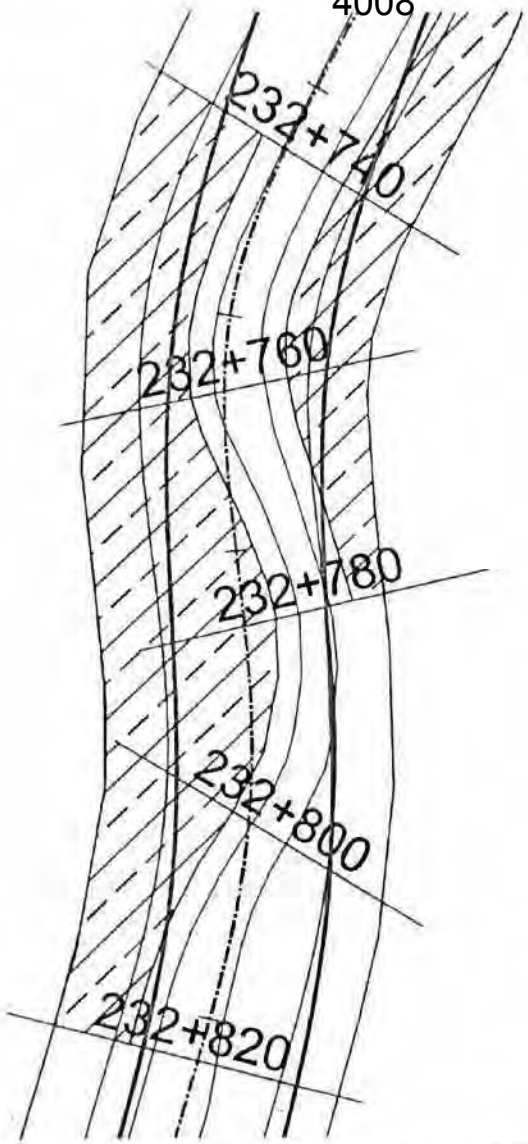
10	Lalduhawma	Bualte	110768	His complaint is that due to cutting of land on his site affectad heavy landslides, which is half part of his land	This has verified on the site and Surveyor's report states that Pu Lalduhawma's land which is beyond ROW (Right of Way) slide down affected additional damage of trees and crops	1. Pu Laldyhawma's land is situated from 232+700 to 232+780 2. The land slide in the strech after completion of earth cutting works is an act of God. 3. The continuous land slide due to heavy rain is damageing the road and causing huge irrecoverable loss to the contractor. 4. we have noted the stretch. **5. The neccssary protection works will be done in this stretch on priority basis, the weather permits and his land becomes stable.**

4. we have noted the stretch.
						5. The neccssary protection works will be done in this stretch on priority basis, the weather permits and his land becomes stable.

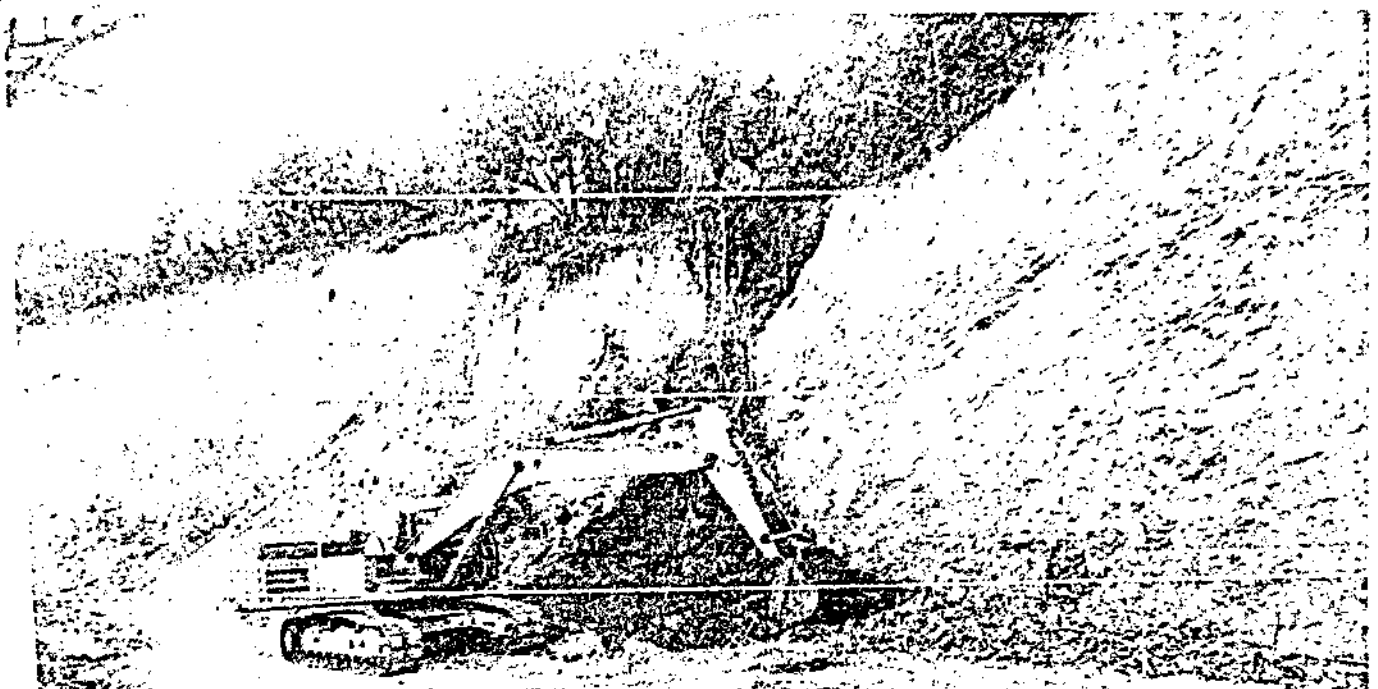
ecture-1:-

DPR Chainage - 136+840 to 136+933 Km (RHS)
Design Chainage - 139+250 to 139+270 Km (RHS)

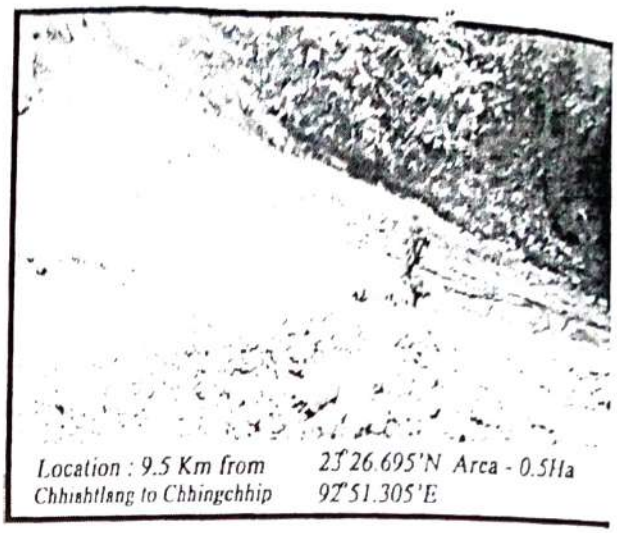
Location-2:

Location : 9.5 Km from Chhiahtlang to Chhingchhip — 23°26.695'N 92°51.305'E Area - 0.5Ha

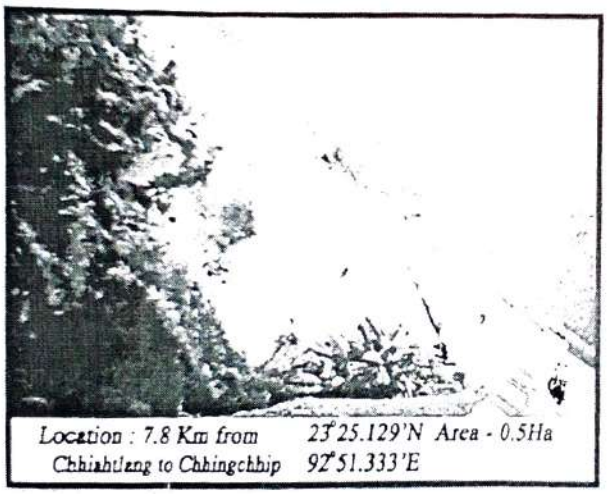
Location-3:

Location : 7.8 Km from Chhiahtlang to Chhingchhip — 23°25.129'N 92°51.333'E Area - 0.5Ha

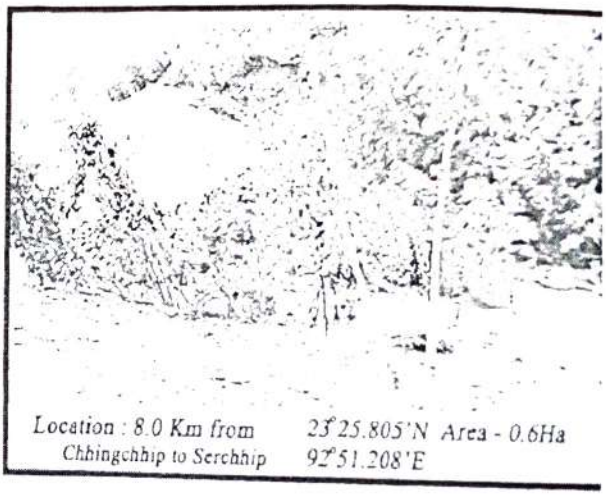
Location-4:

Location : 8.0 Km from Chhingchhip to Serchhip — 23°25.805'N 92°51.208'E Area - 0.6Ha

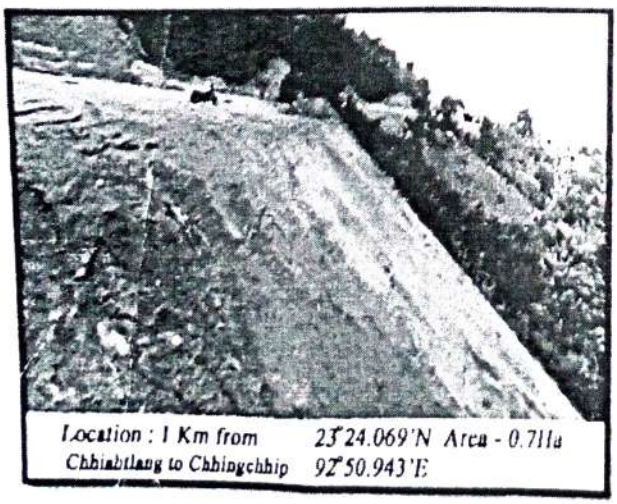
Location-5:

Location : 1 Km from Chhiahtlang to Chhingchhip — 23°24.069'N 92°50.943'E Area - 0.7Ha

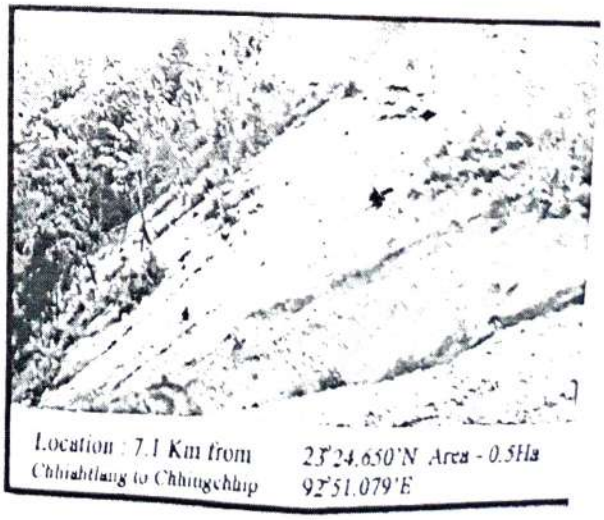
Location-6:

Location : 7.1 Km from Chhiahtlang to Chhingchhip — 23°24.650'N 92°51.079'E Area - 0.5Ha

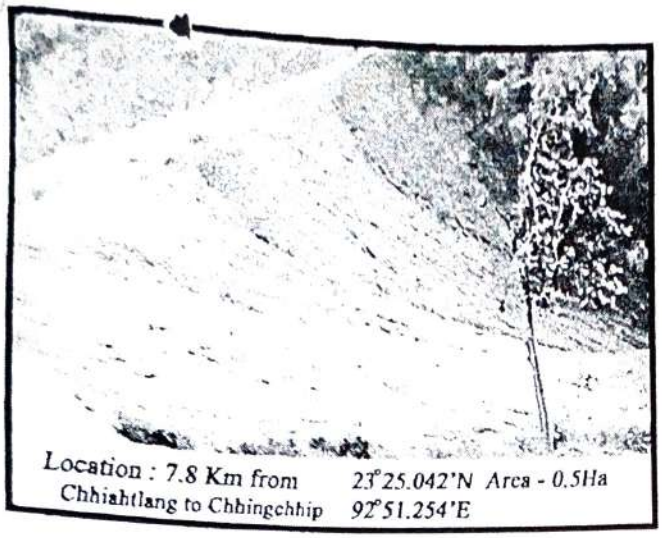
Location-7:

Location : 7.8 Km from Chhiahtlang to Chhingchhip — 23°25.042'N 92°51.254'E Area - 0.5Ha

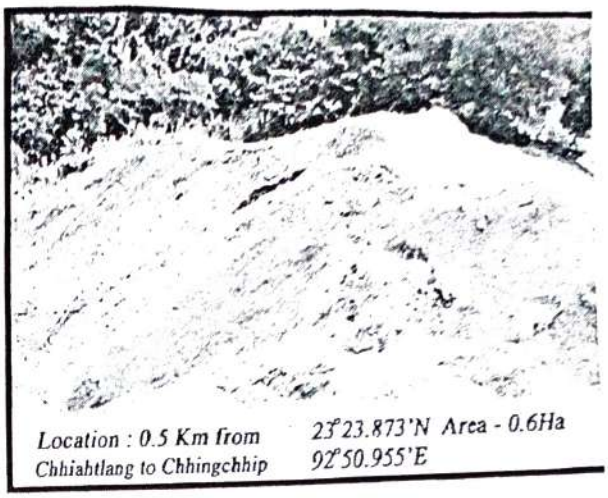
Location-8:

Location : 0.5 Km from Chhiahtlang to Chhingchhip — 23°23.873'N 92°50.955'E Area - 0.6Ha

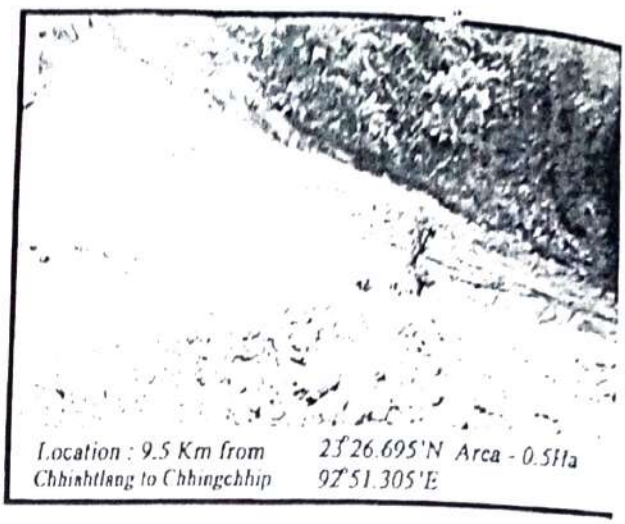
Location-2:

Location : 9.5 Km from Chhiahtlang to Chhingchhip — 23°26.695'N Area - 0.5Ha, 92°51.305'E

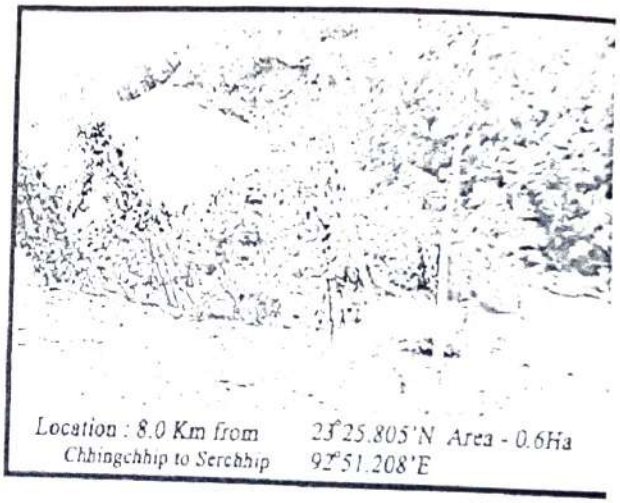
Location-4:

Location : 8.0 Km from Chhingchhip to Serchhip — 23°25.805'N Area - 0.6Ha, 92°51.208'E

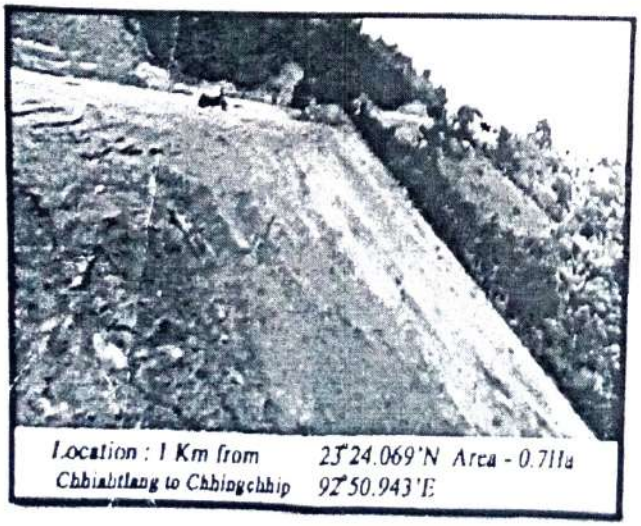
Location-5:

Location : 1 Km from Chhiahtlang to Chhingchhip — 23°24.069'N Area - 0.7Ha, 92°50.943'E

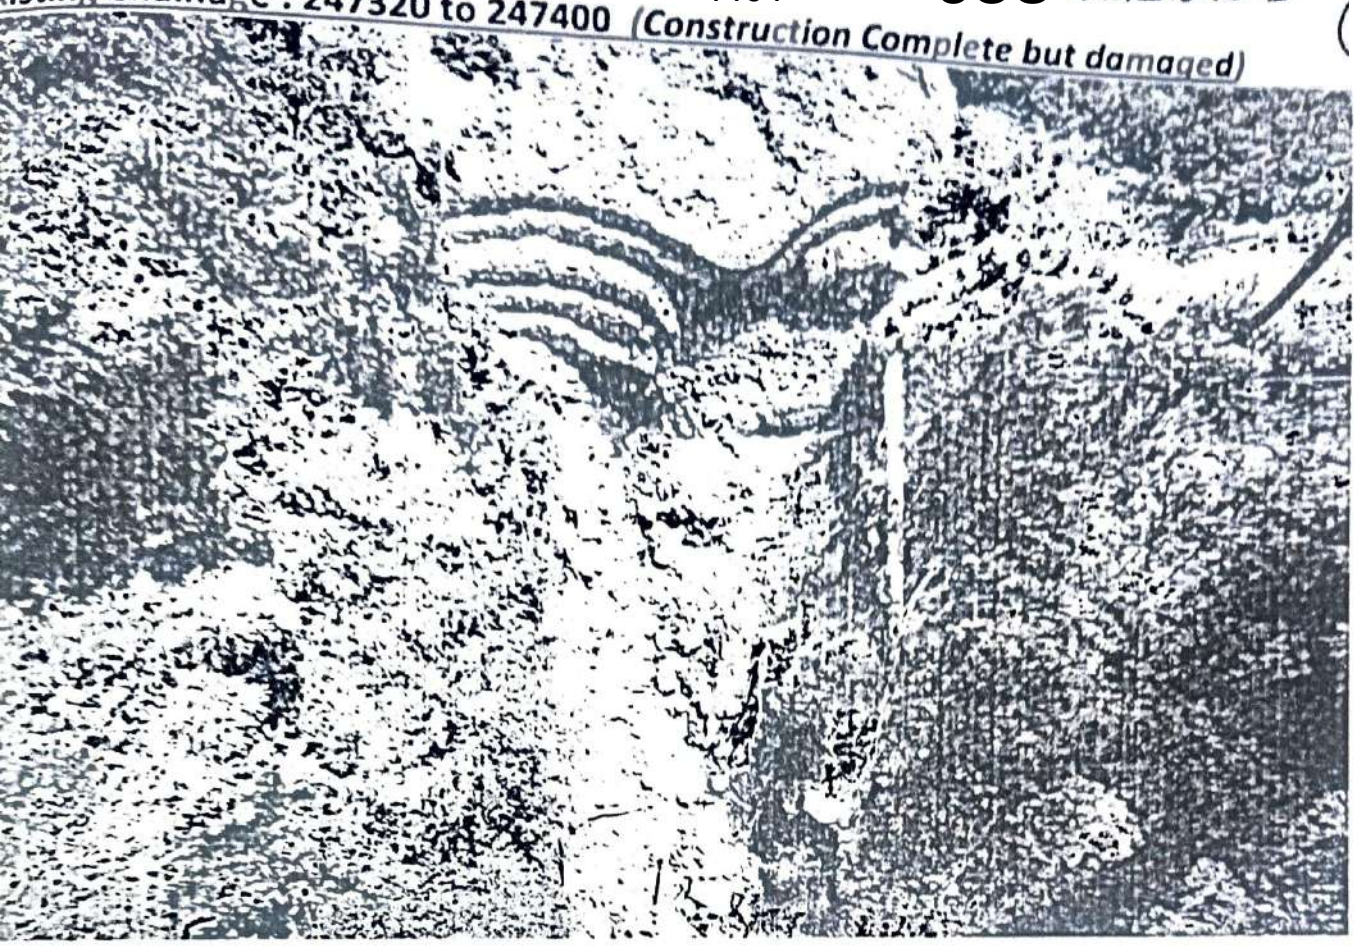
erial Photo of Sl No. 1

Existing Chainage : 247320 to 247400 *(Construction Complete but damaged)*

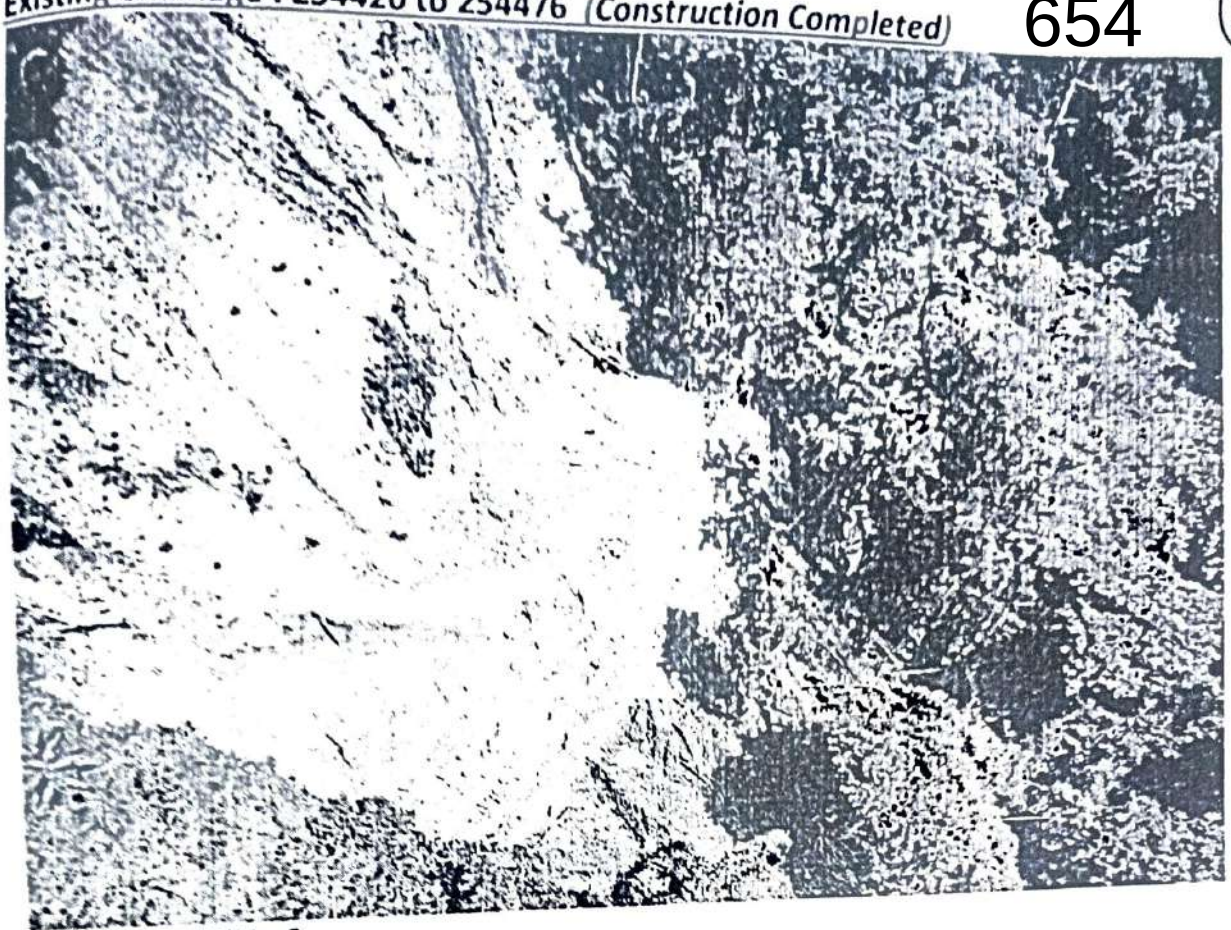
Aerial Photo of Sl No. 6

Existing Chainage : 254420 to 254476 *(Construction Completed)*

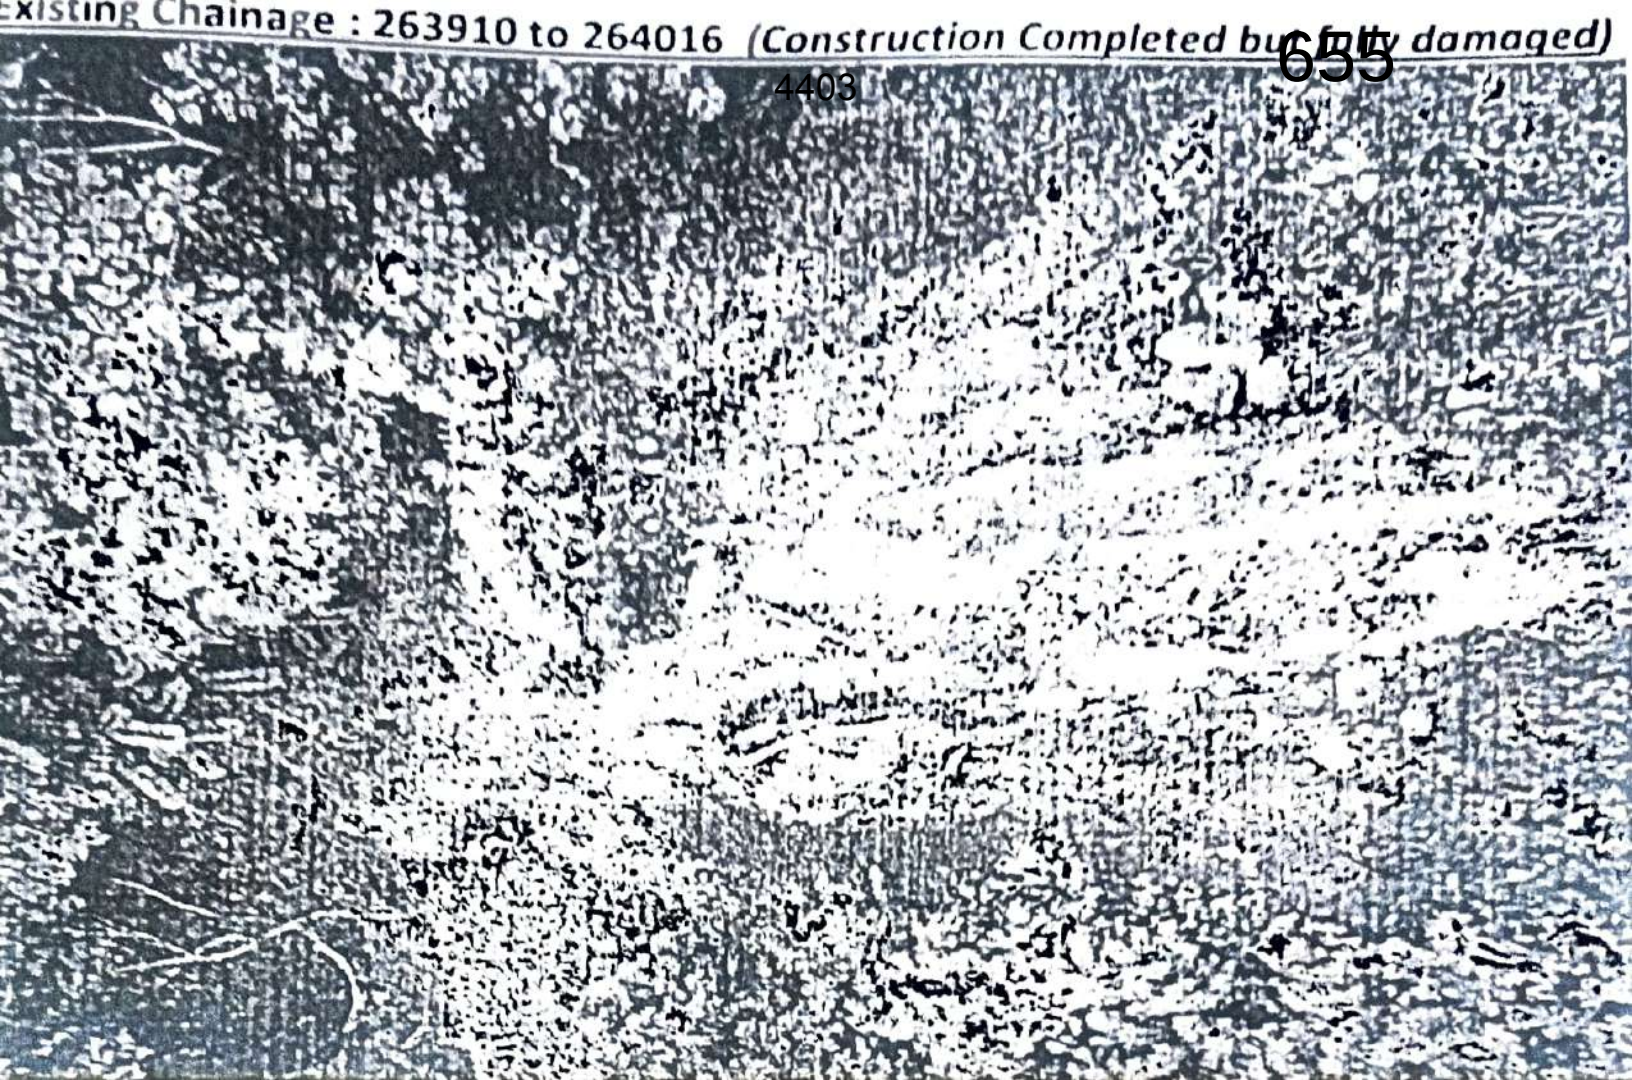
Existing Chainage : 263910 to 264016 *(Construction Completed but fully damaged)*

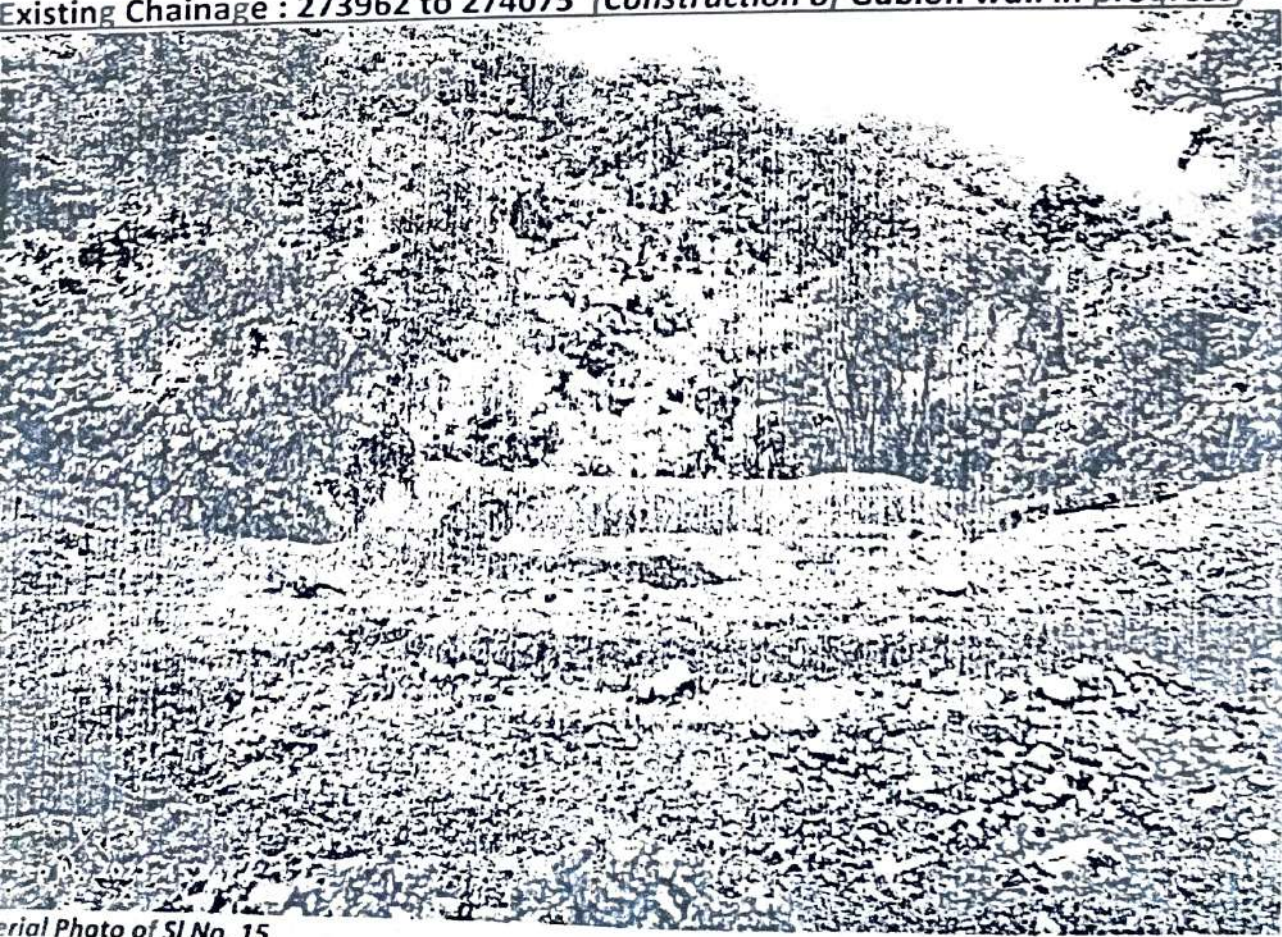
erial Photo of Sl No. 15

Existing Chainage : 273962 to 274075 *(Construction of Gabion wall in progress)*

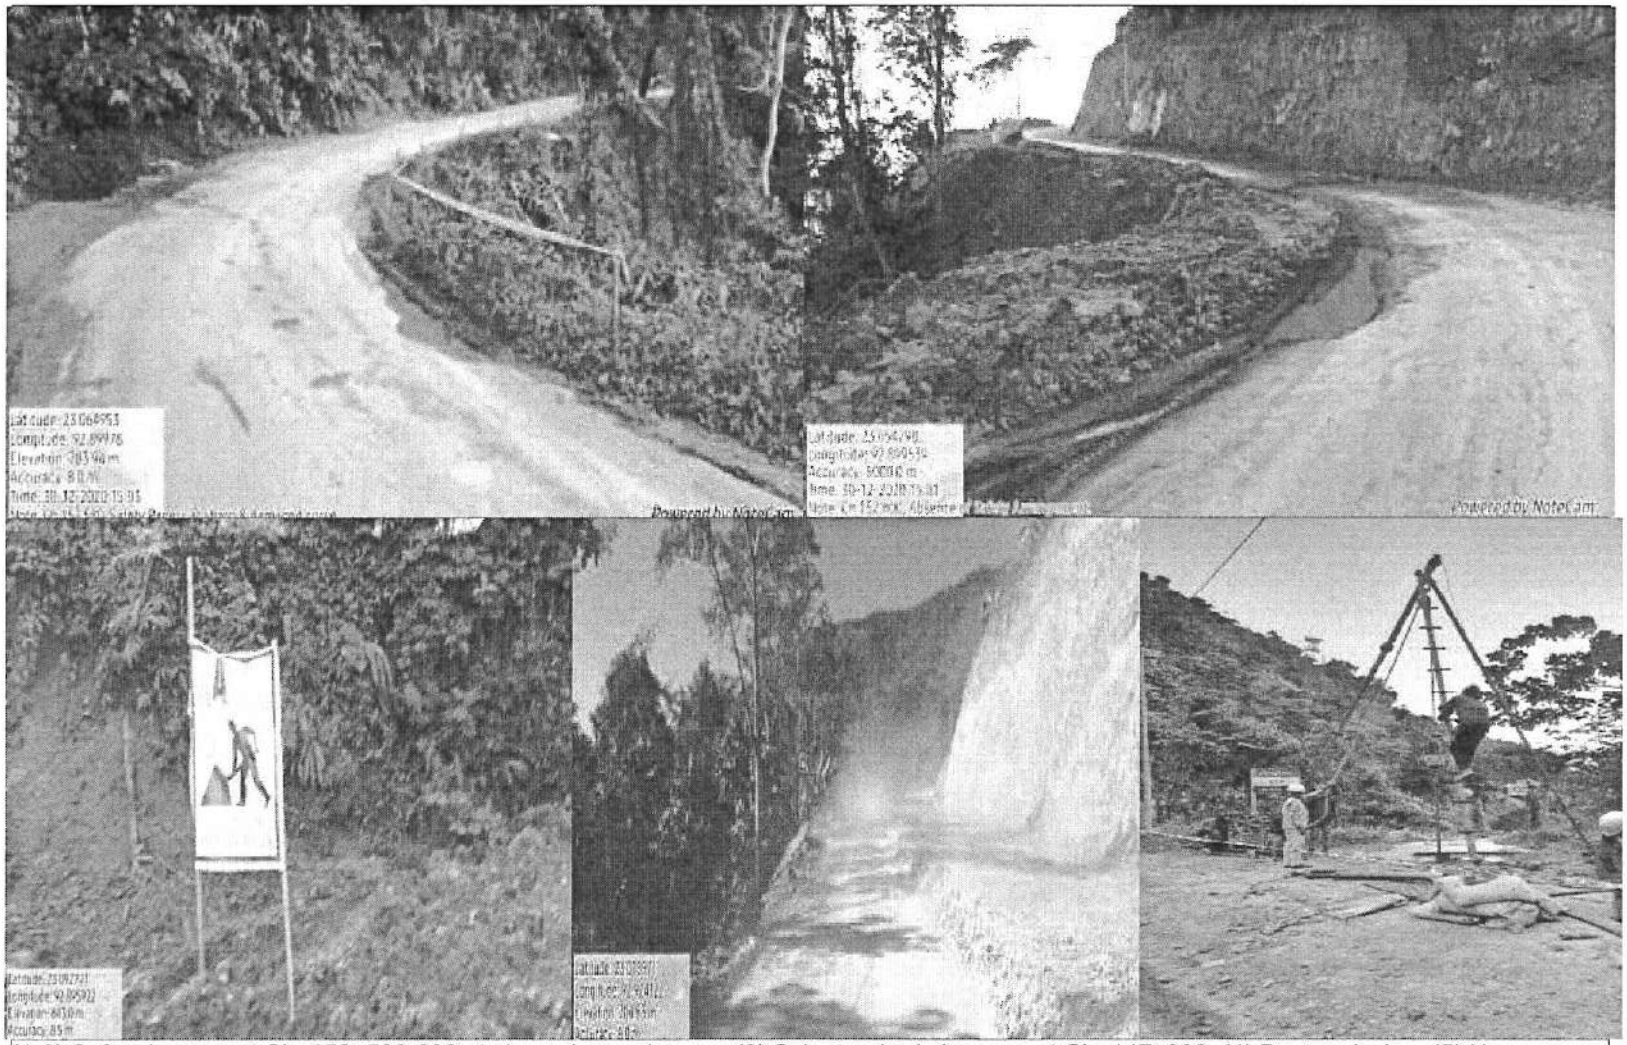
(1-2) Safety Lapses at Ch. 152+500-600 at sharp damged curve, (3) Sub standard signages at Ch. 147+800, (4) Dust emission, (5) Non usage of PPEs

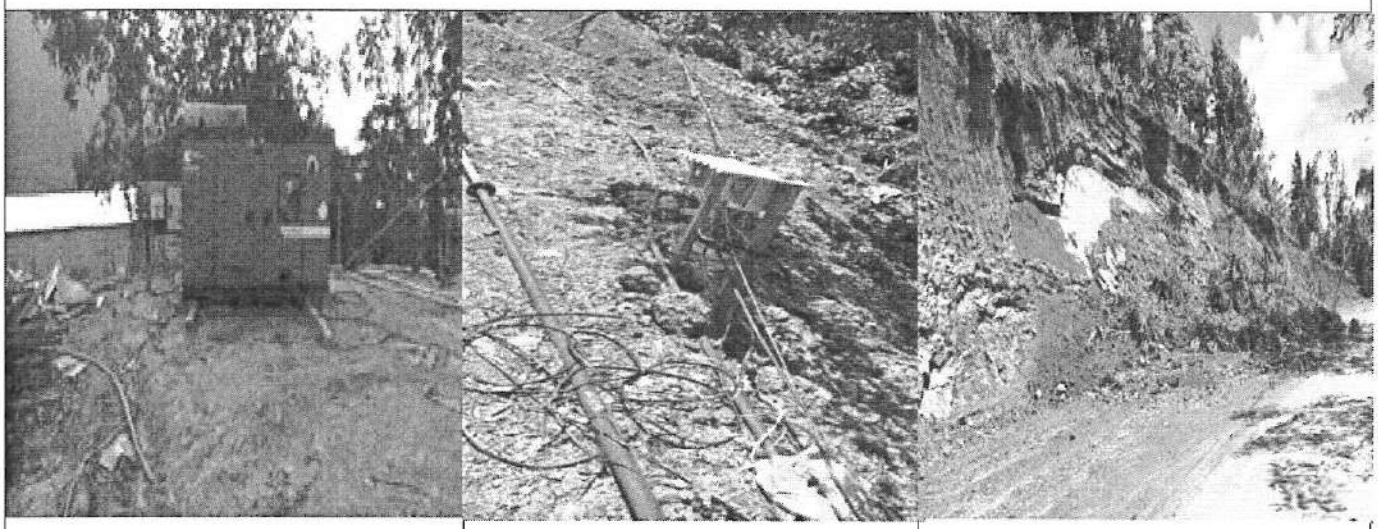
(1-2) DG set stack height, electrical hazard, (3-4) Hazard prone locaitons, (5) First aid centre, (6) Water facilitation at Staff's camp

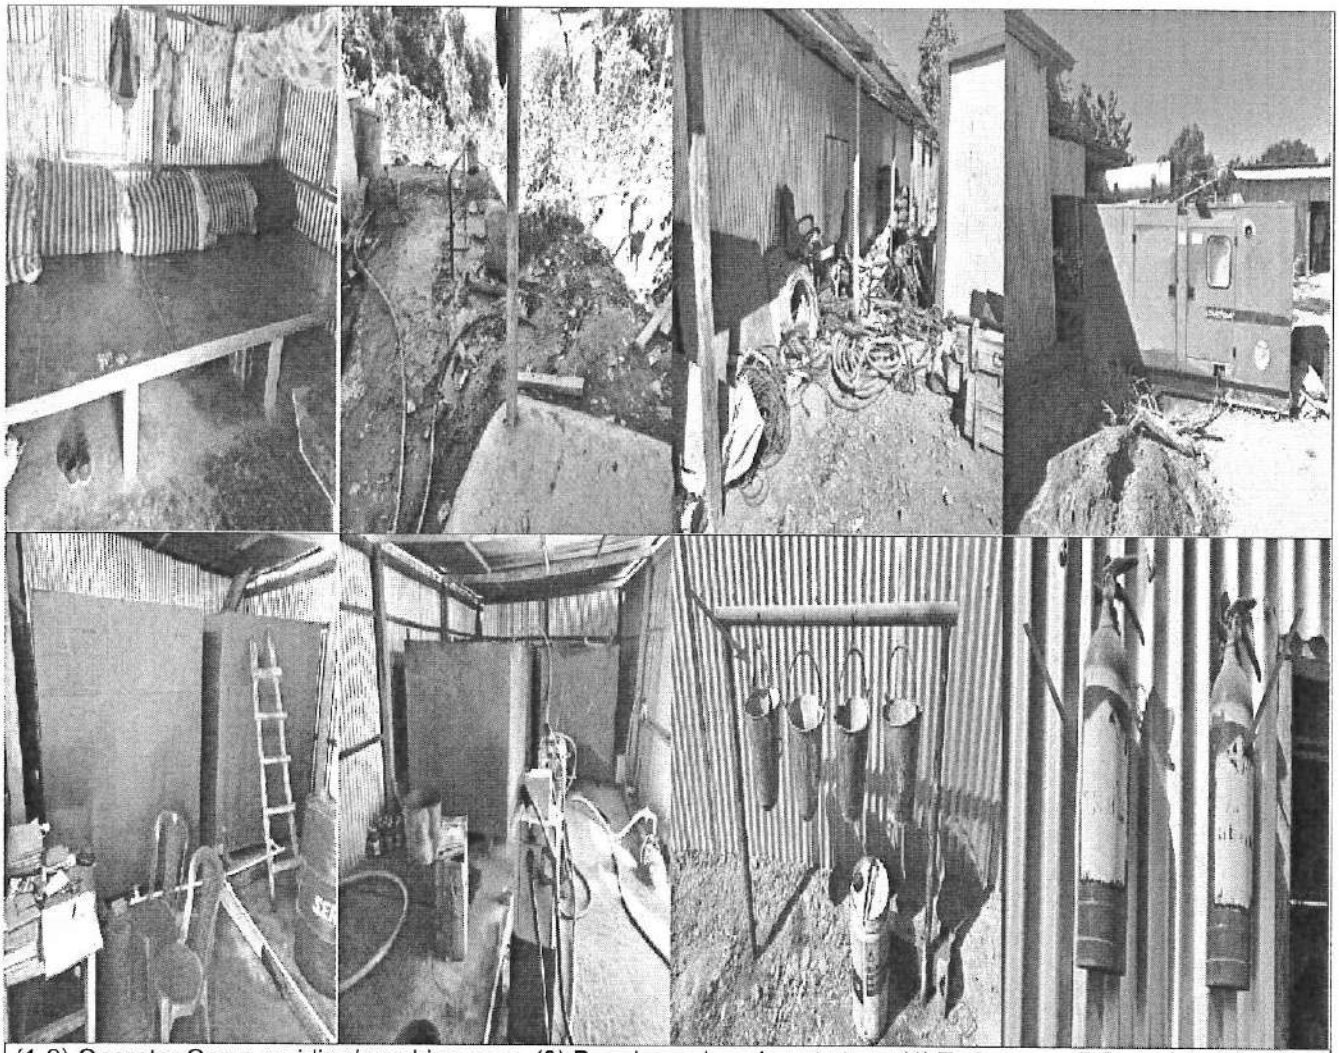
(1-2) Operator Camp residing/ washing area, (3) Poor housekeeping at store, (4) To increase DG stack height, (5-8) Fuel storage tank, Empty fire bucket & unspecified fire extinguisher

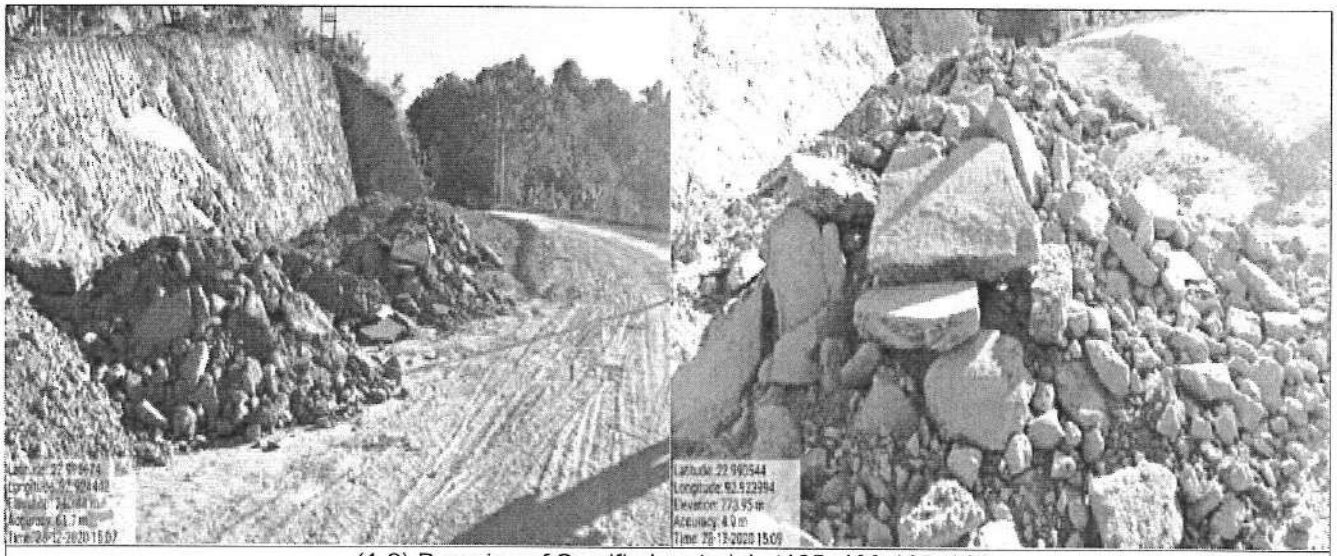
(1-2) Dumping of Scarified material at165+100-165+300
