BEFORE THE NATIONAL GREEN TRIBUNAL
SOUTHERN ZONE BENCH, CHENNAI
ORIGINAL APPLICATION NO. 291/2024 (SZ)

REPORT ON BEHALF OF DEPUTY COMMISSIONER AND THE DEPARTMENT OF MINES AND GEOLOGY

Joint Inspection Report

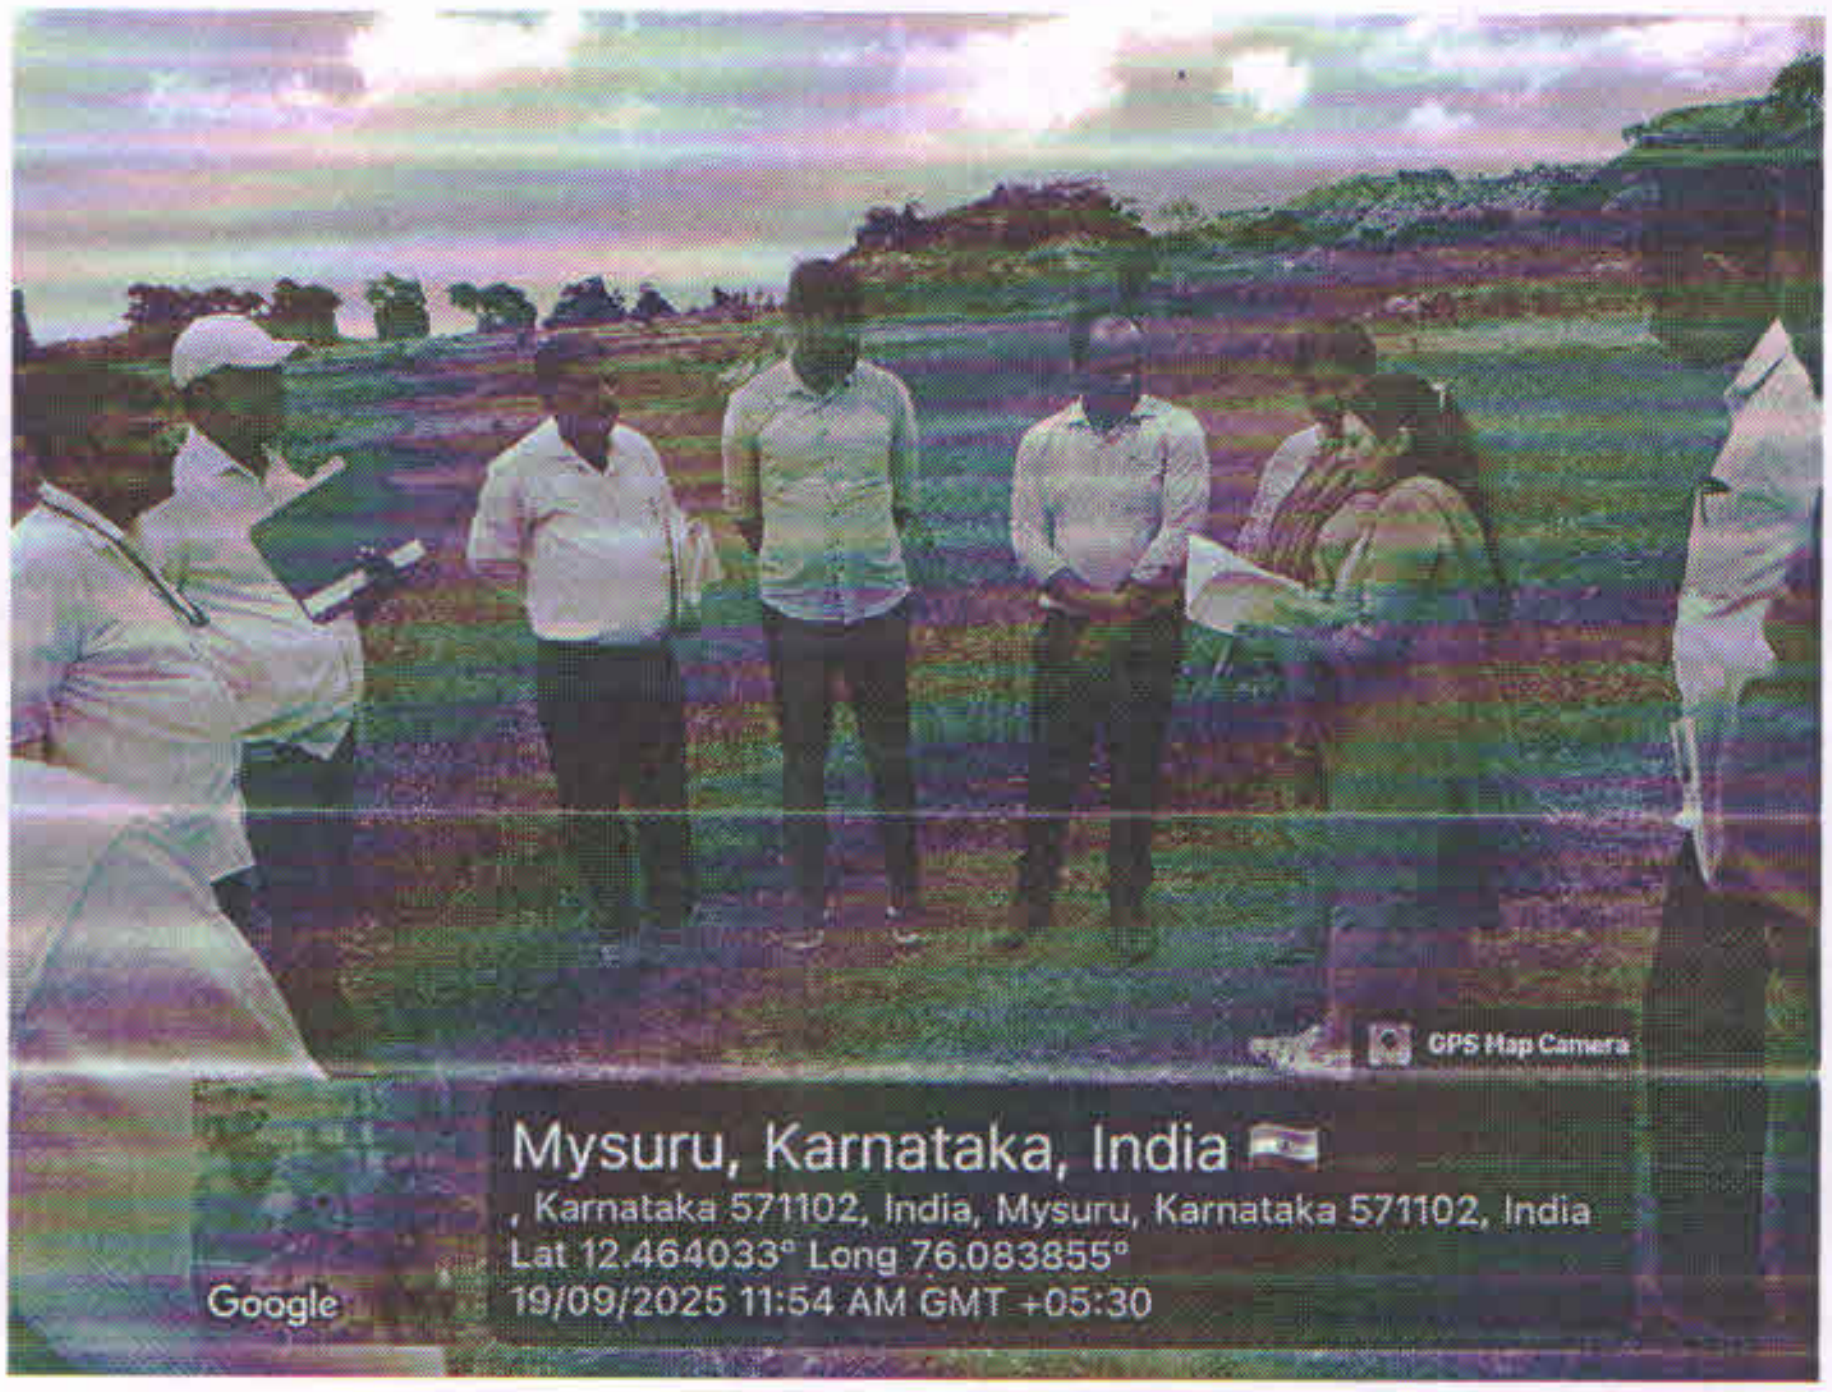
ನೈಸರ್ಗಿಕವಾಗಿ ಹರಿಯುವ ಹಳ್ಳವಾಗಲೀ ನಕಾಶೆಯಂತೆ ಇರುವುದಿಲ್ಲ. ಉಳಿದಂತೆ ಸ.ನಂ. 454, 456 ಮತ್ತು 457 ರ ಪ್ರದೇಶಗಳ ಸ್ಥಳ ಪರಿಶೀಲಿಸಲಾಗಿ ಭೌಗೋಳಿಕವಾಗಿ ಕಟ್ಟೆ ಇಲ್ಲದಿರುವುದು ಹಾಗೂ ನೀರಿನ ಸಂಗ್ರಹಣೆ ಇಲ್ಲದ ಕಾರಣ ಪರಿಸರಕ್ಕೆ ಹಾನಿಯಾಗುತ್ತಿರುವ ಬಗ್ಗೆ ಅಥವಾ ಪರಿಸರಕ್ಕೆ ಹಾನಿಯಾಗುವ ಸಂಭವವನ್ನು ಅಂದಾಜಿಸಲು ಸಾಧ್ಯವಿರುವುದಿಲ್ಲ. ಸದರಿ ಸ.ನಂ.ಗಳ ಪ್ರದೇಶಗಳಲ್ಲಿ ವಾಸ್ತವಾಂಶದಂತೆ ಕಟ್ಟೆ ಇರುವುದಾಗಲಿ ಅಥವಾ ನೀರು ನಿಂತಿರುವುದಾಗಲಿ ಕಂಡುಬಂದಿರುವುದಿಲ್ಲ. ಆದಾಗಿ ದೂರುದಾರರು ತಿಳಿಸಿರುವಂತೆ ನೀರಿನ ಮೂಲಗಳಿರುವ ಬಗ್ಗೆ ಹಾಗೂ ಸದರಿ ನೀರಿನ ಕಟ್ಟೆಯಿಂದ ಸಾರ್ವಜನಿಕ ಉಪಯೋಗಕ್ಕೆ ನೀರನ್ನು ಬಳಸುತ್ತಿರುವುದಾಗಲಿ ಅಥವಾ ಜನ ಜಾನುವಾರುಗಳು ಸದರಿ ನೀರನ್ನು ಬಳಸುತ್ತಿರುವುದು ಸ್ಥಳ ಪರಿಶೀಲನೆಯಲ್ಲಿ ಕಂಡುಬಂದಿರುವುದಿಲ್ಲ. ಸದರಿ ಸ್ಥಳ ಪರಿಶೀಲನೆಯಲ್ಲಿ ತೆಗೆಯಲಾದ ಛಾಯಾ ಚಿತ್ರಗಳನ್ನು ಹಾಗೂ ಭೂಮಾಪಕರ ನಕ್ಷೆ ಈ ಕೂಡ ಲಗತ್ತಿಸಿದೆ.

- No physical evidence of a "katte" (water body) or water accumulation was found at the site or within the applied area for the stone quarry lease.
- While land records for Sy. No. 454 mention a "katte" mark, Sy. No. 456 and 457 do not have katte mark. The map for Sy. No. 454 does not show any connecting roads or natural streams leading to this "katte".

- The inspection found no evidence to support the complainant's claim that a water source exists on the land, or that it's being used by the public or livestock.
