**BEFORE THE HON'BLE NATIONAL GREEN TRIBUNAL
EASTERN ZONE BENCH, KOLKATA
ORIGINAL APPLICATION NO. 14 OF 2026**

REPLY ON BEHALF OF THE RESPONDENT NO. 8, M/S VEDANTA LIMITED TO THE ORIGINAL APPLICATION

1. That the present Original Application has been instituted by the Applicant, alleging breach of the red mud pond/process water lake dyke on 15.09.2024 at the premises of Respondent No. 8, M/s Vedanta Limited [Alumina Refinery Unit], located at Lanjigarh, Kalahandi, Odisha, and its impact on the agricultural field and Bansadhara River. The Applicant further alleges that no environmental compensation has been imposed and collected from Respondent No. 8, M/s Vedanta Ltd.

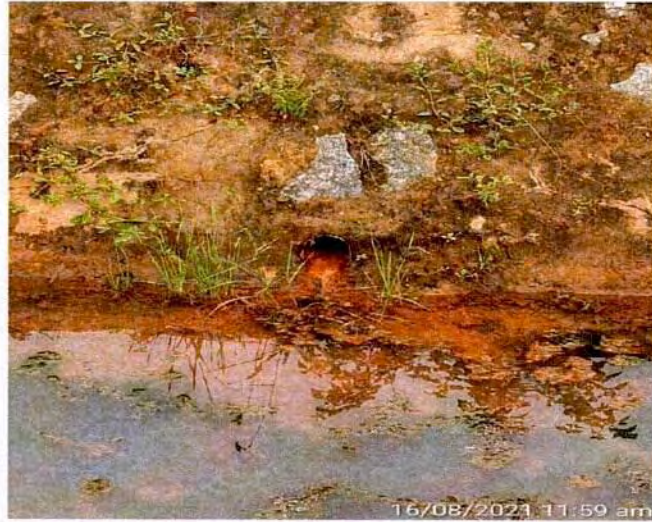
Seepage point 1:

Fig. 5.3 Seepage point location 1 between section A8-A9

A marginal seepage was also observed at the other locations. However, the seepage in these locations is sporadic and highly depended on seasonal variance. A typical flow is measured at these locations is $7.064 \times 10^{-5} \text{ m}^3/\text{sec}$

Based on the analyses, it is concluded that the structural safety of the fly ash dike of Cell-A and Cell-B are stable against slope failure and are sufficient for both usual load combinations at its current condition. Also, there is no sign of seepage has been observed at any location along the circumference of the ash dike during the visit. However, it is advised to keep monitoring and measuring the seepage in the section A8 to A9 for future reference purpose.

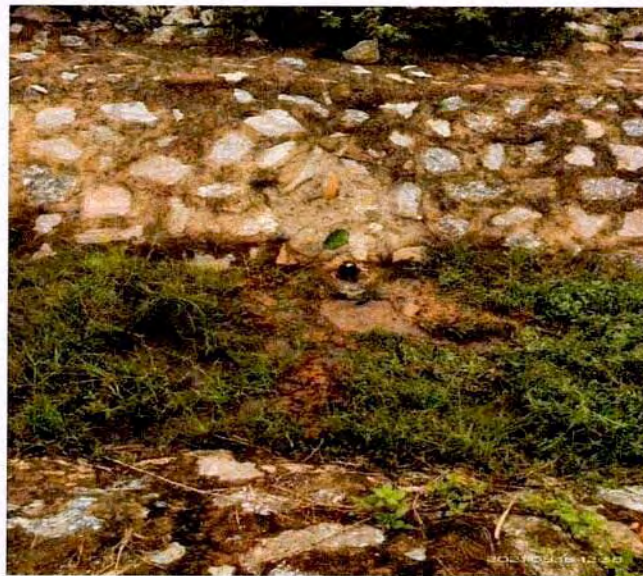
Seepage point no-2

Fig. 5.4 Seepage location-2 between section A8-A9

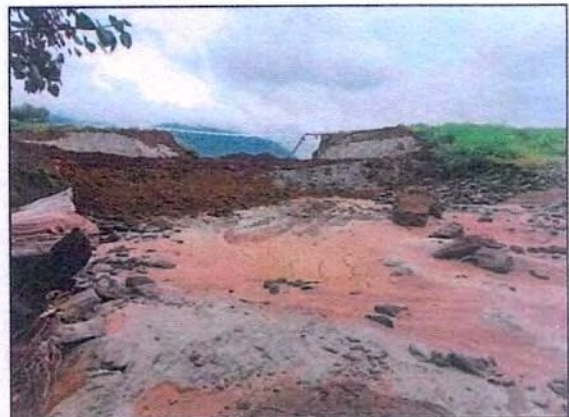
Though it is difficult to attribute a particular cause for the dyke breach, the analysis reveals that a particular combination of factors including high water level, presence of porous soil and damage to HDPE liner joints together might have caused the dyke breach.

Fig. 2b: Temporarily closing of breach with locally available soil

- 1) First, the breach portion of dyke shall be repaired by filling it with suitable soil temporarily in order to avoid further out flow of water having a caustic nature into the land that not belong to Vedanta.

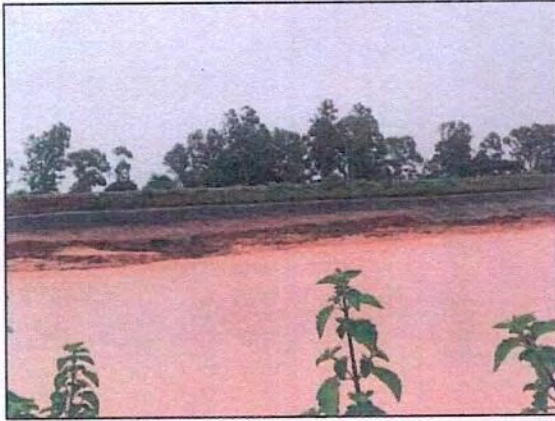
Fig. 2c: High water level mark on the upstream side of north dyke due to heavy rainfall
