Original Application No. 71 of 2021 (SZ)

Tribunal on its own motion-SUO MOTU
based on the News items in The New
Indian Express Newspaper, dated
10.02.2021, "Oil leak from titanium
factory hits Thiruvananthapuram coast,
public barred from affected stretch"

JOINT COMMITTEE REPORT SUBMITTED BEFORE THE HON'BLE NATIONAL GREEN TRIBUNAL, SOUTHERN ZONE, CHENNAI IN THE MATTER OF O.A. NO. 71/2021 - TRIBUNAL ON ITS OWN MOTION-SUO MOTU BASED ON THE NEWS ITEMS ON OIL LEAK INTO SEASHORE FROM M/S. TRAVANCORE TITANIUM (P) LTD.

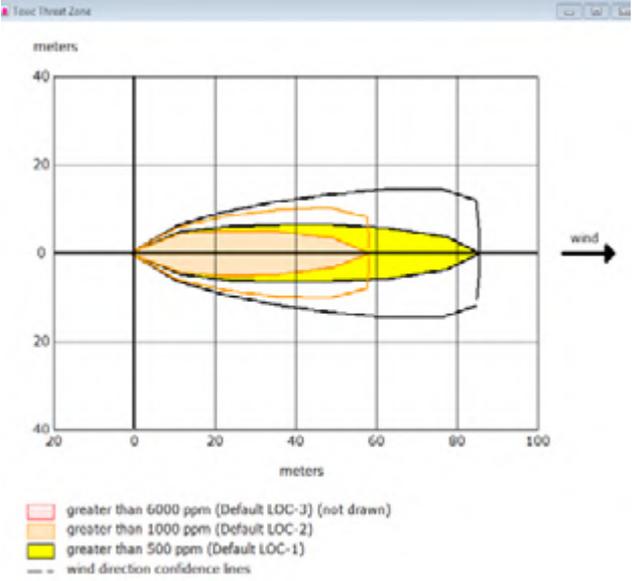
Sl. No	Risk Scenario	Effect	Figure
1.	<p>Toxic threat zone- leak at 2 Kg/sec for 1 hr.</p> <p>Leak may occur during unloading, tank body leak, leak in transfer line from tank area.</p>	<p>Concentration of vapour :</p> <p>Red : 20 meters --- (6000 ppm)</p> <p>Orange: 58 meters --- (1000 ppm)</p> <p>Yellow: 86 meters --- (500 ppm)</p>

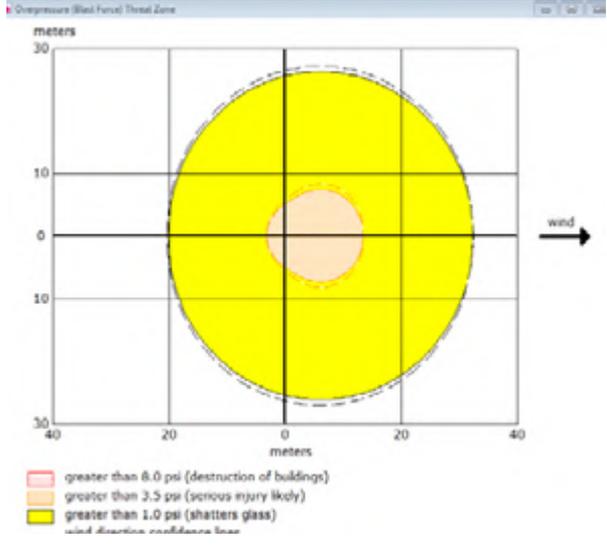
<p>3)</p>	<p>Overpressure (blast force) from vapor cloud explosion from 2kg/sec leak</p>	<p>Type of Ignition: ignited by spark or flame.</p> <p>Red : LOC was never exceeded --- (8.0 psi = destruction of buildings)</p> <p>Orange: 14 meters --- (3.5 psi = serious injury likely)</p> <p>Yellow: 32 meters --- (1.0 psi = shatters glass)</p>

Remedial measures: Isolate minimum 60 x 60 m area as shown in the fig. Stop movement of vehicles and isolate all source of ignition. Remove persons & vehicles from the circled area

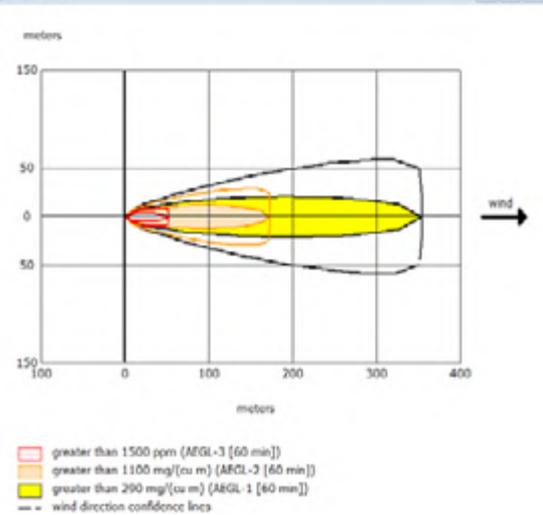
Sl. No	Risk Scenario	Effect	Figure
1.	<p>Toxic threat zone- leak at 2 Kg/sec for 30 mins.</p> <p>Leak may occur during unloading, tank body leak, leak in transfer line from tank area.</p>	<p>THREAT ZONE: Model Run: Heavy Gas Red : 53 meters --- (1500 ppm = AEGL-3 [60 min]) Orange: 174 meters --- (1100 mg/(cu m) = AEGL-2 [60 min]) Yellow: 355 meters --- (290 mg/(cu m) = AEGL-1 [60 mi])</p>

The tank locations are in oil storage area (2 nos.), sulphuric acid plant -1 no (Tk. No. 6). which is in near the plant area. Any leak in this area will call for removing all ignition sources including vehicle movement which may not be possible and will result in massive fire. Since no effective fire protection measure is available, the result will be catastrophic.

Area which will be covered by vapour leak based on wind direction south to north. This will vary depending on wind direction. In case of north to south, entire plant area will be affected.

In case of other horizontal tanks in Oil Storage area of the company, the inter tank distance is less . Vapour that will be generated by any leakage will spread all over. In case of any ignition source, the situation will be out of control.

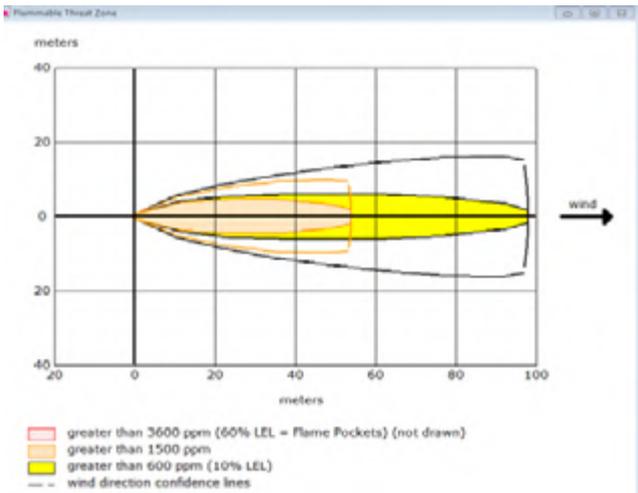
<p>2.</p>	<p>Flammable Area of Vapor Cloud</p>	<p>Threat Modeled: Flammable Area of Vapor Cloud Model Run: Heavy Gas Red : 31 meters --- (3600 ppm = 60% LEL = Flame Pockets) Note: Threat zone was not drawn Orange: 54 meters -- (1500 ppm) Yellow: 98 meters -- (600 ppm = 10% LEL)</p>

Remedial measures: Isolate at least 100 m down side and remove any ignition source

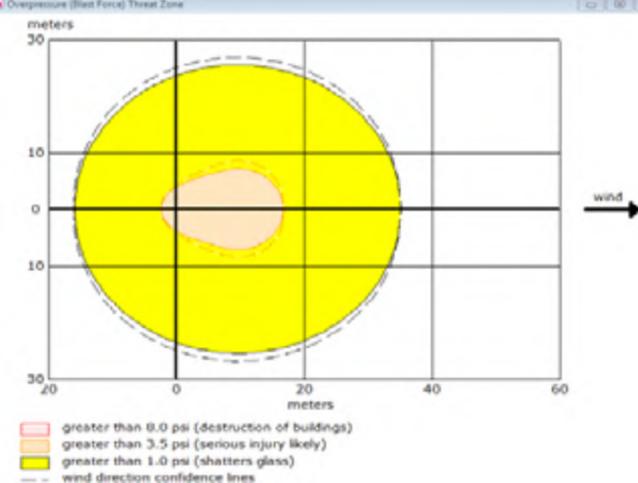
<p>3.</p>	<p>Overpressure (blast force) from vapor cloud explosion Type of Ignition: ignited by spark or flame</p>	<p>Red : LOC was never exceeded --- (8.0 psi = destruction of buildings) Orange: 39 meters -- (3.5 psi = serious injury likely) Yellow: 41 meters -- (1.0 psi = shatters glass)</p>

Remedial Measures: Isolate 50 m area. Evacuate man power from the area. Remove all source of ignition.

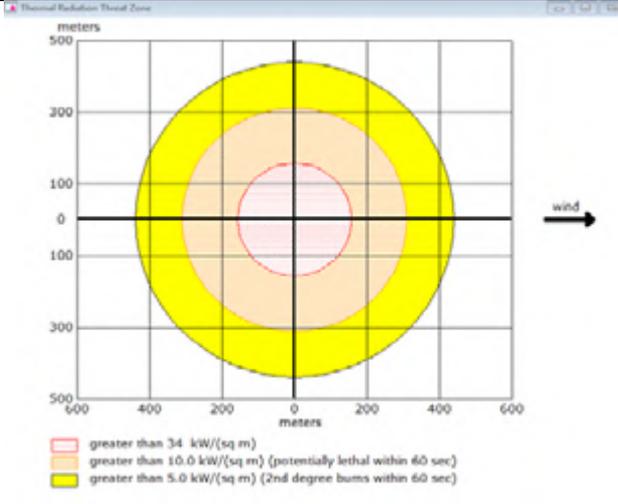
Sl. No	Scenario	Effect	Figure
	<p>BLEVE Tank Diameter: 1.7 meters Tank Length: 13 meters Tank Volume: 29.5 cubic meters Tank contains liquid Internal Storage Temperature: 35° C Chemical Mass in Tank: 19.8 tons Tank is 90% full Percentage of Tank Mass in Fireball: 100% Fireball Diameter: 152 meters Burn Duration: 10 seconds</p>	<p>Threat Modeled: Thermal radiation from fireball</p> <p>Red : 157 meters --- (34 kW/(sq m))- FATAL</p> <p>Orange: 311 meters --- (10.0 kW/(sq m) = potentially lethal within 60 sec)</p> <p>Yellow: 439 meters --- (5.0 kW/(sq m) = 2nd degree burns within 60 sec)</p>

As can be seen, the effect will be catastrophic. In the absence of any fire fighting system, this type of situation cannot be avoided. In the inner envelop there will be 100% fatality.

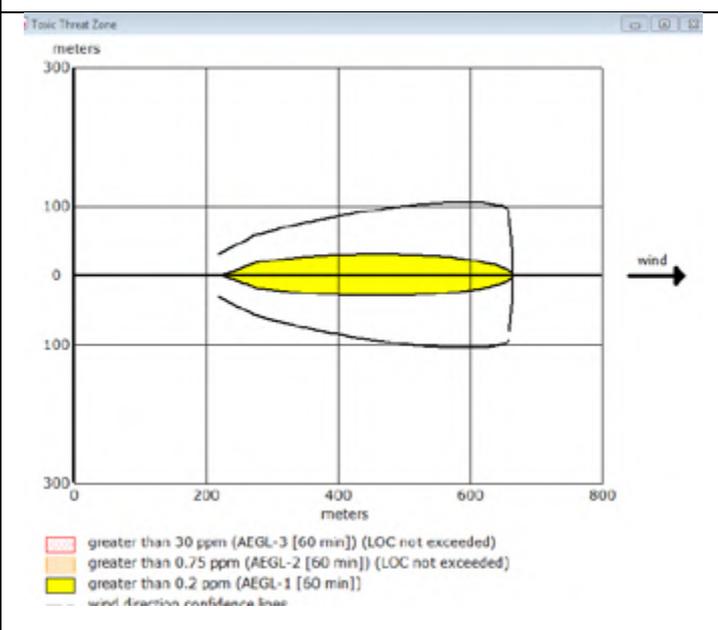
Sl. No	Risk Scenario	Effect	Figure
1.	<p>Direct Source: 50 grams/sec Source Height: 25 meters Release Duration: 30 minutes Release Rate: 3 kilograms/min Total Amount Released: 90.0 kilograms.</p> <p>Release from scrubber</p>	<p>Red : LOC is not exceeded -- (30 ppm = AEGL-3 [60 min])</p> <p>Orange: LOC is not exceeded --- (0.75 ppm = AEGL-2 [60 min])</p> <p>Note: Threat zone was not drawn because the ground level concentrations never exceed the LOC.</p> <p>Yellow: 666 meters --- (0.2 ppm = AEGL-1 [60 min])</p>

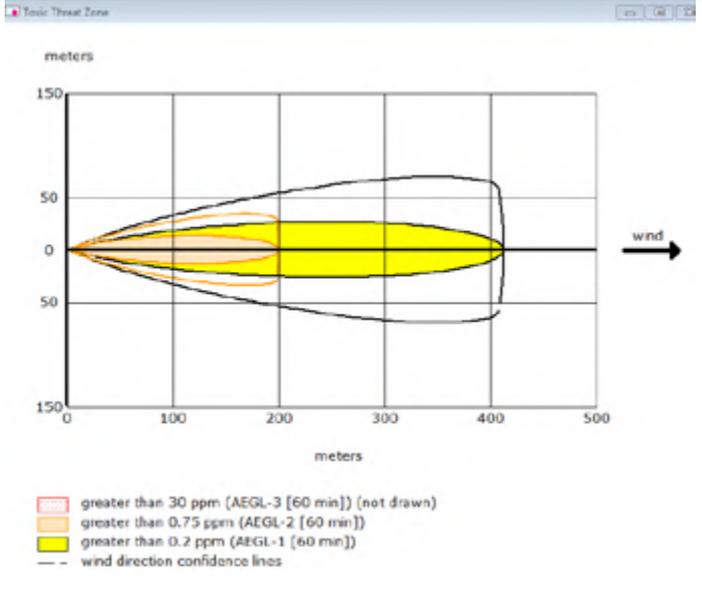
<p>2</p>	<p>Direct Source: 10 grams/sec Source Ground level Release Duration: 30 minutes Release Rate: 600 grams/min Total Amount Released: 18.0 kilograms</p>	<p>Red : 30 meters --- (30 ppm = AEGL-3 [60 min]) Note: Threat zone was not drawn Orange: 201 meters --- (0.75 ppm = AEGL-2 [60 min]) Yellow: 412 meters --- (0.2 ppm = AEGL-1 [60 min])</p>

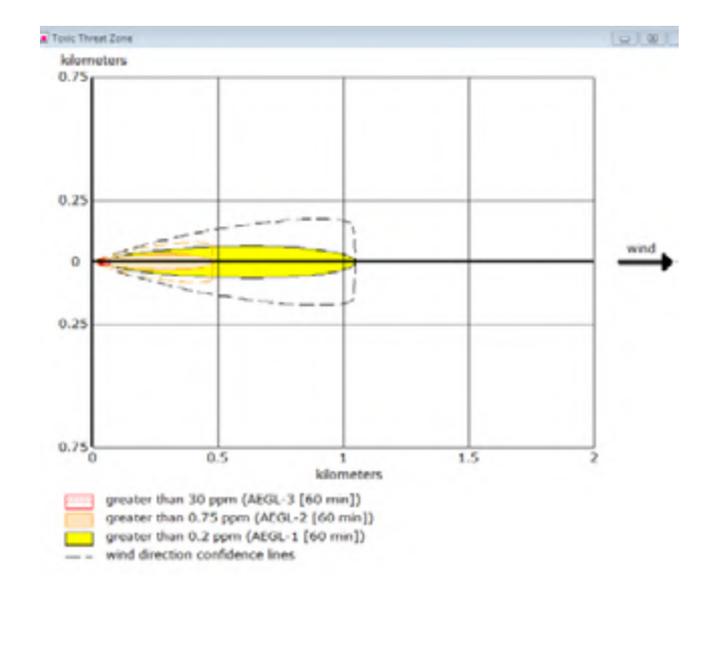
<p>3.</p>	<p>Toxic threat zone-major leak . Direct Source: 50 grams/sec Source Height: 0 Release Duration: 30 minutes Release Rate: 3 kilograms/min Total Amount Released: 90.0 kilograms</p>	<p>Red : 68 meters --- (30 ppm = AEGL-3 [60 min]) Orange: 484 meters --- (0.75 ppm = AEGL-2 [60 min]) Yellow: 1.1 kilometers --- (0.2 ppm = AEGL-1 [60 min])</p>

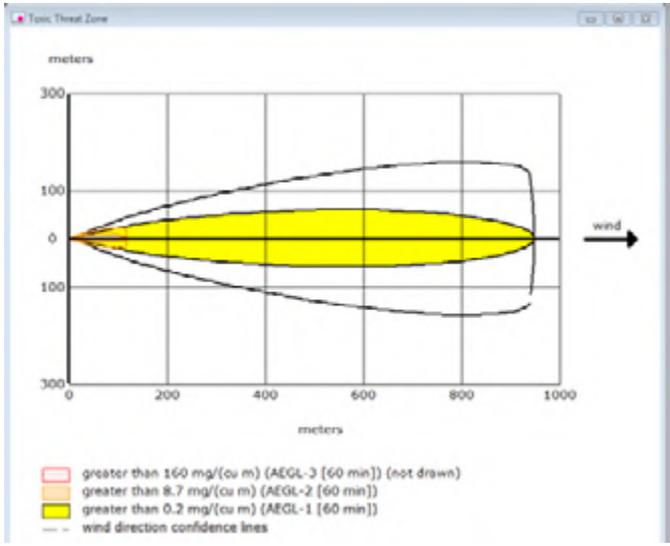
Sl. No	Risk Scenario	Effect	Figure
1.	<p>Major leakage: Direct Source: 1.0 kilograms/min Source Height: 0 Release Duration: 15 minutes Release Rate: 1,000 grams/min Total Amount Released: 15.0 kilograms</p>	<p>Red : 27 meters --- (160 mg/(cu m) = AEGL-3 [60 min]) Note: Threat zone was not drawn because effects of near-field patchiness make dispersion predictions less reliable for short distances. Orange: 117 meters --- (8.7 mg/(cu m) = AEGL-2 [60 min]) Yellow: 949 meters -- (0.2 mg/(cu m) = AEGL-1 [60 min])</p>

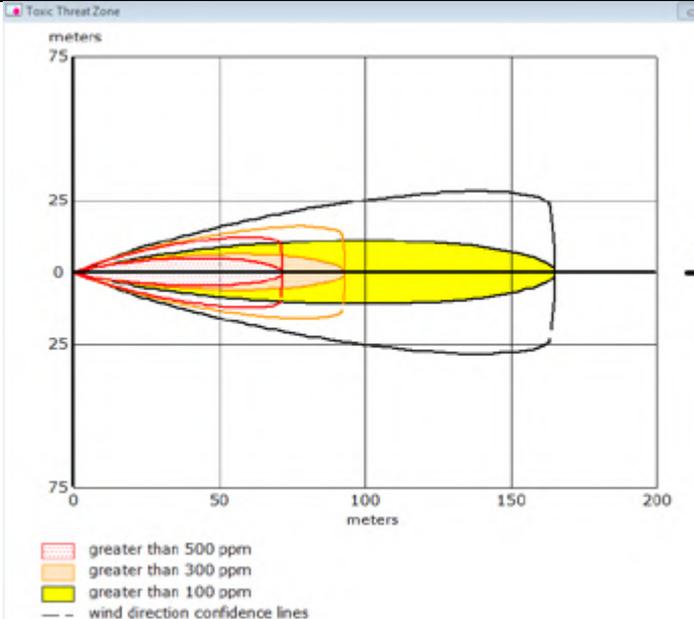
Sl. No	Risk Scenario	Effect	Figure
1.	Leakage due to hose rupture, leakage from unloading pump, tank body leak. Leak qty. 5 kg/sec for 30 mins.	<p>Red : 72 meters - -- (500 ppm)</p> <p>Orange: 93 meters --- (300 ppm)</p> <p>Yellow: 165 meters --- (100 ppm)</p>

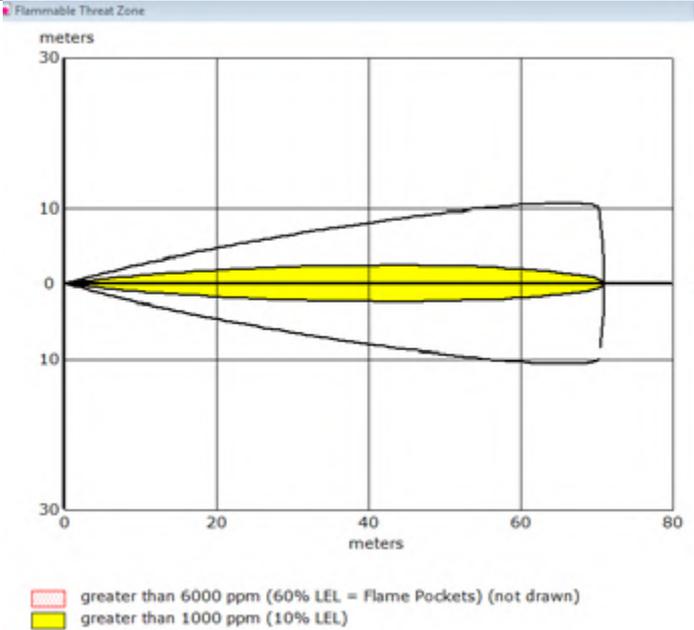
<p>Toxic Threat Zone</p> <p>Y-axis: meters (-75 to 75) X-axis: meters (0 to 200)</p> <p>Legend: [Red] greater than 500 ppm [Orange] greater than 300 ppm [Yellow] greater than 100 ppm --- wind direction confidence lines</p>
	Flammable Area of Vapor Cloud	<p>Red : 28 meters - -- (6000 ppm = 60% LEL = Flame Pockets)</p> <p>Yellow: 71 meters --- (1000 ppm = 10% LEL)</p>

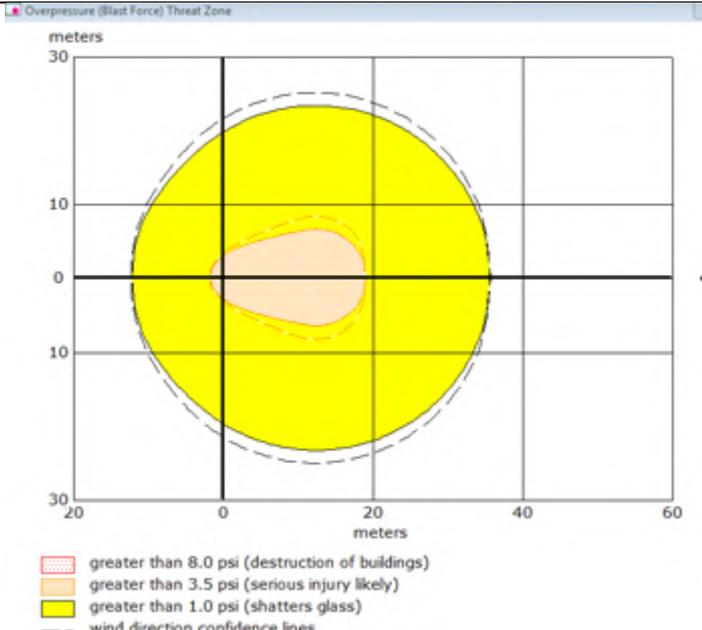
<p>Overpressure (blast force) from vapor cloud explosion</p>	<p>Model Run: Gaussian Red : LOC was never exceeded --- (8.0 psi = destruction of buildings) Orange: 19 meters --- (3.5 psi = serious injury likely) Yellow: 36 meters --- (1.0 psi = shatters glass)</p>

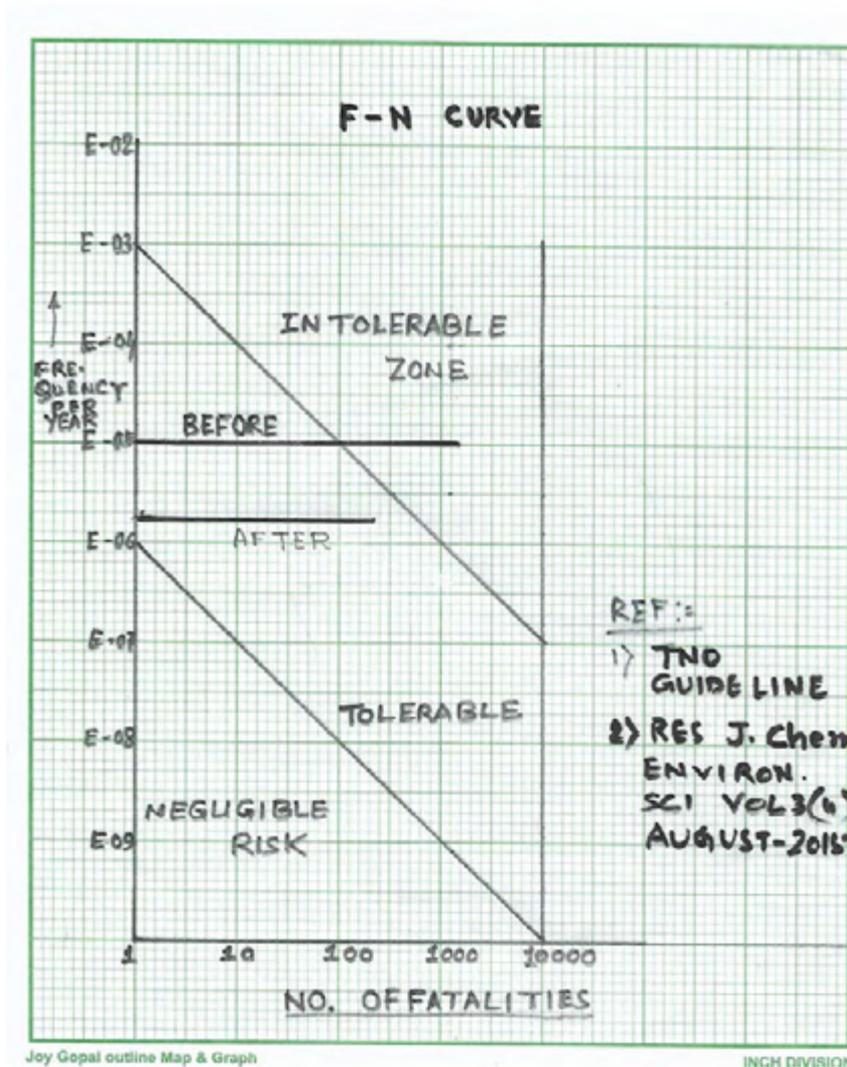
9.0 Societal Risk:

Societal risk has been calculated based on the guide line of TNO and reference from Res J. Chem. Environ. Sci. Vol 3 [4] August 2015: 36-43;. As can be seen risk is outside the tolerable limit in case of BLEVE of HSD tank. The risk can be brought down further by adopting the risk mitigation as explained earlier. Slope of the curve is considered as -1.

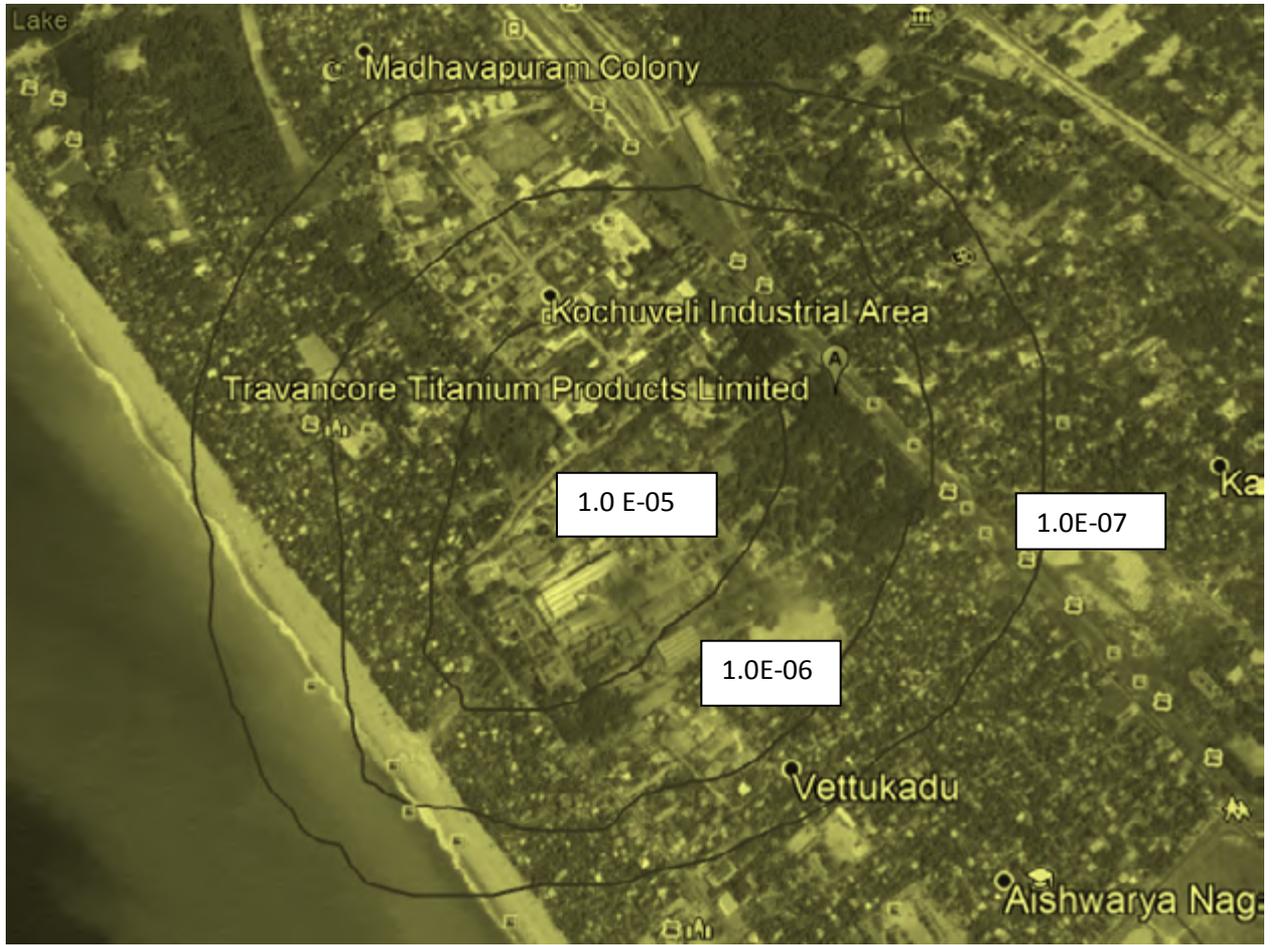
10.0 Individual Risk:

Individual risk curve is enclosed.
