**BEFORE THE NATIONAL GREEN TRIBUNAL,
PRINCIPAL BENCH, NEW DELHI.**

In re: News item published in the Indian Express Newspaper dated 02.01.2022 titled "Four Killed in Haryana Mine Landslide"

S.No	Particulars	Pages
1	Affidavit on behalf of Respondent-M/s Goverdhan Mines & Minerals, Hisar, Haryana	1-2
2	Compliance by respondent to the Report of DFO, Bhiwani and Report of DGM, Ghaziabad	3-11
3	ANNEXURE –R-1 /1 Report of DGMS, Ghaziabad dated 31.12.2020	12-14
4	ANNEXURE R-1/2 Photographs of Benches	15-18
5	ANNEXURE R-1/3 Chapter-XI of MMR 1961 and Circular 71 of 1963	19-20
6	ANNEXURE R-1/4 DGMS Technical Circular No.3/2019 along with format of status report on progress made into Mitigation of all the identified principal hazard	21-26
7	ANNEXURE R-1/5 Letter addressed by Govardhan Mines & Minerals to the Director of Mine Safety dated 22.12.2020	27
8	ANNEXURE R-1/6 E-mail dated 30.03.2022 submitting revised copy of the safety management plan	28
11	ANNEXURE R-1/7 Letter dated 13.4.2022 from Directorate General of Mines Safety to Manager Goverdhan Mines & Minerals	29
12	ANNEXURE R-1/8 Study on stability status of slopes in Dadam Stone Mine of M/s Govardhan Mines & Minerals,	31-51

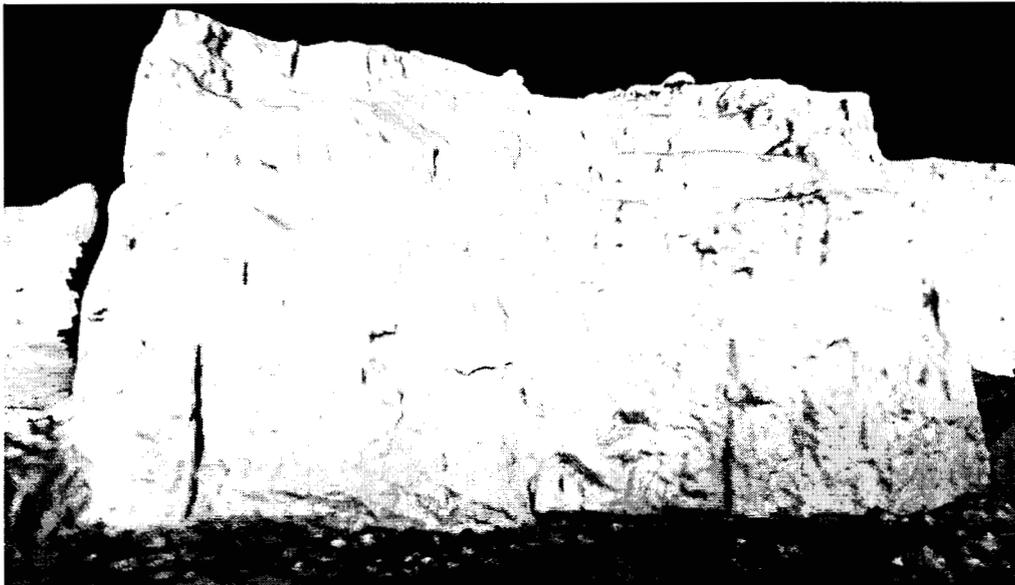
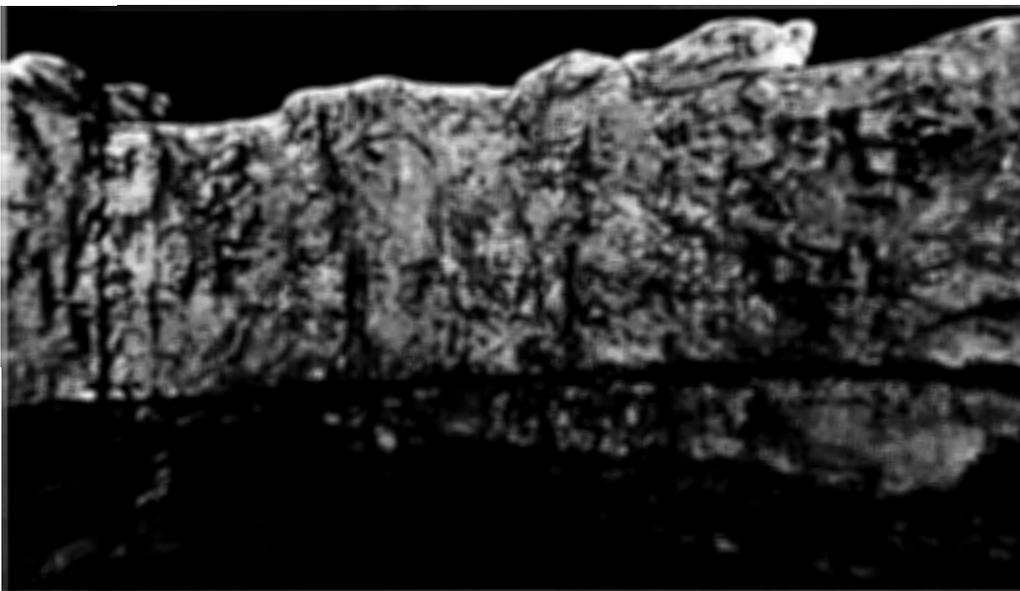
Figure 9: Three-dimensional profile of Pits No. 37 & 38 of the East (upper) & West wall
(lower)

The exiting slope section consists of three sets of major joints with random ones (Fig. 8 a). The exposed joints are quite persistent (> 22 to 55 m) with wide to very wide spacing (8-10 m) that instigate the occurrence of very large to extremely large in-situ blocks potential for failure (Fig. 8b). The three-dimension profile of the pits scanned by Lidar is shown in Fig. 9.

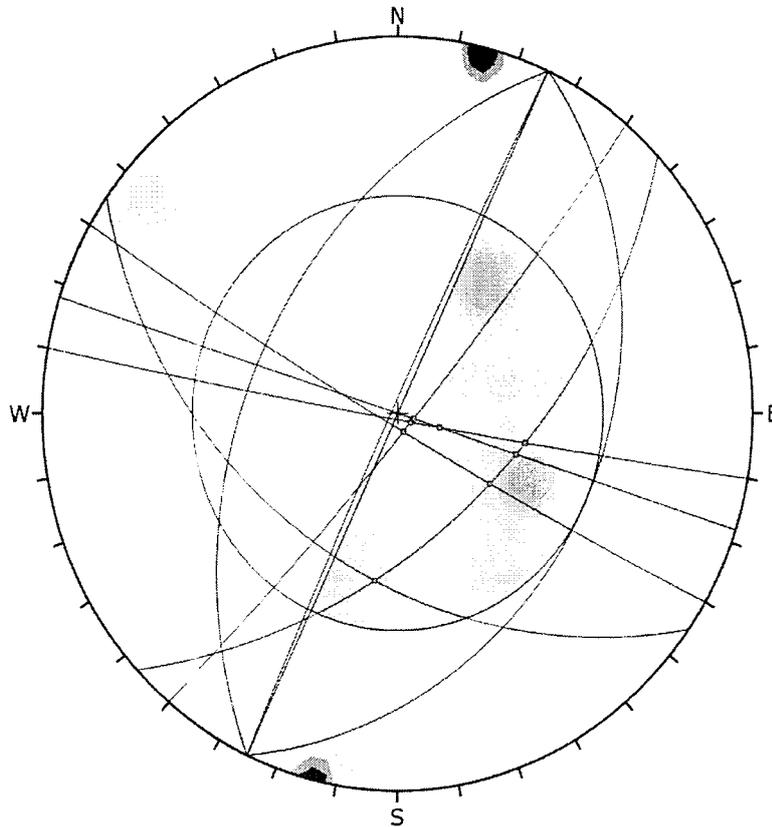
Figure 10a: Potential wedges from collected joint data

The visual inspection suggests that mine slopes are the potential for geologically controlled block failures that also include intermittent rockfall of varied scales due to overhanging blocks. Kinematic analysis of the failed slope suggests a high potential for large wedge type

failure released from the near-vertical joint and gravitation sliding on the obliquely laid daylighted joints (Fig. 10a-d).

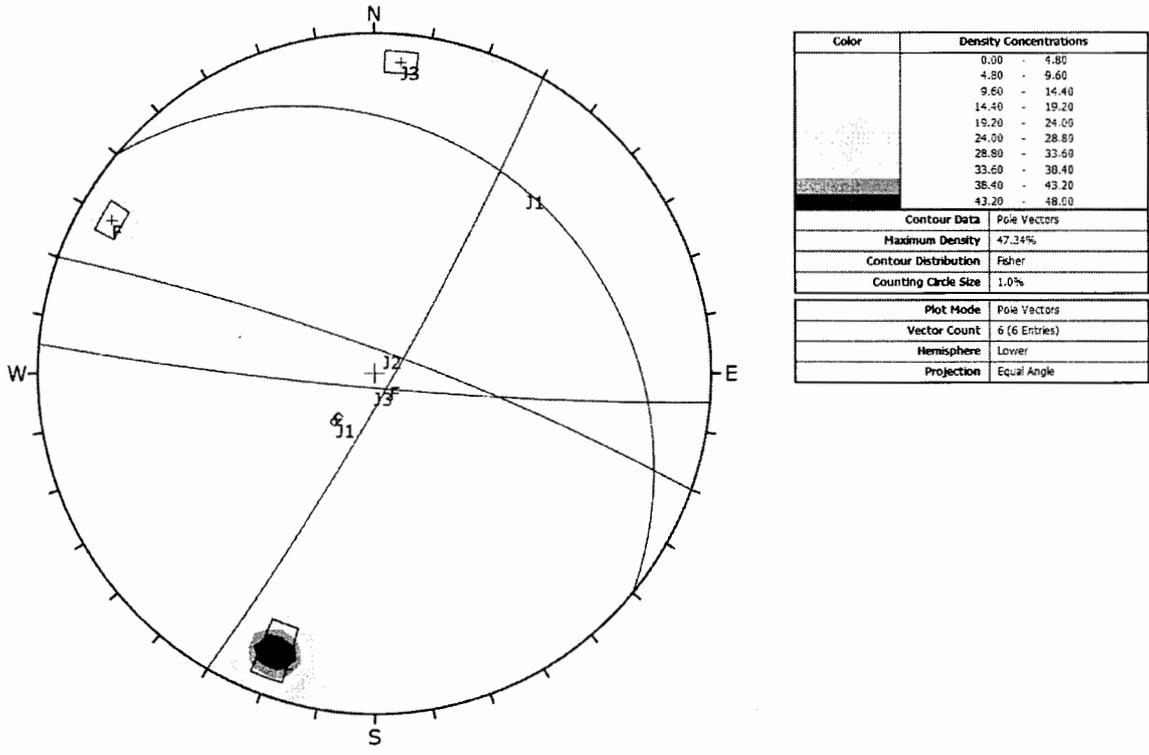
Figure 12: Joint data for West wall of Pit 47

Locations		Parameters									Final rating RMR _{basic}
		UCS (MPa)	RQD (%)	Spacing (mm)	Joint condition					Ground water condition	
					Persistence (m)	Aperture (mm)	Roughness	Infilling	Weathering		
Pit No. 47	Range	100- 250	75-90	60-200	>20	>5	Planar undulating to rough	Soft < 5 mm	Mod. Weathered	Completely dry	62
	Rating	12	17	10	0	0	3	2	3	15

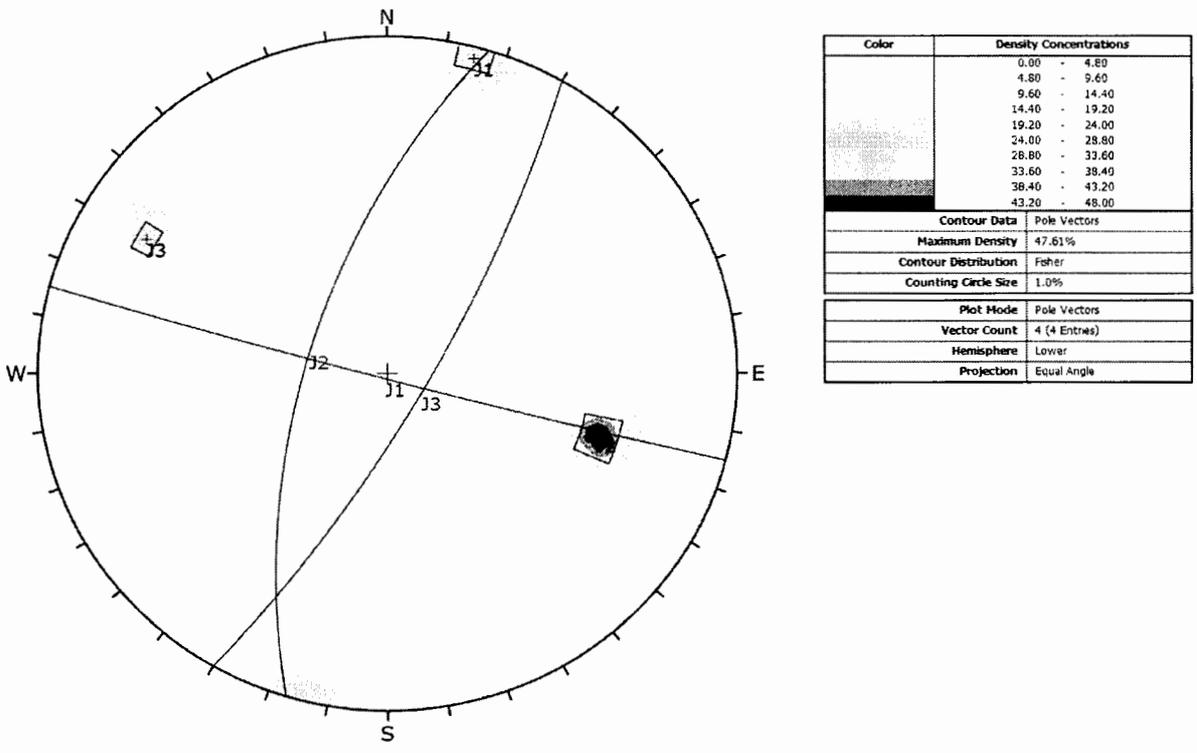
Figure 13: Joint data for the East wall of Pit No. 47

Locations		Parameters									Final rating RMR _{basic}
		UCS (MPa)	RQD (%)	Spacing (mm)	Joint condition					Ground water condition	
					Persistence (m)	Aperture (mm)	Roughnes s	Infillin g	Weatherin g		
Pit no. 47	Range	100- 250	50- 50	< 60	>20	>5	Planar undulating to rough	Soft < 5 mm	Mod. Weathered	Completel y dry	53
	Rating	12	13	5	0	0	3	2	3	15

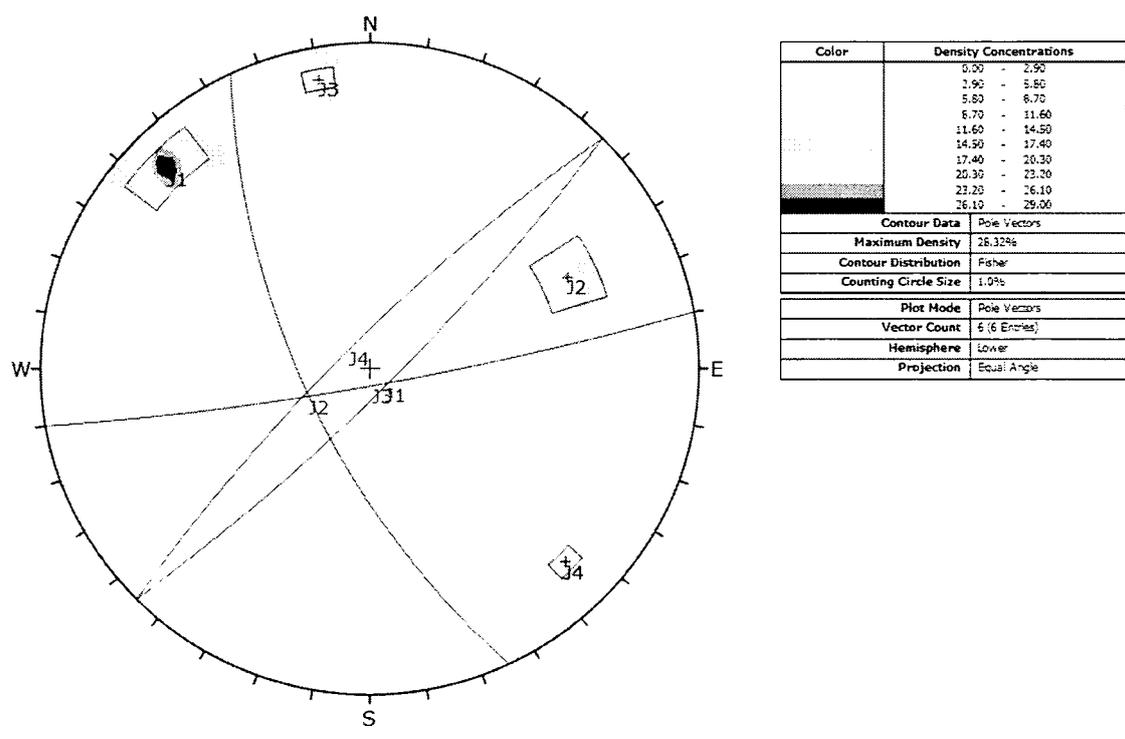
Figure 16: Joint data for Pit No. 3

The west wall of the Pit No 3 is varying from 15 m to 20 m high with loose blocky masses overhanging on the slope and prone to failure (Fig. 15) and a 3D view of the slope has been shown in (Fig. 14). The weathering condition in the upper part of the slope is quite high and blocks are loosened up with wide-open joints. Thus, the adverse orientation of joints concerning the slope face, high weathering coupled with slope inclination allow the blocks to move from the slope face. The observed RMR_{basic} for the slope is 48 (Table 6).

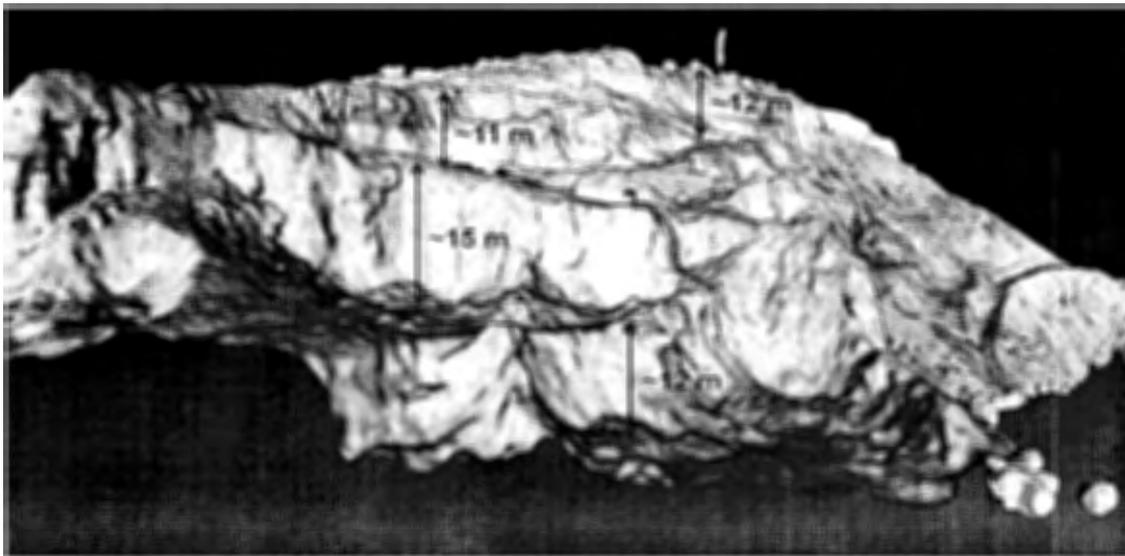
Figure 21: Three-dimensional pit geometry of working benches of Pit No. 22 & 23

Pit No. 22 & 23 are the working pit located close to the mine boundary near Pillars No. 9 & 10. Whereas Pit No. 25, 27 & 52 are adjacent to it. The slope inclination of the lowermost benches is varying from 85° to 90° with a bench height of 12 m. The middle and uppermost benches have slopes varying from 76° to 88° with heights varying from 11 to 15 m. All these benches are facing towards N195°. The sand/silt overburden is lying throughout the outer boundary of Pit No. 22, 23. The three-dimensional pit geometry of working benches was acquired from LIDAR data is shown in Fig. 21. It is depicting the heights of existing pits which are under the development stage to keep the bench height around 8m to 12 m. The same can be observed from the field photograph shown in Fig. 22. The rock masses encountered in 22, 23, 25, 27 & 52 are jointed and competent depicting the good rock mass quality. Joints controlled intermittent block

failures are observed to be feasible at some sections of the pit which can be dealt with pit geometry alteration.

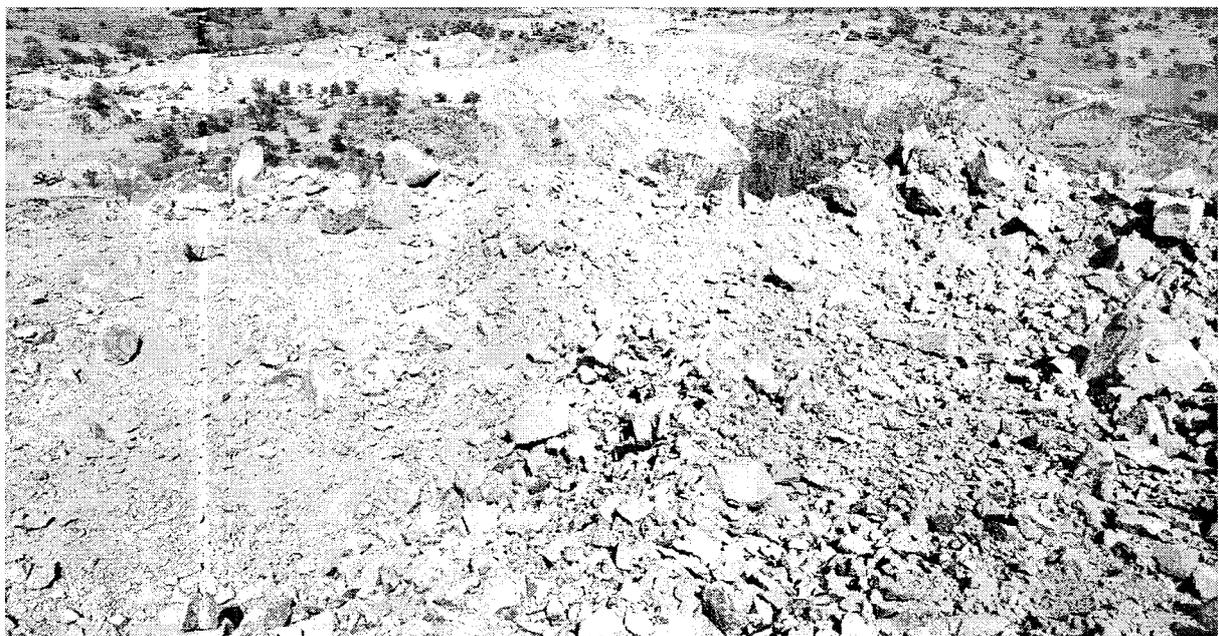
Figure 24: Field photograph after blasting in Pits No. 12, 13

These are working pits where sequential excavation of benches are being carried out from hill top. All the benches are height of 10 meter approximately with varying slope of 70 to 80 degrees. During the site visit CSIR-CIMFR firing sequence and blast pattern were modified as per the rock mass classification in view of maintaining the stability of pit benches. The figure no 23 and 24 presented below showing the field conditions of pits.

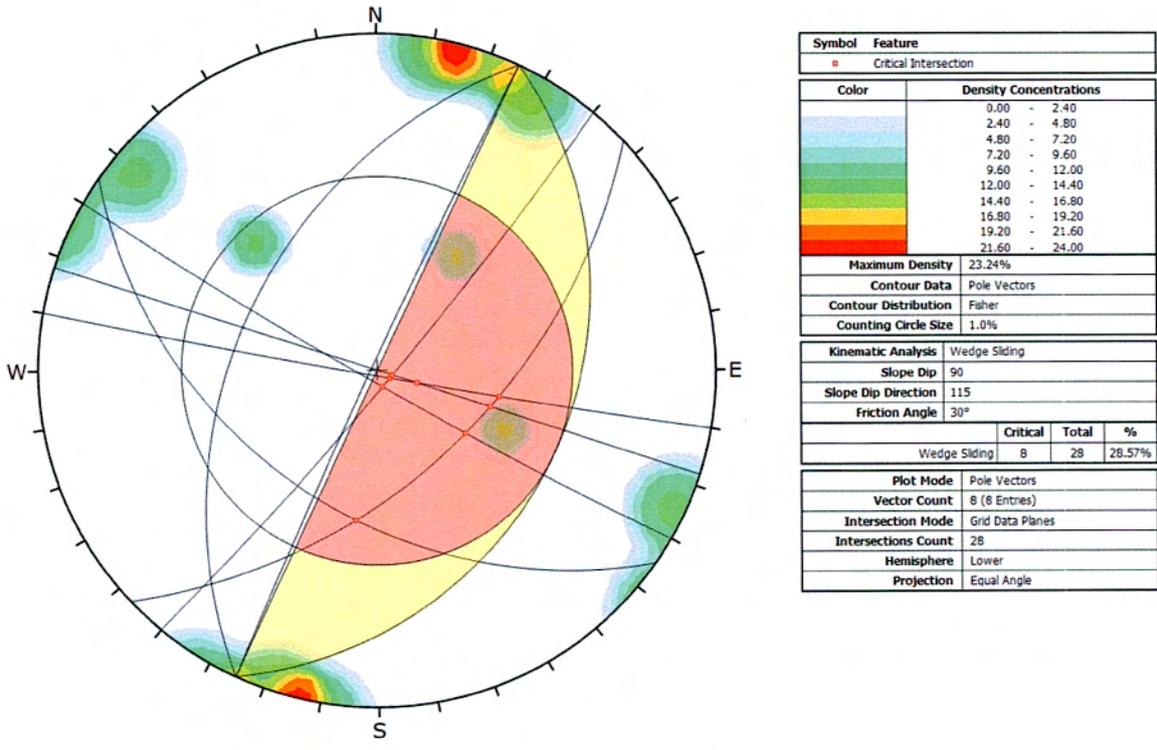
Figure 4a. Potential wedges from collected joint data

Kinematic analysis of the failed slope suggests a high potential for large wedge type failure released from the near-vertical joint and gravitation sliding on the obliquely laid day-lighted joints (Figure 4a-d). Considering the back-calculated Slope Mass Rating using the continuous function (CSMR), the kinematically potential wedge falls CLASS IV & V (CSMR ranging from 16 to 27) which suggests completely unstable to unstable stability conditions. As per the SMR classification (Romana 1985), very large to large wedge or big planar failure is likely in that scenario (Figure 4a, b) that exactly had happened resulted dislodgment of extremely large wedge.

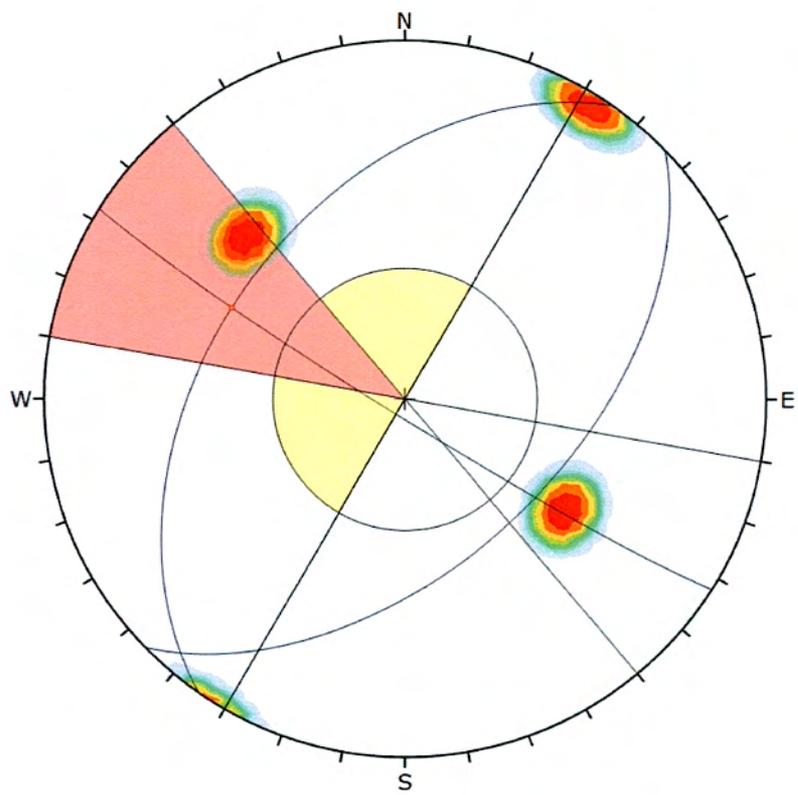
Figure 4c. Potential planar failure from mean joint data

Thus considering the geological and geotechnical aspects; adverse orientation of naturally occurring joints with reference to the slope face, natural weathering of the basal and release joint planes and progressive dilation of joints upon saturation of infilled soft (clayey silt/sand) materials are the reasons for the movement of such big wedge failure.
