**IN
ORIGINAL APPLICATION No. 1115/2024**

News Item titled "Rampant mining causes Joshimath-like crisis in Uttarakhand's Bageshwar" appearing in India Today dated 14.08.2024

SITE INSPECTION REPORT

Subject: Original Application No. 1115/2024 in respect of News Item titled "Rampant mining causes Joshimath-like crisis in Uttarakhand's Bageshwar" appearing in India Today dated 14.08.2024 before the Hon'ble National Green Tribunal, Principal Bench, New Delhi.

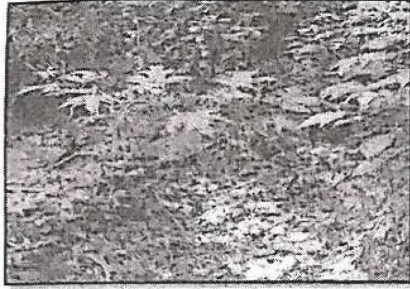
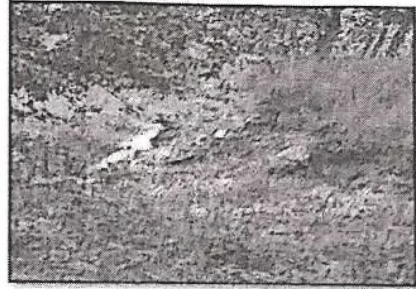
स्थल के चित्र

स्थल 03—किशन राम पुत्र श्री दौलत राम, पूरन राम पुत्र श्री दौलत राम, प्रेम राम पुत्र श्री दौलत राम—आवासीय भवन की बाहर की दीवार पर हल्की दरार है। आंगन में हल्का धंसाव व हल्की दरार है। आंगन के बाये किनारे पर हल्का धंसाव हो रहा है। परिवार भवन में निवास कर रहे हैं। निरीक्षण के दौरान भवन स्वामी द्वारा अवगत कराया गया कि भवन लगभग 25-30 वर्ष पुराना है। भवन से लगभग 20 मी० की दूरी पर मोटर मार्ग है। स्थल से खनन क्षेत्र की दूरी लगभग 25-30 मी० है।
