10.0) Reinstatement confirmation

Road damage claim A/c - M/s. Shivalik
Buildtech (P) Ltd.
NH 707 (Gumna - Fediz Road)

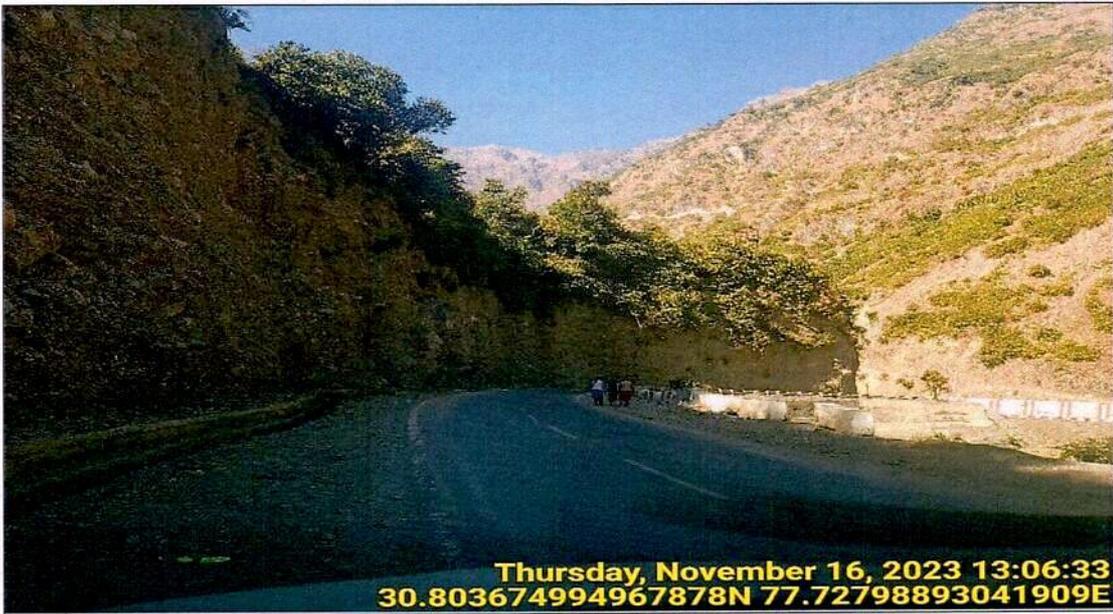
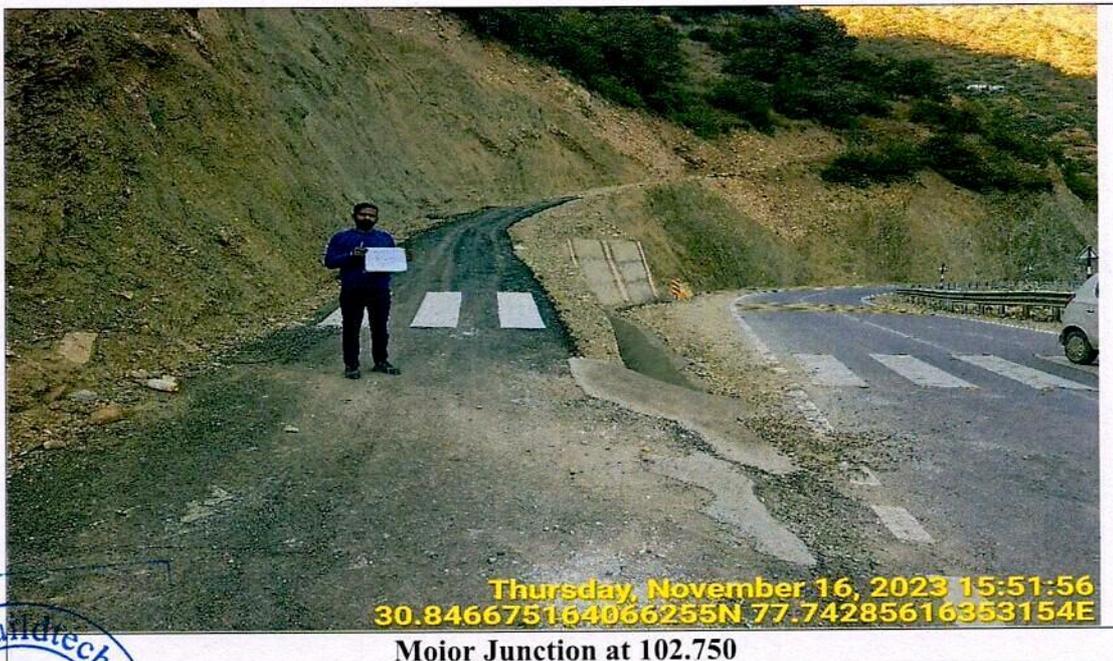
The reinstatement of the road was confirmed during visit on 16.11.2023 wherein various photos were taken few of which are attached hereunder for ready reference –

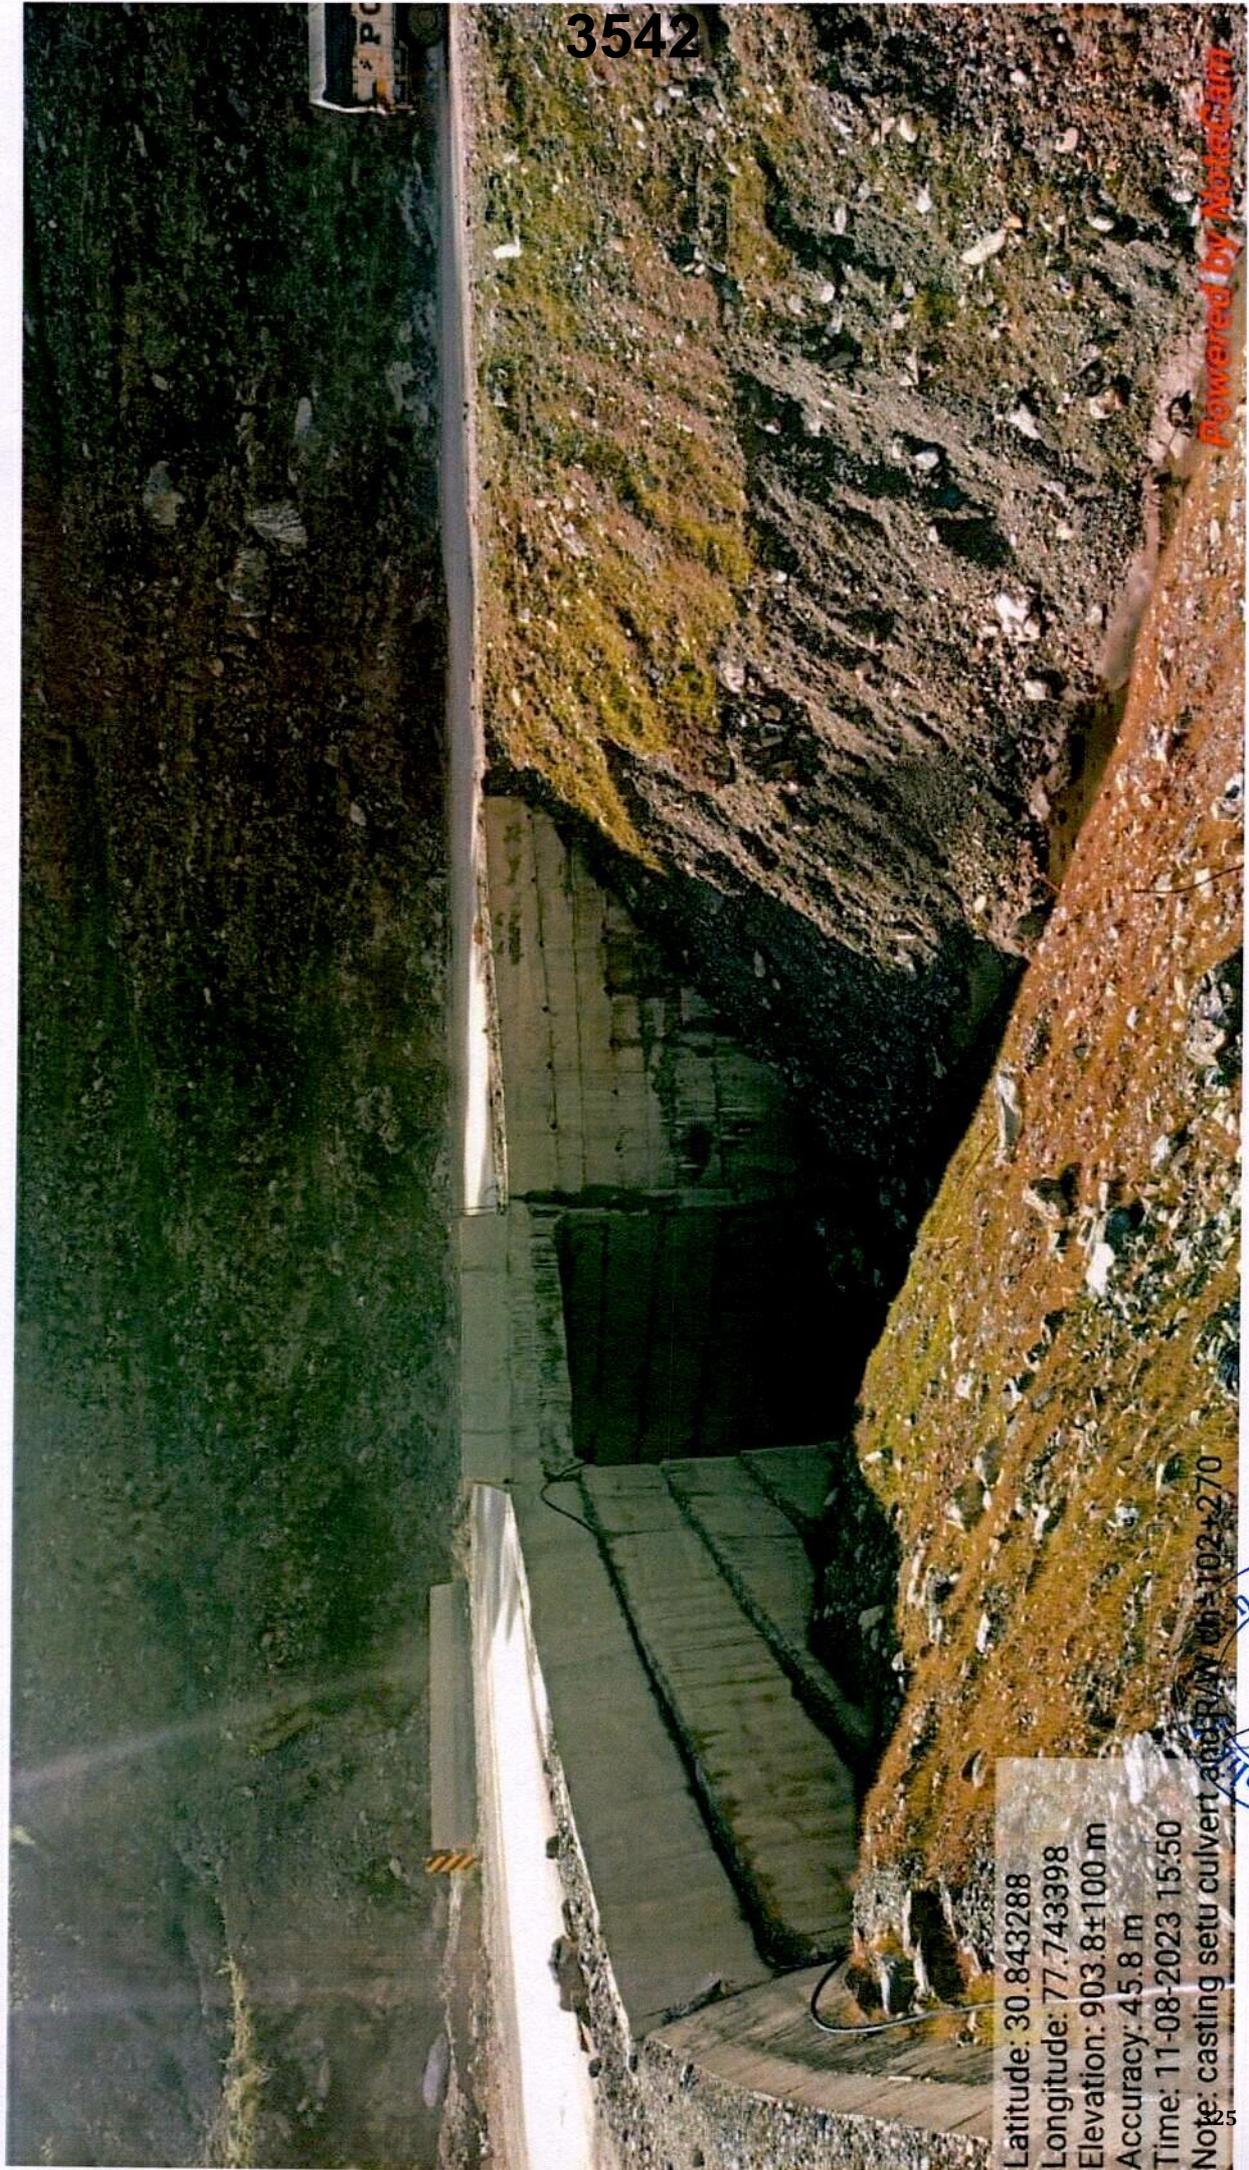
Latitude: 30.843288
Longitude: 77.743398
Elevation: 903.8±100 m
Accuracy: 45.8 m
Time: 11-08-2023 15:50
Note: casting setu culvert and PAV on 102+270
