EA NO. 23/2024
IN
ORIGINAL APPLICATION NO. 295/2016

7.	Annexure R-2/6 True copy of the JKPCC site visit report dated 10.01.2025.	101-184
8.	Annexure R-2/7 True copy of e-mail dated 22.10.2024.	185-228
9.	Proof of service.	229

**COMPLIANCE REPORT ON BEHALF OF RESPONDENT NO.2/NHAI
IN TERMS OF ORDER DATED 15.07.2024 & 15.10.2024**

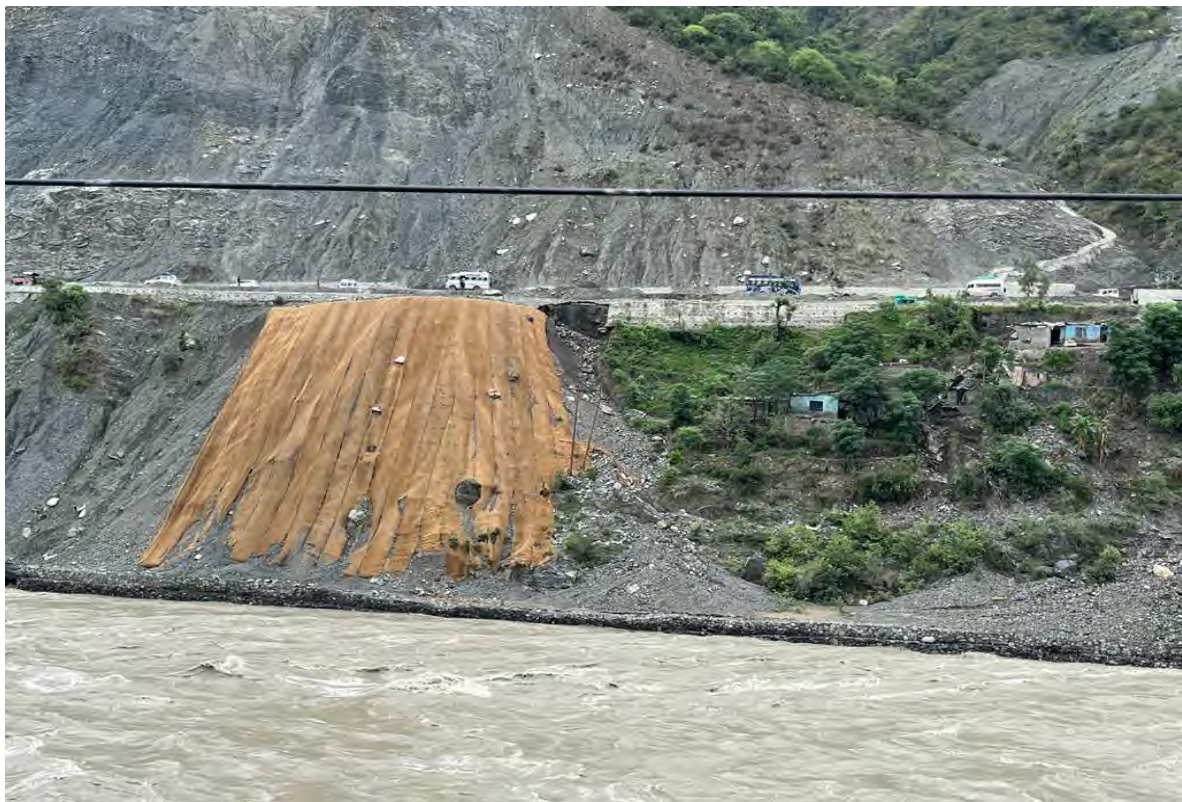
Dumping Yard at Mehar Km 145+470

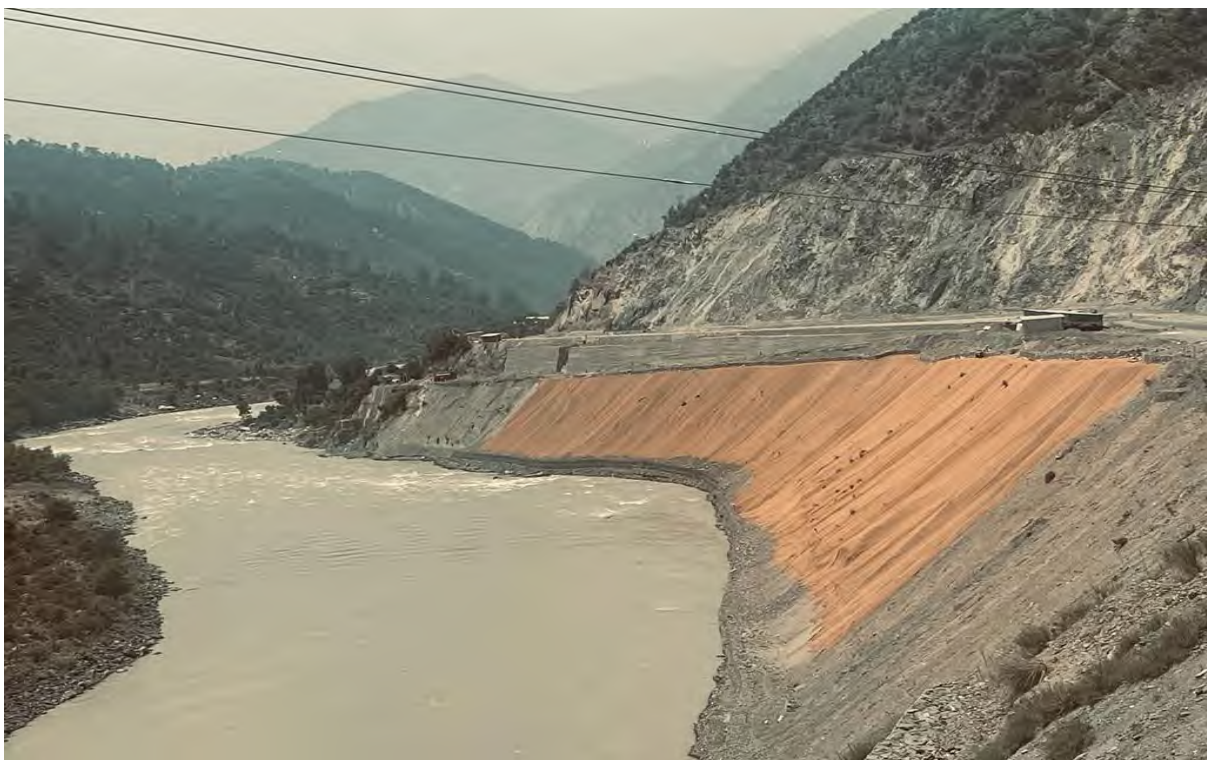
Dumping Yard at Trishul Morh Km 151+00

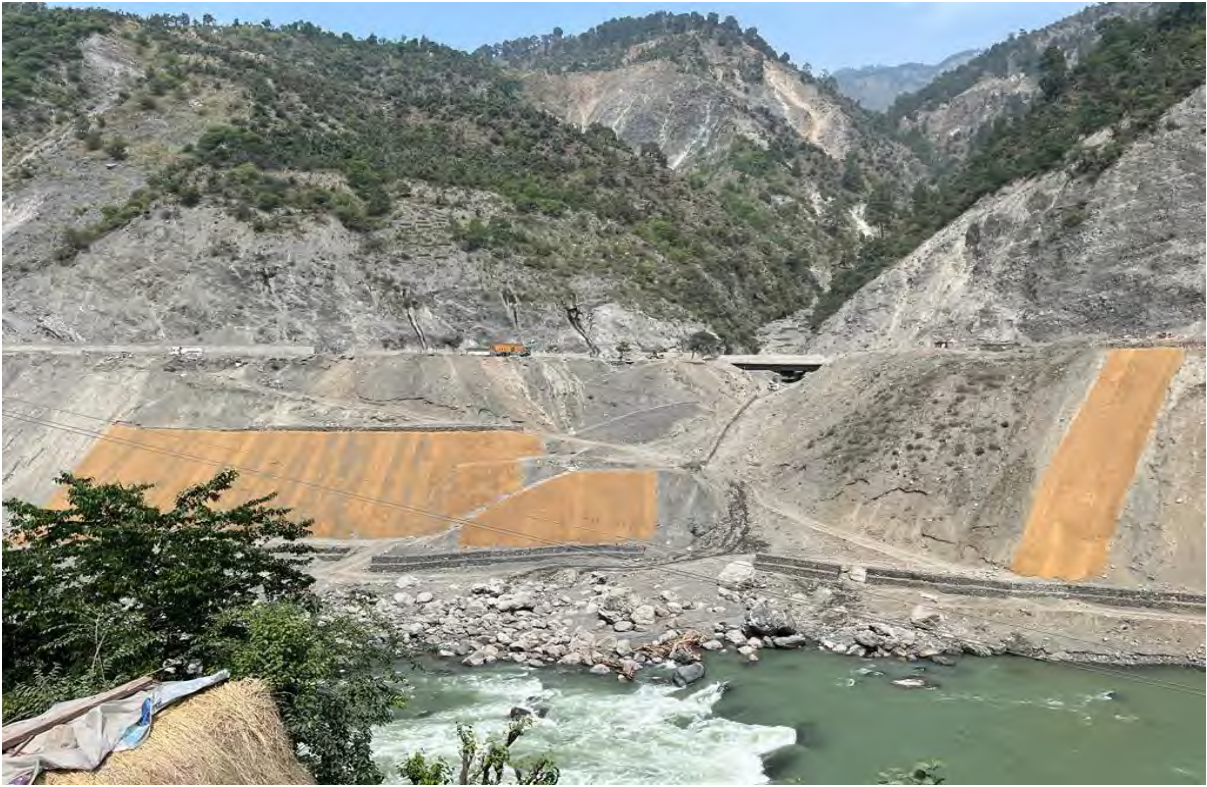
Dumping Yard at Karol Km 143+200

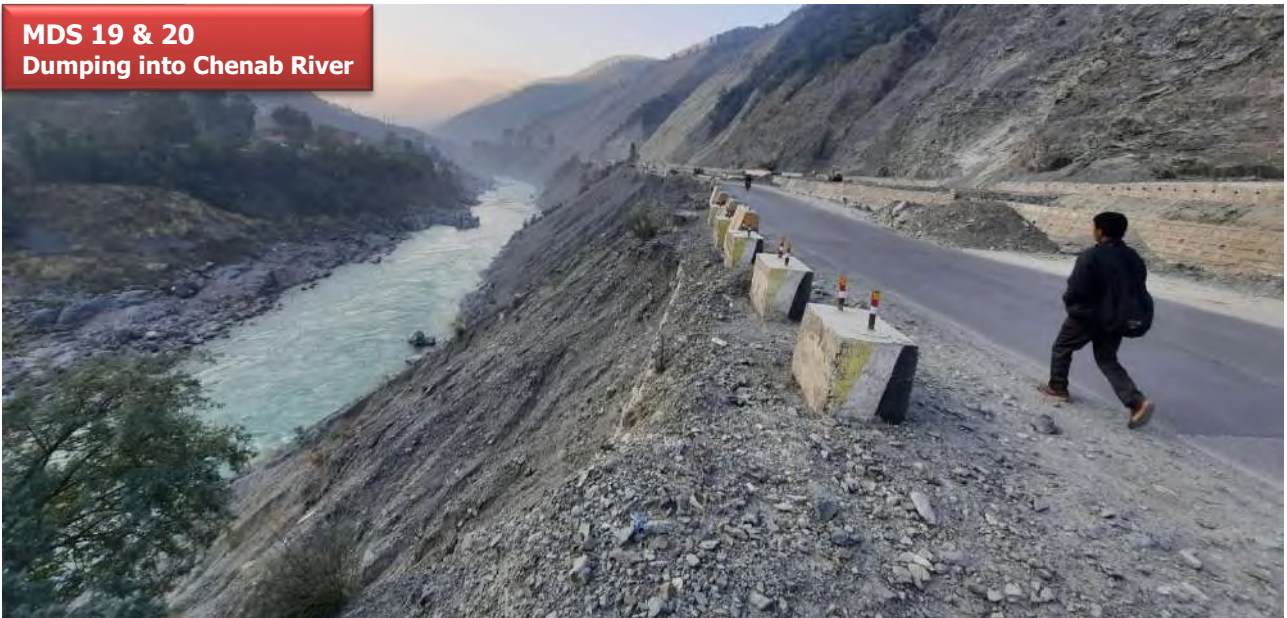
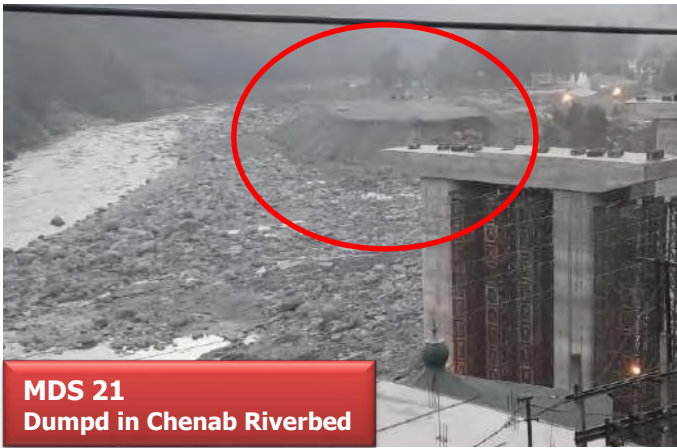
MDS 21
Dumpd in Chenab Riverbed

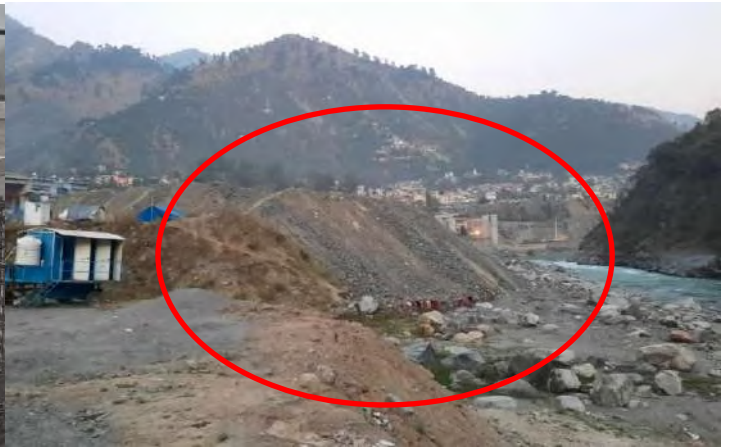
MDS 23
Stone crushing and storage of Muck Debris in Chenab riverbed

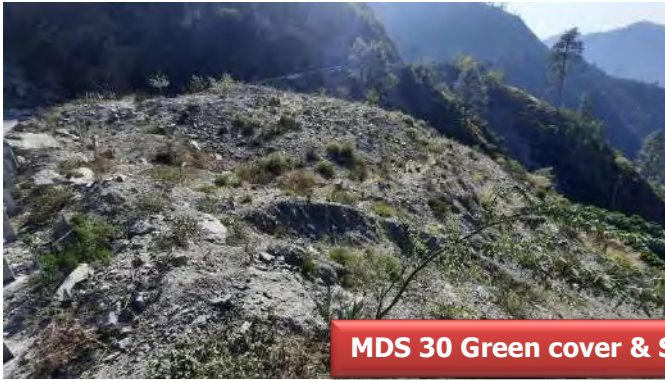
MDS 30 Green cover & Stable slopes in Closed MDS

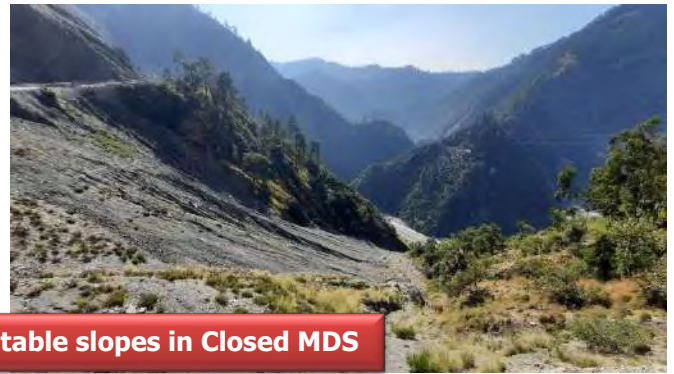
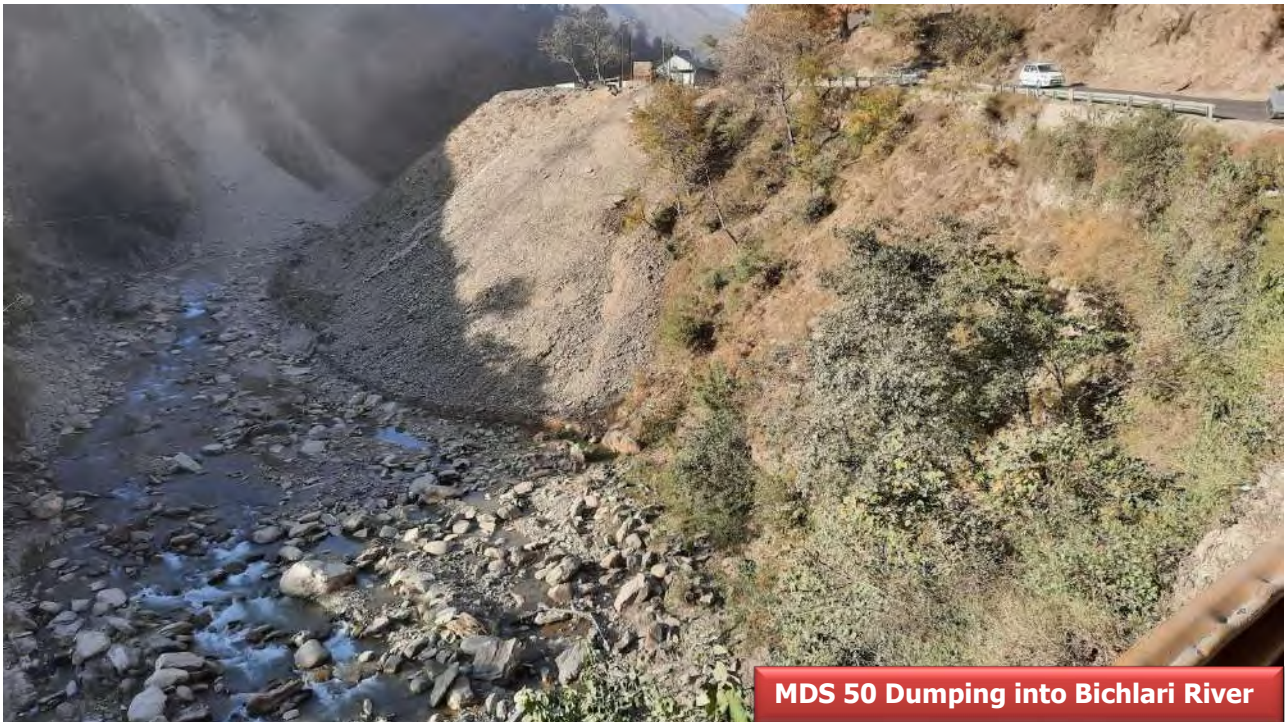
MDS 50 Dumping into Bichlari River

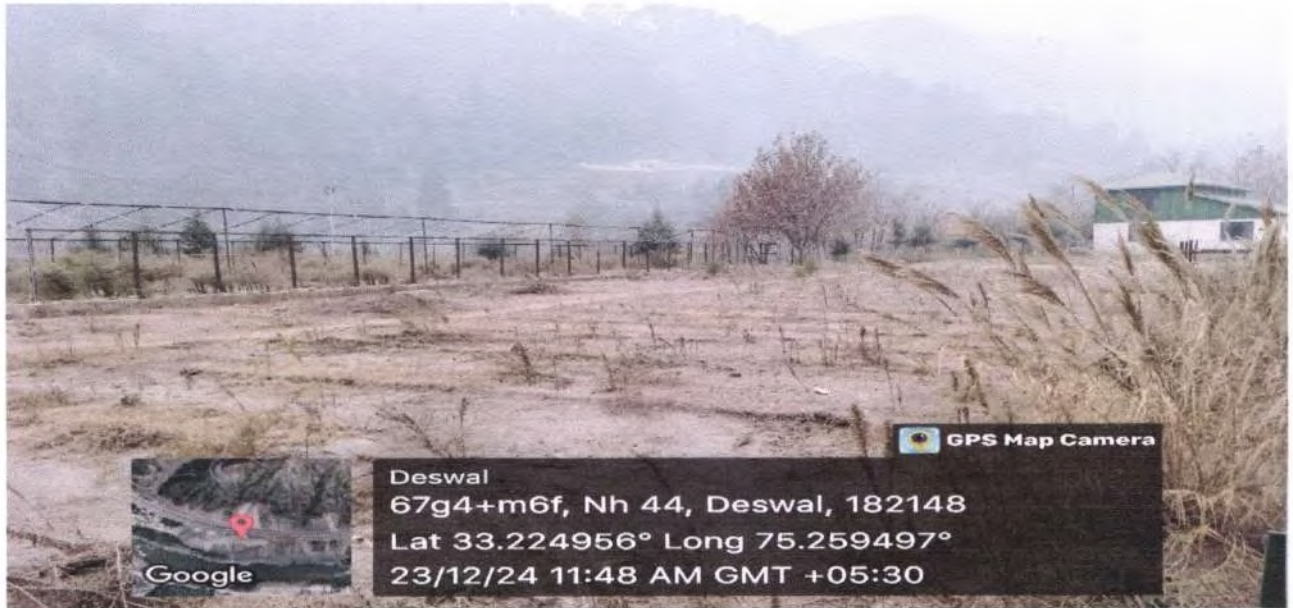
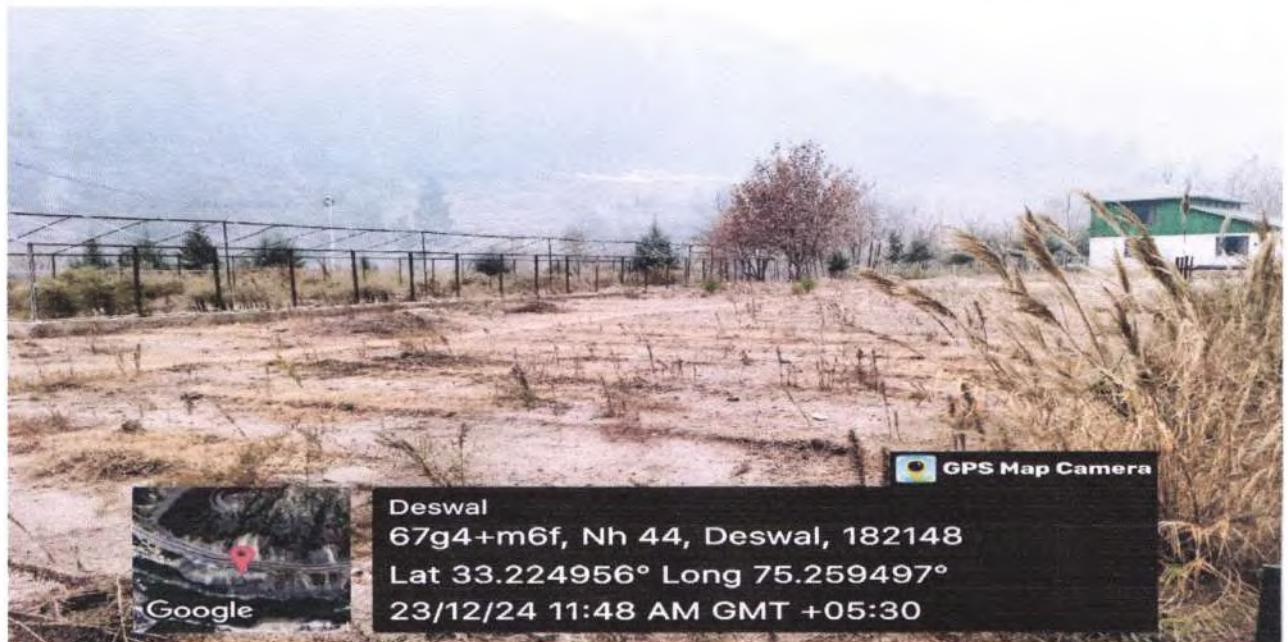
MDS - 01 (NGT Site no. nil)

Location: Nashri, Ramban

Details of Work done for Restoration: The site is stabilized with vegetation over the slope. No further restoration is required.

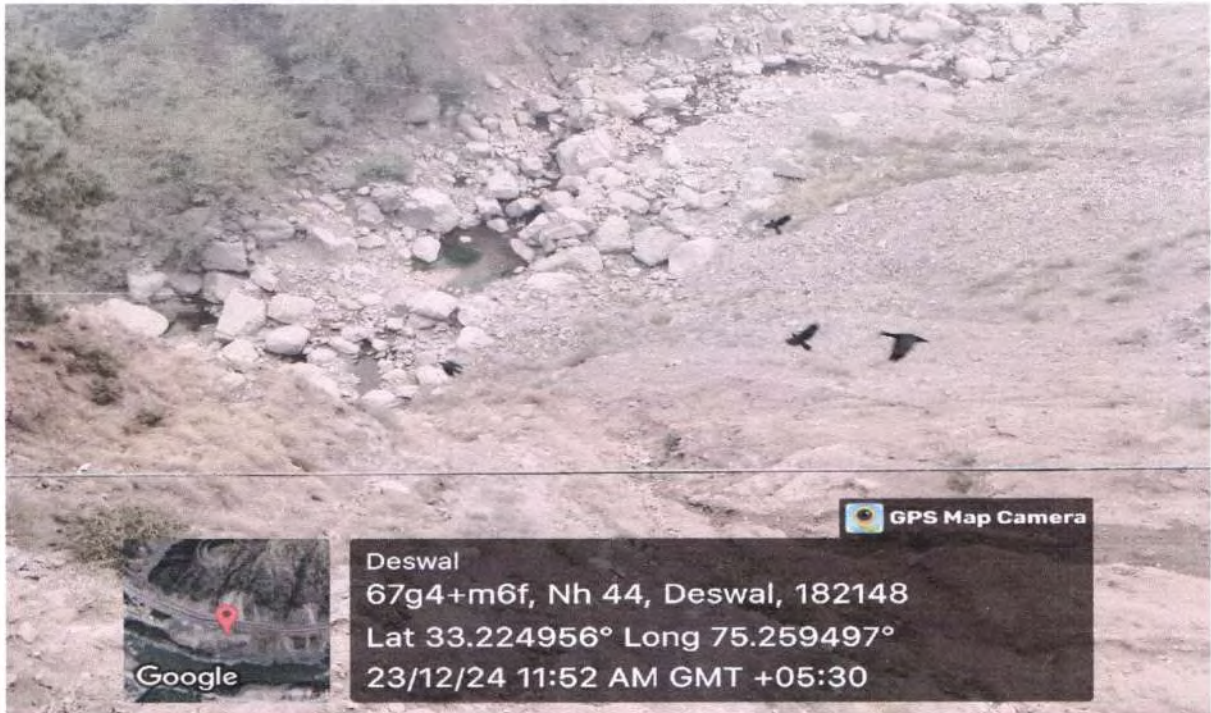
MDS - 02 (NGT Site no. nil)

Location: Nashri, Ramban

Details of Work done for restoration: Slope protection through coir mat & hydroseeding has been done and no additional stabilization measure is required.

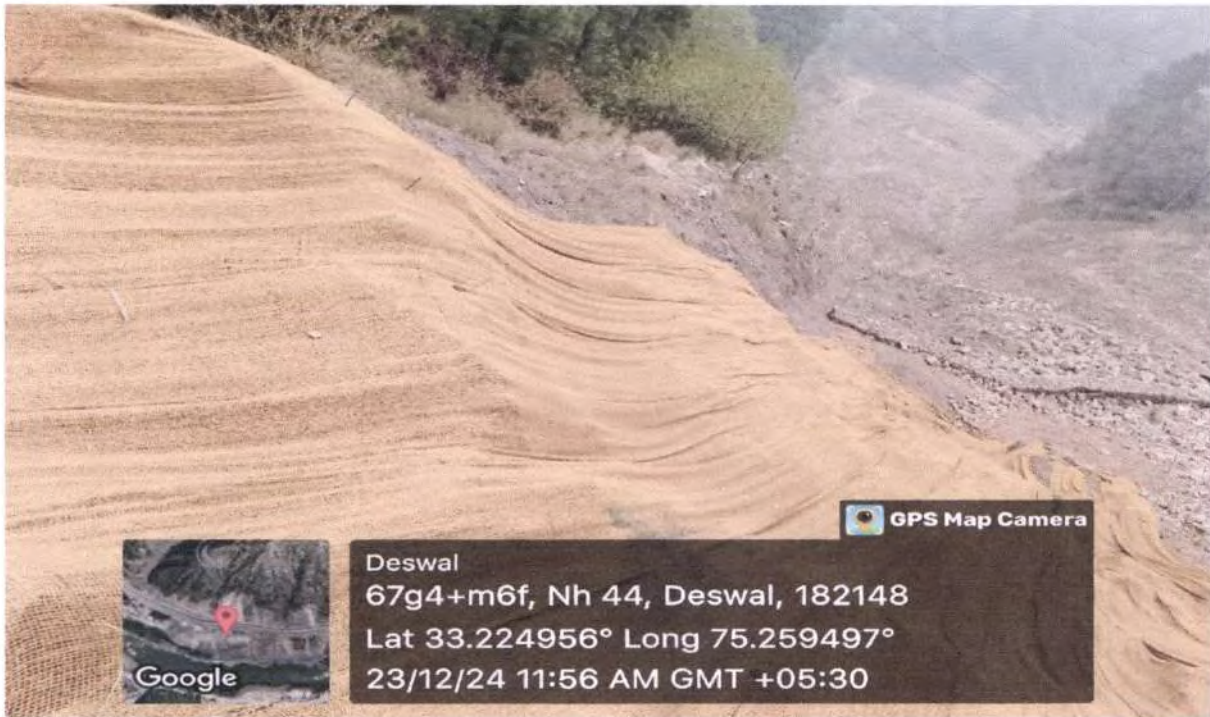
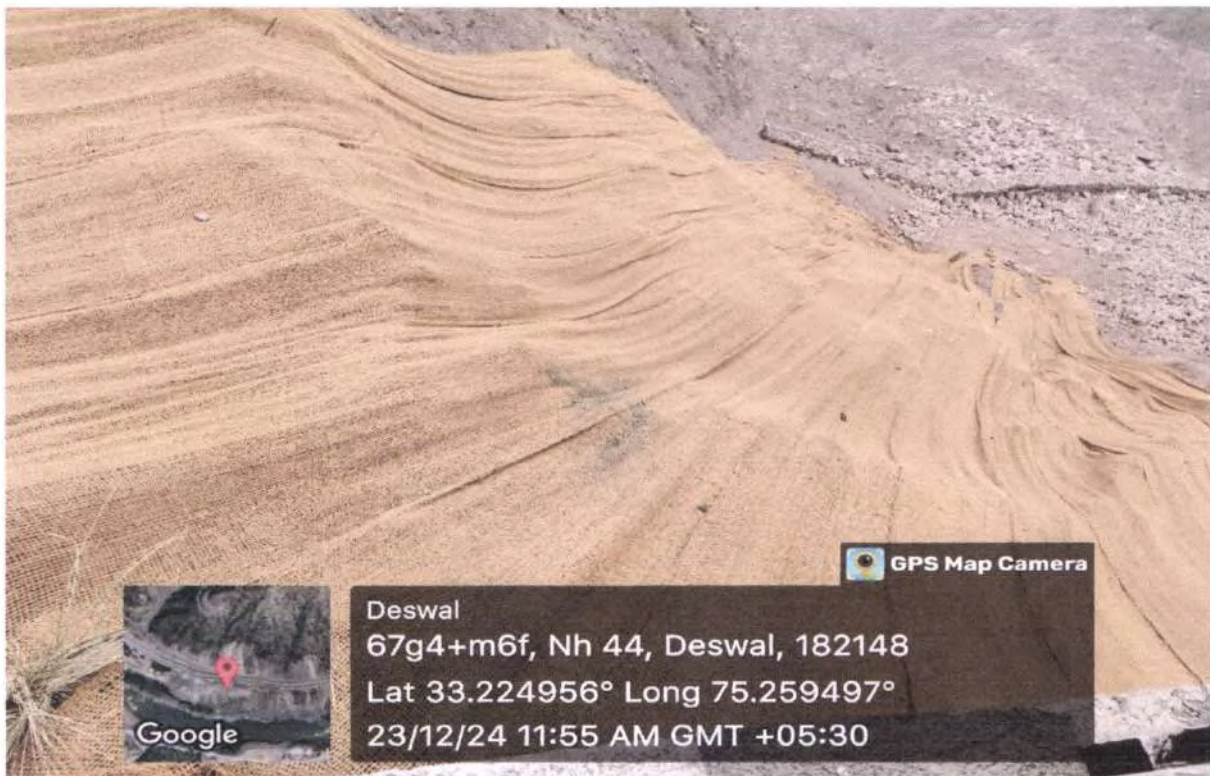
MDS - 03 (NGT Site no. 01)

Location: Nashri, Ramban

Details of Work done for restoration: Slope has been stabilized by providing Gabion & Coir Matting.

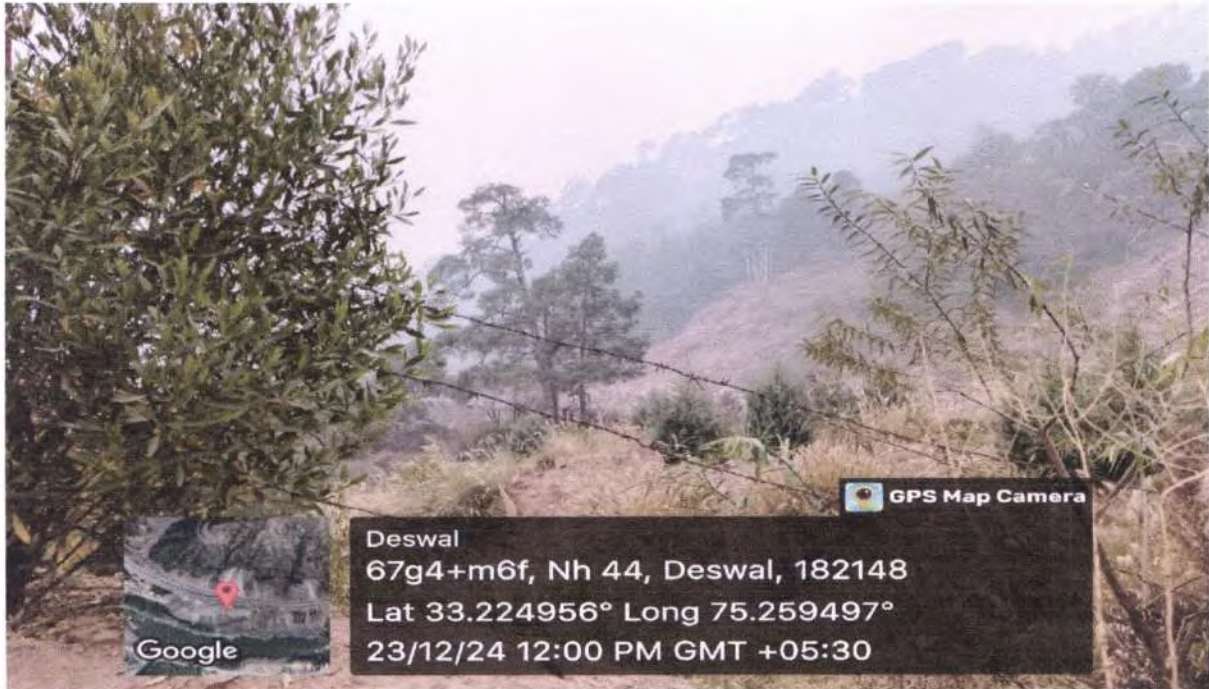
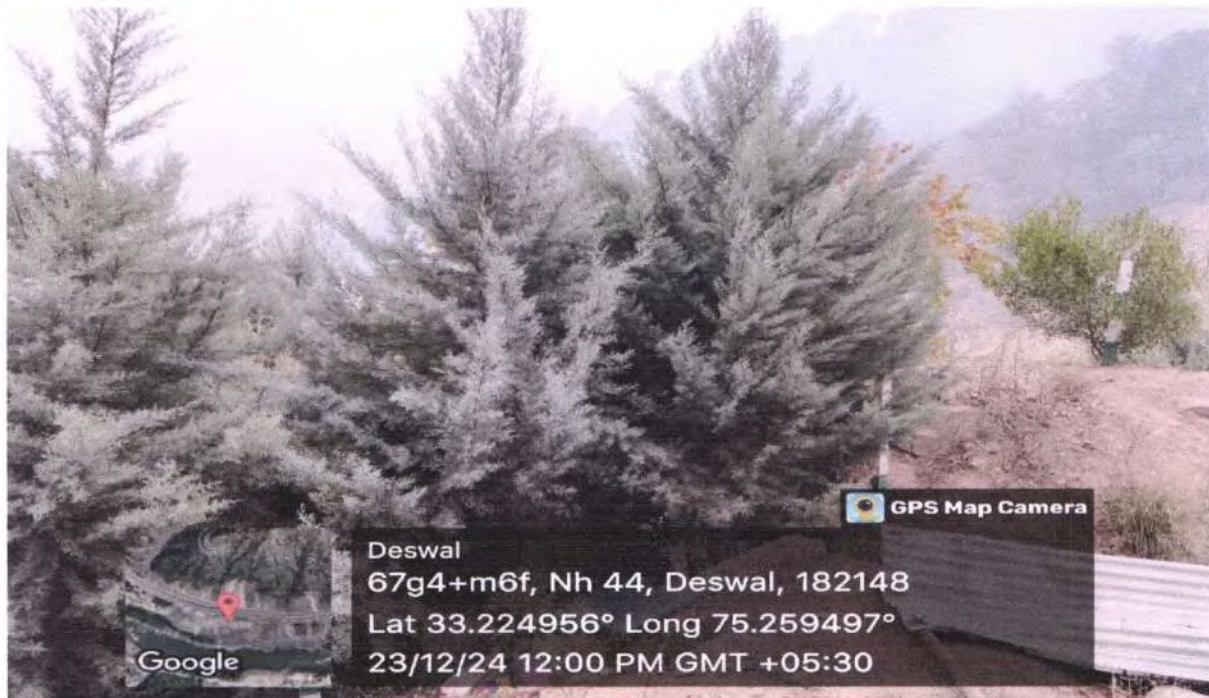
MDS - 04 (NGT Site no. nil)
Location: Dhalwas, Ramban

Details of Work done for restoration: Natural Vegetation has occurred and no further treatment is required.

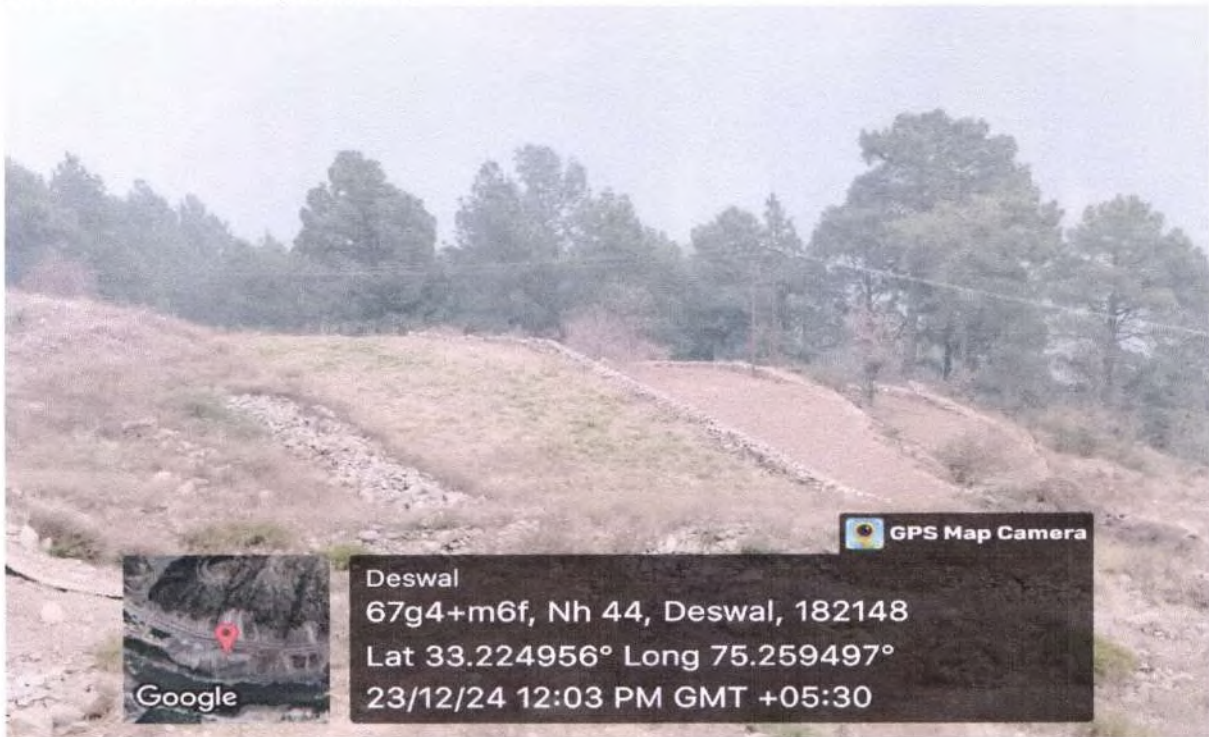
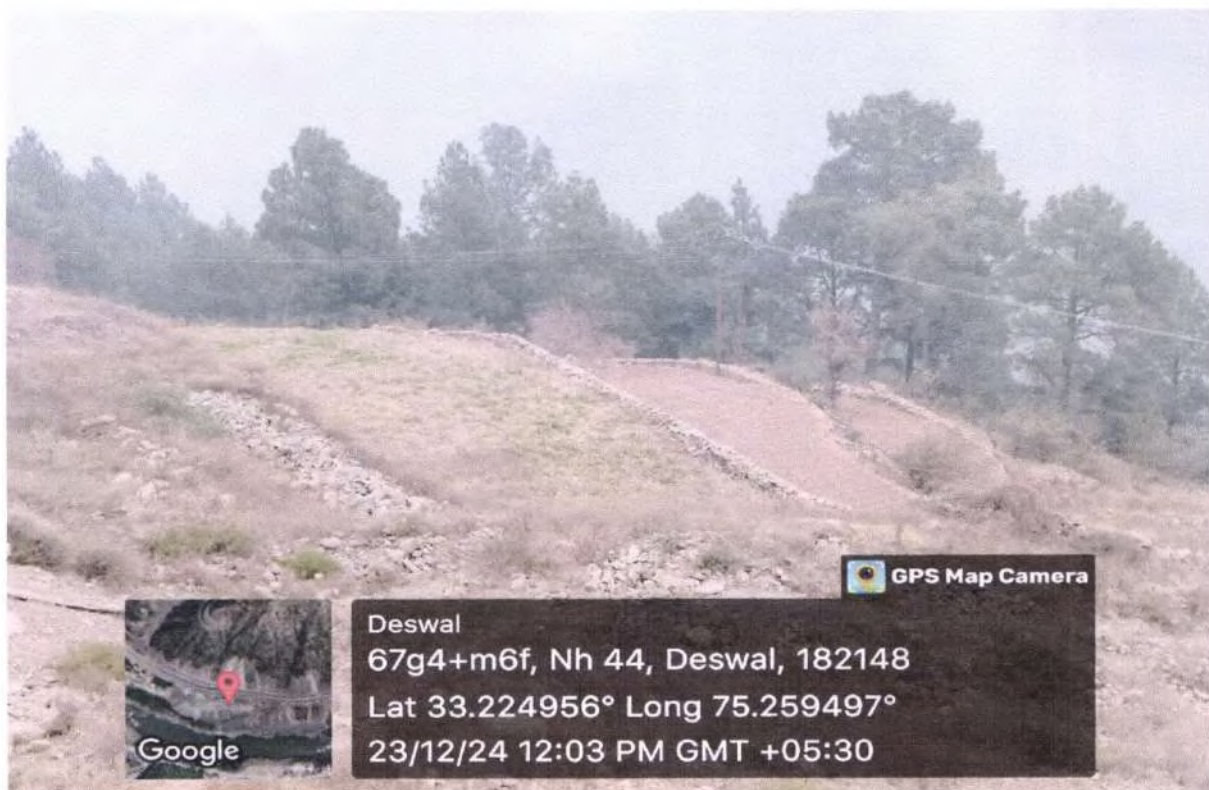
MDS - 05 (NGT Site no. 02)

Location: Dhalwas, Ramban

Details of Work done for restoration: Gabion walls have been provided after making bench and natural Vegetation has occurred and no further treatment is required.

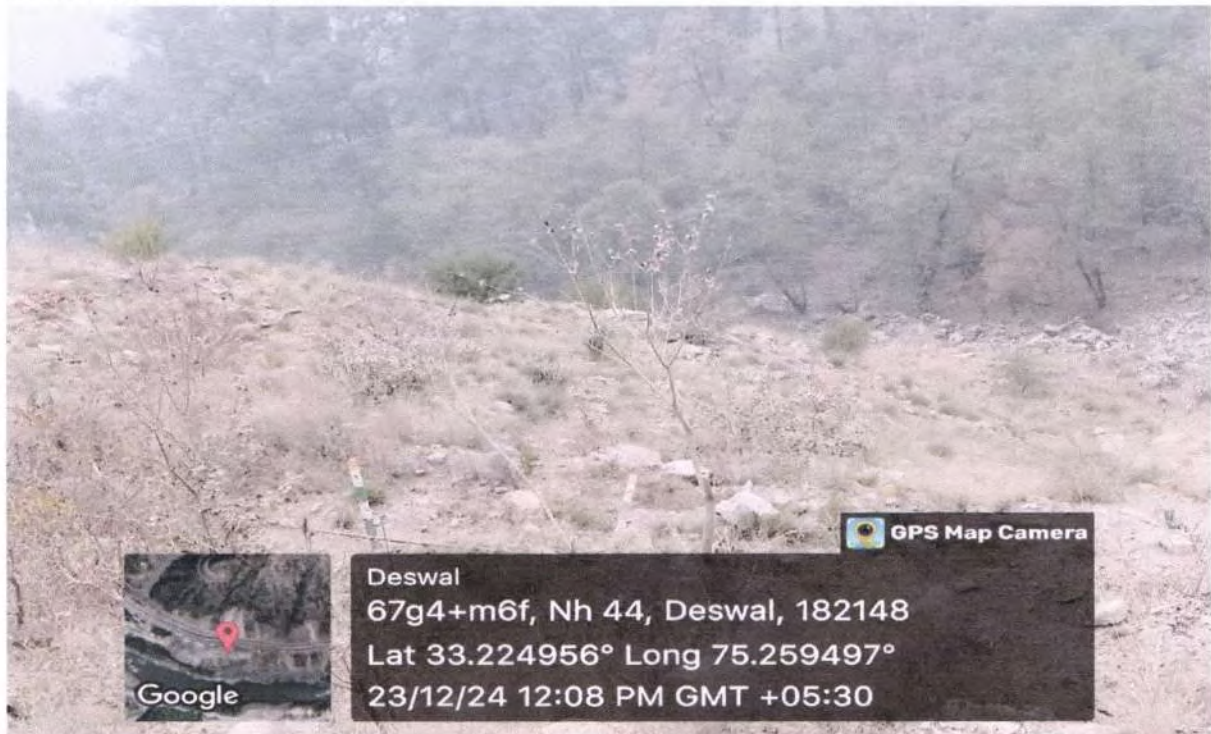
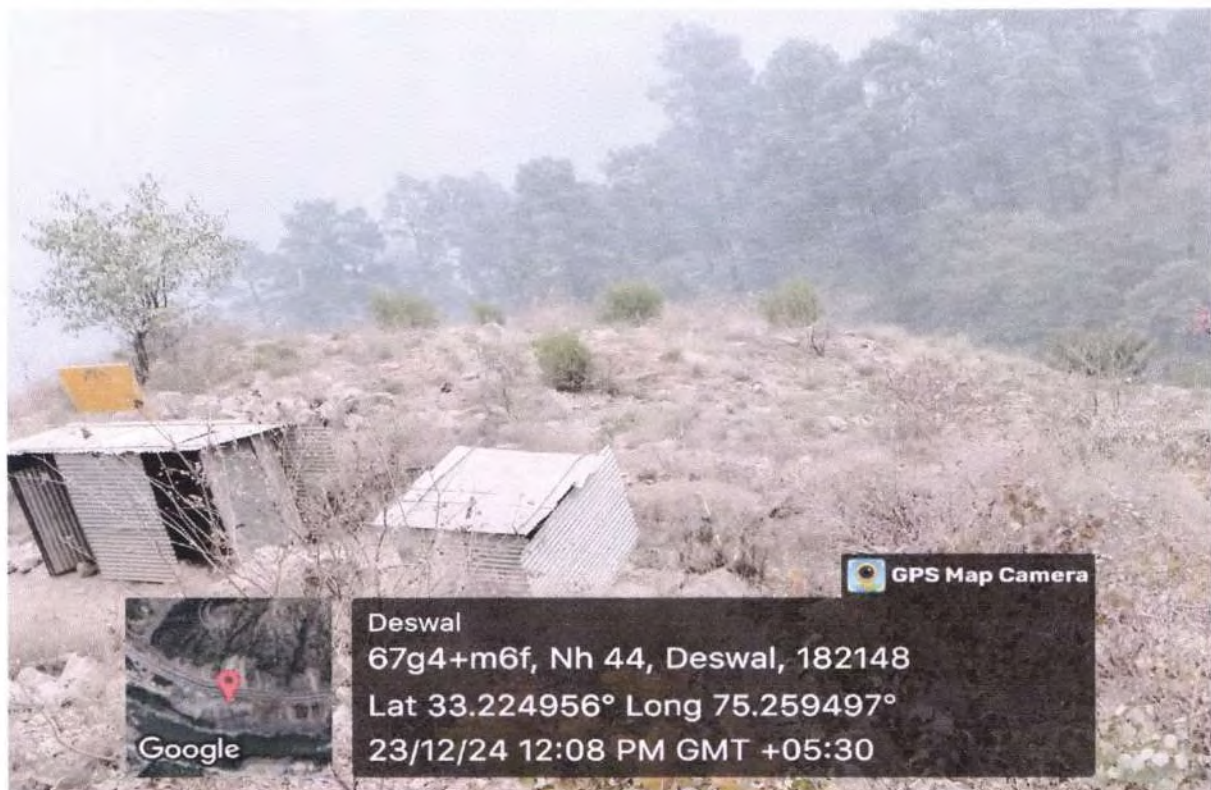
MDS - 06 (NGT Site no.3)**Location: Dhalwas, Ramban**

Details of Work done for restoration: Natural Vegetation has occurred and no further treatment is required.

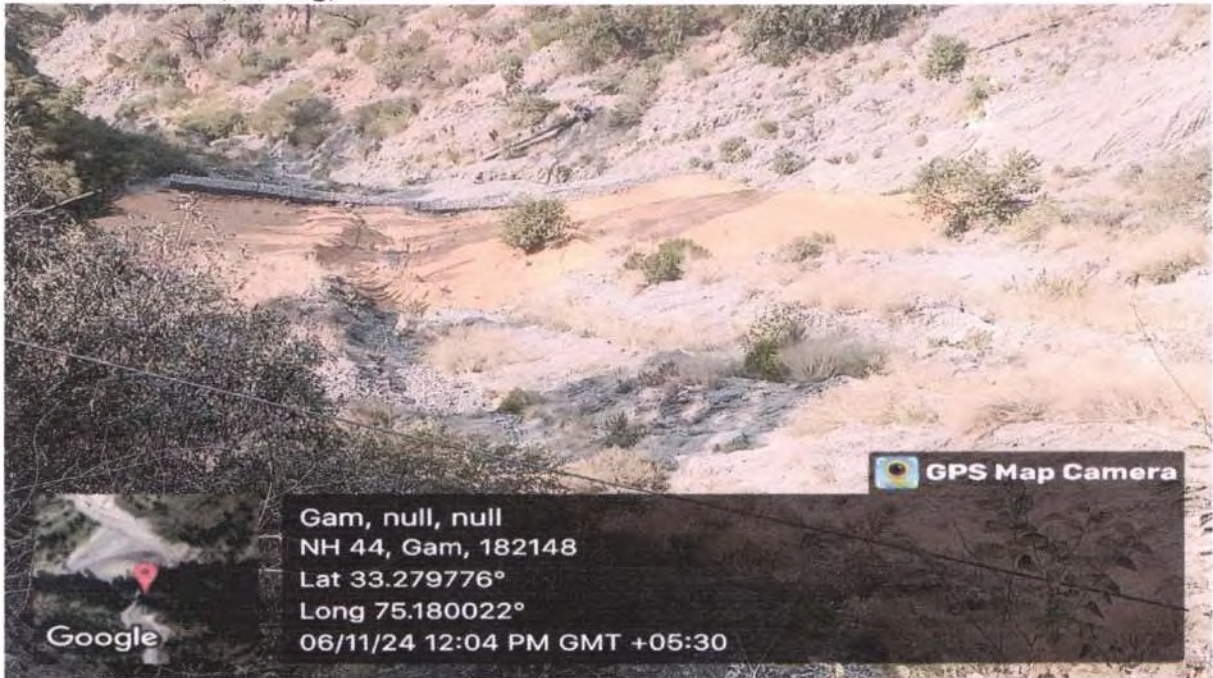
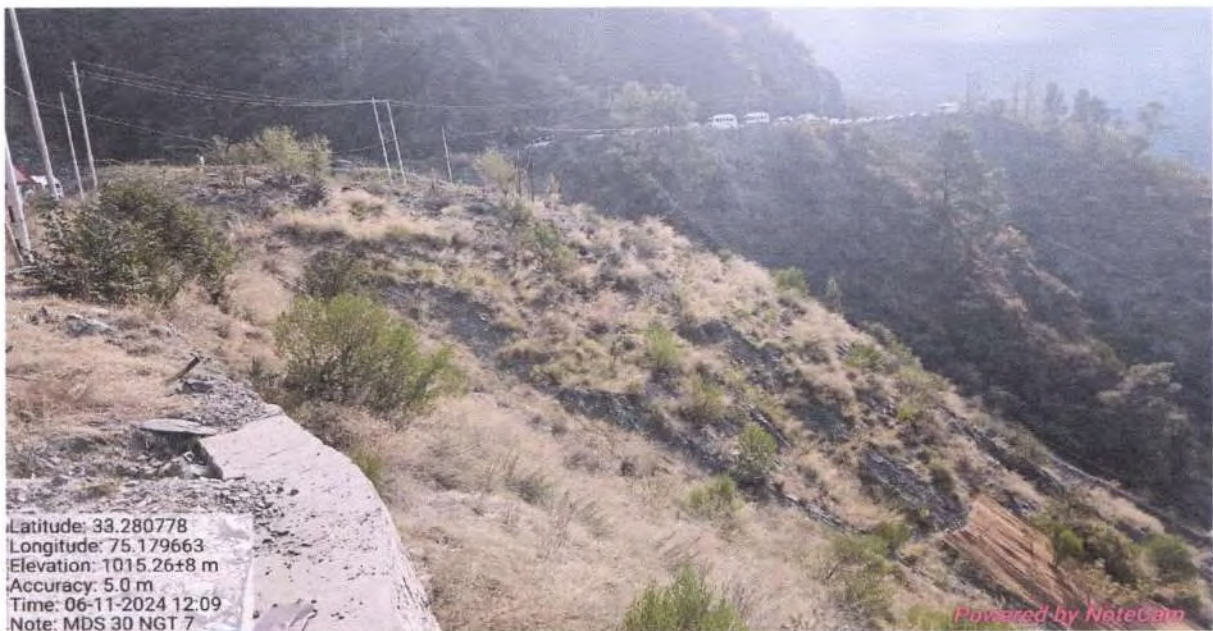
MDS - 30, (NGT Site no. 07)
Location: Gam, Marog, Ramban

Details of Work done for restoration: Gabion walls & Coir Matting have been provided for stabilizing the site. Natural vegetation on slopes.

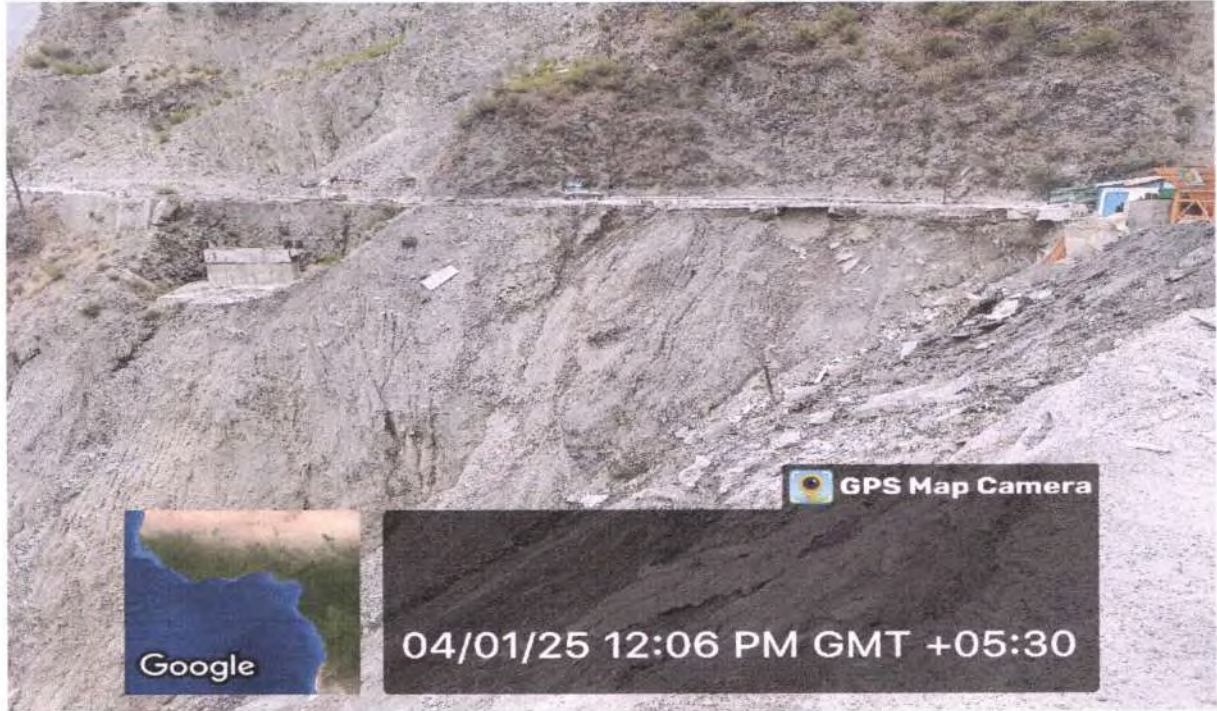
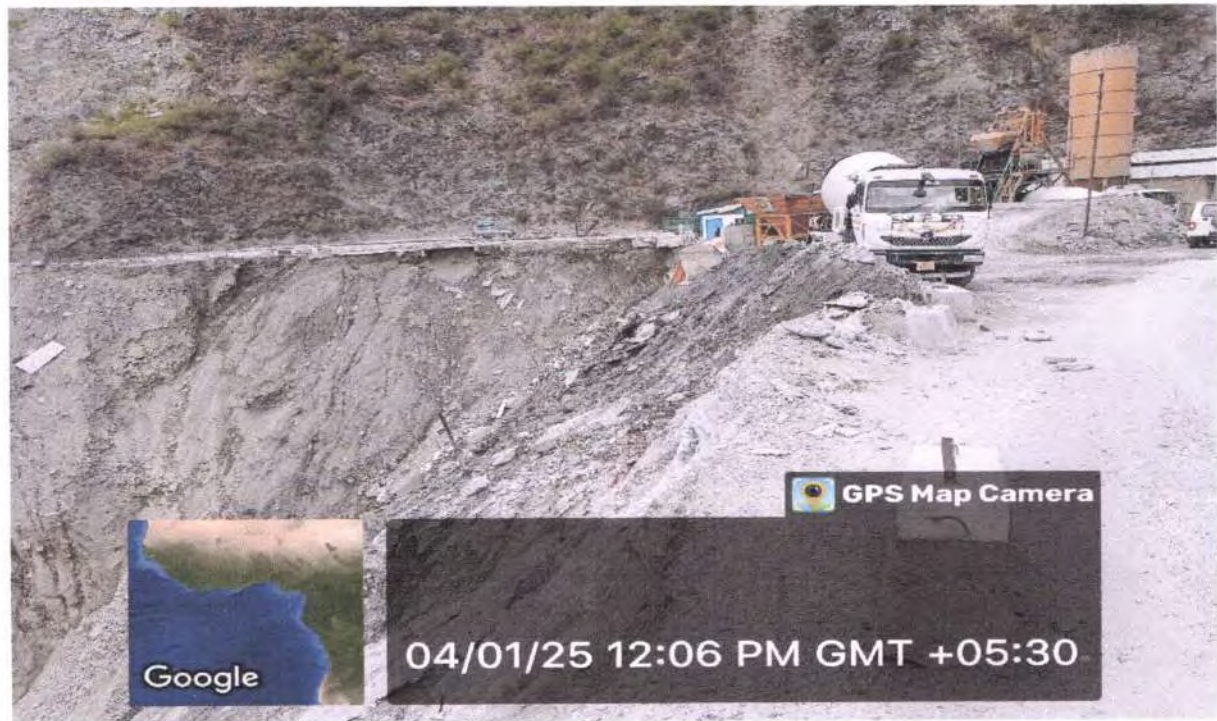
MDS - 31, (NGT Site no. 08)
Location: Anokhi Fall, Ramban

Details of Work done for restoration: Gabion walls & Coir Matting have been provided for stabilizing the site.

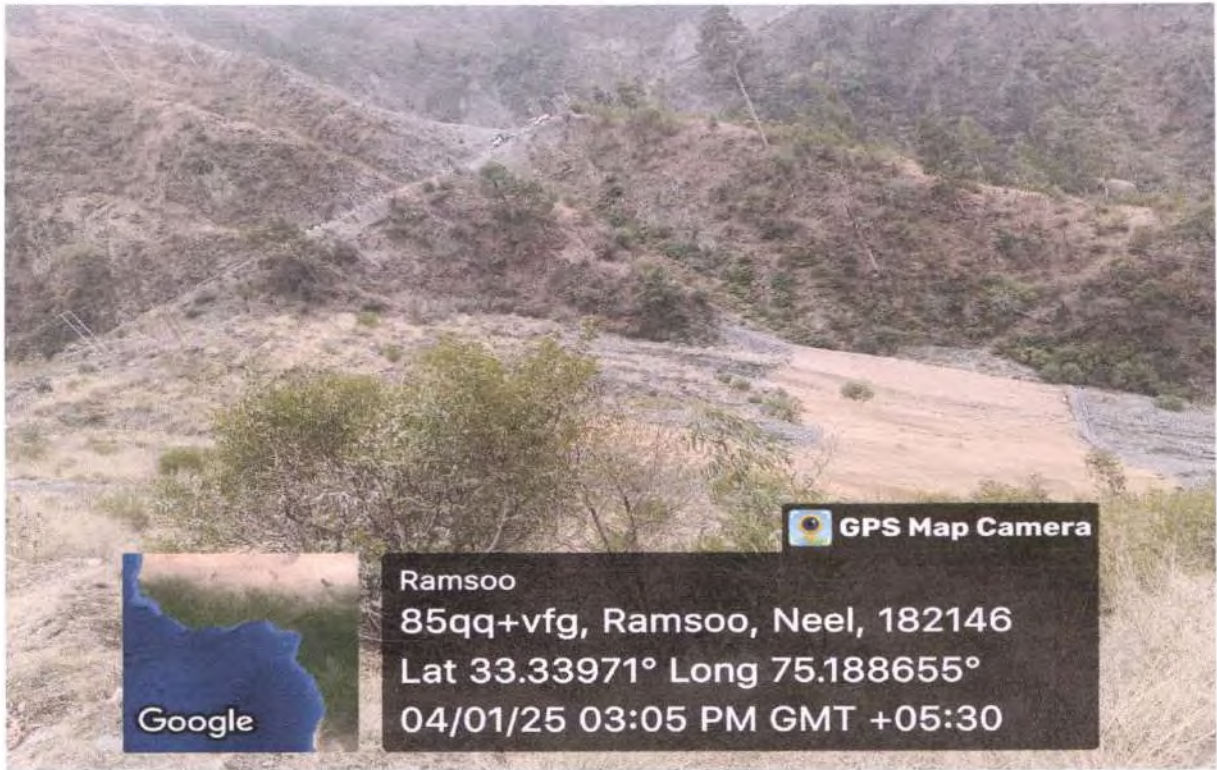
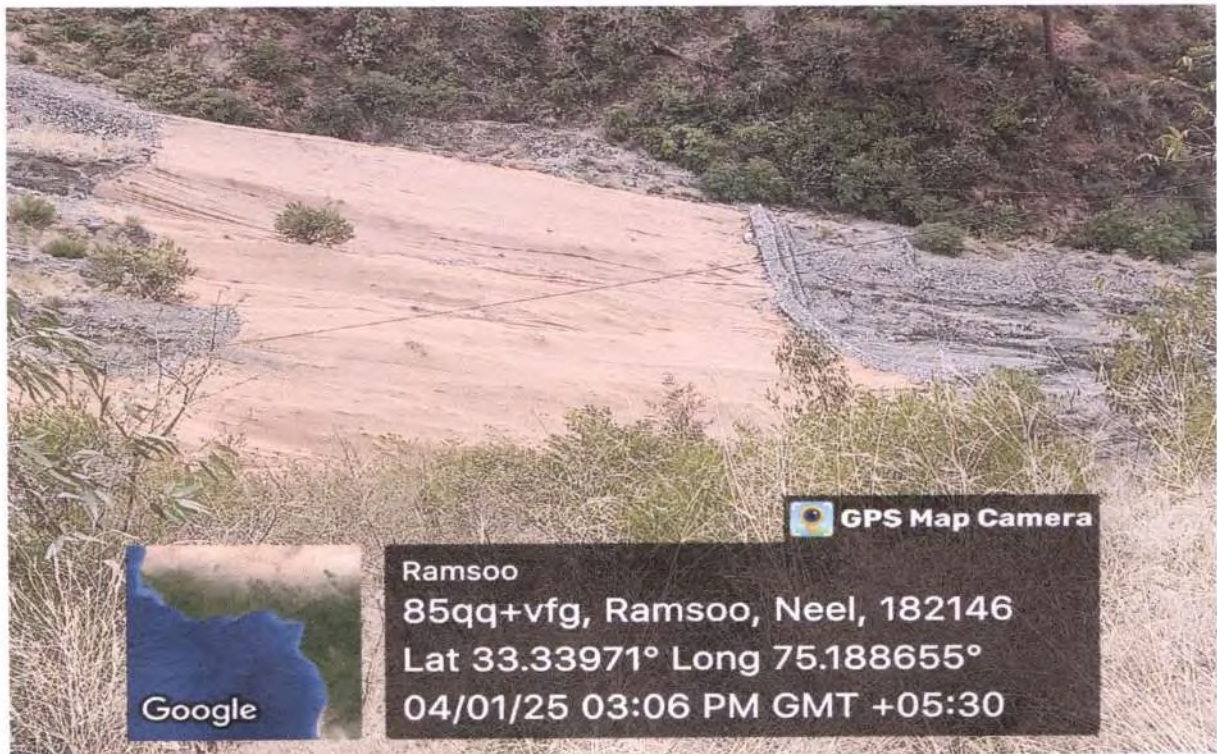
MDS - 32, (NGT Site no. 09)

Details of Work done for restoration: More area about 60 kanals acquired for dumping of tunnel muck. New dumping will start only after proper protection.

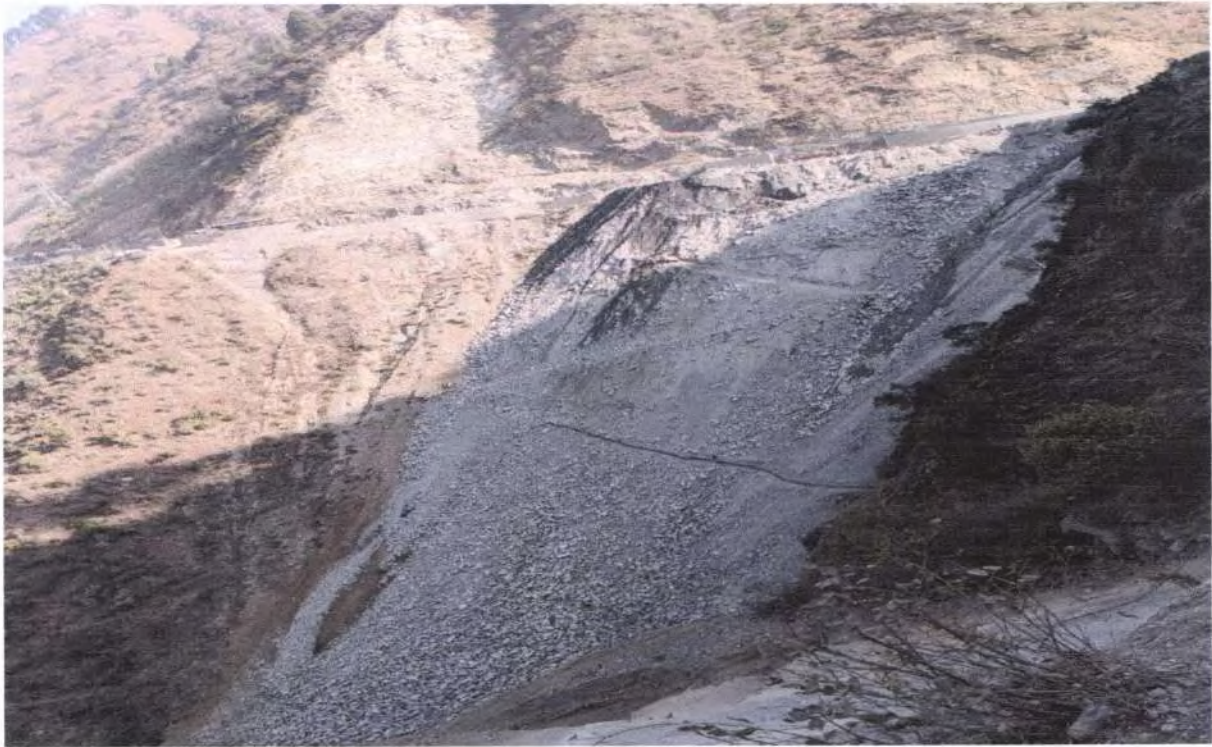
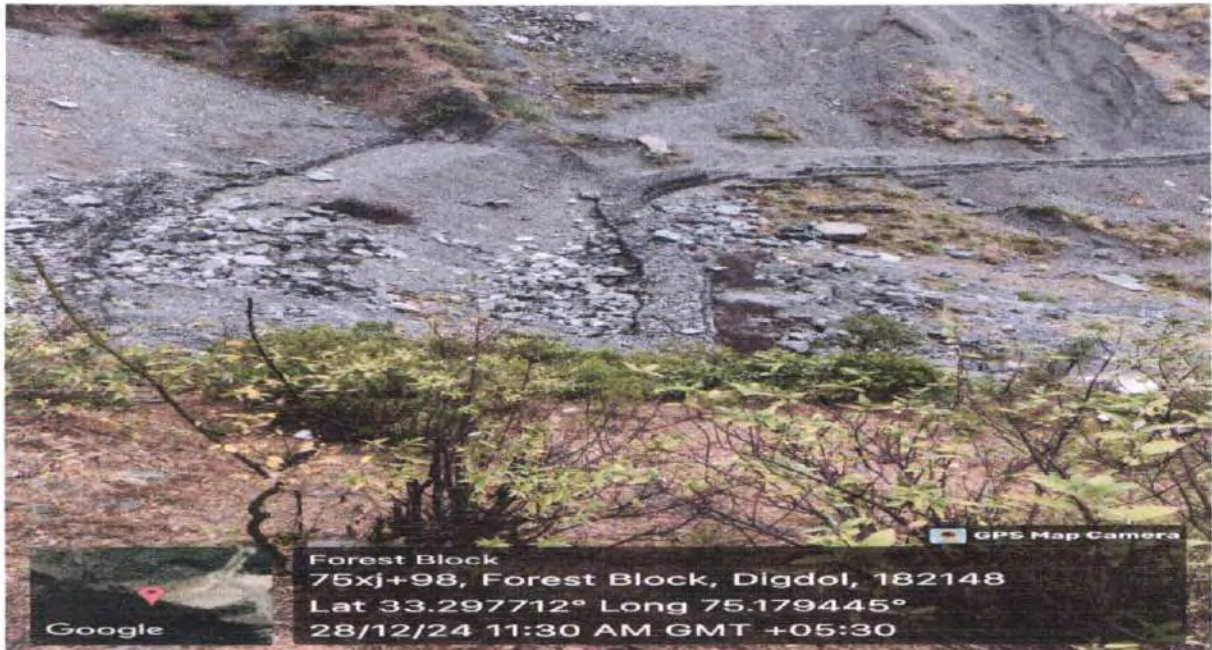
MDS-33, (NGT Site no. 10-11)

Details of Work done for restoration: Additional Forest land acquired for dumping of tunnel muck in realigned section. Gabions walls constructed at toe and completion will be done after completion tunnel excavation.
