EA NO. 23/2024
IN
ORIGINAL APPLICATION NO. 295/2016

7.	Annexure R-2/6 True copy of the JKPCC site visit report dated 10.01.2025.	101-184
8.	Annexure R-2/7 True copy of e-mail dated 22.10.2024.	185-228
9.	Proof of service.	229

**COMPLIANCE REPORT ON BEHALF OF RESPONDENT NO.2/NHAI
IN TERMS OF ORDER DATED 15.07.2024 & 15.10.2024**

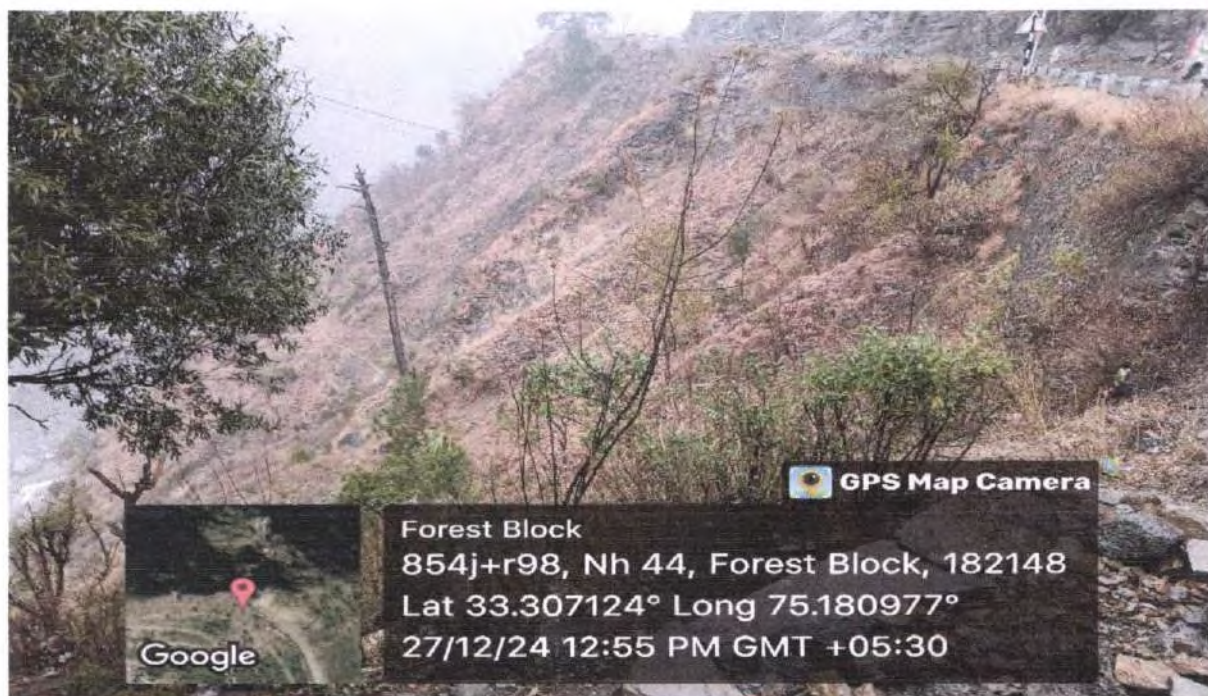
MDS - 34, (NGT Site no. 12)

Details of Work done for restoration: Natural vegetation available on slope. No further protection required.

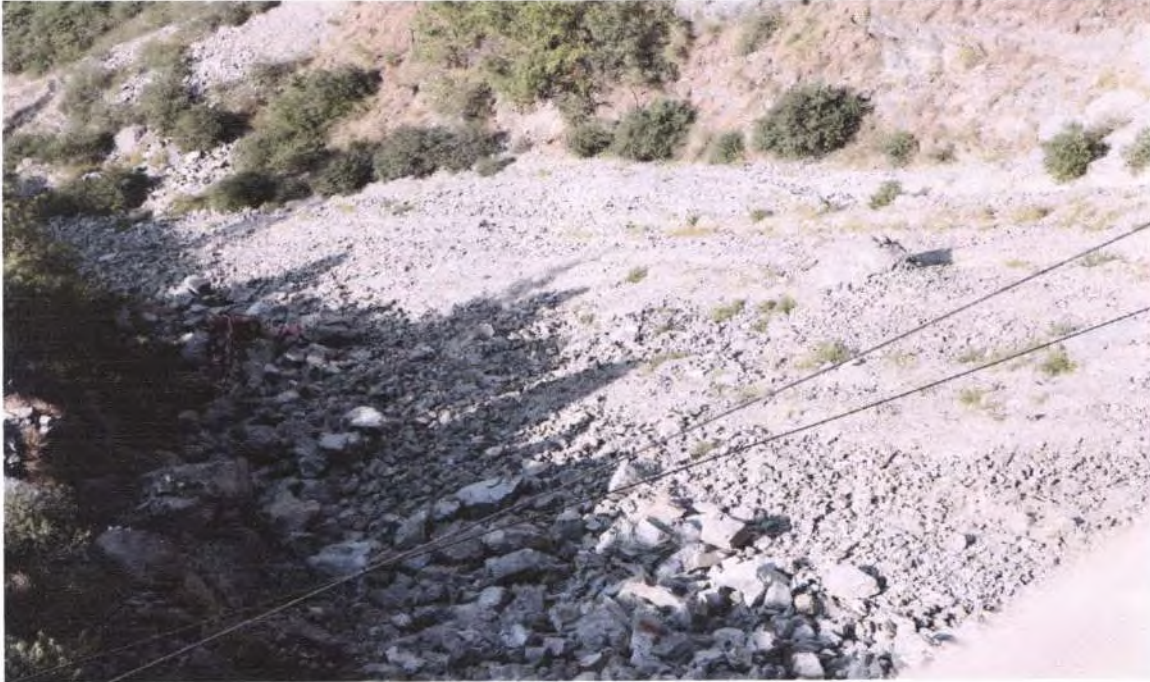
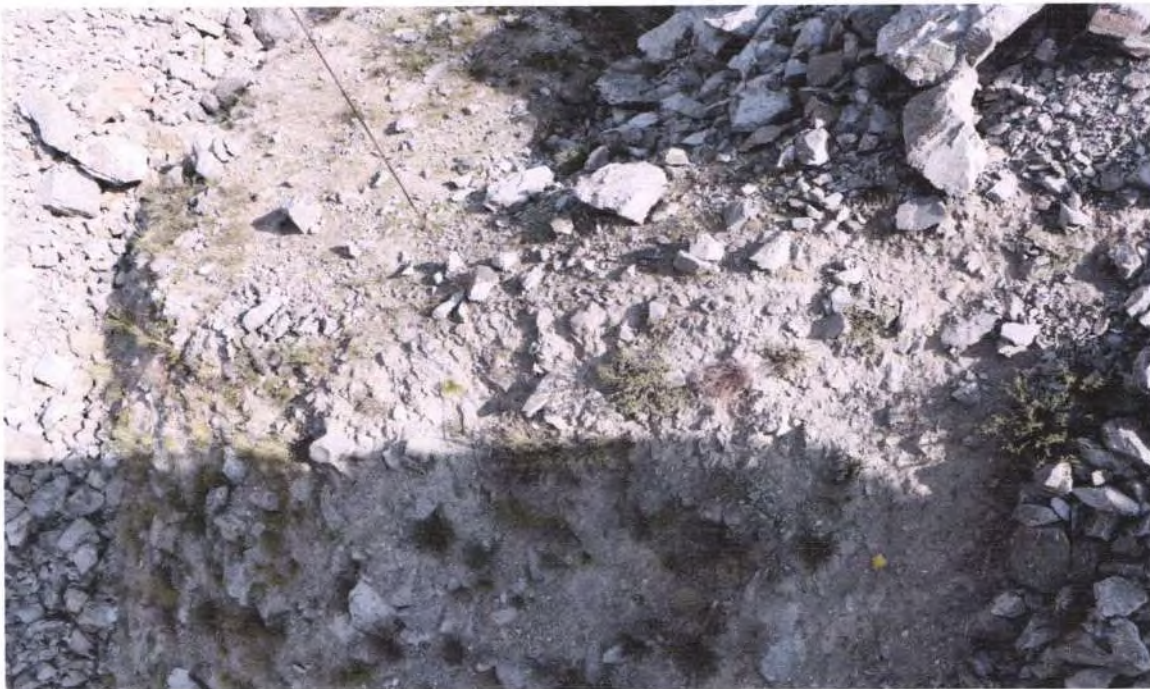
MDS - 35 (NGT Site no. nil)

Details of Work done for restoration: No mulba dumped but mulba available along slopes is due to natural slides. Protection measure is not possible due to steep slope.

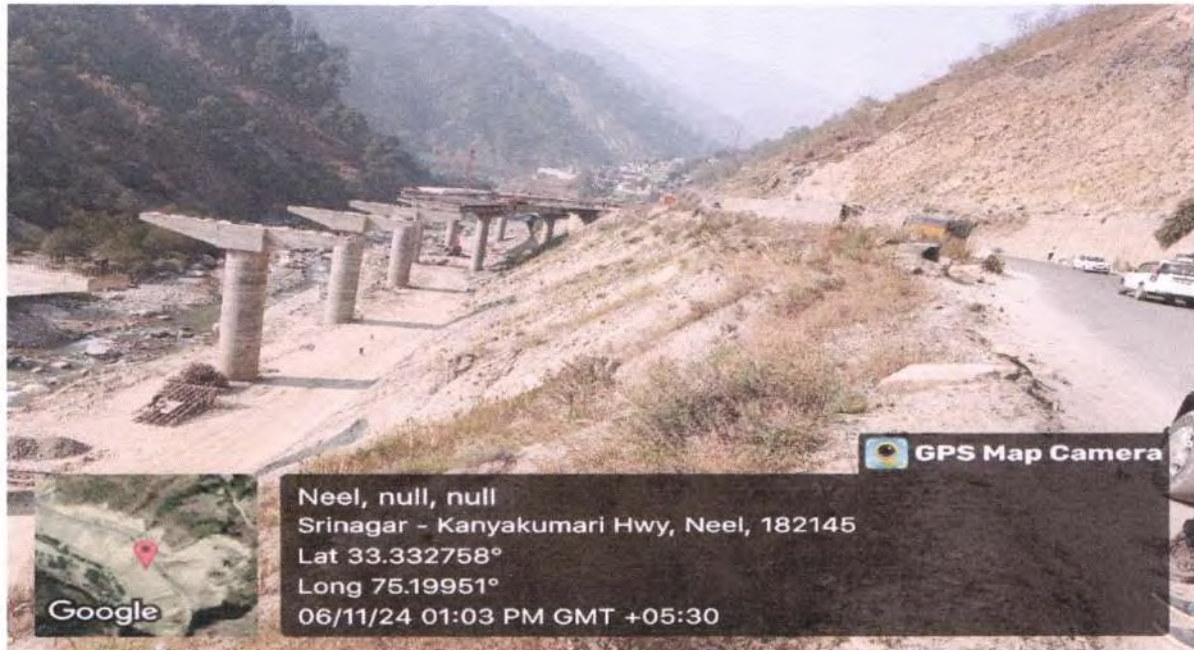
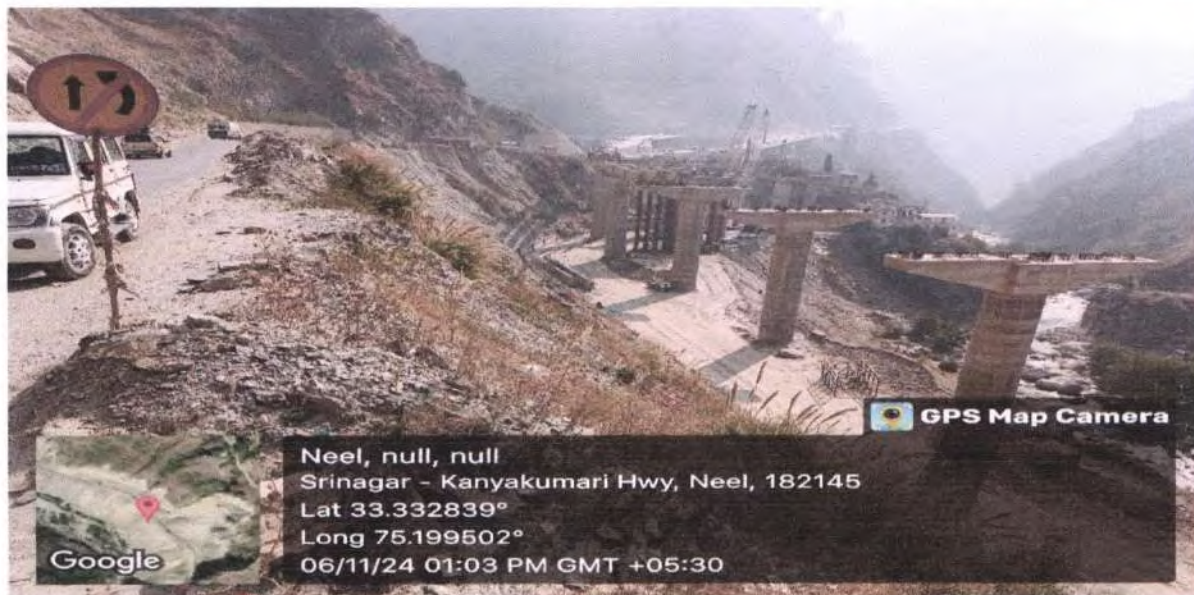
MDS - 37, (NGT Site no. 14)

Details of Work done for restoration: Hill cutting has been stopped so as to reduce impact on the environment and the alignment has been changed by introducing viaducts which are under construction. Complete protection of bridge in the scope of contractor and will be completed after completion of Viaduct.

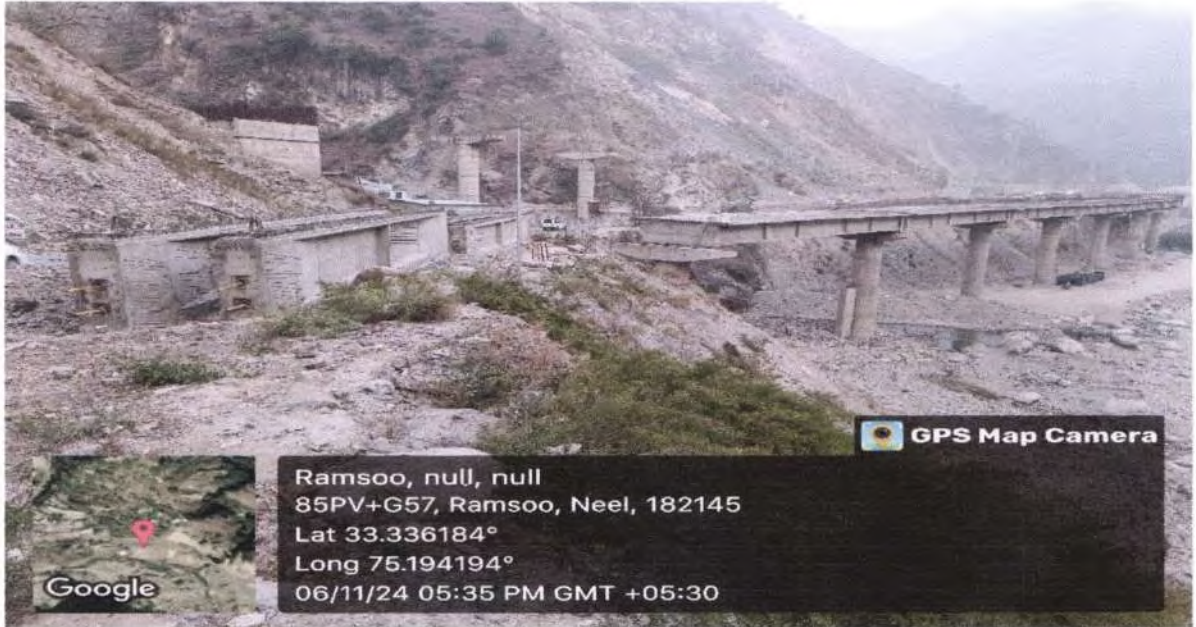
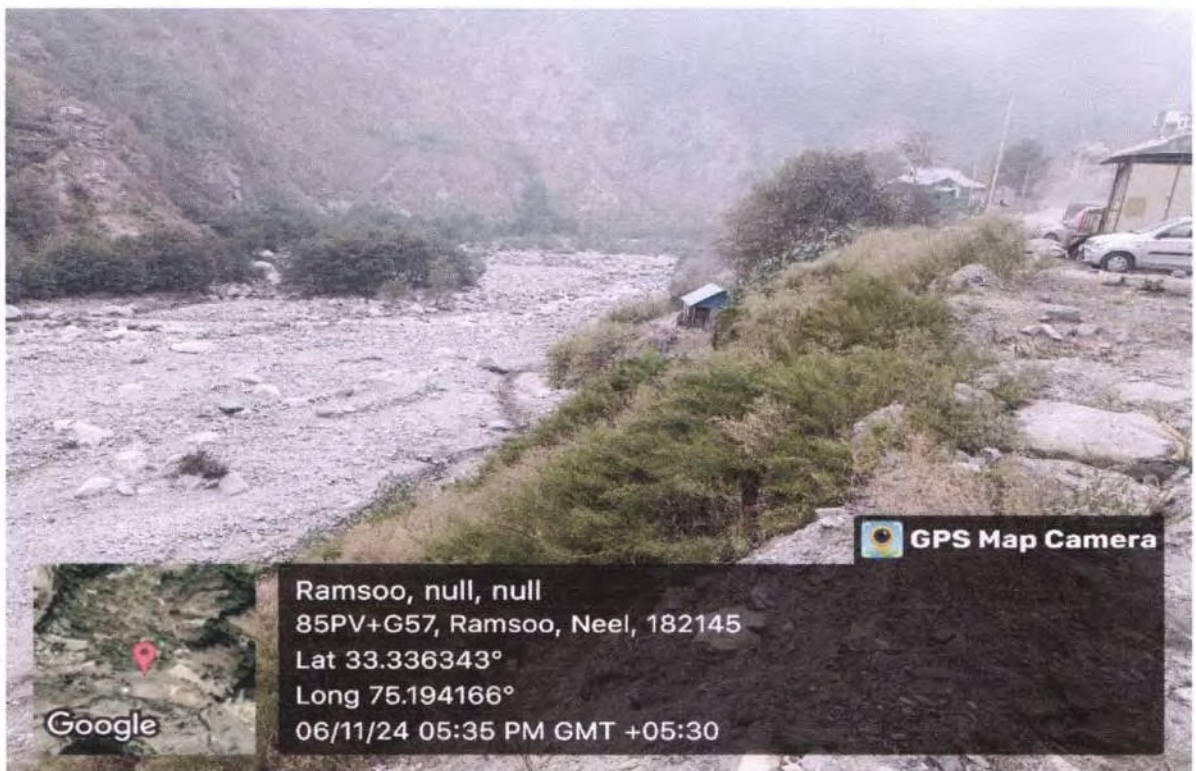
MDS - 38, (NGT Site no. 15)

Details of Work done for restoration: Already stabilized and vegetation on slope.

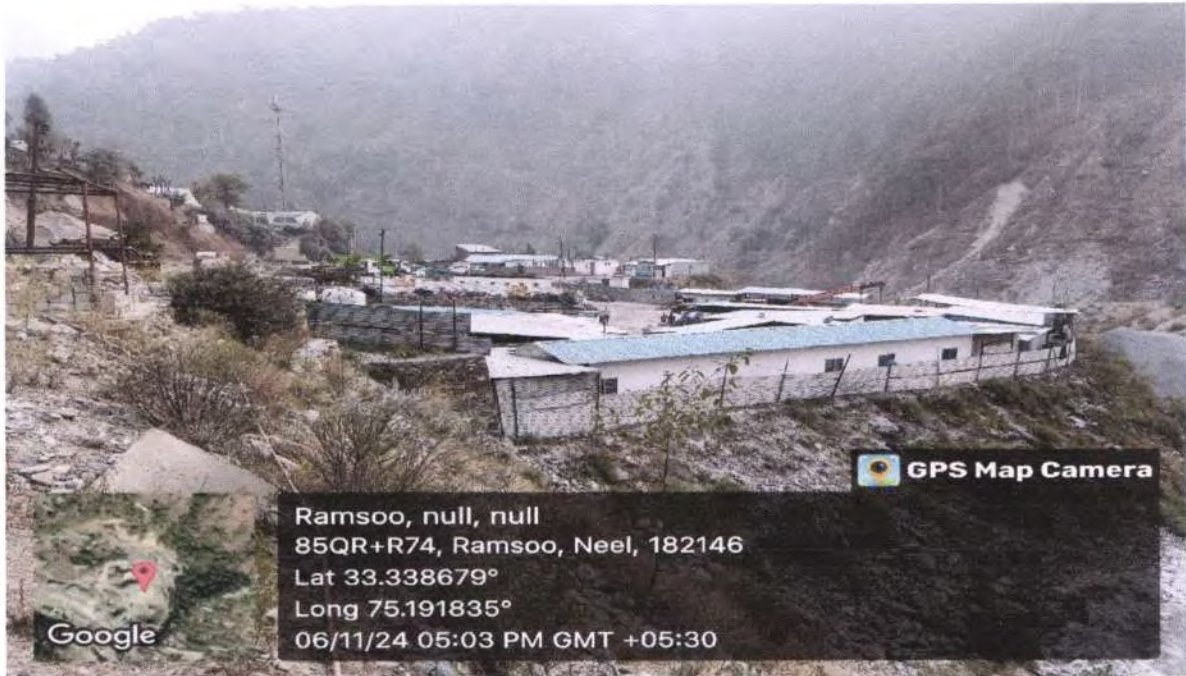
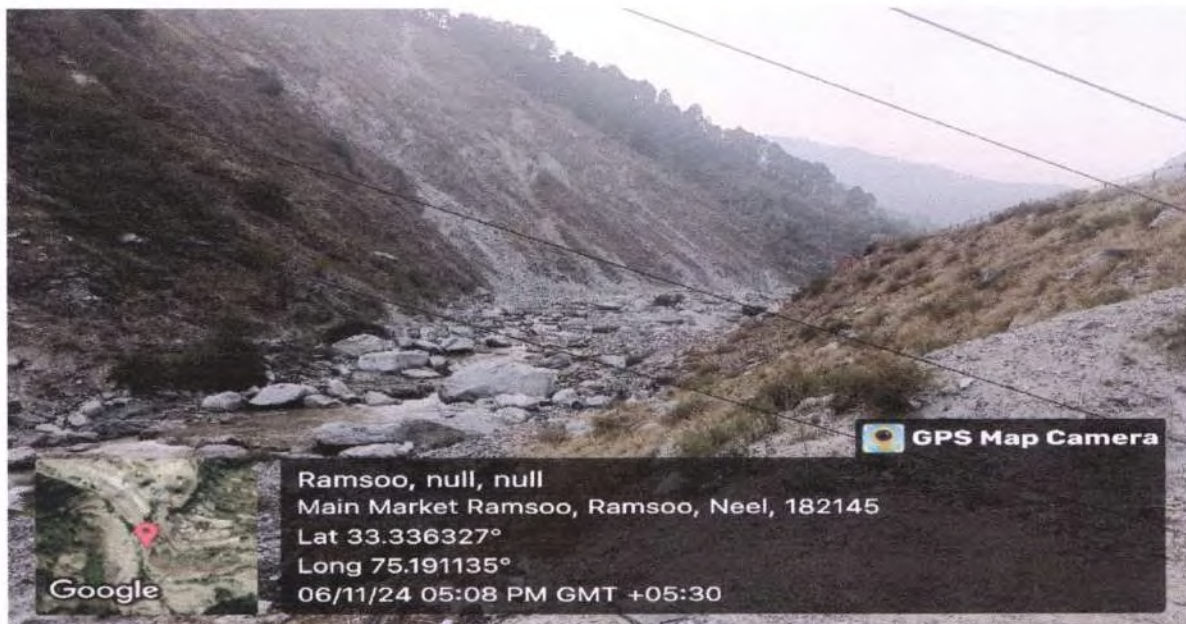
MDS - 39, (NGT Site no. nil)

Details of Work done for restoration: site stabilized and vegetation on slope.

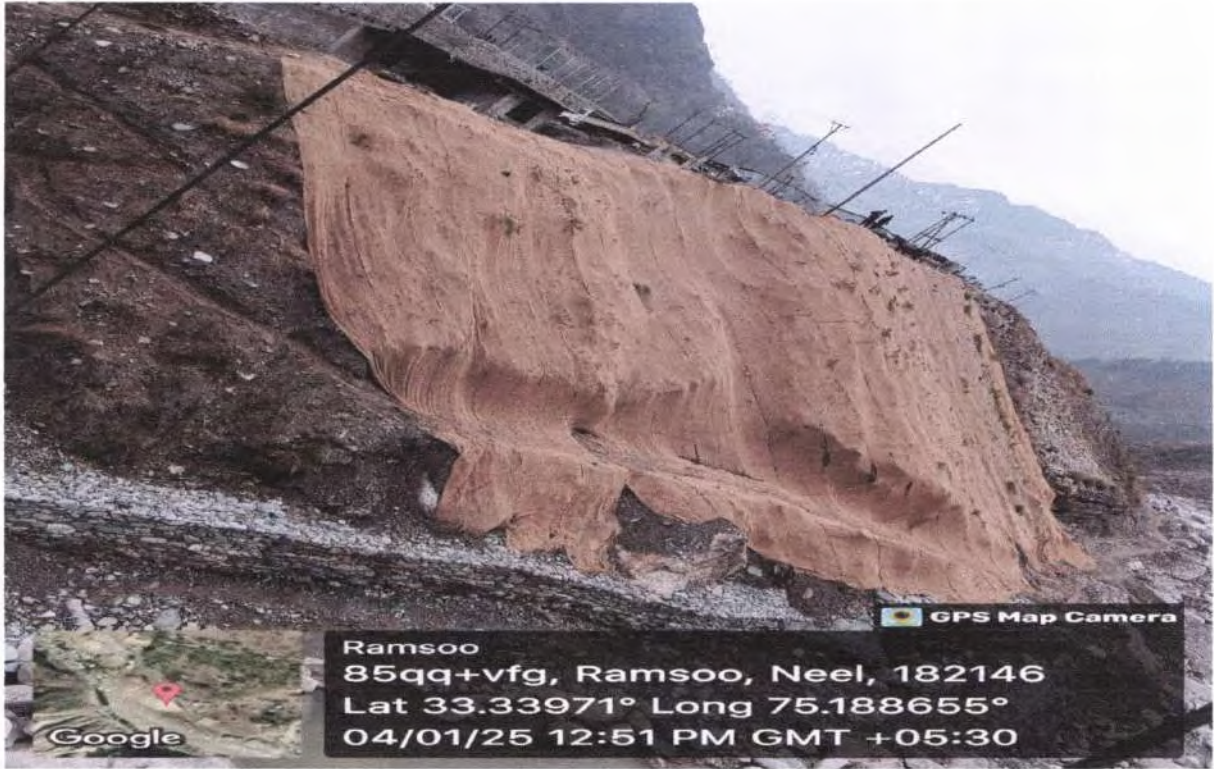
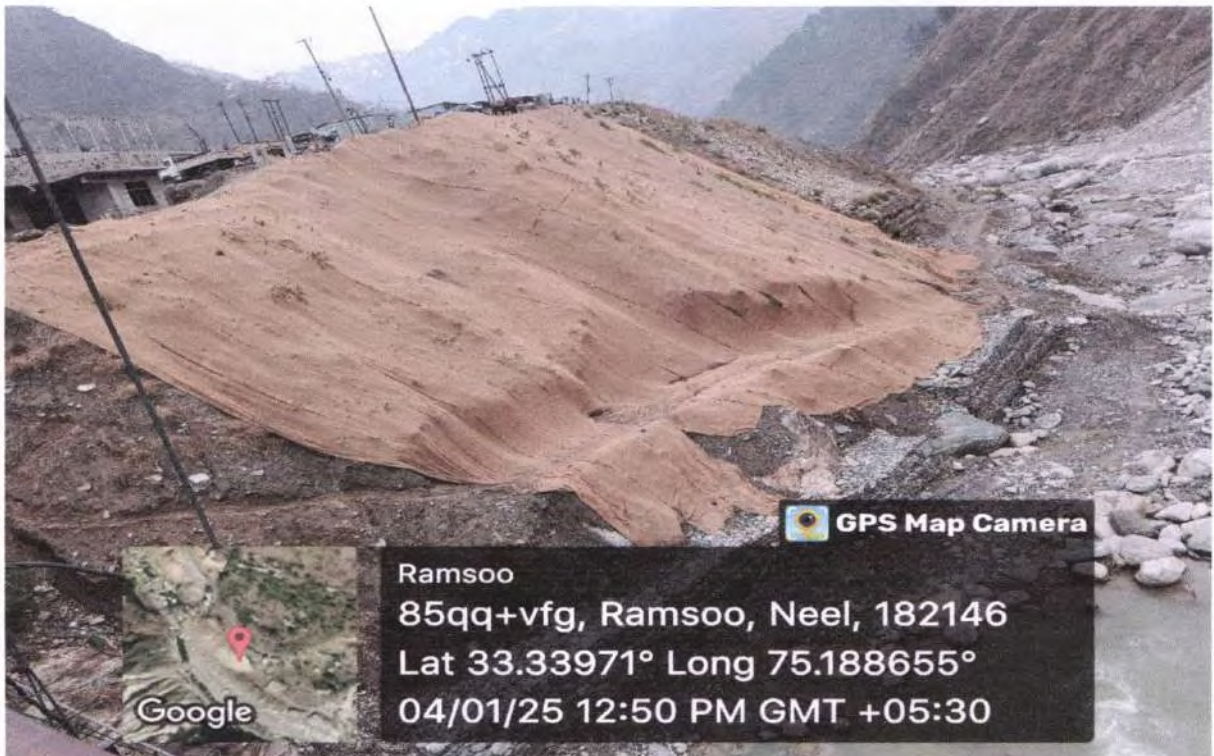
MDS - 40, (NGT Site no. 16)
Location: Ramsoo

Details of Work done for restoration: Gabion walls & Coir Matting have been provided for stabilizing the site.

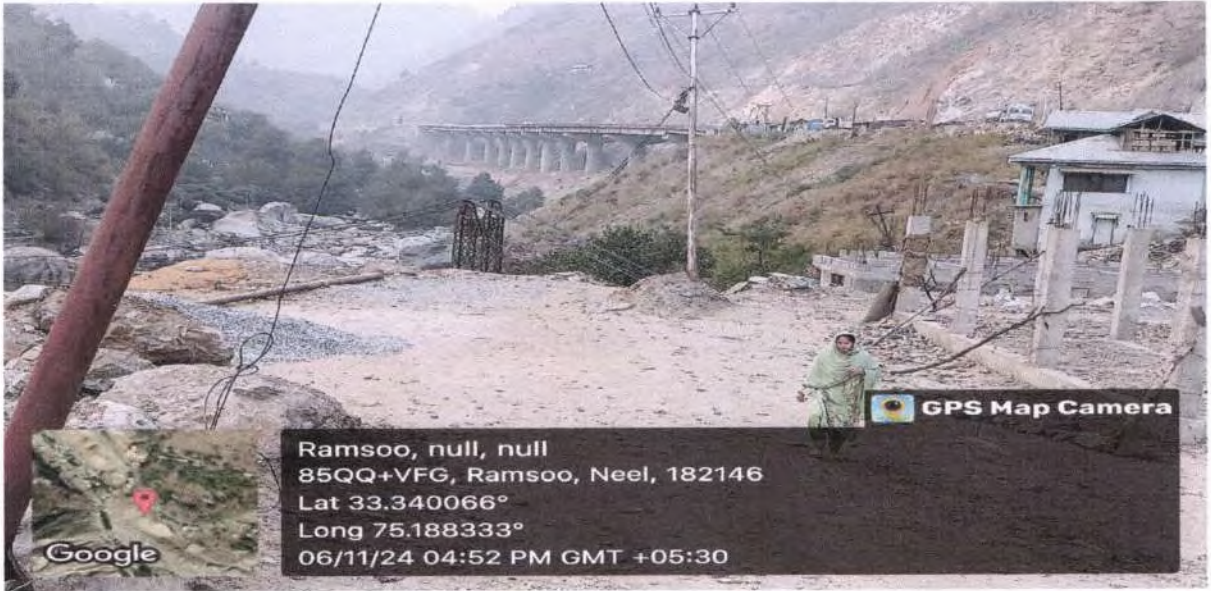
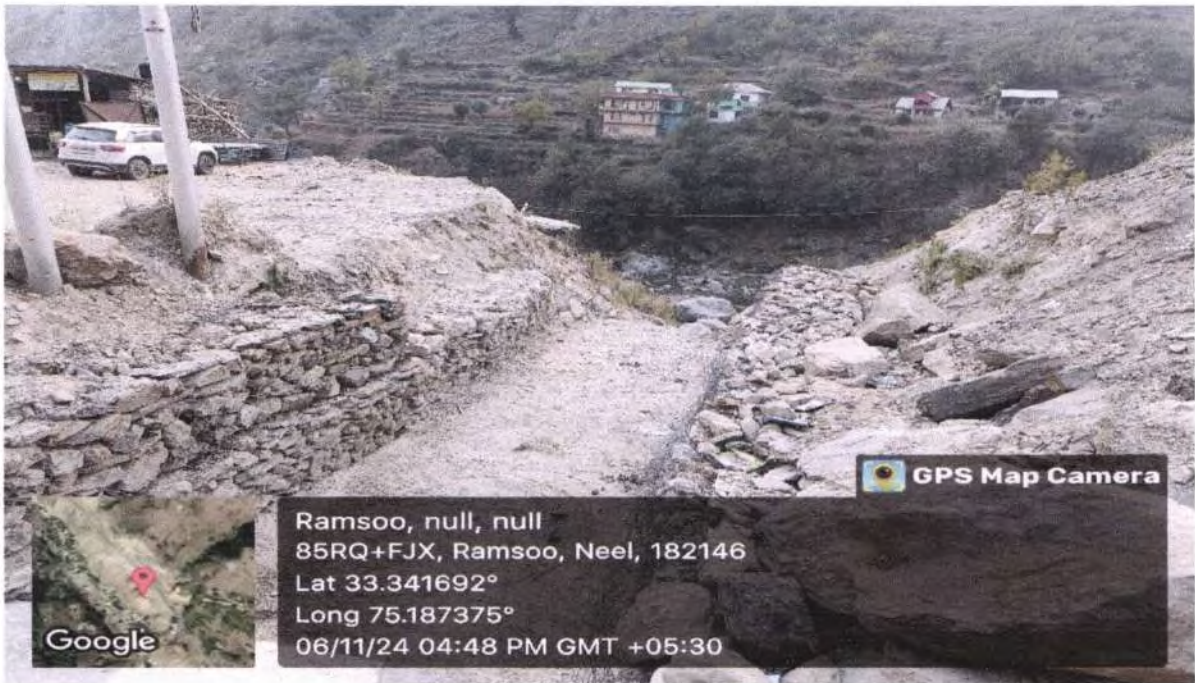
MDS - 41, (NGT Site no. 17-18)
Location: Ramsoo near Viaduct-2

Details of Work done for restoration: Gabion walls & Coir Matting have been provided for stabilizing the site. Natural vegetation has also grown on the site making it more stable.

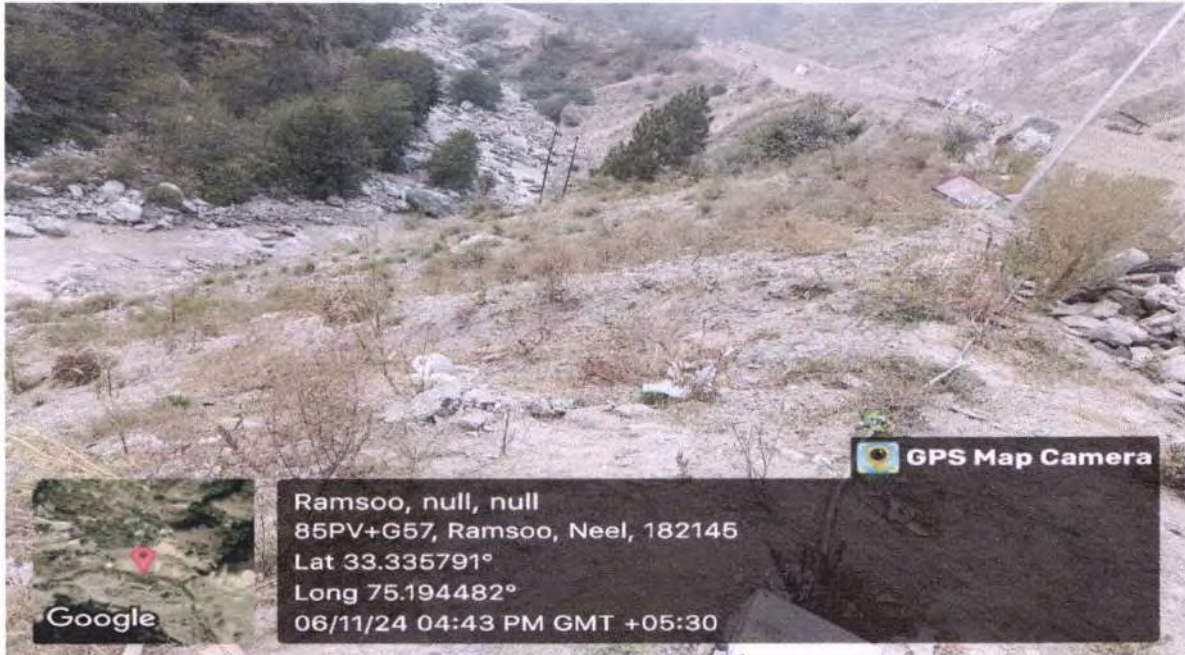
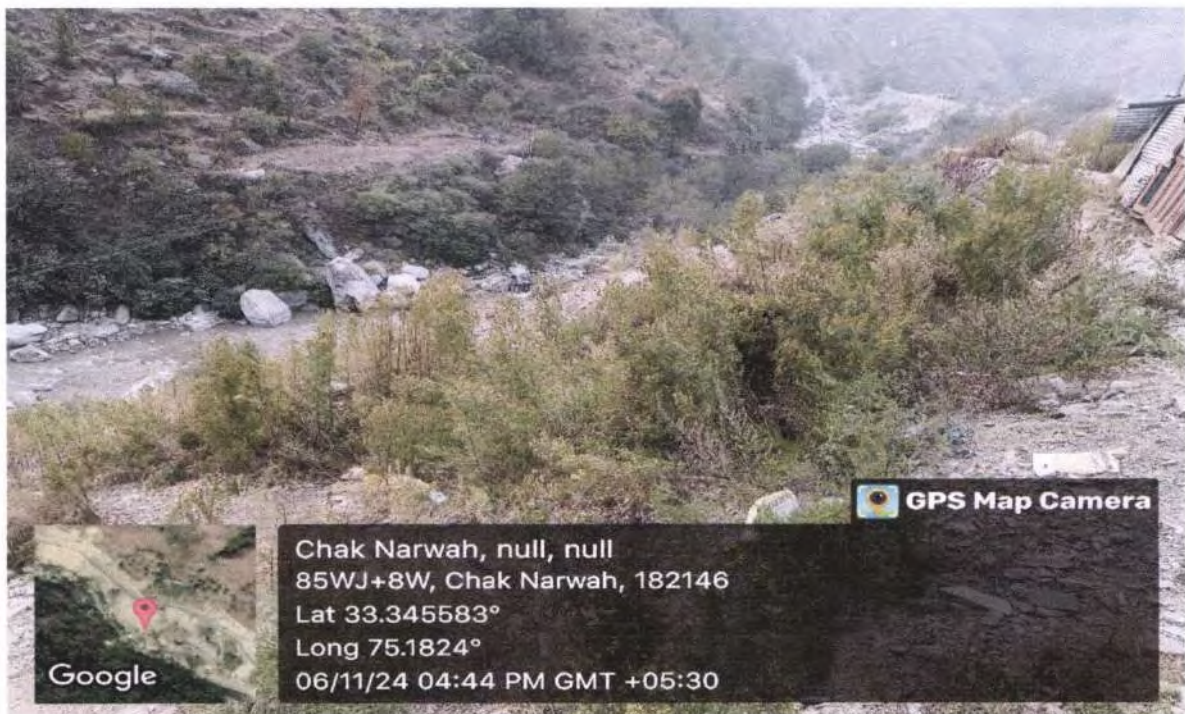
MDS - 42, (NGT Site no. nil)

Details of Work done for restoration: Gabion walls & Coir Matting have been provided for stabilizing the site. Natural vegetation has also grown on the site making it more stable.

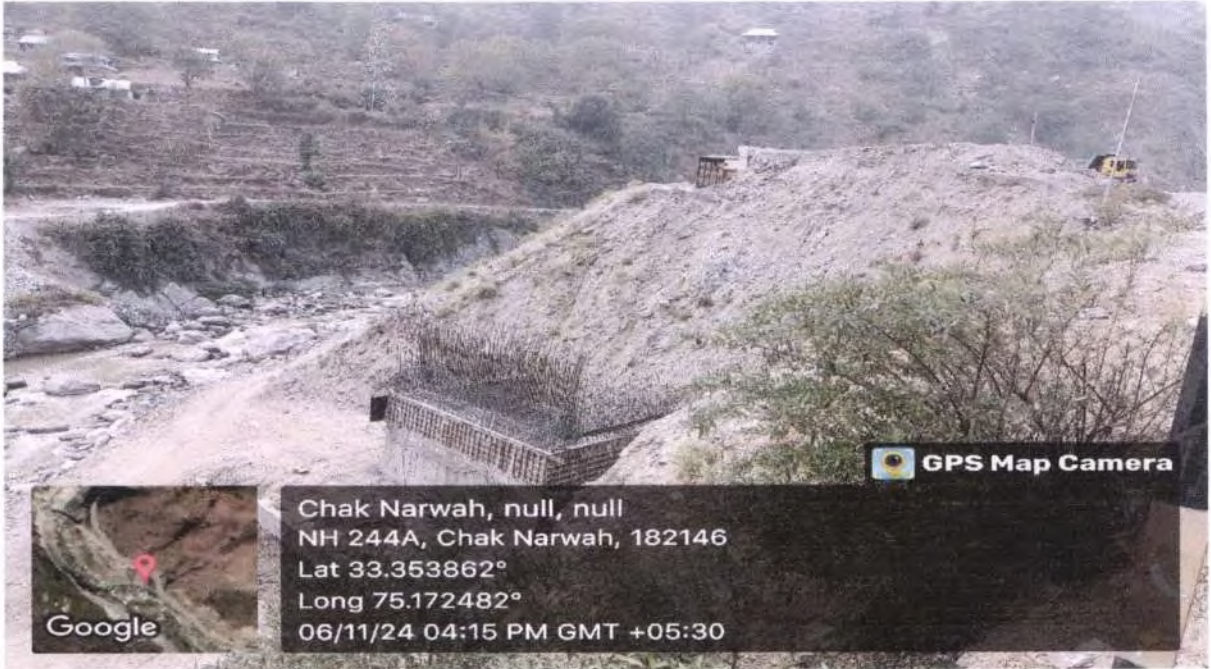
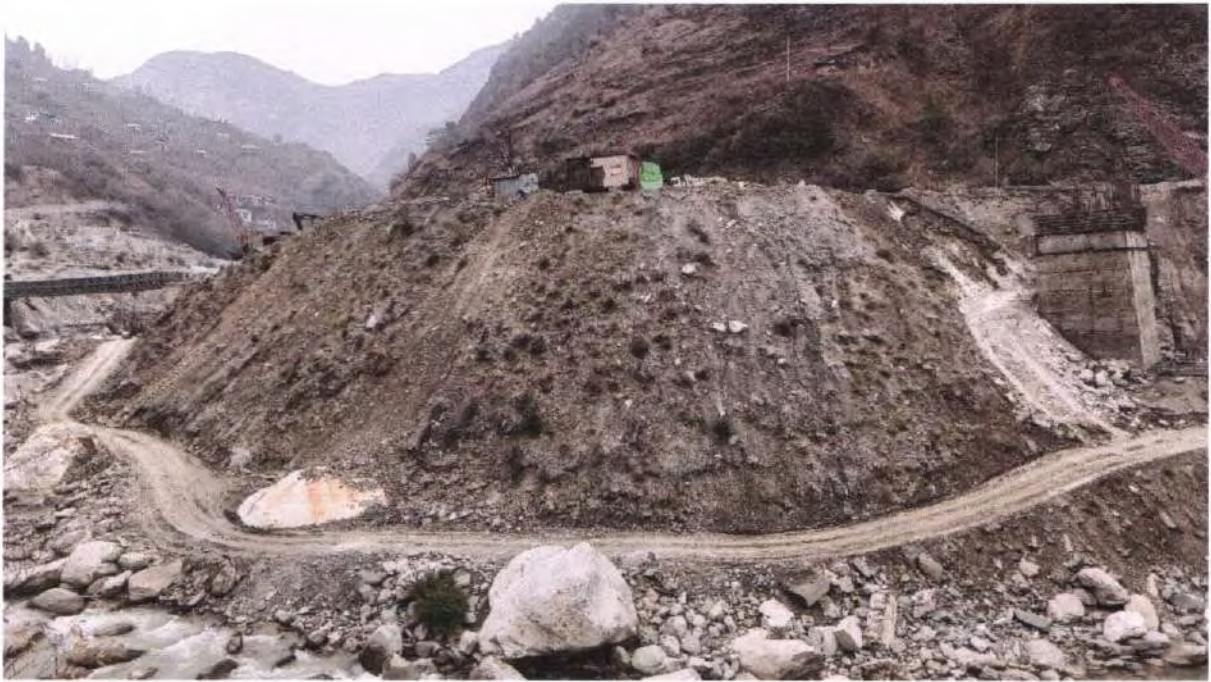
MDS - 46, (NGT Site no. 19)
Location: Hingni, Ramssoo, Ramban

Details of Work done for restoration: Gabion wall provided. This dumping also the part of road in realignment.

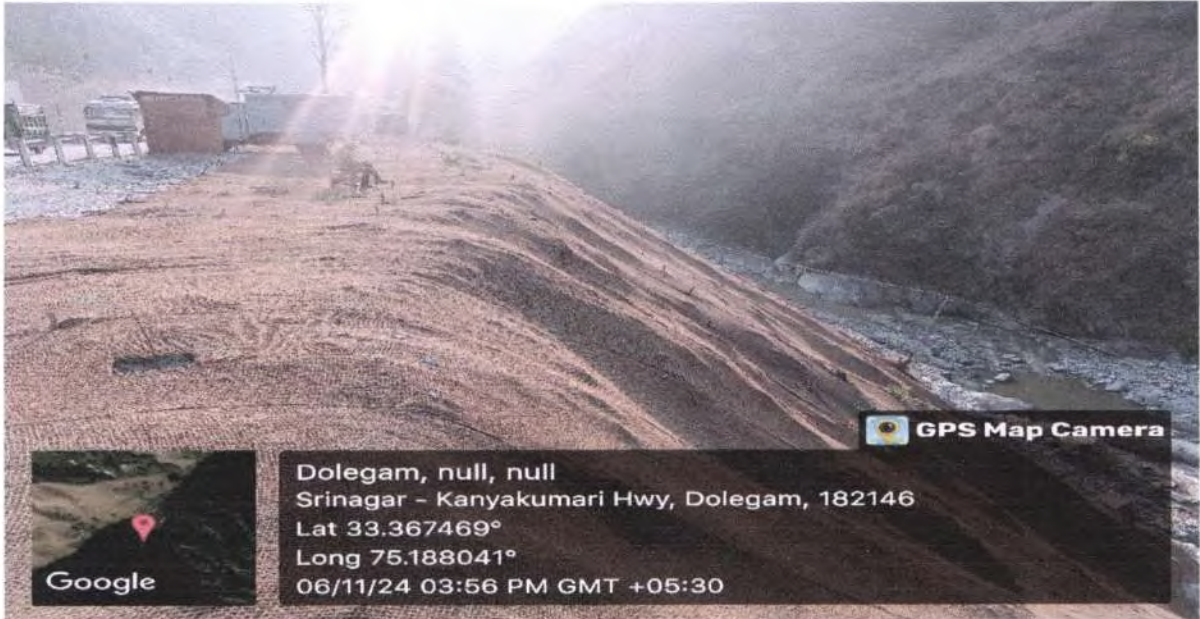
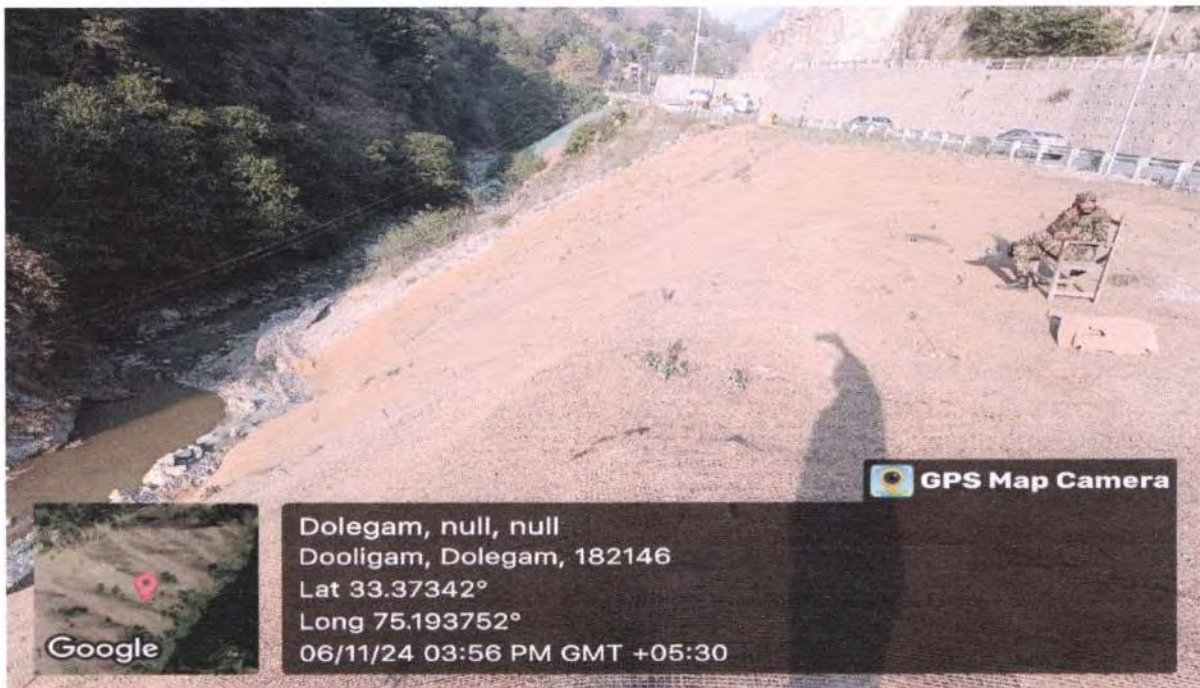
MDS - 47, (NGT Site no. 20)

Details of Work done for restoration: Gabion walls & Coir Matting have been provided for stabilizing the site.

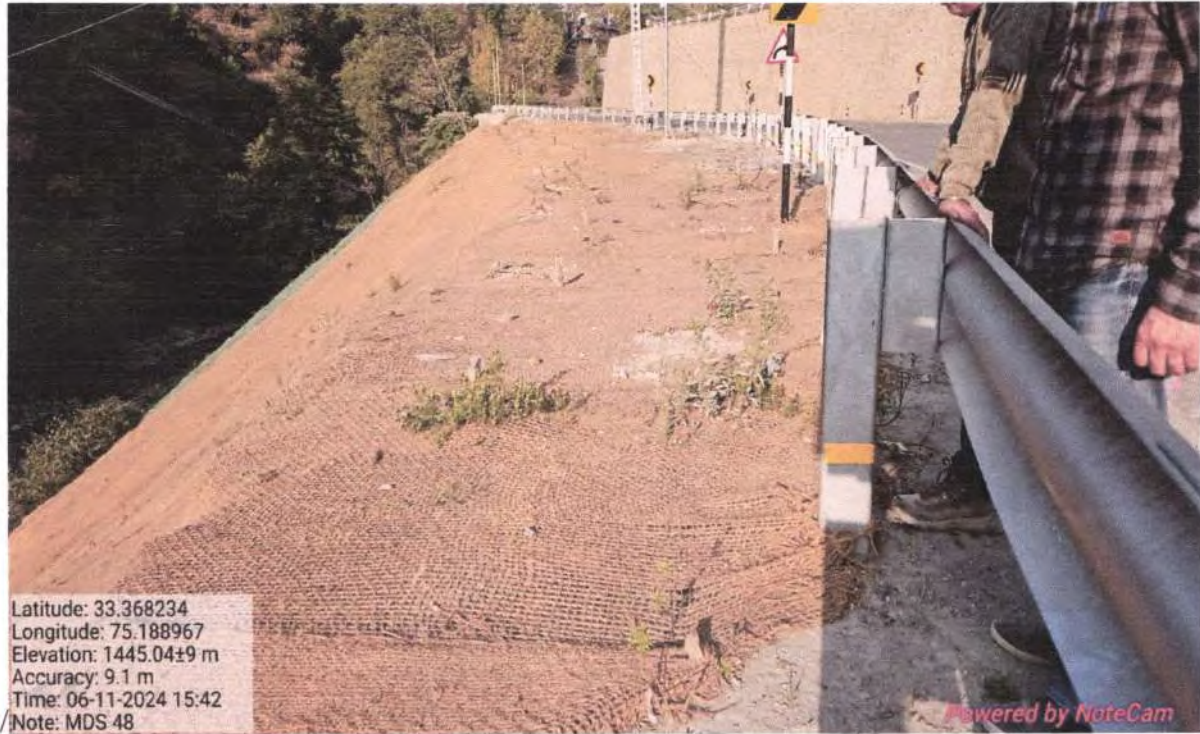
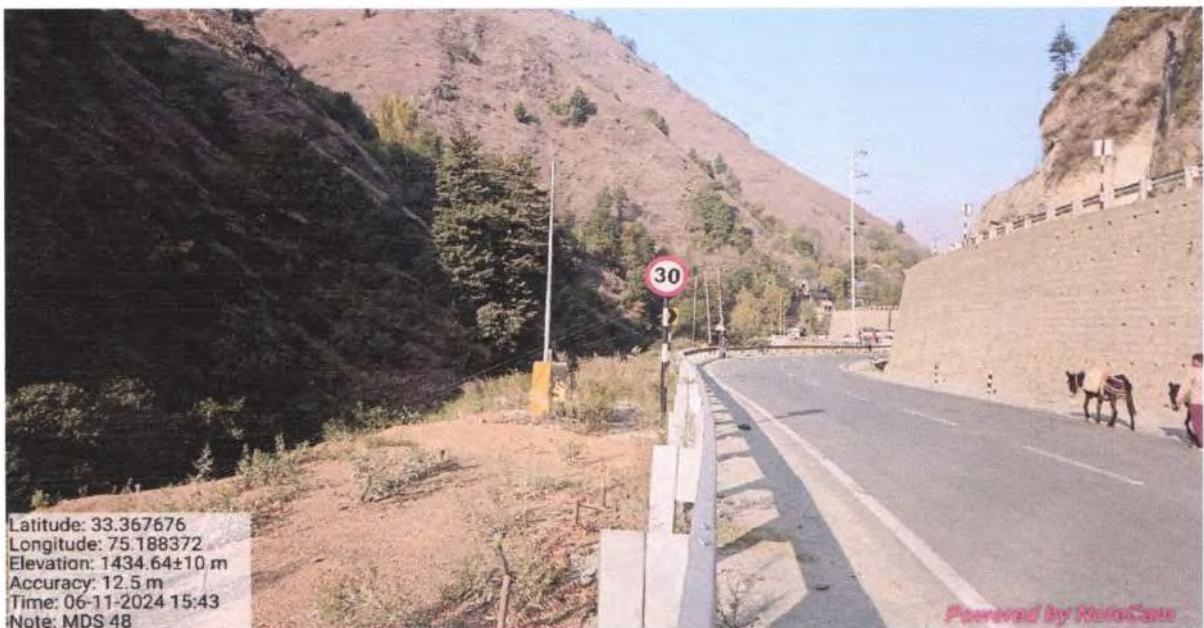
MDS - 48, (NGT Site no. nil)

Details of Work done for restoration: Gabion walls & Coir Matting have been provided for stabilizing the site. Natural vegetation has also grown on the site making it more stable.

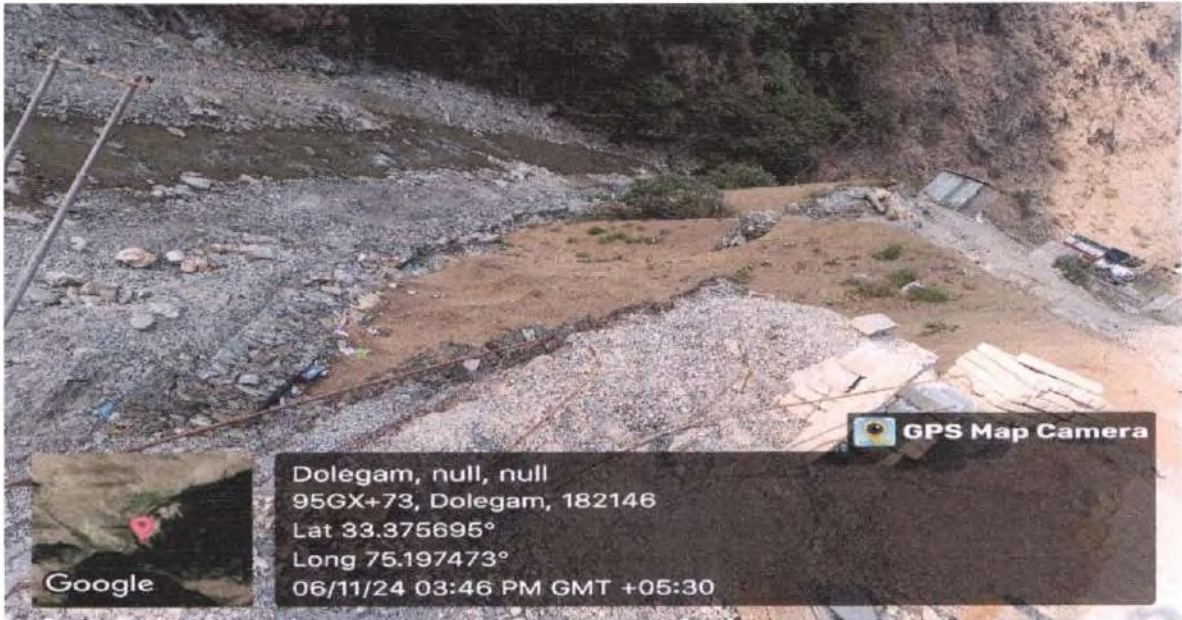
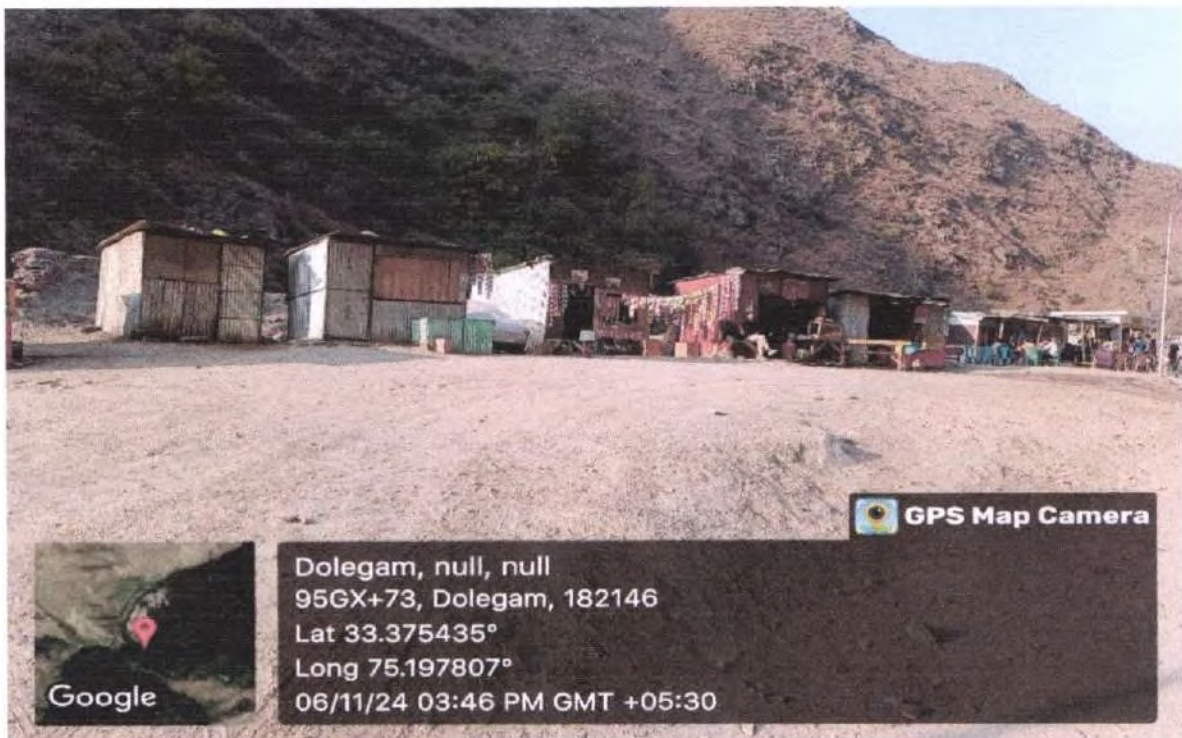
MDS - 49, (NGT Site no. nil)

Details of Work done for restoration: Gabion walls & Coir Matting have been provided for stabilizing the site. Natural vegetation has also grown on the site making it more stable.

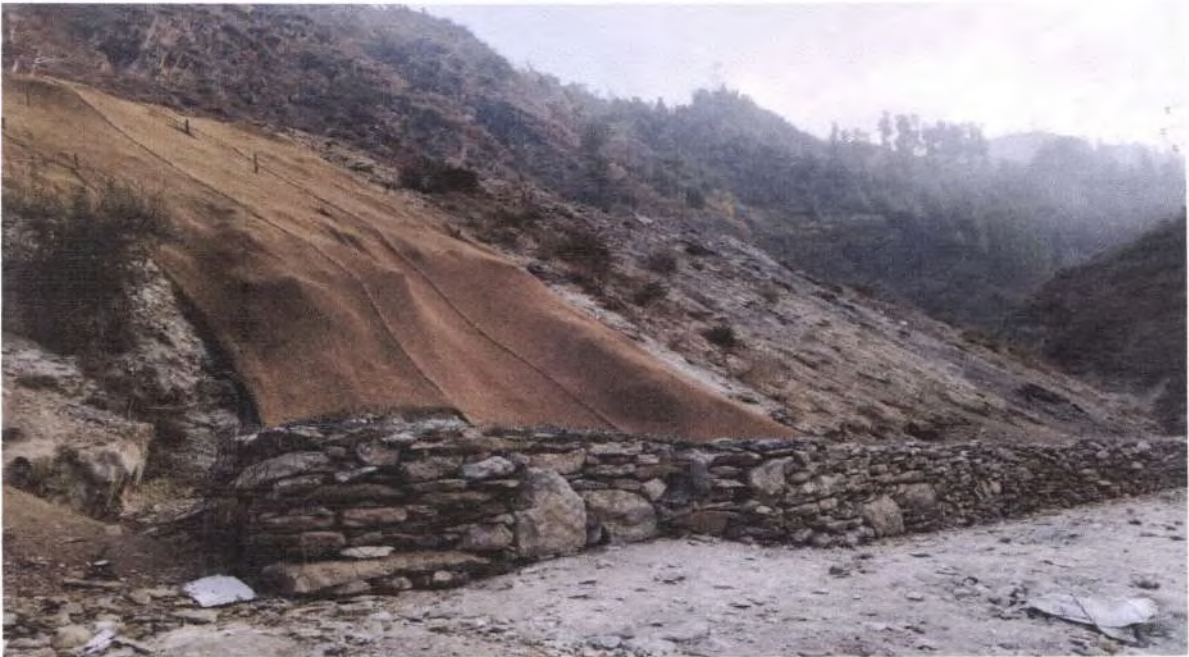
MDS - 50, (NGT Site no. 21)

Details of Work done for restoration: Gabion walls & Coir Matting have been provided for stabilizing the site. Natural vegetation has also grown on the site making it more stable.

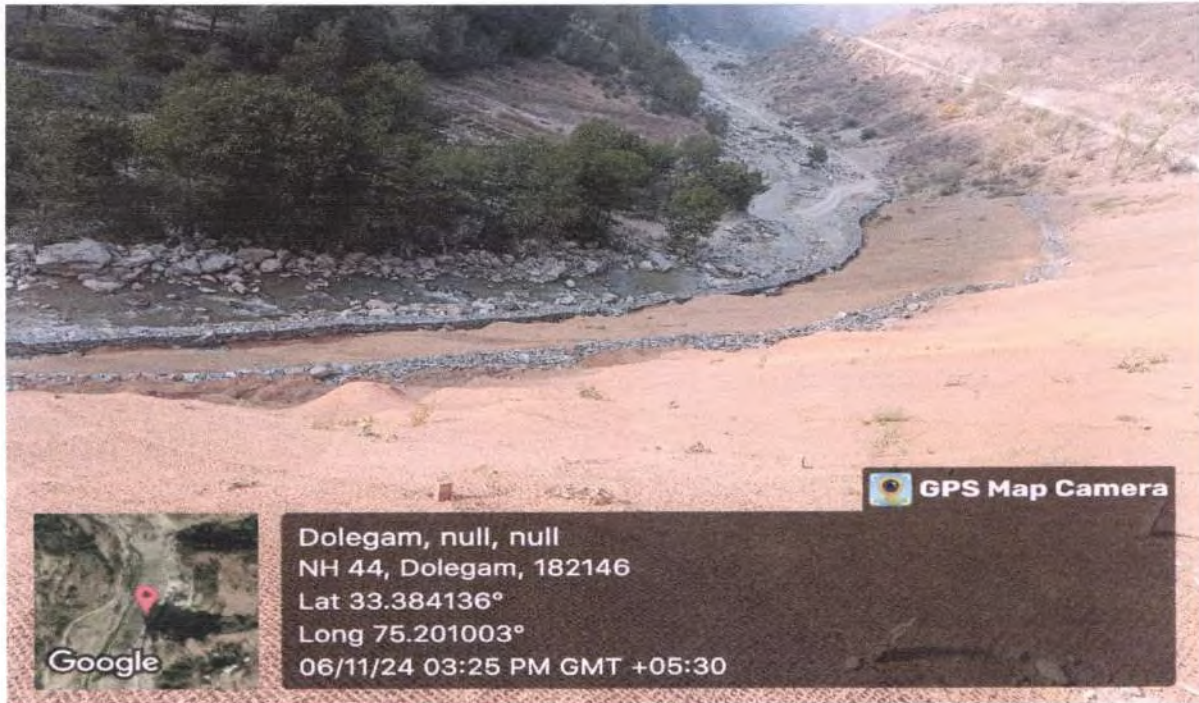
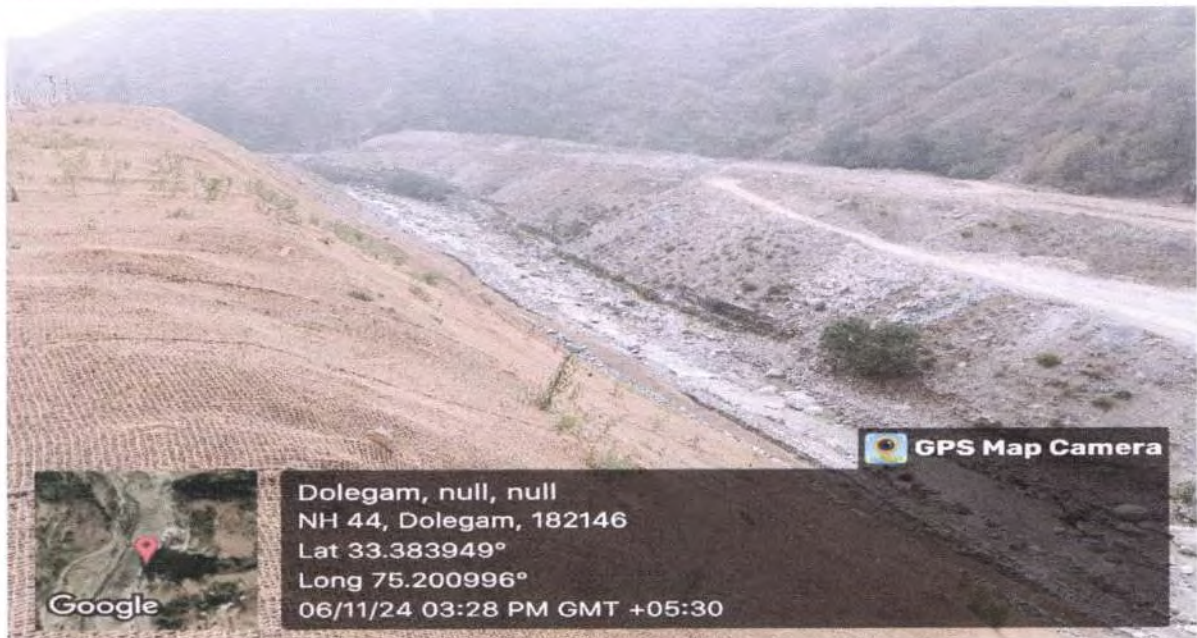
MDS - 52, (NGT Site no. 22)

Details of Work done for restoration: Gabion walls & Coir Matting have been provided for stabilizing the site. Natural vegetation has also grown on the site making it more stable.
