EA NO. 23/2024
IN
ORIGINAL APPLICATION NO. 295/2016

7.	Annexure R-2/6 True copy of the JKPCC site visit report dated 10.01.2025.	101-184
8.	Annexure R-2/7 True copy of e-mail dated 22.10.2024.	185-228
9.	Proof of service.	229

**COMPLIANCE REPORT ON BEHALF OF RESPONDENT NO.2/NHAI
IN TERMS OF ORDER DATED 15.07.2024 & 15.10.2024**

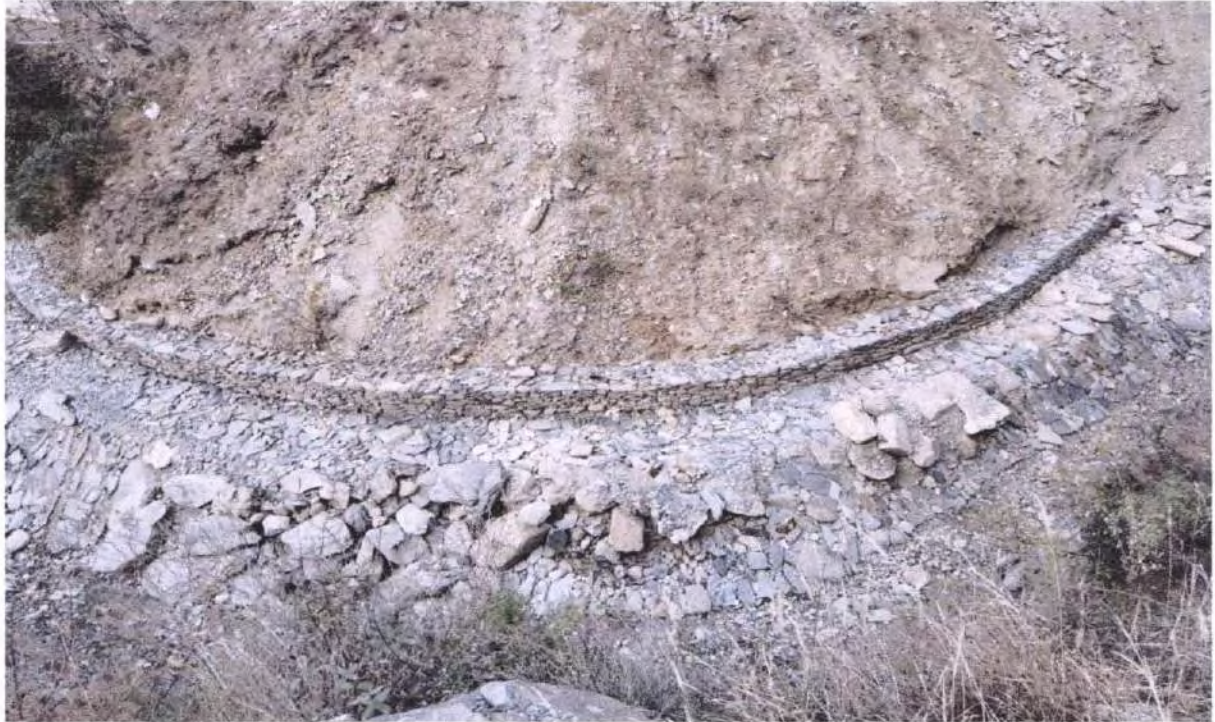
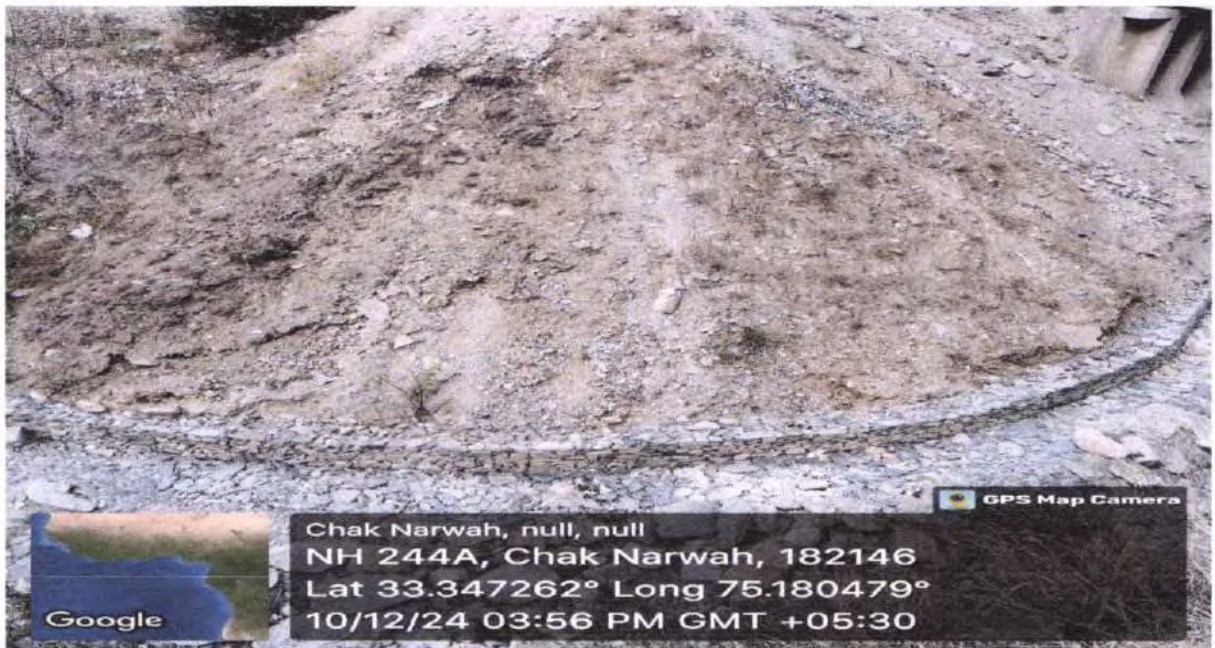
MDS - 53, (NGT Site no. 23)

Details of Work done for restoration: Gabion walls have been provided for stabilizing the site.

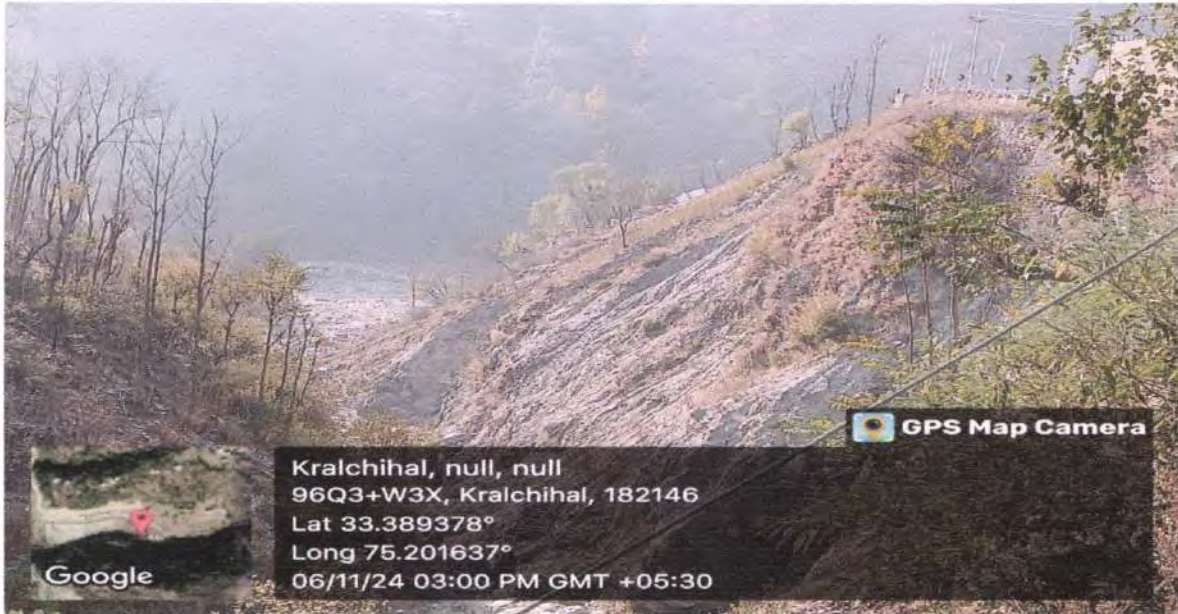
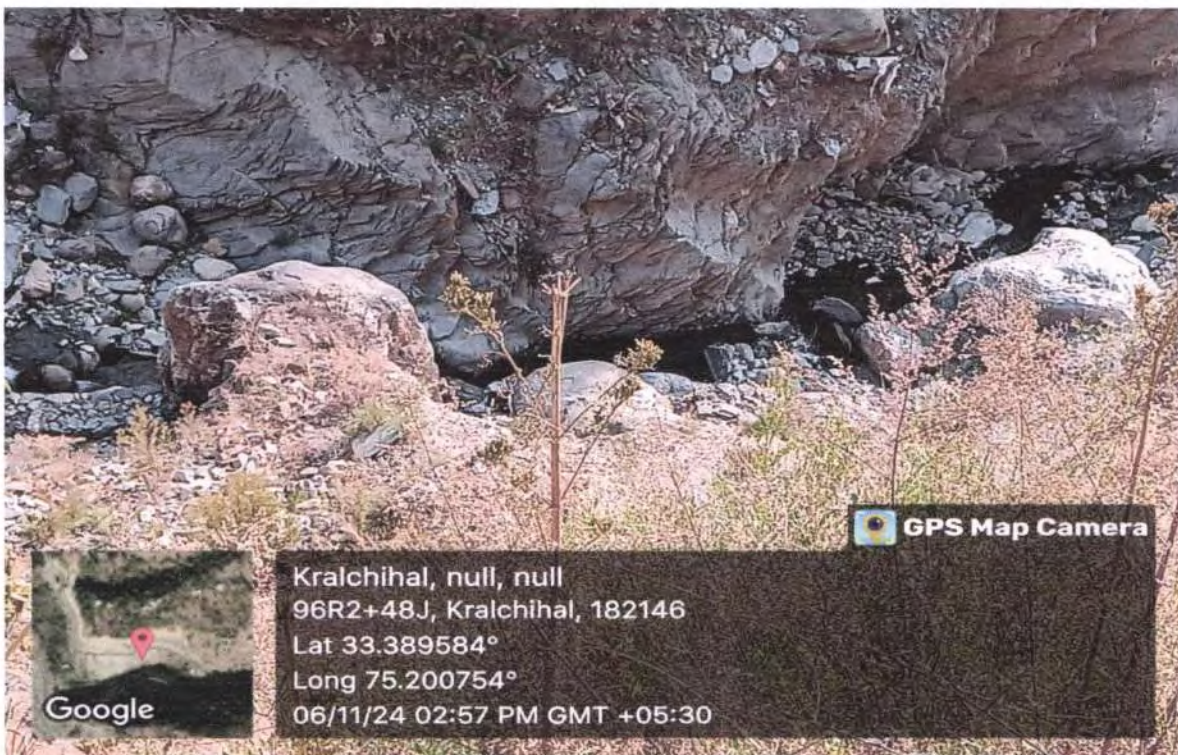
MDS - 54, (NGT Site no. 24)

Details of Work done for restoration: Site fully stabilized. Natural vegetation also occurred.

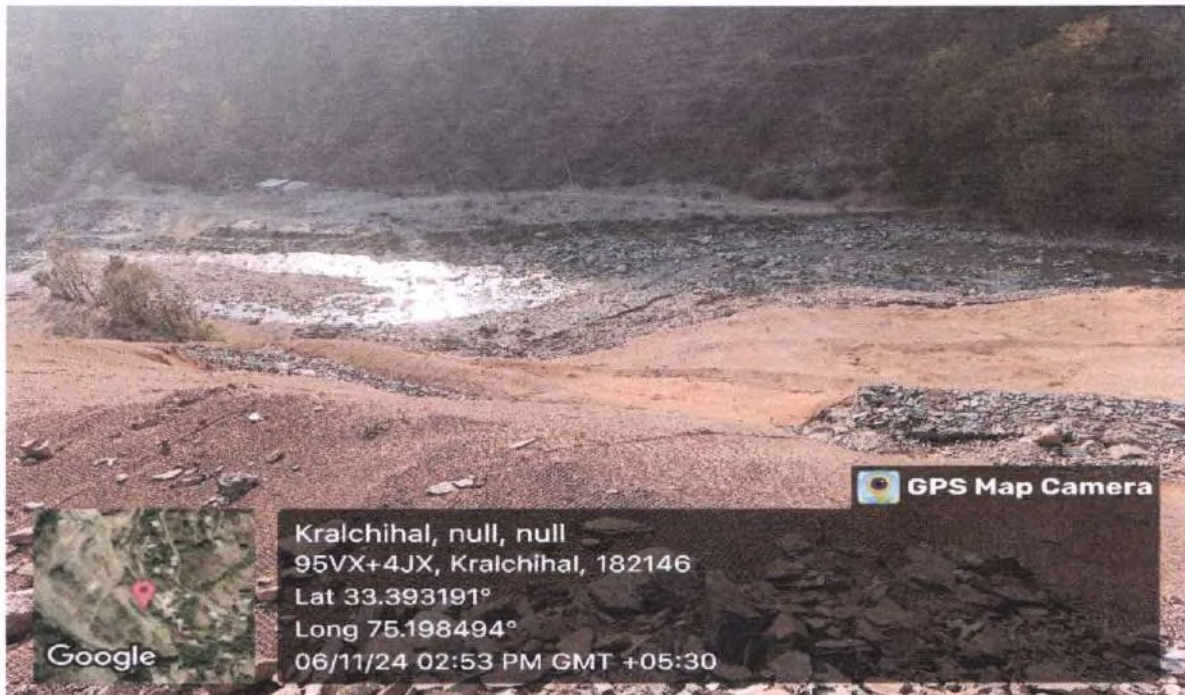
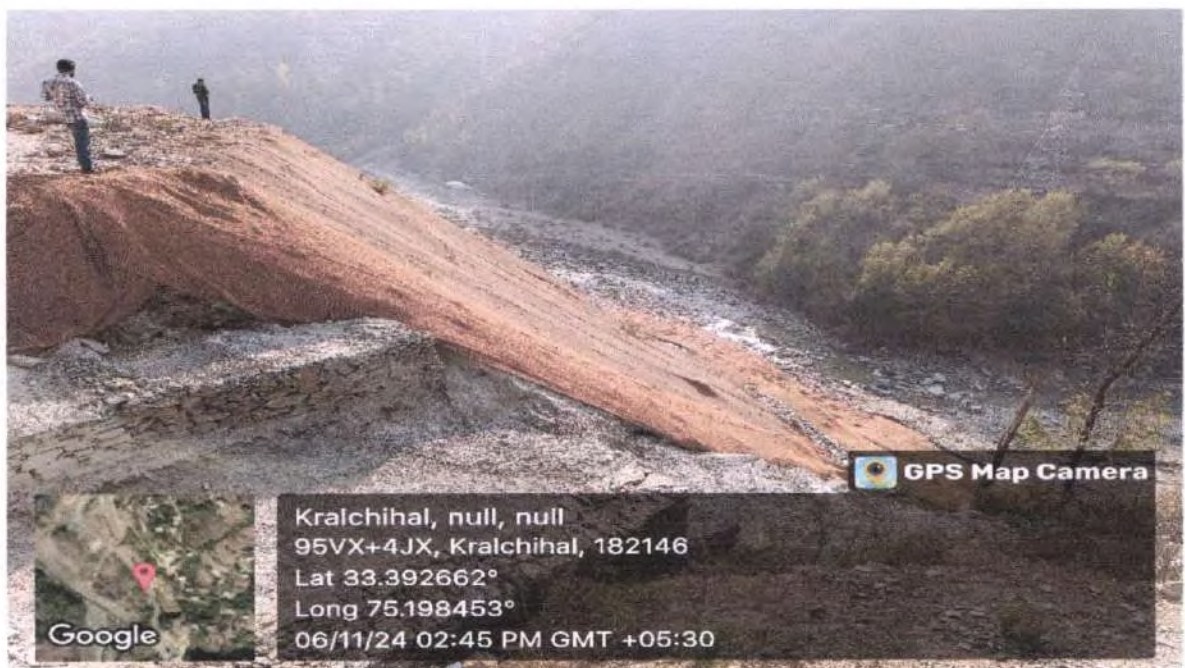
MDS - 55, (NGT Site no. nil)

Details of Work done for restoration: Gabion walls & Coir Matting have been provided for stabilizing the site.
