INSPECTION REPORT**Sub: - Widespread fish mortality at Velsao Beach, in Mormugao**

As directed, the undersigned official of the Board JEE – Siddhant Desai, along with Smt. Milagrina Colaco(JLA) & Shri. Sanmesh Borkar (SA) inspected Velsao Beach and M/s Paradeep Phosphates Limited located at Survey No. 110-252, Zuarinagar, Sancoale, Mormugao-Goa (hereafter referred to as “Unit”) on 08/06/2024, with regards to the above-mentioned subject.

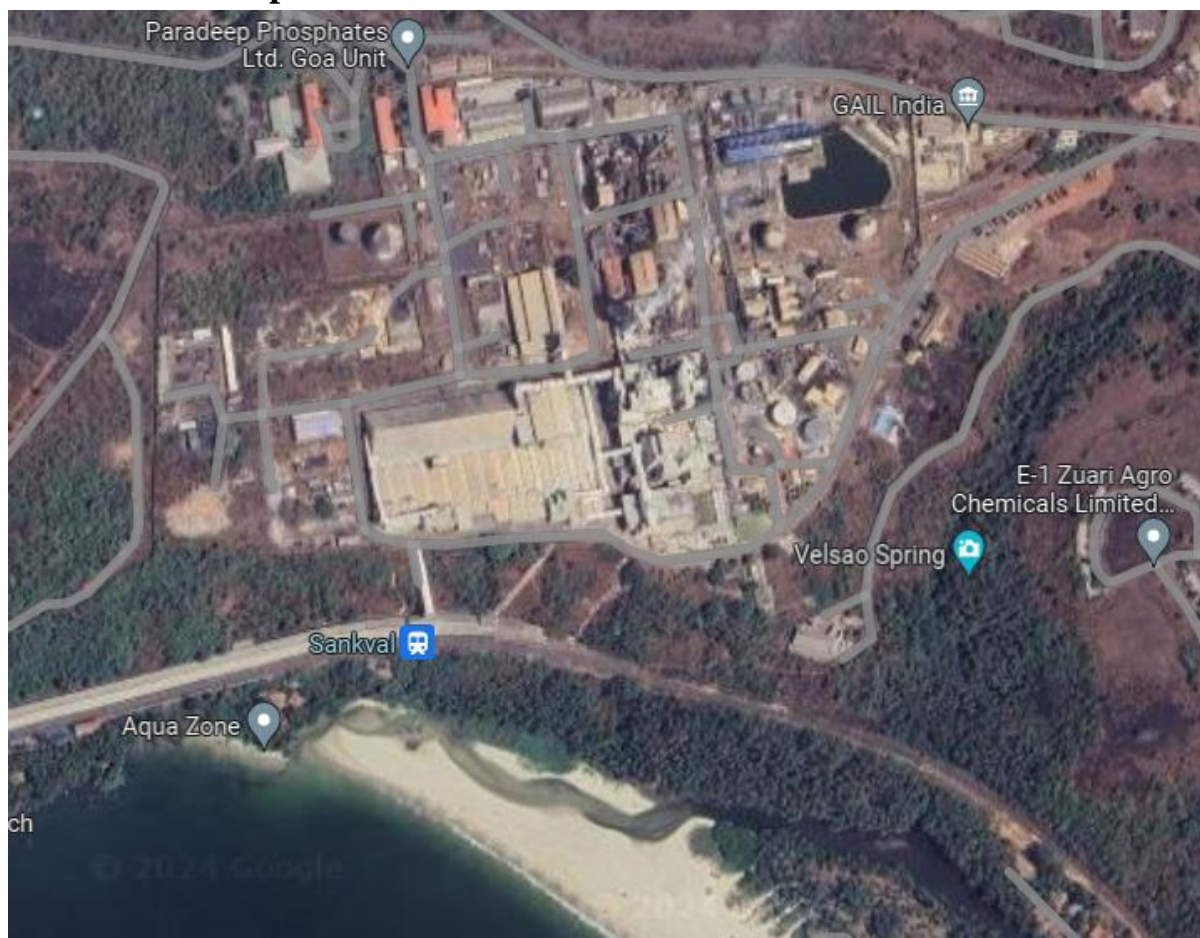
13.Site description and schematic sketch of site: -

14.Type of area: - The unit lies within Sancoale Industrial Area, schools of fish were found dead on the beach towards the south of the Unit called Velsao Beach
