Report on environmental pollution by Monnet Daniel Washery situated at Khalari Block of Ranchi District, Jharkhand, in the matter of Krishna Chouhan Vs State of Jharkhand in O.A No. 479/2022 pending before Hon'ble National Green Tribunal, Principal Bench, New Delhi.

The above committee members inspected/visited Monnet Daniels Coal Washery situated in the area of KDH in Khalari Block of District Ranchi on 16.03.2023.

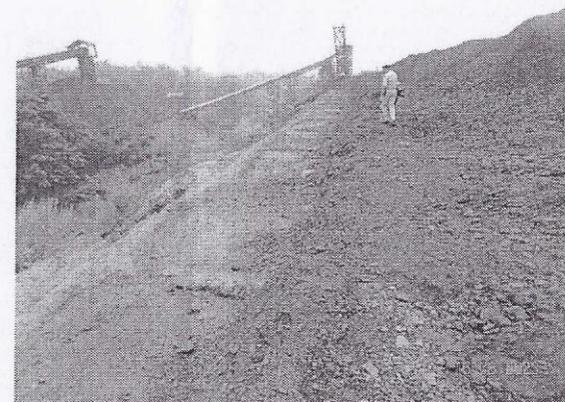
Photo 27& 28: Photo of new grassing and vegetation on the upper portion of the slope between railway sidng and river Sonadubi.
