## **Joint report of CPCB and GPCB on status of restoration processes in place for dumped Gypsum and ground water contamination**

### **Background:**

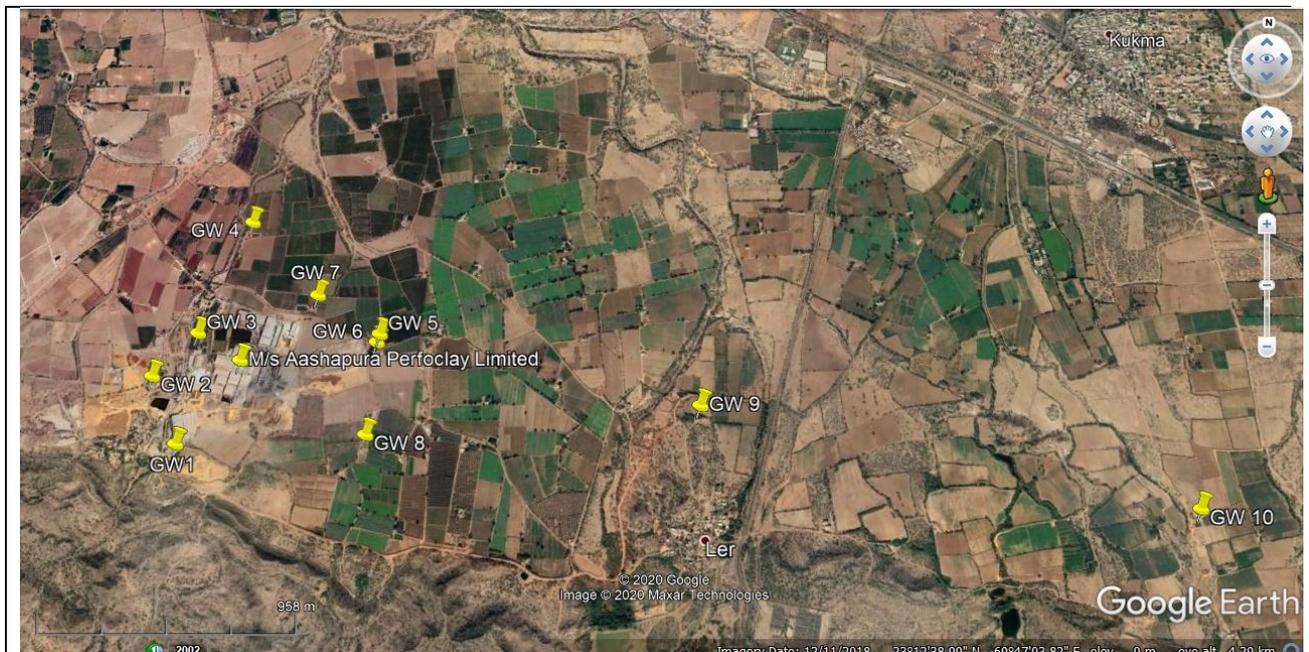
GPCB carried out ground water sampling of 10 bore-wells on 23.12.2019 in and around the unit premises (Unit and sampling locations are depicted on google image below).

The TDS concentration is generally higher on all the locations (1772 – 3940 mg/l) owing to the hydrogeology of the area, however it was significantly higher (7824 and 6238 mg/l) on two locations where NH<sub>3</sub>-N concentration was also found higher.
