**Original Application No. 229 of 2020 (SZ)**

**JOINT COMMITTEE REPORT SUBMITTED BEFORE THE HON'BLE NATIONAL GREEN TRIBUNAL, SOUTHERN ZONE, CHENNAI IN THE MATTER OF O.A. No. 229/2020 - Tribunal on its own motion-SUO MOTU based on the News item on Gas turbine explosion at Power plant:**

**9F.05 Gas Turbine Fire Incident Root Cause Analysis**

**KPCL – Yelahanka, GT-1 (#GT247)**

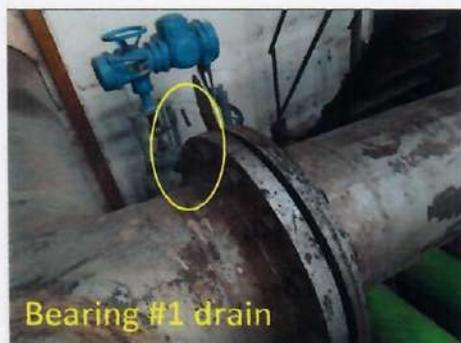
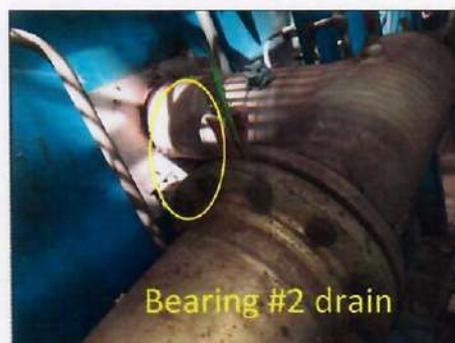
- Improper provisioning of Bearing sealing during commissioning at site
  - Mist eliminator vacuum from operational data is very low
  - However during lube oil system checks the mist eliminator performance found satisfactory
  - Bellow in bearing tunnel cooling fan is found damaged
  - Both the above can result in Low volume high duration leak
- Improper provisioning of Oil drain during installation at site
  - Detailed site simulation study undertaken by GE
  - Picture taken on 01.10.2020 10:45 AM by KPCL engineer indicate presence of strainer mesh in the drain line during operations on 1st & 2nd October 2020
  - Choking of this mesh during operation can lead to backing up of oil causing overflow from bearing seal. This will result in High volume low duration leak
