BEFORE THE NATIONAL GREEN TRIBUNAL,
SOUTH ZONE, CHENNAI

ORIGINAL OA NO. 16 OF 2022(SZ)
[OA.NO.614/2018(PB)]

**REPLY TO IRRIGATION DEPT REPORT DT 22.12.2022 FILED BY
APPLICANT**

PICTORIAL DOCUMENTATION OF FIELD SURVEY OF
BAM RUKNUD DOWLAH LAKE, NEHER E HUSSAINI BOWLI,
FROM BUND VIEW AND GROUND VIEW
ON 26 JULY 2024
(ALL PICTURES ARE GEO-TAGGED)

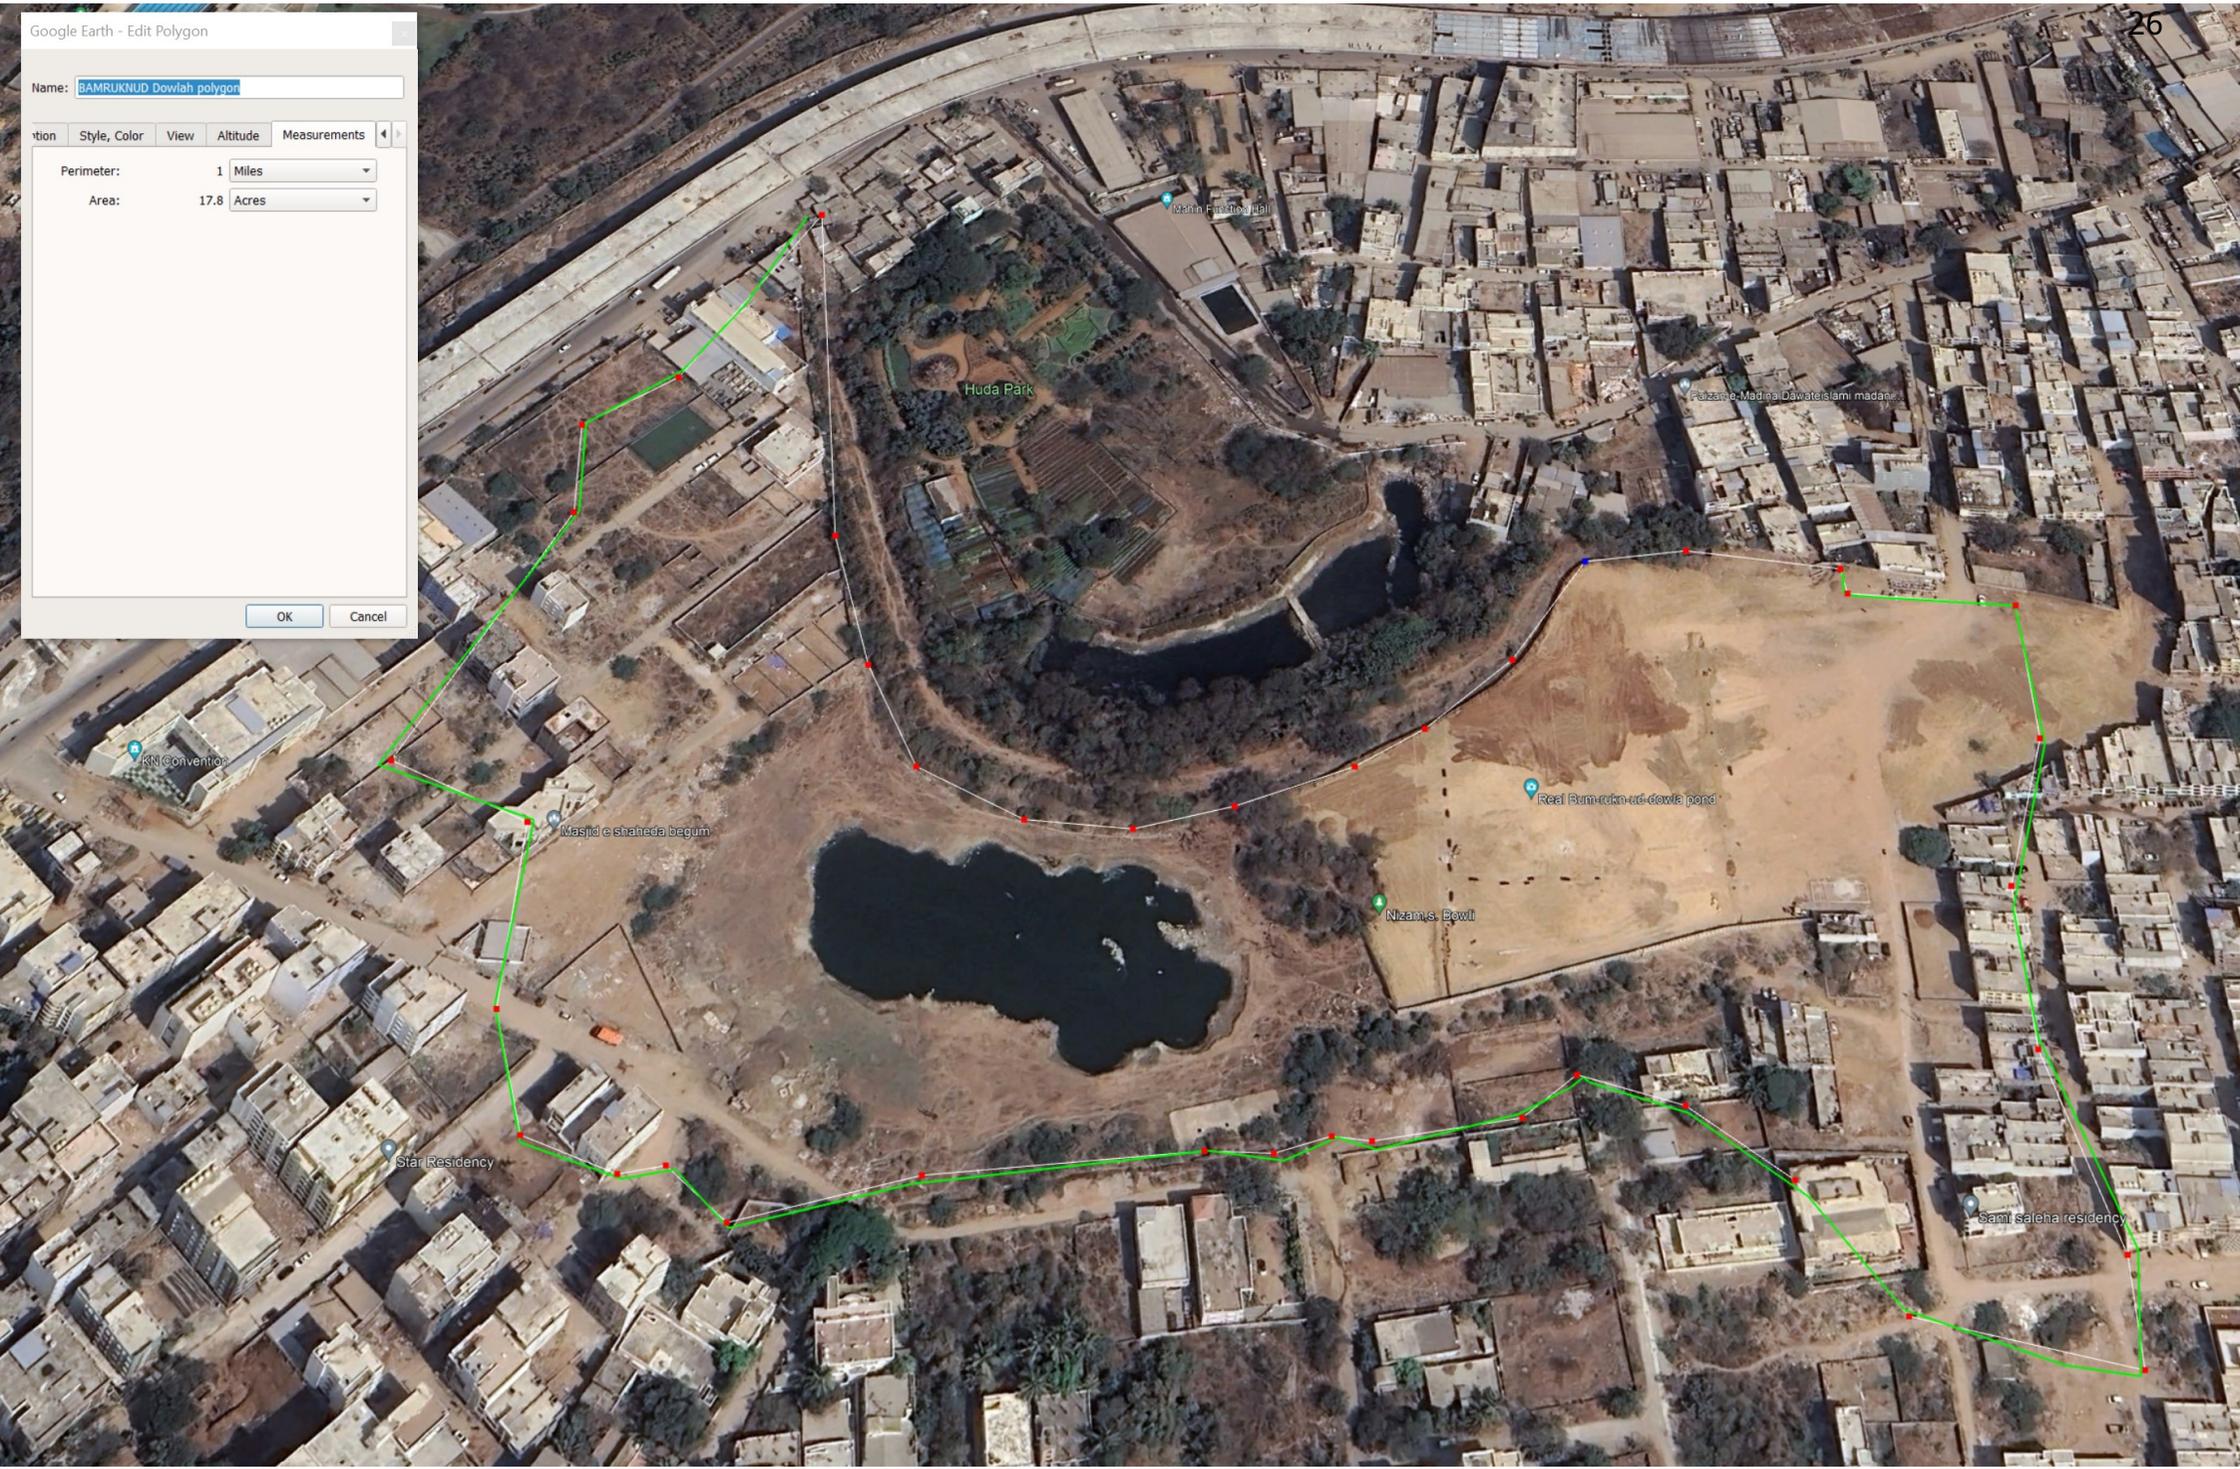
ANNEXURE V

6. It is to submit that, during our survey of 26 July 2024, it was observed that the Neher e Hussaini bowli that is around 1 acre, was totally dry. Even during peak summers the bowli was never dry. As evident from satellite imagery in February 2024 the bowli was full but owing to encroachment at the bowli and due to the entire eastern side of the lake being levelled, the bowli is seen dry for the first time.
(ANNEXURE 5)

SATELLITE IMAGE OF NEHER E HUSSAINI (MARKED IN GREEN)
AS ON FEBRUARY 2024
