BEFORE THE NATIONAL GREEN TRIBUNAL SOUTHERN ZONE,
CHENNAI

O.A. No. 230 of 2025

REPLY FOR THE CORRESPONDING PHOTOS FILED IN ANNEXURES TO THE APPLICATION

The present status of the pipe lines photographed by the petitioner is as detailed below:

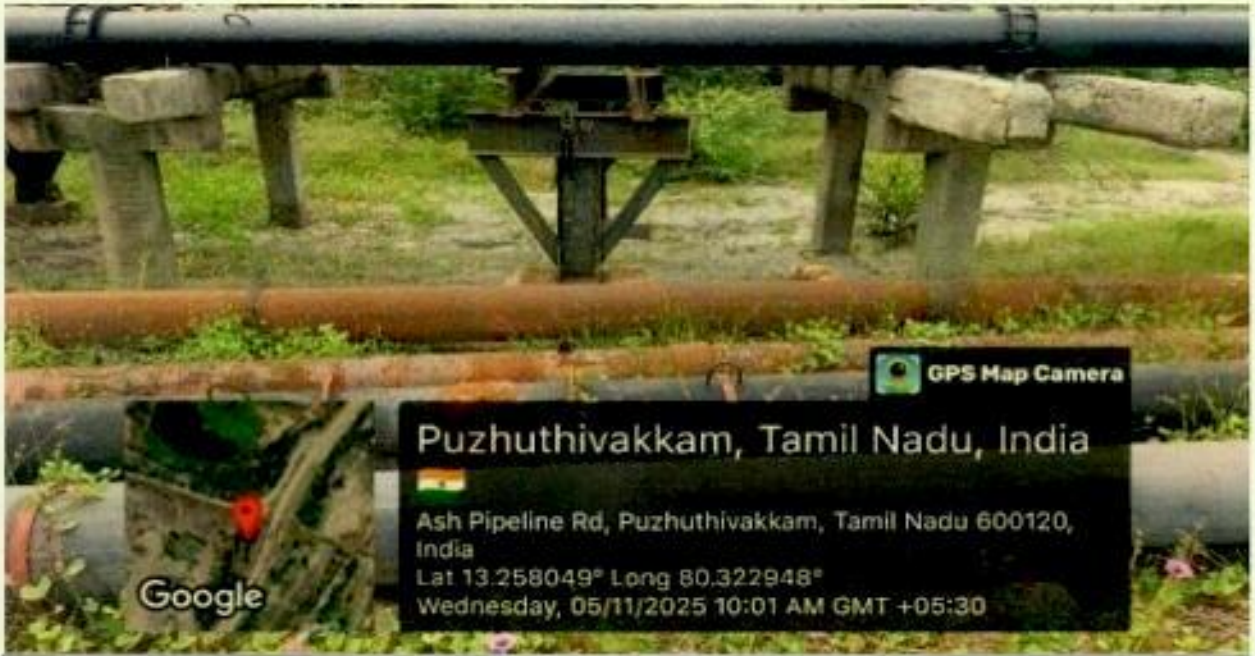
(1) Annexure A1, Page 12. Refer Google Drive video link if available

GPS Location: 13.258053 N, 80.323052 E Dated: 13.07.2025 Leak in the newly laid pipes as directed by the Court.

The leakage is in **Ash Slurry Disposal line No.5** due to damage in the O-ring. These O-rings are consumable items and are subjected to wear and tear due to continuous operation under high pressure and temperature conditions. This may also cause due to pressure fluctuations and mechanical vibrations during starting and stopping of pump. However the Minor leakage in sleeve coupling was attended by replacing Sleeve coupling and welding sleeve provide. Utmost care is taken to replace the O-ring at the weeping stage.

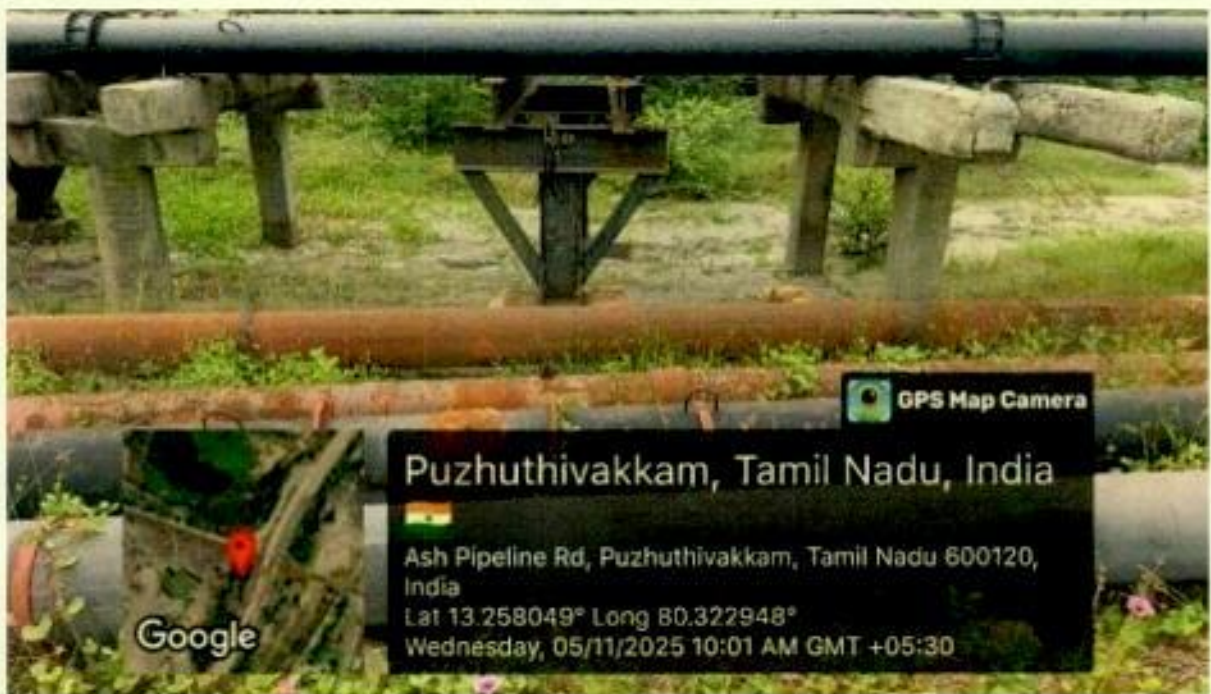
(2) Annexure A1, Page 12. Refer Google Drive video link if available:

The leakage is in **Ash Slurry Disposal line No.5** due to damage in the O-ring. These O-rings are consumable items and are subjected to wear and tear due to continuous operation under high pressure and temperature conditions. This may also cause due to pressure fluctuations and mechanical vibrations during starting and stopping of pump. However the Minor leakage in sleeve coupling was attended by replacing Sleeve coupling and welding sleeve provide. Utmost care is taken to replace the replace the O ring at the weeping stage.

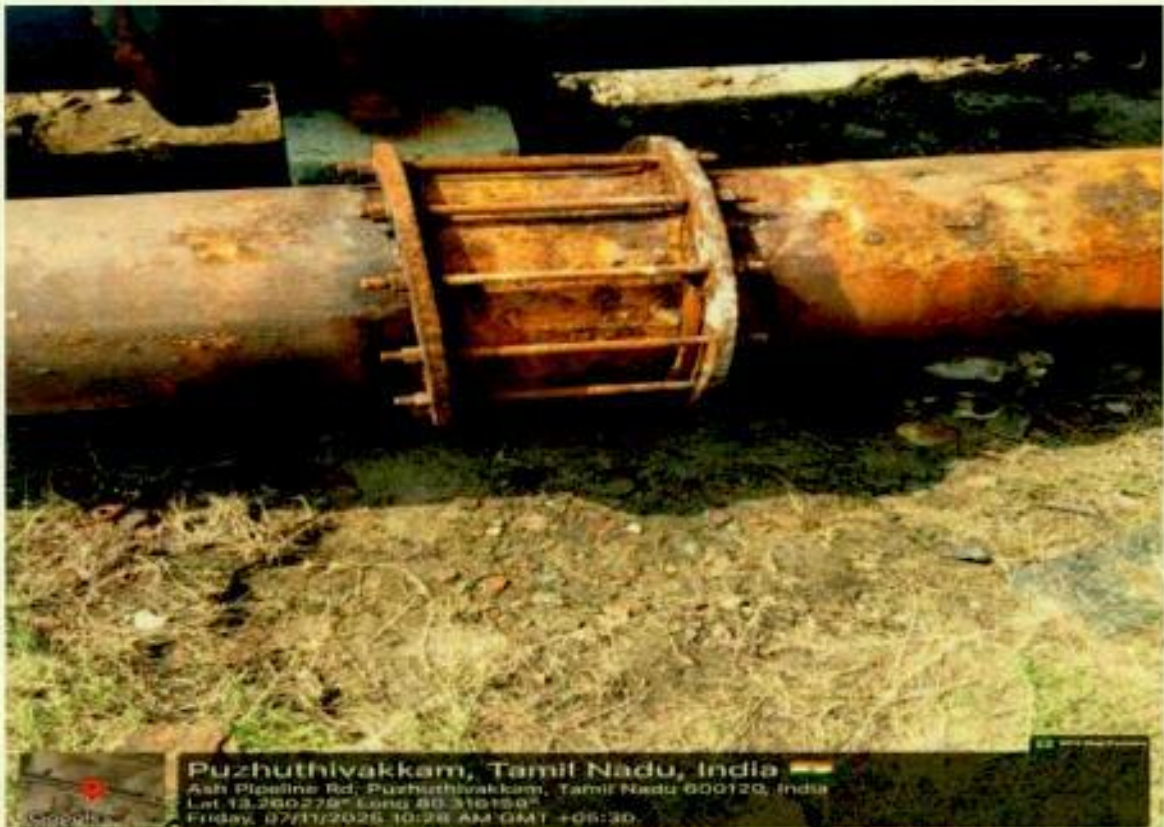
(3) Annexure A1, Page 13. Refer Google Drive video link if available.

It is clarified that the line in which the O-ring leak occurred is not an **Ash Slurry Line**, but the **Recovery Water Line (R3)**, which carries decanted saline water recovered from the Ash Pond for recirculation and reuse within the plant system. However the leak was attended immediately by replacing new O-ring.

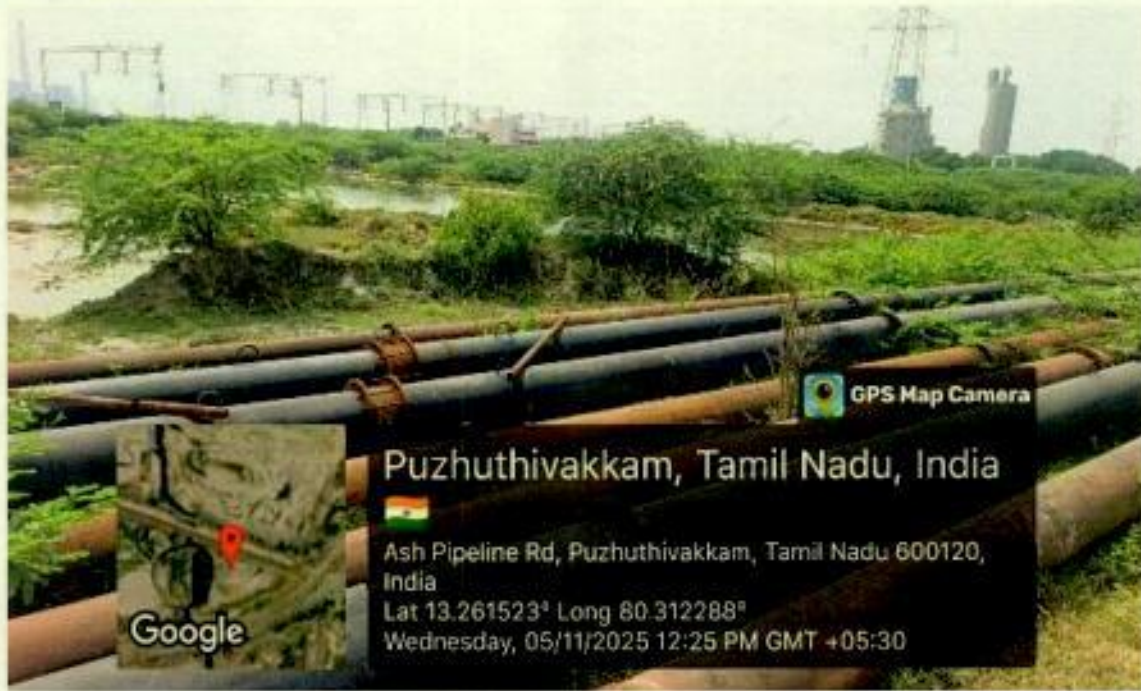
(4) Annexure A1, Page 15.

Leak from new pipeline with rusted coupling.

The leakage is in **Ash Slurry line No.5** due to damage in the O-ring. These O rings are consumable items and are subjected to wear and tear due to continuous operation under high pressure and temperature conditions. This may also cause due to pressure fluctuations and mechanical vibrations. However the Minor leakage in sleeve coupling was attended by replacing the O ring immediately. Utmost care is taken to replace the replace the O ring at the weeping stage.

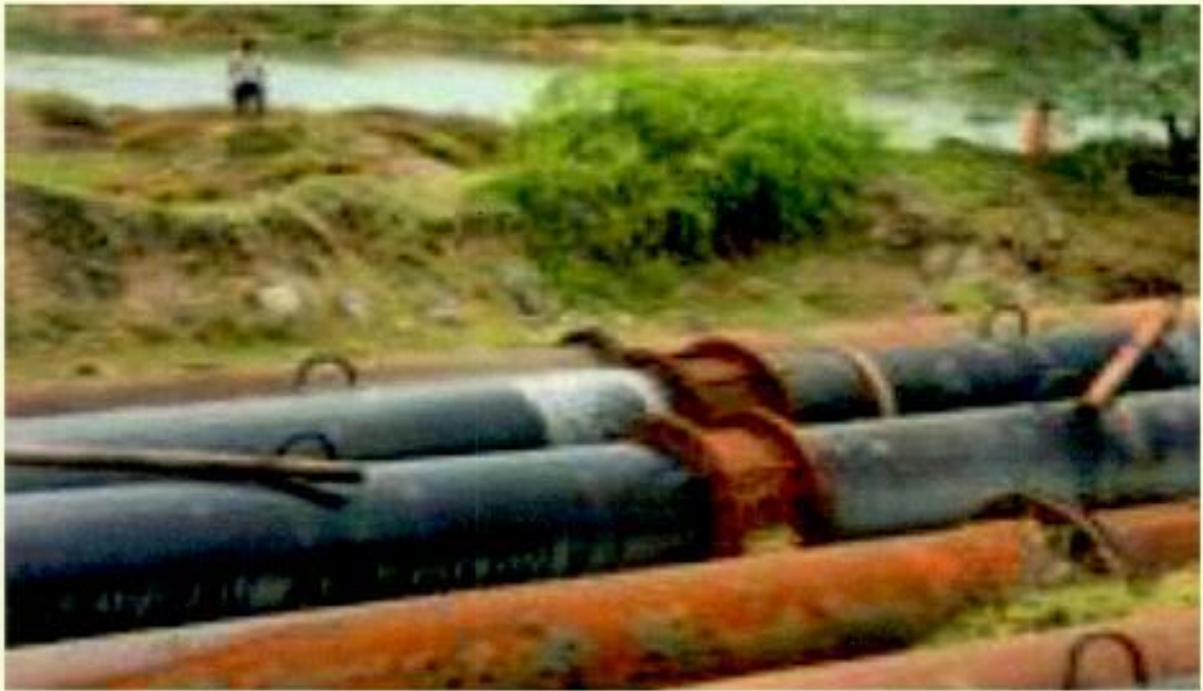
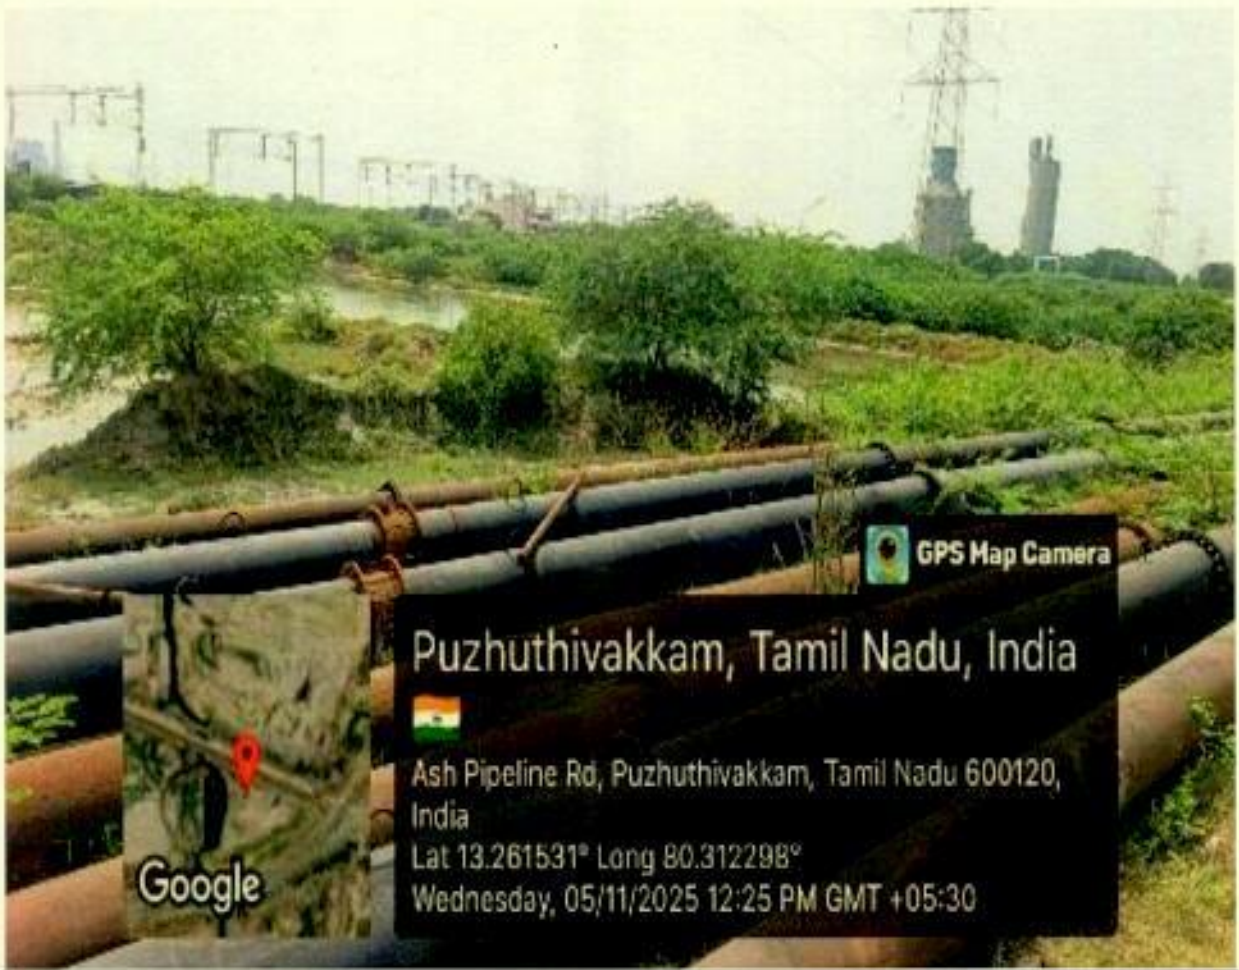
(5) Annexure A1, Page 15.

Same photograph shown above

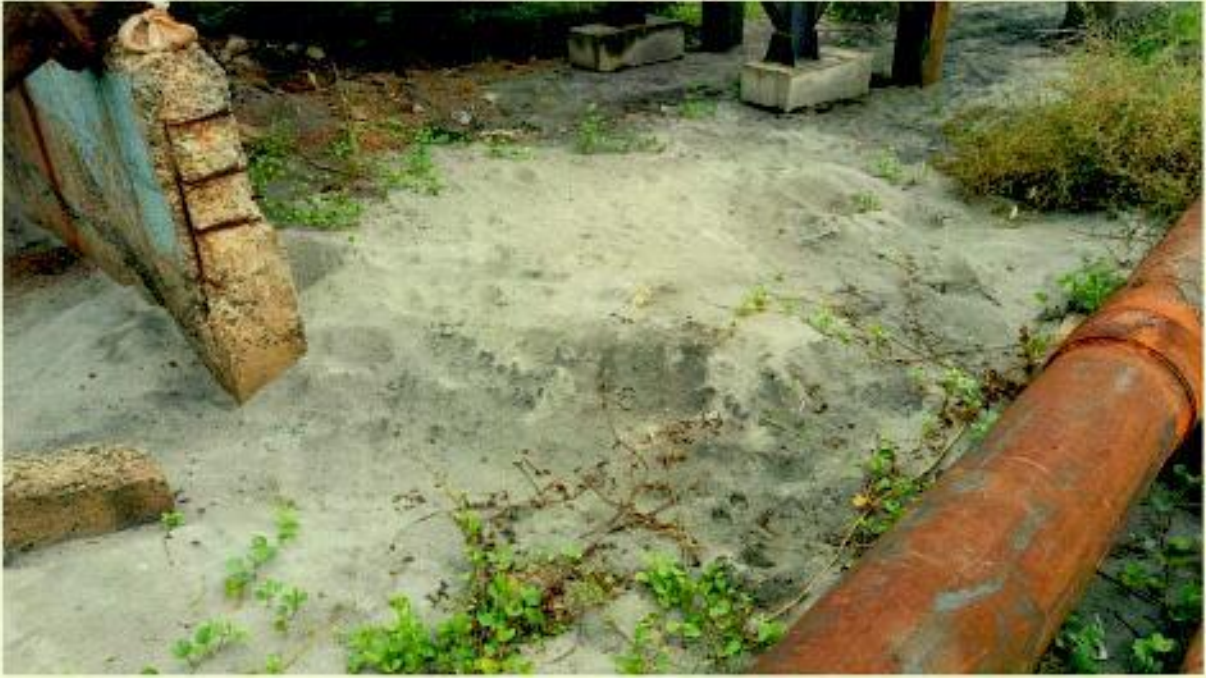
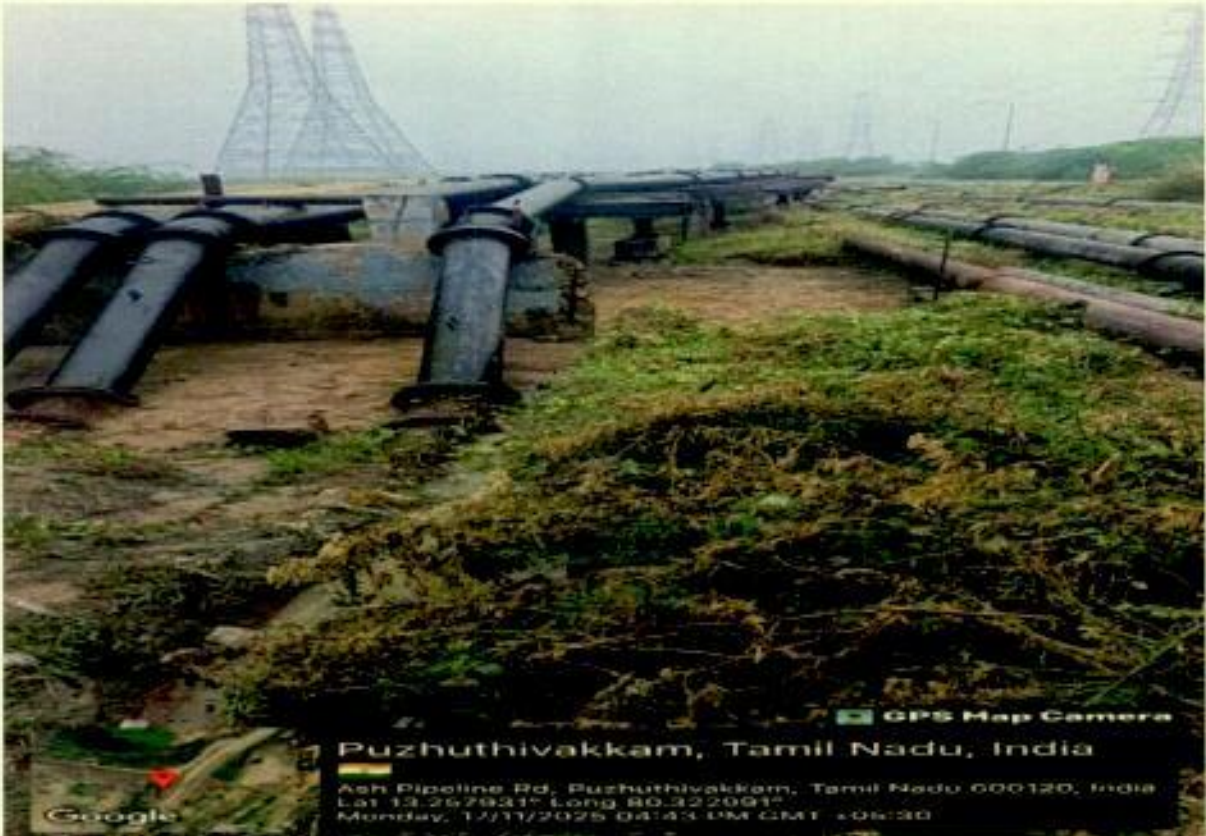
(6) Annexure A1, Page 1

The deposited ash has been removed completely.

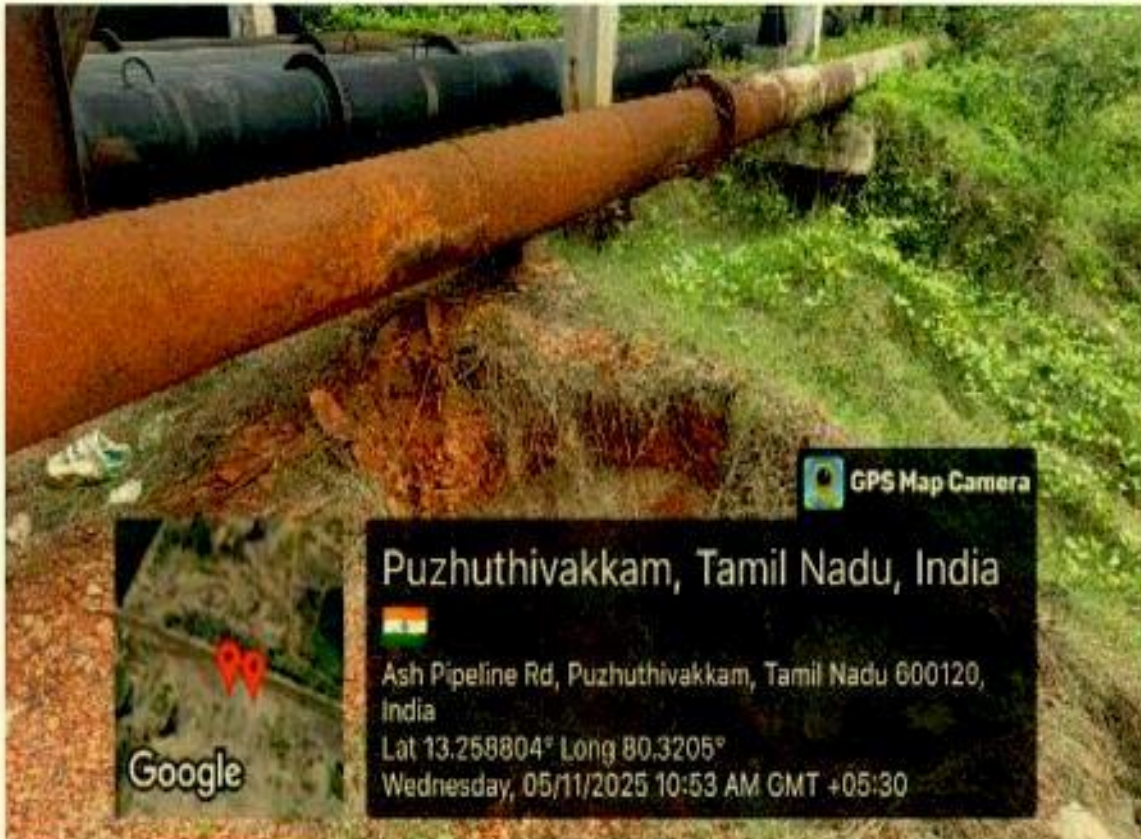
(7) Annexure A1, Page 19.

The line in which the leak occurred **is not an Ash Slurry Line, but the Recovery Water Line (R2)**, which carries decanted saline water recovered from the Ash Pond for recirculation and reuse within the plant system. However the leak was attended immediately by patch welding.

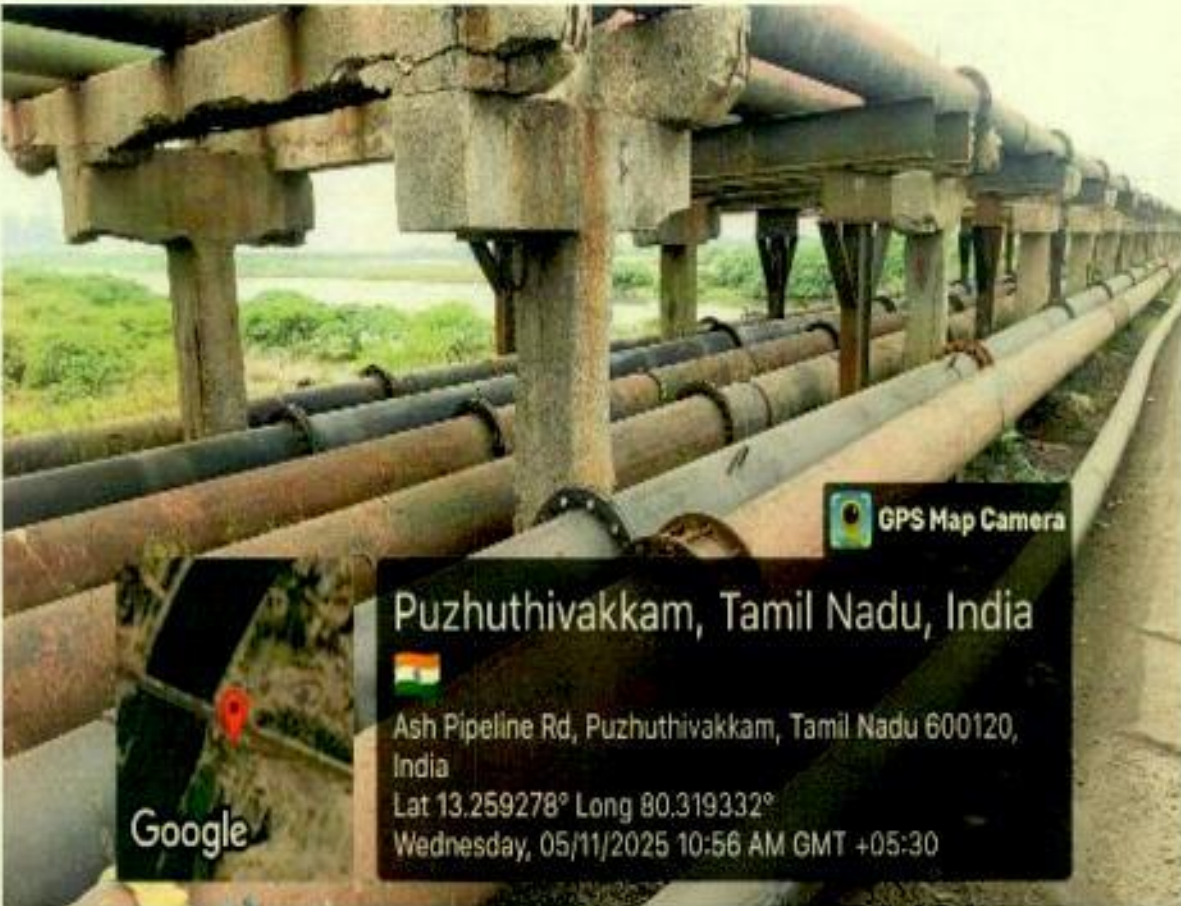
(8). Annexure A1, Page 20.

The line in which the leak occurred due to O-ring **is not an Ash Slurry Line, but the Recovery Water Line (R3)** which carries decanted saline water recovered from the Ash Pond for recirculation and reuse within the plant system. However the leak was attended immediately by replacing the O-ring.

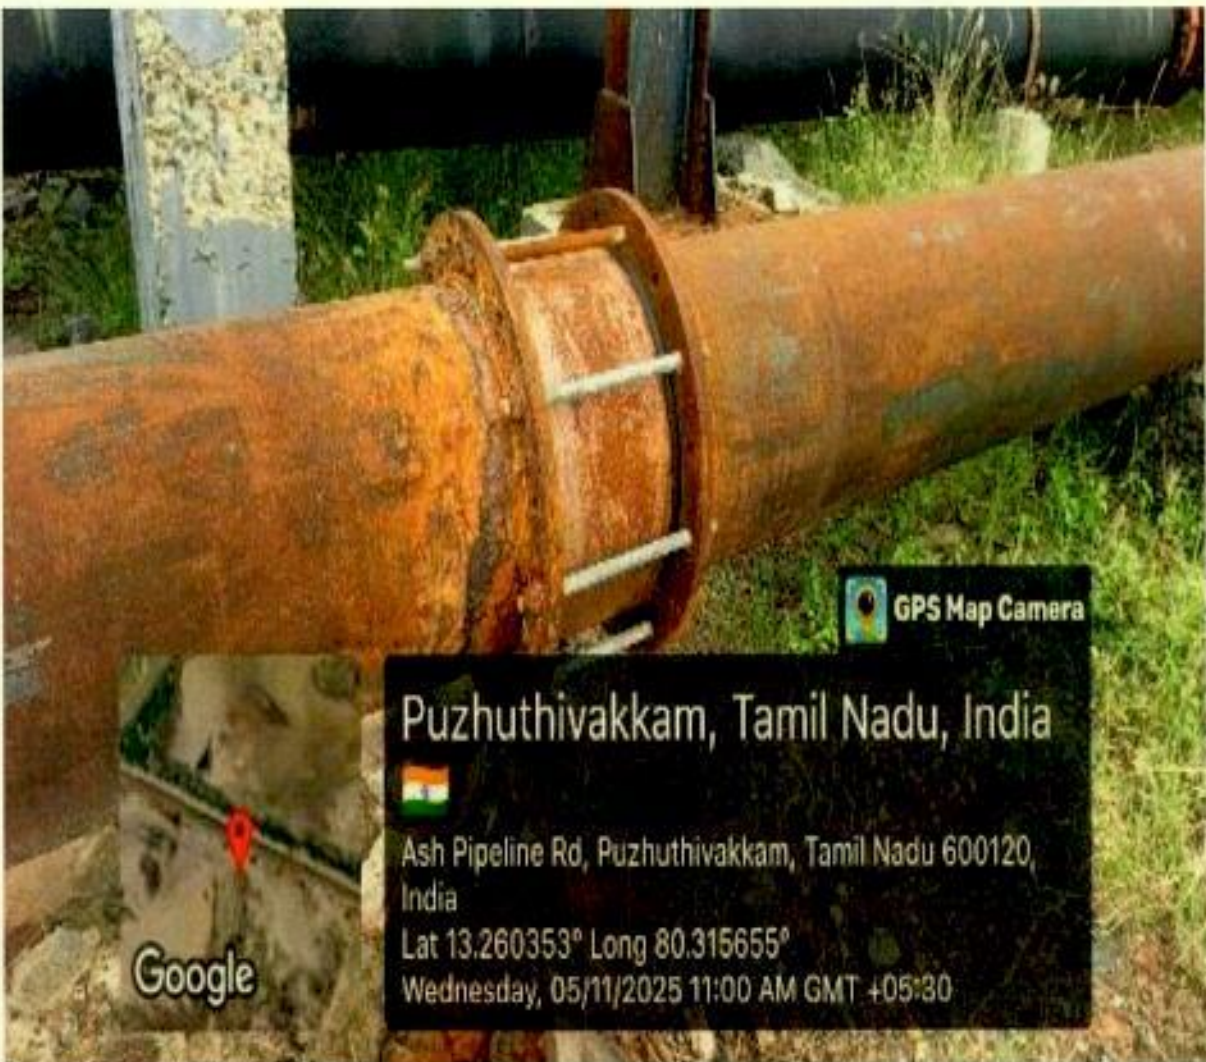
(9) Annexure A1, Page 20. (Picture No.2)

There is **no leak in the pipe however the plastic cover has been removed.**

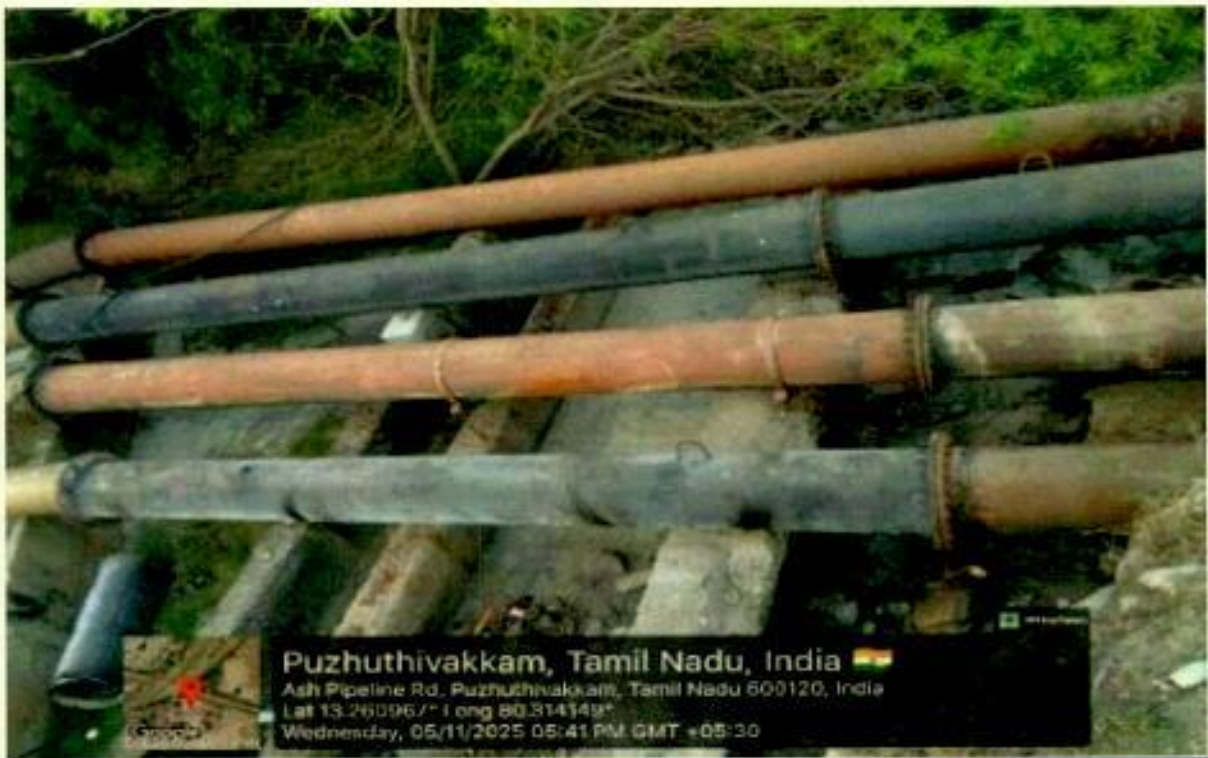
(10) Annexure A1, Page 21 (Picture No.1)

The leakage was noticed in the ASDL line No. 3 welding joint. The Pipe has been renewed with new pipe.

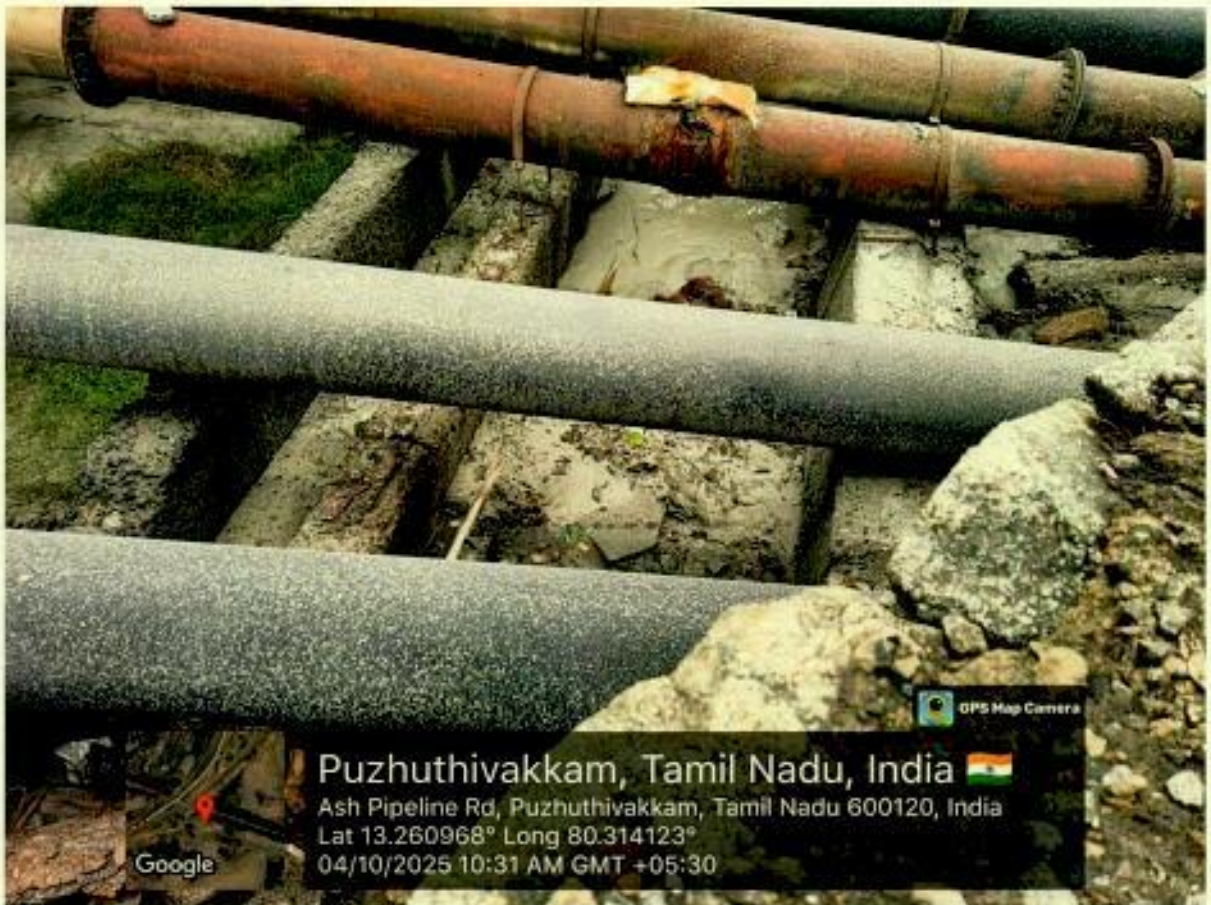
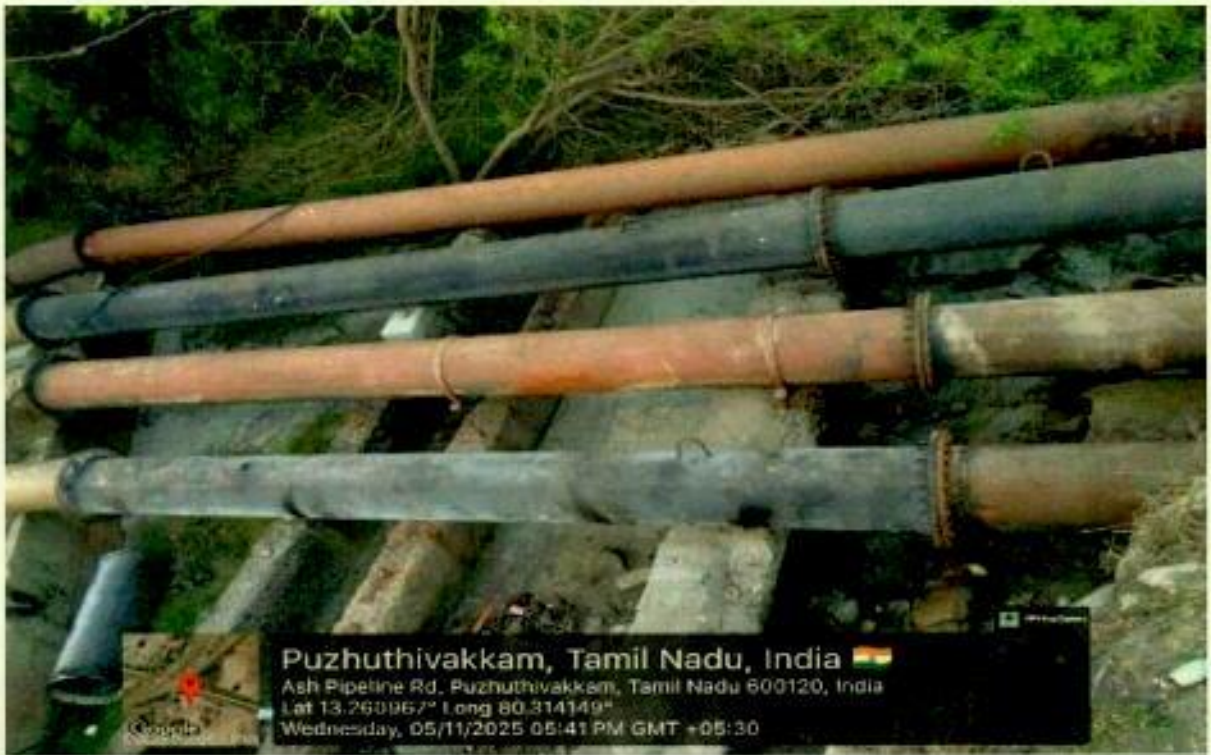
(11) Annexure A1, Page 21 (Picture No.2)

Same photo of ASDL line No. 3 welding joint

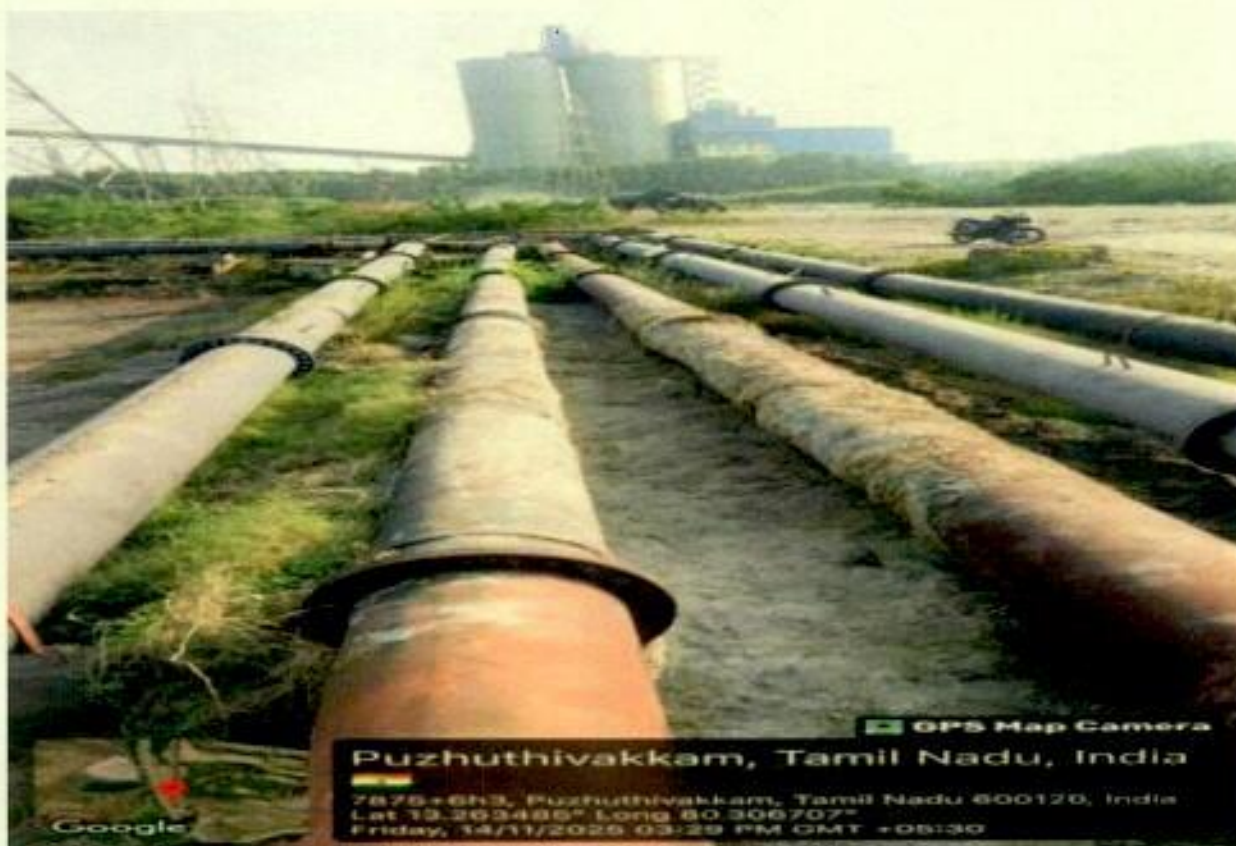
(12) Annexure 1, Page No. 22 (Picture No.1)

These lines (**ASD line 2 and 3**) are laid near to dyke and when water nearby got stagnated the debris and red sand got deposited over the pipes making a rusty look and Since the inner layer is coated with Cast basalt liners there is no potential risk of leak but however the **Pipes will be painted periodically.**

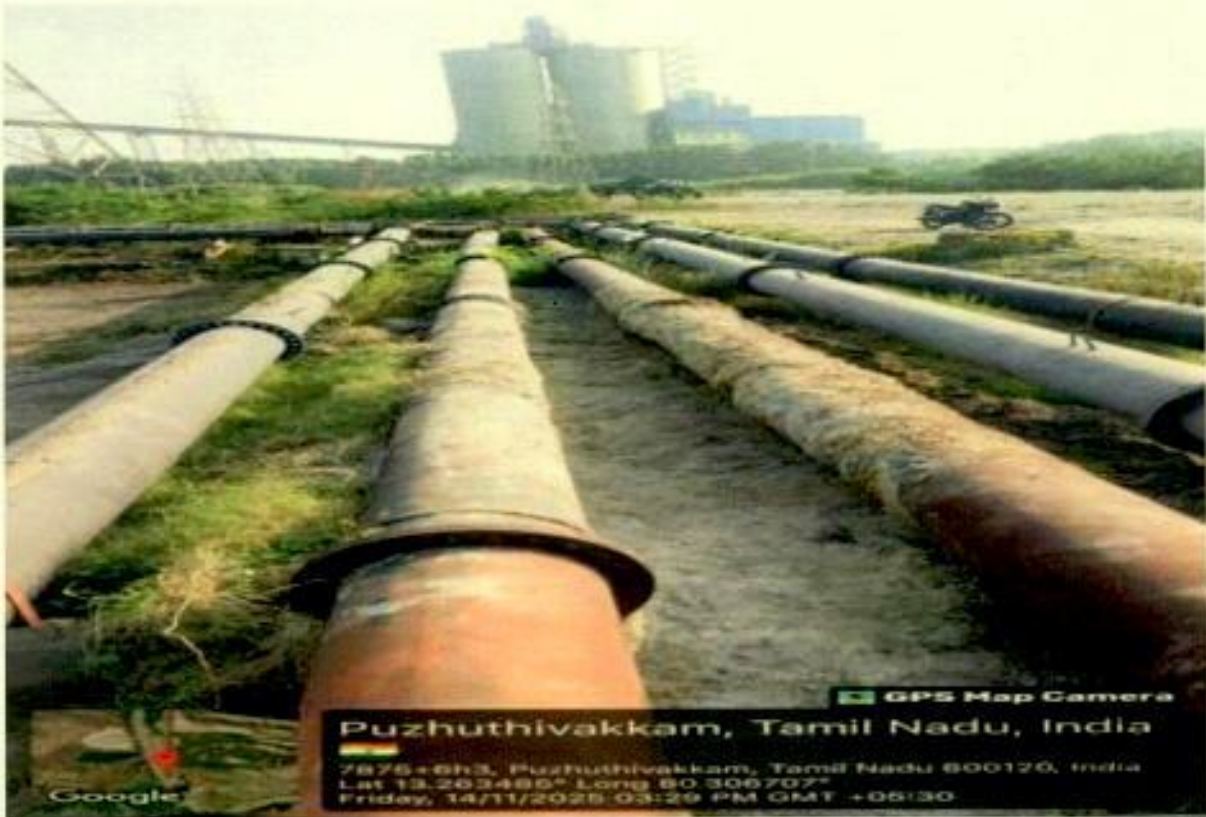
(13) Annexure A1, Page 22 (Picture No.2)

These lines (**ASD line 2 and 3**) are laid near to dyke and when water near by got stagnated the debris and red sand got deposited over the pipes making a rusty look and Since the inner layer is coated with Cast basalt liners there is no potential risk of leak but however the **Pipes will be painted periodically.**

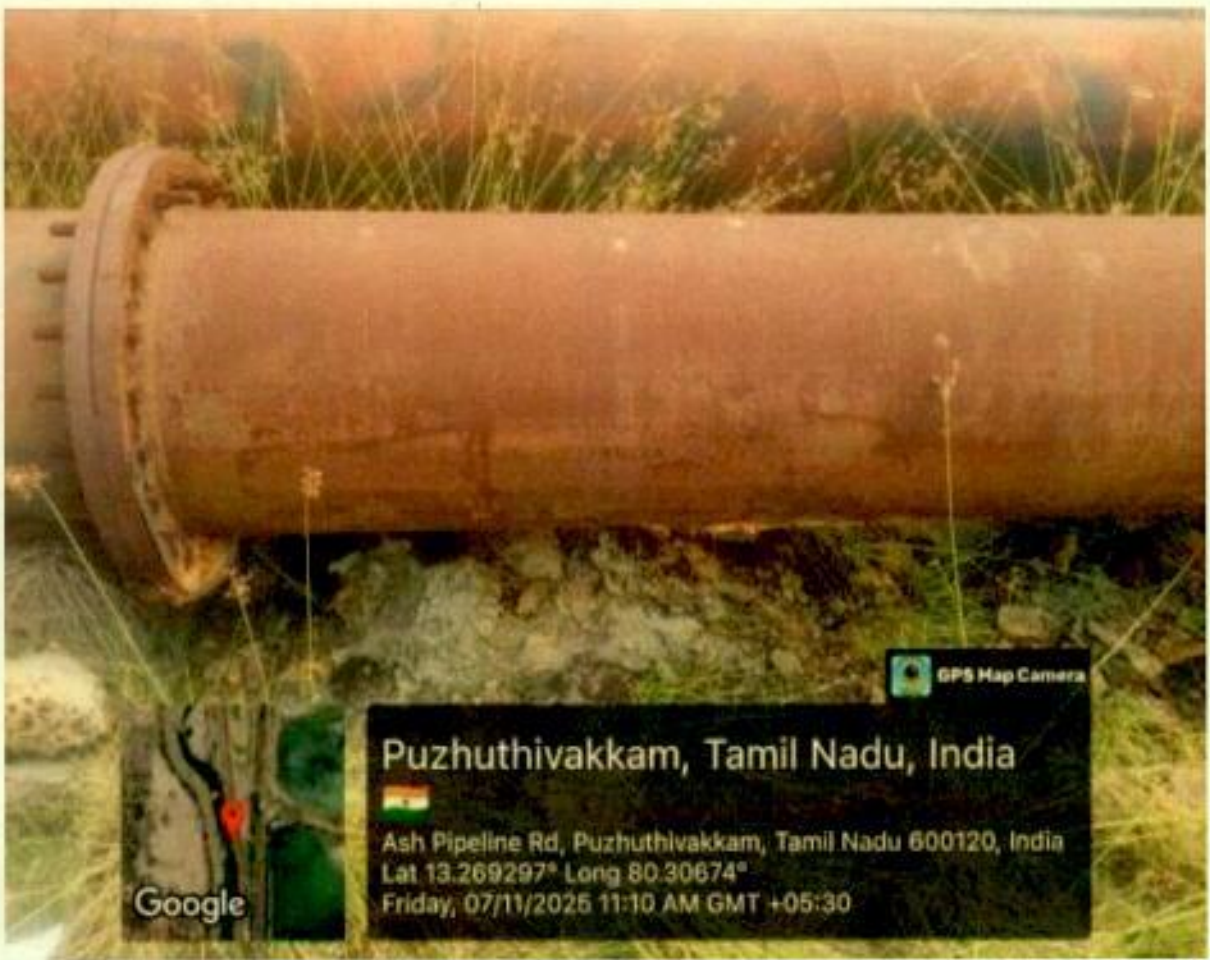
(14) Annexure -1, Page No. 23 (Picture No.1)

The line shown is the **ASDL No. 3** laid during the year 2021 and the outer layer got corroded and **painting proposal under progress.**

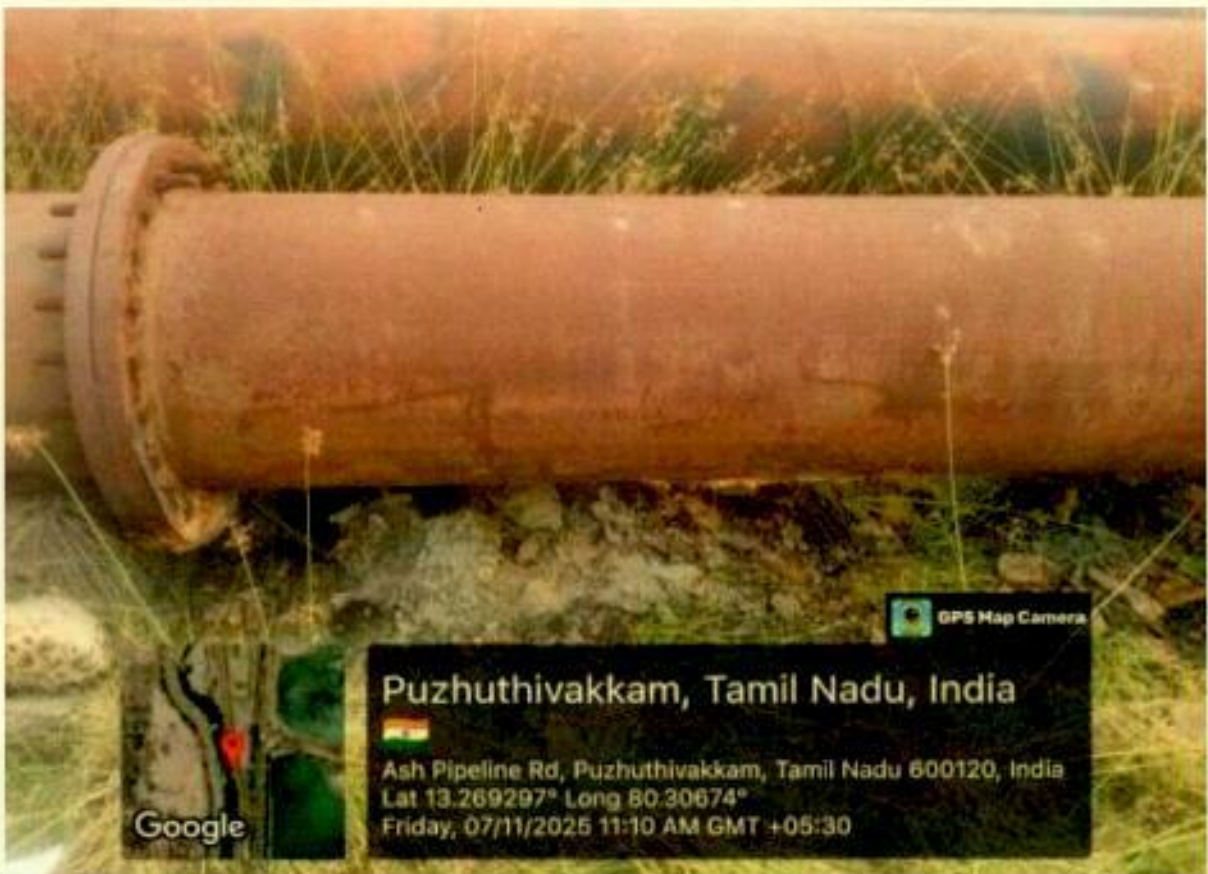
(15) Annexure 1 page No.23 (Picture No.2)

The line shown is the **ASDL No.3** line laid during the year 2021 and the outer layer got corroded and **painting proposal under progress.**

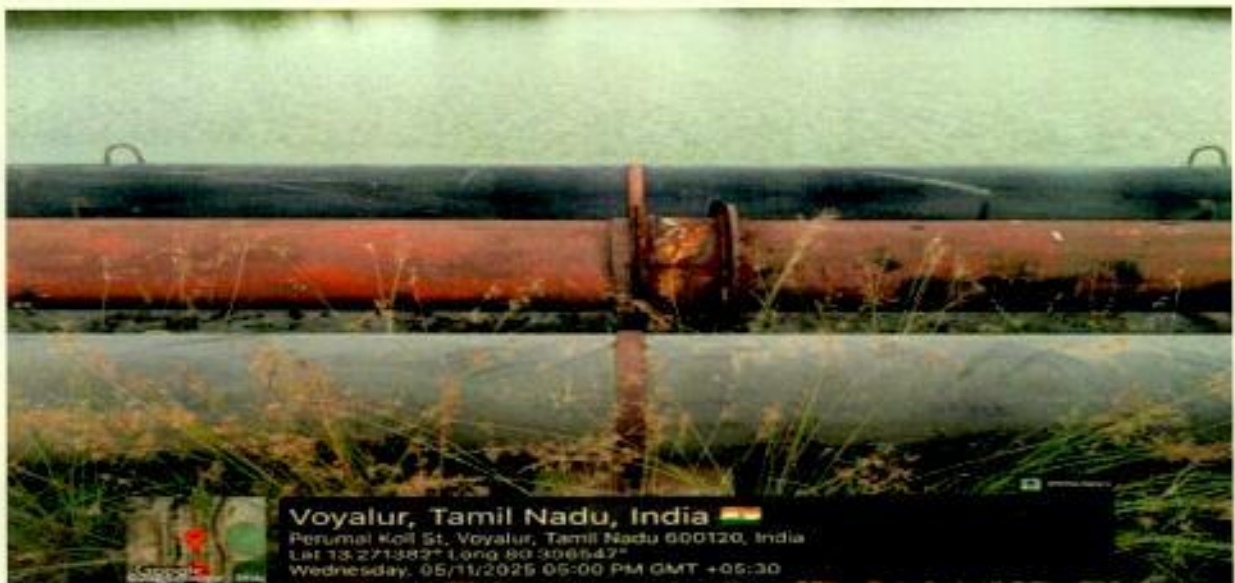
(16) Annexure 1, Page No. 24 (Pictures 1)

It is submitted that, the observation made by the petitioner appears to be misinterpreted. The cloth seen in the photograph over the slurry line is not an intentional attempt to conceal a leak. The Ash Slurry Disposal System of NCTPS-I conveys ash slurry at a **minimum pressure of 5 kg/cm² (ksc)**. **Under such pressure conditions, a piece of cloth or any fabric material cannot physically arrest or hide a leak.** Any leakage under these conditions would be forceful and immediately visible. It might be leftover by the maintenance personnel or an act of outsiders since the pipe lies along the open corridor. **The O-ring of the ASDL No.2 coupling has been replaced as weeping noticed.**

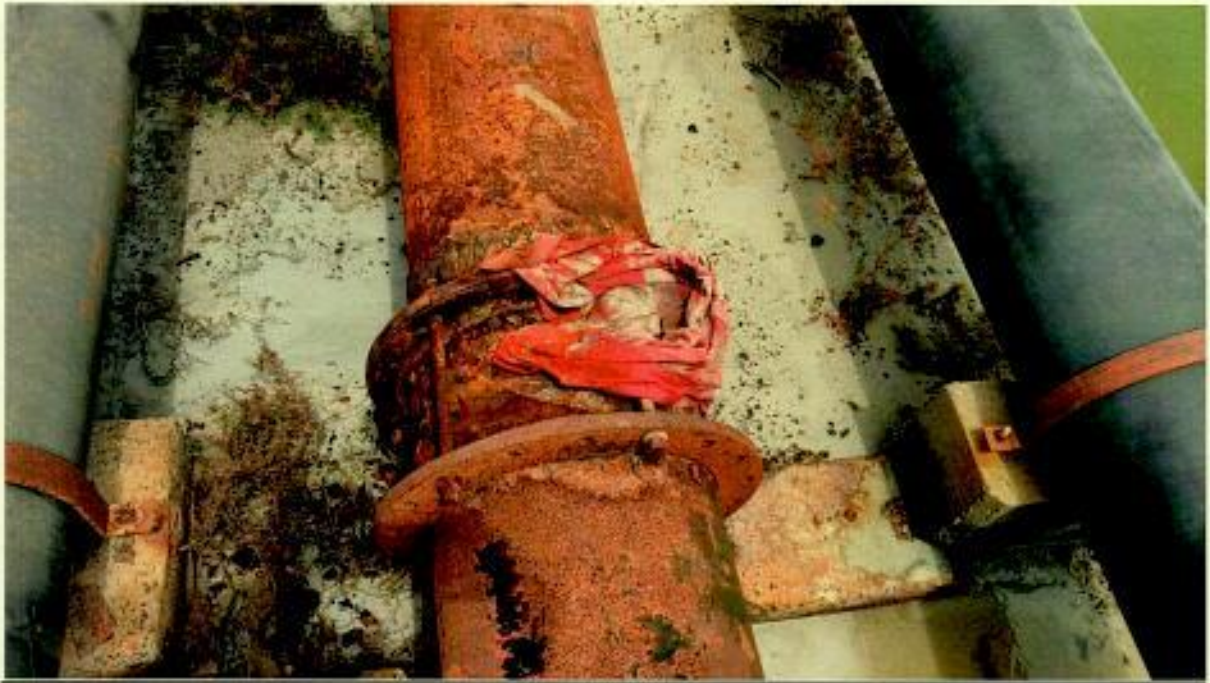
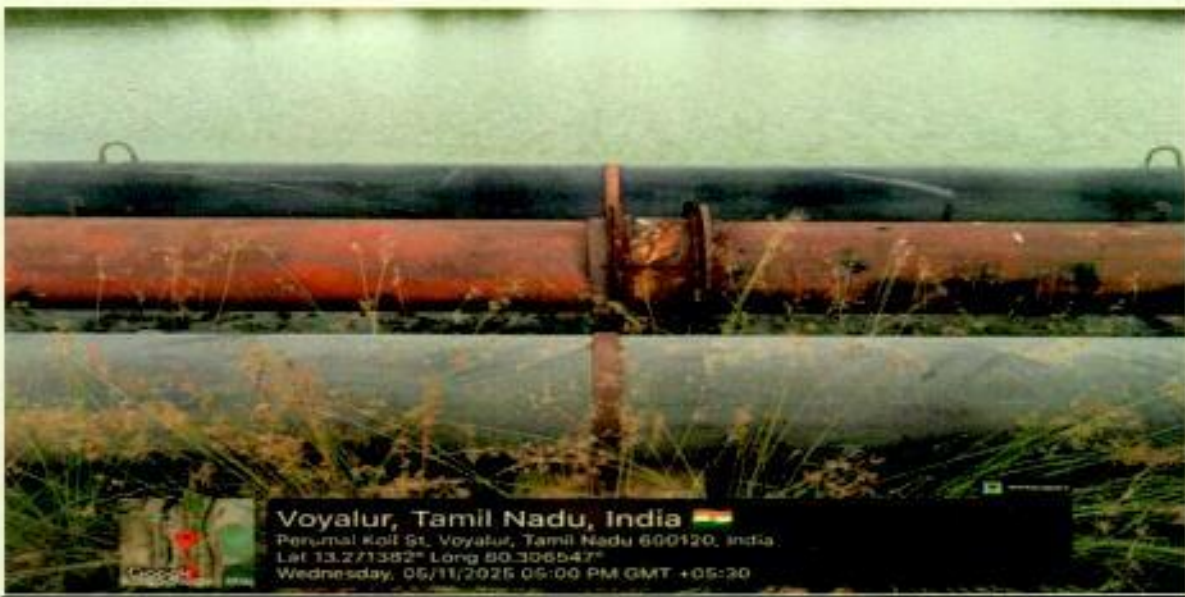
(17) Annexure 1, Page No.24 (Picture 2)

Same O-ring of ASDL No.2 coupling as in (16) Annexure 1, Page No. 24 (Pictures 1) taken from a different angle.

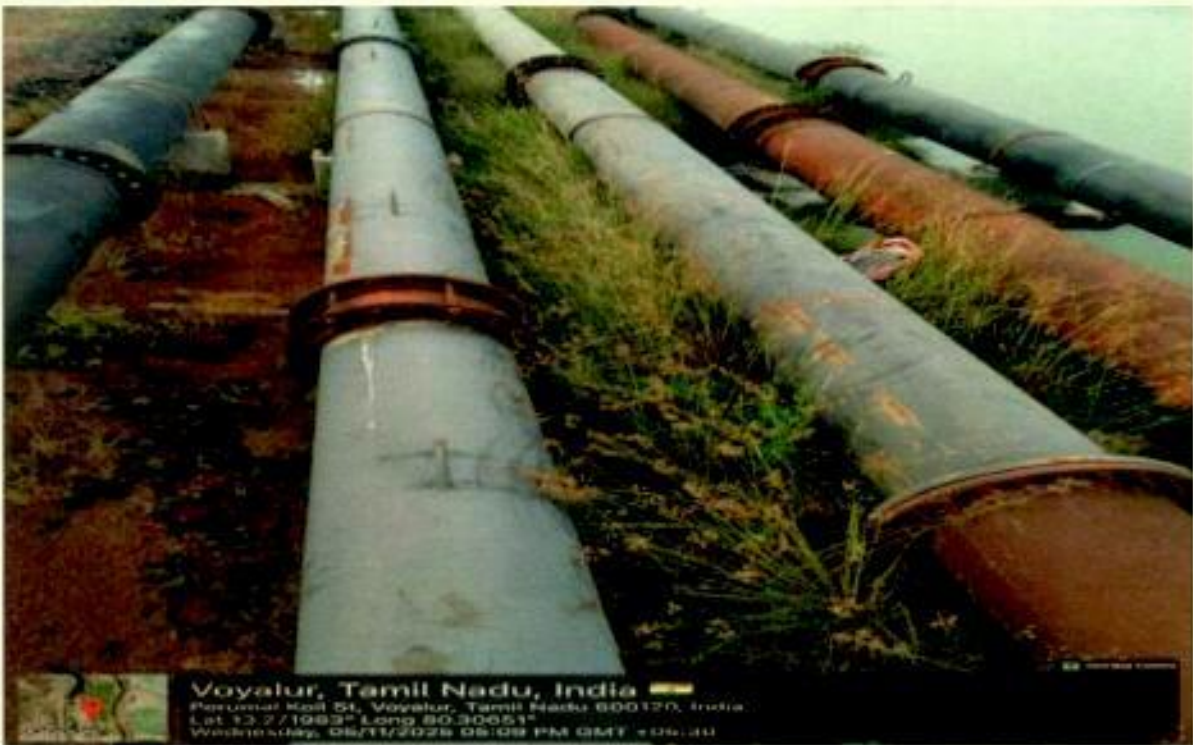
(18) Annexure A1, Page 25 (5 Nos. of Pictures)

The Pipes and coupling were procured from different agencies and the pipe was painted with black paint and the Sleeve coupling was supplied with red oxide paint. Hence it seems to be varying. However it is hereby stated that the coupling is not old and there is no structural damage in the pipes /couplings. **The painting proposal for the ASDL No.2 and 3 is under progress and periodical painting will be carried out in future.**
