BEFORE THE NATIONAL GREEN TRIBUNAL SOUTHERN ZONE,
CHENNAI

O.A. No. 230 of 2025

REPLY FOR THE CORRESPONDING PHOTOS FILED IN ANNEXURES TO THE APPLICATION

The present status of the pipe lines photographed by the petitioner is as detailed below:

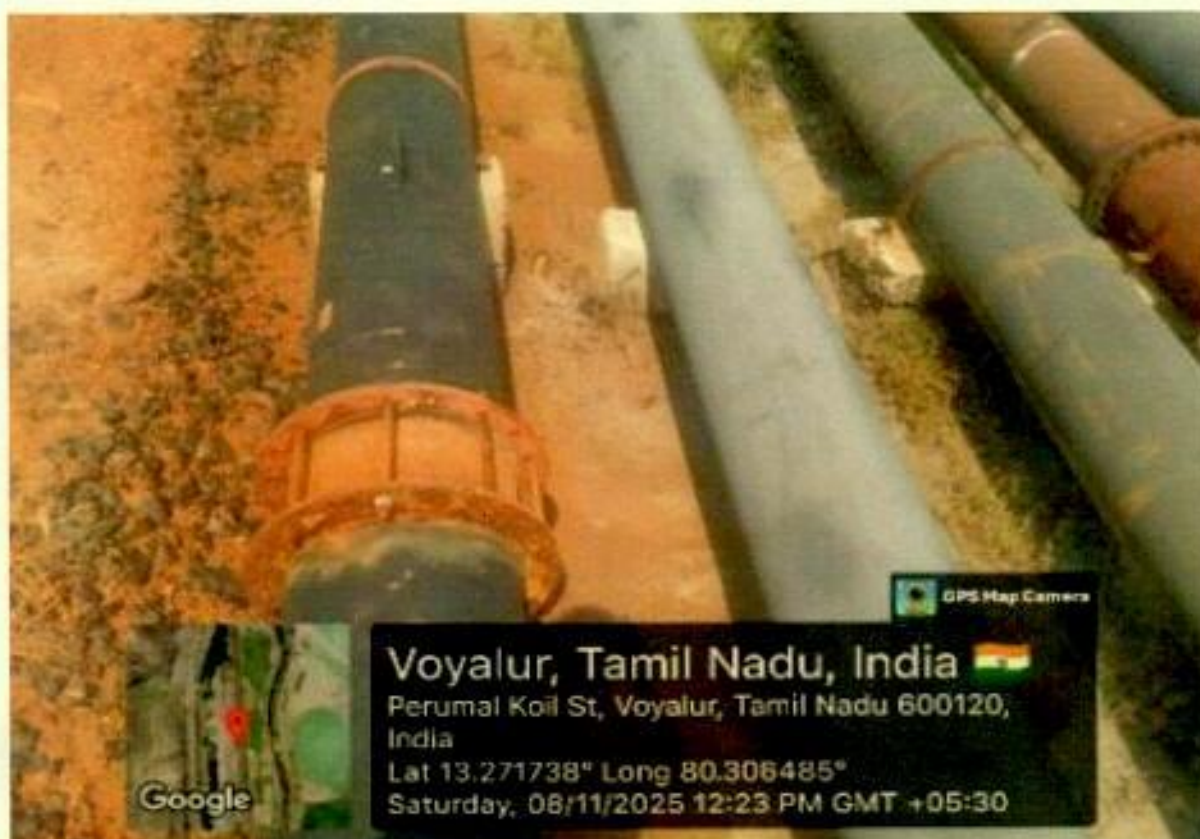
(20) Annexure A1 page No.26 (Picture No.1)

The Pipes and coupling were procured from different agencies and the pipe was painted with black paint and the Sleeve coupling was supplied with red oxide paint. Hence it seems to be varying. However it is hereby stated that the coupling is not old and there is no structural damage in the pipes /couplings. **The painting proposal for the ASDL No.2 and 3 is under progress and periodical painting will be carried out in future.**

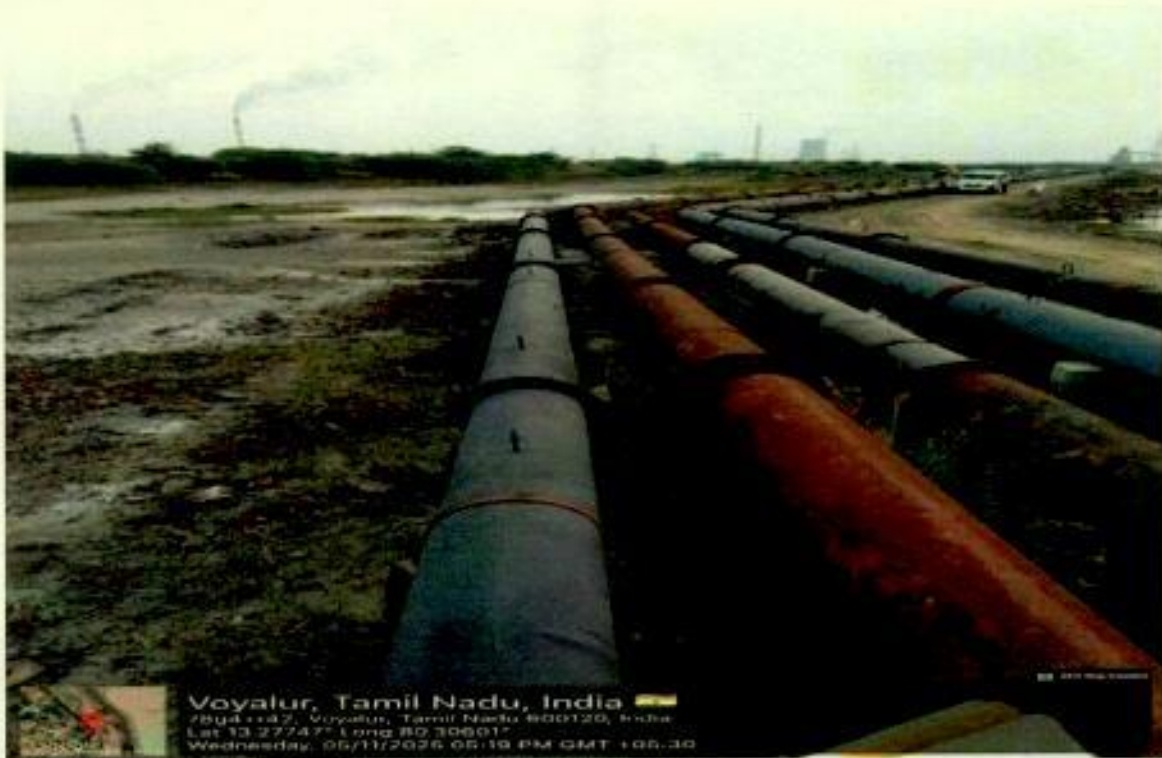
(22) Annexure A1, Page No.27 (Picture No.1)
 14. GPS: 13°16'38.5"N 80°18'21.6"E dated 04.10.2025

The ASDL lines depicted in the photograph are not partially replaced of pipes. The **pipes were renewed in a phased manner from 2021 to 2025** in the order of ASDL 3(2021-22), ASDL 2 (2022-23), ASDL4 (2023-24), ASDL 5(2024-25, ASDL1(2024-25). Hence there is no partial replacement. Also new pipes were replaced in the existing pipes ASDL 3 and 2 whenever emergency rises. Also written submission were filed before the Hon'ble NGT after replacement of ASDL pipes as directed by the Hon'ble NGT.

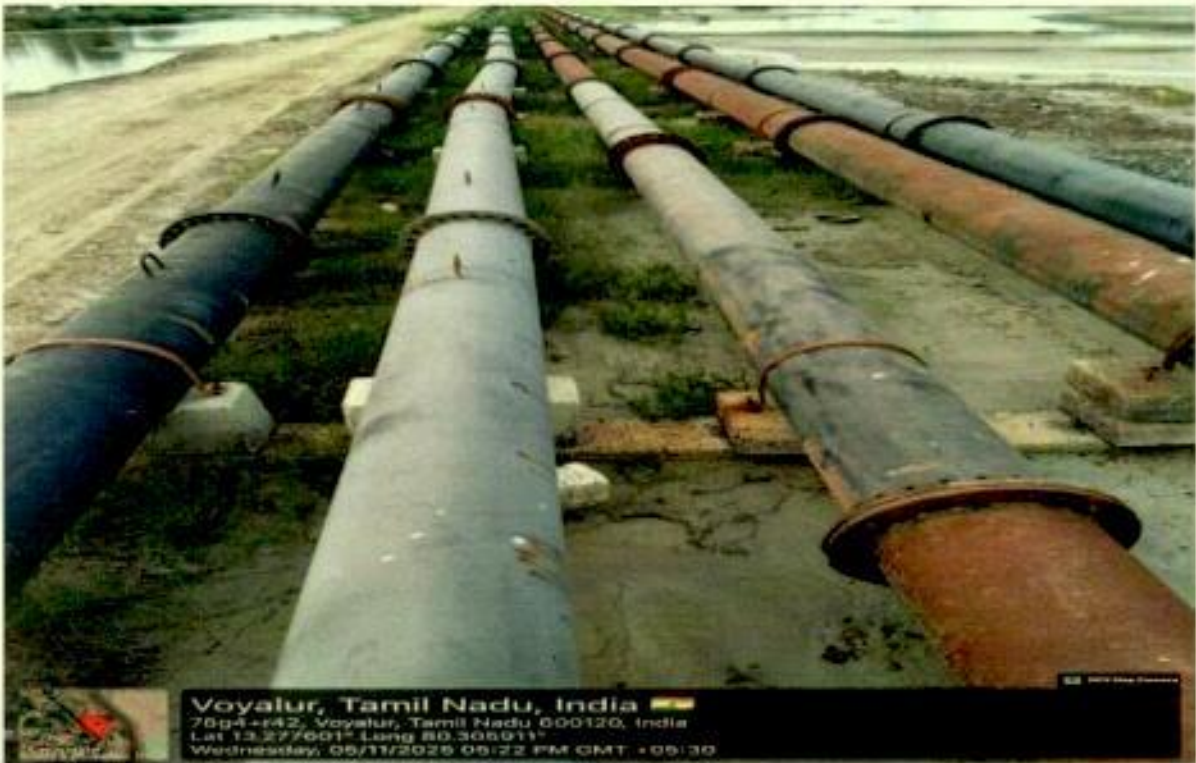
(23) Annexure A1, page No.27 (Picture No.2)

The ASDL lines depicted in the photograph are not partially replaced of pipes. The **pipes were renewed in a phased manner from 2021 to 2025** in the order of ASDL 3(2021-22), ASDL 2 (2022-23), ASDL4 (2023-24), ASDL5(2024-25, ASDL1(2024-25). Hence there is no partial replacement. Also new pipes were replaced in the existing ASDL 3 and 2 whenever emergency rises.

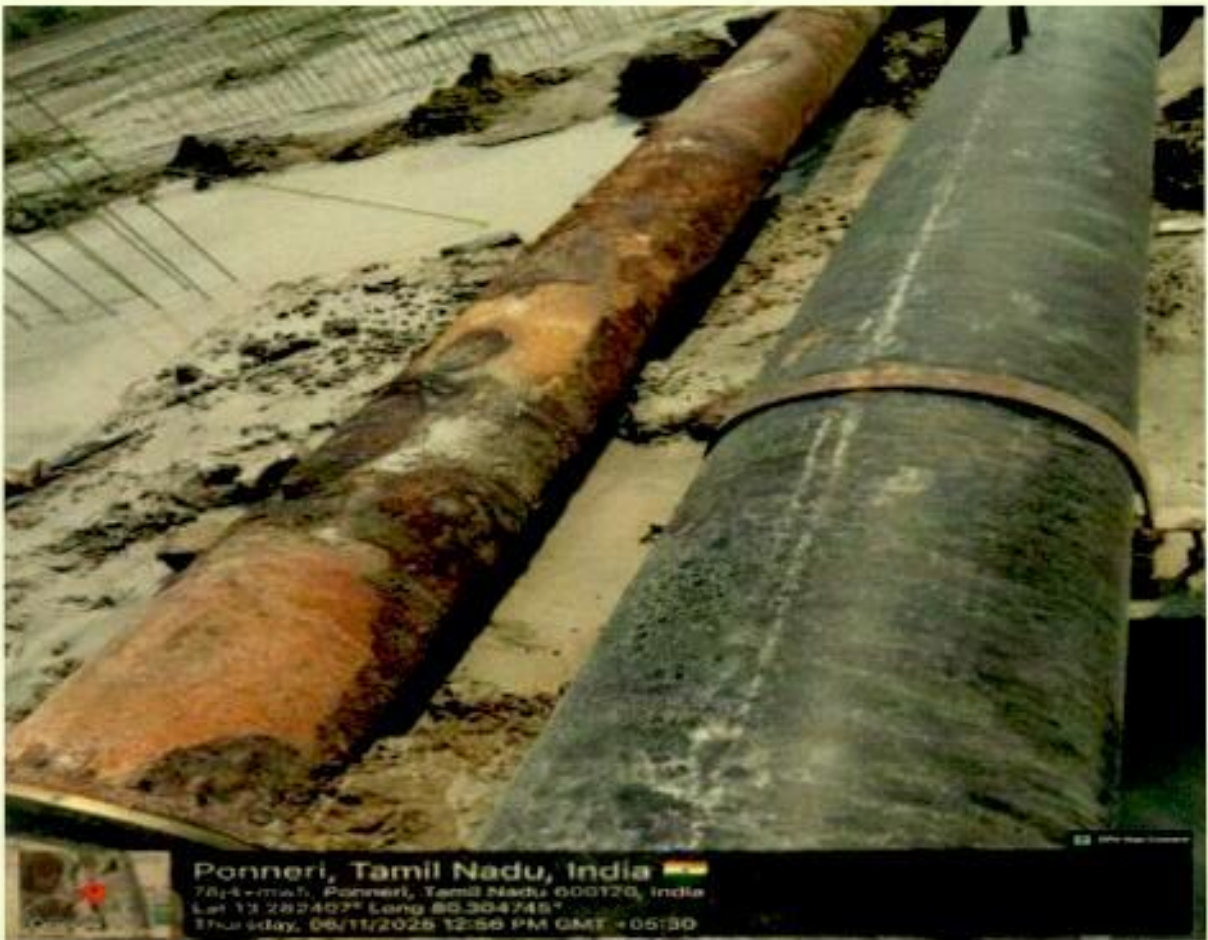
(24) Annexure A1, page No. 28 (Picture No.1 and 2)

During rainy season the pipes got submerged and the Red soil and tiny stone particles got stuck to the pipe lines showing a rusty look and **beyond the soil area it could be seen clear.**

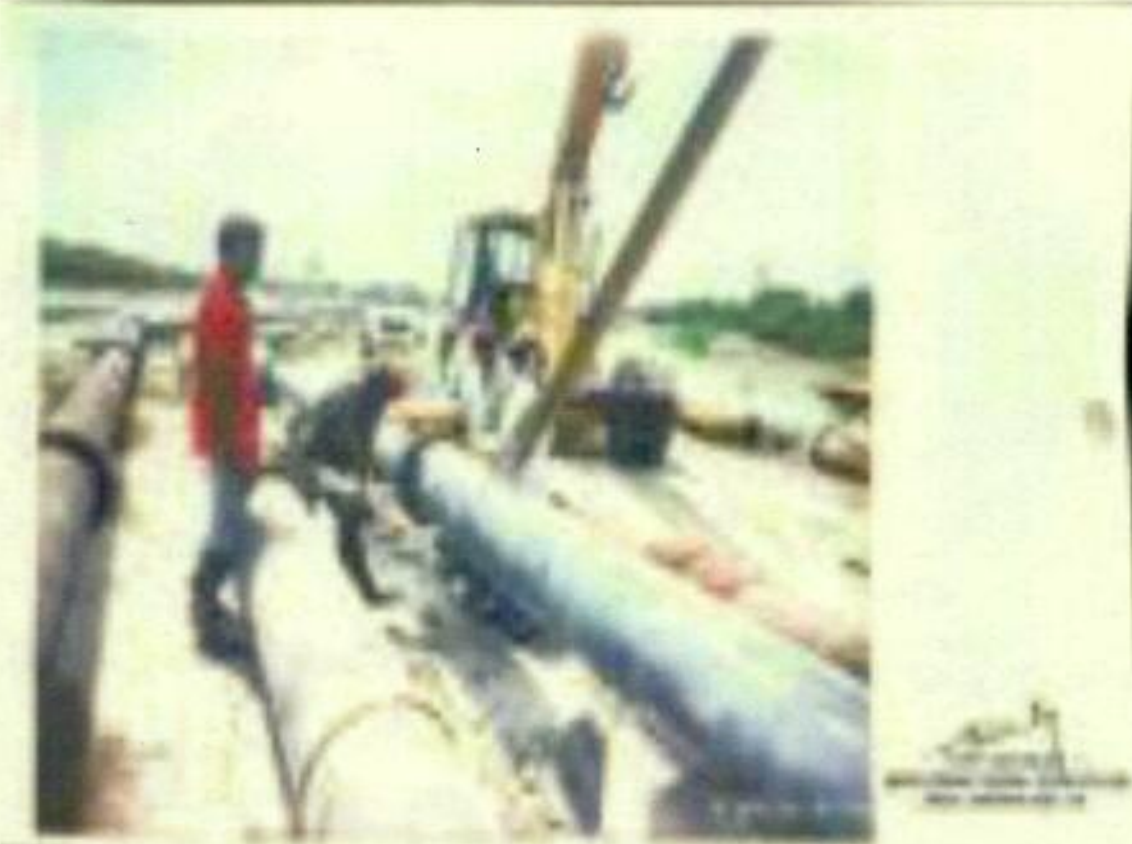
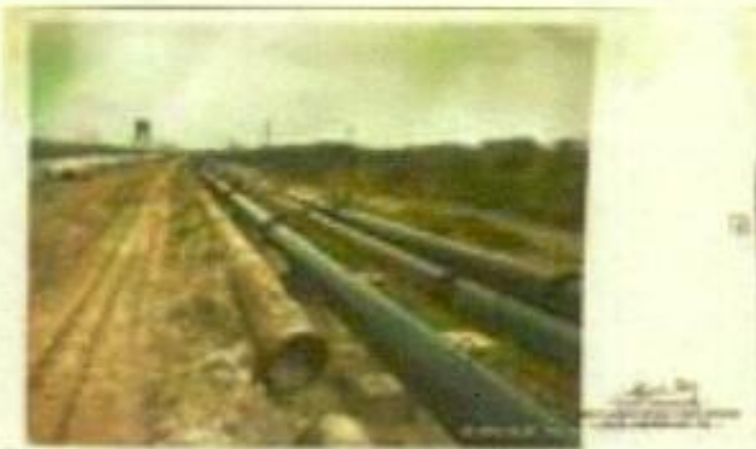
(25) Annexure A5, Page No.49

These Photographs depict the erection work of new line in ASDL.

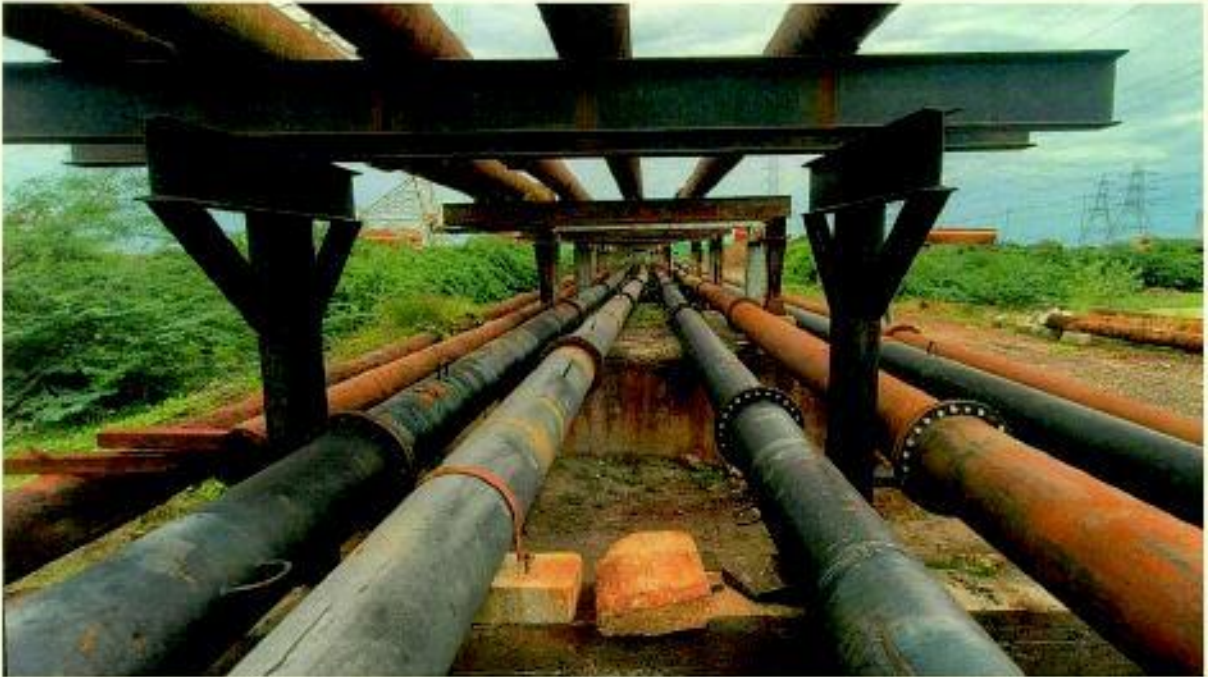
(26) Annexure A7, Page No.57,
Date : October 4, 2025 / 9:00 A.M. to 1:00 P.M.

The lines laid under the steel structure pertain to NCTPS-I, **out of which 5 Nos. are Ash Slurry disposal lines and 3 Nos. are Recovery water lines.** The lines laid over the structure pertain to NCTPS-II.

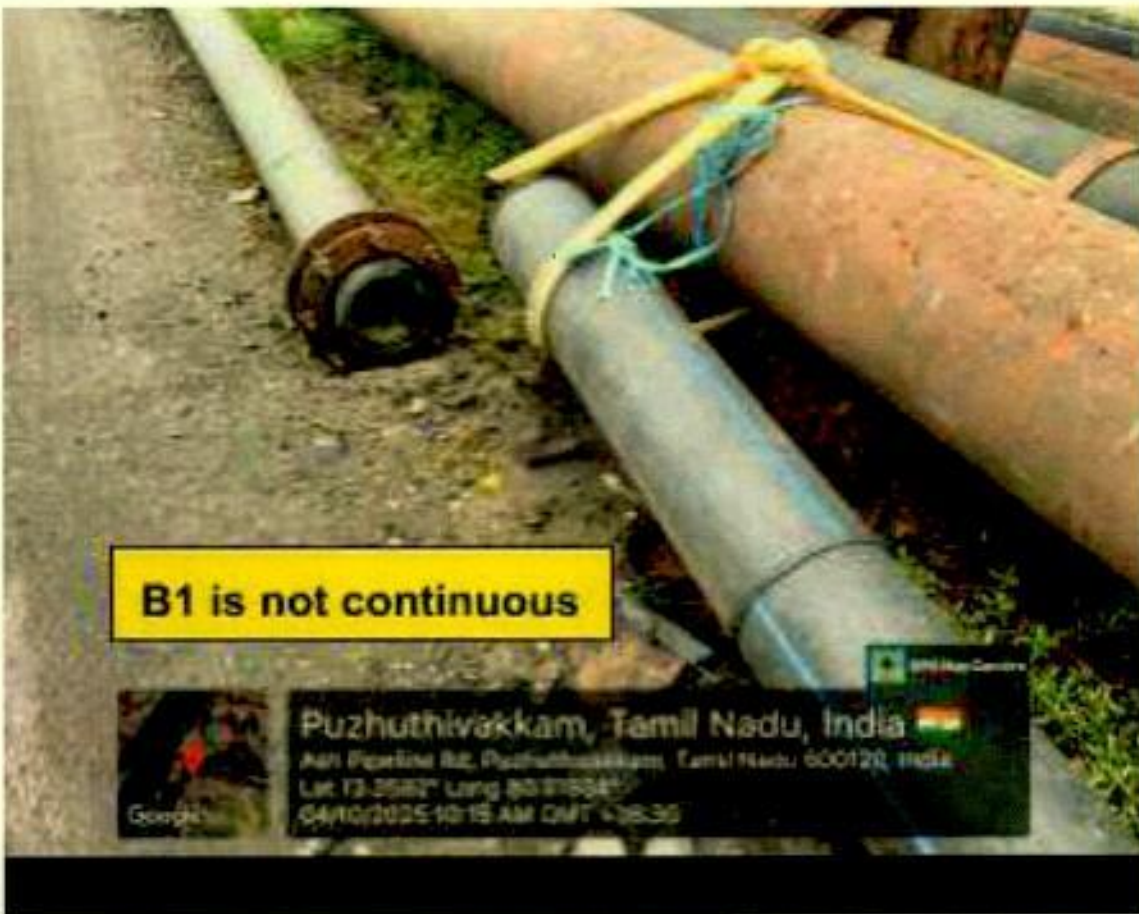
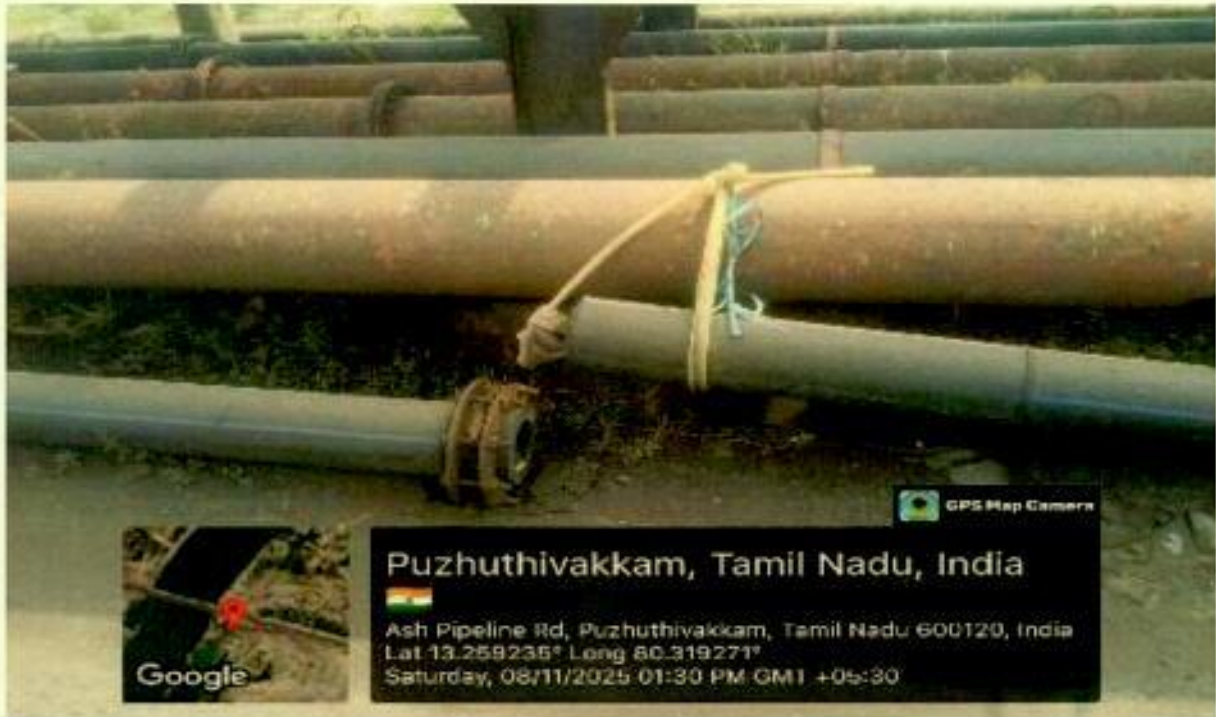
(27) Annexure A7, Page No.60 (Picture No.2)

The HDPE pipe does not pertain to NCTPS-I and also it is clarified it is **not a slurry or recovery water line it is an abandoned drinking water line of Ennore SEZ TPP.**

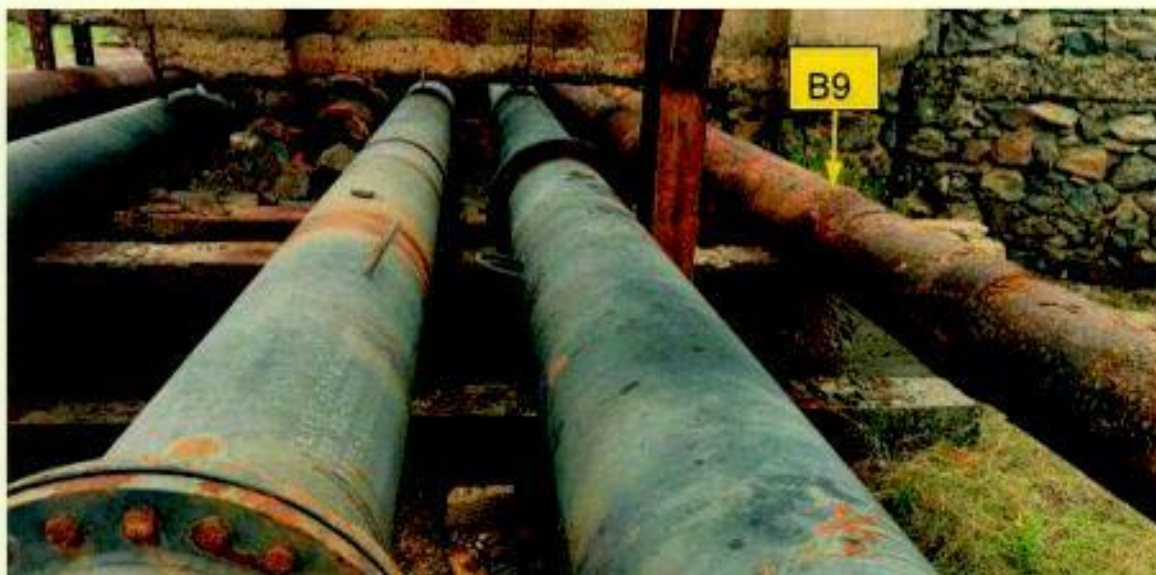
(29) Annexure A7, Page No. 63 (Picture No. 1)

The B2 line is the **Recovery water line and not slurry line. B8 is not in service** and at present Tender to be called for the procurement of pipe lines for the Recovery water line No.1 (B8). **B2 line is also recovery water line (R3)** and tendering for the partial replacement of the damaged pipe line (**816 M**) is in progress and the work will be completed on or **before July'2026**. For B4 line which is the Ash Slurry Disposal Line and the **proposal for painting the same is under progress**.

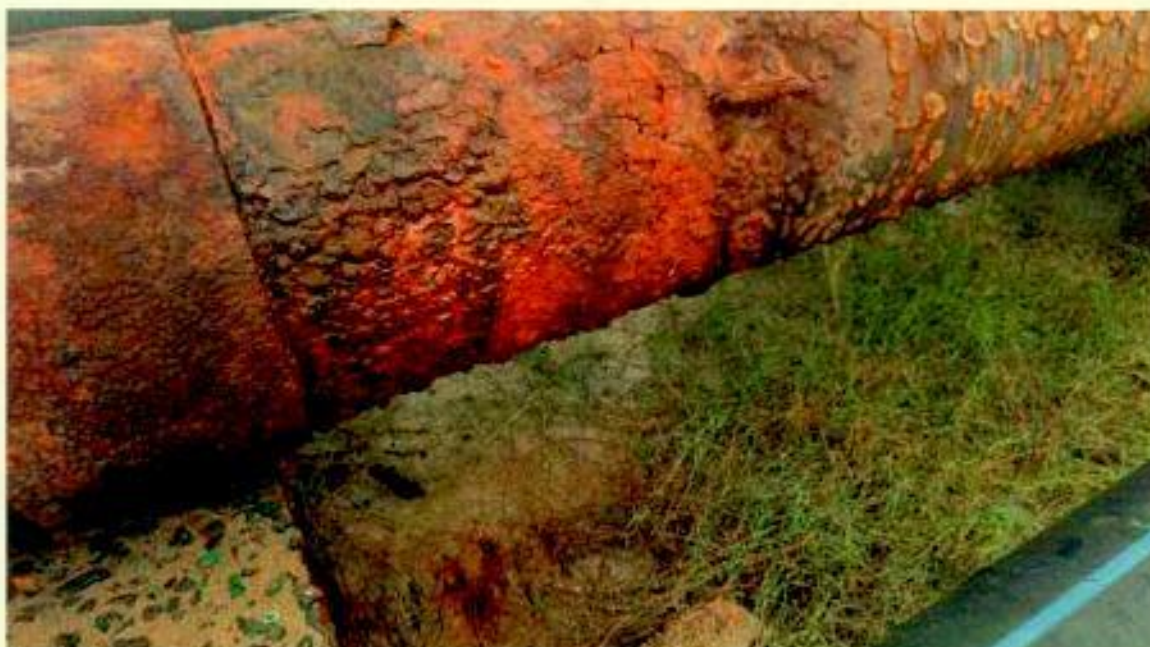
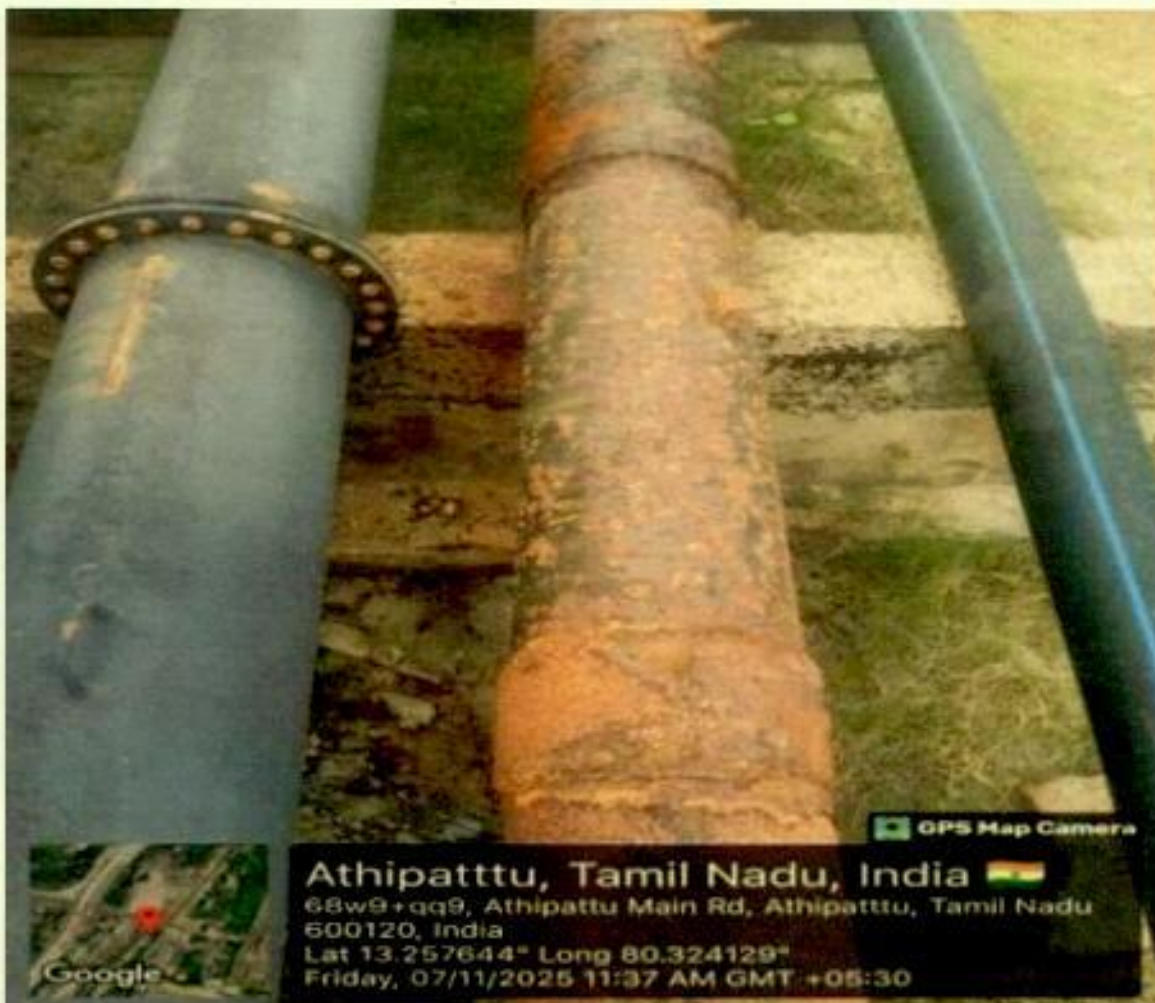
(32) Annexure A7, Page No.64 (Picture No.1)

The rusted line shown is the **Recovery water line R3 carrying recovered water from Ash Dyke for recirculation**. Tendering is in progress for replacement of the damaged pipes (**816 m**) in R3 line (B2).

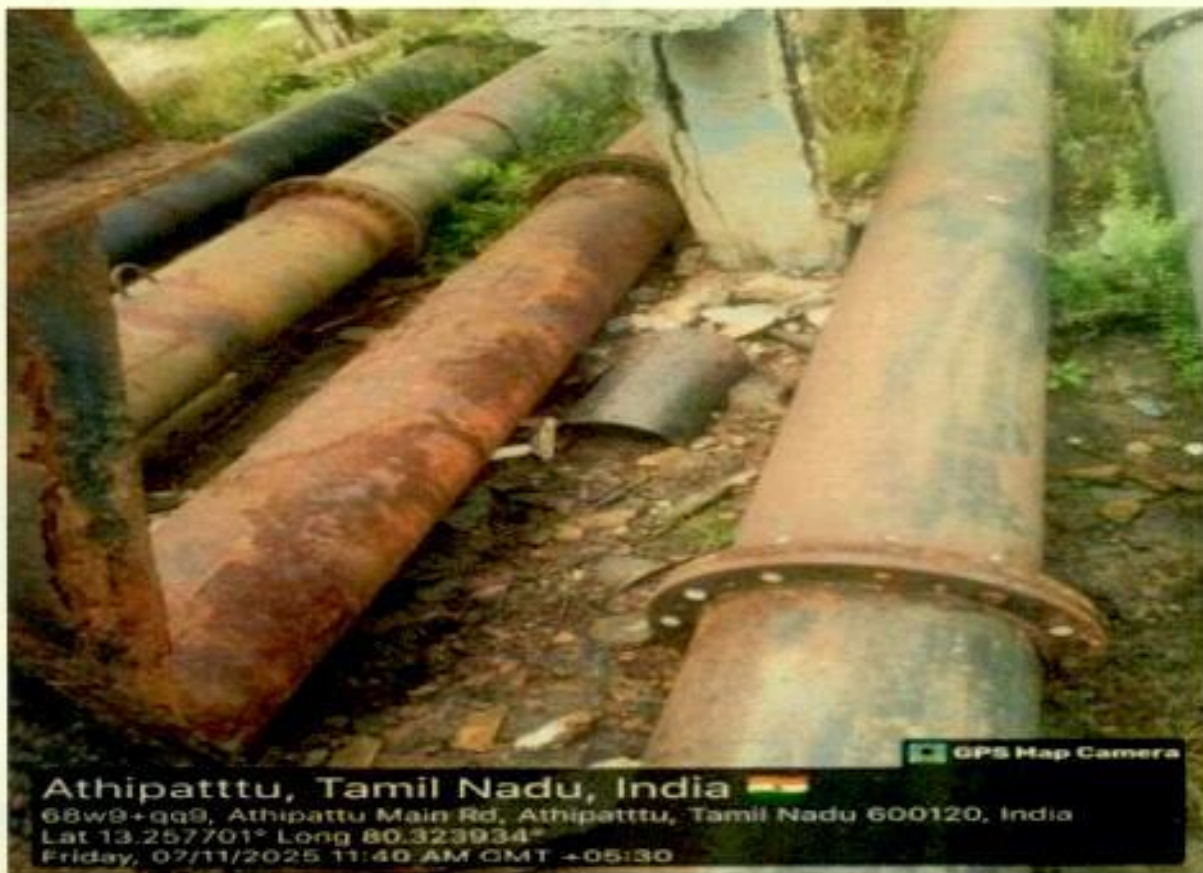
(33) Annexure A7, Page No.65 (Picture No.1) GPS: 13°15'27.5"N

The **Ash Slurry Disposal Line No. 3** was commissioned during the year **2021**. The corrosion is due to prolonged exposure to saline and humid coastal atmosphere, accelerating oxidation. The lines are lined with cast basalt lining of 20 mm Thickness. However **proposal is under progress for protective coating by painting with epoxy paint and the work will be completed before May'2026**.

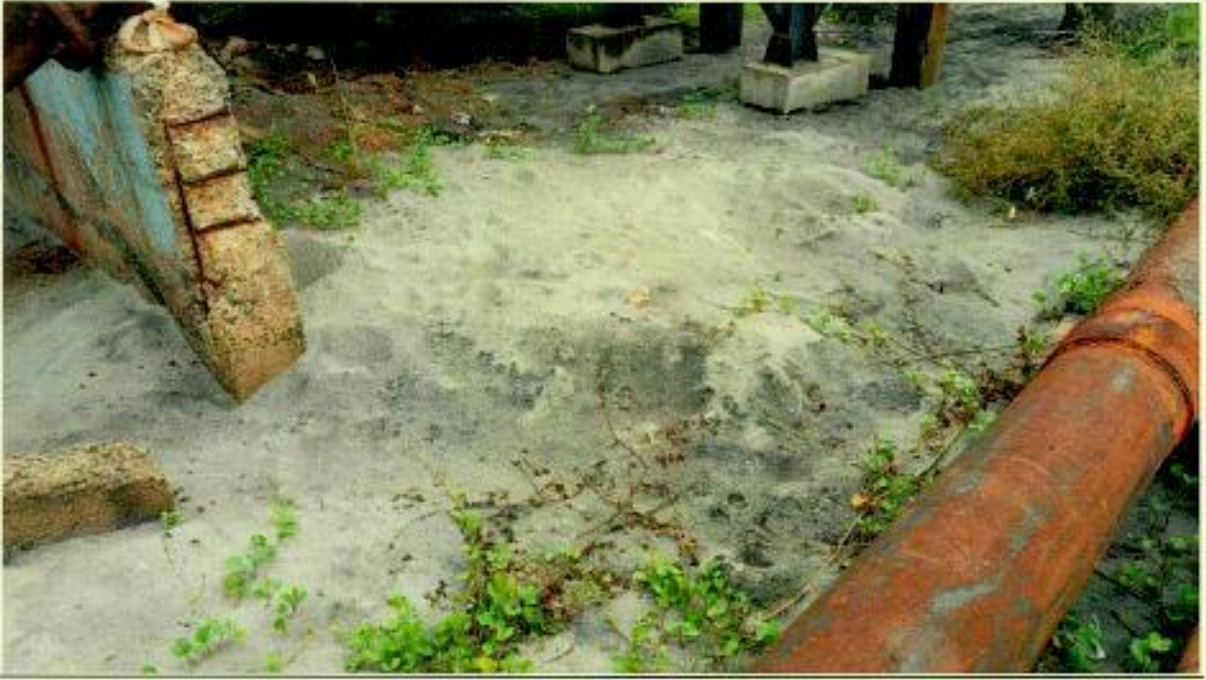
(35) Annexure A7, Page No. 66 (Picture No.2) GPS 13°15'28.3"N

The same photograph from Annexure A1, page No. 16. The deposited ash has been removed completely.

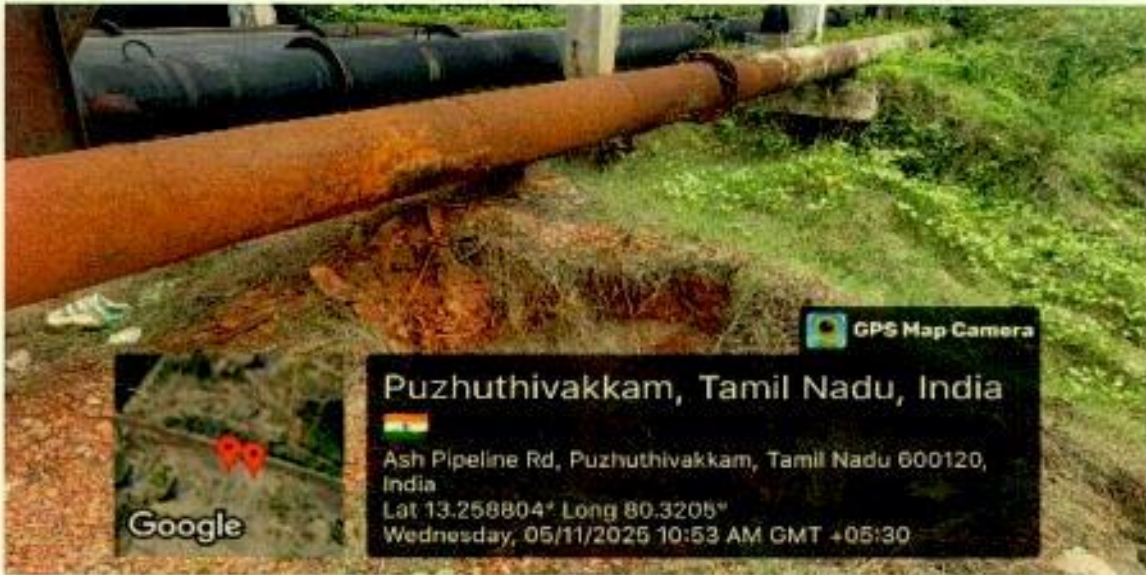
(37) Annexure A7, Page No.68 (Picture No.1)

It is submitted that the photograph referred to by the petitioner **does not pertain to an ash slurry disposal line, but rather to a recovery water line that conveys decanted saline water from the Recovery Water Pump House back to the NCTPS-I for reuse / recirculation in the Ash Handling System** and other auxiliary processes. The leak has been attended.

The recovery water system is a closed-loop circuit designed to minimize freshwater intake by re circulating the decanted supernatant water from the ash pond after the heavier ash particles have settled at the dyke. The recovered water thus transported contains **only trace suspended solids** within permissible limits and no fly ash or bottom ash particles in significant quantity.

The Ash Slurry Disposal Lines are of **higher diameter 406 mm** and specifically designated for ash transport. But the Recovery water line is smaller in diameter than Slurry line i.e. **350 mm dia.**

However the leak is due to mechanical failure and a pinhole puncture occurred which was attended immediately.

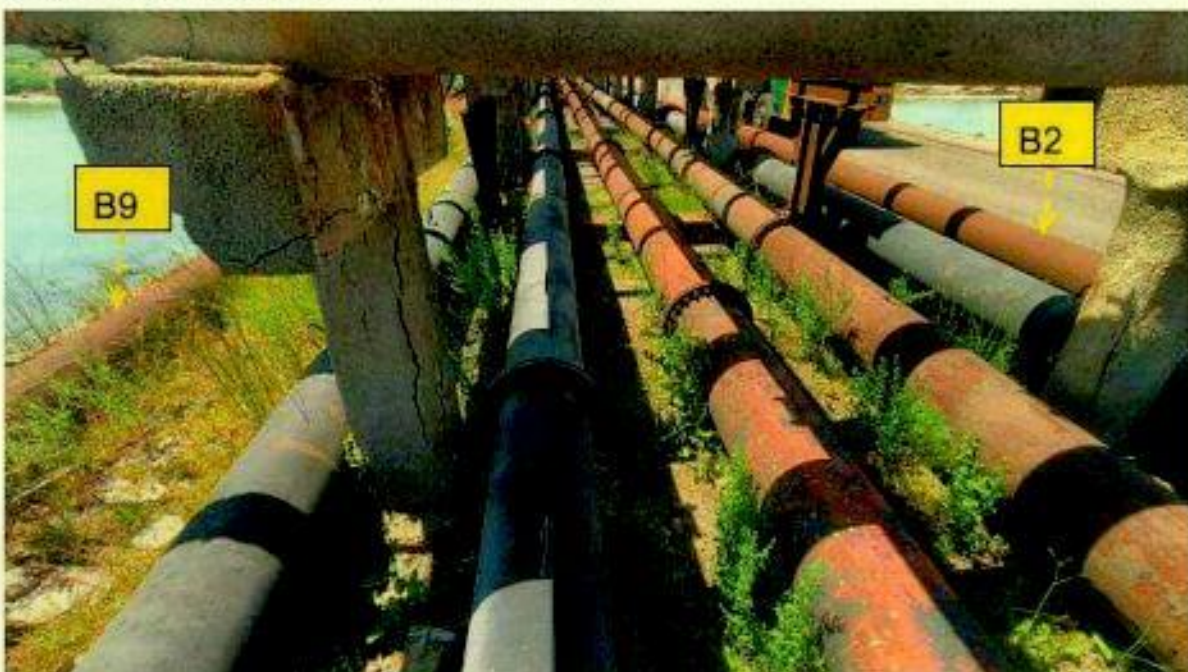
(38) Annexure A7, Page No.69 (Picture No.1)

The **B2 line is also recovery water line (R3)** and the tender for the partial replacement of the damaged lines (**816 M**) is in progress and the work will be completed on or **before July 2026**.

The **B9 line is also recovery water line (R2)** and the administrative approval from the Board Level Tender Committee is awaited and after obtaining the Administrative approval is obtained tendering process will be initiated for the replacement of the entire length of **2,910 M** progress and the work is expected to complete on or **before November 2026**.

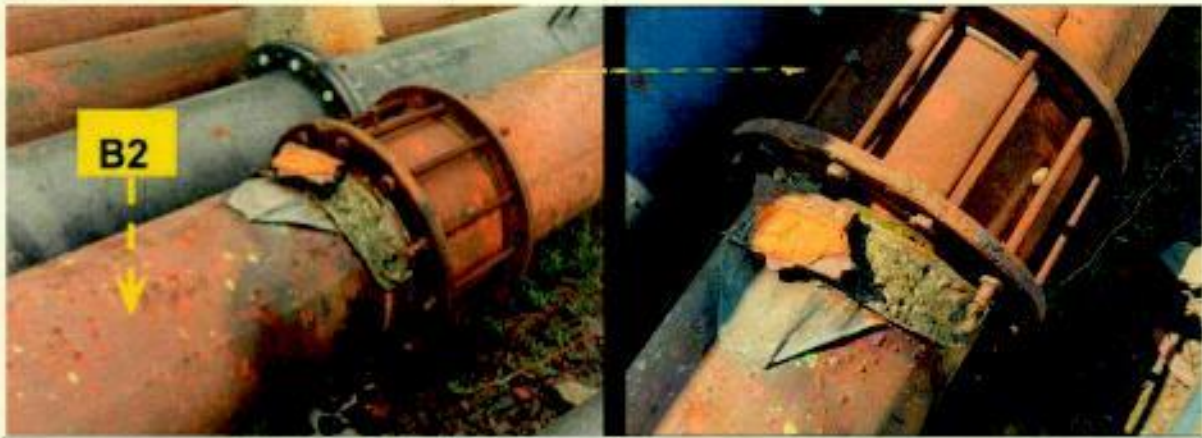
(39) Annexure A7, Page No.69 (Picture No.2)

It is submitted that the line referred to as "B2" by the petitioner **is not an ash slurry disposal line, but a recovery water line** that conveys clarified saline water from the Ash Dyke back to the Thermal Power Station for reuse in the ash handling process and other plant auxiliaries.

The location shown in the photograph depicts a sleeve coupling joint used for joining two pipeline sections. The observed feature is not a broken pipe, but a standard mechanical joint assembly consisting of a sleeve, flanges, and an internal rubber O-ring to provide a watertight seal.

During a routine inspection, a minor leak was detected at this joint due to O-ring deterioration within the sleeve coupling. The pump was stopped immediately and till draining of pipe to attend the leak by replacement of O-ring. The waste cloth was used to identify the coupling in the particular area since the line stretches to about 5.5 km.

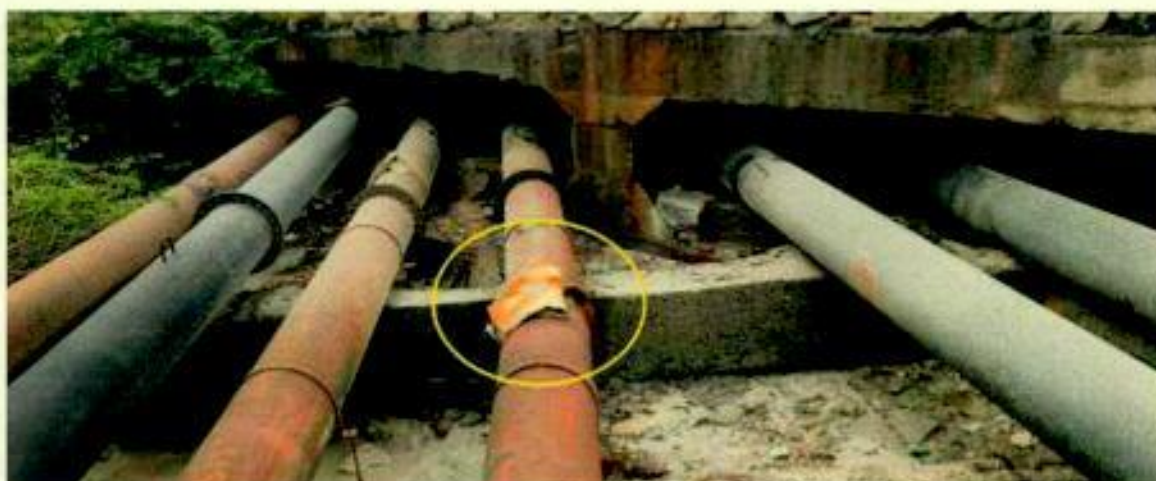
(42) Annexure A7, Page No.71,(Picture No.2), GPS: 13°15'39.6"N, 80°18'50.1"E

The cement sack seen in the photograph over the slurry line is not an intentional attempt to conceal a leak. The Ash Slurry Disposal System of NCTPS-I conveys ash slurry at a **minimum pressure of 5 kg/cm² (ksc). Under such pressure conditions, a piece of cement sack cannot physically arrest or hide a leak.** Any leakage under these conditions would be forceful and immediately visible. It might be leftover by the maintenance personnel or an act of outsiders since the pipe lies along the open corridor. It is submitted that, now the cement sack and the deposited ash have been removed.

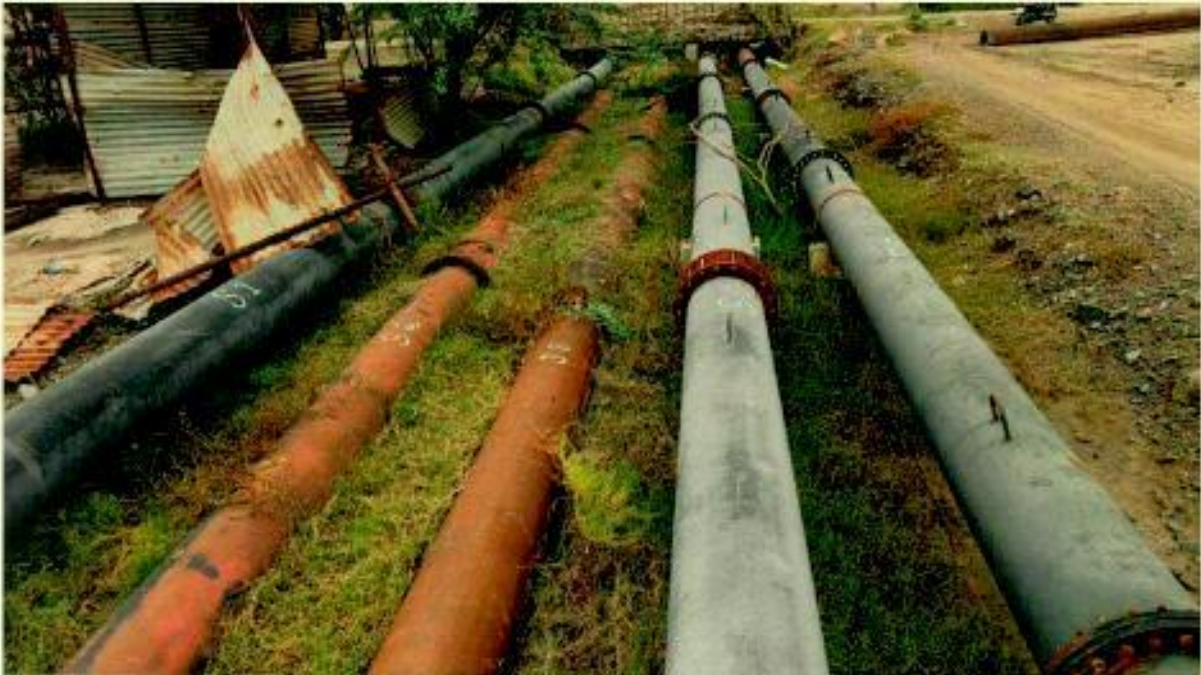
(48) Annexure A7, Page No.76 (Picture No.1)

Clamps are provided below the pipelines which are made up of Mild steel coated with red oxide. Since these clamps are exposed to humid coastal atmosphere, it is subjected to rusting and corrosion due to saline breeze. There is no physical damage noticed in the clamps. In case of occurrence of damage it will be replaced immediately. **However during the course of painting of pipes the same clamps also will be painted.**

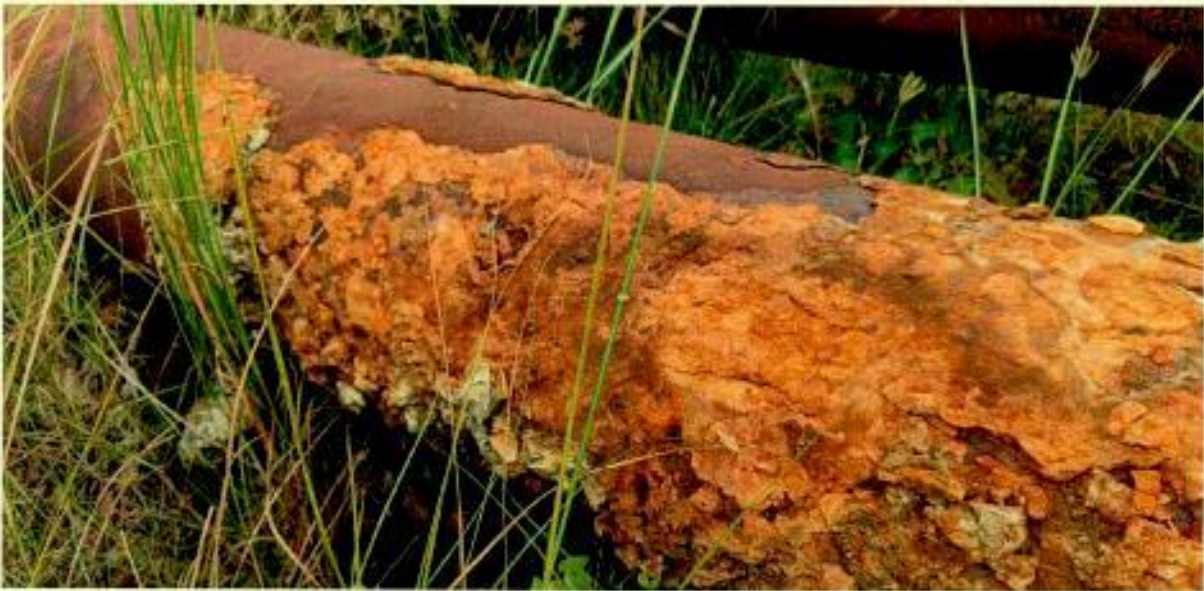
(50) Annexure A7, Page No.77 (Picture No.2)

B7 is the new line ASD line 5 which was replaced during the year 2024 and due to the red soil deposit over the lines it seems to be rusted but there is no structural damage to the pipe line since the pipe line is made up of cast basalt liner of 20 mm thick and there is no potential risk to the pipes.

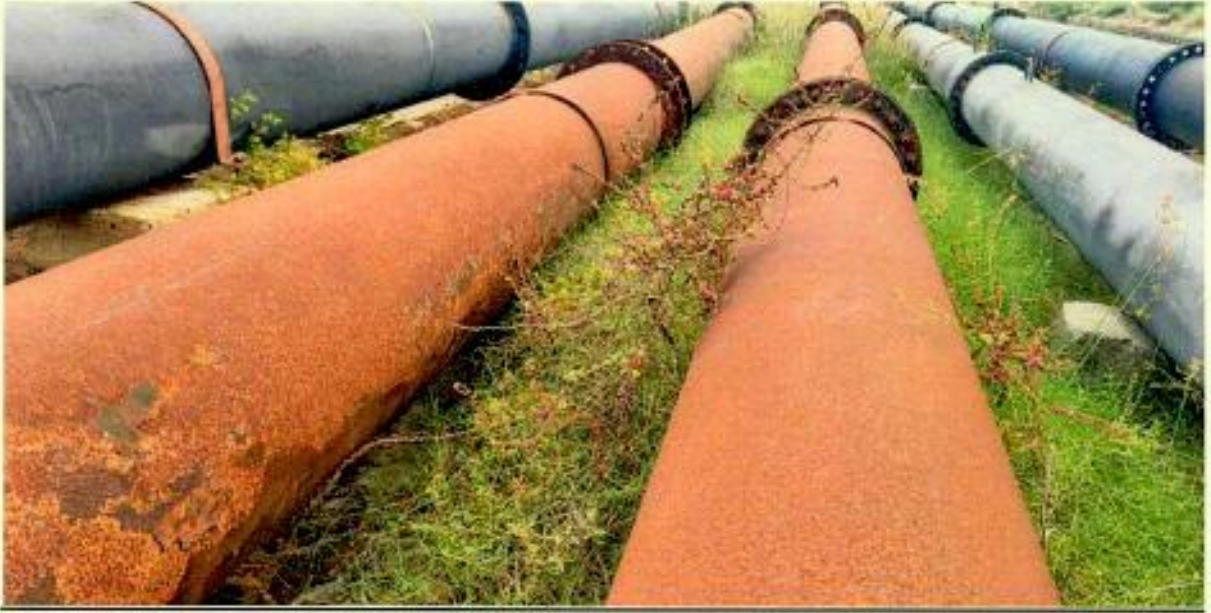
(52) Annexure A7, Page No. 79 (Picture No.1)

These lines S2 (B4) and S3 (B5) were erected during the year 2021 to 2022 and laid along the coastal area there. Since the inner layer is coated with Cast basalt liners there is no potential risk of leakage of Wet Ash, however proposal for Painting of the the Pipe lines is proposed **and will be painted on or before May'2026.**

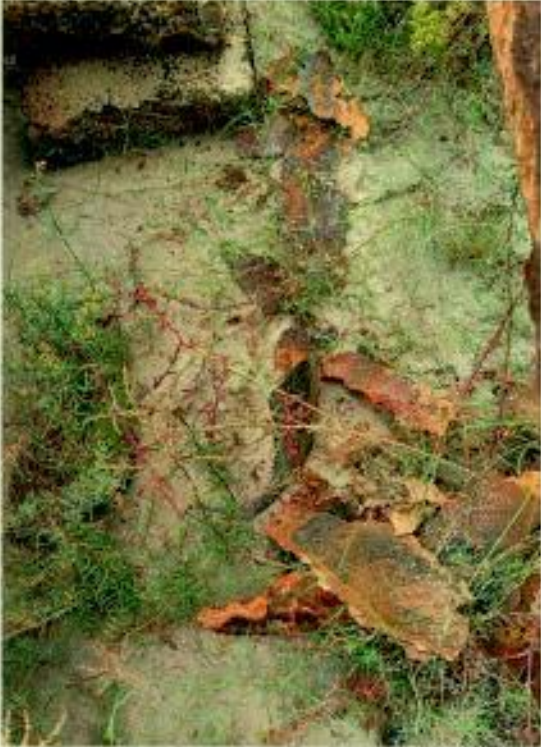
(54) Annexure A7, Page No.80 (Picture No.1)

These are the picture of the scale formation of the outer layer of the Ash Slurry Disposal Line S3. However there is no physical damage to the pipe line and the pipes will be painted on or before May'2026.

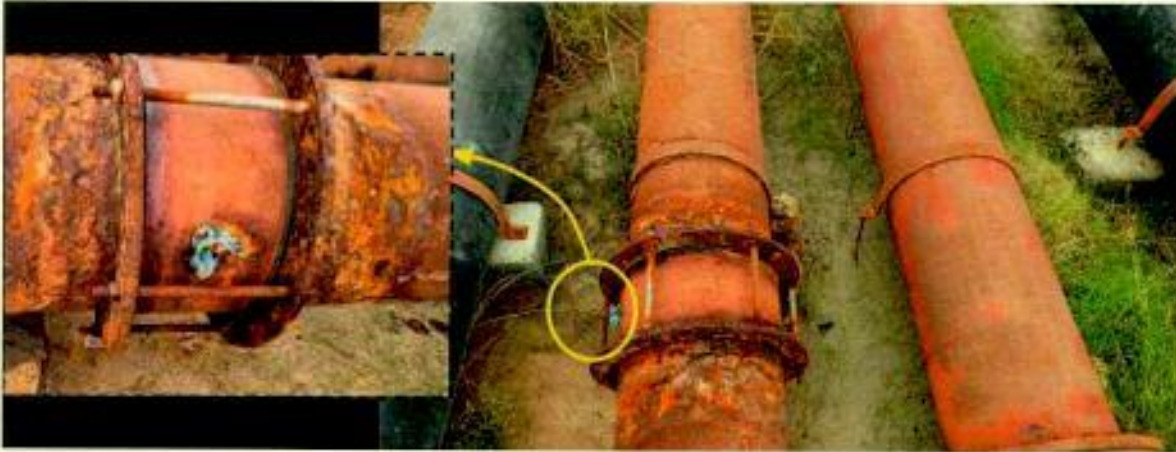
(55) AnnexureA7, Page No.80(Picture No.2)

The Sleeve coupling is provided with air release screw. Due to pressure variation and mechanical vibration the Bolt got sheared leading to leak in the pipe line. During replacement of the coupling to avoid the water passing through the bolt which hindered the replacement it was temporarily arrested by wooden plug.

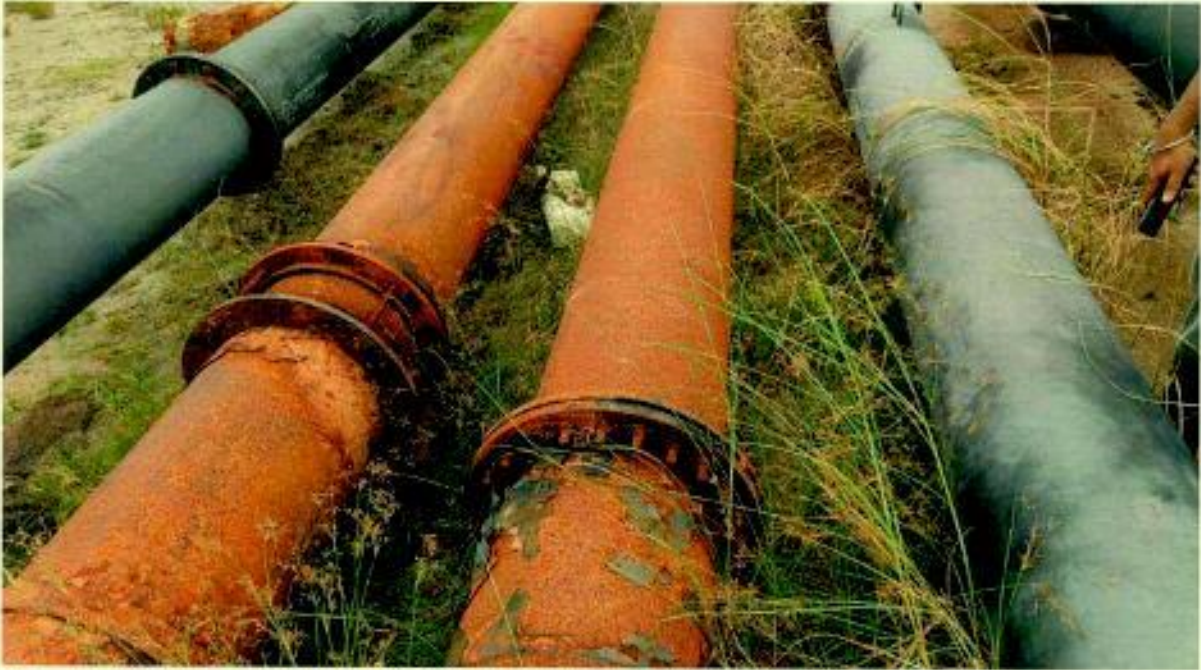
(56) Annexure A7, Page No. 81(Picture No.1)

The clamps are generally made of Mild steel and due to continuous exposure to saline atmosphere and humid coastal atmosphere the surface protection of the clamps and pipes gets easily deteriorated. During painting of the pipe lines the clamps also will be painted and **the work will be completed on or before May'2026.**

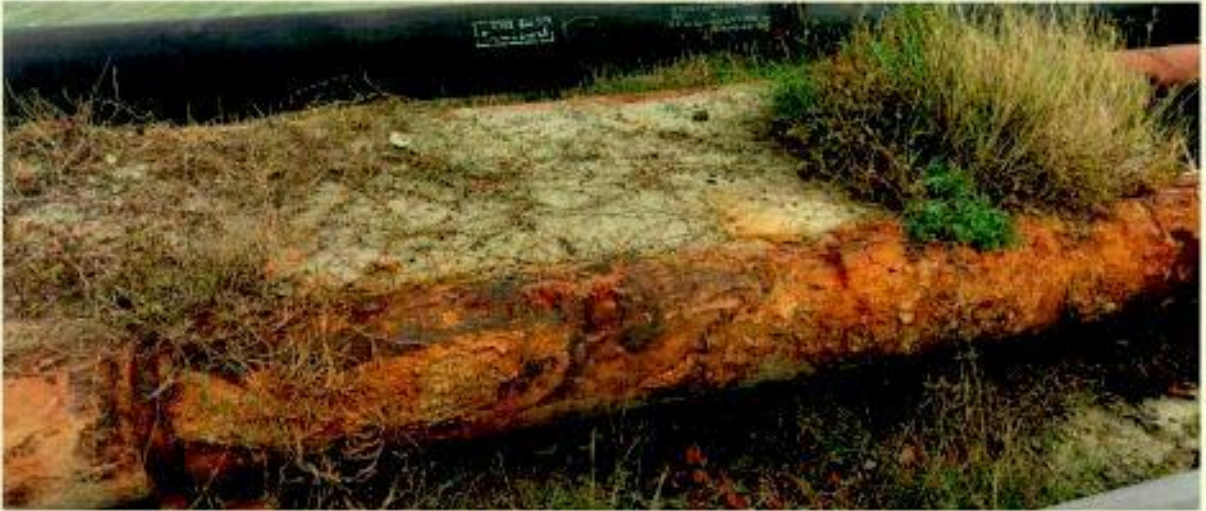
(58) Annexure A7, Page No.82 (Picture No.2)

These lines S2 (B4) and S3 (B5) were erected during the year 2021 to 2022 and laid along the coastal area. During the recent rain the pipes got submerged and during draining the mud and debris got settled in between the pipes and now it has been cleared. Since the inner layer is coated with Cast basalt liners there is no potential risk of leakage of Wet ash Slurry. However the proposal for painting these Pipes are in progress and will be painted on or before May'2026.
