BEFORE THE NATIONAL GREEN TRIBUNAL SOUTHERN ZONE,
CHENNAI

O.A. No. 230 of 2025

REPLY FOR THE CORRESPONDING PHOTOS FILED IN ANNEXURES TO THE APPLICATION

The present status of the pipe lines photographed by the petitioner is as detailed below:

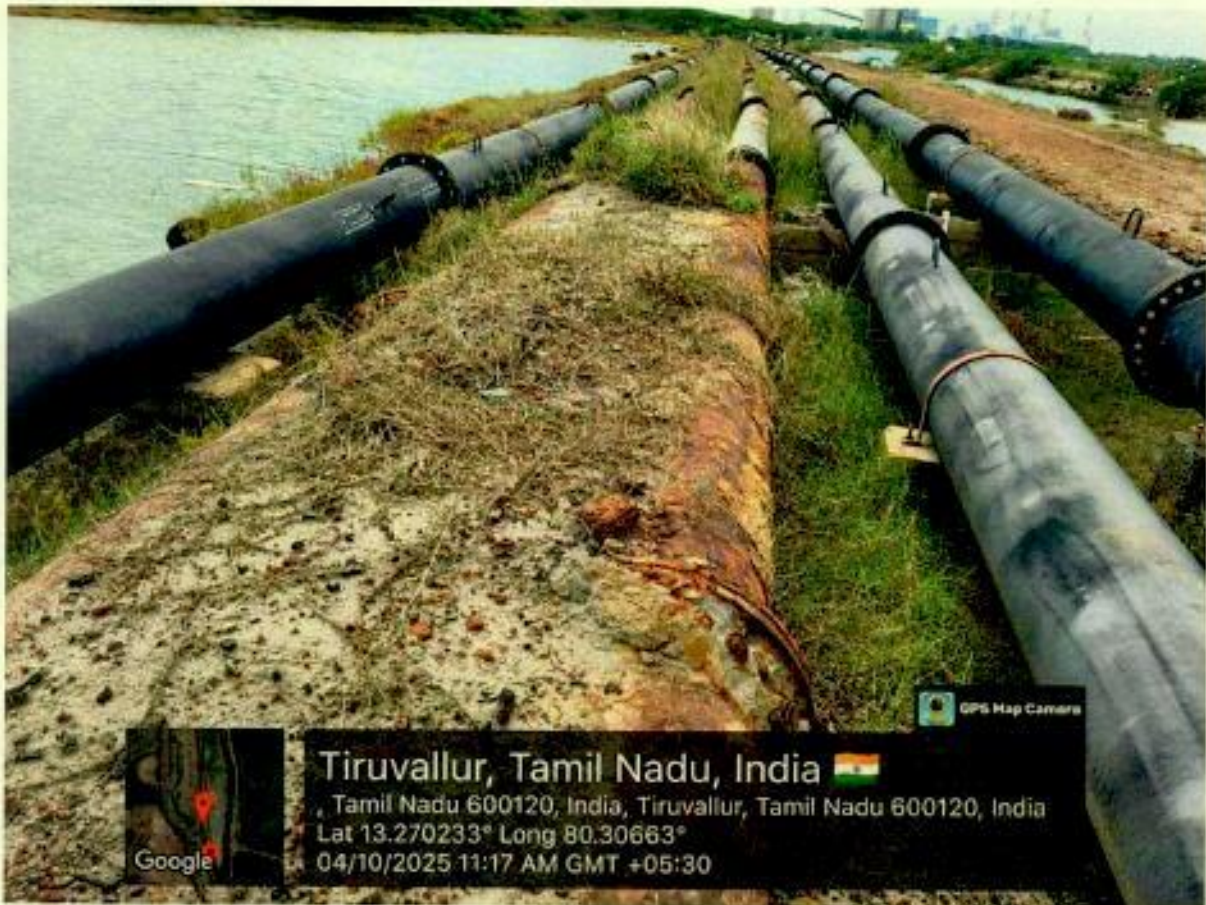
(59) Annexure A7, Page no.83 (Picture No.2)

Same image as above.

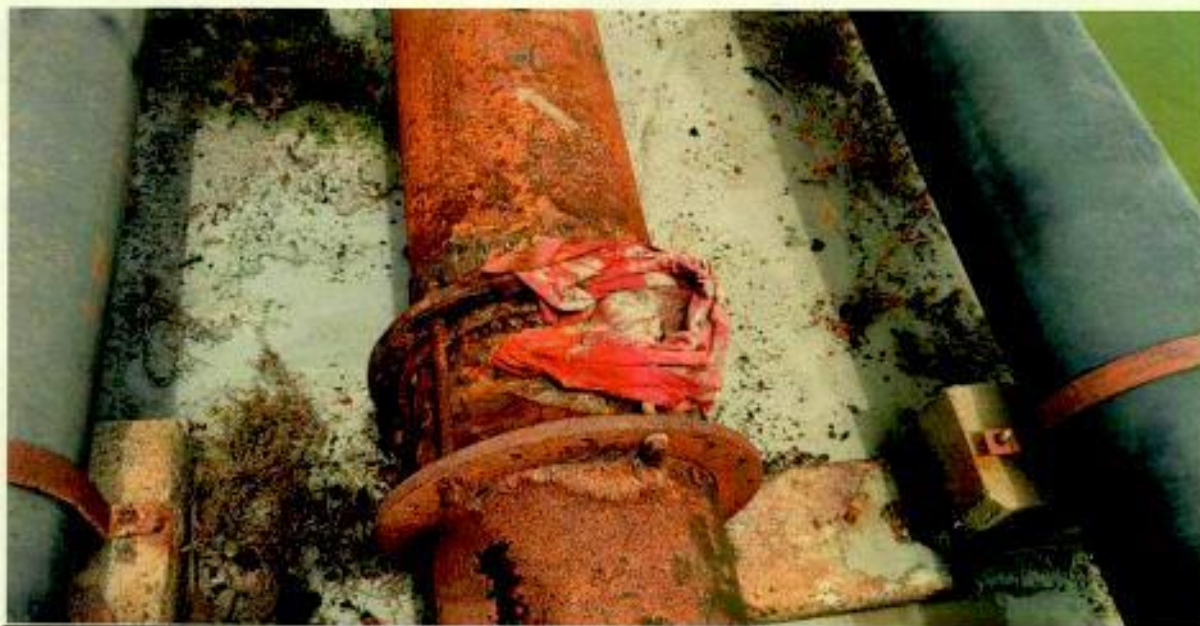
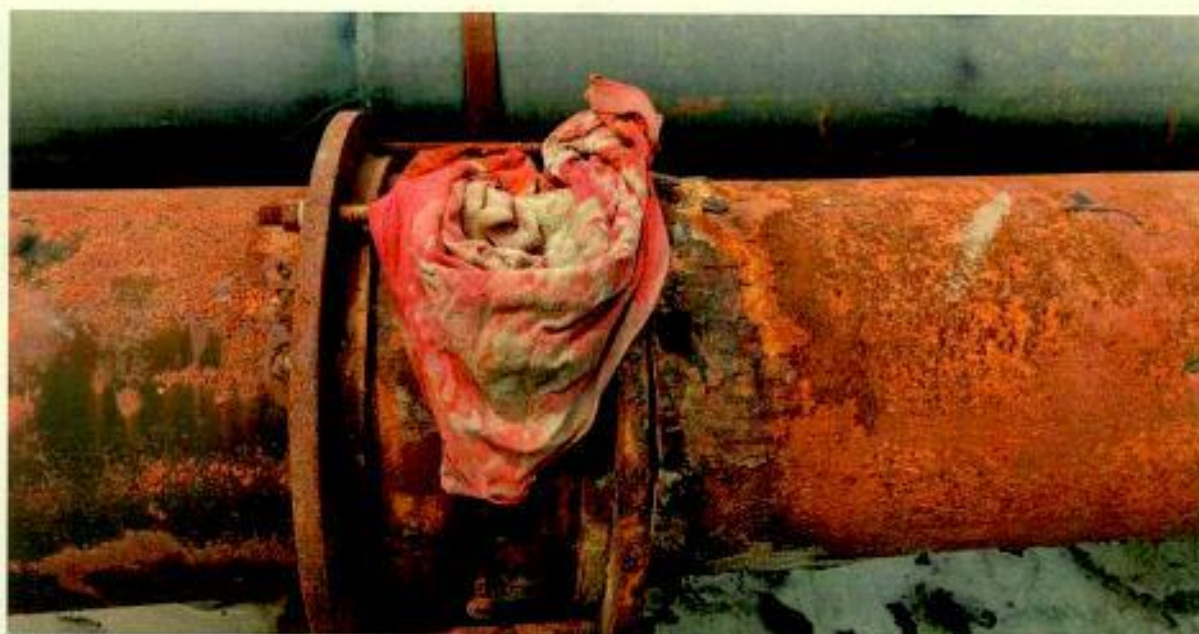
(60) Annexure A7, Page No.84 (Picture No. 2 and 3) GPS : 13°16'18.2"N 80°18'23.5"E

Same image as in Annexure 1, page No.23.

The Ash Slurry Disposal System of NCTPS-I conveys ash slurry at a **minimum pressure of 5 kg/cm² (ksc)**. Under such pressure conditions, a piece of cloth or any fabric material cannot physically arrest or hide a leak. Any leakage under these conditions would be forceful and immediately visible. It might be leftover by the maintenance personnel or an act of outsiders since the pipe lies along the open corridor. **The O-ring of the ASDL No.2 coupling has been replaced as weeping noticed.**

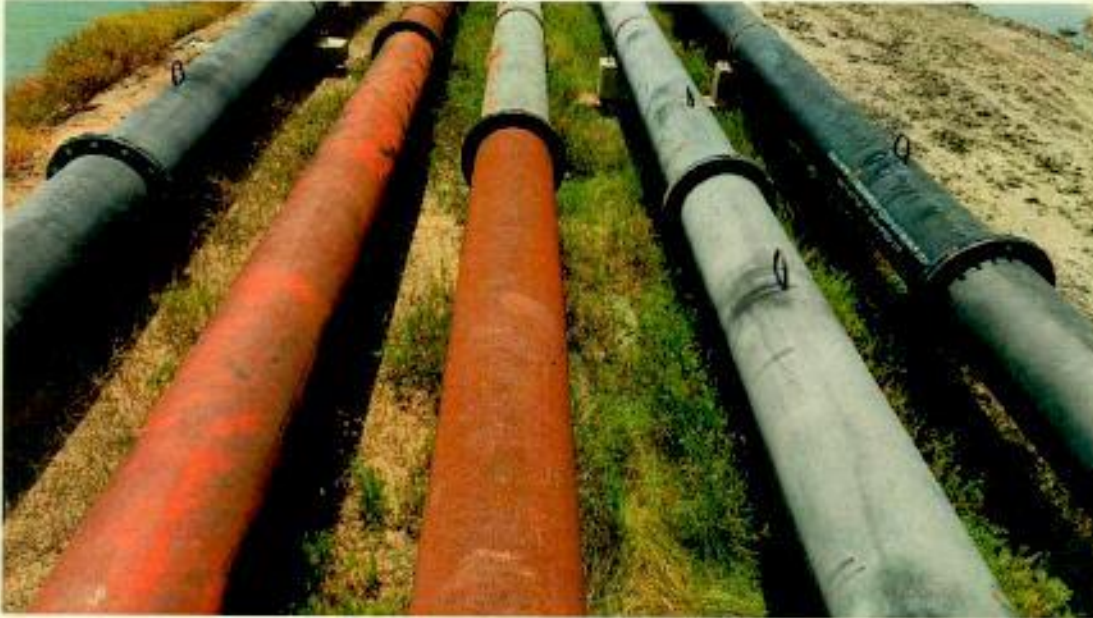
(63) Annexure A7, Page No.86 (Picture No.2)
GPS: 13°16'28.8"N 80°18'22.7"E

These lines S2 (B4) and S3 (B5) were erected during the year 2021 to 2022 and laid along the coastal area. During the recent rain the pipes got submerged and during draining the mud and debris got settled in between the pipes and now it has been cleared. Since the inner layer is coated with Cast basalt liners there is no potential risk of leakage of Wet ash Slurry. **However the proposal for painting these Pipes are in progress and will be painted on or before May'2026.**

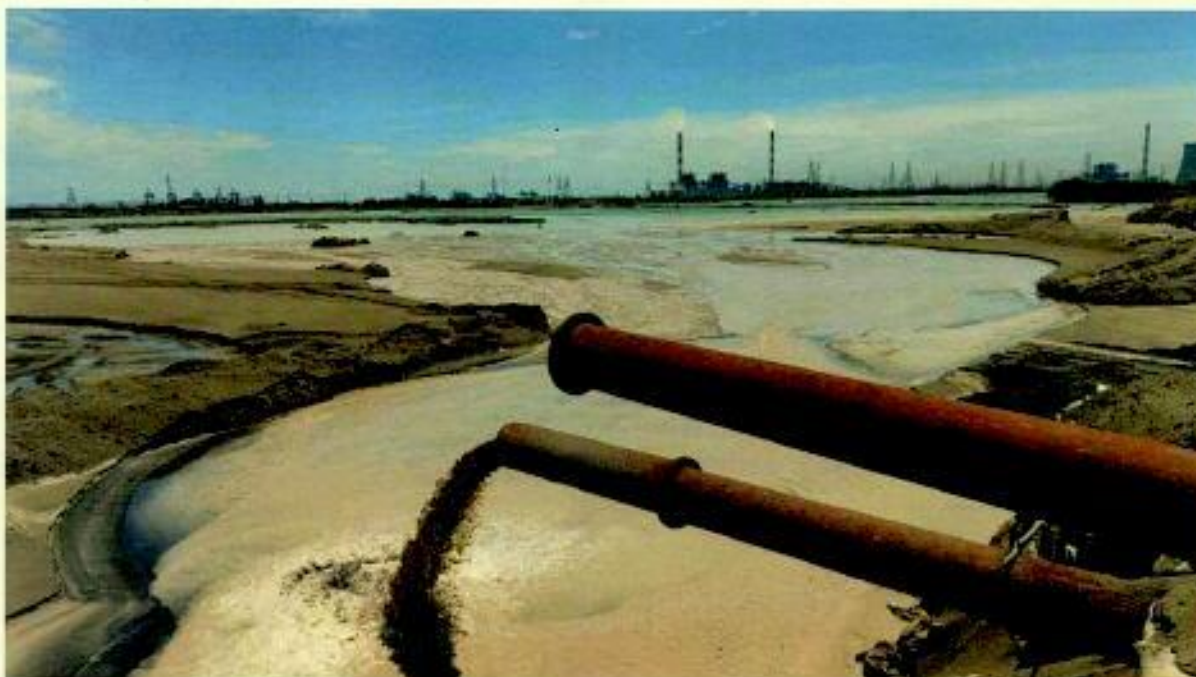
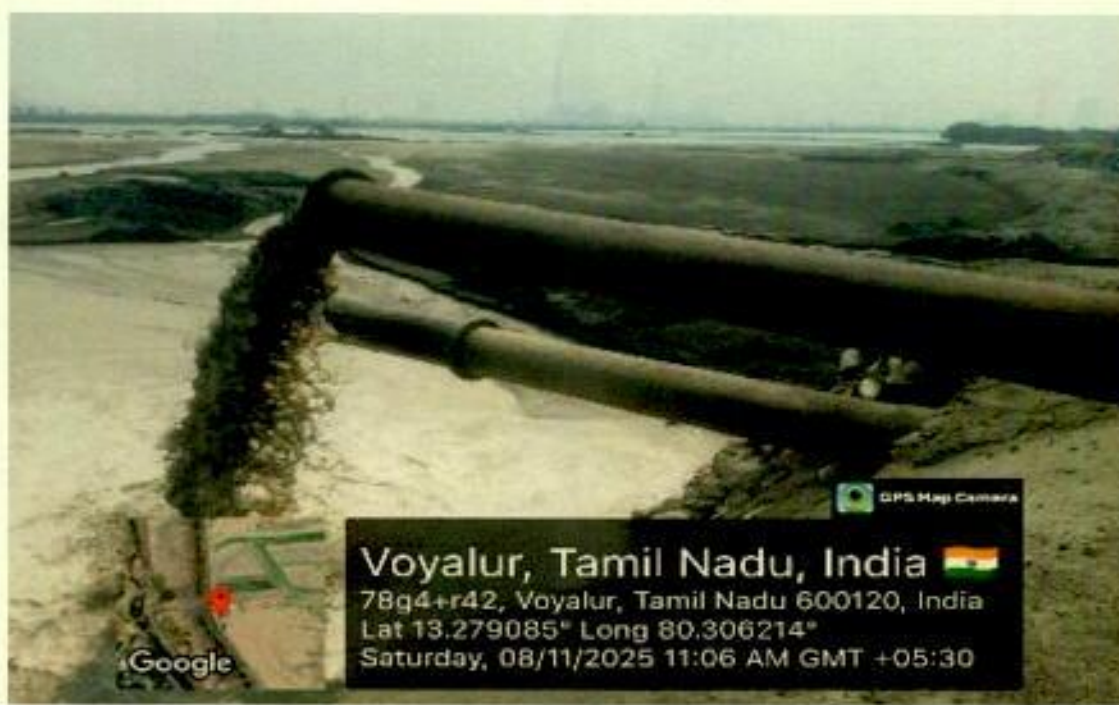
(69) Annexure A7, Page No. 91

These are the end of the B5 and B6 discharging the Wet Ash Slurry to the ash pond.
