**BEFORE THE HON'BLE NATIONAL GREEN TRIBUNAL,  
SOUTHERN ZONE, CHENNAI**

**ORIGINAL APPLICATION NO. 261 OF 2024  
(EARLIER ORIGINAL APPLICATION NO. 1055/2024- PB)**

Tribunal on its own motion Suo Moto based on News Item titled "Unscientific work by NHAI led to Shirur landslide Geological Survey of India report" appearing in the Indian Express dated 02.08.2024

National Highways Authority of India & Ors.

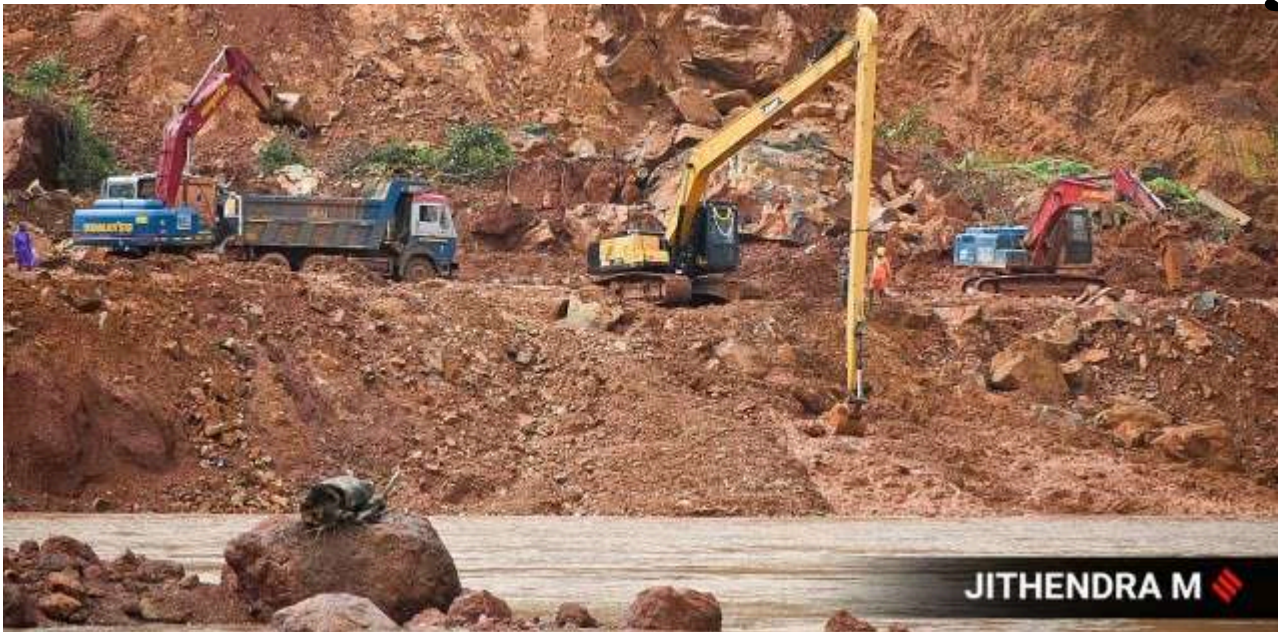
The landslide site on NH-66 in Ankola. (Express photos by Jithendra M)

A preliminary report by a technical team looking into the causes of the July 16 landslide in coastal Karnataka's Uttara Kannada district has listed "unscientific" construction of National Highway (NH) 66 by the National Highway Authority of India (NHAI), combined with heavy rainfall in a short span of time, among factors responsible for the disaster.

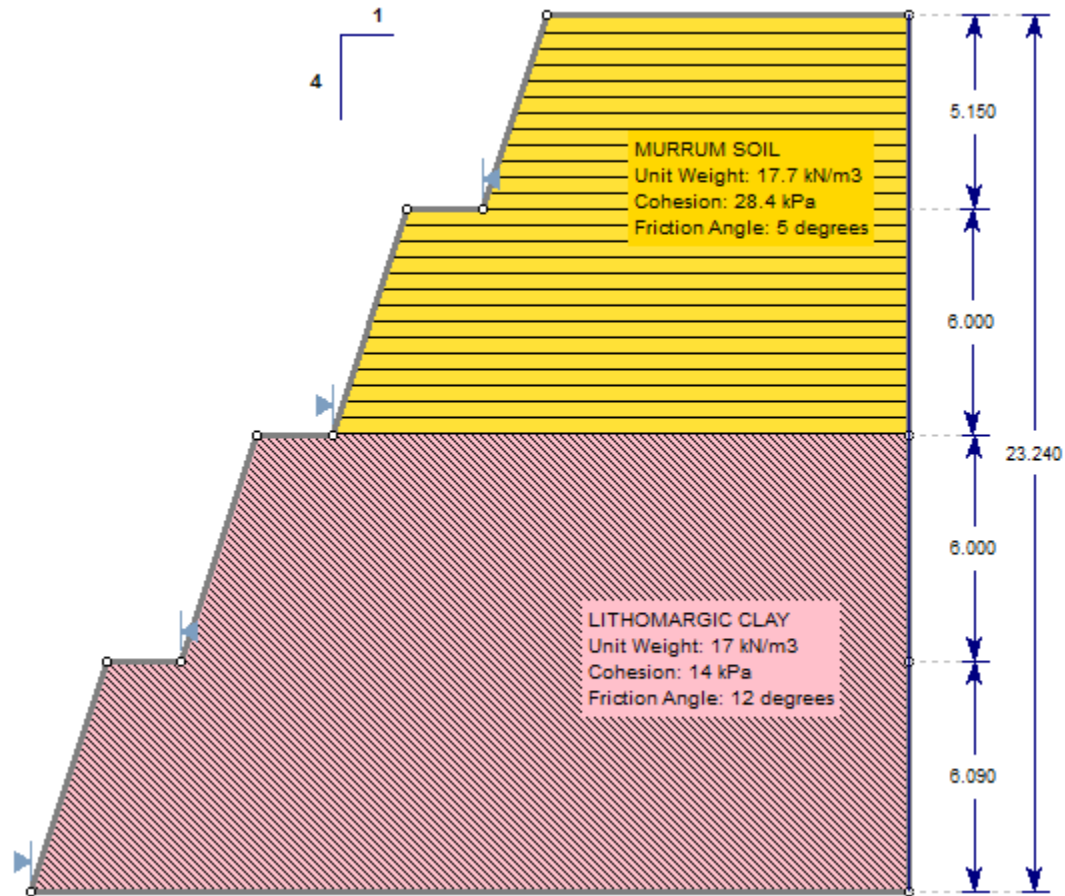
a. Critical section selected at 160.020 chainage

**Cross section analyzed:** Chainage 160 – critical section at chainage at 160.020 - 23.240 m height of slope as shown in Fig.1 is selected. All existing slopes are unstable. After remedial measures (with Soil nails –6m length and 32 mm diameter at spacing of 0.9

Fig. 1 Critical Section selected at chainage 160.020 km

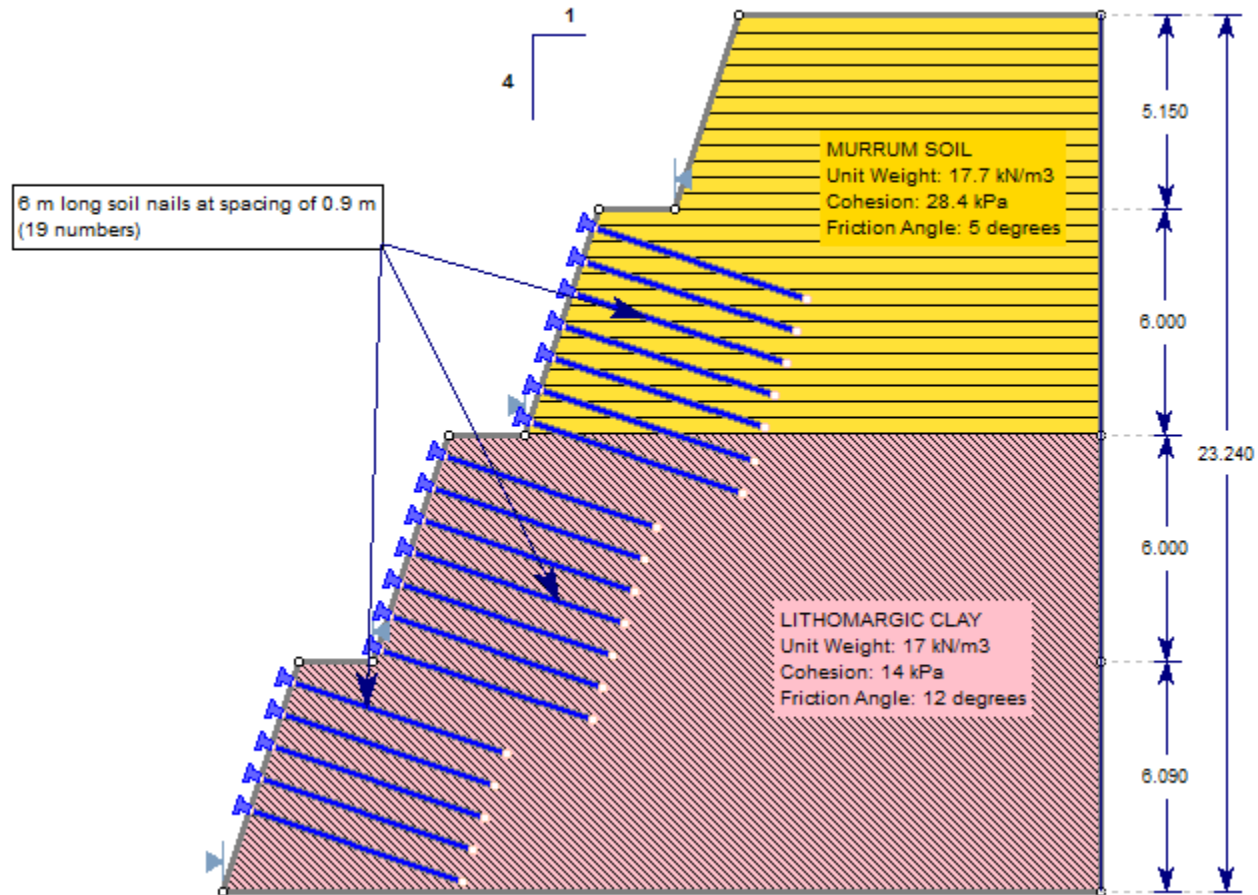
c. Proposed remedial measures at 160.020 chainage

Fig.3 Cross-section of slope at 160.020 with remedial measure, providing 19 numbers of soil nails of 6 m length at spacing of 0.9m

*Adopted* : 32 mm diameter soil nail , length = 6 m, spacing =0.9 m

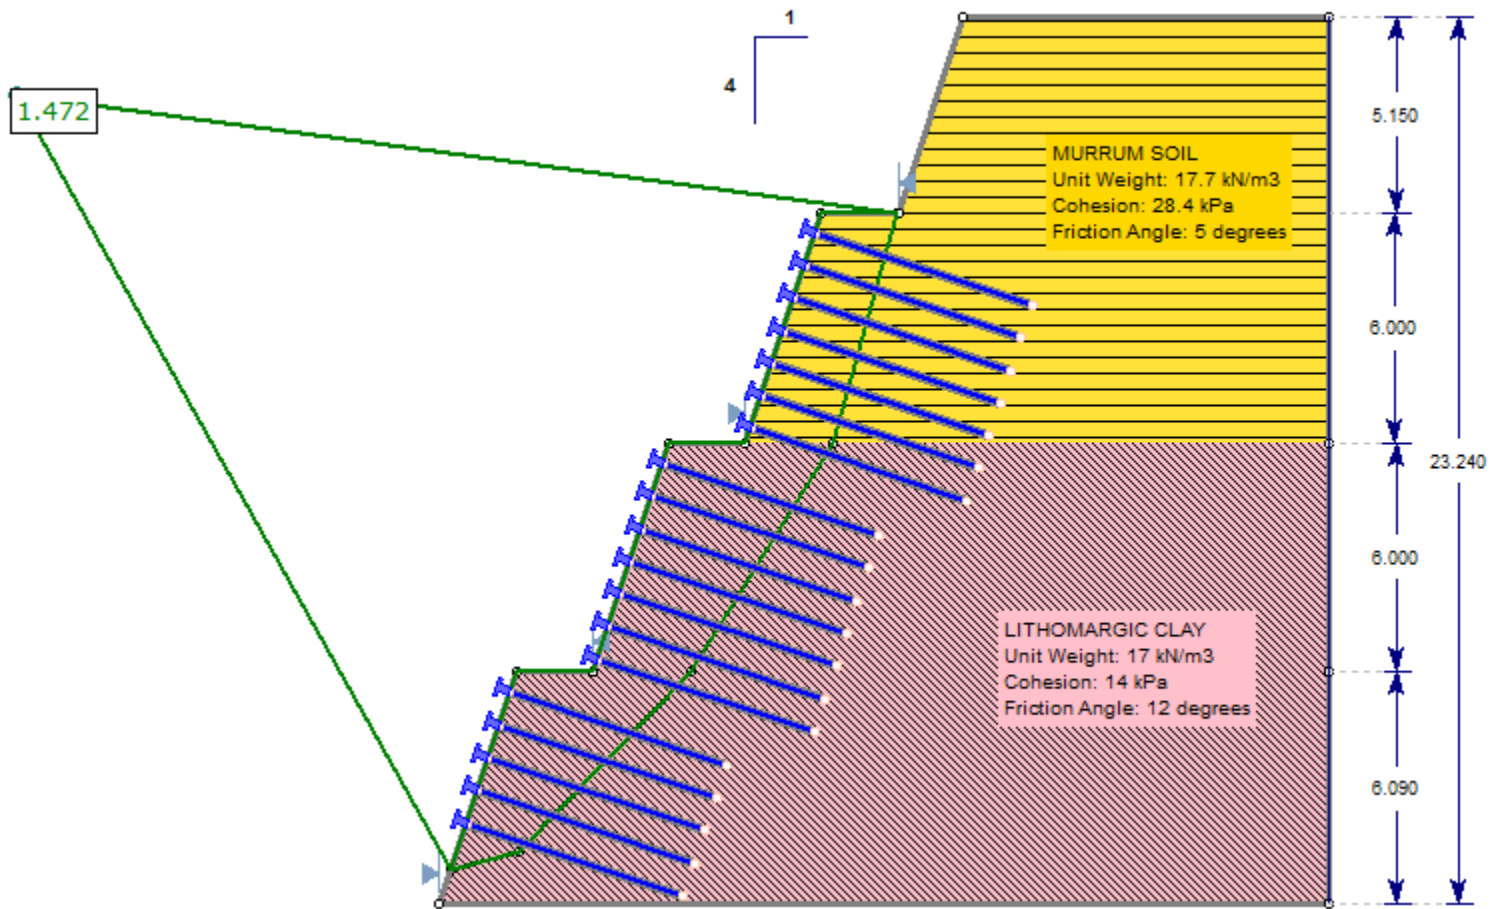
| S.No | Chainage | Condition | Factor of safety | Remark |
|---|---|--|---|---|
| 2 | 160.020 km | Slope with Soil nail as Remedial measure | 1.472 (Fig 4) | <b>Safe</b> |

Fig.4 Stability analysis of slope at 160.020 km chainage ,providing 19 numbers of soil nails of 6 m length at spacing of 0.9m (FS= 1.472, SAFE)

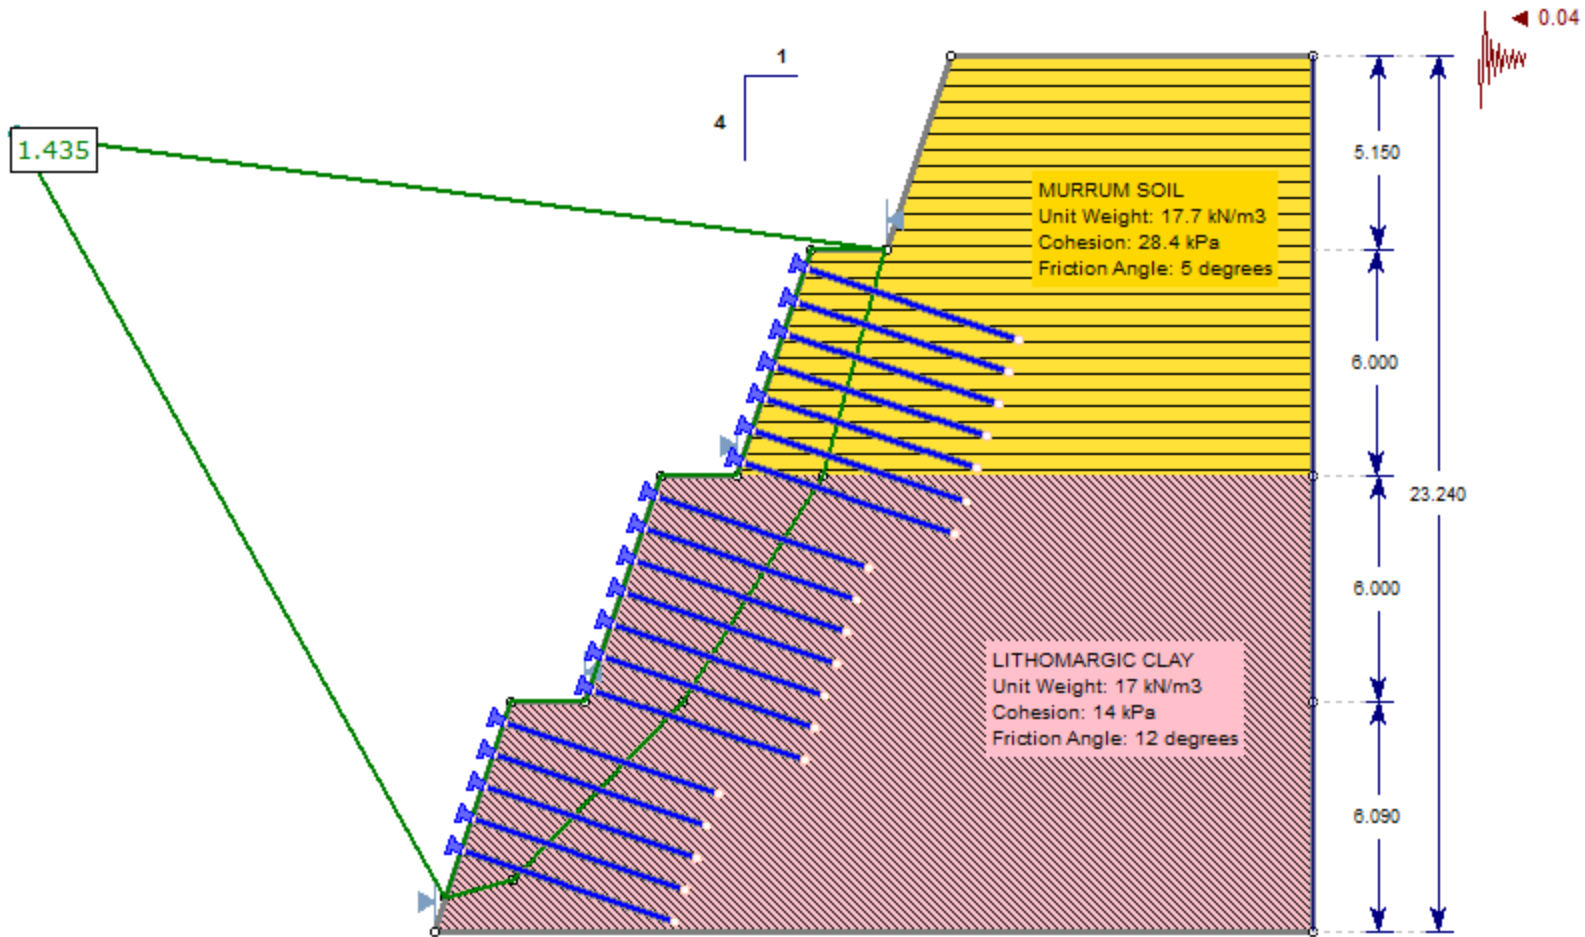
| S.No | Chainage | Condition | Factor of safety | Remark |
|---|---|--|---|---|
| 3 | 160.020 km | Slope with Soil nail as Remedial measure with seismic coefficient 0.04 | 1.435 (Fig 5) | |

Fig.5 Stability analysis of slope at 160.020 km chainage ,providing 19 numbers of soil nails of 6 m length at spacing of 0.9m seismic coefficient 0.04 (FS= 1.435, SAFE)

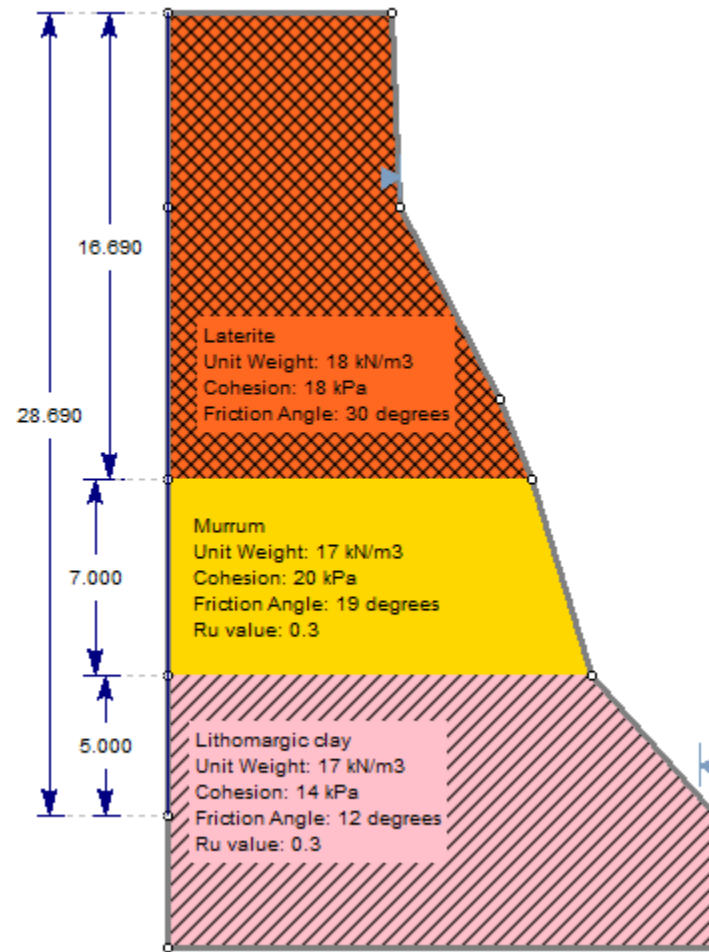
e. Critical section selected at 190.640 chainage

Fig.6 Critical Section selected at chainage 190.640 km

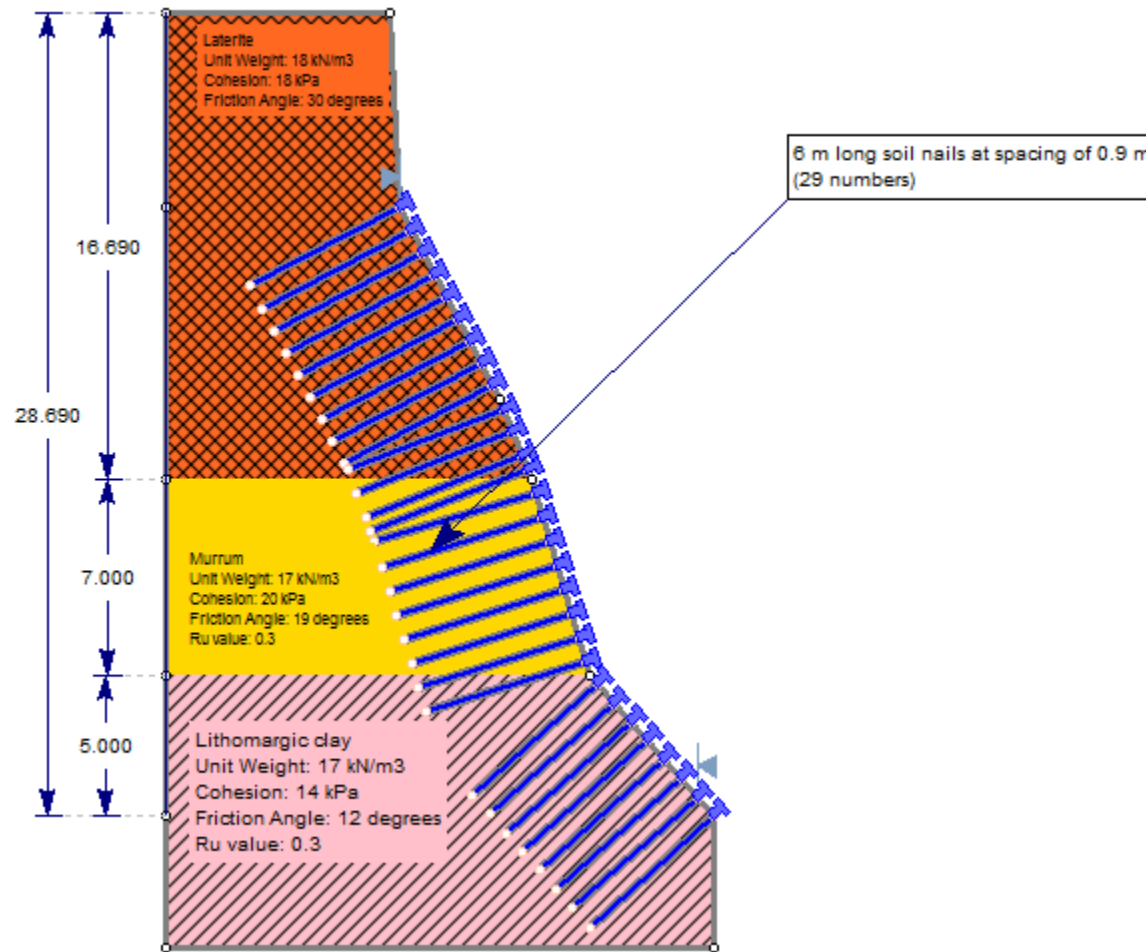
g. Proposed remedial measures at 190.640 chainage

**Fig.8** Cross-section of slope at 190.640 with remedial measure, providing 29 numbers of soil nails of 6 m length at spacing of 0.9m

**Adopted** : 32 mm diameter soil nail , length = 6 m , spacing =0.9 m , 29 numbers

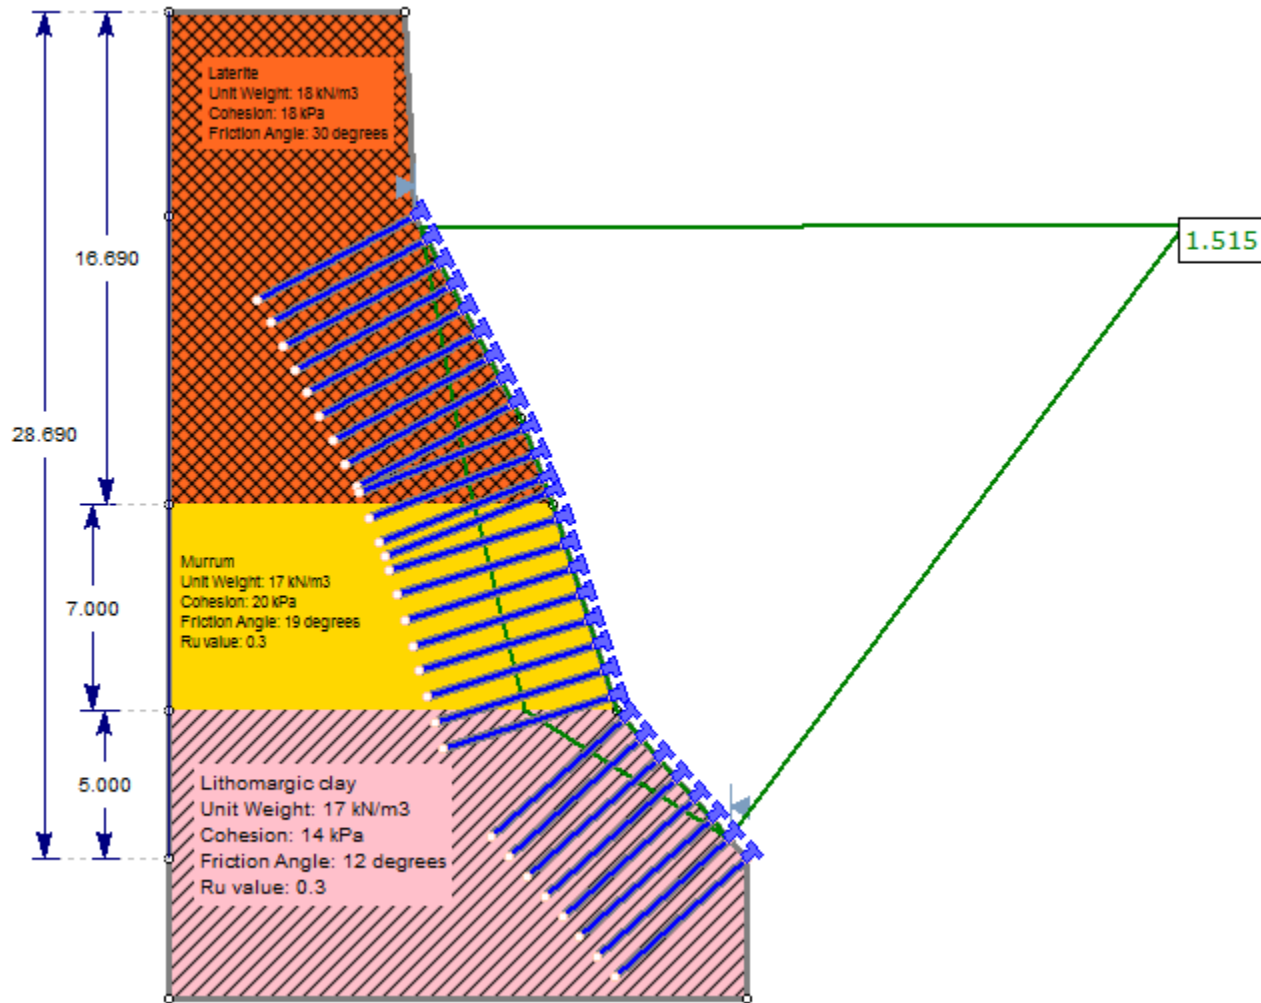
Fig.9 Stability analysis of slope at 190.640 km chainage ,providing 29 numbers of soil nails of 6 m length at spacing of 0.9m  
**(FS= 1.515, SAFE)**

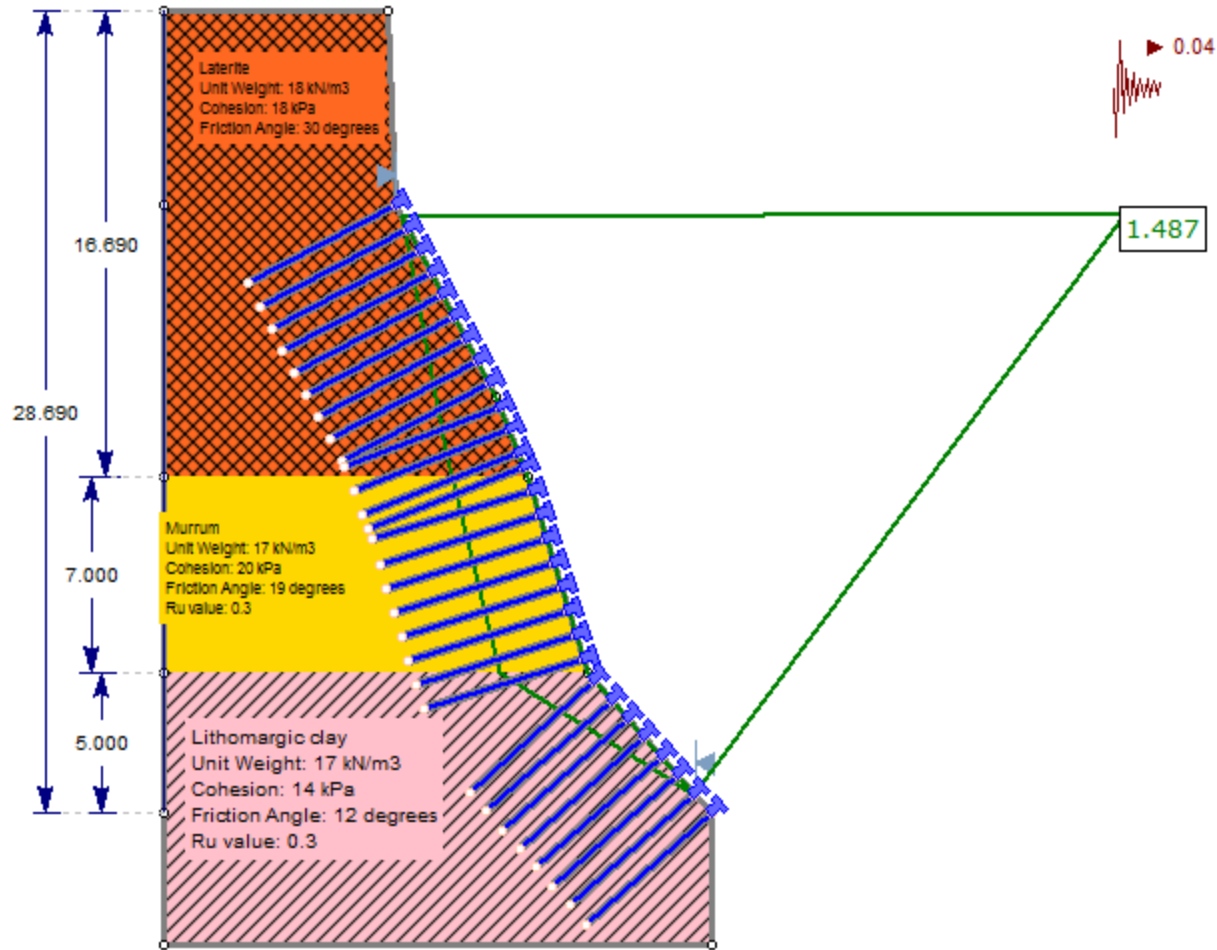
Fig.10 Stability analysis of slope at 190.640 km chainage ,providing 29 numbers of soil nails of 6 m length at spacing of 0.9m with seismic coefficient 0.04 (FS= 1.487, SAFE)

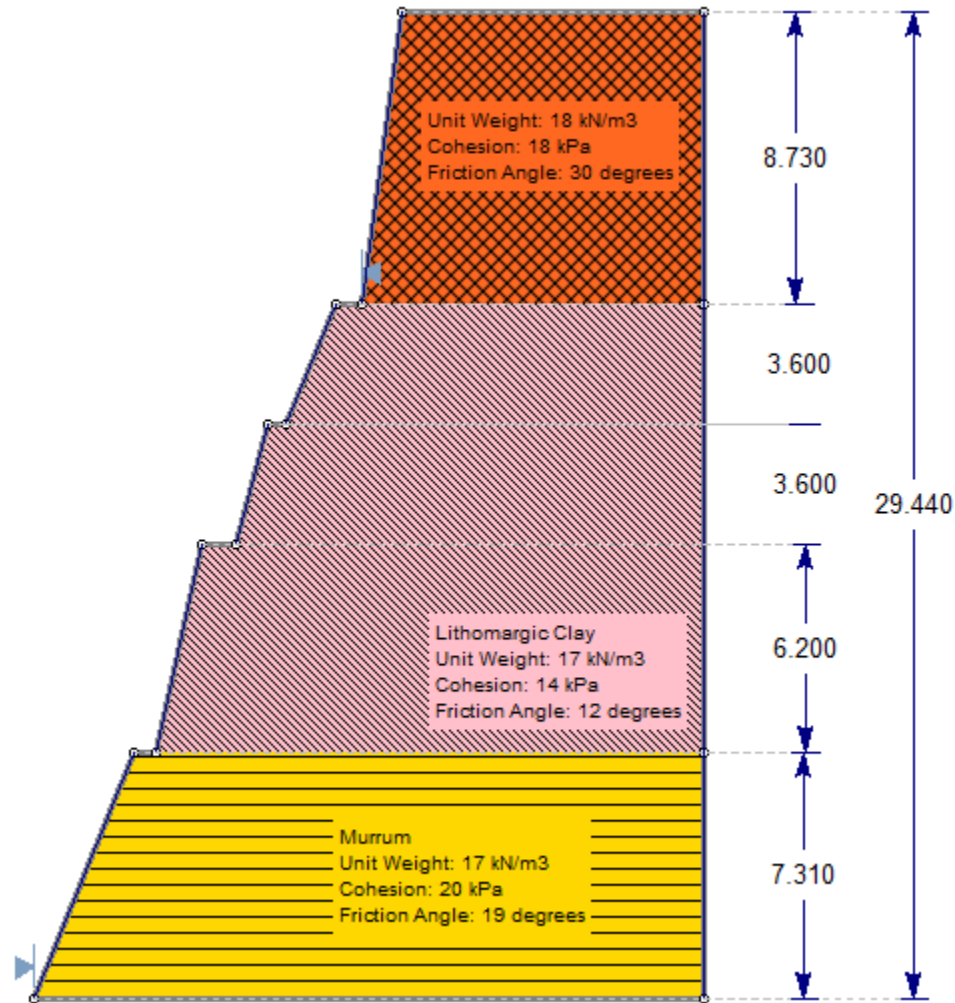
i. Critical section selected at 246.900 chainage

**Cross section analyzed:** Chainage 246 – critical section at chainage 246.900-29.440 m height of slope as shown in Fig.11) is selected. All existing slopes are unstable. After remedial measures (with Soil nails –6m length and 32 mm diameter at spacing of 0.9 m) the slopes are found to be safe. An assumption has been made regarding ground water considering Ru Coefficient. Analyses has been carried out considering Ru coefficient =0.3. Seismic coefficient of (horizontal acceleration coefficient =0.04 as per IS 1893:1984) 0.04 was selected for the Kundapura – Karwar area. Cross sections were provided by M/s Modern Road makers Pvt Ltd. Geotechnical report of each site was provided which was reviewed and site properties were selected after a review of geotechnical report and are presented in Table1. Suggested remedial measures are

Fig. 11 Critical Section selected at chainage 246.900 km

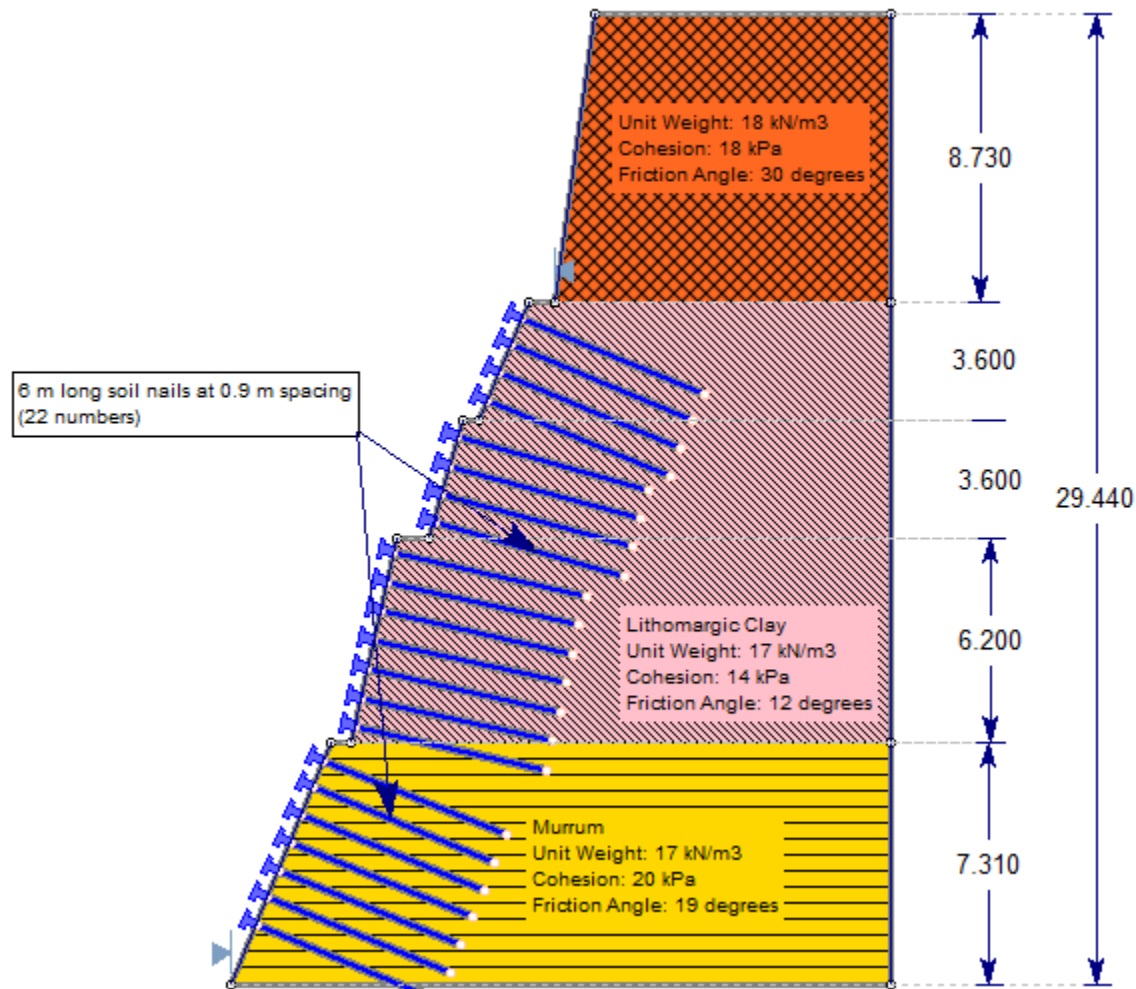
k. Proposed remedial measures at 246.900 chainage

Fig.13 Cross-section of slope at 246.900 with remedial measure, providing 22 numbers of soil nails of 6 m length at spacing of 0.9m

Adopted : 32 mm diameter soil nail , length = 6 m , spacing =0.9 m , 22 numbers

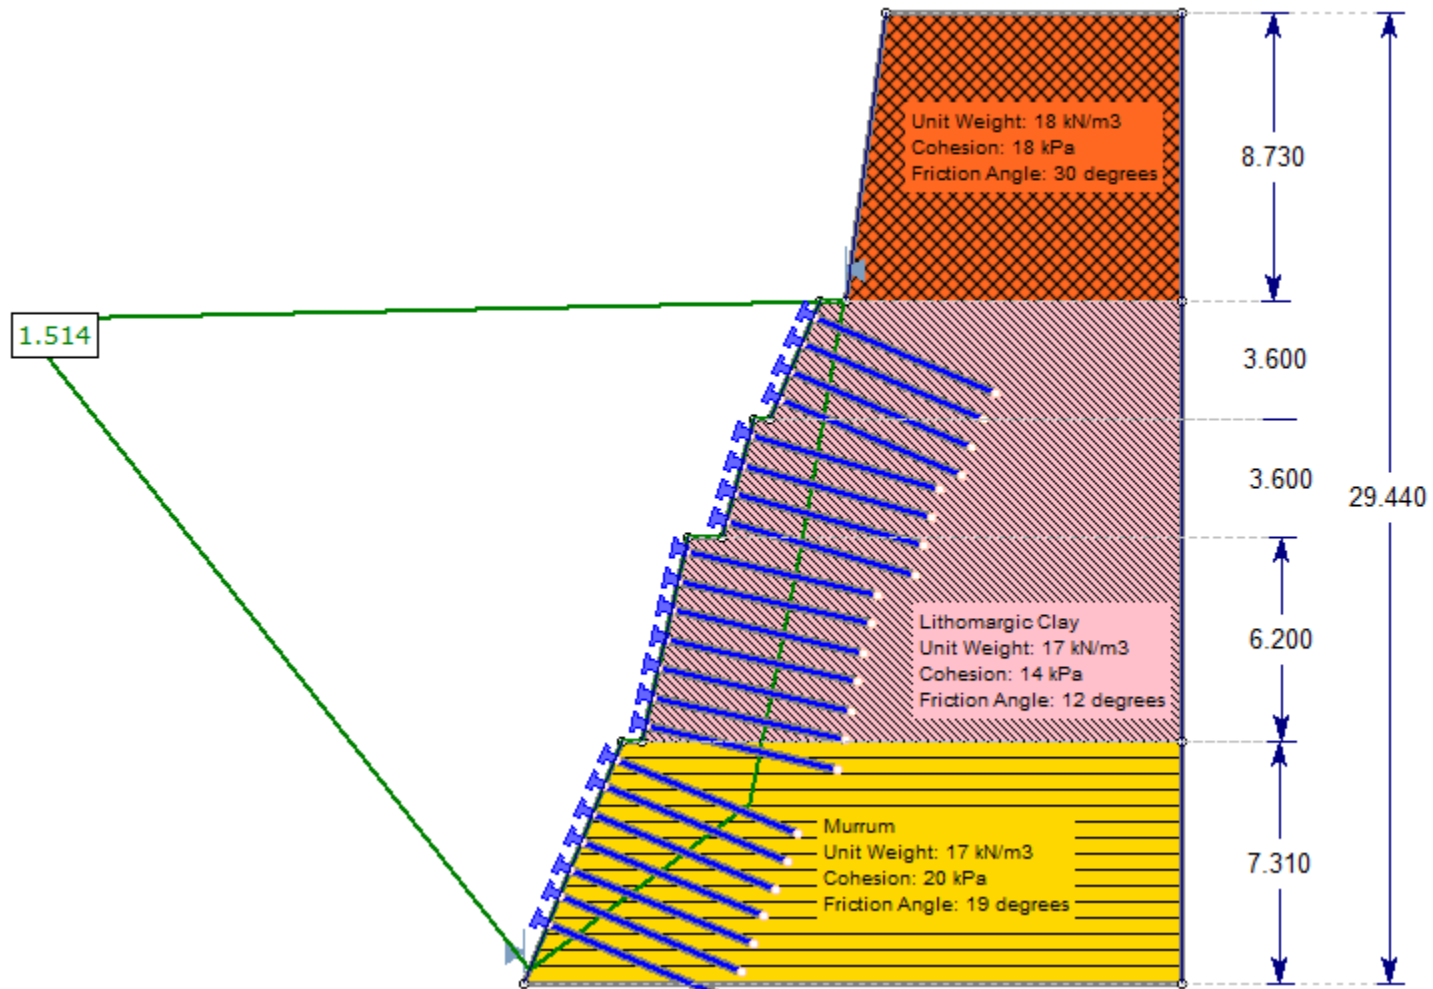
| S.No | Chainage | Condition | Factor of safety | Remark |
|---|---|--|---|---|
| 2 | 246.900 km | Slope with Soil nail as Remedial measure | 1.514 (Fig 9) | Safe |

| S.No | Chainage | Condition | Factor of safety | Remark |
|---|---|--|---|---|
| 2 | 246.900 km | Slope with Soil nail as Remedial measure | 1.514 (Fig 14) | <b>Safe</b> |

Fig.14 Stability analysis of slope at 246.900 km chainage ,providing 22 numbers of soil nails of 6 m length at spacing of 0.9m  
 (FS= 1.514, SAFE)

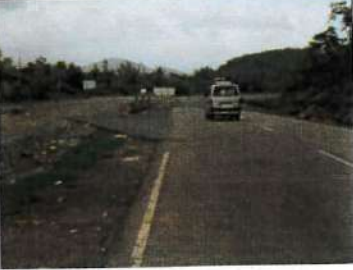
| Annexure-3: Detailed Work zone Safety Audit | | | | |
|---|---|---|--|--|
| 1 | 94+500 | | Deep cut is observed at RHS side near diversion. Vehicle entering into work zone | Provide barricading to keep away traffic from deep excavation. Close the work zone with barricade with retro reflective for night visibility |

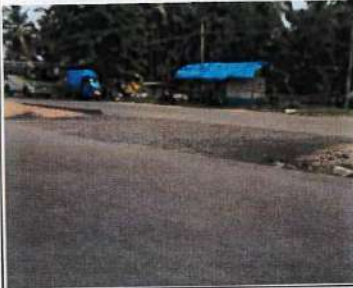
| Annexure-3: Detailed Work zone Safety Audit | | | | |
|---|---|---|--|--|
| 2 | 95+610 | | un authorized Median opening observed and minor road merging here | Immediate closure of median opening is required to control the access at minor road providing speed breaker. |

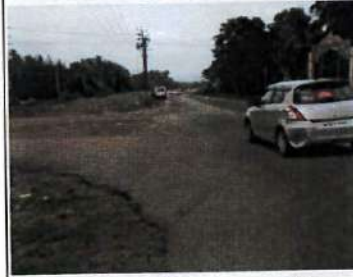
| Annexure-3: Detailed Work zone Safety Audit | | | | |
|---|---|---|--|--|
| 3 | 96+030 | | Median opening formed unauthorized T-junction | Immediate closure of median opening is required. |

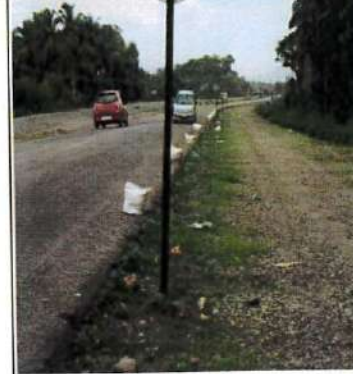
| Annexure-3: Detailed Work zone Safety Audit | | | | |
|---|---|---|--|--|
| 4 | 98+450 | | Wrong sign board placed "Diversion Ahead" at Diversion. A minor road is meeting just after diversion at LHS side. Minor Road traffic is entering in very high speed at MCW and situation becomes hazard due to diversion location. | Replace sign board indicating "Take Diversion"<br>Provide speed breaker on minor road, so vehicle enters in slow speed at MCW. |

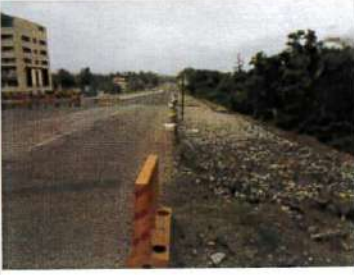
| Annexure-3: Detailed Work zone Safety Audit | | | | |
|---|---|---|---|---|
| 5 | 101+700 | | Other CW is not properly closed at diversion. It may hazards due to traffic is getting confuse just before diversion. | Other CW need to properly closed with adequate barricading and provide effective diversion sign board. |

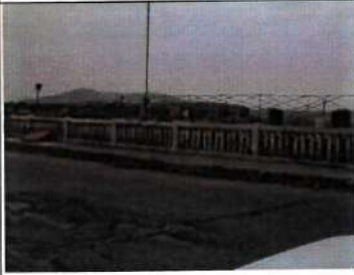
| Annexure-3: Detailed Work zone Safety Audit | | | | |
|---|---|---|---|---|
| 6 | 102+000 to 102+100 | | Existing road is passing through high hillock. Pavement surface is found damaged | Provide road delineators at both side of CW for better night visibility. Maintain existing pavement surface |

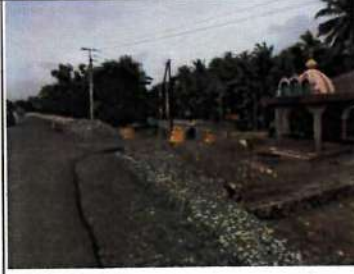
| Annexure-3: Detailed Work zone Safety Audit | | | | |
|---|---|---|---|---|
| 7 | 103+200 | | Minor road meeting at MCW at very steep ascending grade. | It should be closed or maintain properly. Provide speed breaker on minor road. |

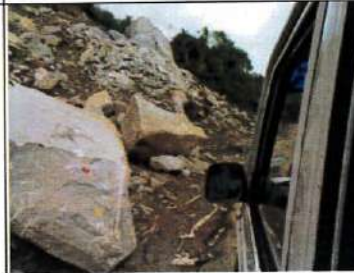
| Annexure-3: Detailed Work zone Safety Audit | | | | |
|---|---|---|---|---|
| 8 | 112+000 | | LHS side high hillock is observed with very big stone which may come in to MCW during heavy rain. | Provide cautionary sign board so that traffic can plying with caution. |

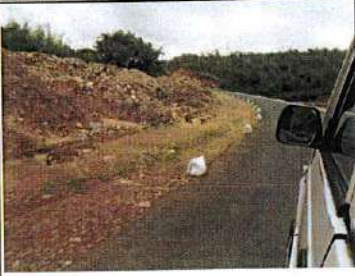
| Annexure-3: Detailed Work zone Safety Audit | | | | |
|---|---|---|--|--|
| 9 | 124+700 | | Very sharp curve with high embankment at outer side. | Provide delineators at outer edge of sharp curve. |

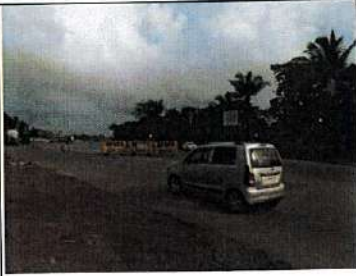
| Annexure-3: Detailed Work zone Safety Audit | | | | |
|---|---|---|--|--|
| 14 | 138+000 | | A minor road is meeting just after diversion. Minor Road traffic is entering in very high speed at MCW and situation becomes hazard due to diversion location. | Provide speed breaker on minor road, so vehicle enters in slow speed at MCW. |

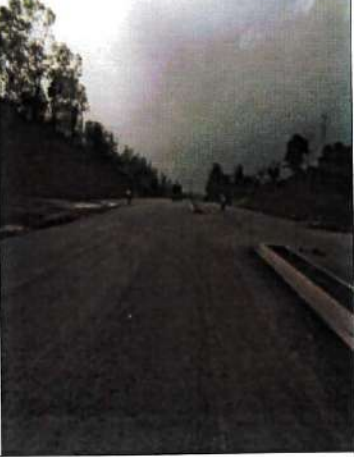
| Annexure-3: Detailed Work zone Safety Audit | | | | |
|---|---|---|---|---|
| 17 | 142+200 | | Both side cross road meeting with MCW with very steep descending grade. Also there is median opening is provided which creates dangerous. | Provide speed breaker on minor road, so that vehicles enters in slow speed at MCW |

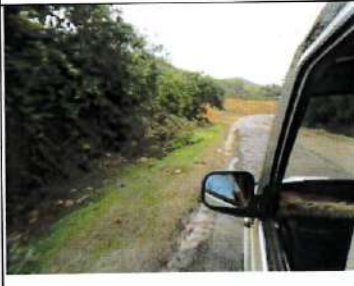
| Annexure-3: Detailed Work zone Safety Audit | | | | |
|---|---|---|---|---|
| 19 | 146+000 | | Existing pavement condition is found very poor | Maintain existing pavement surface. |

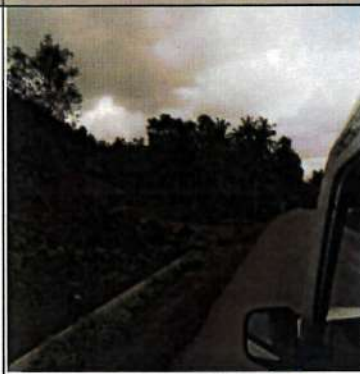
| Annexure-3: Detailed Work zone Safety Audit | | | | |
|---|---|---|---|---|
| 20 | 147+350 | | Minor road (almost parallel to MCW alignment) is meeting with MCW | Provide speed Breaker on minor roads |

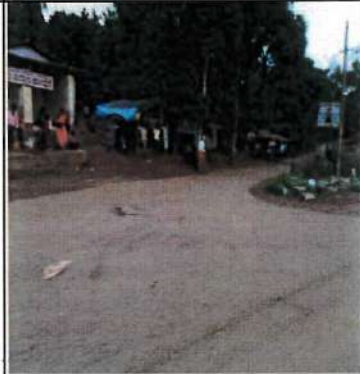
| Annexure-3: Detailed Work zone Safety Audit | | | | |
|---|---|---|---|---|
| 21 | 149+240 | | A minor road (having very steep ascending grade) is meeting with MCW having very sharp curve. | Provide speed Breaker on minor roads |

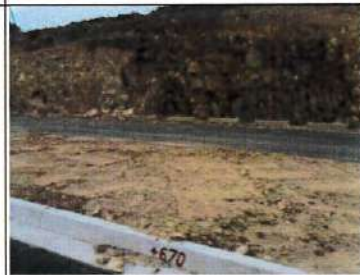
| Annexure-3: Detailed Work zone Safety Audit | | | | |
|---|---|---|---|---|
| 24 | 151+580 | | Steep vertical cutting at LHS side. | It is recommended that the Concessionaire shall construct <b>gentle cut slope instead of steep cut to avoid land slide</b> . As reported by the Concessionaire, land is not available to carryout gentle slope at steep hill cut locations mostly being Forest lands. It is |

| Annexure-3: Detailed Work zone Safety Audit | | | | |
|---|---|---|---|--|
| | | | | observed during safety audit at site that Concessionaire has tried their best to flatten the cut slope in the land made available to them. |

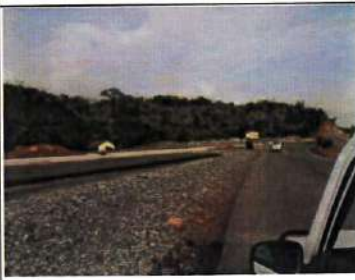
| Annexure-3: Detailed Work zone Safety Audit | | | | |
|---|---|---|---|--|
| 25 | 156+800 | | Both side traffic is playing on LHS side newly constructed CW which having vertical curve with poor sight distance. | Provide no overtaking sign board. |

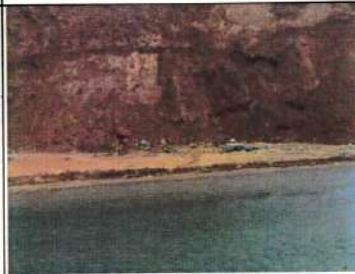
| Annexure-3: Detailed Work zone Safety Audit | | | | |
|---|---|---|---|--|
| 27 | 160+000 | | Steep vertical cutting at RHS side. | It is recommended that the Concessionaire shall construct <b>gentle cut slope instead of steep cut to avoid land slide</b> . As reported by the Concessionaire, land is not available to carryout gentle slope at steep hill cut locations mostly being Forest lands. It is observed during safety audit at site that Concessionaire has tried their best to flatten the cut slope in the land made available to them. |

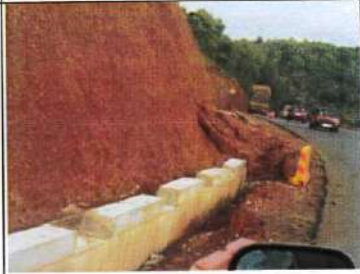
| Annexure-3: Detailed Work zone Safety Audit | | | | |
|---|---|---|---|--|
| 32 | 165+000 | | Steep vertical cutting at LHS side. | It is recommended that the Concessionaire shall construct <b>gentle cut slope instead of steep cut to avoid land slide</b> . As reported by the Concessionaire, land is not available to carryout gentle slope at steep hill cut locations mostly being Forest lands. It is observed during safety audit at site that Concessionaire has tried their best to flatten the cut slope in the land made available to them. |

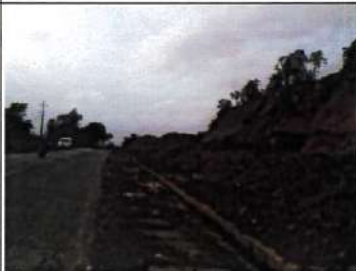
| Annexure-3: Detailed Work zone Safety Audit | | | | |
|---|---|---|---|--|
| 35 | 167+700 | | Steep vertical cutting at LHS side. Accident Prone location. | It is recommended that the Concessionaire shall construct <b>gentle cut slope instead of steep cut to avoid land slide</b> . As reported by the Concessionaire, land is not available to carryout gentle slope at steep hill cut locations mostly being Forest lands. It is observed during safety audit at site that Concessionaire has tried their best to flatten the cut slope in the land made available to them. |

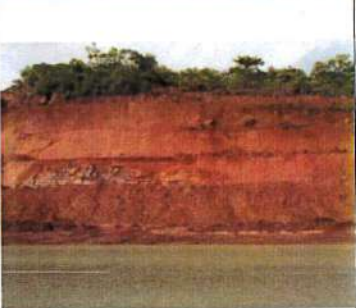
| Annexure-3: Detailed Work zone Safety Audit | | | | |
|---|---|---|--|--|
| 37 | 167+850 | | Steep vertical cutting at LHS side. | It is recommended that the Concessionaire shall construct <b>gentle cut slope instead of steep cut to avoid land slide</b> . As reported by the Concessionaire, land is not available to carryout gentle slope at steep hill cut locations mostly being Forest lands. It is observed during safety audit at site that Concessionaire has tried their best to flatten the cut slope in the land made available to them. |

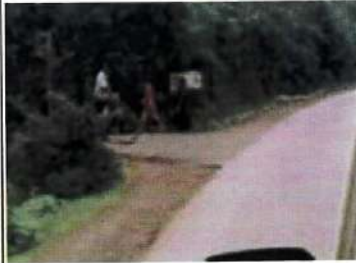
| Annexure-3: Detailed Work zone Safety Audit | | | | |
|---|---|---|--|--|
| 38 | 169+000 | | A minor road is meeting at LHS side just near to diversion. Minor Road traffic is entering in very high speed at MCW and situation becomes hazard due to diversion location. | Provide speed breaker on minor road, so that vehicle can enter in slow speed at MCW. |

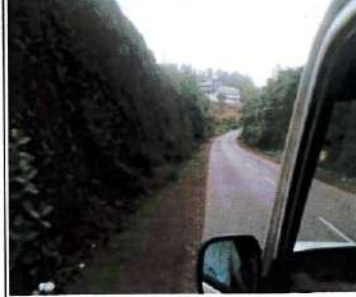
| Annexure-3: Detailed Work zone Safety Audit | | | | |
|---|---|---|--|--|
| 39 | 170+250 | | Steep vertical cutting at LHS side. | It is recommended that the Concessionaire shall construct <b>gentle cut slope instead of steep cut to avoid land slide</b> . As reported by the Concessionaire, land is not available to carryout gentle slope at steep hill cut locations mostly being Forest lands. It is observed during safety audit at site |

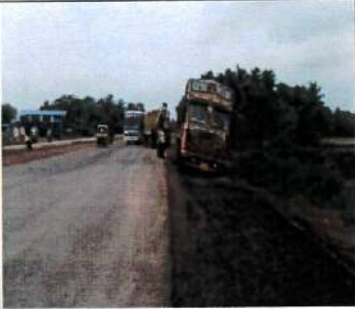
| Annexure-3: Detailed Work zone Safety Audit | | | | |
|---|---|---|---|--|
| 42 | 186+900 | | Shoulder is not compacted adequately , A truck is stuck on shoulder | Shoulder is need to be compacted adequately |

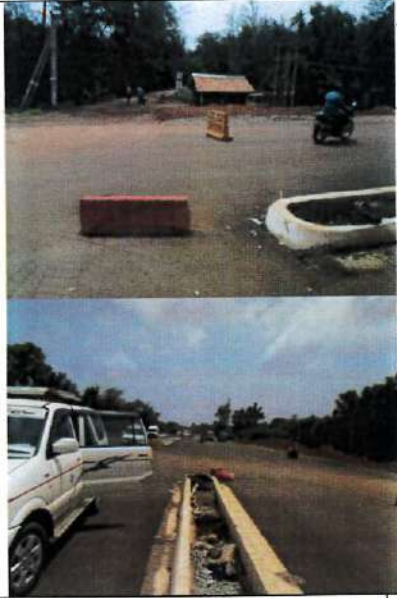
| Sr. No. | Chainage | Photographs | Observation/Summary | Recommendations/Requirements |
|---|---|---|---|--|
| 45 | 192+000 | | A minor road is meeting (having steep descending grade) with MCW. | Provide speed breaker so that traffic from minor road can enter in slow speed at MCW. |

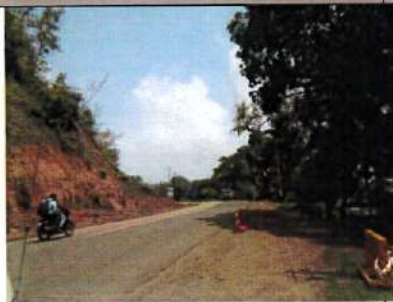
| Sr. No. | Chainage | Photographs | Observation/Summary | Recommendations/Requirements |
|---|---|---|--|--|
| 48 | 197+400 | | Land slide prone area is observed | It is recommended that the Concessionaire shall construct <b>gentle cut slope instead of steep cut to avoid land slide</b> . As reported by the Concessionaire, land is not available to carryout gentle slope at steep hill cut locations mostly being Forest lands. It is observed during safety audit at site that Concessionaire has tried their best to flatten the cut slope in the land made available to them. |

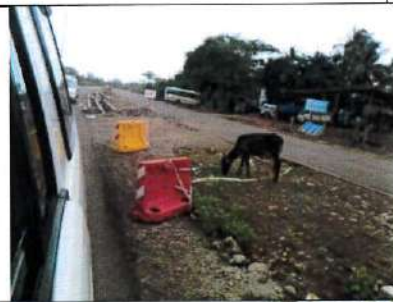
| Sr. No. | Chainage | Photographs | Observation/Summary | Recommendations/Requirements |
|---|---|---|--|--|
| 49 | 198+100 | | Unauthorized median opening is observed | It is recommended that close the median immediately. |

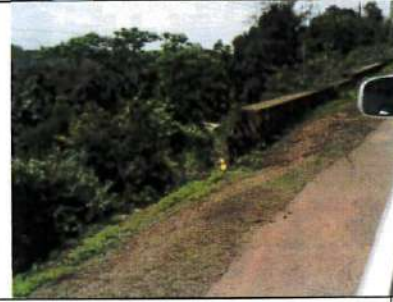
| Sr. No. | Chainage | Photographs | Observation/Summary | Recommendations/Requirements |
|---|---|---|--|--|
| 50 | 199+800 | | High embankment is observed at RHS side of MCW | Provide close delineators to keep away traffic from high embankment edge. |

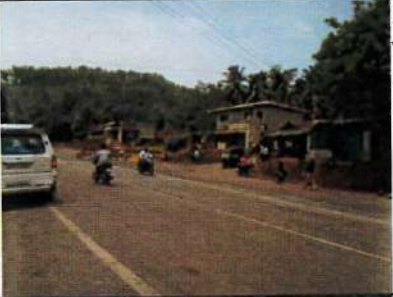
| Sr. No. | Chainage | Photographs | Observation/Summary | Recommendations/Requirements |
|---|---|---|---|---|
| 52 | 205+200 | | Minor road meeting with MCW and sight distance obstructing by existing buildings. | Provide speed breaker on minor road. |

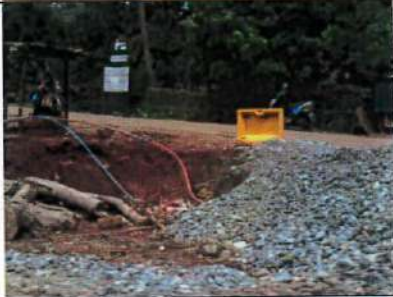
| Sr. No. | Chainage | Photographs | Observation/Summary | Recommendations/Requirements |
|---|---|---|---|---|
| 53 | 206+100 | | Deep cuts are observed at near Culvert. | Provide barricading to keep away traffic from deep cut. |

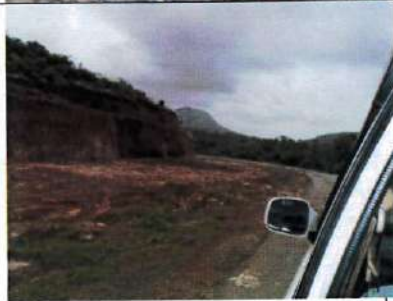
| Sr. No. | Chainage | Photographs | Observation/Summary | Recommendations/Requirements |
|---|---|---|---|---|
| 54 | 208+000 | | Land slide prone area is observed | It is recommended that the Concessionaire shall construct <b>gentle cut slope instead of steep cut to avoid land slide</b> . As reported by the Concessionaire, land is not available to carry out gentle slope at steep hill cut locations mostly being Forest lands. It is observed during safety audit at site that Concessionaire has tried their best to flatten the cut slope in the land made available to them. |

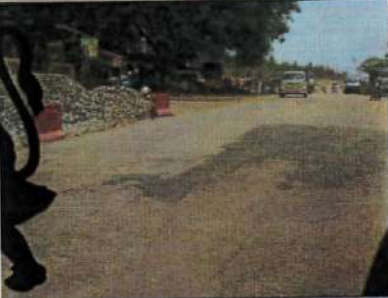
| Sr. No. | Chainage | Photographs | Observation/Summary | Recommendations/Requirements |
|---|---|---|--|--|
| 55 | 209+00 | | Deep excavation near MCW | Concessionaire is filling up the deep cut by GSB material at this location. |

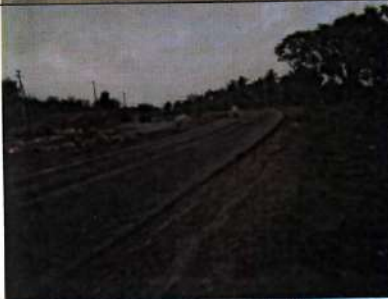
| Sr. No. | Chainage | Photographs | Observation/Summary | Recommendations/Requirements |
|---|---|---|--|--|
| 56 | 210+600 | | A fatal accident is reported due to overtaking. | Provide no overtaking sign, speed limit board of 40km/h |

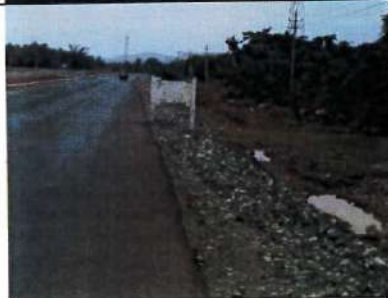
| Sr. No. | Chainage | Photographs | Observation/Summary | Recommendations/Requirements |
|---|---|---|--|--|
| 57 | 211+500 | | A board of village name very near to carriageway without retro reflection. | Remove and replace at suitable location. |

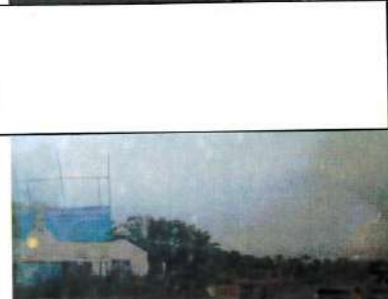
| Sr. No. | Chainage | Photographs | Observation/Summary | Recommendations/Requirements |
|---|---|---|--|--|
| 59 | 221+400 | | It is observed that barricading are not provide properly to close the CW. | Provide adequate barricading so that traffic movement safely pass from work zone area. |

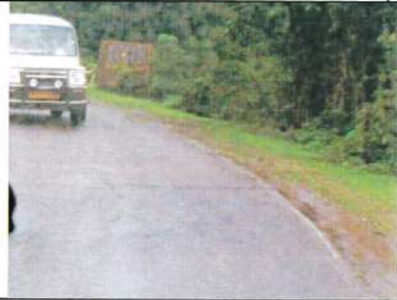
| Sr. No. | Chainage | Photographs | Observation/Summary | Recommendations/Requirements |
|---|---|---|---|--|
| 62 | 232+800 | | High embankment and sharp curve is observed | Provide barricading / delineators to keep away traffic from high embankment |

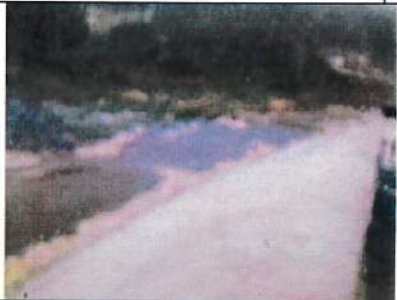
| Sr. No. | Chainage | Photographs | Observation/Summary | Recommendations/Requirements |
|---|---|---|---|--|
| 65 | 245+000 | | High embankment is observed at RHS side of MCW. | Provide delineators to keep away traffic from high embankment. |

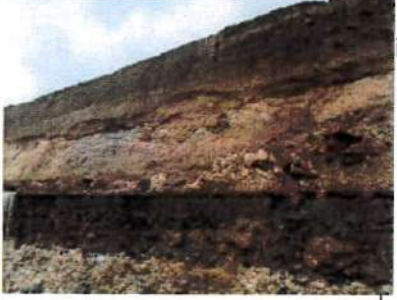
| Sr. No. | Chainage | Photographs | Observation/Summary | Recommendations/Requirements |
|---|---|---|---|--|
| 66 | 246+000 | | Land slide prone area is observed. | It is recommended that the Concessionaire shall construct <b>gentle cut slope instead of steep cut to avoid land slide</b> . As reported by the Concessionaire, land is not available to carryout gentle slope at steep hill cut locations mostly being Forest lands. It is observed during safety audit at site that Concessionaire |

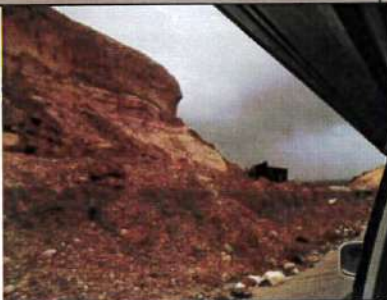
| Sr. No. | Chainage | Photographs | Observation/Summary | Recommendations/Requirements |
|---|---|---|---|---|
| 67 | 247+000 | | RHS rain cut are observed at shoulder at high embankment | Provide barricading/delineators to keep away traffic from high embankment |

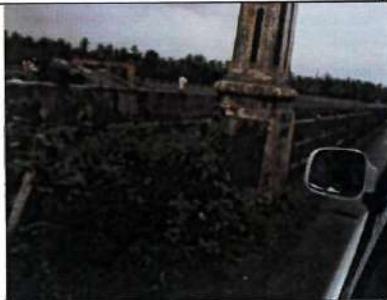
| Sr. No. | Chainage | Photographs | Observation/Summary | Recommendations/Requirements |
|---|---|---|---|---|
| 68 | 250+625 | | Railing is absent on existing bridge. | It is recommended to provide railing on the bridge. |
