**BEFORE THE HON'BLE NATIONAL GREEN TRIBUNAL,  
SOUTHERN ZONE, CHENNAI**

**ORIGINAL APPLICATION NO. 261 OF 2024  
(EARLIER ORIGINAL APPLICATION NO. 1055/2024- PB)**

Tribunal on its own motion Suo Moto based on News Item titled "Unscientific work by NHAI led to Shirur landslide Geological Survey of India report" appearing in the Indian Express dated 02.08.2024

National Highways Authority of India & Ors.

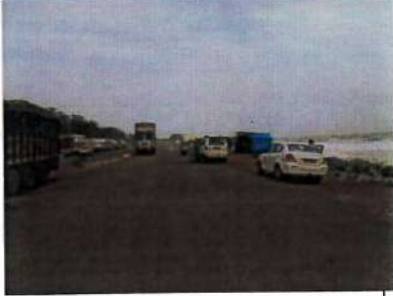
| Sr. No. | Chainage | Photographs | Observation/Summary | Recommendations/Requirements |
|---|---|---|--|---|
| 77 | 267+00 to 267+650 | | Road is passing very near to beach at appx 300-400m length. Large number of trucks and tourist vehicle are stopped and parked at/very near to MCW. | Provide speed limit sign board before this location. |

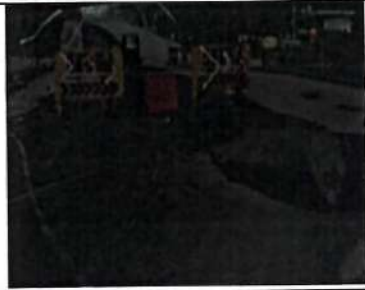
| Sr. No. | Chainage | Photographs | Observation/Summary | Recommendations/Requirements |
|---|---|---|--|---|
| 78 | 269+750/269+850 | | Few sign board are missing at diversion. | Provide missing signs, like barricading and advance warning sign. |

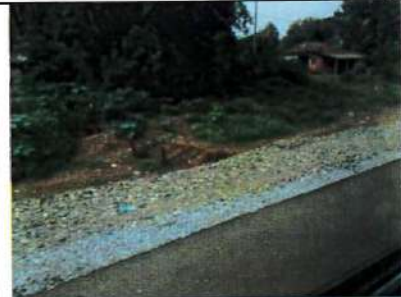
| Sr. No. | Chainage | Photographs | Observation/Summary | Recommendations/Requirements |
|---|---|---|--|---|
| 80 | 271+200 | | Deep excavation is observed at RHS side of MCW | Provide barricading to keep away traffic from deep excavation. |

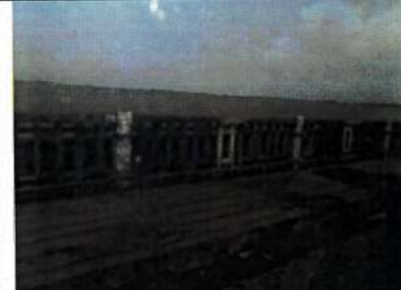
| Sr. No. | Chainage | Photographs | Observation/Summary | Recommendations/Requirements |
|---|---|---|--|---|
| 81 | 272+850 | | railing of existing bridge damaged and not effective during night<br>Very high embankment is observed at approach of existing bridge | Provide safety measures & reflective tape for better night visibility.<br>Provide delineators to keep away traffic from high embankment |

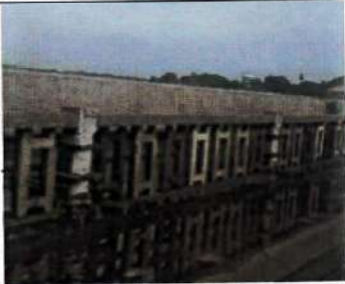
| Sr. No. | Chainage | Photographs | Observation/Summary | Recommendations/Requirements |
|---|---|---|--|---|
| 84 | 278+530 | | railing of existing bridge damaged and not effective during night<br>Very high embankment is observed at approach of existing bridge | Provide safety measures and reflective tape for better night visibility.<br>Provide barricading/delineators to keep away traffic from high embankment |

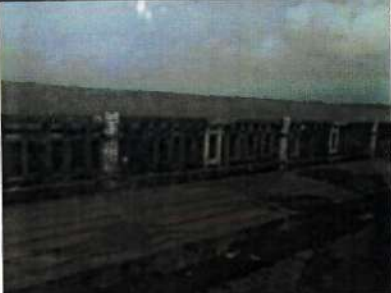
| Sr. No. | Chainage | Photographs | Observation/Summary | Recommendations/Requirements |
|---|---|---|--|---|
| 85 | 279+540 | | railing of existing bridge damaged and not effective during night<br>Very high embankment is observed at approach of existing bridge | Provide Safety measures and reflective tape for better night visibility.<br>Provide barricading/delineators to keep away traffic from high embankment |

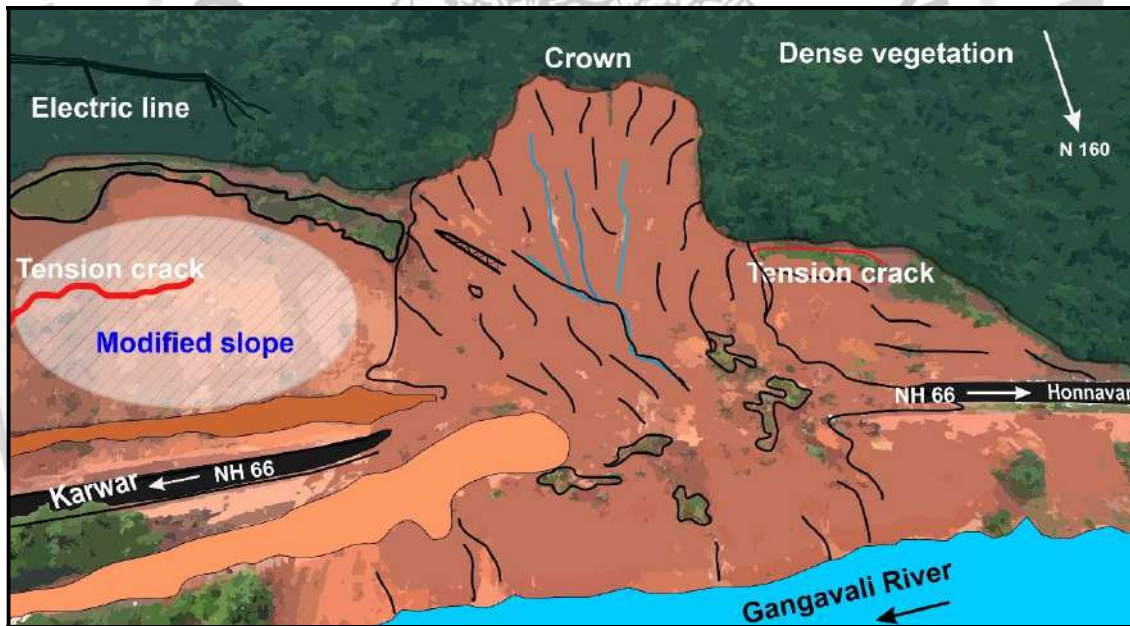
Fig. 1.1: Schematic sketch of Shirur landslide (Not to scale)

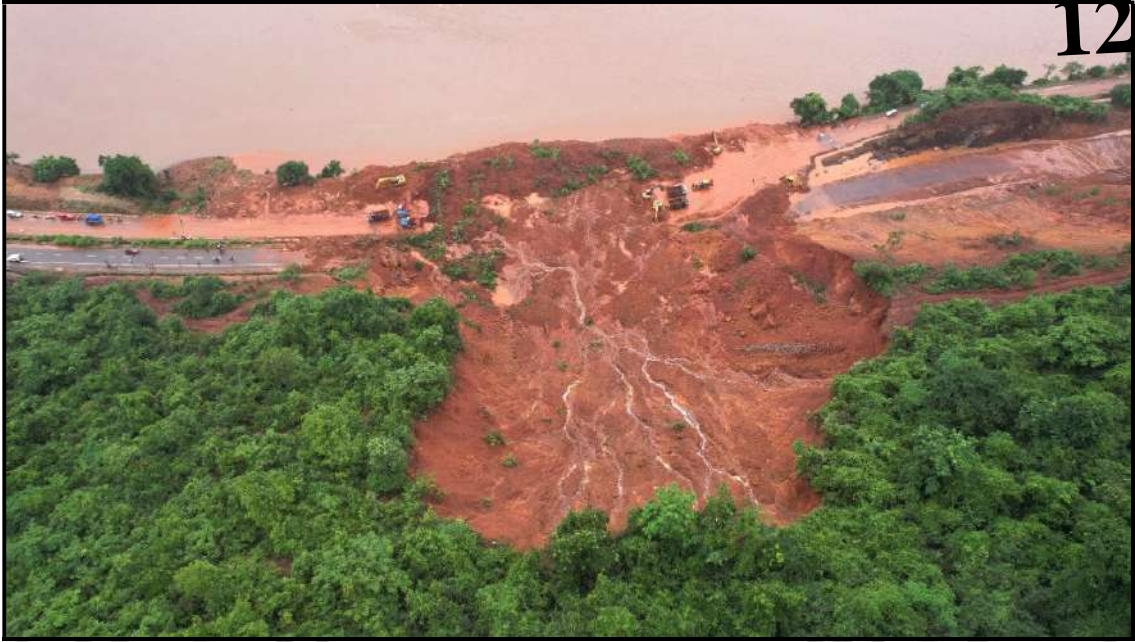
Fig. 1.2: Aerial view of Shirur landslide blocking the communication corridor NH-66 (courtesy IRB)

The landslide resulted in ten fatalities and washed away two gas tankers and one truck. Additionally, a semi-permanent hotel structure was destroyed. The debris from the landslide travelled over 200 meters, eventually depositing into the Ganagavali River, creating an impact wave that demolished four houses on the opposite bank. The scar left by the landslide measured approximately 150 meters in length, 120 meters in width, and 60 meters in height, with the total volume of debris exceeding 100,000 cubic meters (Fig. 1.2).

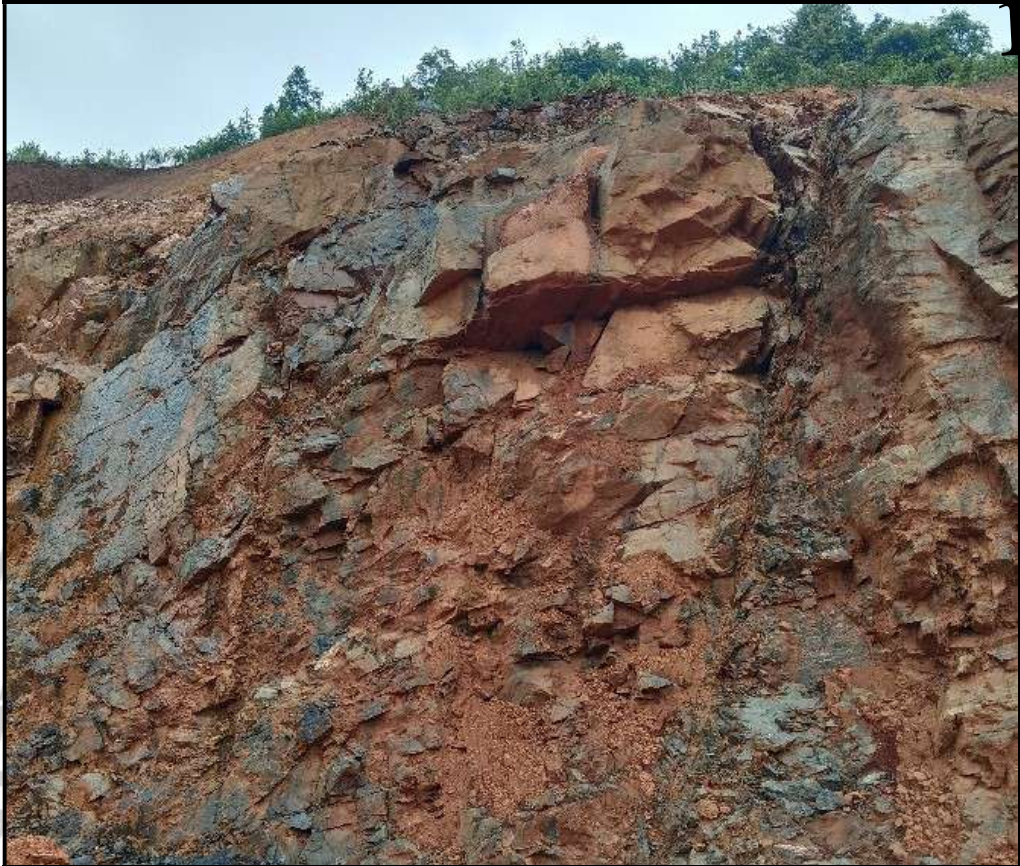
The site is mainly comprised of Pyroxenite of the Motimakki Ultramafites (Fig. 1.3). The base of the landslide exposes medium to coarse-grained, dark green to black pyroxenite with high specific gravity, dominated by pyroxenes that exhibit a characteristic luster on the cleavage surfaces. Intermittent pegmatite intrusions, 5-10 meters wide, are present on both flanks of the slide. These pegmatites are highly weathered, forming whitish clay (Fig. 1.4). The depleted zone of the landslide has greenish-tinted, medium to coarse-grained boulders, rich in olivine, and showing serpentinization. Vanadiferous titanomagnetite bodies are observed at higher elevations above the landslide, composed mainly of magnetite with subordinate plagioclase, exhibiting banding and high specific gravity. The flanks and crown area also expose large laterite boulders.

Fig. 1.3: Pyroxenite exposed at the base of cut slope section near Shirur landslide

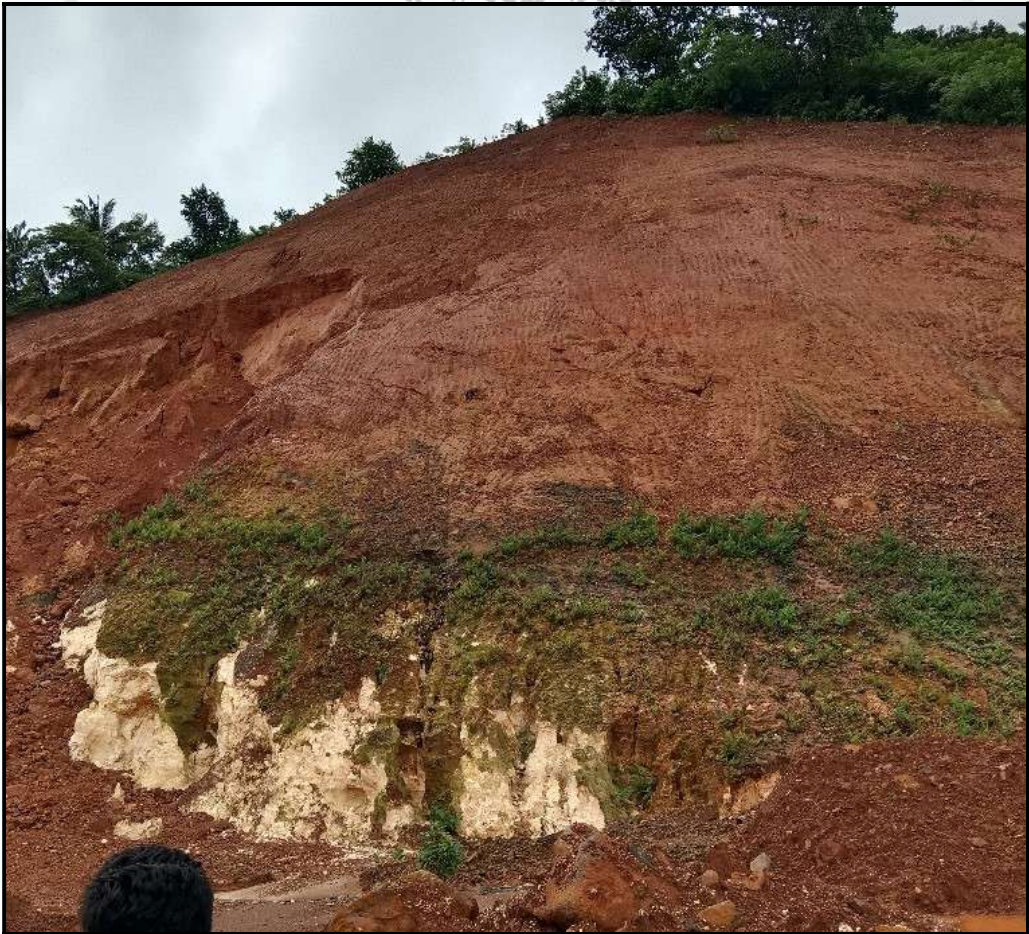
Fig. 1.4: Weathered pegmatite forming whitish clay Kaolinite

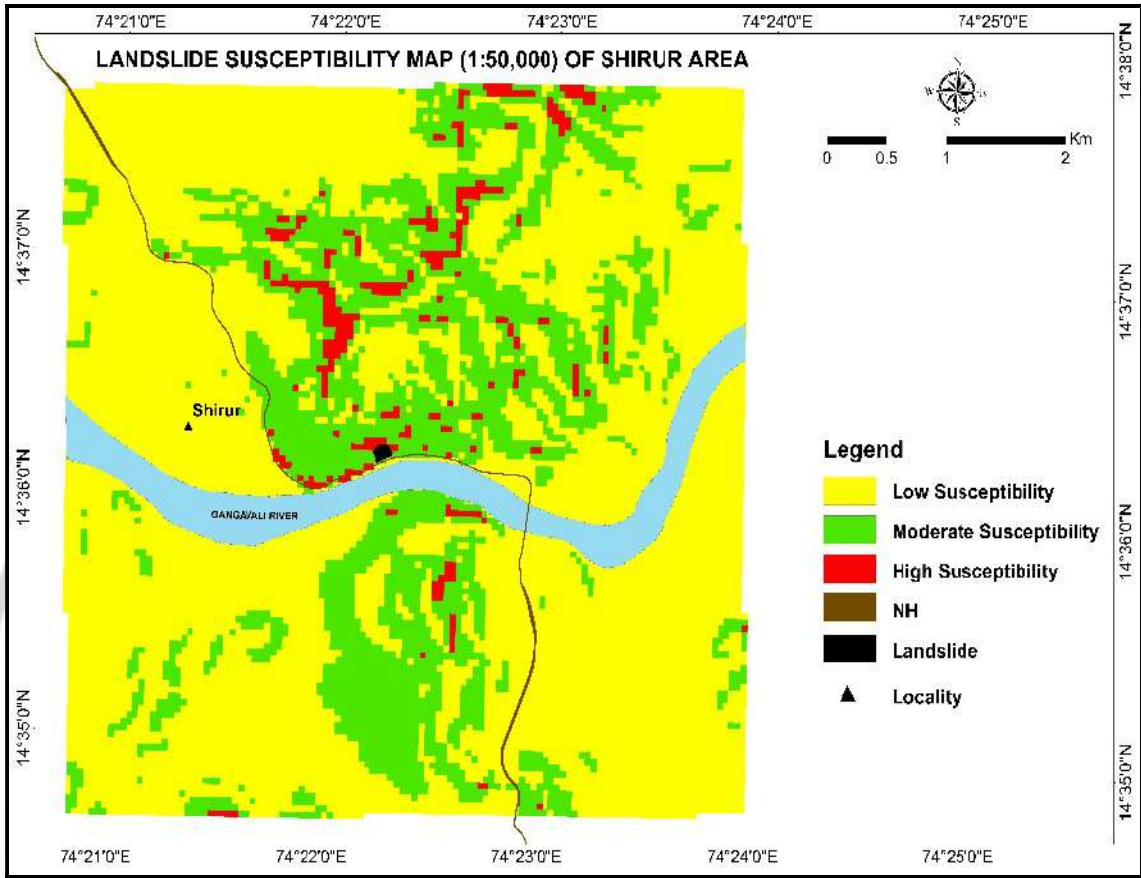
The slope sector from Chainage 147.400 to 148.200 shows moderate to high susceptibility according to the National Landslide Susceptibility Map (NLSM) of GSI (Fig. 1.6). Multi-temporal satellite imagery indicates anthropogenic interference on the slopes from

Fig. 1.6: Landslide Susceptibility Map of Shirur area, (NLSM GSI)

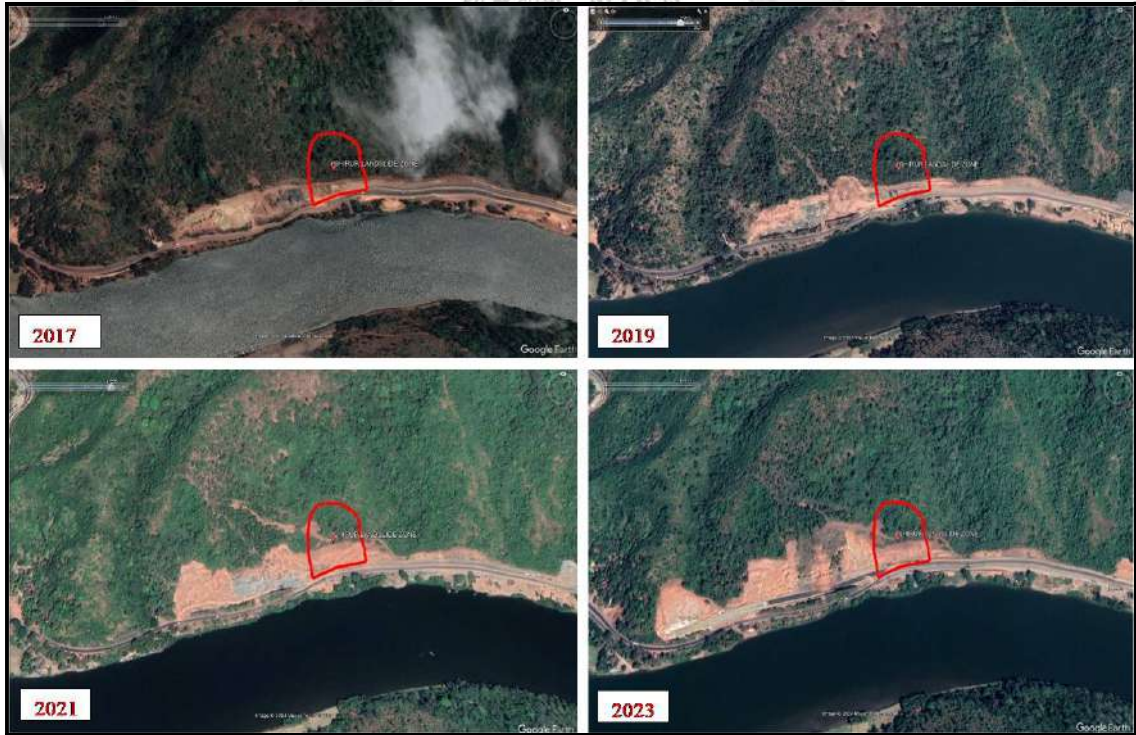
Chainage 147.400 to 148.200 since 2017, exacerbating some landslide scars above the cut slopes (Fig.1.7). 124

Fig. 1.7: Multi-temporal satellite imageries of Shirur

Multi-temporal satellite imagery has shown significant anthropogenic interference with the slopes since 2017. Continuous slope modifications and the presence of landslide scars above the cut slopes have exacerbated the slope's vulnerability. The lack of proper retaining structures further destabilized the area, increasing the risk of slope failure.

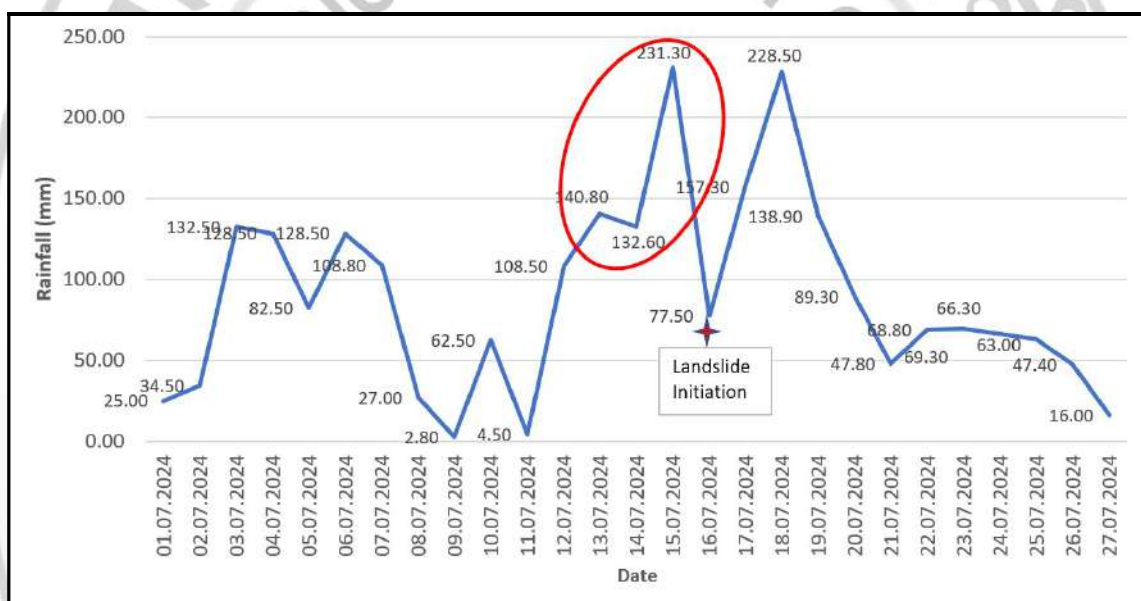
Intense and prolonged rainfall acted as the immediate trigger for the landslide. Specifically, a three-day antecedent rainfall totalling 503 mm led to the saturation of debris material, increasing pore water pressure and reducing shear strength (Fig.1.14). This intense rainfall significantly weakened the slope's stability, and acted as a trigger.

Fig. 1.14: Rainfall distribution near Shirur during July 2024 (source:IRB)

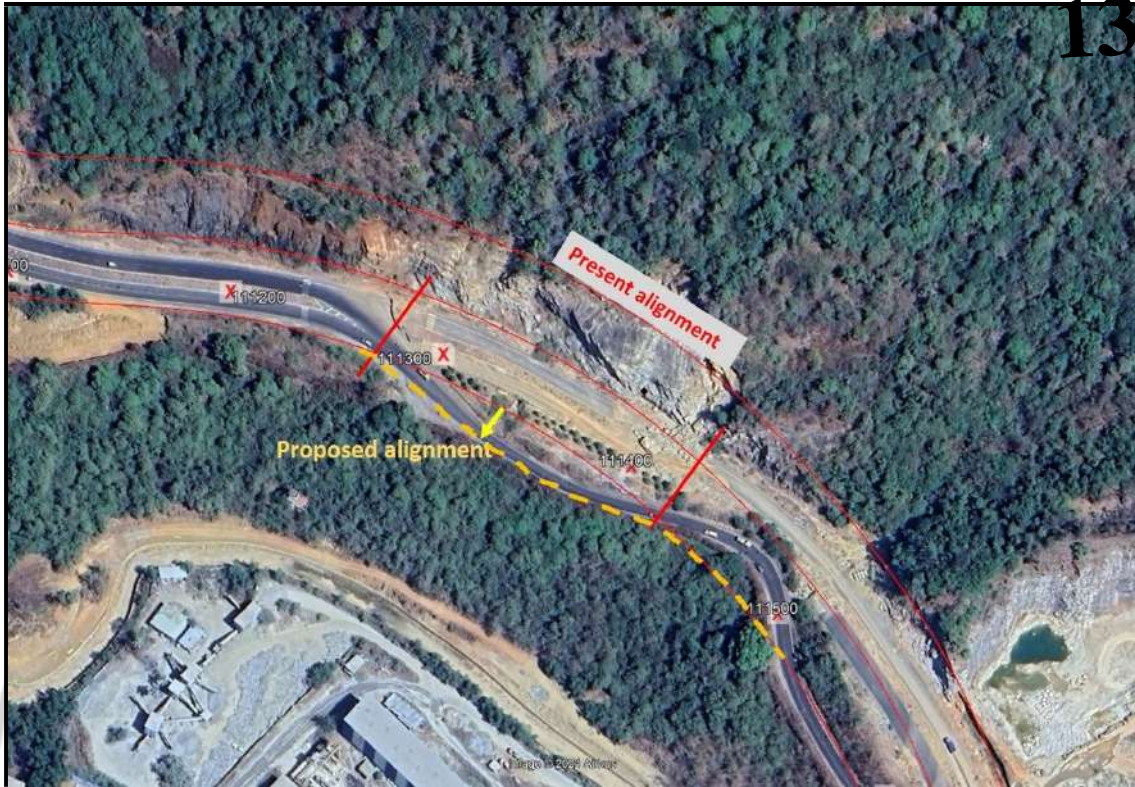
At chainages 111.300 to 111.400 where the relative relief is very high and the road cut is steep, the rocks are highly jointed with some having near vertical dips. The rocks also exhibit exfoliation joints which are formed due to repeated heating and thawing of the rocks. The intersection of these two planes produces blocks, which fall along the slope (Fig. 2.3). The stretch requires a detailed study to figure out engineering solutions such as rock bolting intervals, shotcreting, etc. However, if the land is available, a slight deviation (20m) in the road alignment towards the south western side away from the vertical slope cut can be considered after detailed studies to minimize the risk factor associated with rock falls (Fig. 2.4).

Fig. 2.4: Proposed alignment to mitigate the direct risk of rockfalls

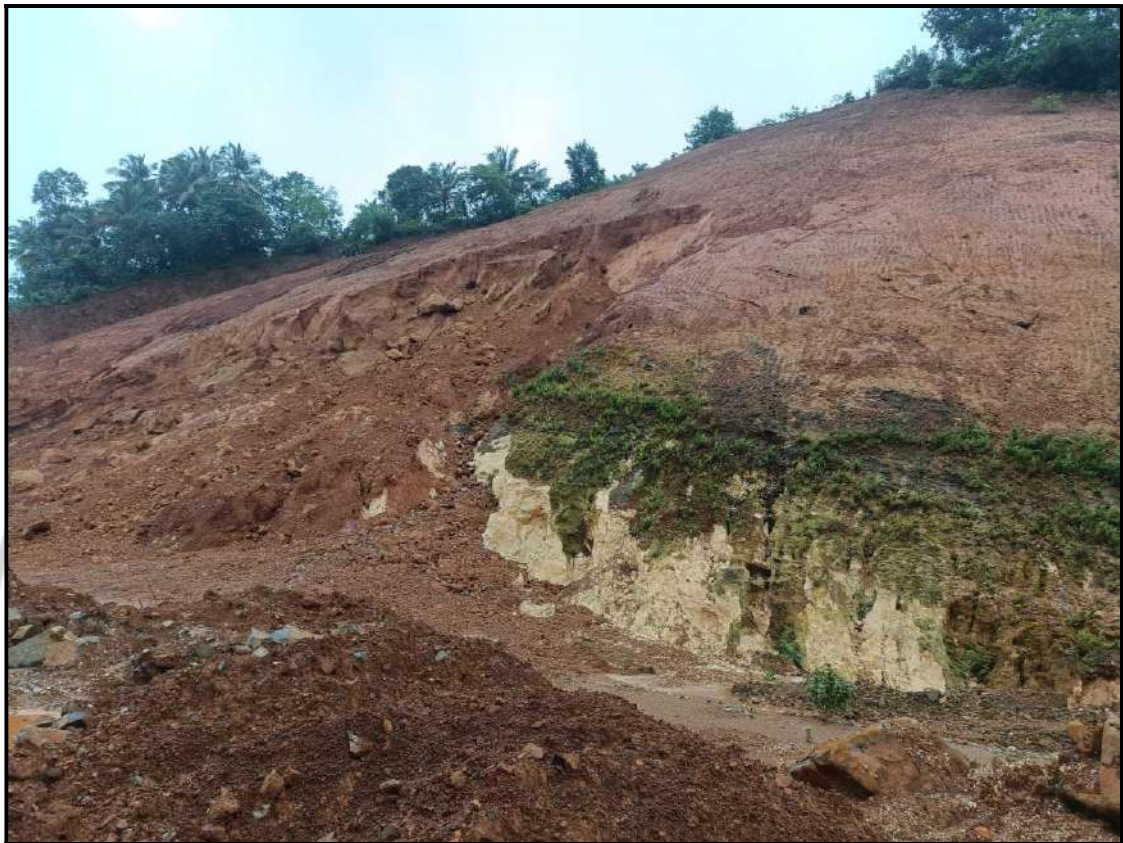
The ultramafic rocks are susceptible to a high degree of weathering. The thickness of debris and lithomarge would be higher as compared to areas occupied by granitic rocks. There is also a considerable variability in the litho units exposed from bottom to top as is typical in such layered complexes. The weathered rock horizon and soil also show vertical variability where the top of the hill is characterized by ferruginous laterite and the middle part shows lateritic clay-rich horizons. The clay layers have lesser permeability, leading to water accumulation in the column. Slope cuts in this region should be kept to a minimal height as possible so that the exposed cut slopes can be stabilized by providing good drainage and retaining structures. Benching of slopes alone is not an effective slope stabilization method as observed in the Shirur site. Shotcreting in such thick debris cover also would be ineffective. The landslide management strategy in such cases should be to minimize the slope cut height

Fig. 2.5: Variability in lithounits near the right flank of the Shirur landslide

by shifting the alignment wherever land is available and providing efficient surface and subsurface drainage solutions.

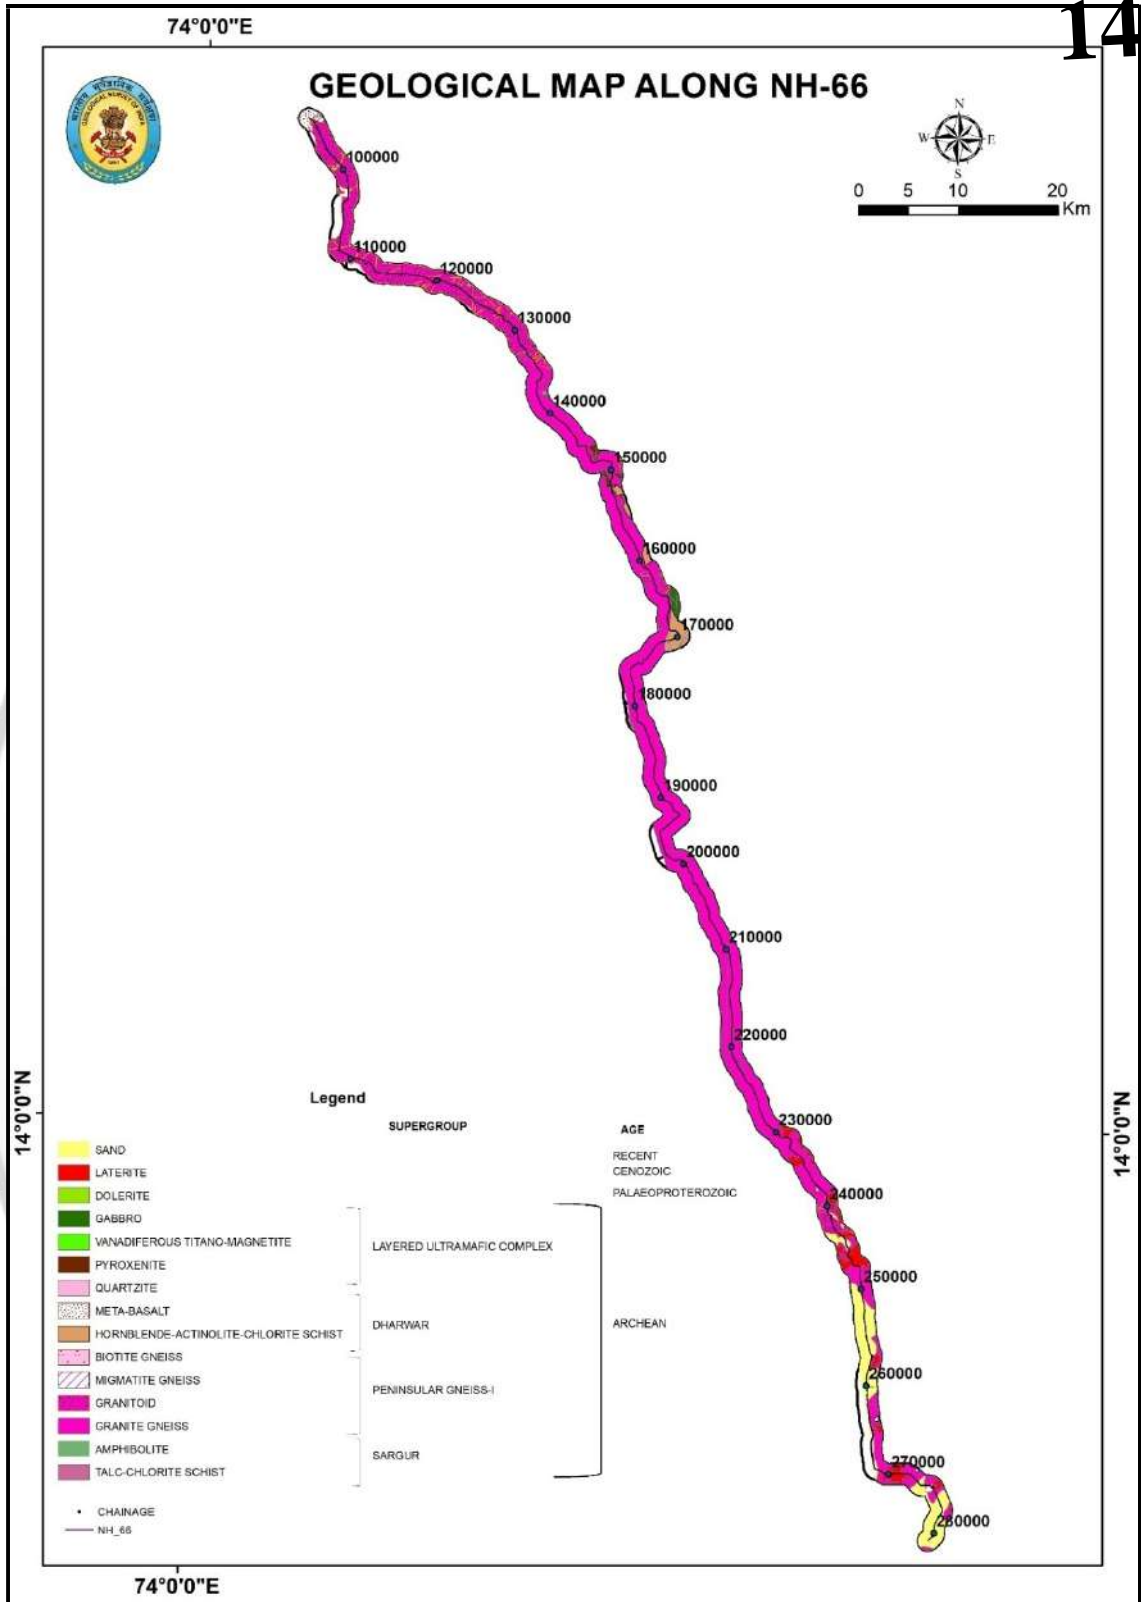
The highway passes through the western margin of Western Ghat mountain ranges and has a few sections where the hill slopes had to be cut to make way for the road corridor. The major geological unit exposed in the corridor is the Peninsular Gneissic Complex (PGC), a suite of rocks with mainly granitic composition. The corridor also cut through various mafic and ultramafic rock units at different locations (Fig. 2.10).

Fig. 2.10: Geological map of the road corridor

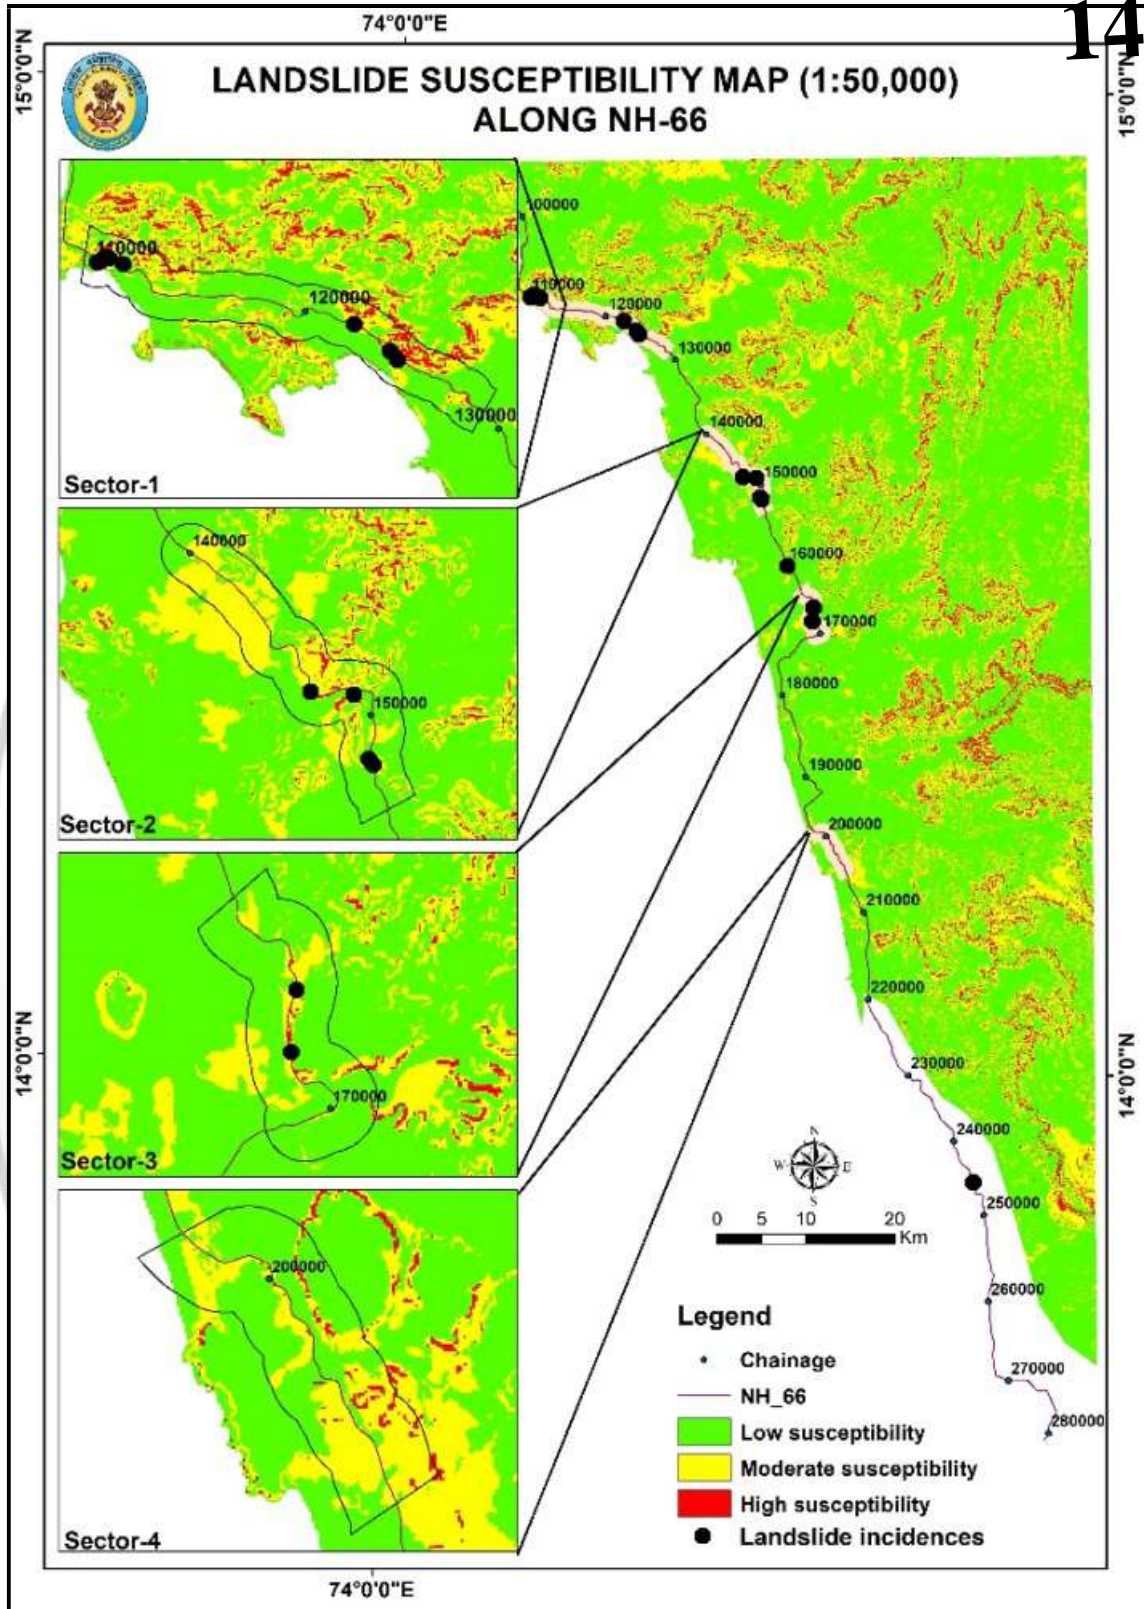
The landslide susceptibility map, produced after the National Landslide Susceptibility Mapping (NLSM) of GSI in 1:50,000 scale, is available for the road corridor up to 220.000 chainages (Fig. 2.11). Most of the landslide incidences in the corridor have occurred in moderate to high landslide susceptibility areas. The road corridor was divided into four sectors, each with unique slope instability scenarios and contributing factors.

Fig. 2.11: Landslide susceptibility map of the road corridor

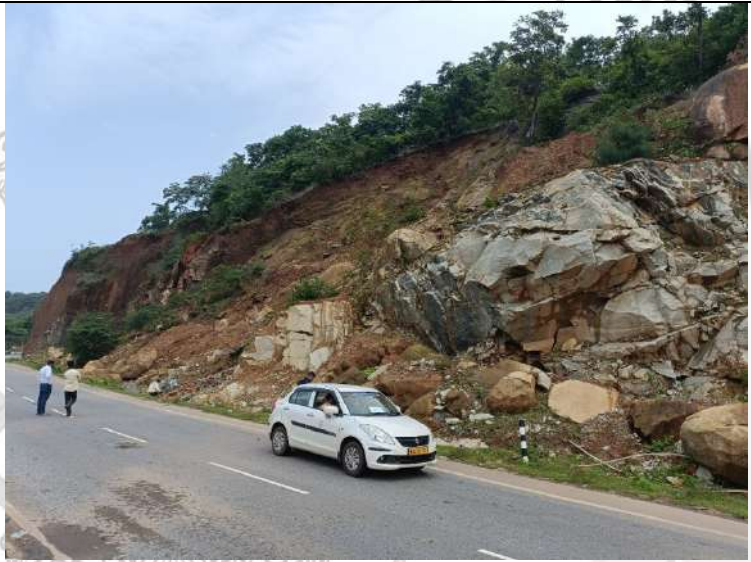
| 38 | Remarks, if any | The debris has been depleted from the slide area. Debris exposed on the crown and the flanks of the slide may lead to minor slides during intense rainfall events. |

| 37 | Remedial measures | Monitor the slide area regularly for any movement. Any further slope modification might contribute to further instability |

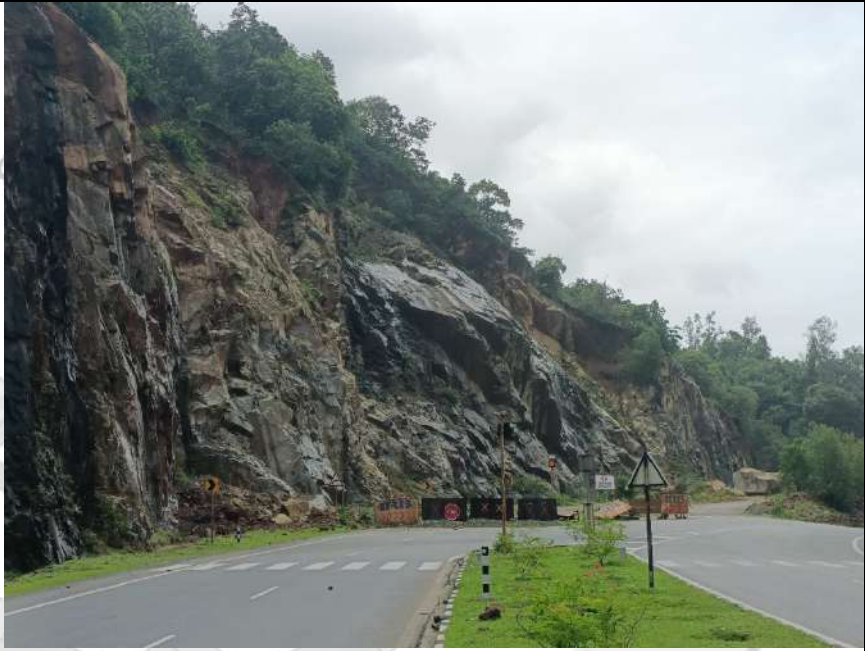
| 38 | Remarks, if any | The area is highly susceptible to rock falls. Traffic may continue in the old parallel alignment and only be resumed after geotechnical interventions are made in the slope |

| 37 | Remedial measures | Detailed studies are required along the Chainage 111.300 to 111.450. Precarious blocks may be removed and adequate support measures like proper netting should be provided for the slope. |

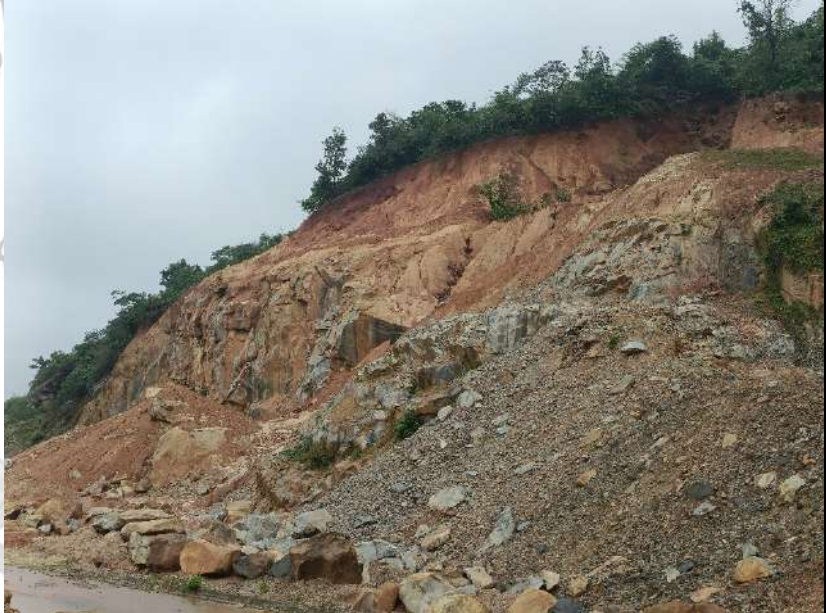
| 38 | Remarks, if any | The location has chances for further landslides |

| 37 | Remedial measures | Easing of the slope of the debris layer. Providing erosion control mats like geo jute with suitable grass variety plantation can be an effective solution for such slopes |

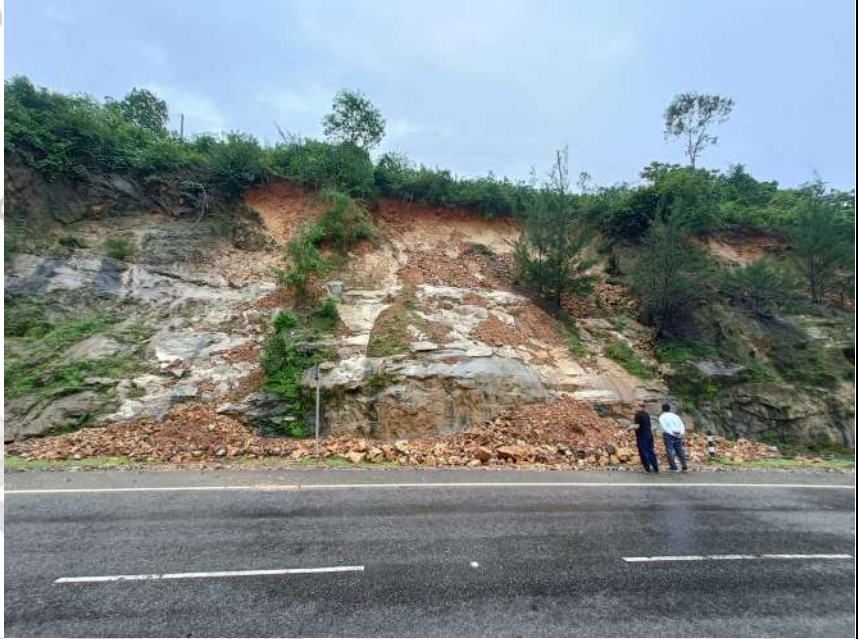
| 38 | Remarks, if any | The area is susceptible to minor slope failures from the laterite layer. |

| 37 | Remedial measures | The slope may not be disturbed by any excavation as it may further destabilize the slope. |

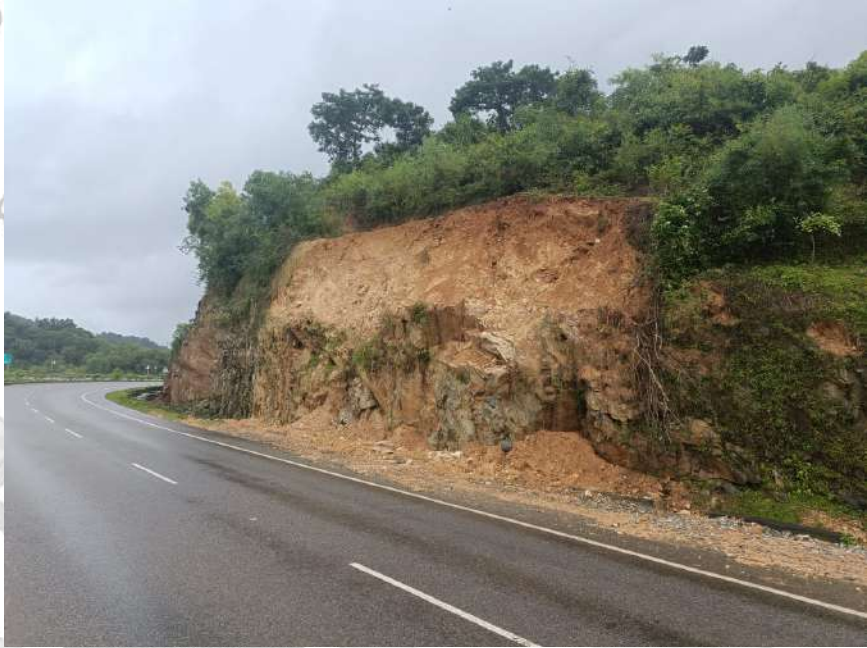
| 38 | Remarks, if any | The area is susceptible to minor slope failures from the laterite layer. |

| 37 | Remedial measures | The slope may not be disturbed by any excavation as it may further destabilize the slope. |

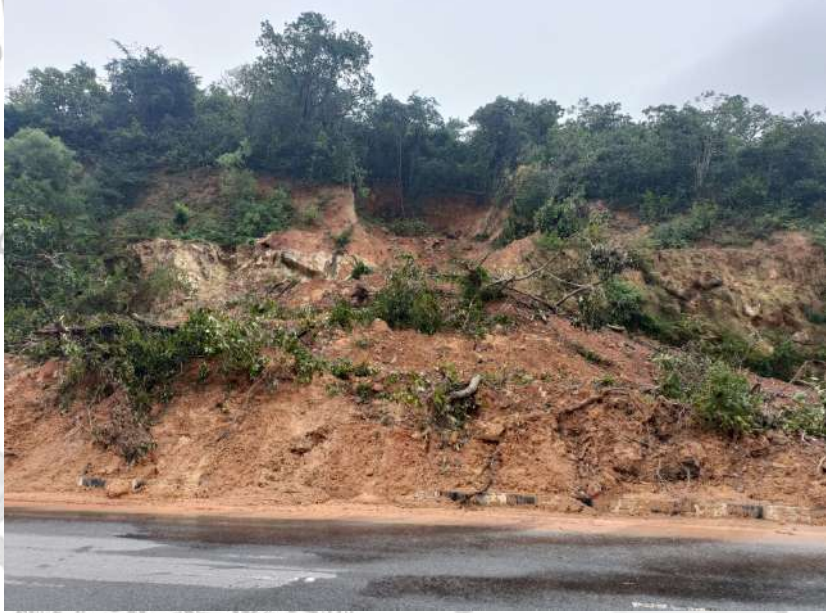
| 38 | Remarks, if any | The area is susceptible to similar failures in the future. |

| 37 | Remedial measures | Remove the debris from the run-out zone. Any further slope modification without detailed studies is not recommended. |

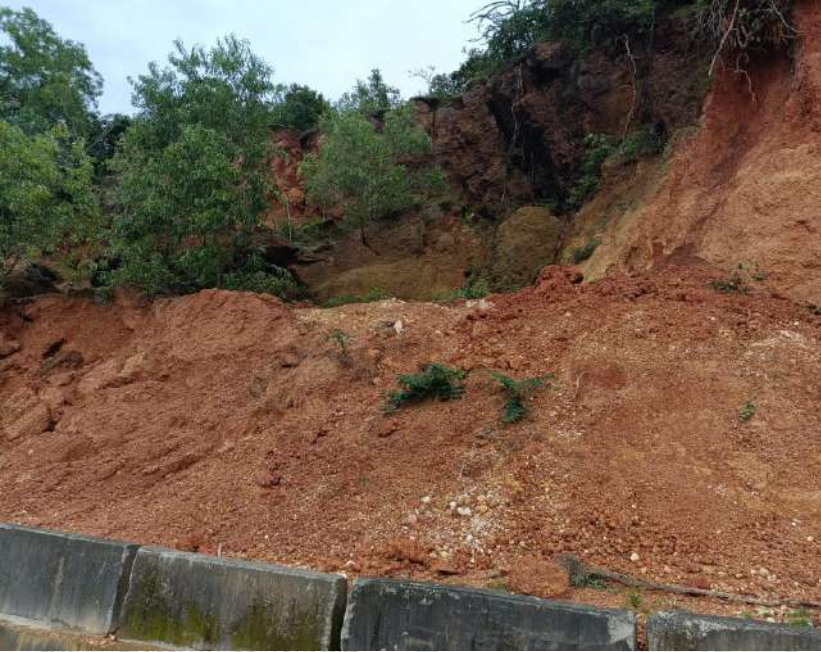
| 38 | Remarks, if any | The slope is not susceptible to deep rotational failure |

| 37 | Remedial measures | The existing retaining wall may be continued till the slide location to arrest the movement of the blocks till the road. Else steel piles may also be erected instead of the RCC wall. Enough provisions should be provided for the unhindered flow of the subsurface water. |

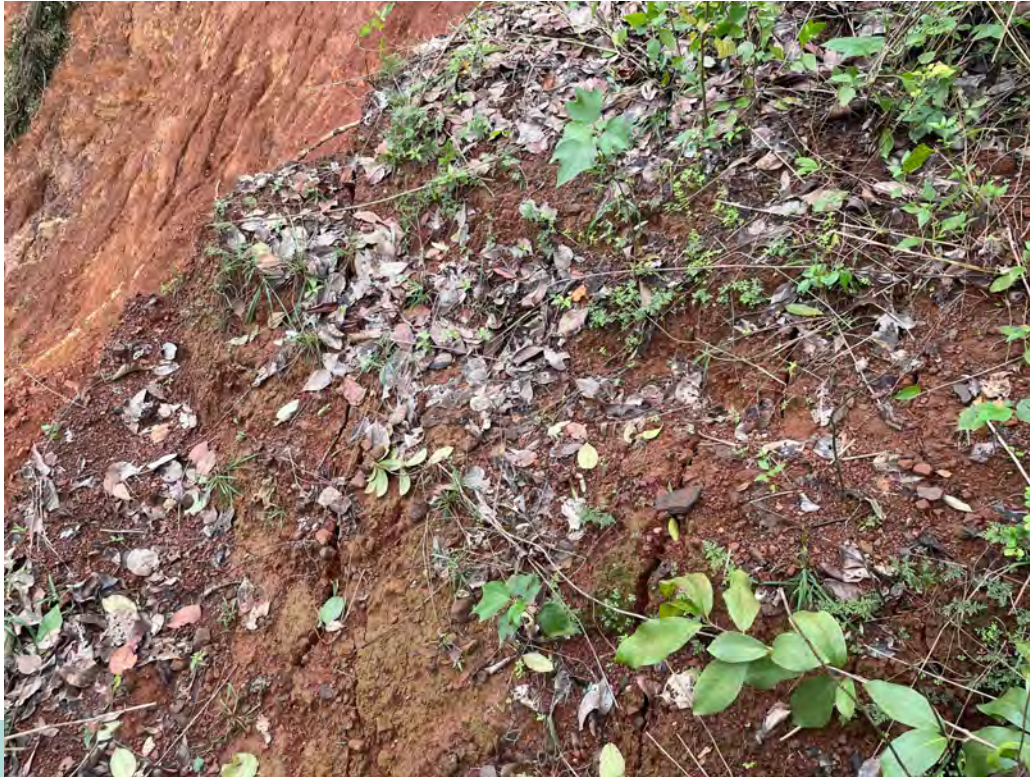
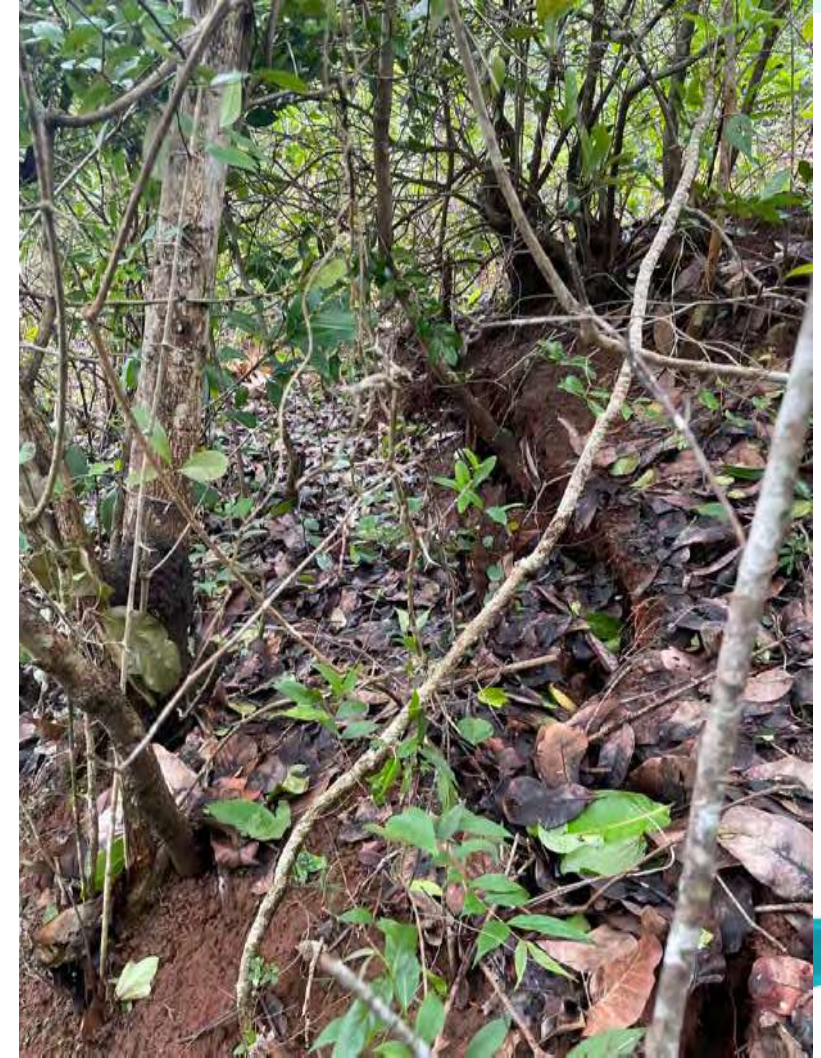
Tension cracks and subsidence is visible on the left flank of the slide.

These could have been prior existing or appeared post slide due to steep retained slopes.

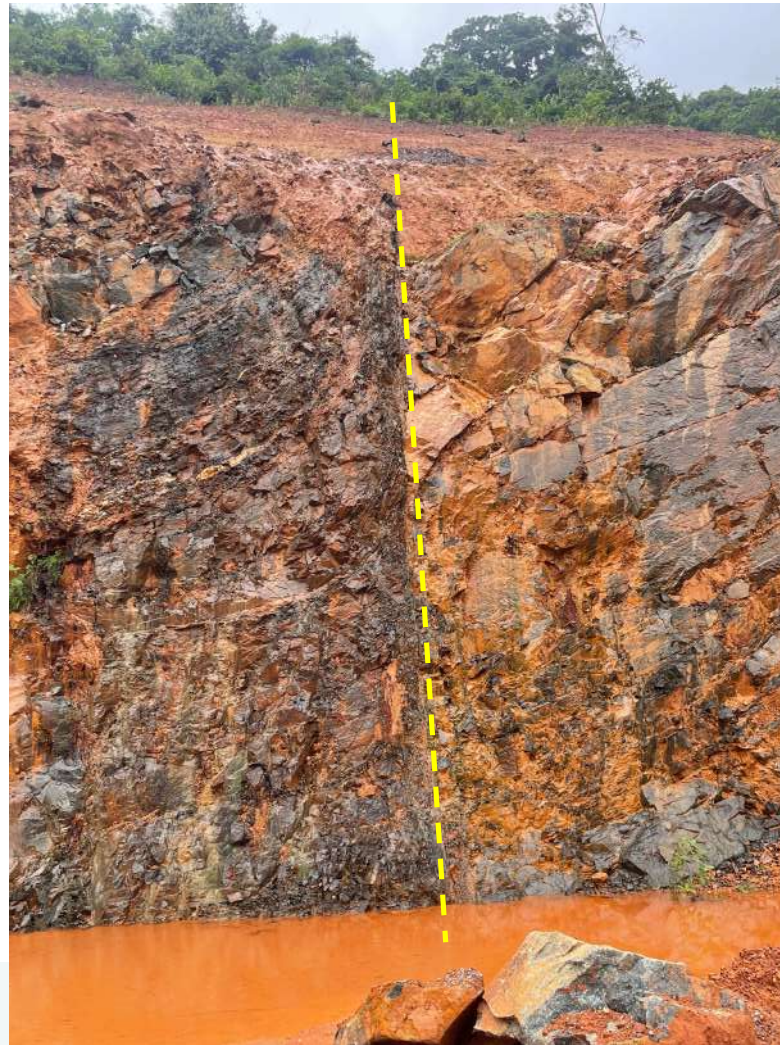
A local fault was clearly visible at the adjacent cut with folding strata

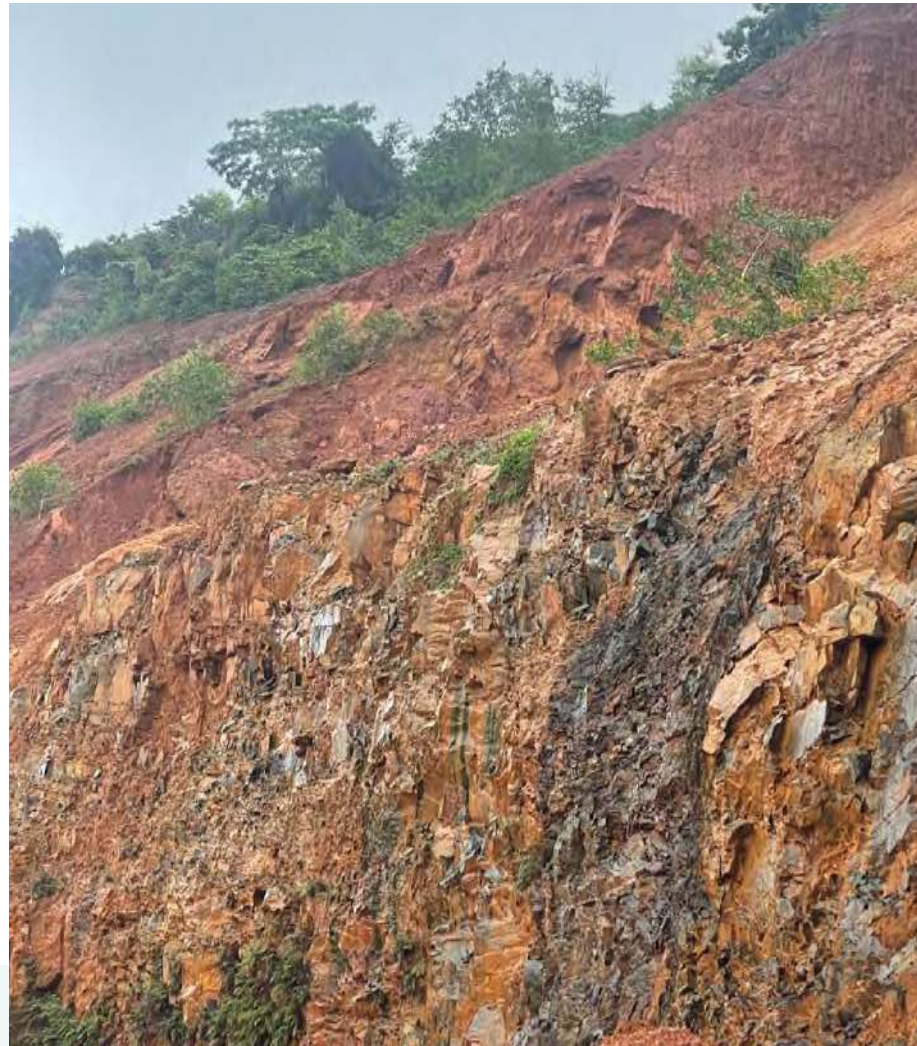
Overburden slide has already been triggered at this adjacent location with visible crown and scarps.

A judgement needs to be taken after accessing behind the present crown whether a larger mass movement is expected.

A top down cutting with geometric corrections may be needed before deciding on removing the toe debris.

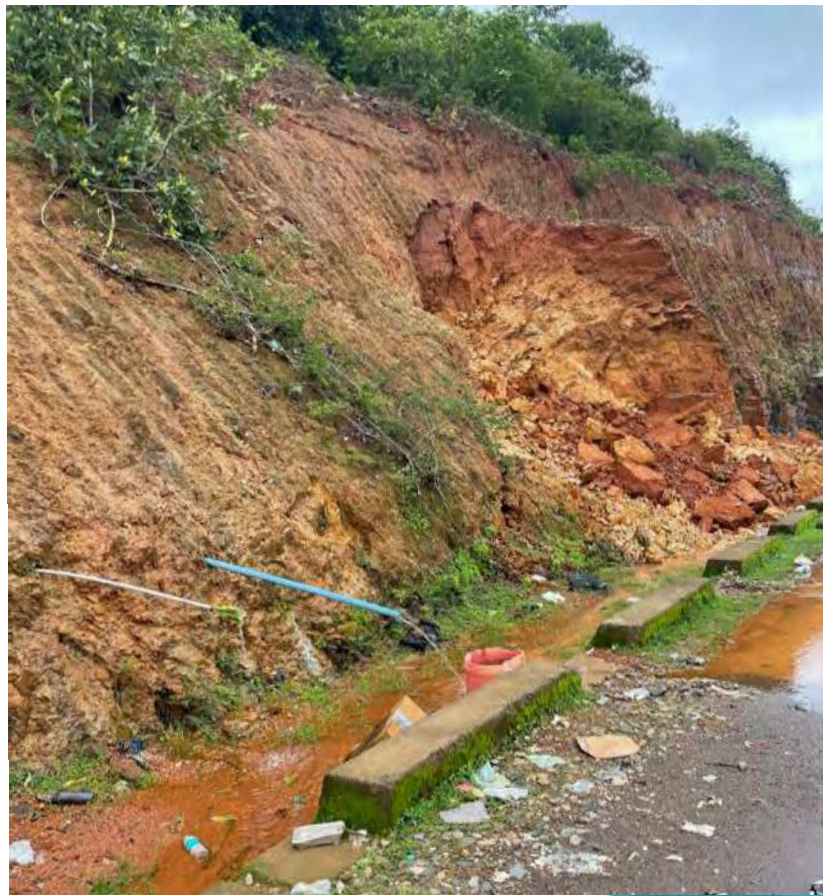
Charged hills can be provided with ample sub-surface drainage arrangements. Some sub-surface pipe drains can be seen here.

Low permeability Lithomargic clays create obstructions to otherwise porous and permeable lateritic matrix and can cause excess water pressure behind it and subsequent collapse.

Such clay masses are difficult to anticipate when in substrata. Some Geophysical tests may spot it.
