**BEFORE THE HON'BLE NATIONAL GREEN TRIBUNAL,  
SOUTHERN ZONE, CHENNAI**

**ORIGINAL APPLICATION NO. 261 OF 2024  
(EARLIER ORIGINAL APPLICATION NO. 1055/2024- PB)**

Tribunal on its own motion Suo Moto based on News Item titled "Unscientific work by NHAI led to Shirur landslide Geological Survey of India report" appearing in the Indian Express dated 02.08.2024

National Highways Authority of India & Ors.

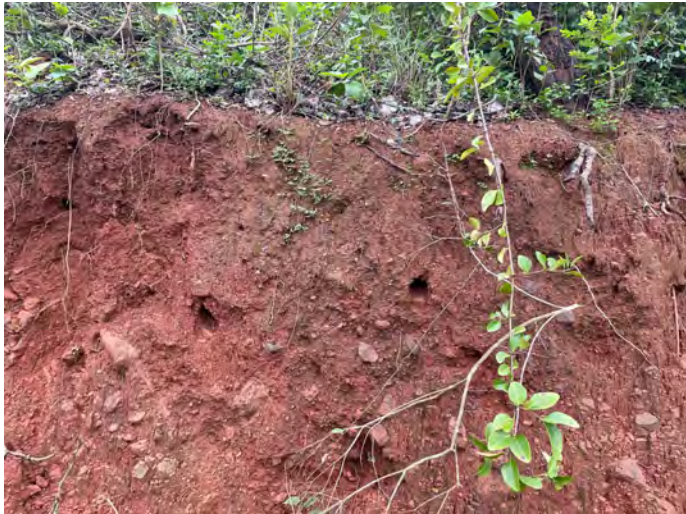
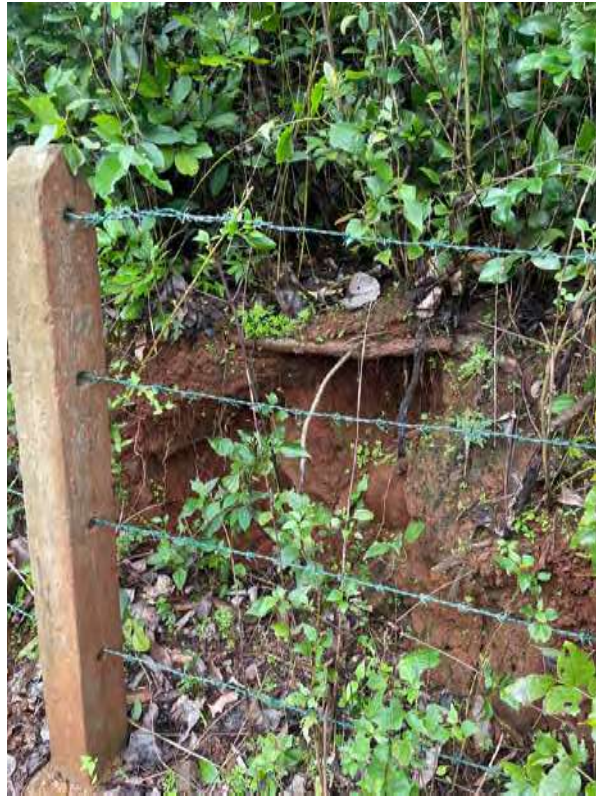
Various stages of piping phenomenon due to heterogeneous soil strata can be seen at different stage of evolution. At extreme stage even sink-holes are caused in similar strata.

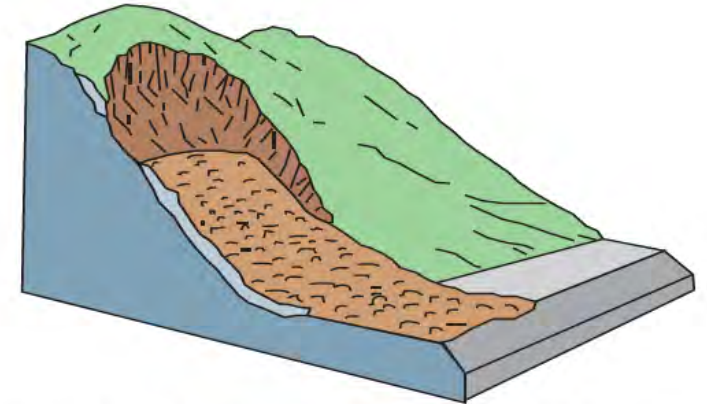
Figure 17. Schematic of a debris avalanche. (Schematic modified from Reference 9.)

The slope failure can be termed as Debris Avalanche with following definition

While above is true, we need to remember that it was not a natural landslide and by cutting steep, a critical triggering possibility was introduced.

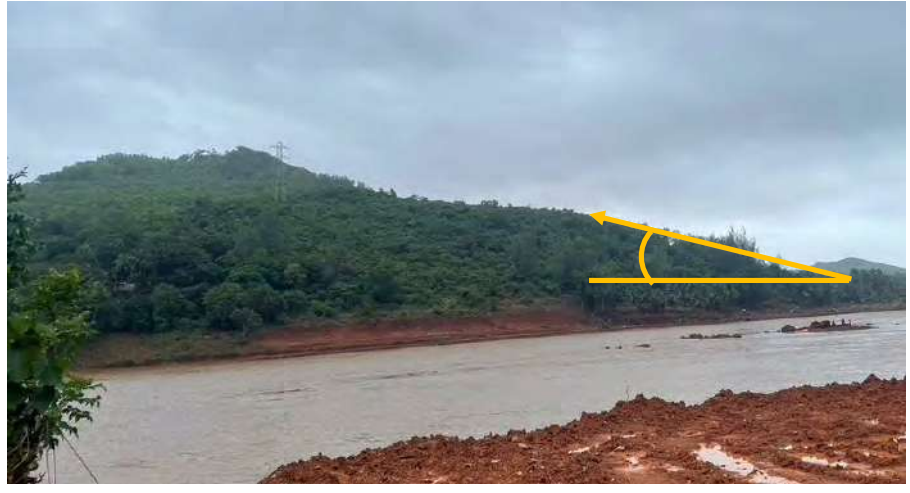
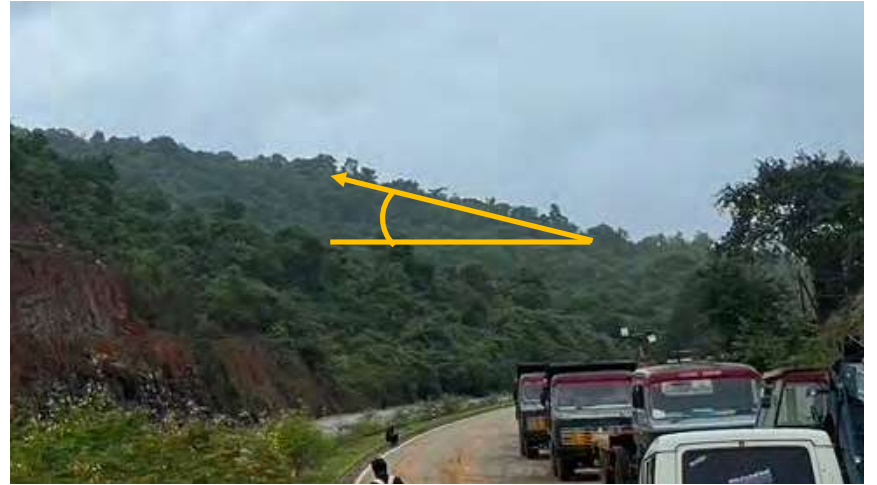
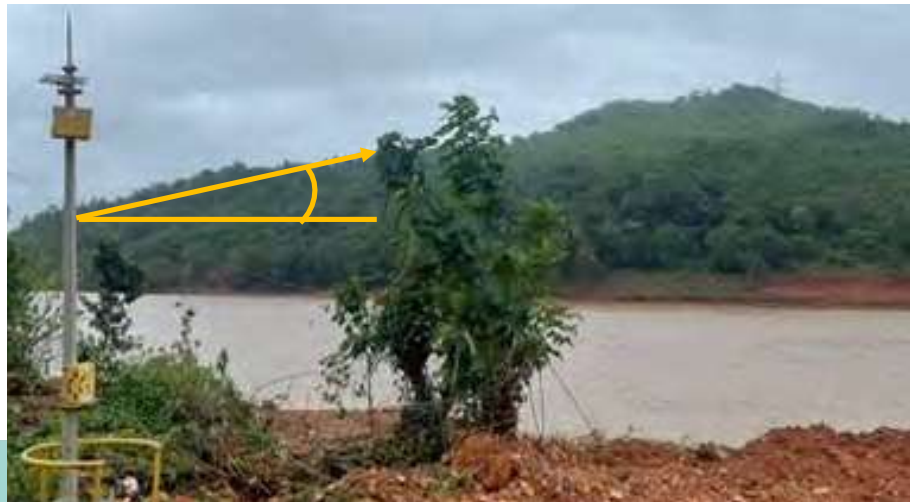
All Surrounding Hills are flat sloped and thus depict that natural repose angle of the formation matrix is low

**For failed slope at 148 –**

1. Flattening the top overburden portion to 2H:1V slope and greening it
2. Providing small toe structure at the junction of overburden and rock strata with drainage arrangement
3. Making berm at intermediate level with berm drain for collecting surface and sub-surface water and bringing it down with a cascade to merge with road side drain.
4. Once the rock strata cut is cleared explore a possibility of making anchored wall extending above the rock strata so that in case of future sloughing from top the failed mass can be contained behind the extended portion of wall.
5. A schematic section for mitigation measure is enclosed. Detailed design and further detailing on drainage and sizing etc will be required for implementation.

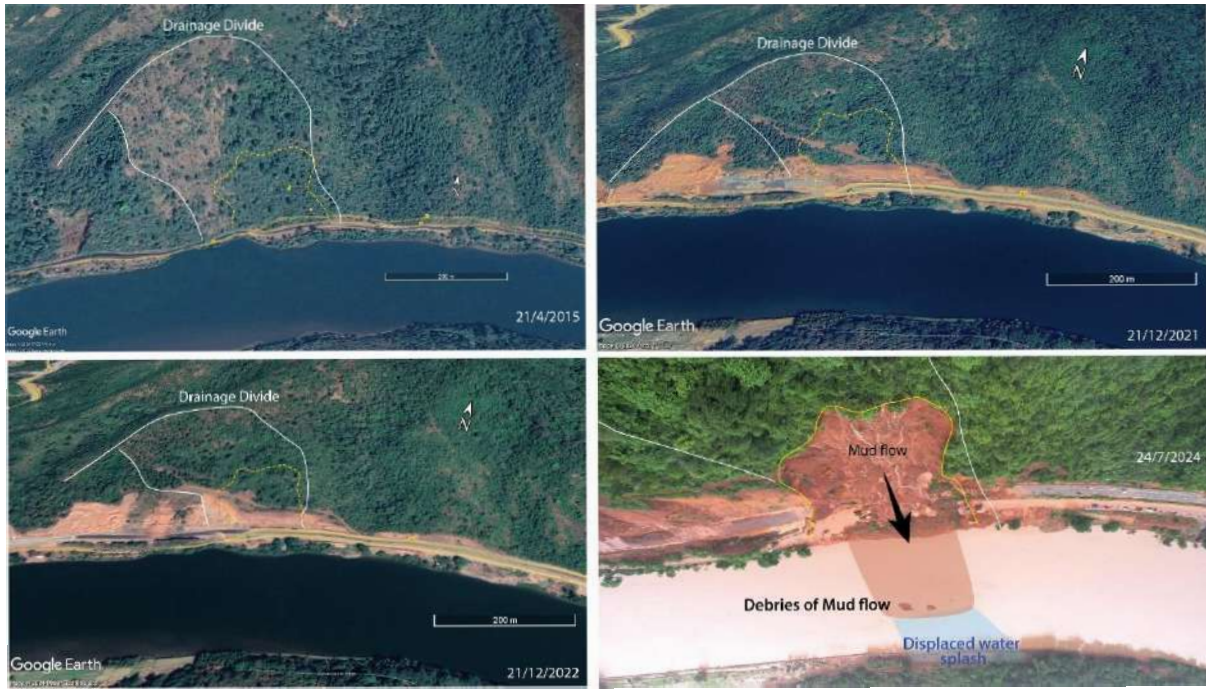
On 16<sup>th</sup> July 2024, a portion of the northern slope of the NH-66 between CH 147.950 km to 148.100 km developed a mudflow, which covered the road with the oversaturated mud-debris moving as far as >200m into the adjoining river. The rapid outburst of the Mud-debris flow has overwhelmed and buried/washed away a hut and a truck, along with ~10 people, into the river bed. The velocity and mass of the debris flow created a splash of water across the river with a wave height of >5m, affecting the southern bank (Fig. 1).

To understand the slope instability, it is imperative to understand the evolution of the slope vis a vis the construction of the NH-66. The historical Google images for the last ten years have been analyzed, which clearly points towards the removal of slope toe for extensions/construction of the NH-66 (Fig. 1). The pristine slope with the local watershed (21.4.2015) shows highly vegetated west-facing slope experienced toe cutting and modification (during 21.12.2021) and degradation of the lower slope. The expansion of vegetation cover in the catchment is also evident during the period. By 21.12.2022, the slope toe was further degraded with the excavation (following TSC-17 guidelines), and Mud (debris) flow during 16th July 2024 removed >50000 m<sup>3</sup> of highly saturated clay-lateritic soil.

Figure 1: The slope growth in the past decade with the construction of NH-66. (a) The pristine slope with the local watershed (21.4.2015) shows a highly vegetated west-facing slope, which was affected by slope failure during 2024 (marked with a dotted line). (b) The toe cutting and modification of the slope during 21.12.2021 clearly show degradation of the lower slope and expansion of vegetation cover. (c) The slope toe was further degraded during 21.12.2022 by excavation (following TCS-17 guidelines). (d) the occurrence of Mud (debris) flow during 16<sup>th</sup> July 2024, removing >50000 m<sup>3</sup> of highly saturated lithomarge clay

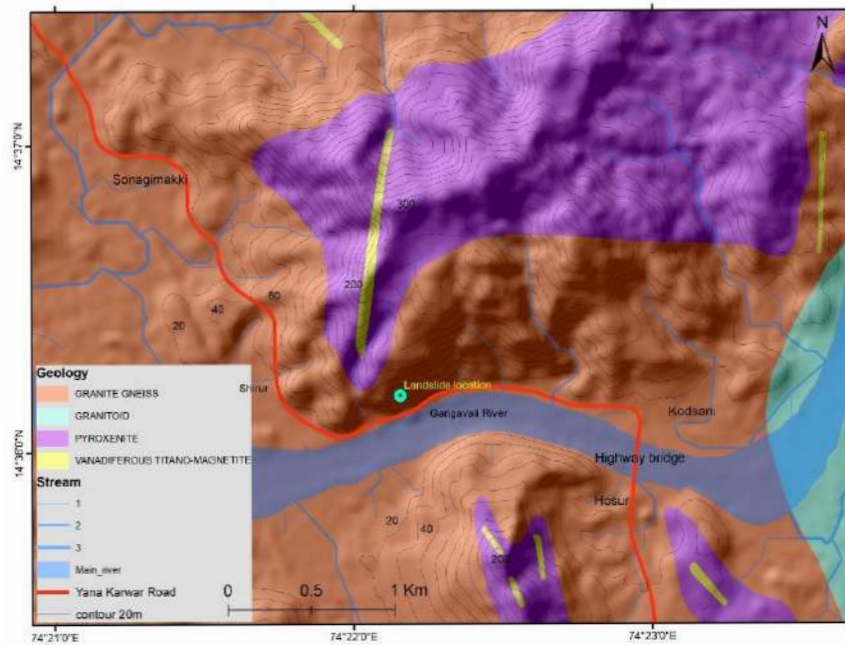
Figure 2: Geology of the landslide affected area.

The Lithomarge (lateritic soil) has well developed over the Precambrian granitic-gneissic basement in the affected region (Fig. 2). The presence of pyroxenite has highly ferruginous lithology, susceptible to weathering. The granitoids also occur in the upstream region.

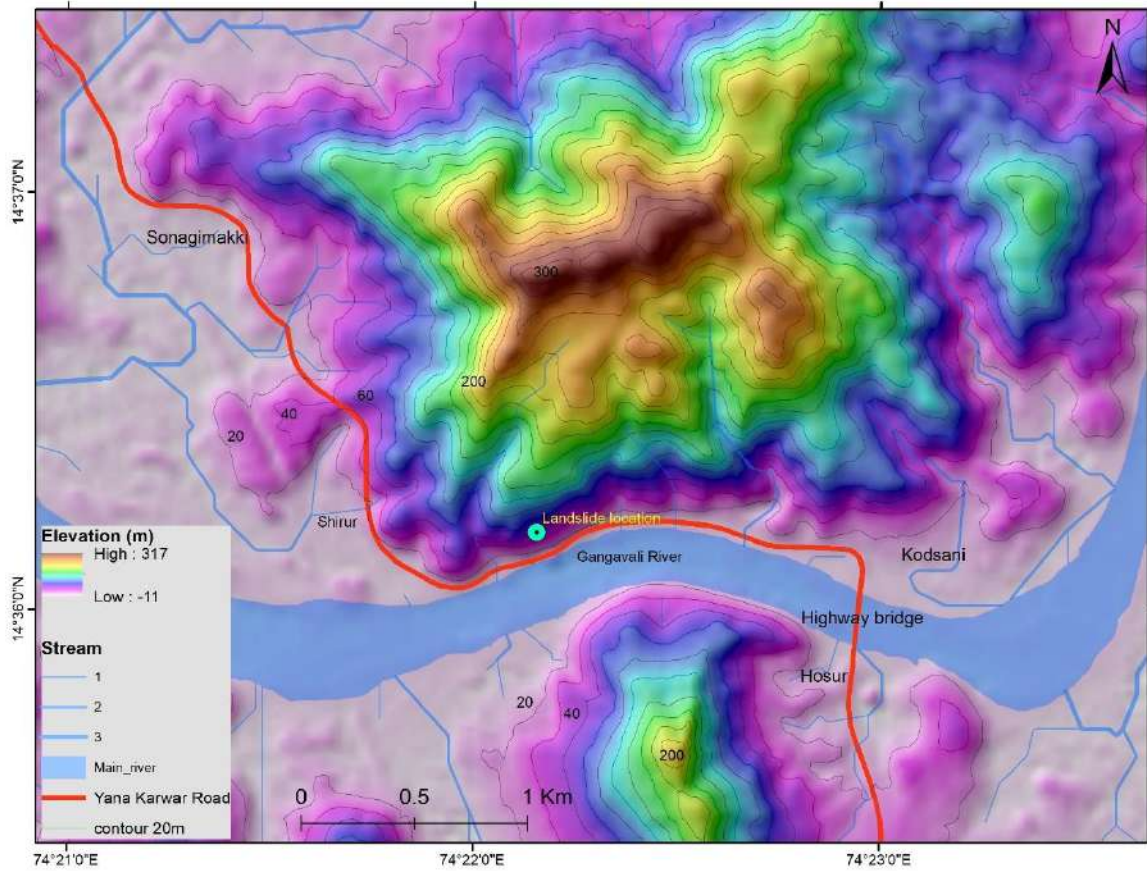
The landslide (mud-debris flow) occurs in the rugged northern slope of the Gangavali River, affecting areas up to >80m amsl (Fig. 3). The area constitutes of

Figure 3: The SRTM DEM of the Shirur area overlaid with the road alignment of NH-66.

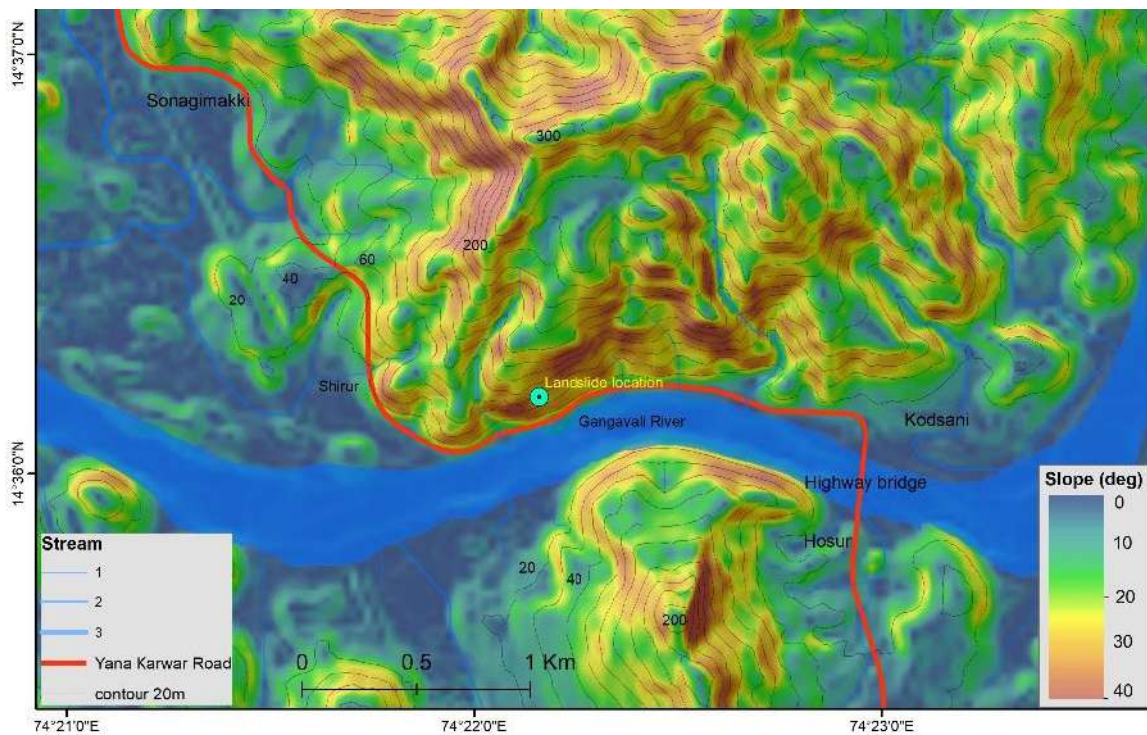
Figure 4: Slope map of the region derived from SRTM DEM data.

- The area affected by the landslide has, in general, a high slope.
- The aspect of the slope in landslide-affected regions is the S-SE direction.

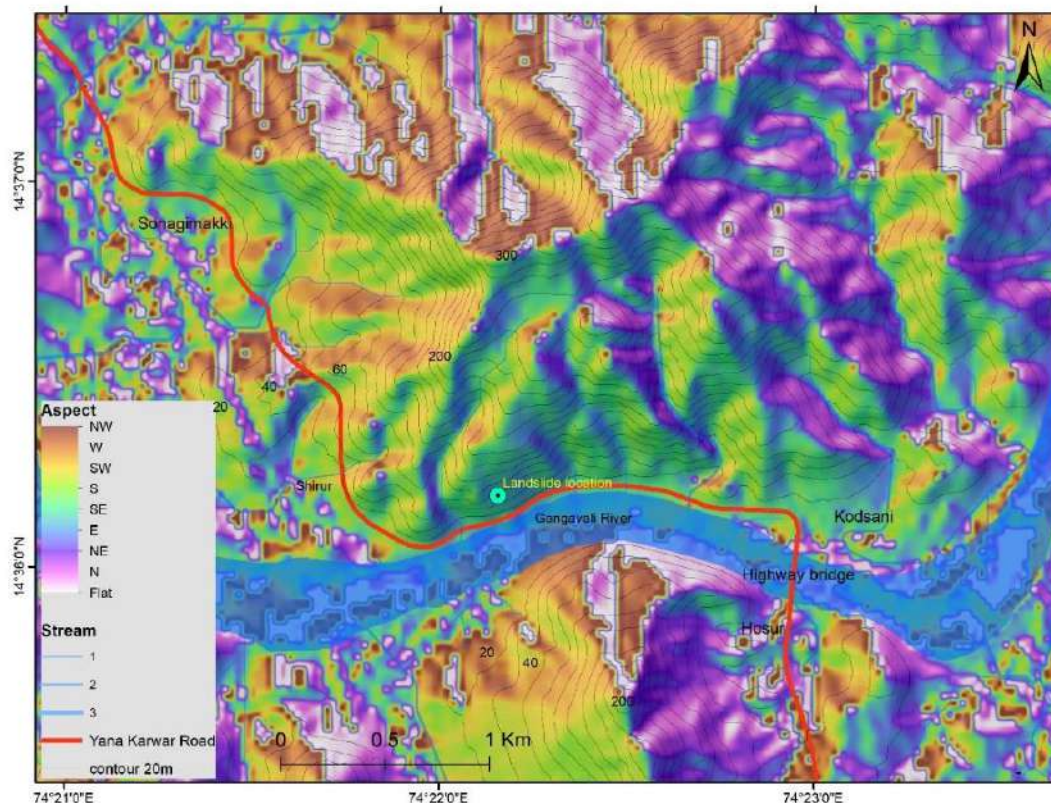
Figure 5: Slope aspect map of the region. Please note the landslide occurred in the S-SE facing slope.

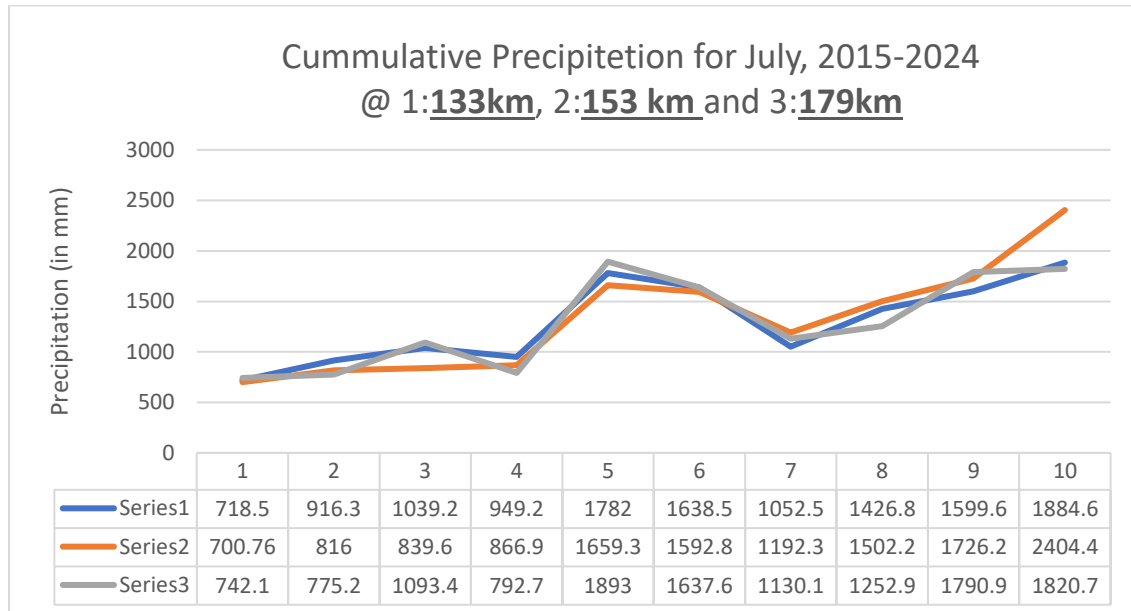
- The region experienced very high precipitation in the early fortnight of July 2024, which exceeded the limits of the past ten years.
- The landslide zone is being fed by infiltration from the upstream region.

Figure 7: Cummulative precipitation for the month of July from 2015 to 2024 at locations surrounding the landslide zone. Please note the high rain in the series 2. Also, note that the data for July 2024 is only for 24 days.

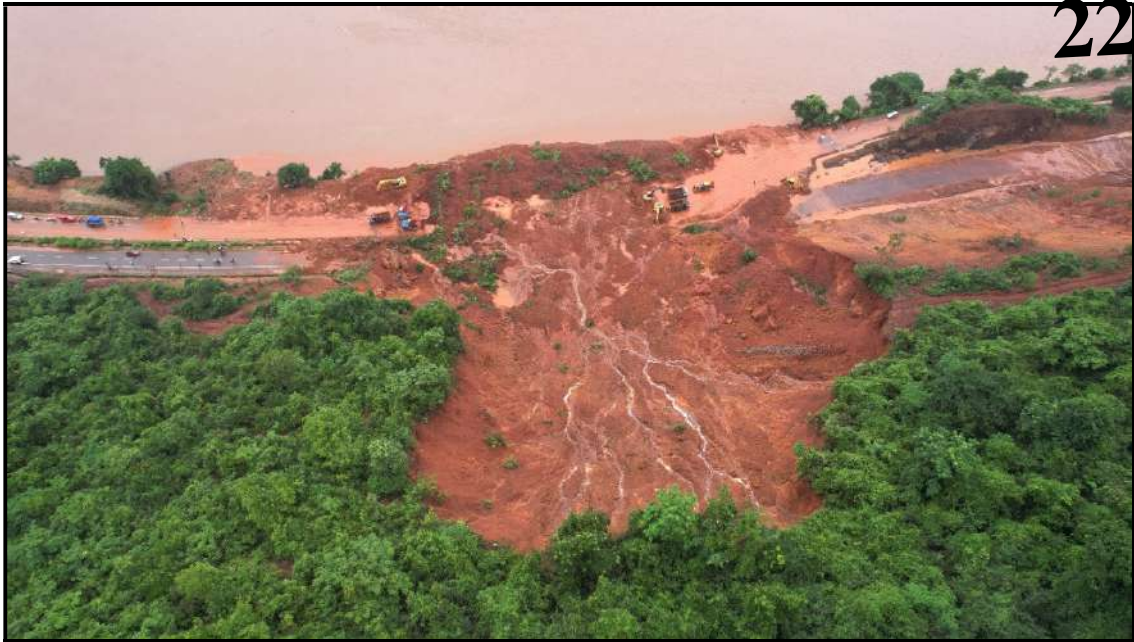
Fig. 1.2: Aerial view of Shirur landslide blocking the communication corridor NH-66 (courtesy IRB)

The landslide resulted in ten fatalities and washed away two gas tankers and one truck. Additionally, a semi-permanent hotel structure was destroyed. The debris from the landslide travelled over 200 meters, eventually depositing into the Ganagavali River, creating an impact wave that demolished four houses on the opposite bank. The scar left by the landslide measured approximately 150 meters in length, 120 meters in width, and 60 meters in height, with the total volume of debris exceeding 100,000 cubic meters (Fig. 1.2).

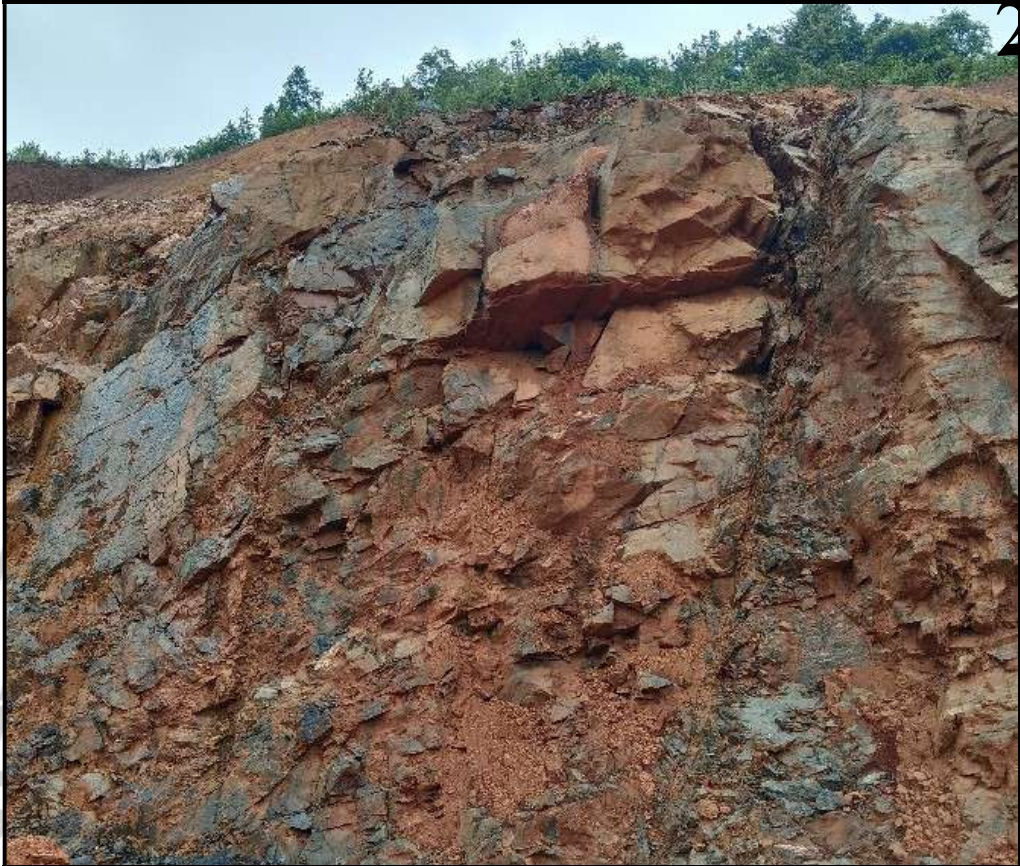
The site is mainly comprised of Pyroxenite of the Motimakki Ultramafites (Fig. 1.3). The base of the landslide exposes medium to coarse-grained, dark green to black pyroxenite with high specific gravity, dominated by pyroxenes that exhibit a characteristic luster on the cleavage surfaces. Intermittent pegmatite intrusions, 5-10 meters wide, are present on both flanks of the slide. These pegmatites are highly weathered, forming whitish clay (Fig. 1.4). The depleted zone of the landslide has greenish-tinted, medium to coarse-grained boulders, rich in olivine, and showing serpentinization. Vanadiferous titanomagnetite bodies are observed at higher elevations above the landslide, composed mainly of magnetite with subordinate plagioclase, exhibiting banding and high specific gravity. The flanks and crown area also expose large laterite boulders.

Fig. 1.3: Pyroxenite exposed at the base of cut slope section near Shirur landslide

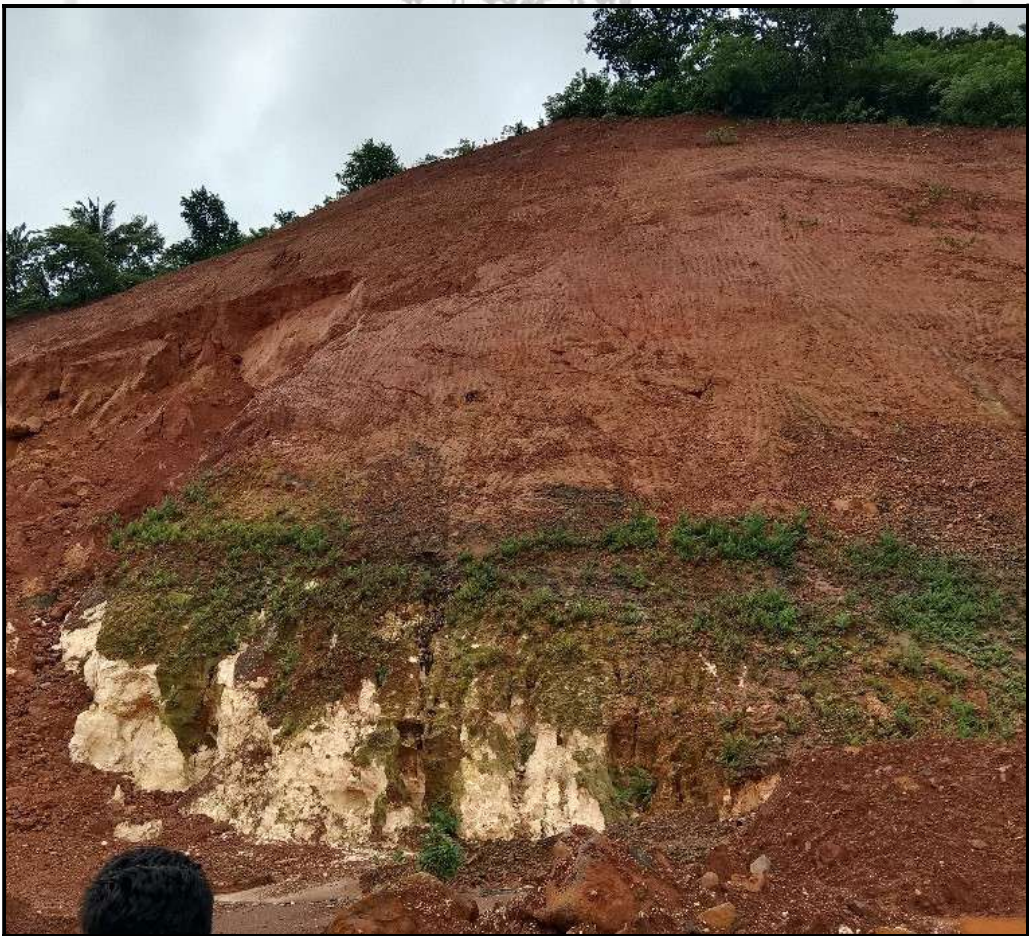
Fig. 1.4: Weathered pegmatite forming whitish clay Kaolinite

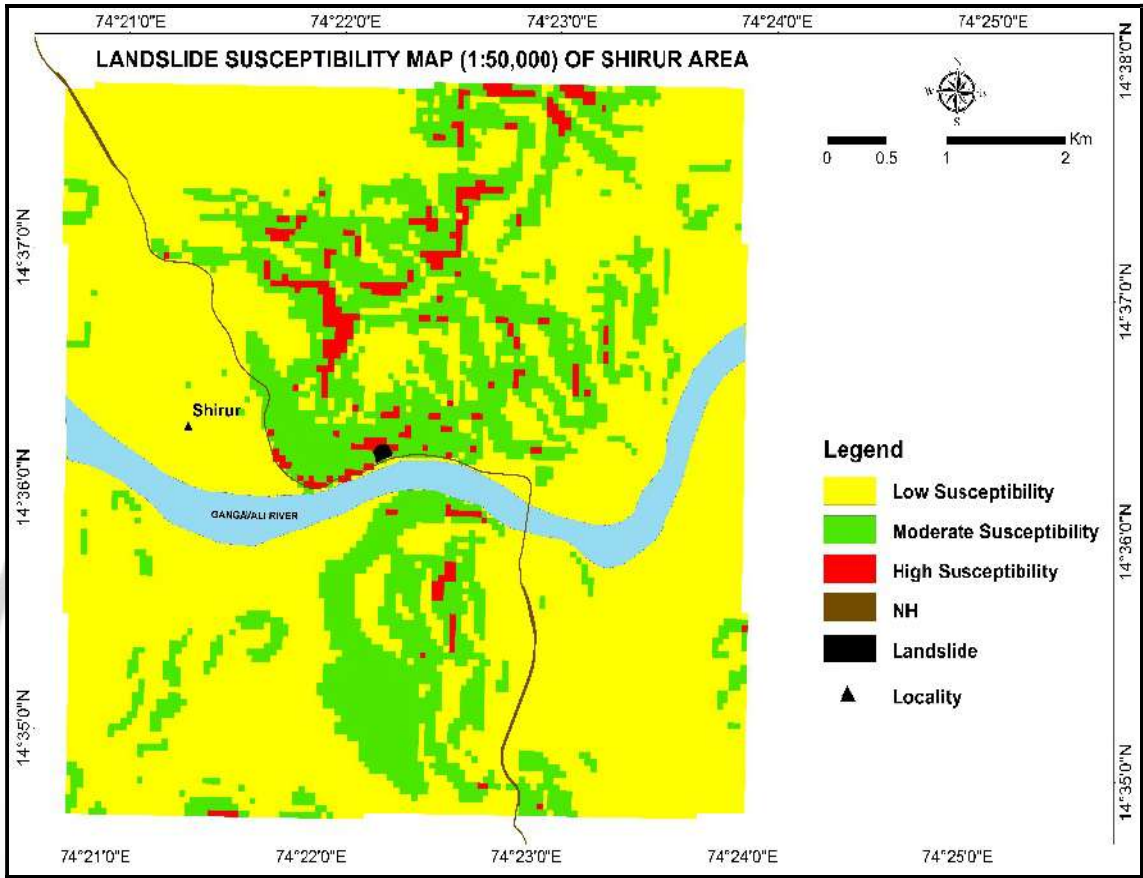
Fig. 1.6: Landslide Susceptibility Map of Shirur area, (NLSM GSI)

The slope sector from Chainage 147.400 to 148.200 shows moderate to high susceptibility according to the National Landslide Susceptibility Map (NLSM) of GSI (Fig. 1.6). Multi-temporal satellite imagery indicates anthropogenic interference on the slopes from

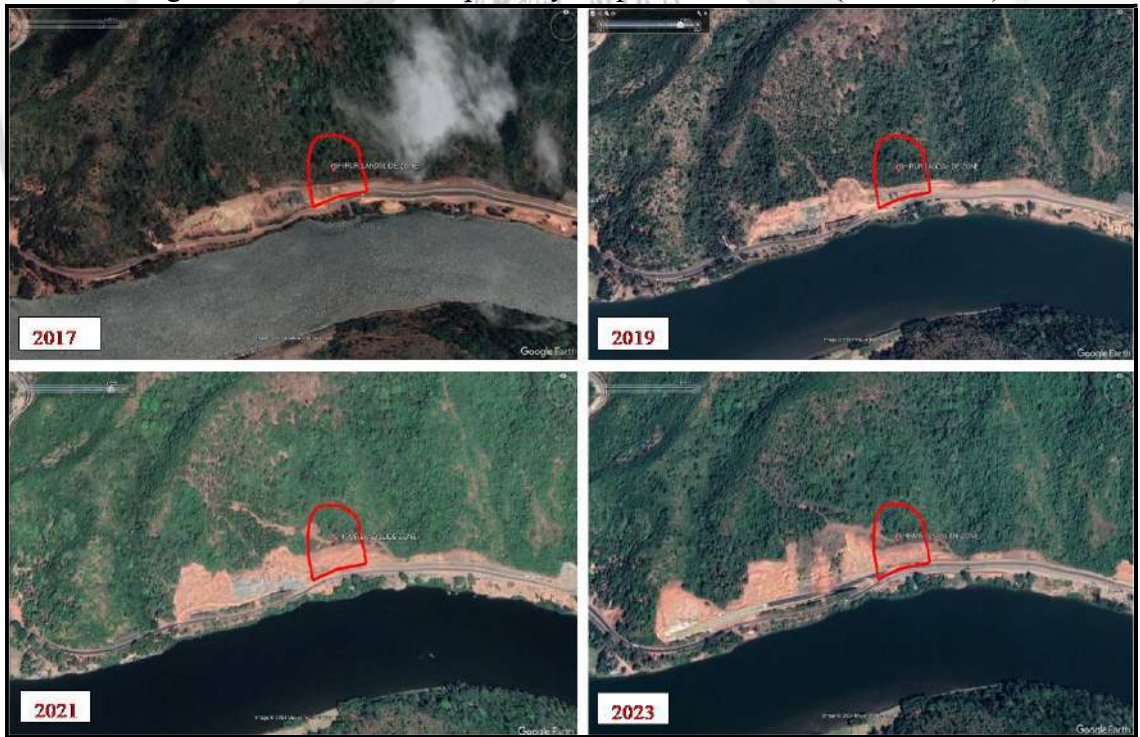
Fig. 1.7: Multi-temporal satellite imageries of Shirur

Chainage 147.400 to 148.200 since 2017, exacerbating some landslide scars above the slopes (Fig.1.7).

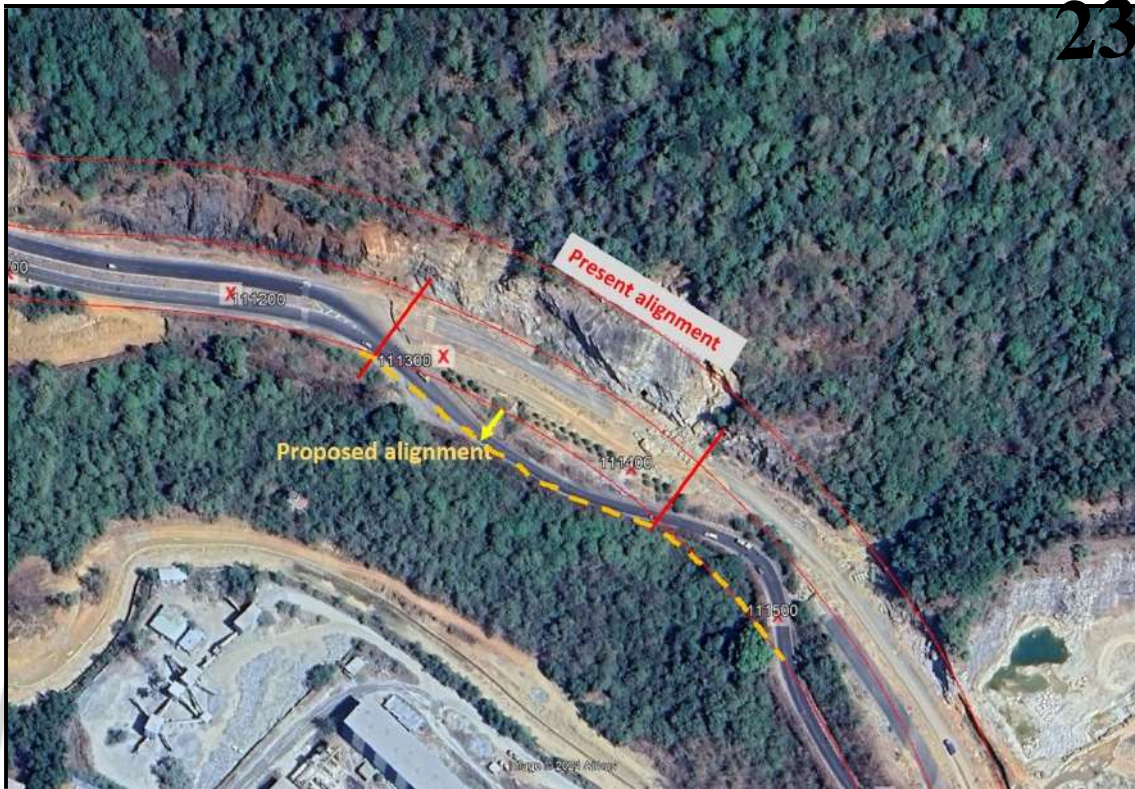
Fig. 2.4: Proposed alignment to mitigate the direct risk of rockfalls

At chainages 111.300 to 111.400 where the relative relief is very high and the road cut is steep, the rocks are highly jointed with some having near vertical dips. The rocks also exhibit exfoliation joints which are formed due to repeated heating and thawing of the rocks. The intersection of these two planes produces blocks, which fall along the slope (Fig. 2.3). The stretch requires a detailed study to figure out engineering solutions such as rock bolting intervals, shotcreting, etc. However, if the land is available, a slight deviation (20m) in the road alignment towards the south western side away from the vertical slope cut can be considered after detailed studies to minimize the risk factor associated with rock falls (Fig. 2.4).

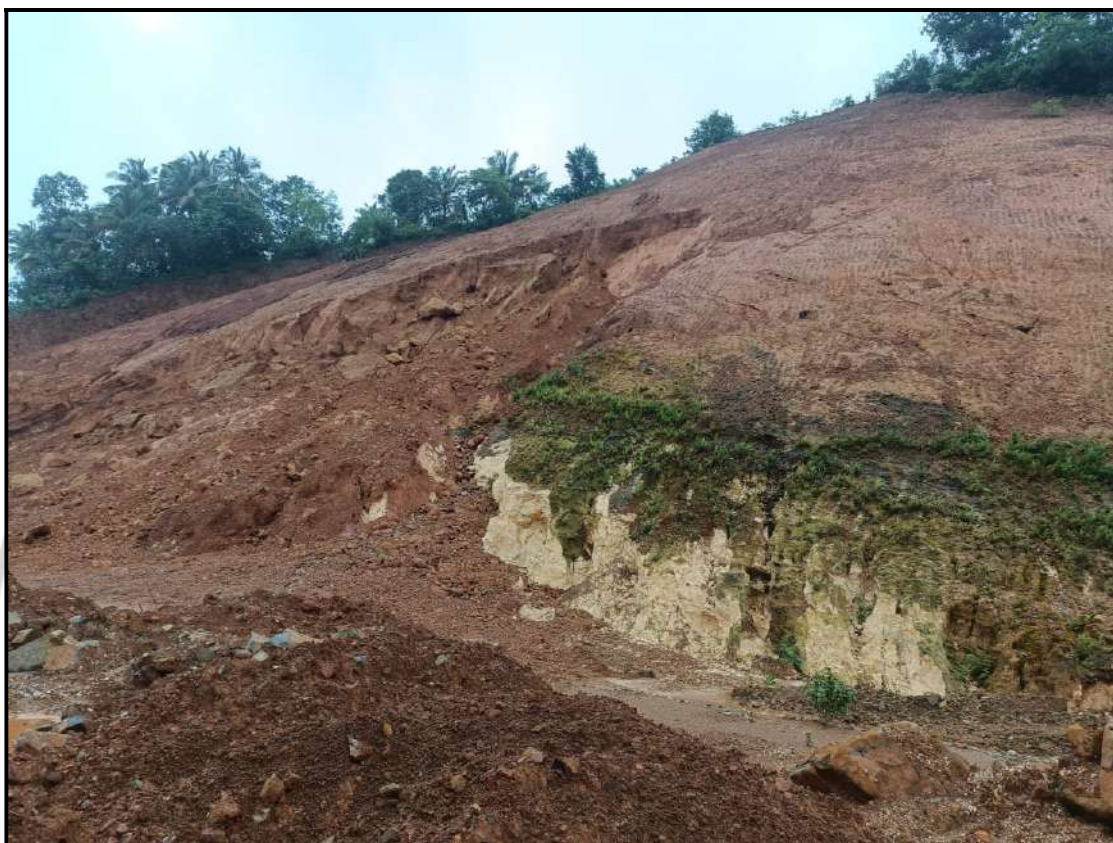
Fig. 2.5: Variability in lithounits near the right flank of the Shirur landslide

The ultramafic rocks are susceptible to a high degree of weathering. The thickness of debris and lithomarge would be higher as compared to areas occupied by granitic rocks. There is also a considerable variability in the litho units exposed from bottom to top as is typical in such layered complexes. The weathered rock horizon and soil also show vertical variability where the top of the hill is characterized by ferruginous laterite and the middle part shows lateritic clay-rich horizons. The clay layers have lesser permeability, leading to water accumulation in the column. Slope cuts in this region should be kept to a minimal height as possible so that the exposed cut slopes can be stabilized by providing good drainage and retaining structures. Benching of slopes alone is not an effective slope stabilization method as observed in the Shirur site. Shotcreting in such thick debris cover also would be ineffective. The landslide management strategy in such cases should be to minimize the slope cut height

by shifting the alignment wherever land is available and providing efficient surface and subsurface drainage solutions. 236

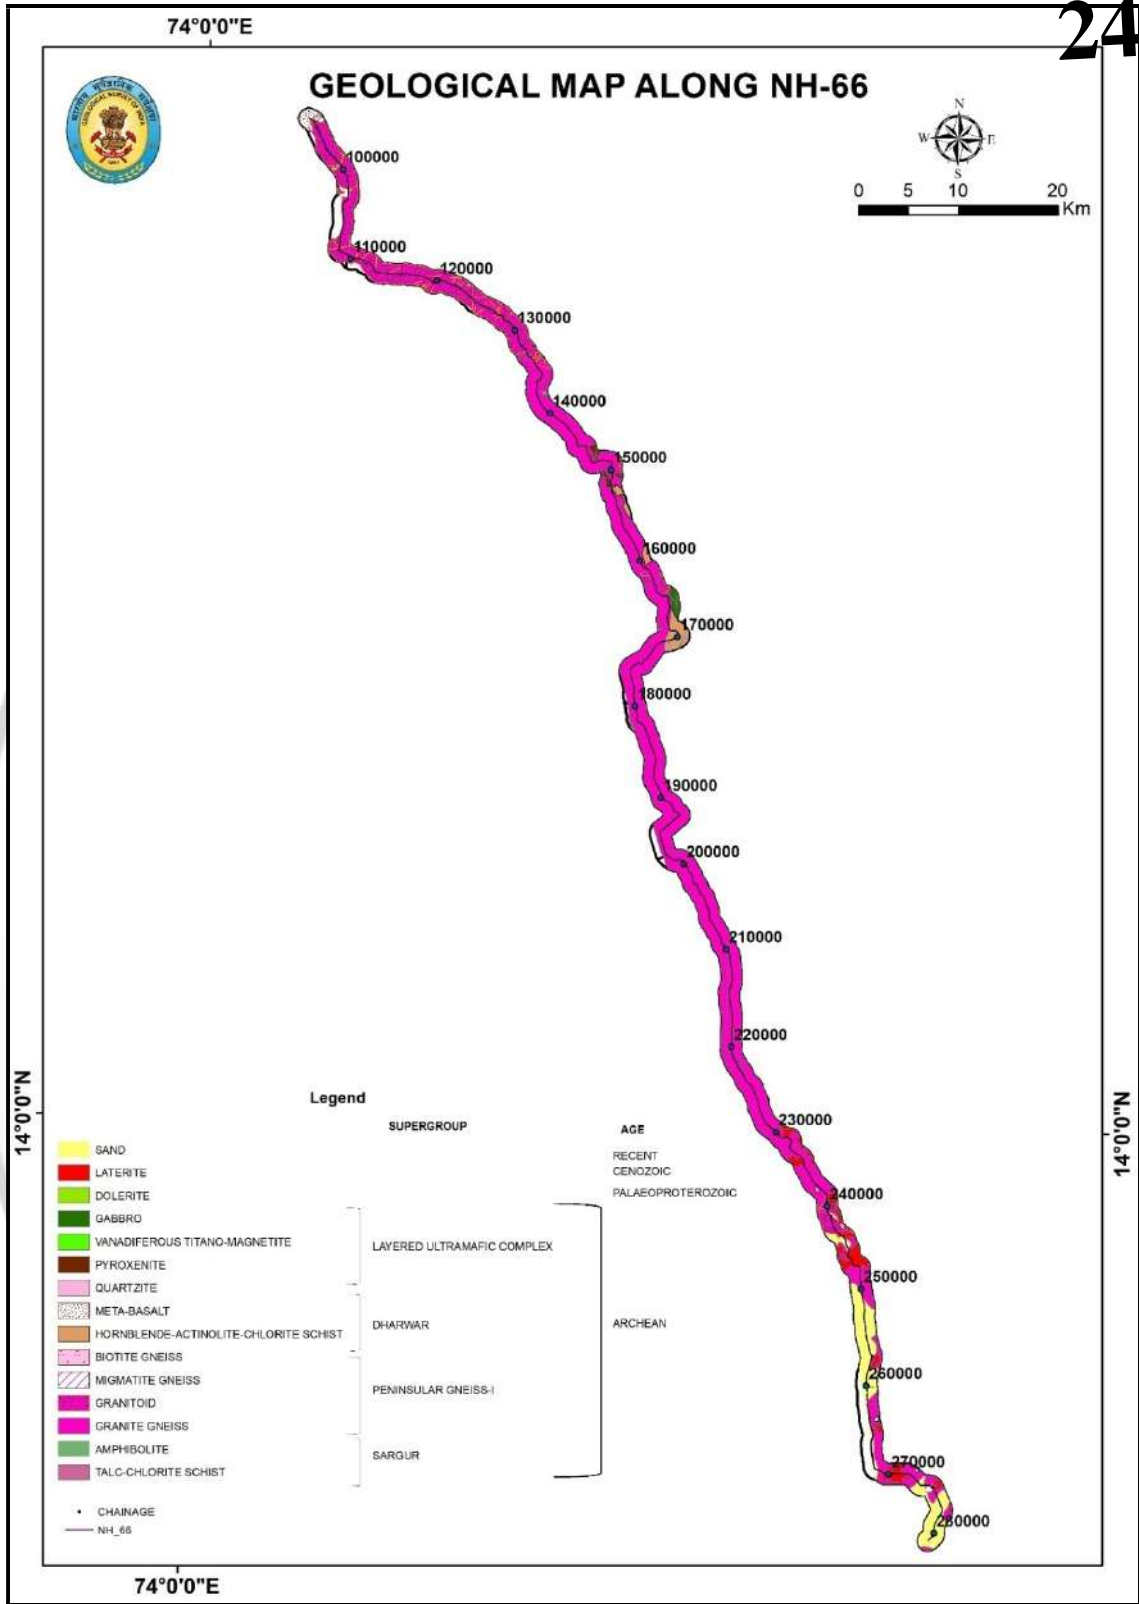
Fig. 2.10: Geological map of the road corridor

The highway passes through the western margin of Western Ghat mountain ranges and has a few sections where the hill slopes had to be cut to make way for the road corridor. The major geological unit exposed in the corridor is the Peninsular Gneissic Complex (PGC), a suite of rocks with mainly granitic composition. The corridor also cut through various mafic and ultramafic rock units at different locations (Fig. 2.10).

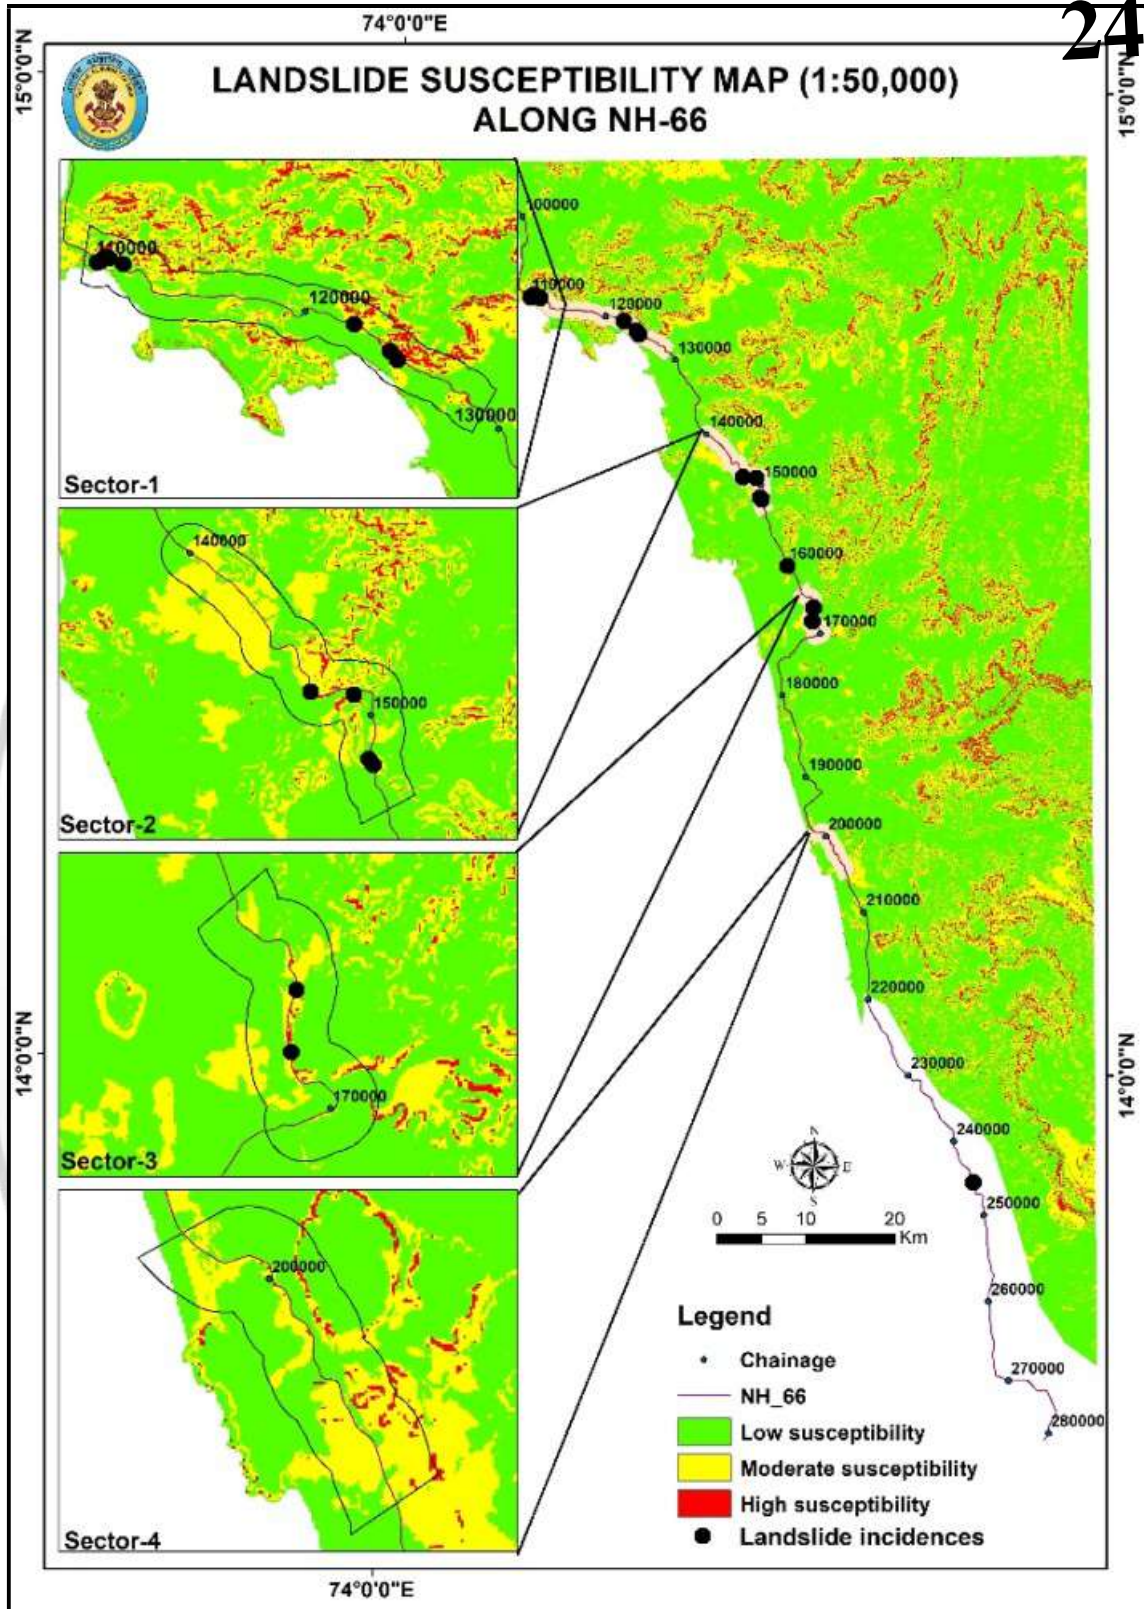
Fig. 2.11: Landslide susceptibility map of the road corridor

The landslide susceptibility map, produced after the National Landslide Susceptibility Mapping (NLSM) of GSI in 1:50,000 scale, is available for the road corridor up to 220.000 chainages (Fig. 2.11). Most of the landslide incidences in the corridor have occurred in moderate to high landslide susceptibility areas. The road corridor was divided into four sectors, each with unique slope instability scenarios and contributing factors.

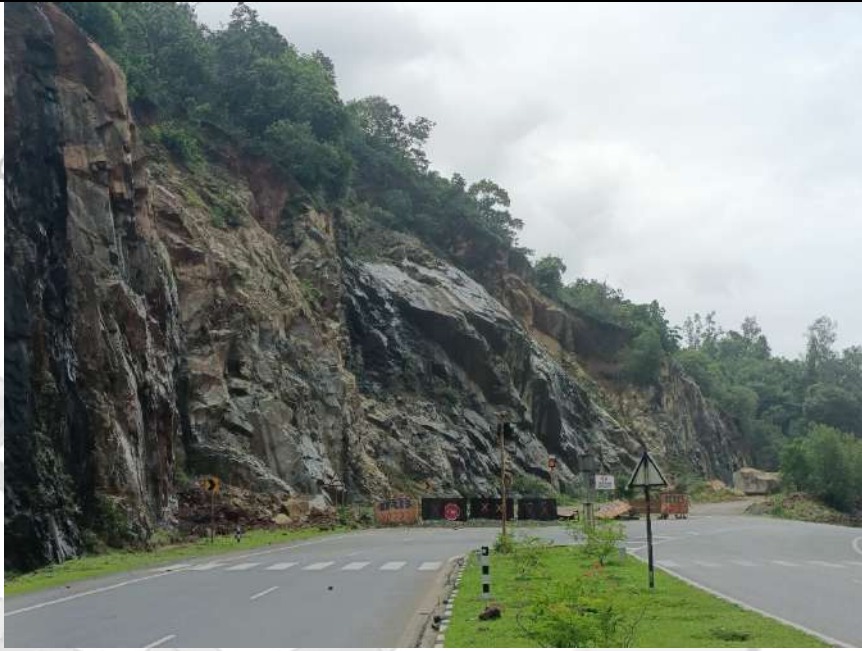
| 38 | Remarks, if any | The area is highly susceptible to rock falls. Traffic may continue in the old parallel alignment and only be resumed after geotechnical interventions are made in the slope |

| 37 | Remedial measures | Detailed studies are required along the Chainage 111.300 to 111.450. Precarious blocks may be removed and adequate support measures like proper netting should be provided for the slope. |

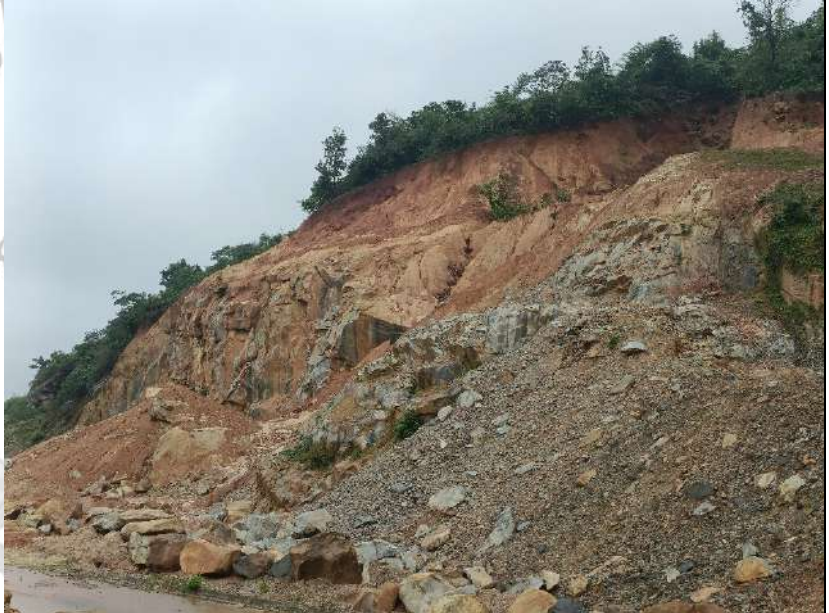
| 38 | Remarks, if any | The location has chances for further landslides |

| 37 | Remedial measures | Easing of the slope of the debris layer. Providing erosion control mats like geo jute with suitable grass variety plantation can be an effective solution for such slopes |

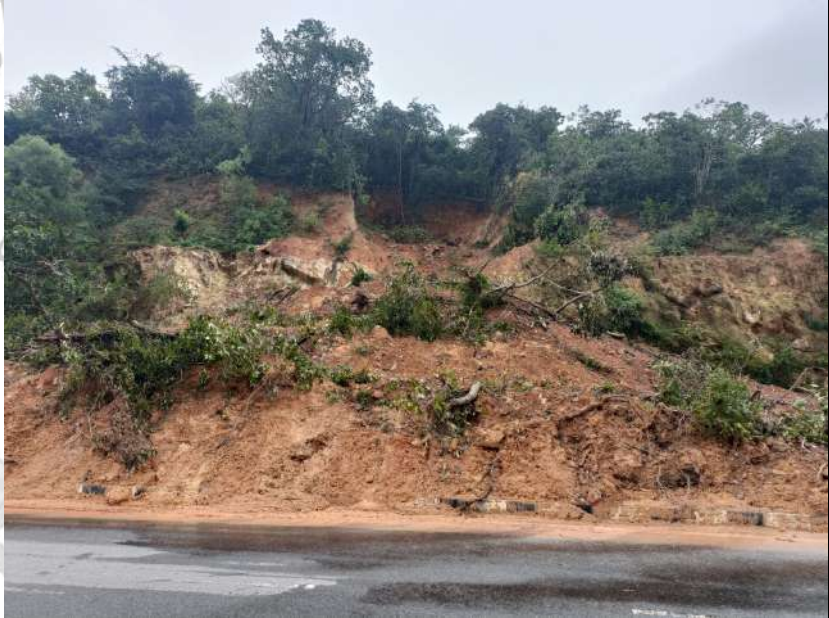
| 38 | Remarks, if any | The area is susceptible to similar failures in the future. |

| 37 | Remedial measures | Remove the debris from the run-out zone. Any further slope modification without detailed studies is not recommended. |

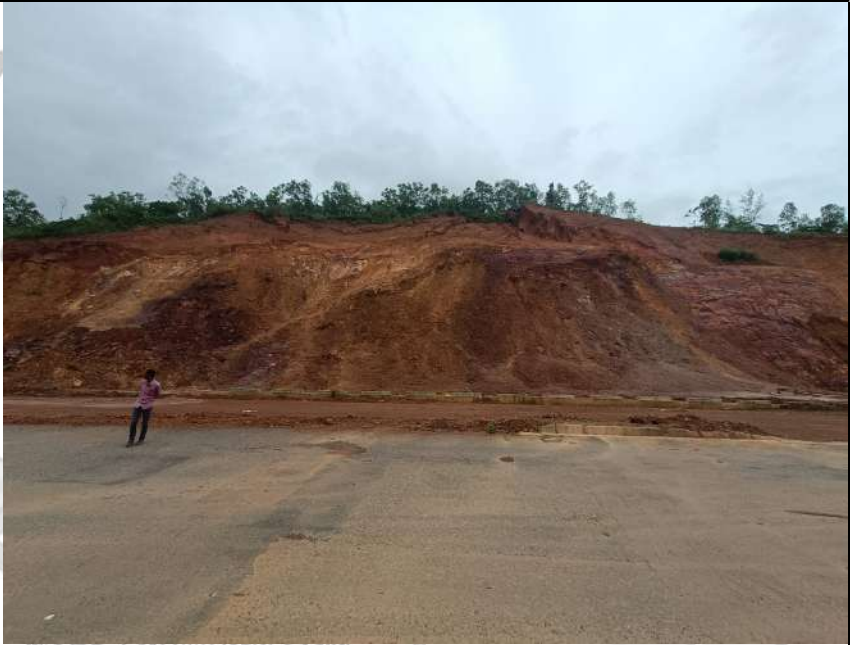
| 38 | Remarks, if any | The latest drone footage has revealed a major scar developed. |

| 37 | Remedial measures | A detailed study on the slope section is recommended with emphasis on drainage management, slope geometry modification and structural support measures. Since the slide scar has almost reached the hilltop, major retrogression may not occur, but widening of the slide is likely |
