O.A.261 OF 2024

Suo moto News Item titled "Unscientific Work by NHAI led to Shirur landslide Geological Survey of India Report appearing in the Indian Express dated 02.08.2024

REPORT ON
SHIRUR LANDSLIDE, ANKOLA TALUK, UTTARA KANNADA DISTRICT,
KARNATAKA
&
LANDSLIDE SUSCEPTIBILITY ALONG NH-66 (KARWAR TO NORTH OF BAINDUR)

M4LS/NC/SR/SU-KG/2024/50072

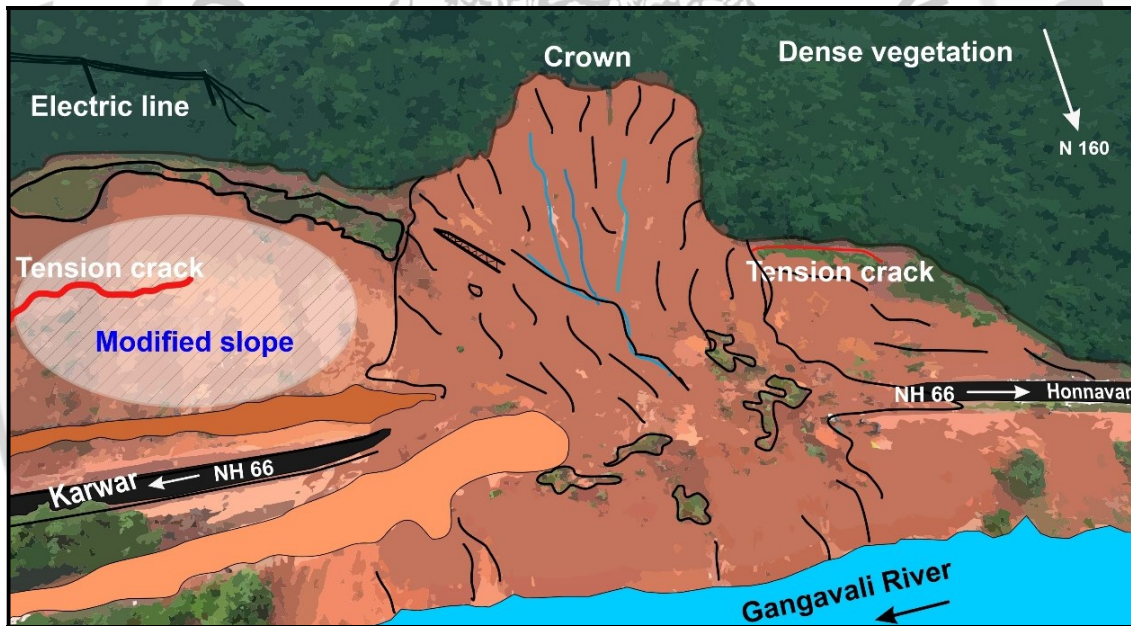
Fig. 1.1: Schematic sketch of Shirur landslide (Not to scale)

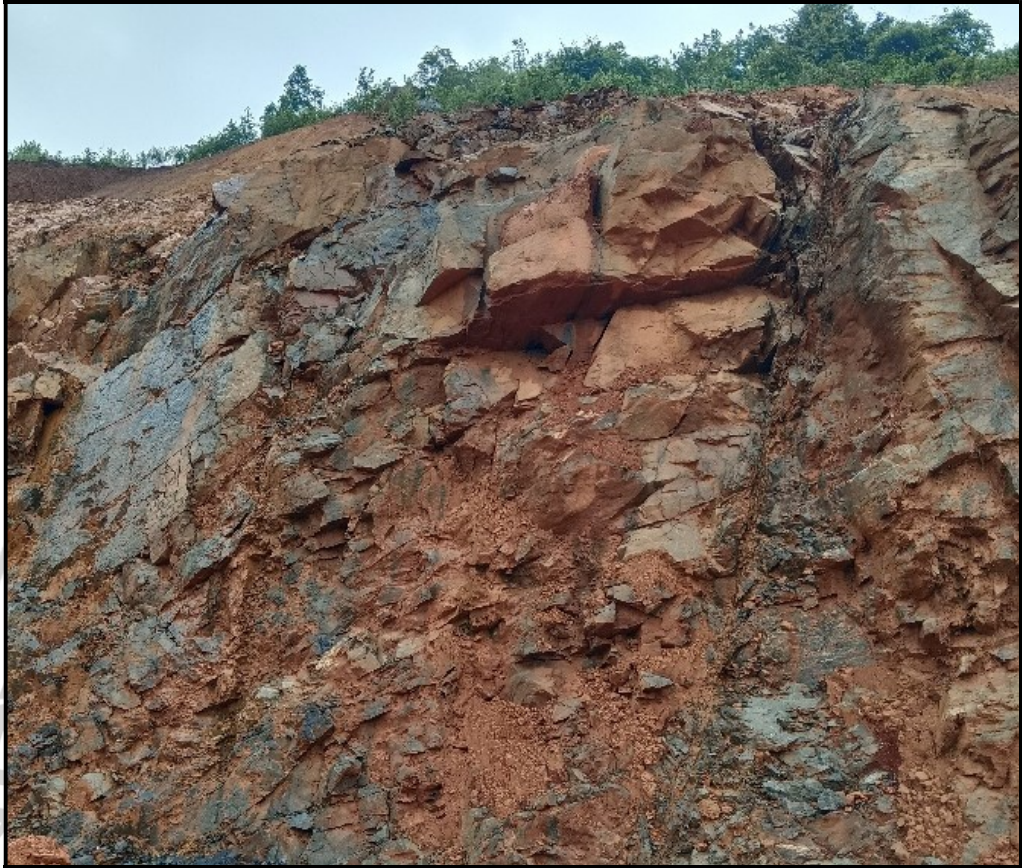
The site is mainly comprised of Pyroxenite of the Motimakki Ultramafites (Fig. 1.3). The base of the landslide exposes medium to coarse-grained, dark green to black pyroxenite with high specific gravity, dominated by pyroxenes that exhibit a characteristic luster on the cleavage surfaces. Intermittent pegmatite intrusions, 5-10 meters wide, are present on both flanks of the slide. These pegmatites are highly weathered, forming whitish clay (Fig. 1.4). The depleted zone of the landslide has greenish-tinted, medium to coarse-grained boulders, rich in olivine, and showing serpentinization. Vanadiferous titanomagnetite bodies are observed at higher elevations above the landslide, composed mainly of magnetite with subordinate plagioclase, exhibiting banding and high specific gravity. The flanks and crown area also expose large laterite boulders.

Fig. 1.3: Pyroxenite exposed at the base of cut slope section near Shirur landslide

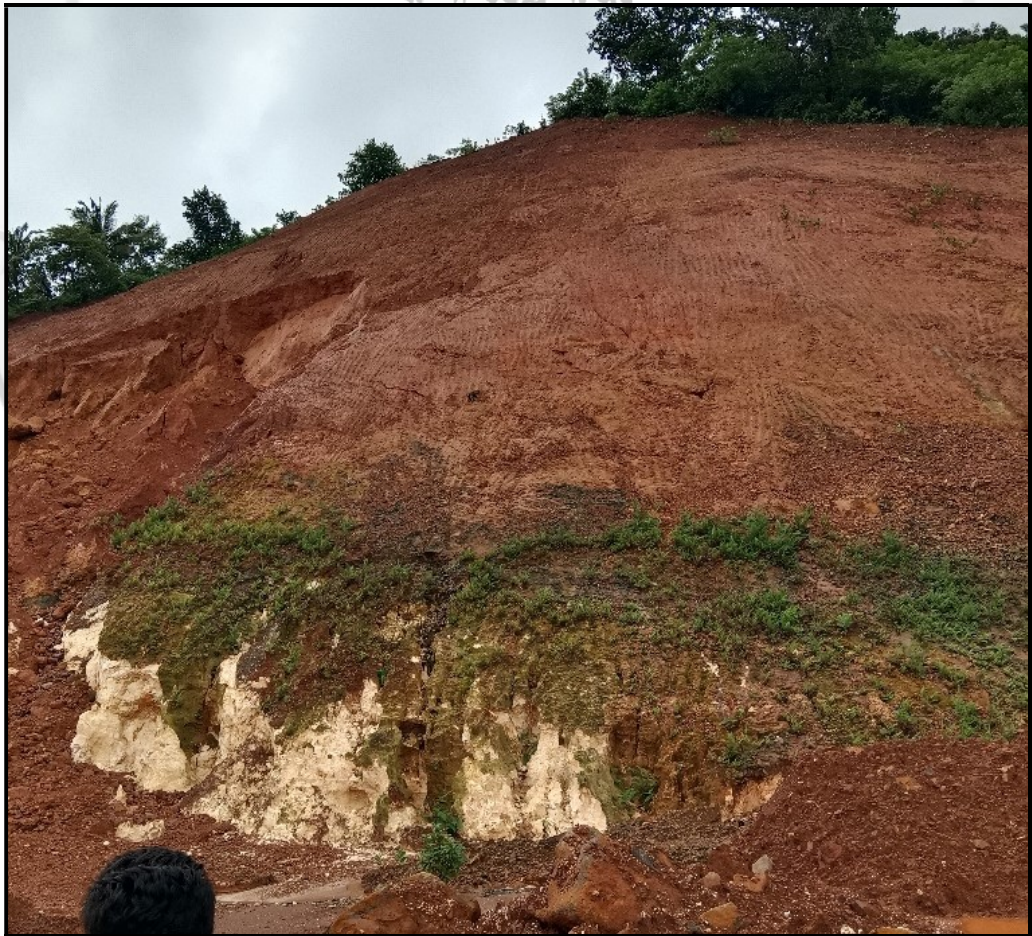
Fig. 1.4: Weathered pegmatite forming whitish clay Kaolinite

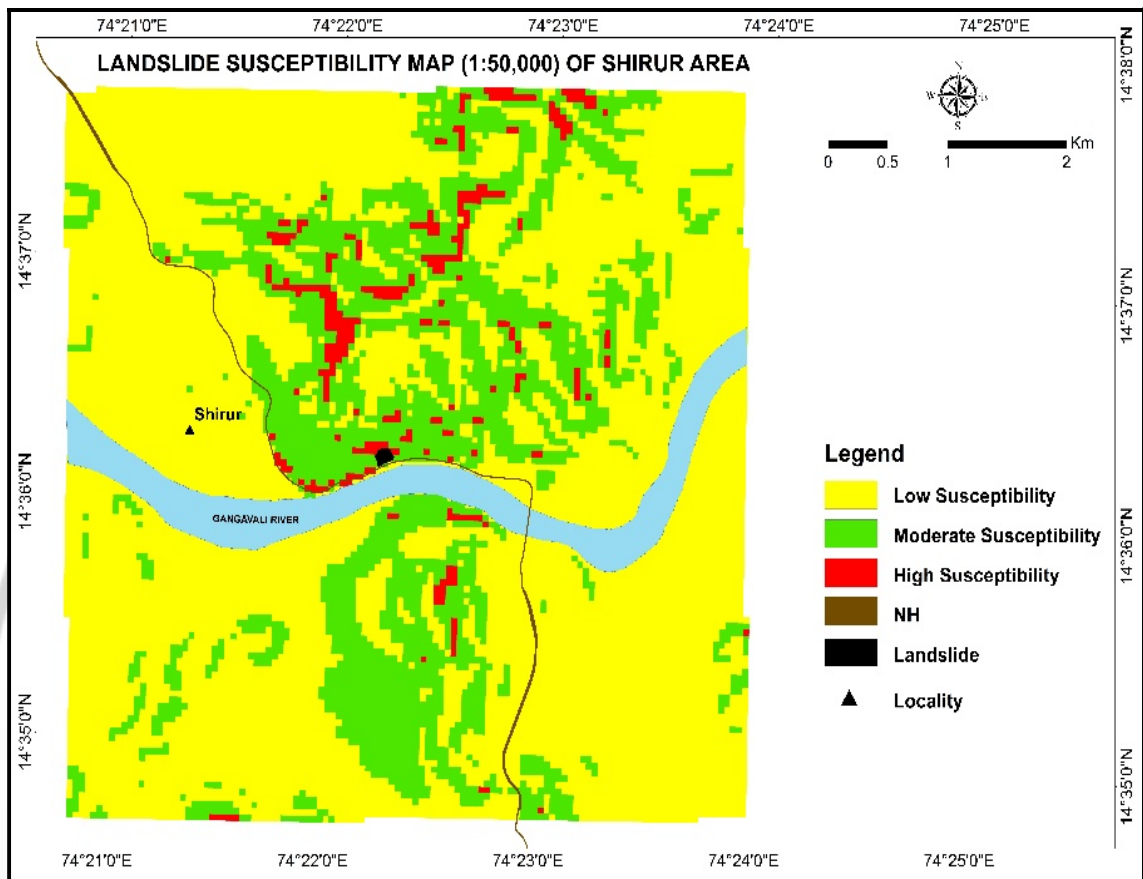
The slope sector from Chainage 147.400 to 148.200 shows moderate to high susceptibility according to the National Landslide Susceptibility Map (NLSM) of GSI (Fig. 1.6). Multi-temporal satellite imagery indicates anthropogenic interference on the slopes from

Fig. 1.6: Landslide Susceptibility Map of Shirur area, (NLSM GSI)

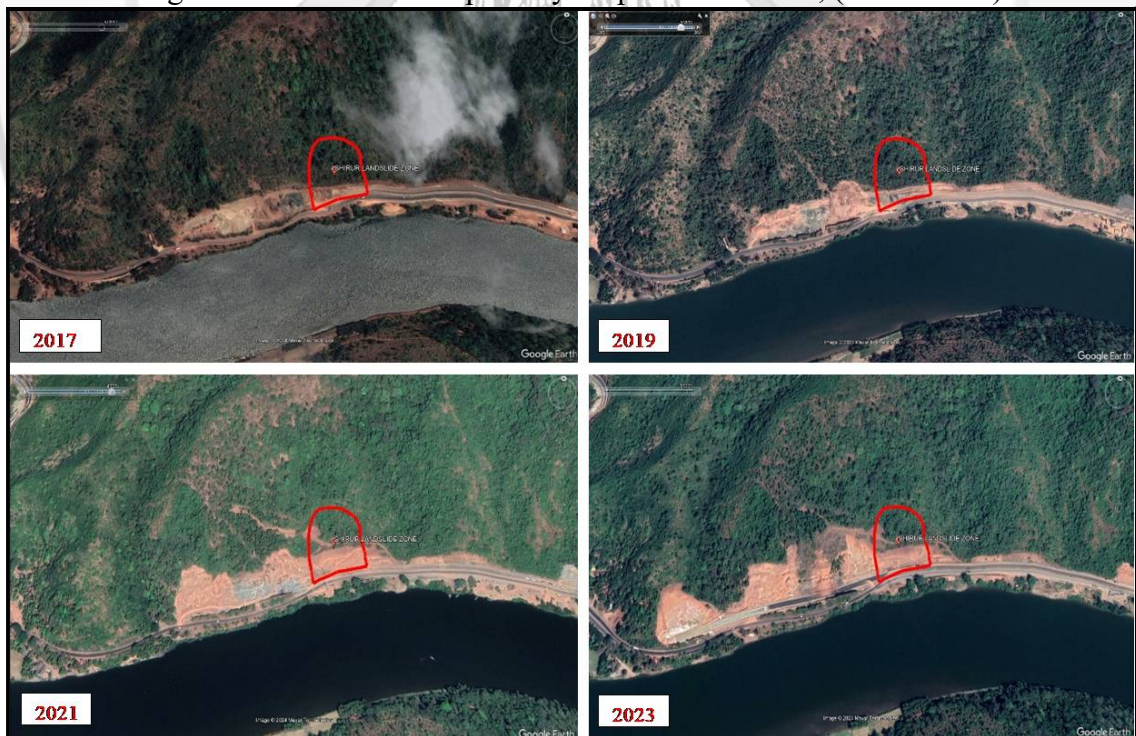
Chainage 147.400 to 148.200 since 2017, exacerbating some landslide scars above the cut slopes (Fig.1.7).

Fig. 1.7: Multi-temporal satellite imageries of Shirur

Multi-temporal satellite imagery has shown significant anthropogenic interference with the slopes since 2017. Continuous slope modifications and the presence of landslide scars above the cut slopes have exacerbated the slope's vulnerability. The lack of proper retaining structures further destabilized the area, increasing the risk of slope failure.

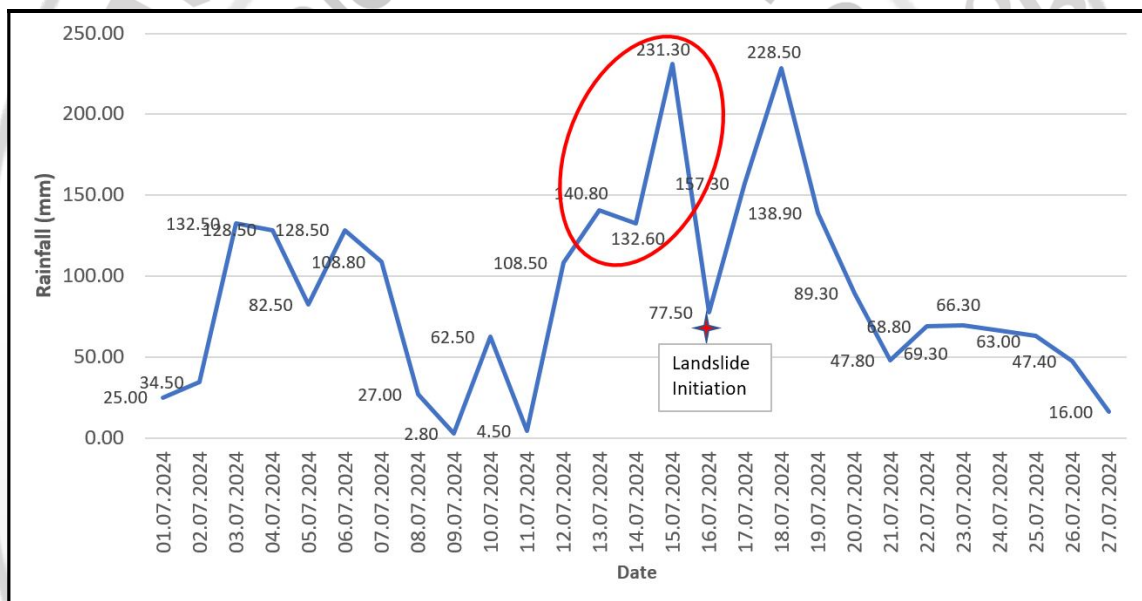
Intense and prolonged rainfall acted as the immediate trigger for the landslide. Specifically, a three-day antecedent rainfall totalling 503 mm led to the saturation of debris material, increasing pore water pressure and reducing shear strength (Fig.1.14). This intense rainfall significantly weakened the slope's stability, and acted as a trigger.

Fig. 1.14: Rainfall distribution near Shirur during July 2024 (source:IRB)

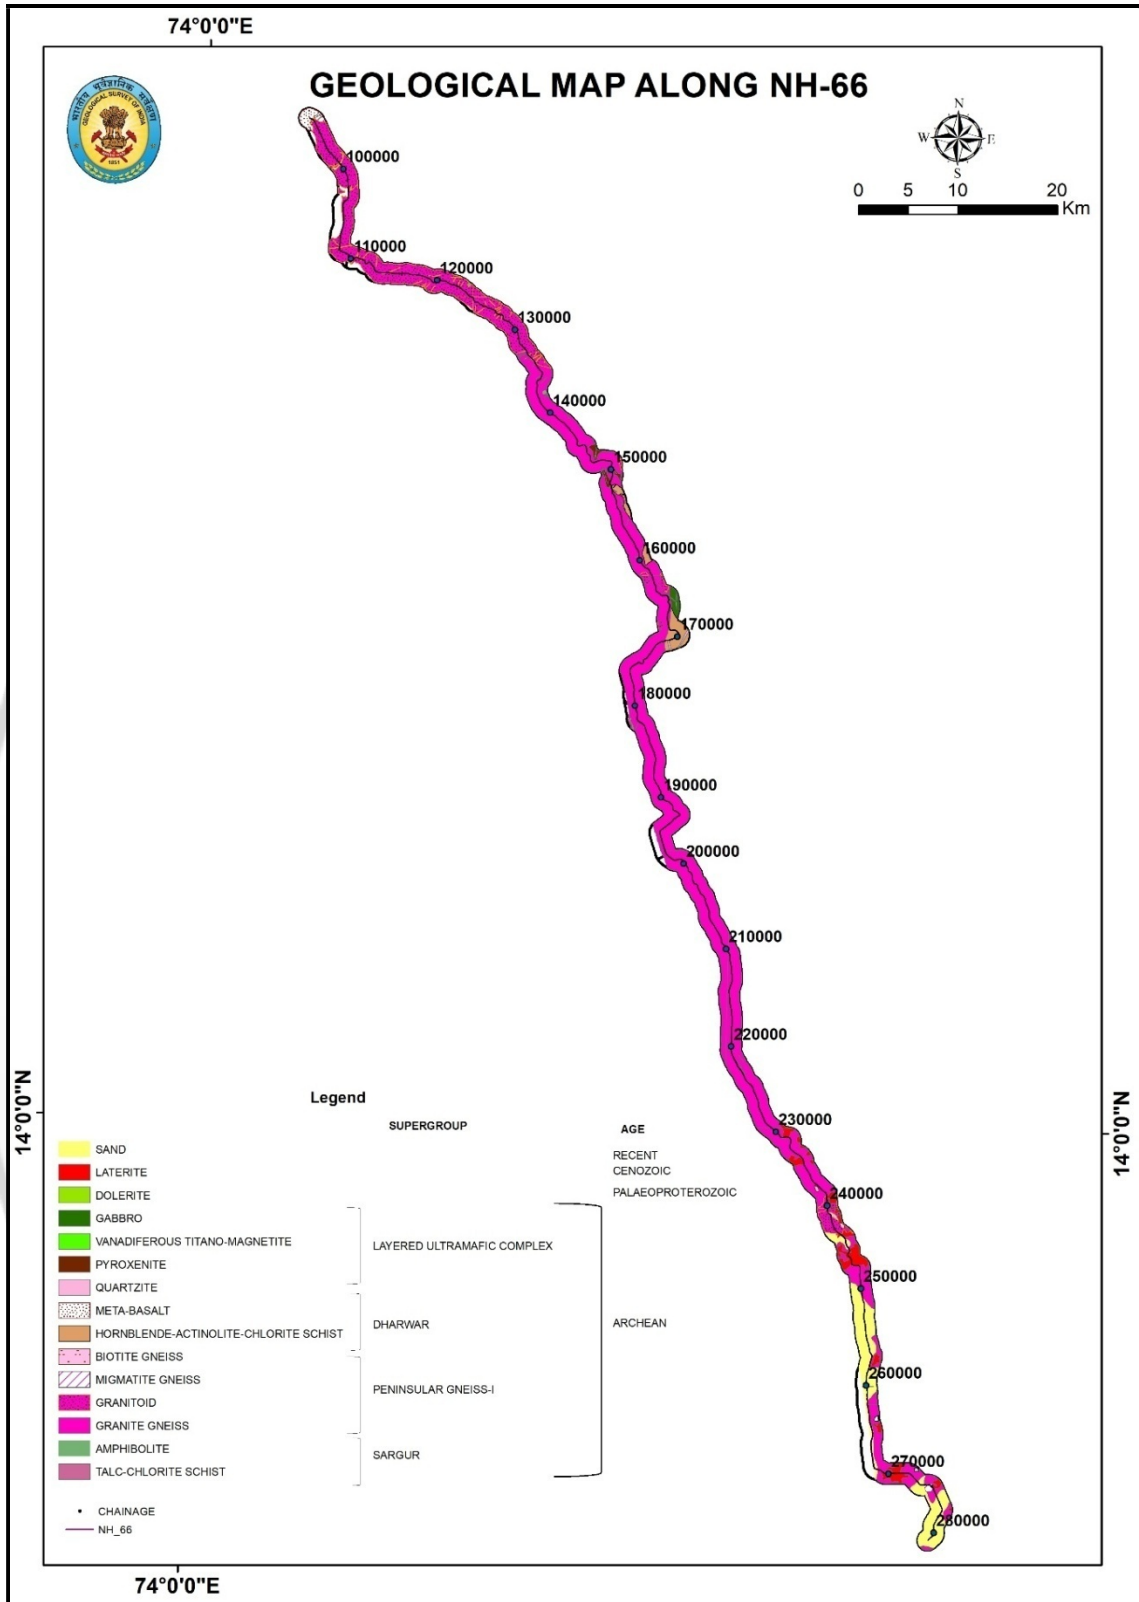
The highway passes through the western margin of Western Ghat mountain ranges and has a few sections where the hill slopes had to be cut to make way for the road corridor. The major geological unit exposed in the corridor is the Peninsular Gneissic Complex (PGC), a suite of rocks with mainly granitic composition. The corridor also cut through various mafic and ultramafic rock units at different locations (Fig. 2.10).

Fig. 2.10: Geological map of the road corridor

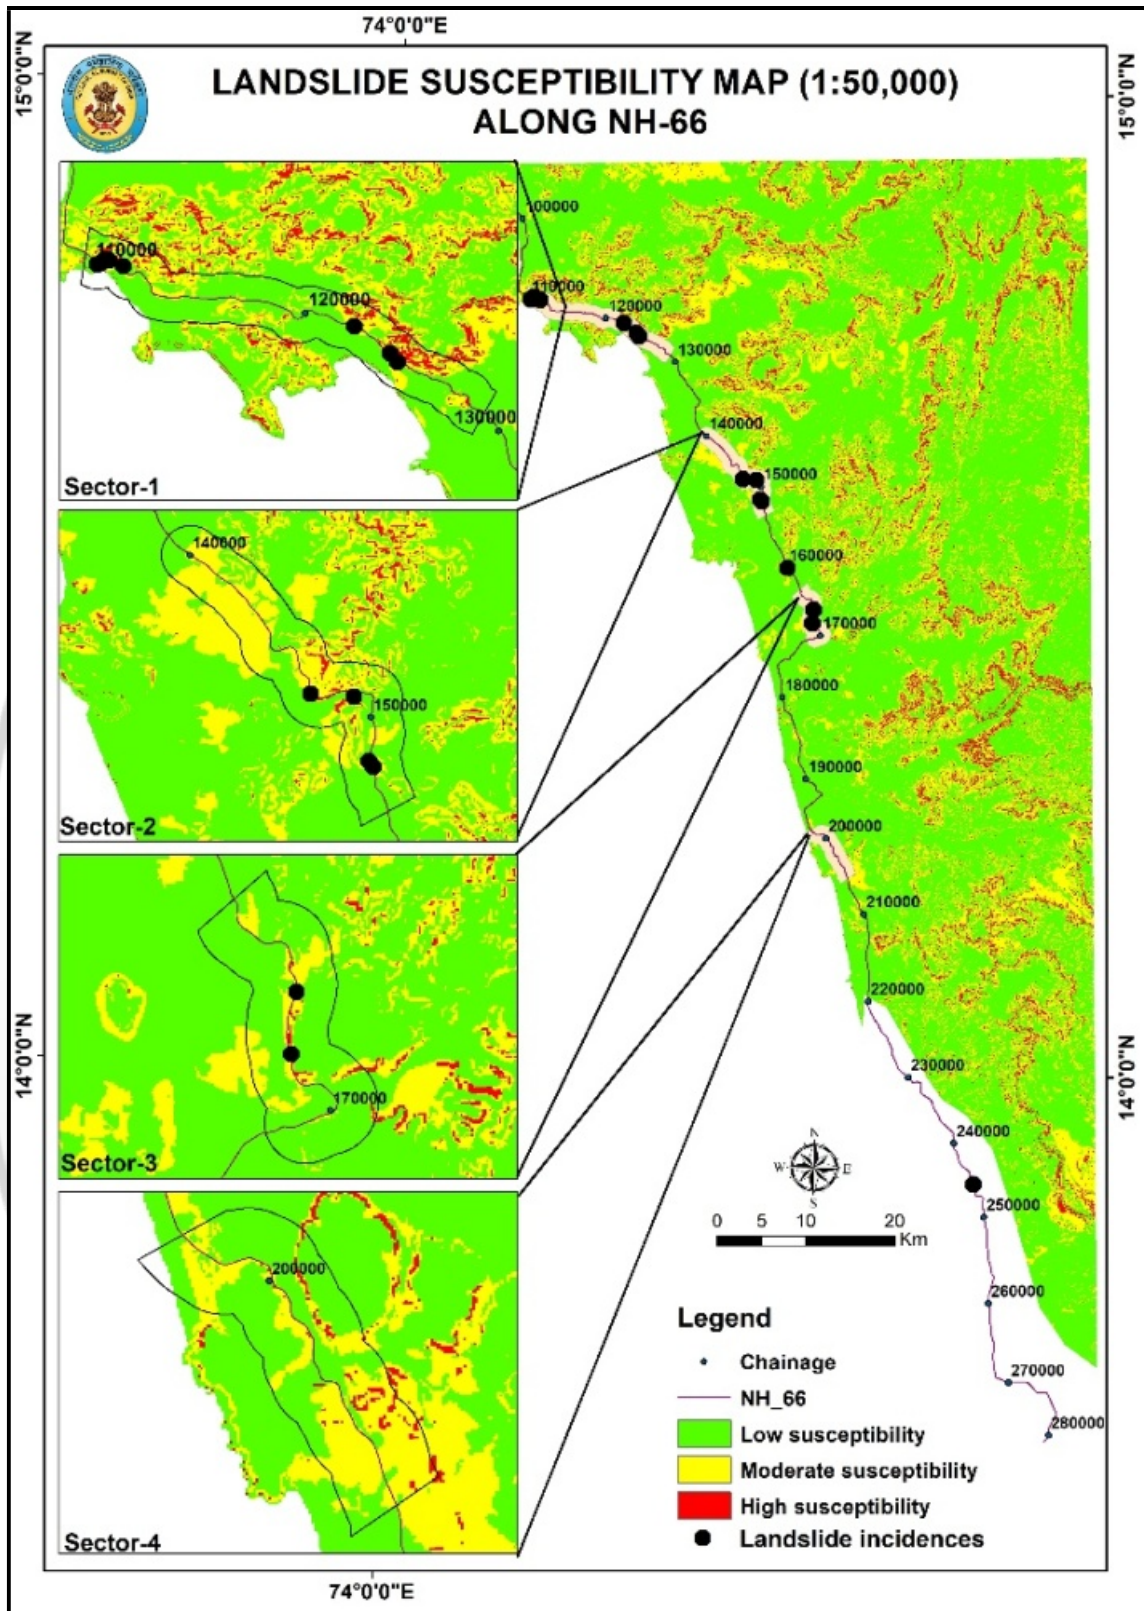
The landslide susceptibility map, produced after the National Landslide Susceptibility Mapping (NLSM) of GSI in 1:50,000 scale, is available for the road corridor up to 220.000 chainages (Fig. 2.11). Most of the landslide incidences in the corridor have occurred in moderate to high landslide susceptibility areas. The road corridor was divided into four sectors, each with unique slope instability scenarios and contributing factors.

Fig. 2.11: Landslide susceptibility map of the road corridor
