**Investigation into Alleged Environmental Violations by
Central Coalfields Ltd in Amrapali OCP:**

**Report of Committee appointed by Hon'ble National Green
Tribunal in *Sanjay Chauhan vs CCL & Ors (OA 28/2020/EZ)*
*vide order dt.11.05.2020***

Date of submission: 14 September 2020

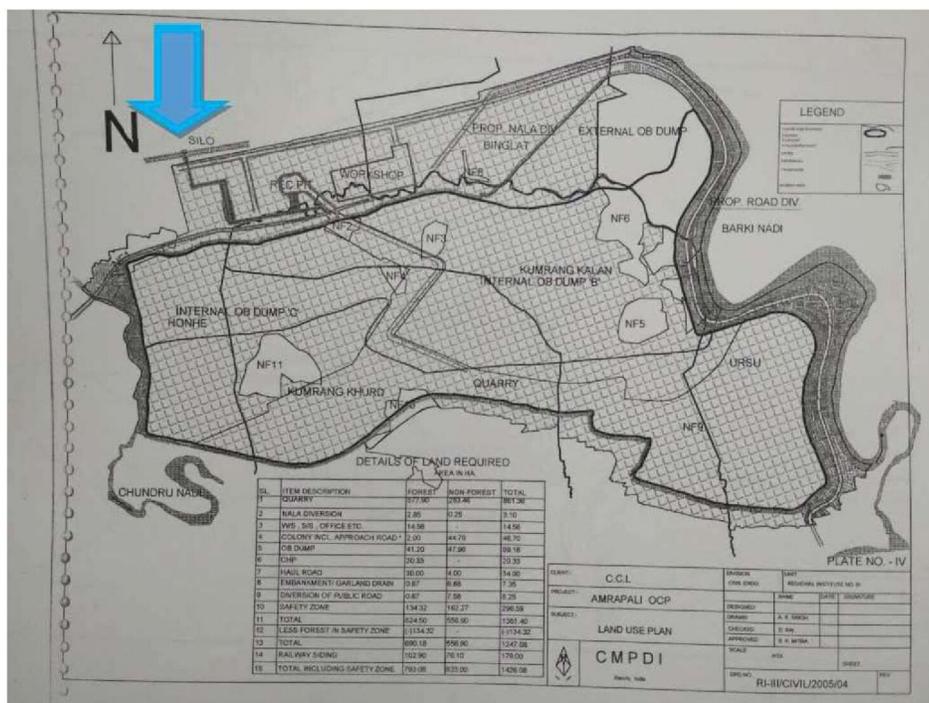
Figure 2. Map of Amrapali OCP in EIA document of 2006, showing location of CHP (Silo) at top left over proposed dedicated railway siding (blue arrow).

The original EIA/EMP of 2006 clearly showed that a CHP was to be constructed in an area of 20.33 ha (see Figure 2), along with a dedicated rail siding (hereinafter Amrapali railway siding) to be constructed in a loop, for which an area of 179 ha was to be set aside. The EC dt.3.01.2006 also clearly requires the construction of a CHP (Specific Condition xiv).
