BEFORE THE HON'BLE NATIONAL GREEN TRIBUNAL**O.A. No. 327 OF 2023**

In ref: News item published in India Today dated 30.04.2023 titled "3 minors among 11 dead in Ludhiana gas leak, Punjab govt. announces Rs 2 lakh ex-gratia".

**Reply in the form of Affidavit by Surabhi Malik, IAS,
Deputy Commissioner, Ludhiana**

**Report of Magisterial Enquiry in Giaspura gas leak incident on
30.4.2023 at Giaspura, Ludhiana**

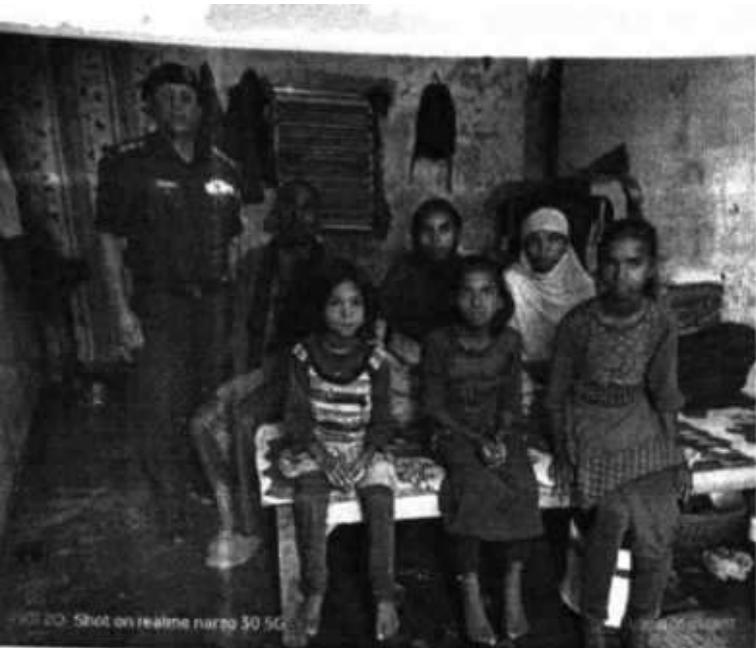
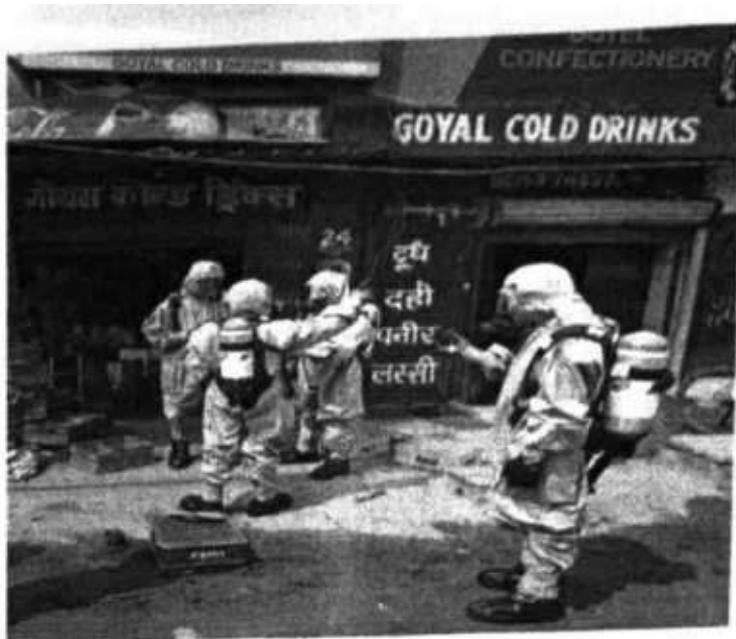
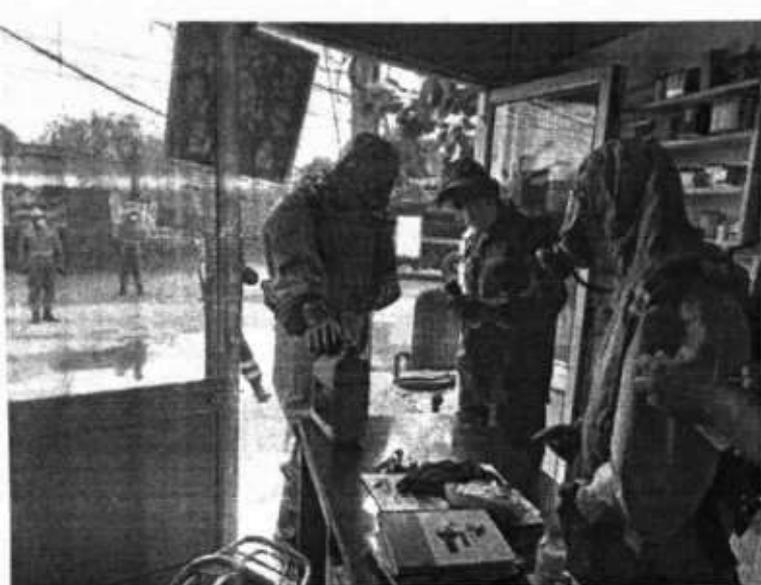
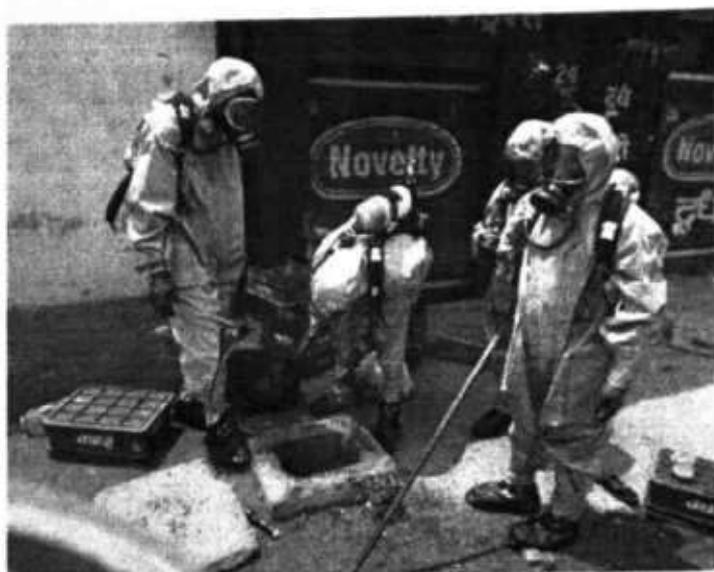
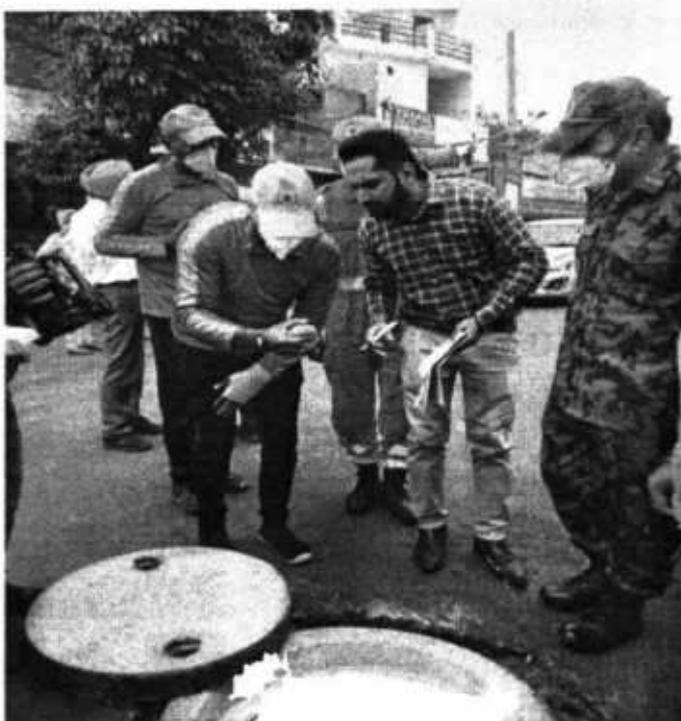
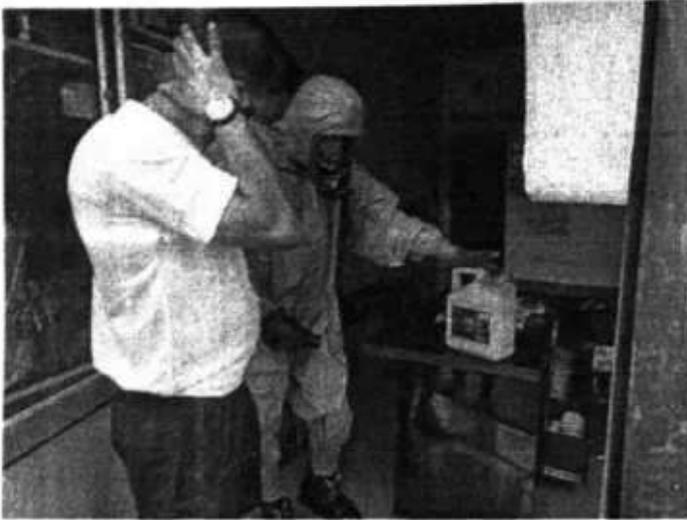
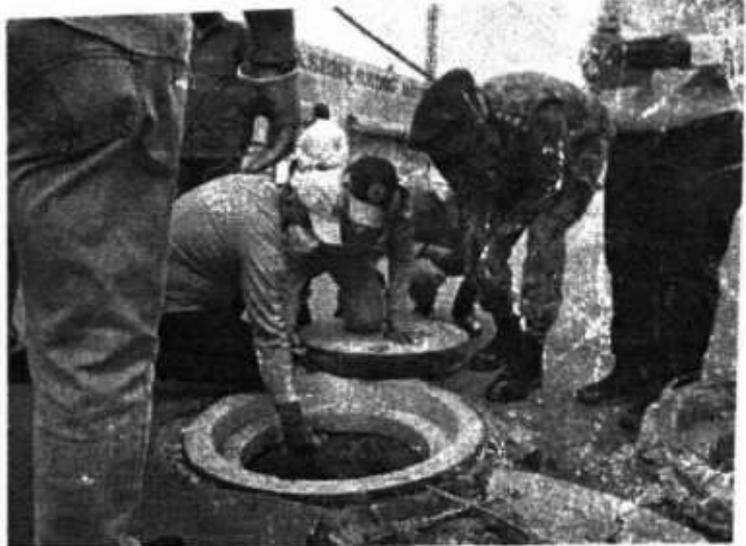
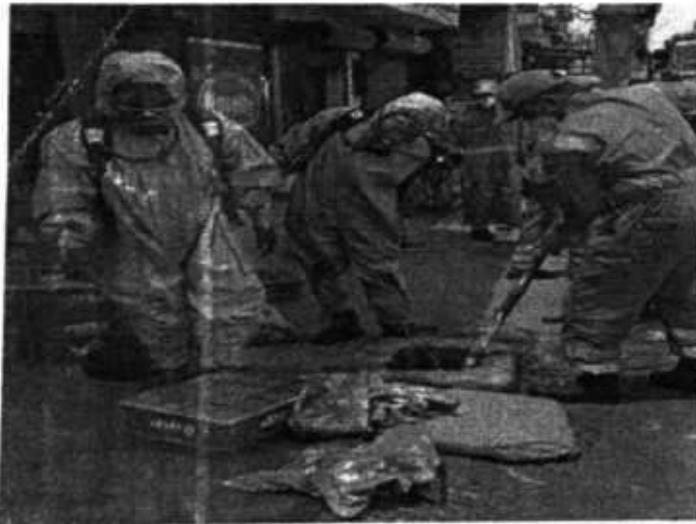
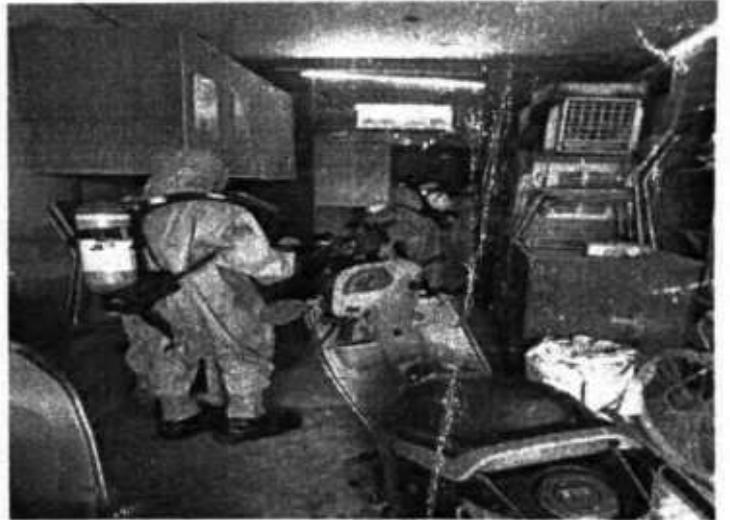
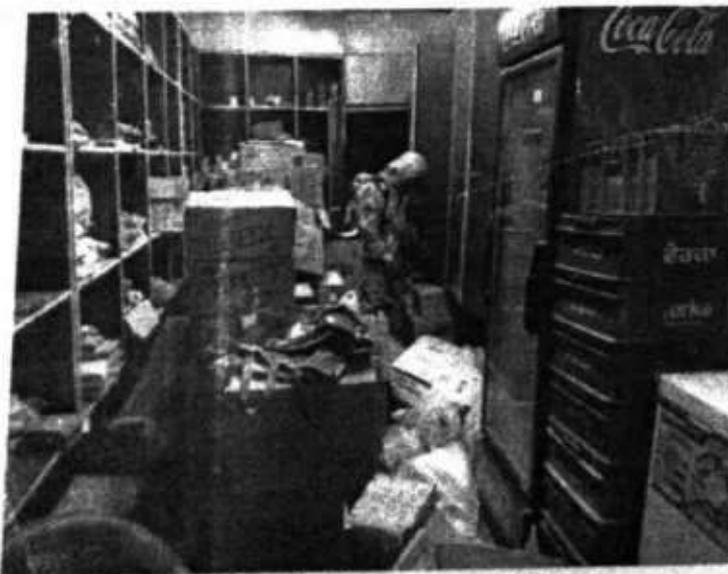
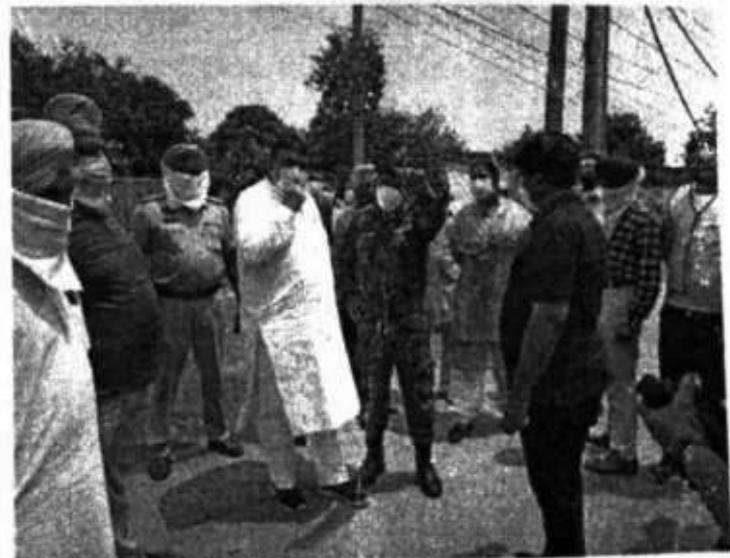
**PHOTOGRAPHS OF OPERATION GAS LEAKAGE INCIDENT AT GIASPUR,
LUDHIANA (PUNJAB) ON 30 APR 2023 : 13TH BN NDRF**

4. A sub team entered into the incident area under supervision of Sh. Dev Raj, Deputy Commandant. Initially the sub team tried to find out live victims in the area but no one was found at first sight. On further search the team observed that the contaminated gas was passing through three manholes of sewage pipe line passing along the road. They successfully plug two of them as the lid of third manhole was broken NDRF team advised Municipal Committee employees to replace the broken lid and which replaced by them. The leakage was reduced to some extent. The sub team further searched the two buildings in which 04 victims were found dead and found a pet dog which was tied with chain on roof and was still alive, team rescued it and handed over to civil authority.

5. After half an hour, sub team was replaced by other sub team and team started confirmatory search of first floor of affected buildings. The team found that a door was latched from inside and it was also revealed that some people were suspected to be inside the room. Matter was informed to team commander and they tried to open the door but even after continuous knocking no one opened the door. The sub team made a lot of efforts to encourage and convinced them and thereafter finally door was opened from inside. After entering the room one male, one female and their 05 children aged approx 07 years to 17 years were found hiding inside the room due to fear of incident.

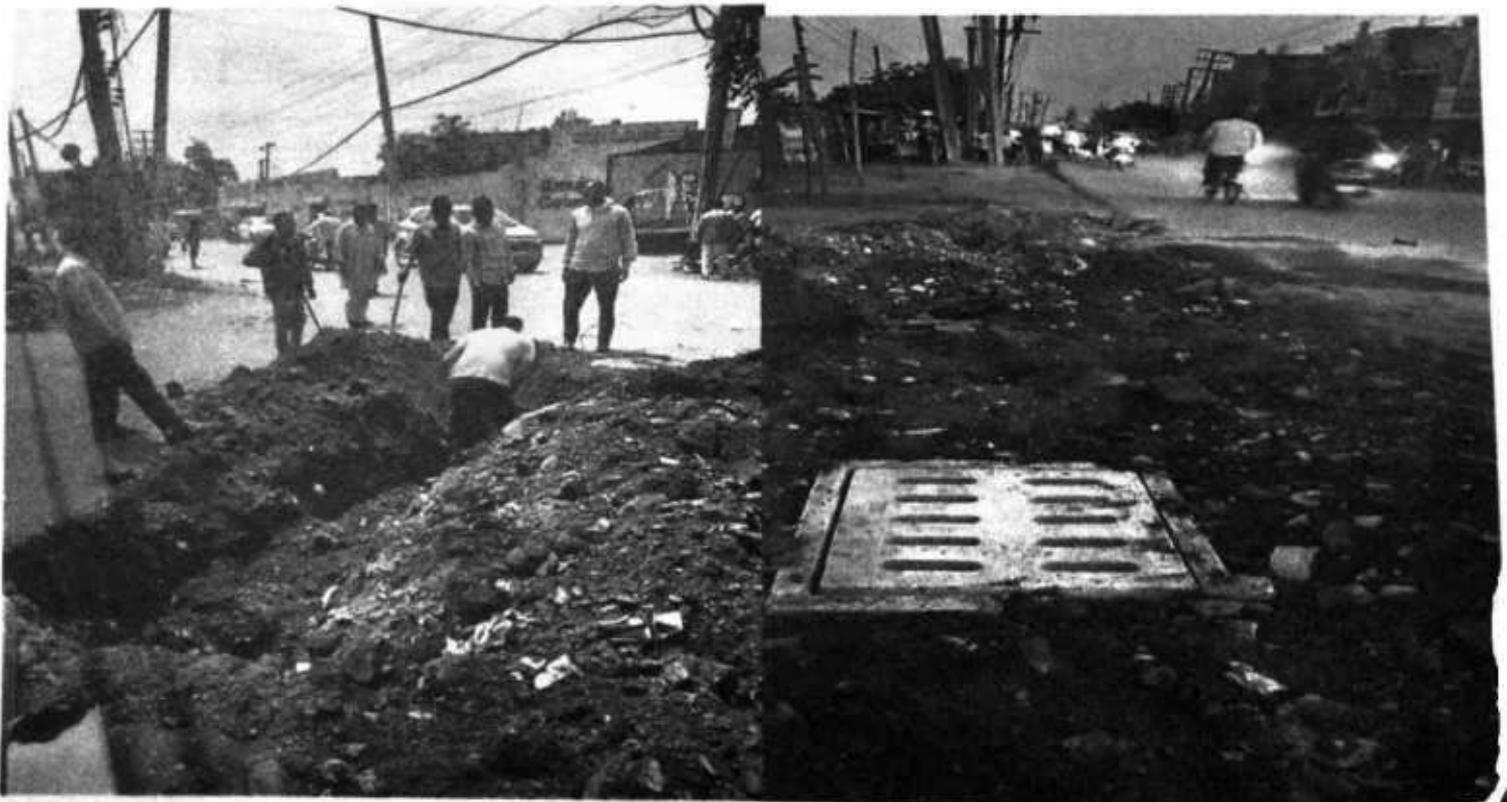
CONSTRUCTION OF ROAD GULLIES AND PROVISION OF VENTILATION JALIS 2 DAYS AFTER INCIDENT

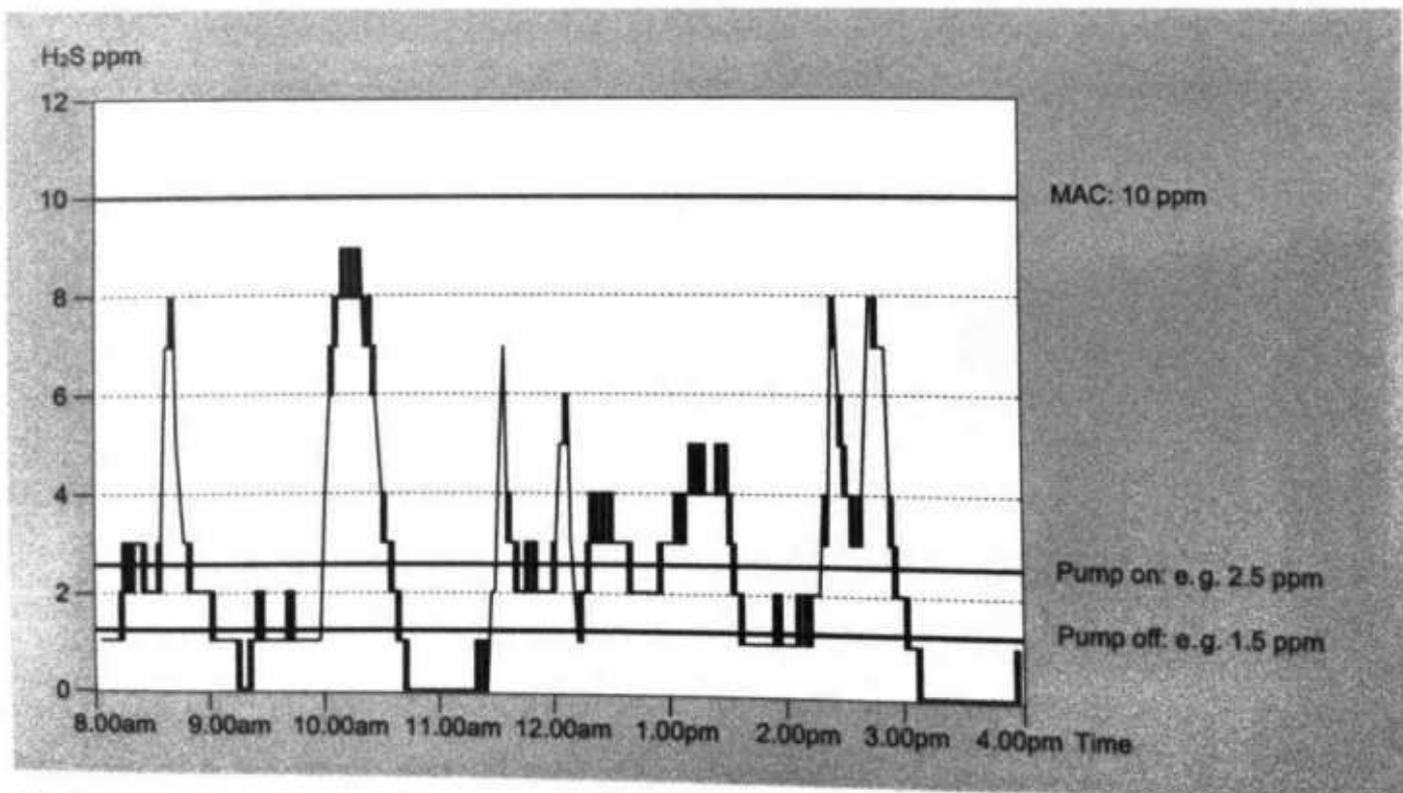
Fig. 10: Typical curve of H₂S concentration with controlled, online addition of iron salts to maintain the MAC value in a grit chamber
