## **Joint report of CPCB and GPCB in compliance with order of the Hon'ble NGT (Principal Bench, Delhi) in the matter O.A. No. 669 of 2018; Marvada Amrutlal Becharlal Vs. State of Gujarat**

# **Annexure-1**

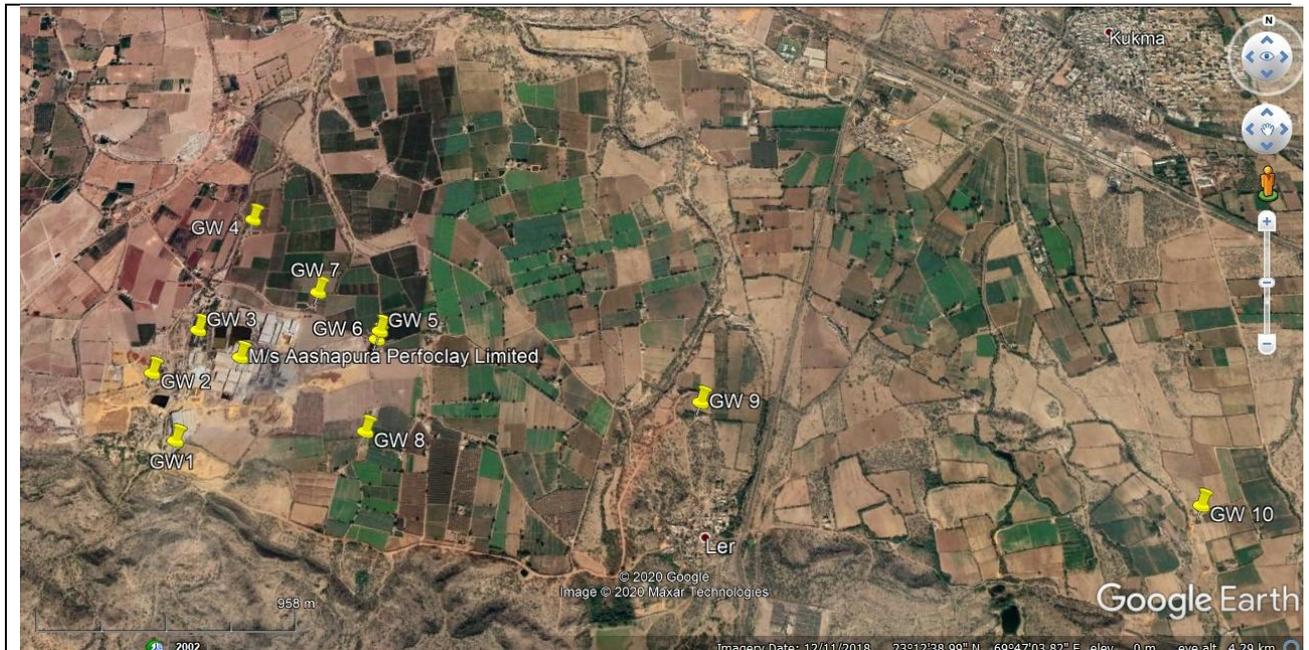
GPCB continued the ground water sampling of 10 bore-wells during April 2020 to December 2020 in and around the unit premises (**google image showing the unit and sampling locations is given below**). It is worth mentioning here that out of 10 bore-wells samples, only 04 were having Ammonia (NH<sub>3</sub>-N) contamination and restoration processes (pump and treat) weremostly aimed at these 04 locations only.

S. No.	Location	Latitude/Longitude	S. No.	Location	Latitude/Longitude
GW-1	Nr. Gate No. 2 of unit	23°11'58.22"N 69°44'29.67"E	GW-6	VasudevPindoriya	23°12'12.53"N 69°44'55.18"E
GW-2	Samavandhsamiti	23°12'6.53"N 69°44'24.78"E	GW-7	GovindHirjiGorasia	23°12'18.47"N 69°44'46.05"E
GW-3	Admin block of unit	23°12'12.53"N 69°44'30.09"E	GW-8	RanubhaJadeja	23°12'0.42"N 69°44'55.25"E
GW-4	ShyamjiVeljiGorasia	23°12'28.15"N 69°44'35.17"E	GW-9	HetubhaJadeja	23°12'6.43"N 69°45'40.66"E
GW-5	Ramesh Pindoriya	23°12'13.65"N 69°44'55.45"E	GW-10	Dineshmaharaj Wadi	23°11'56.65"N 69°46'48.14"E
