**BEFORE THE NATIONAL GREEN TRIBUNAL,
CENTRAL ZONE BENCH, BHOPAL
ORIGINAL APPLICATION NO. 62/2023 (CZ)**

**FACTUAL REPORT OF ILLEGAL SAND MINING ACTIVITIES IN
THE KHARI NADI RIVER BED**

1. That by order dated 31.07.2023 this Hon'ble Tribunal has appointed the undersigned as Amicus Curiae in the present matter to undertake inspection and give correct observation about the relevant issues raised in the present matter. In view of the said order the undersigned took physical inspection and visited the concerned areas alongwith the members of the joint committee or their representatives on 19.08.2023 and 09.09.2023 and apprise this Court about the factual position.

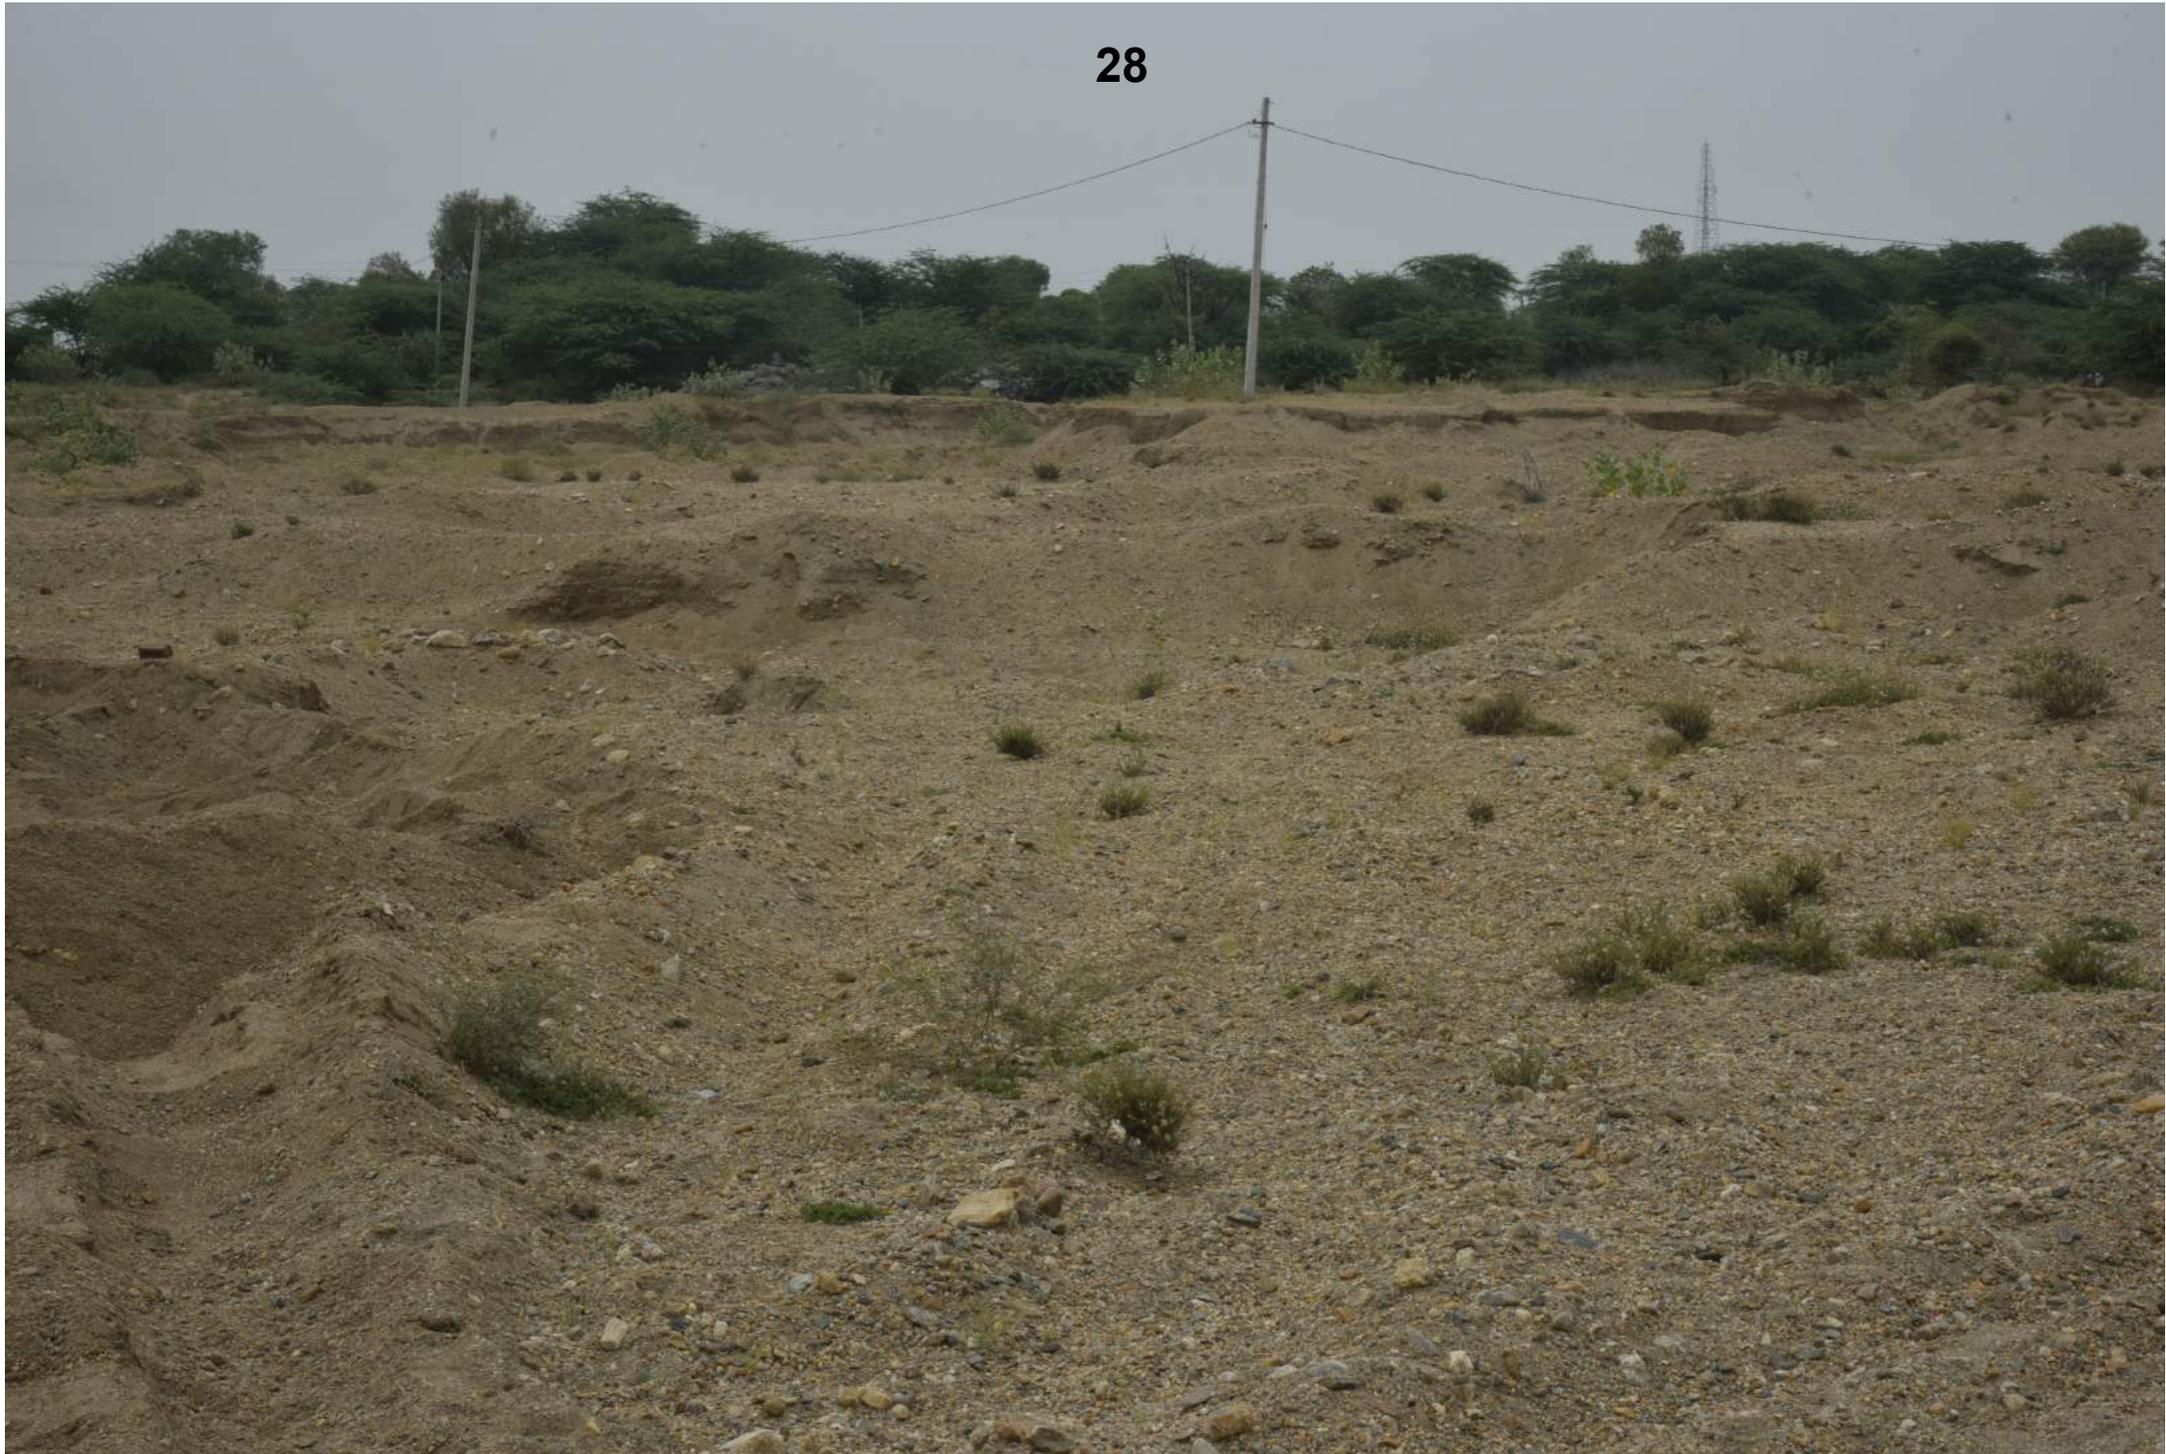
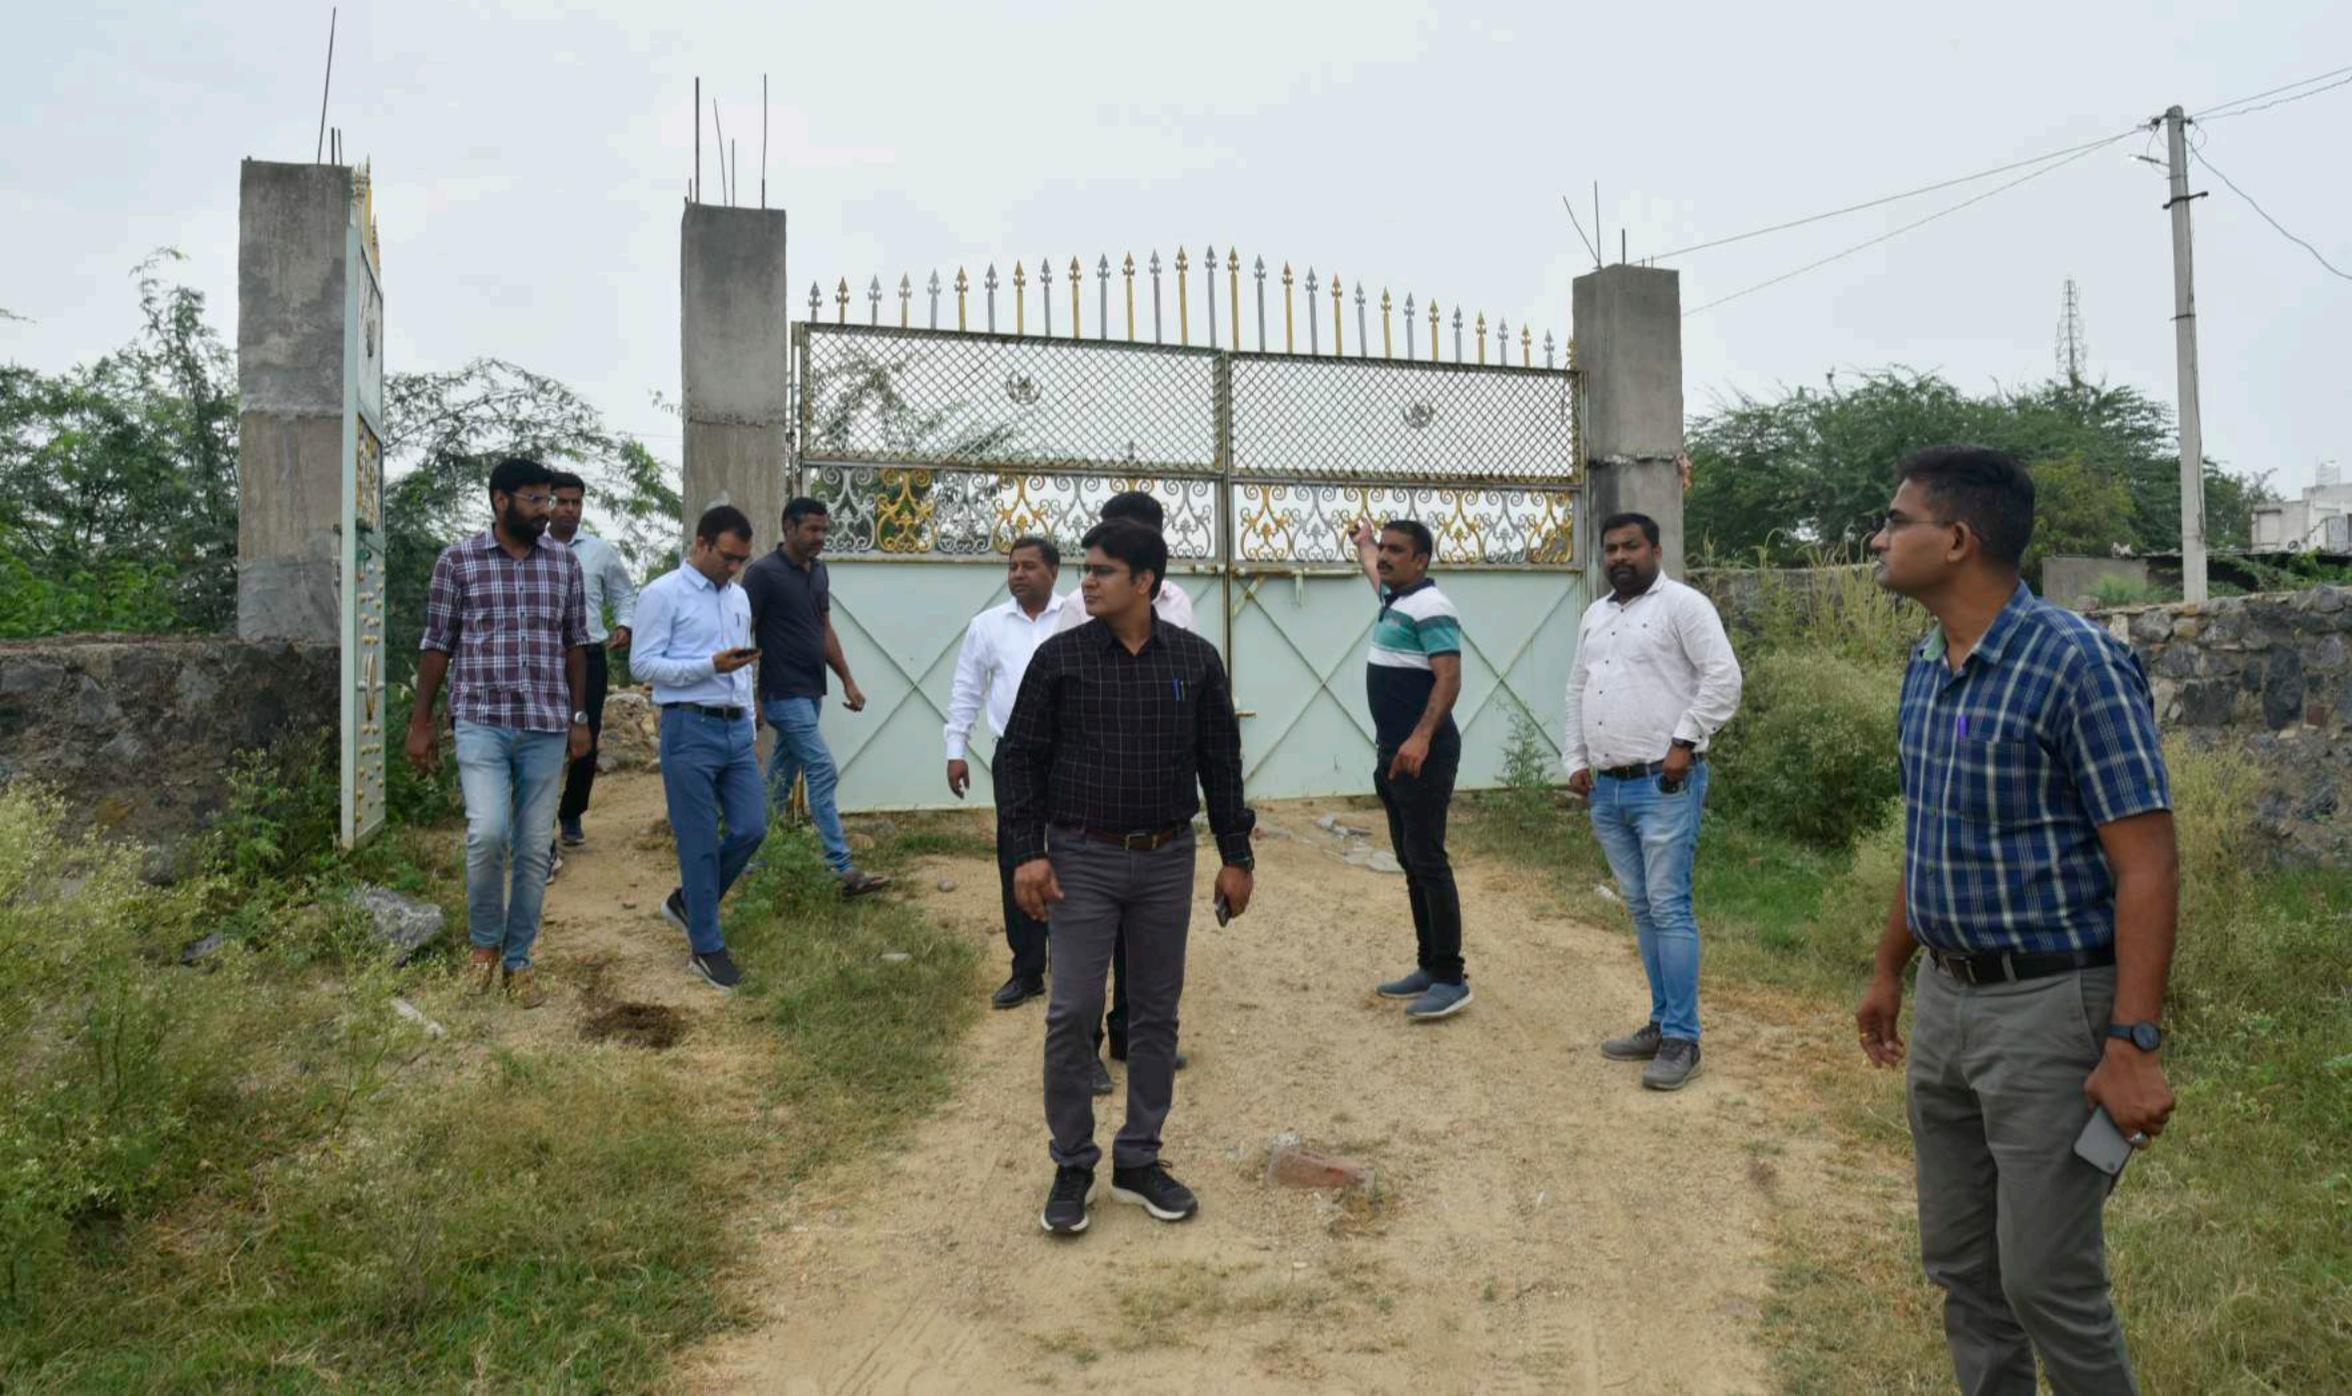
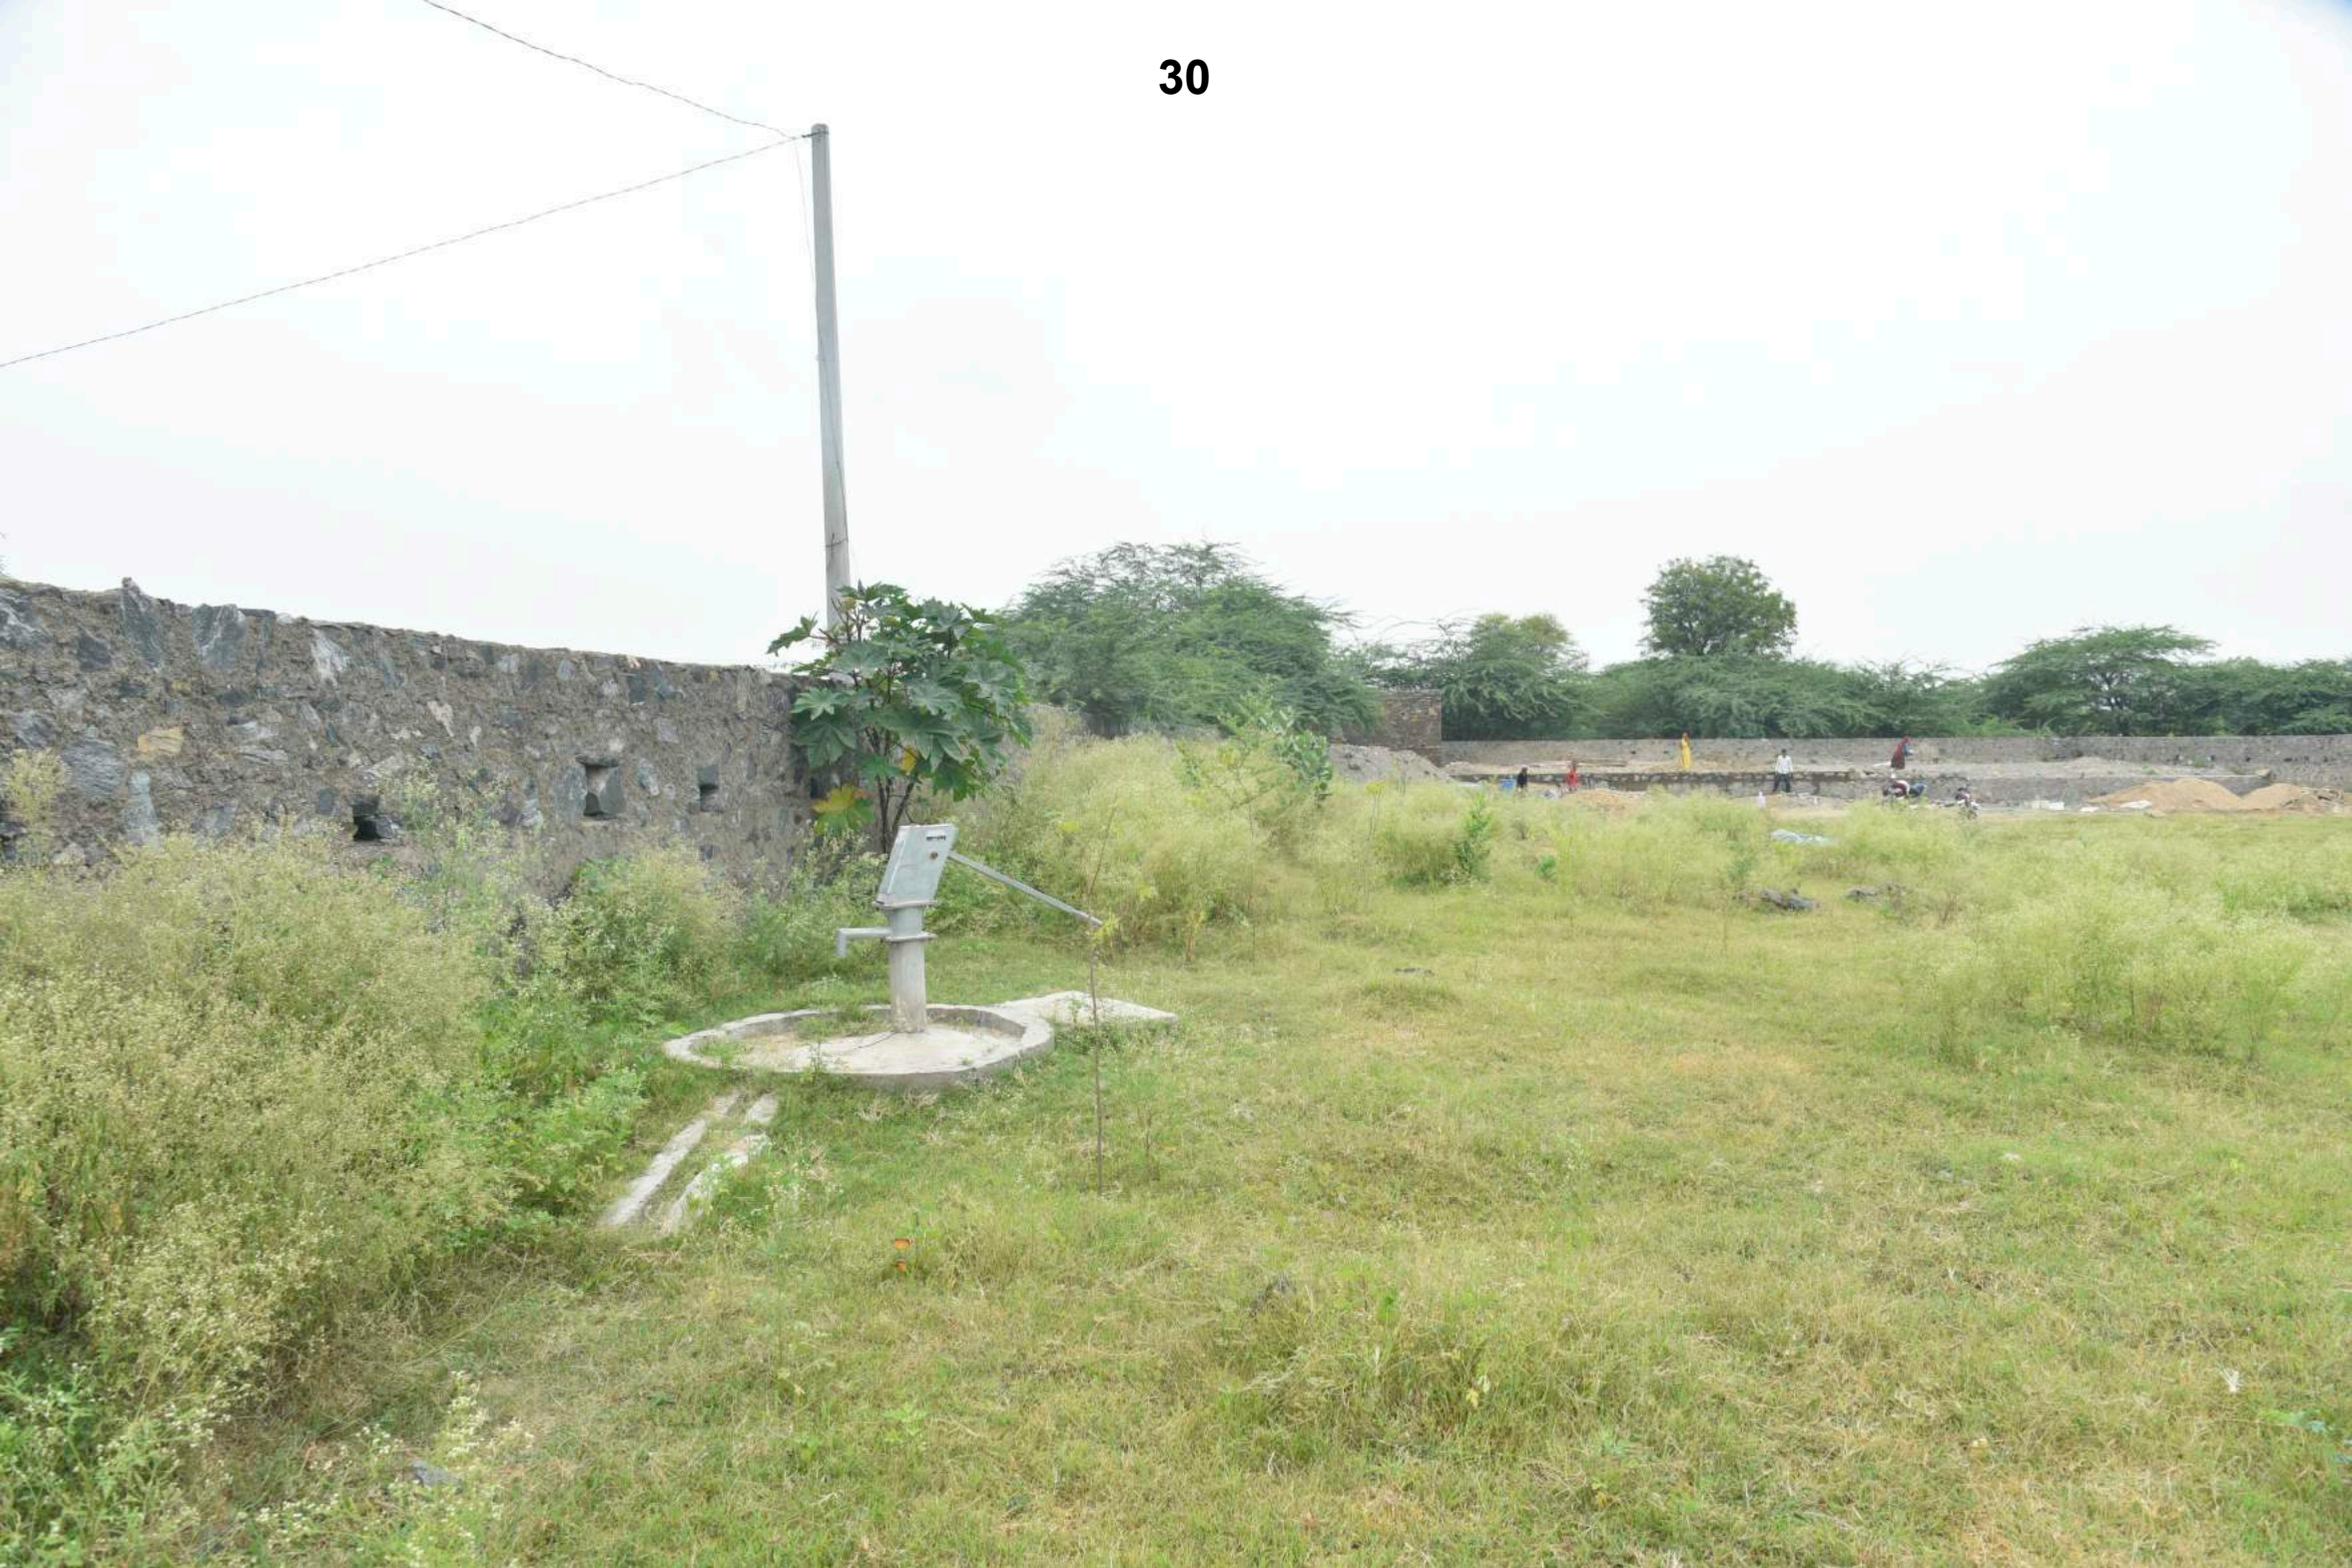
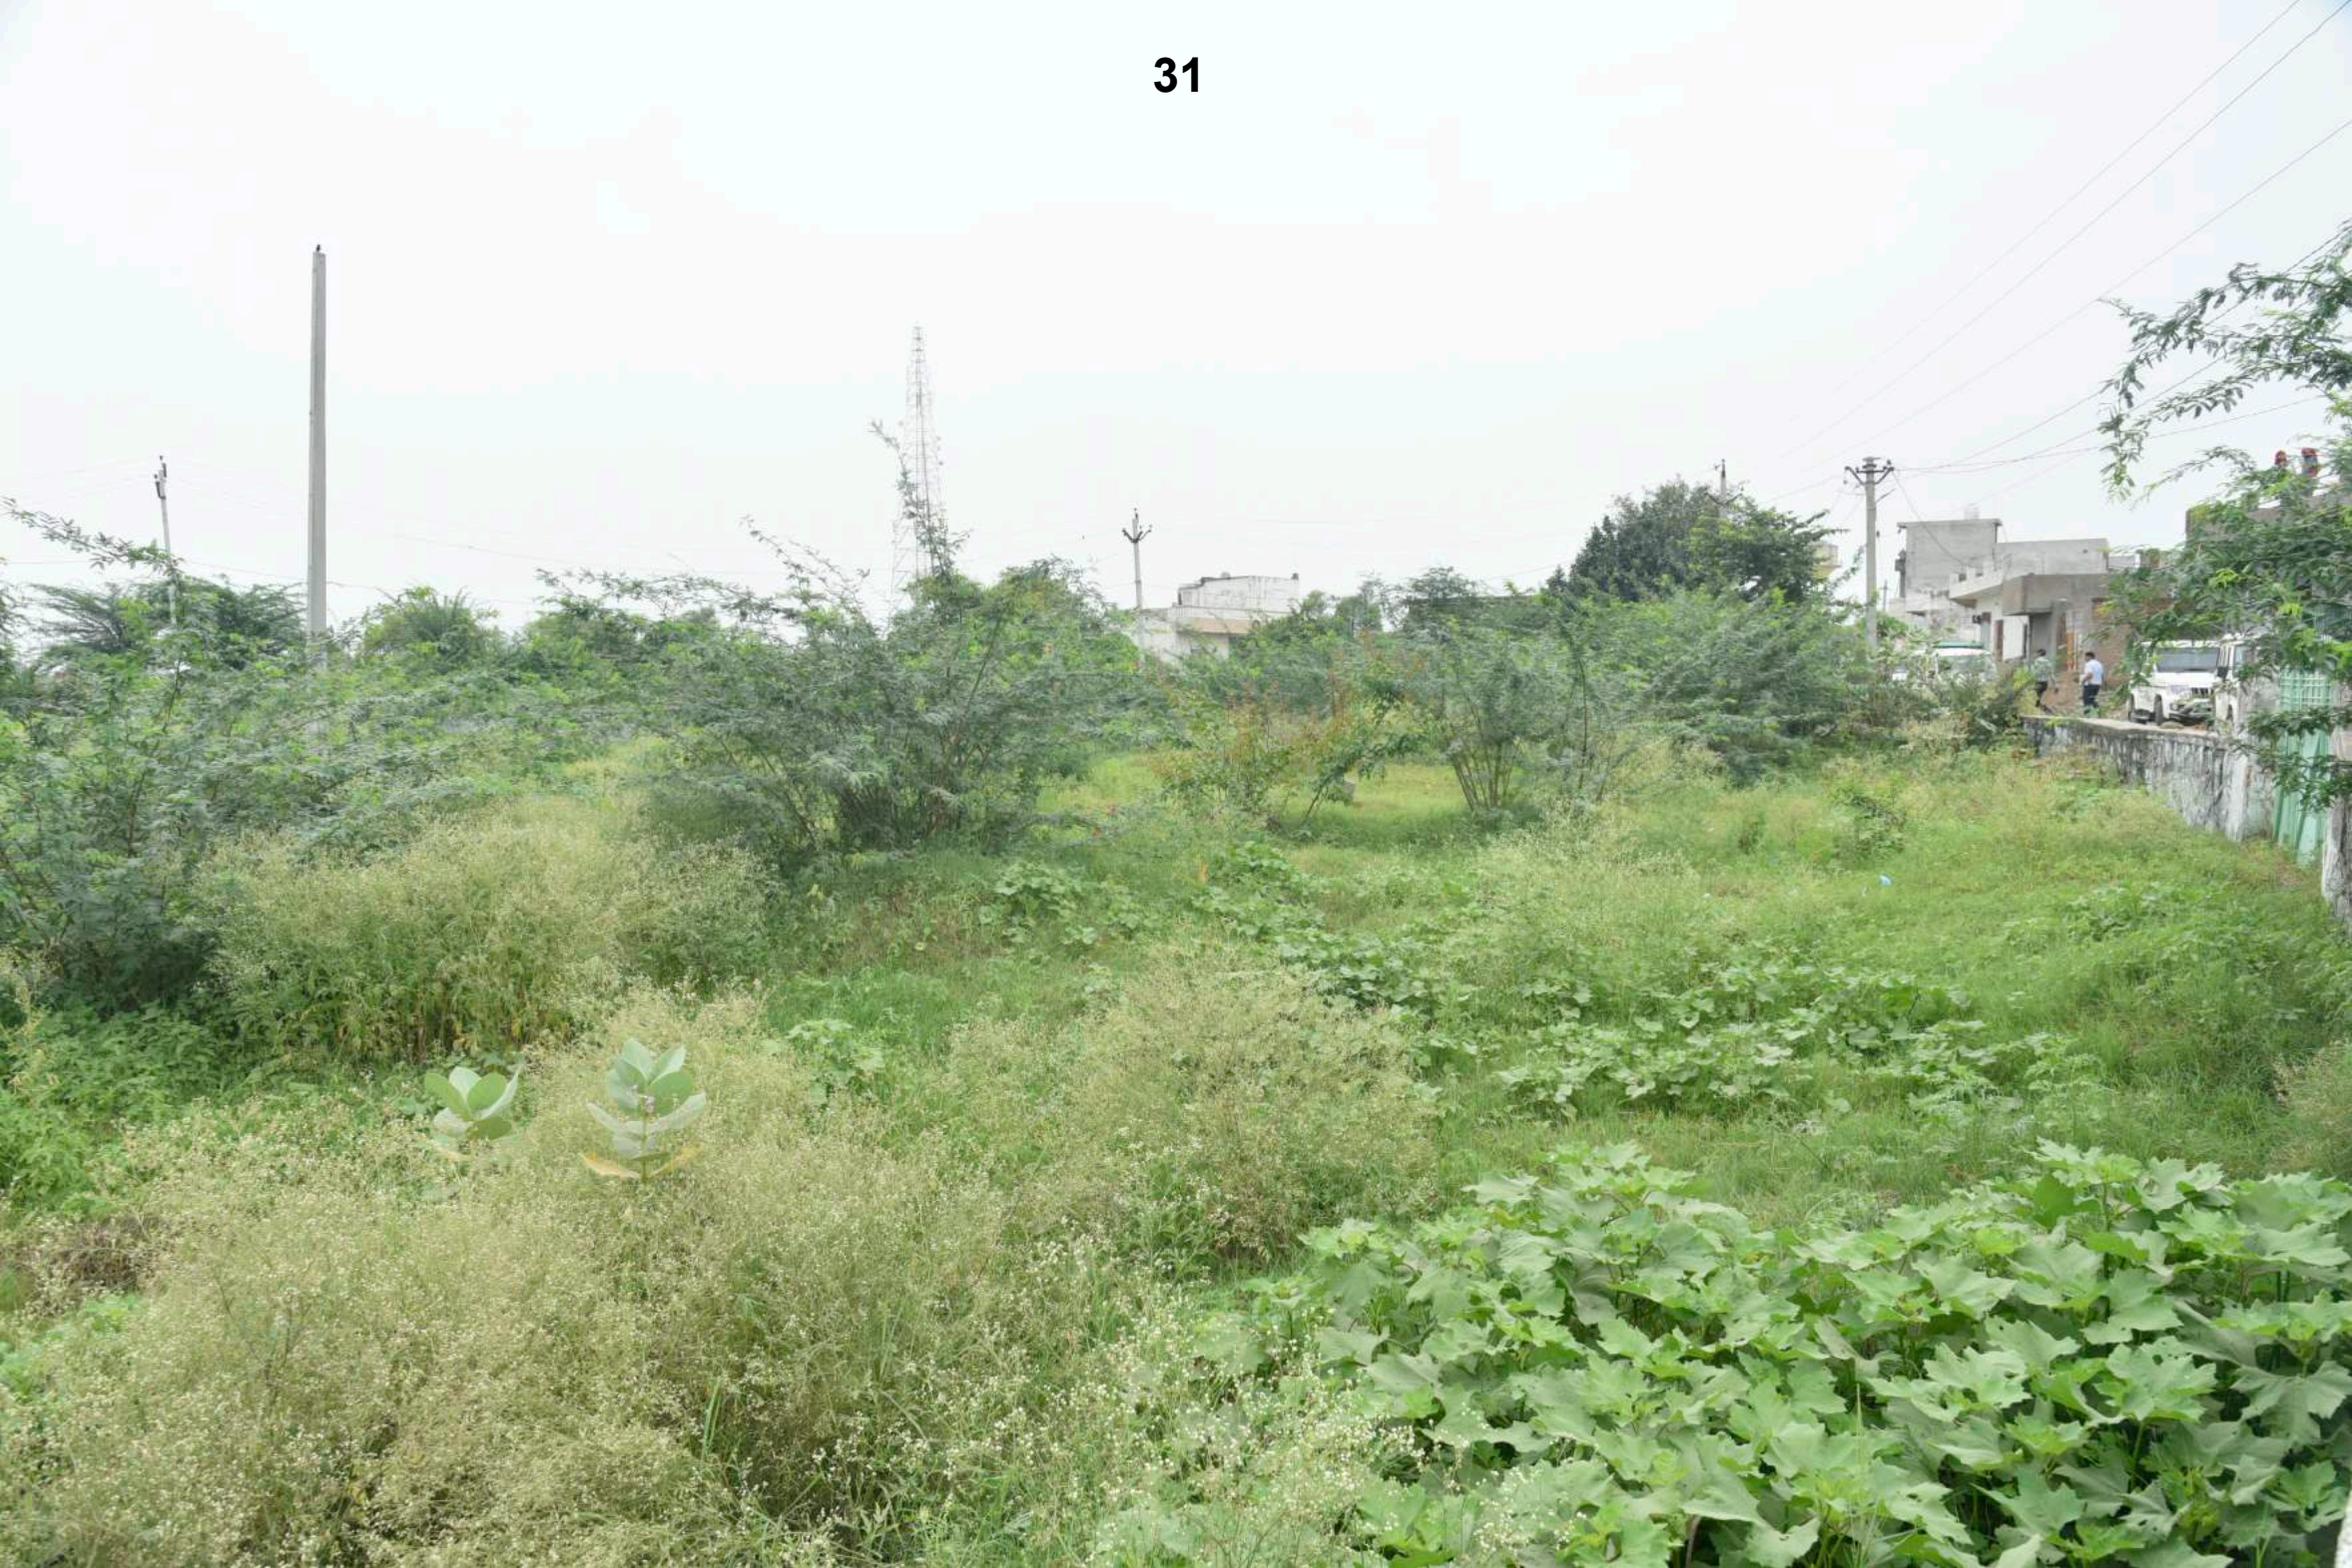
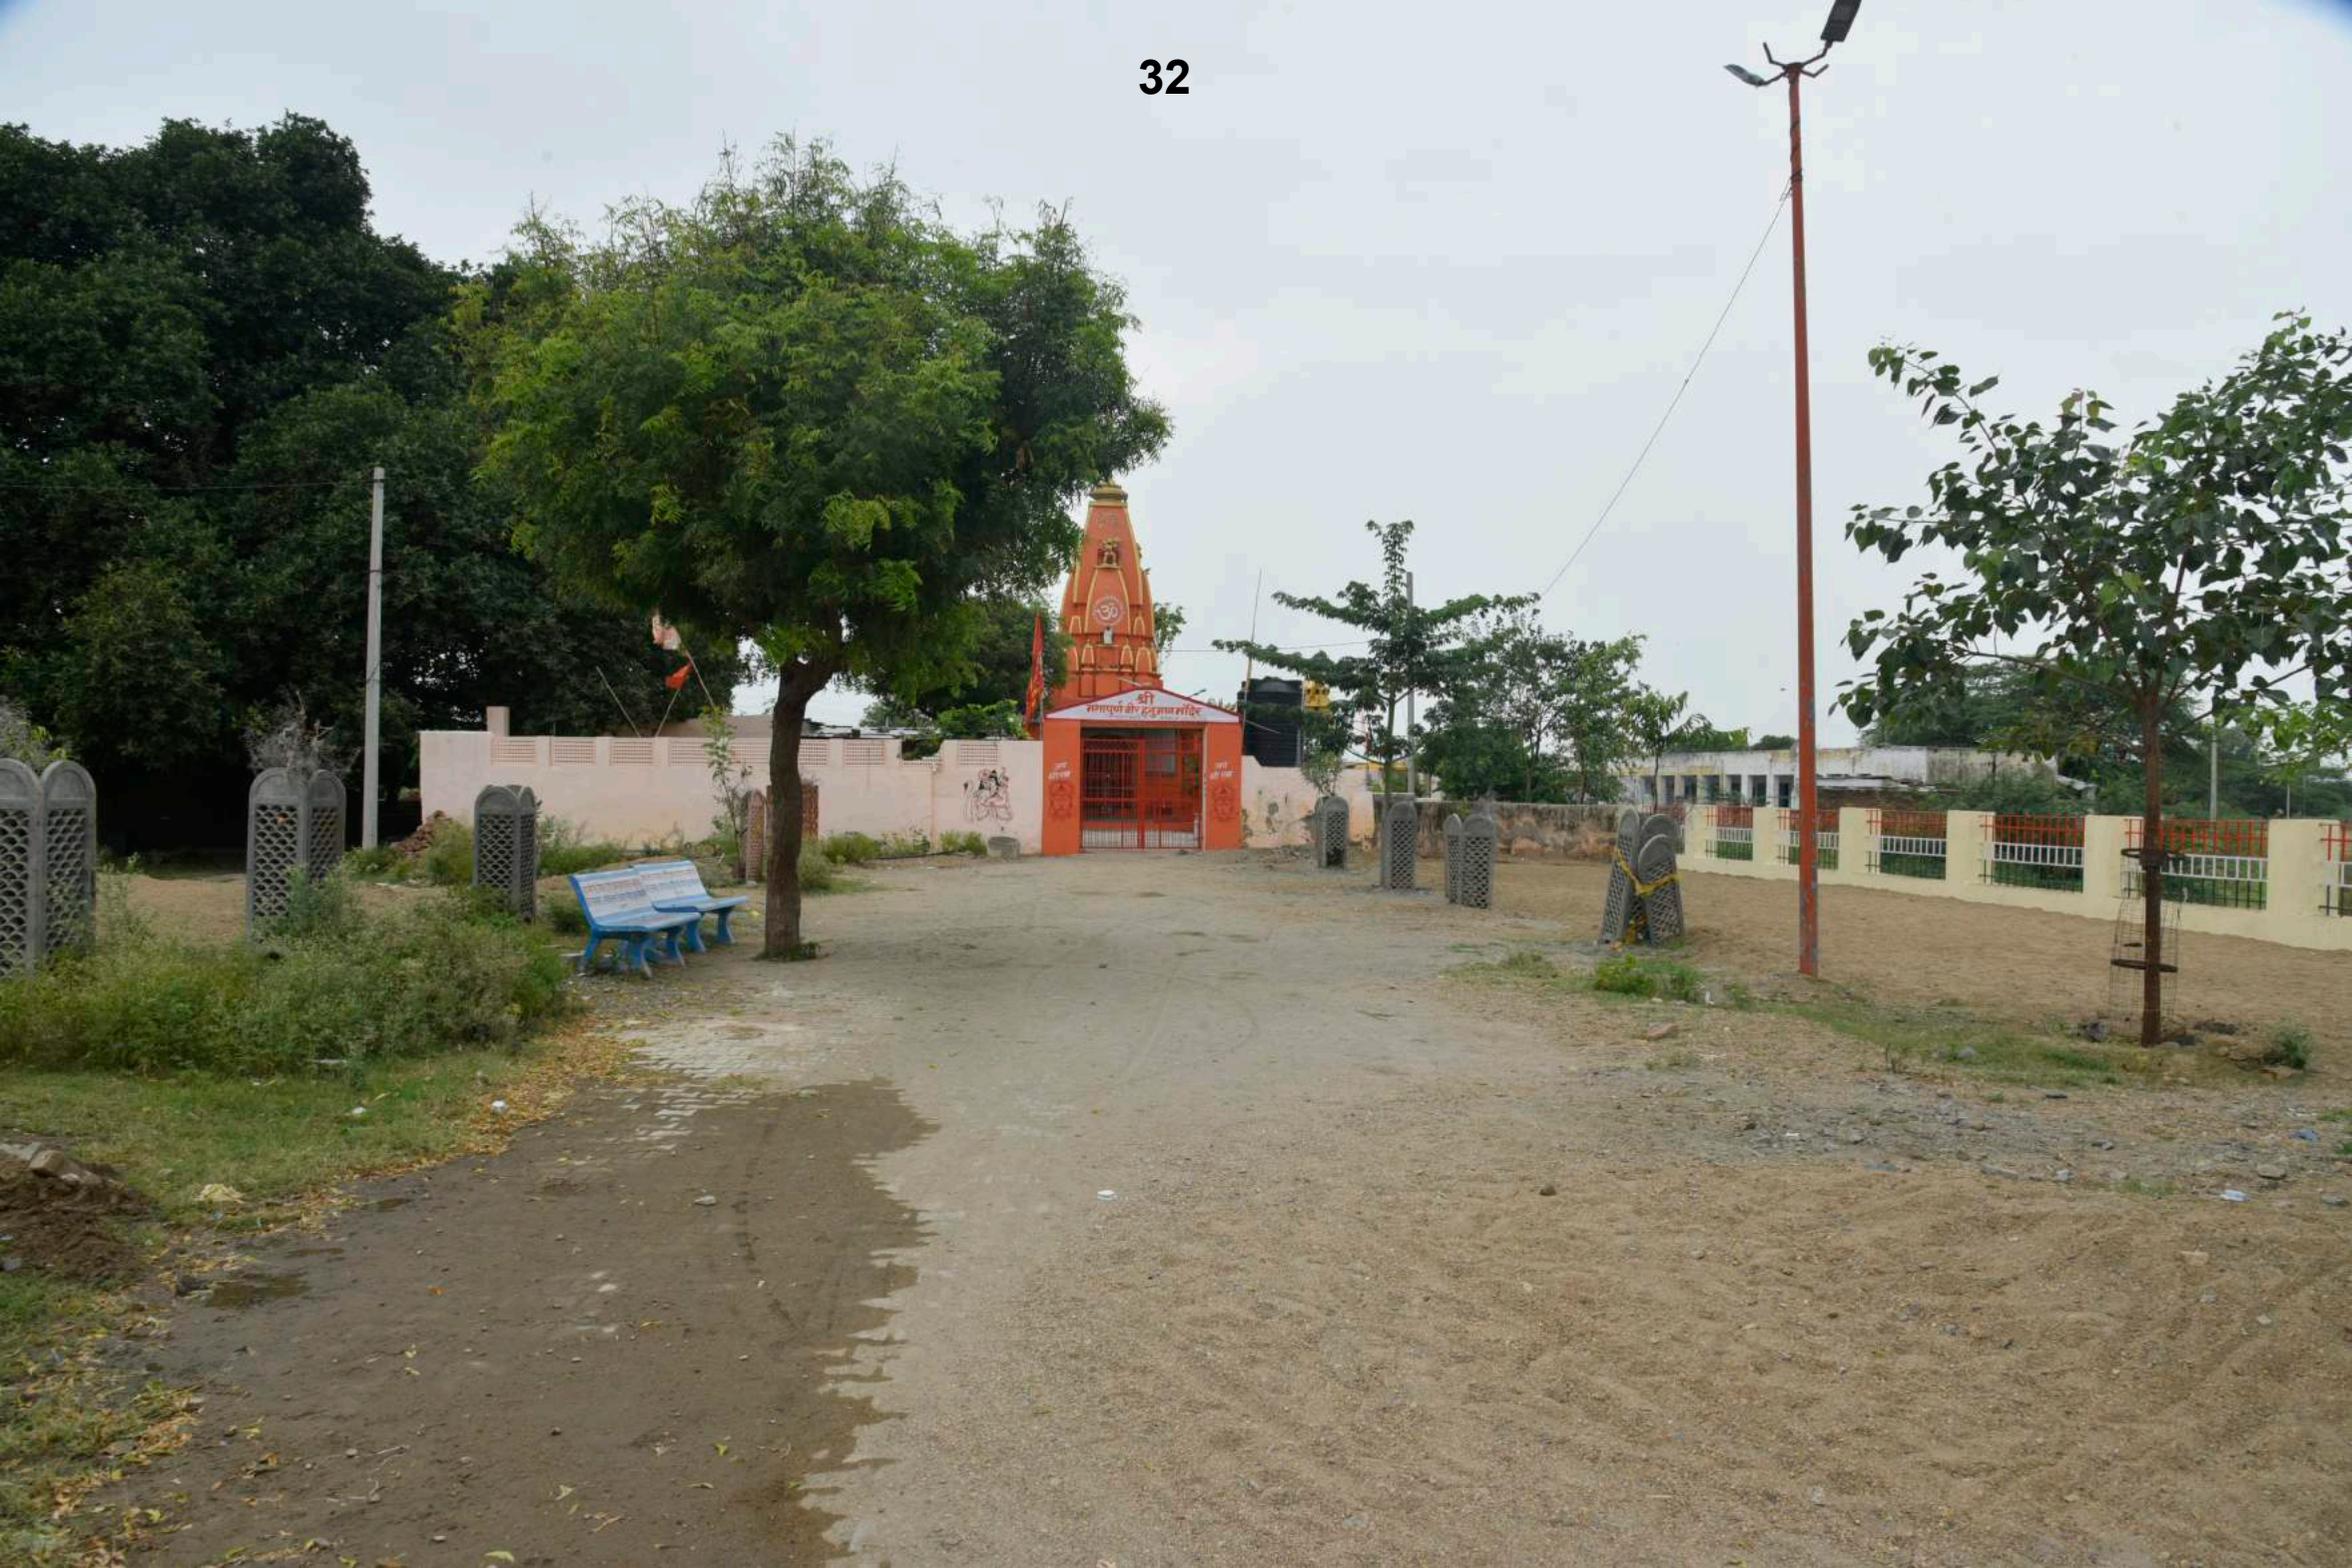
be sufficiently big in size were generally shown at schools, temple and cremation center. Even the lease holders could not establish whether the said plantation is done by them or some other agency. In some areas the plantation shown to carried out by the lease holder was found to be at a distance of 20 km from the actual site and they are not saplings of trees but are found to be flowering plants.
