**BEFORE THE NATIONAL GREEN TRIBUNAL,
CENTRAL ZONE BENCH, BHOPAL
ORIGINAL APPLICATION NO. 62/2023 (CZ)**

**FACTUAL REPORT OF ILLEGAL SAND MINING ACTIVITIES IN
THE KHARI NADI RIVER BED**

1. That by order dated 31.07.2023 this Hon'ble Tribunal has appointed the undersigned as Amicus Curiae in the present matter to undertake inspection and give correct observation about the relevant issues raised in the present matter. In view of the said order the undersigned took physical inspection and visited the concerned areas alongwith the members of the joint committee or their representatives on 19.08.2023 and 09.09.2023 and apprise this Court about the factual position.

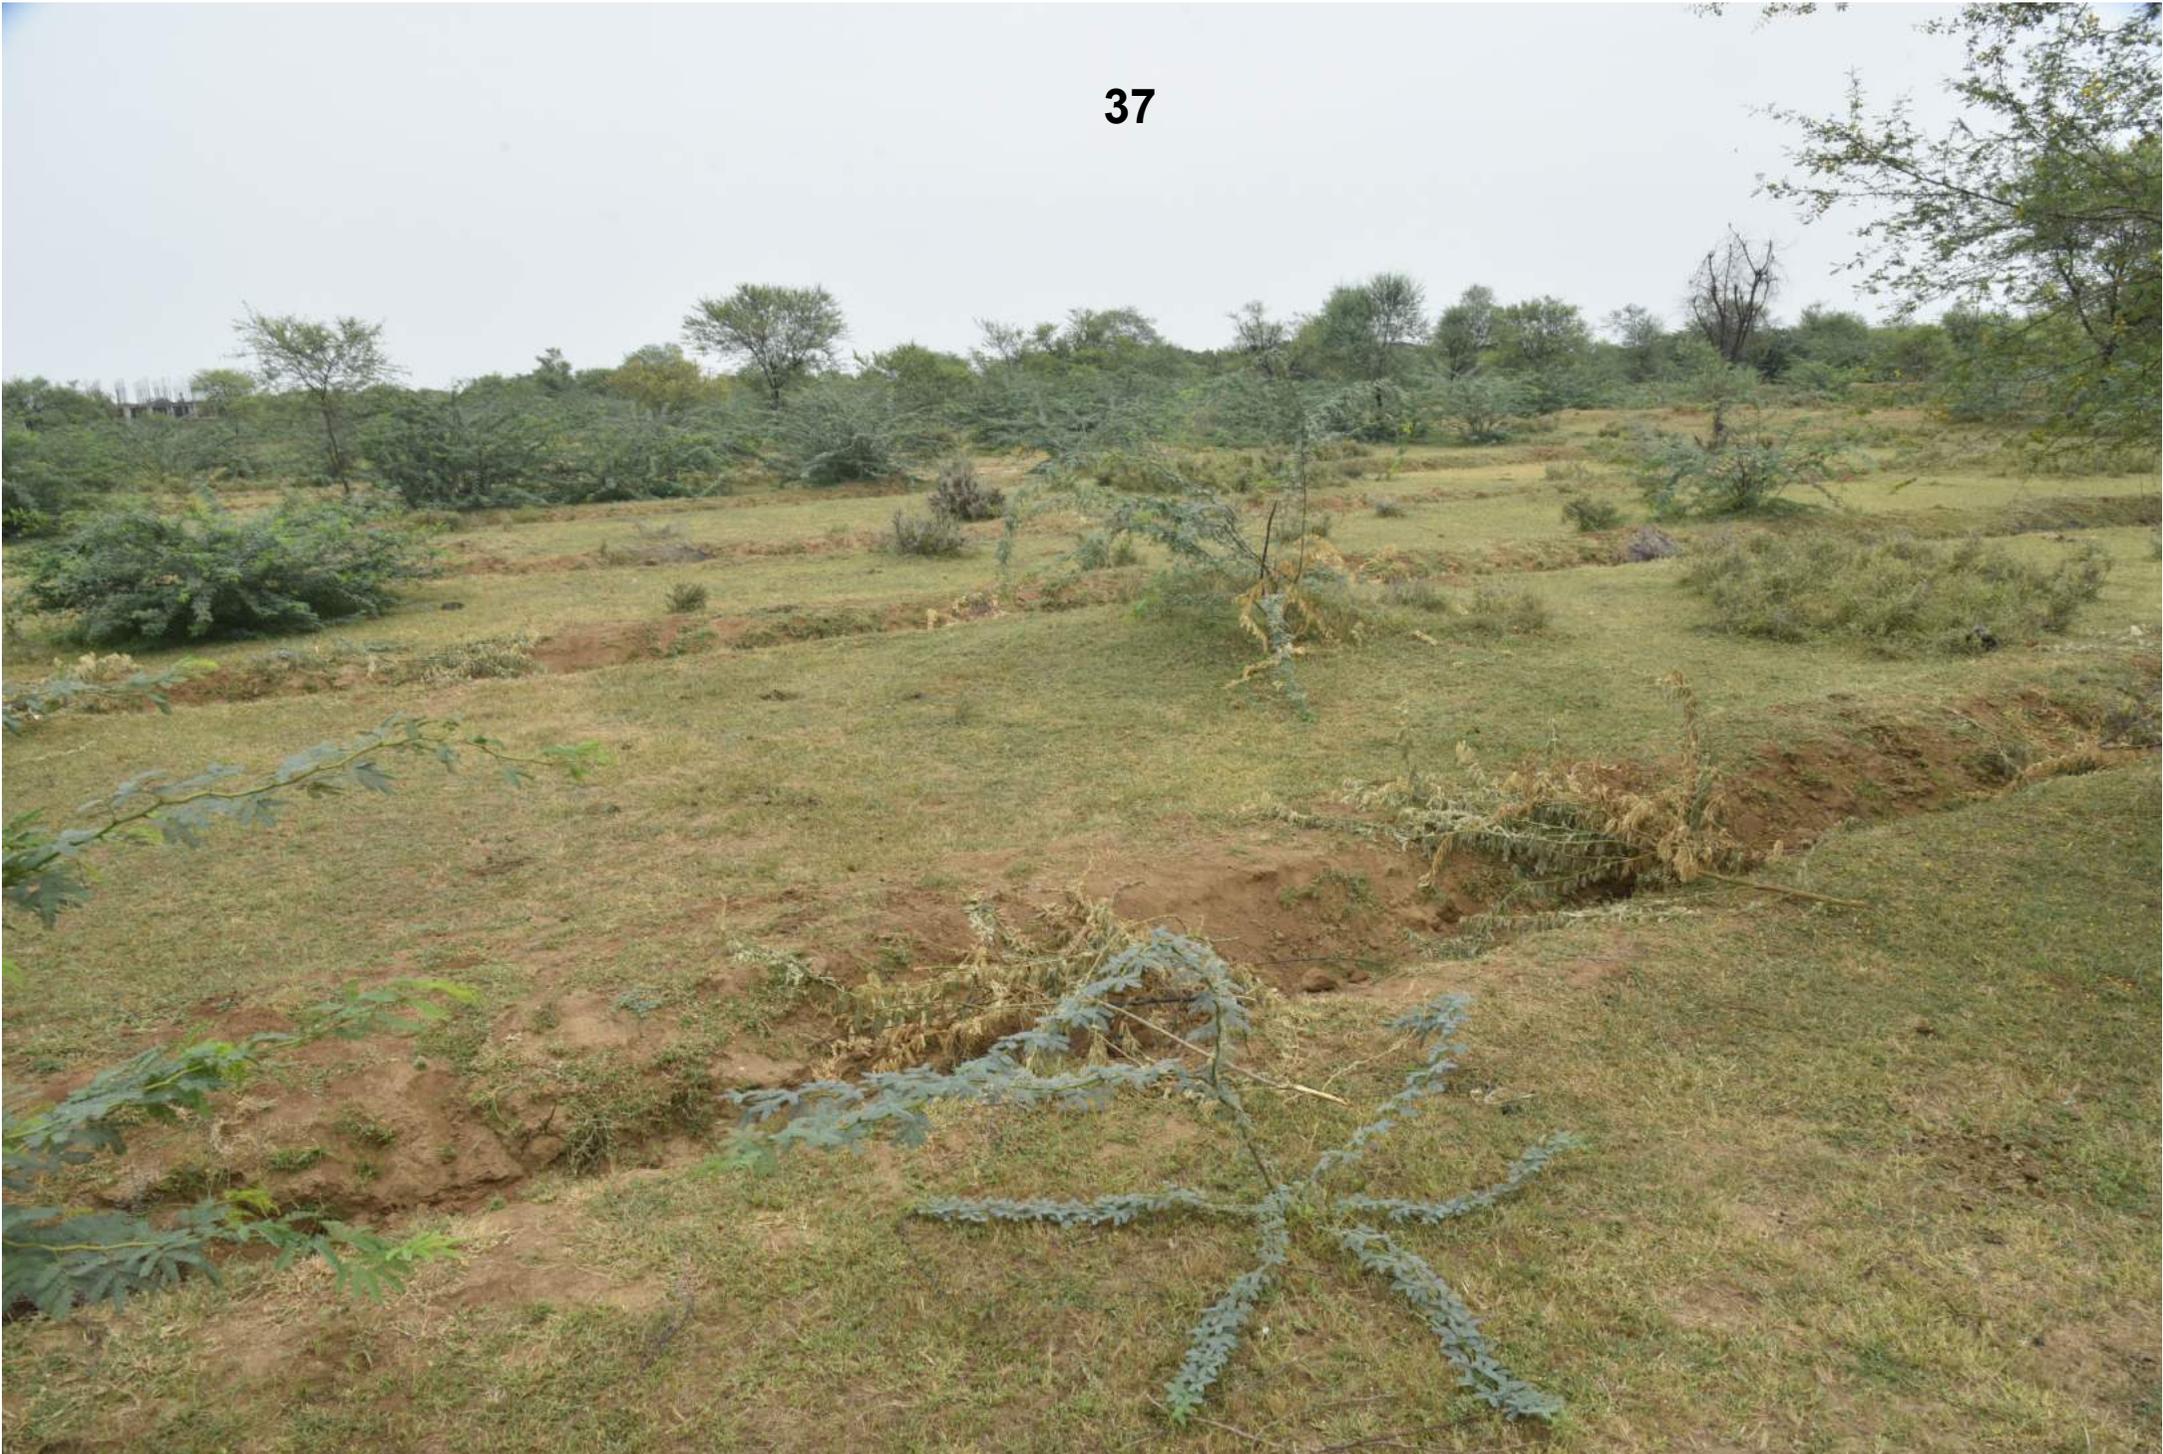
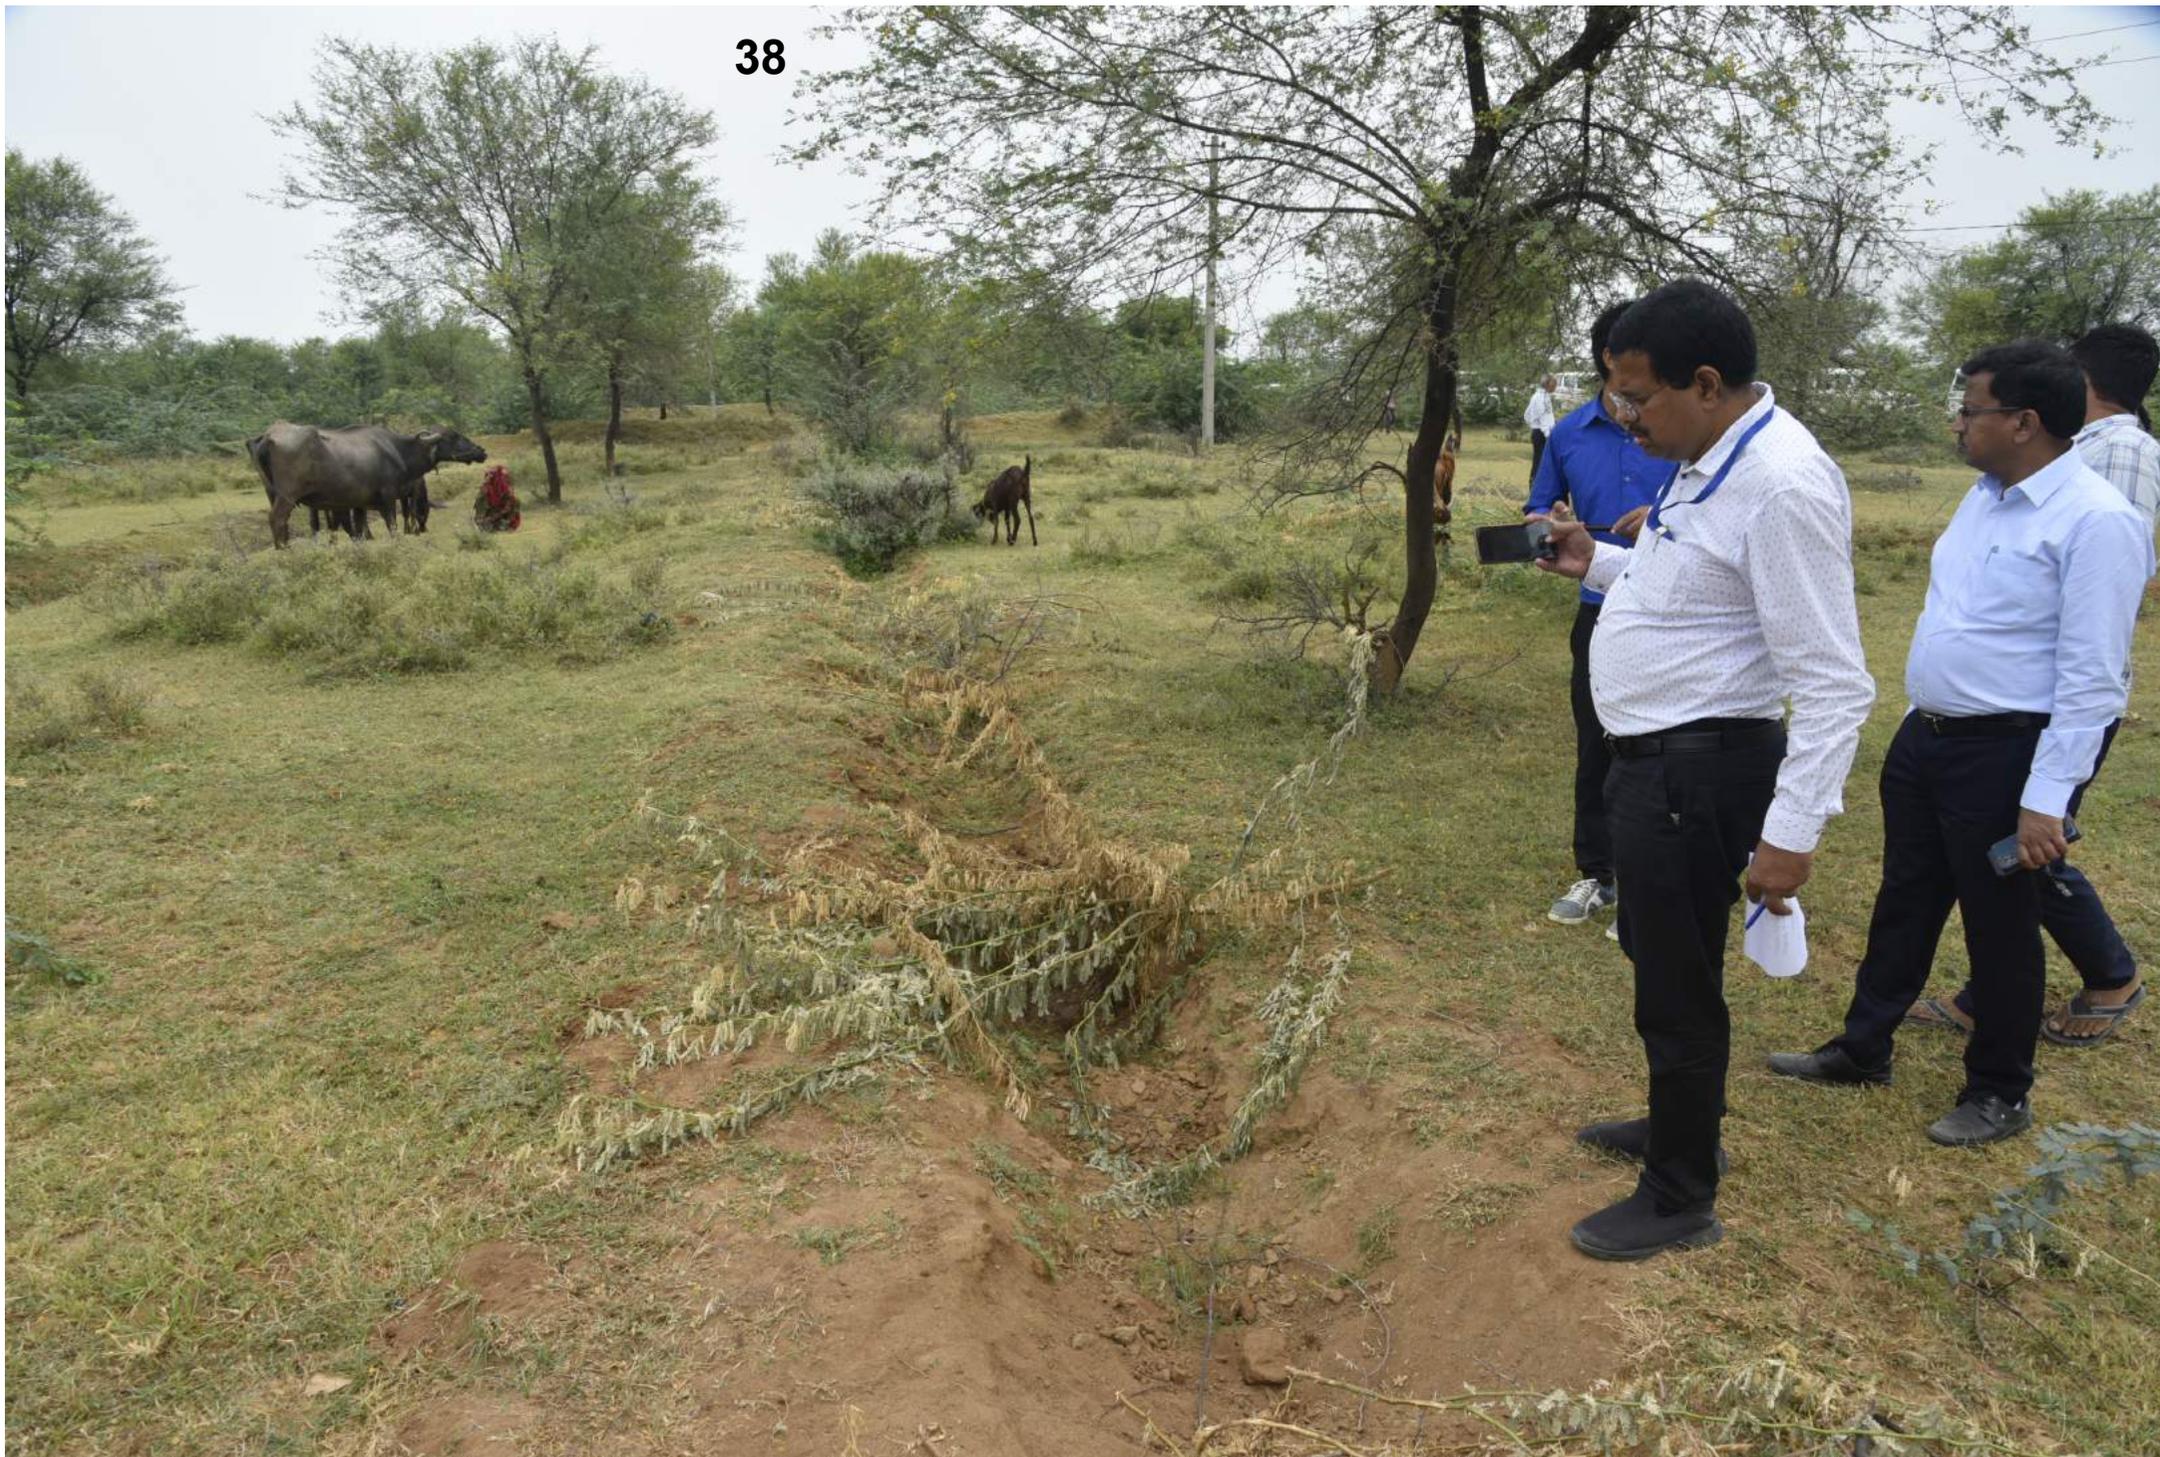
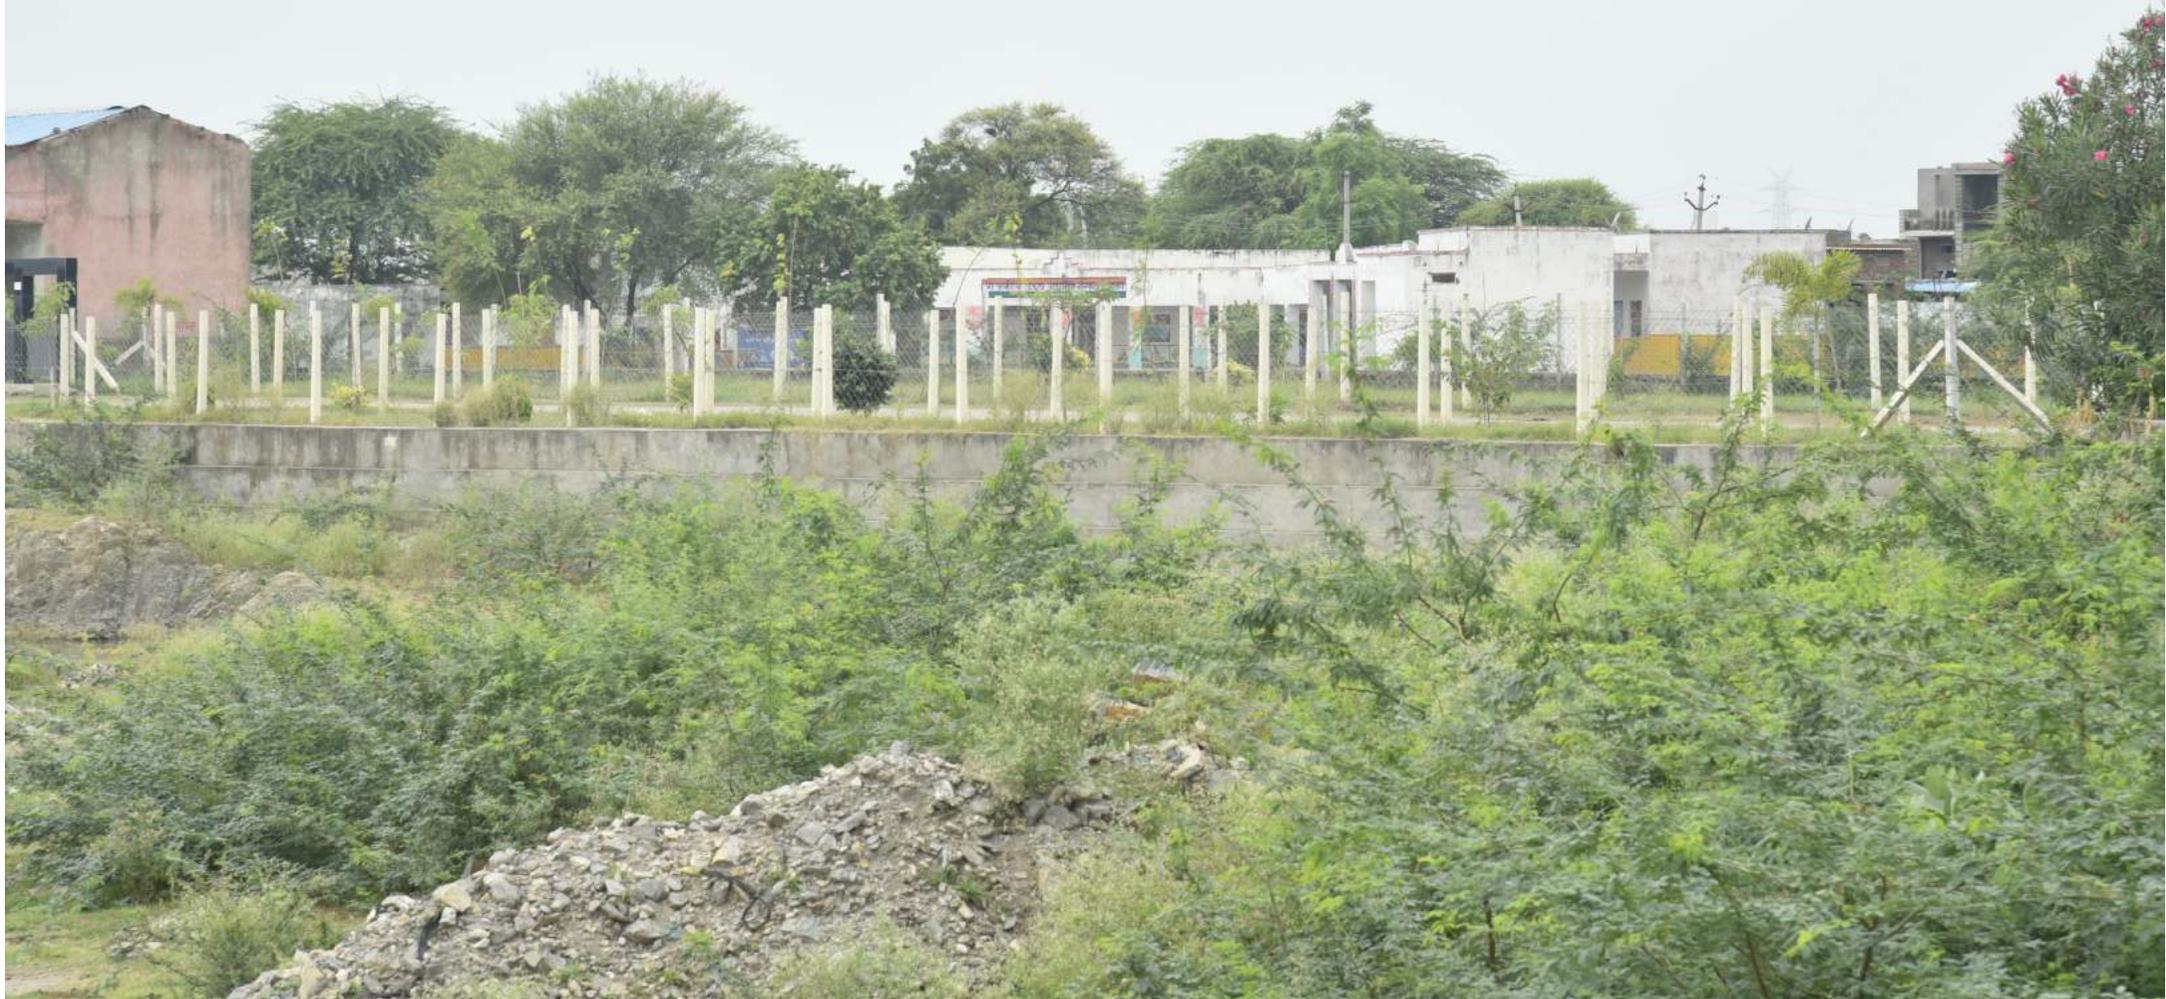
Relevant photographs of plantation carried at Bada Asan is <u>ANNEXURE AC-9 (Pg. No. 36-38)</u>
Jalia	No mining activity	<p>No saplings of trees planted in and around mining area.</p> <p>Around 1000 saplings were claimed to be planted, however, on inspection hardly 50 to 60 saplings were found.</p> <p>Around 20 sapling are claimed to be raised at Govt. Senior Sec. School, Jalia-II, on inspection they were found but they looks very old and are large in size and the leaseholder has failed to show any proof that it has been planted by them.</p> <p>Recent photographs of planting of saplings at Jalia is <u>ANNEXURE CA-10 (Pg. No. 39-40)</u></p>
Hanutia	No mining activity is found.	<p>No plantation is being done in and around mining area.</p> <p>A claim of raising of around 700 saplings is made while on inspection around 50 to 60 saplings were found at village Kheda Dham.</p> <p>Sarpanch Hanutiya was called but not arrived at site.</p>

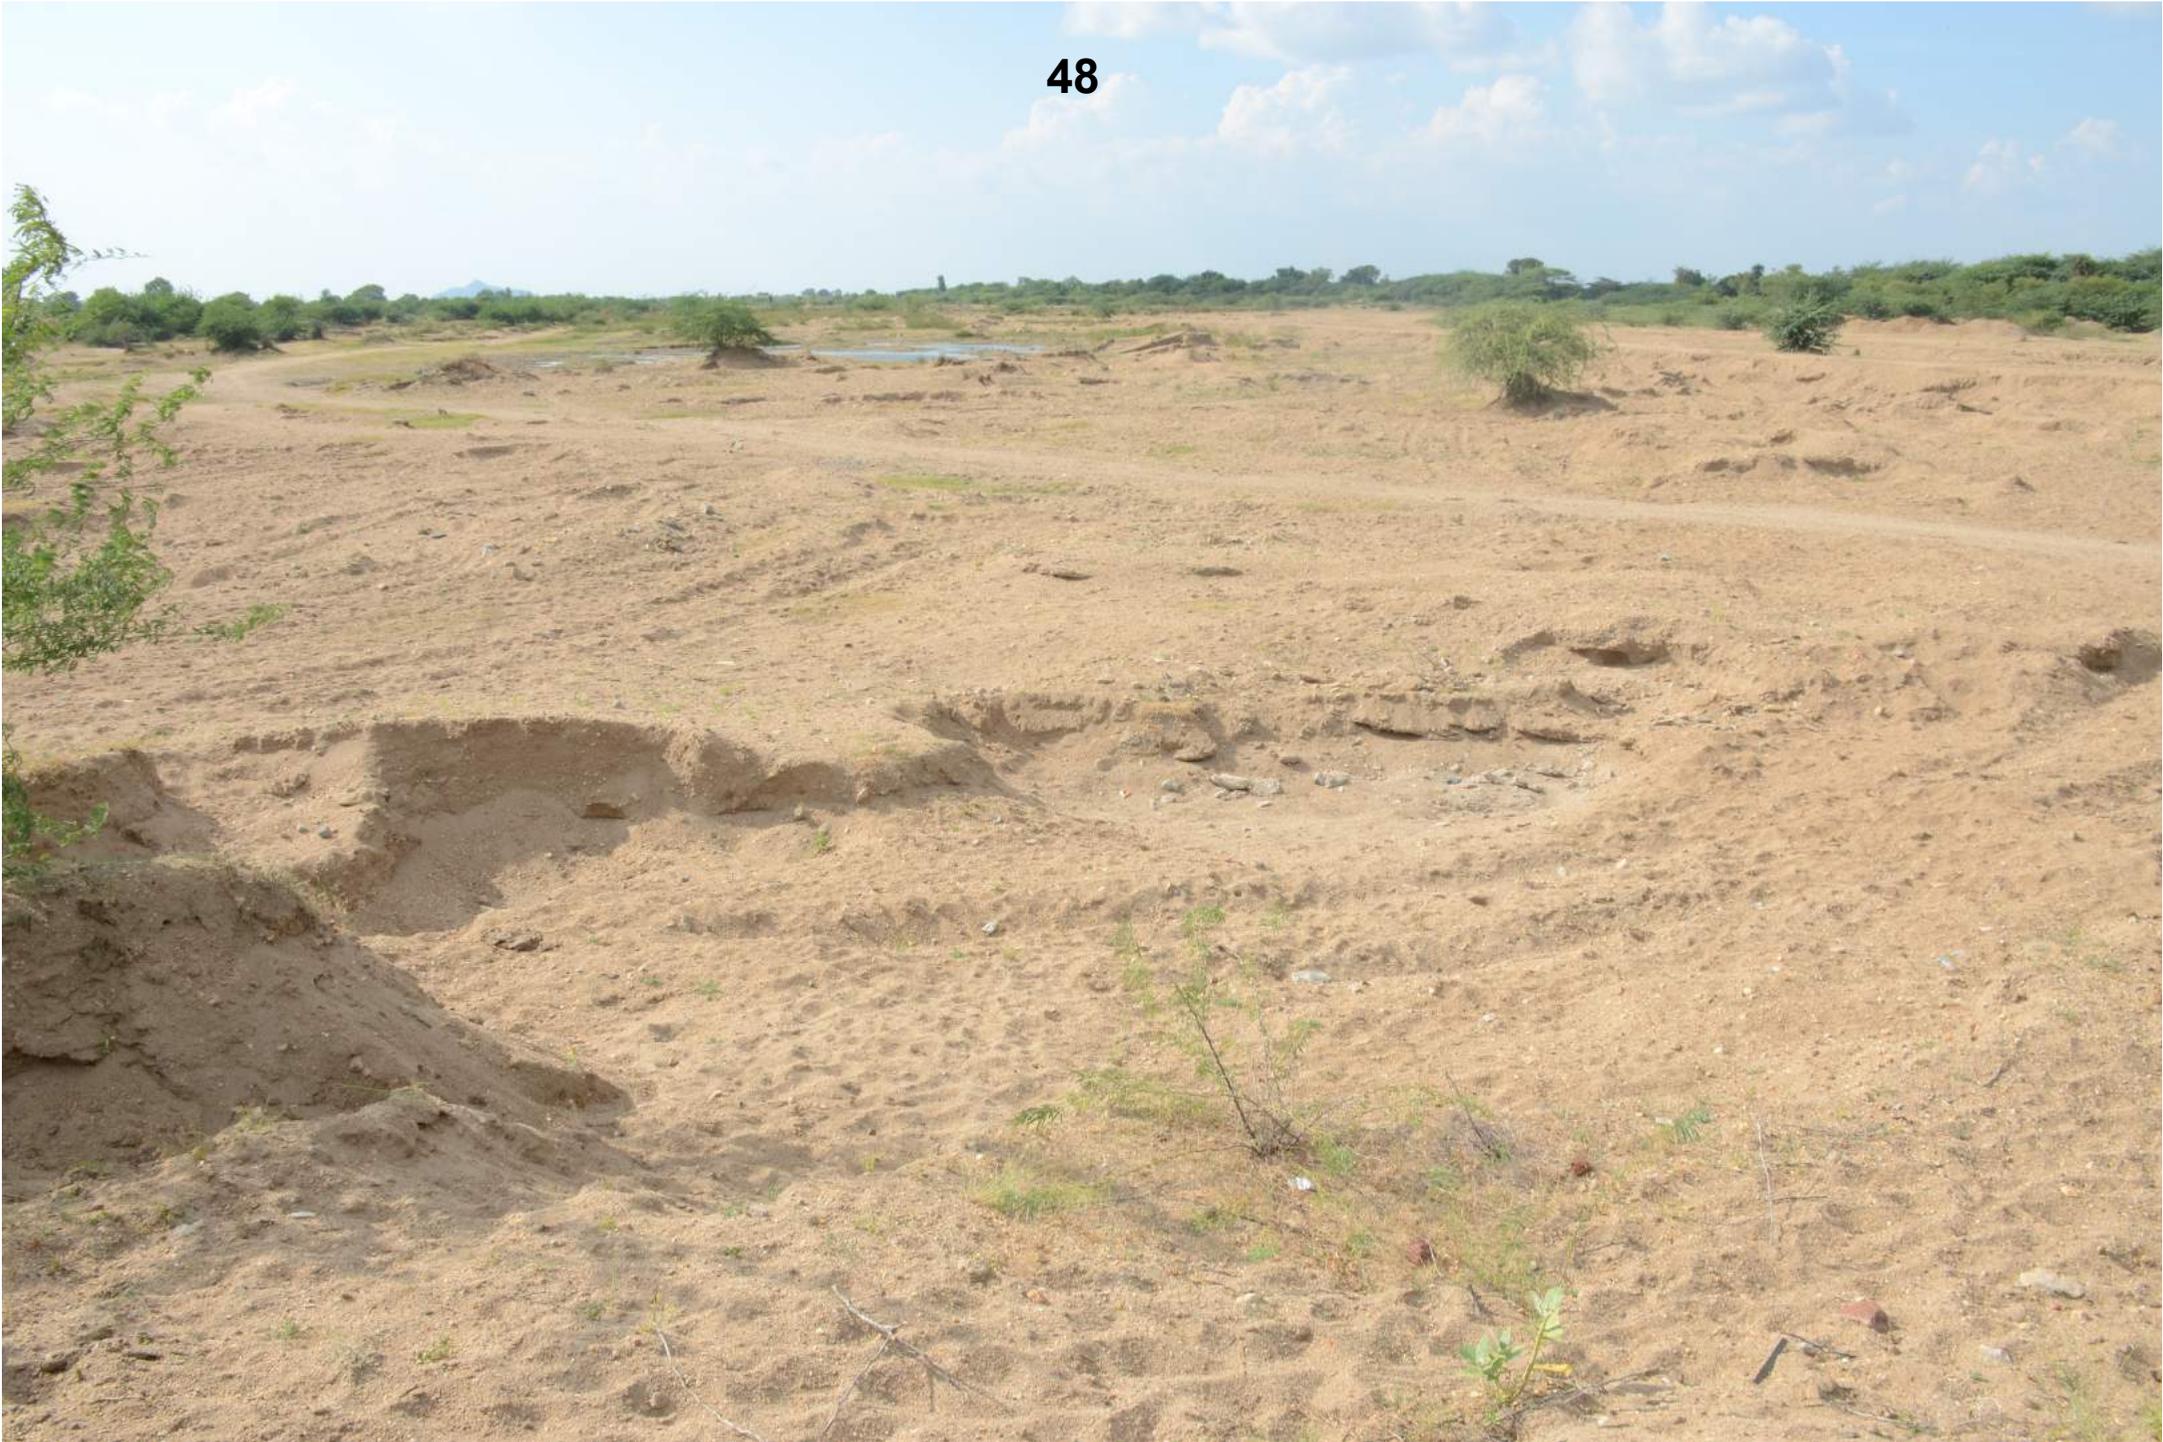
Bhinay	<p>No fresh mining activity was seen.</p>	<p>No plantation is being done in and around mining area.</p> <p>Around 590 saplings were claimed to be planted at various locations. On verification for showing plants the leaseholder took to a site around 20kms away from mining site and there also it was found that they were not trees but flowering plants of temple area. was found that they were not trees but flowering plants. Recent photograph of saplings of flowering plant shown to be planted</p>
