REPORT

**THE FACT-FINDING JOINT COMMITTEE
(FFJC)**

in Original Application no. 327/2023

*(News item Published in India Today dated
30.4.2023 titled "3 minors among 11 dead in
Ludhiana Gas leak", Punjab Govt. announces 2
Lakh Ex-Gratia)*

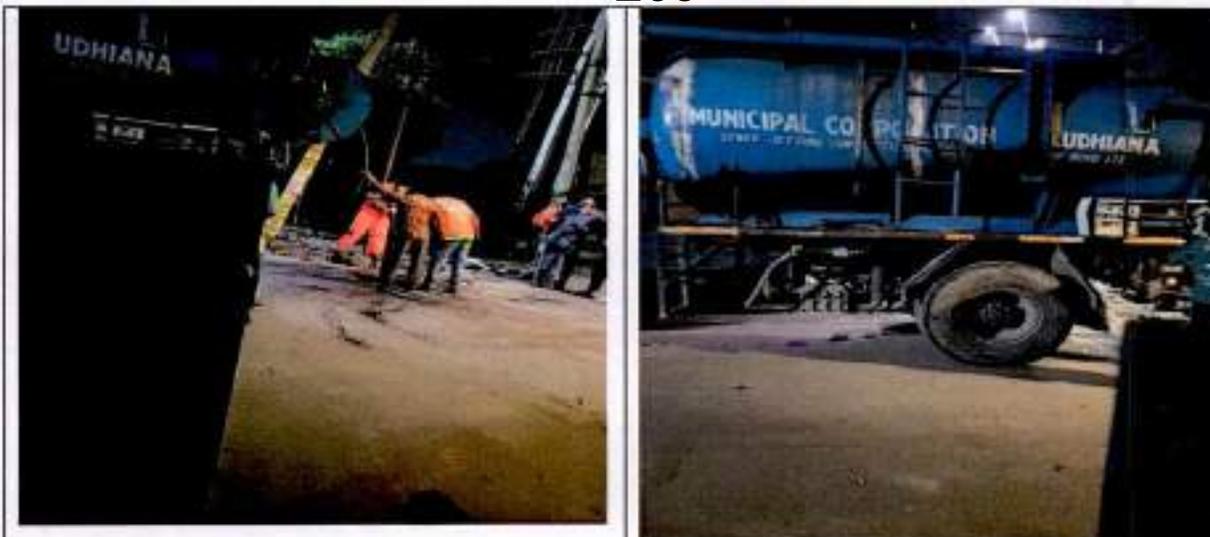
Cleaning of sewer line at the night of incident

Municipal Corporation Ludhiana:- The sewer line was stabilized by using diluted caustic soda in the evening of the incident on the advice of Dr. Anjan Ray (IIP). Sewer line was cleaned at night using machines and fire tender. Road gullies

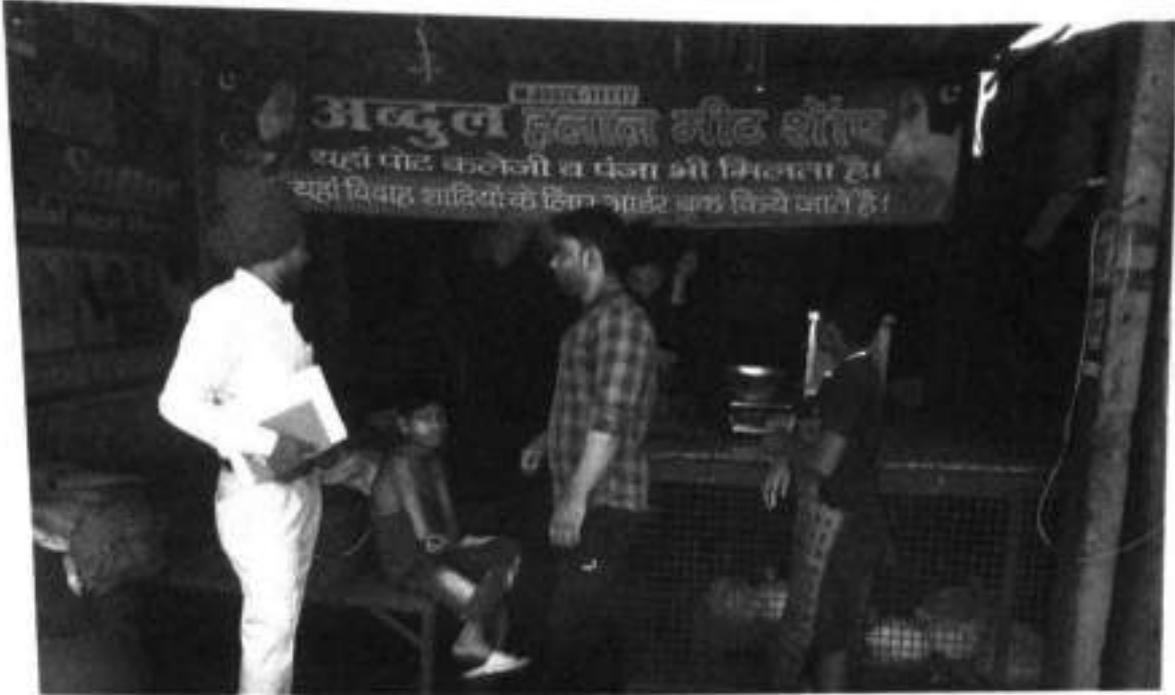
UNAUTHORIZED MEAT/SLAUGHTERING SHOPS

Cluster of meat shops are located in the upstream of the incident point which are discharging the washing water with high Organic loads into sewers

There were many small slaughter houses, dhabas in the close vicinity of the affected site which could have led to release of huge amount of organic content in the sewer lines. Again, this organic content is feeder to anaerobic digestion which ultimately lead to formation of H_2S , CO and other gases.

10. The unauthorized and unscientific disposal of organic matter by meat shops and slaughter houses into sewer cause shock loading of organic

matter in the sewer lines. Unauthorized meat shops and slaughter houses should not be allowed as per the orders of the Supreme court which provides that *"the meat shops/slaughtering houses who have failed to comply with licensing and regulatory norms, food and safety measures, adequate wastewater and solid waste disposal arrangements and any other such legal considerations including non-observance of hygiene imperatives should not be permitted until they become fully compliant of such norms and regulations. A centralized slaughter house having fullfledged compliance arrangements should be provided"*.

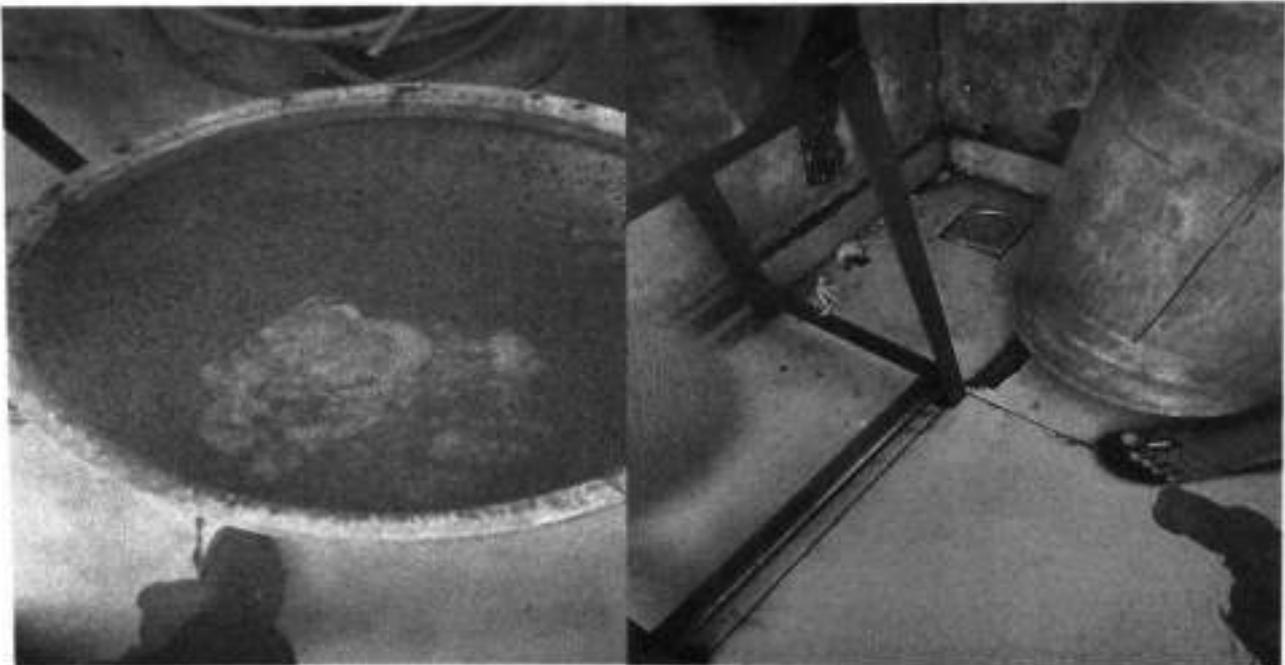
No adequate solid waste handling which leads to choking of sewers

Illegal Outlet for discharge of high organic load directly into sewer .

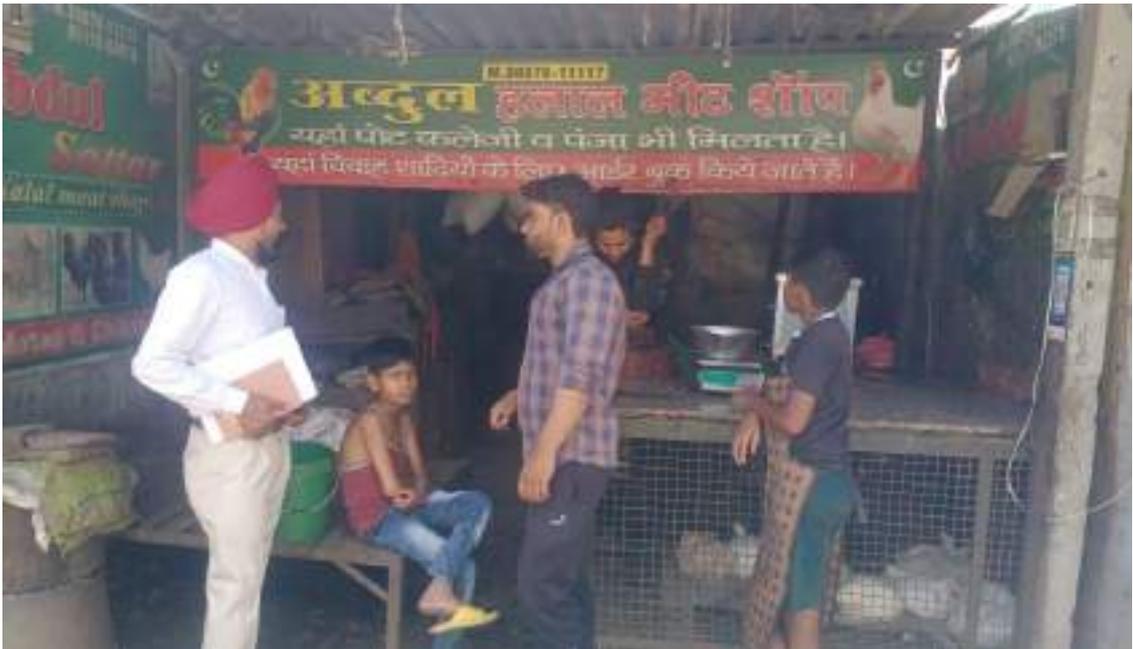
UNAUTHORIZED MEAT/SLAUGHTERING SHOPS

Cluster of meat shops are located in the upstream of the incident point which are discharging the washing water with high Organic loads into sewers

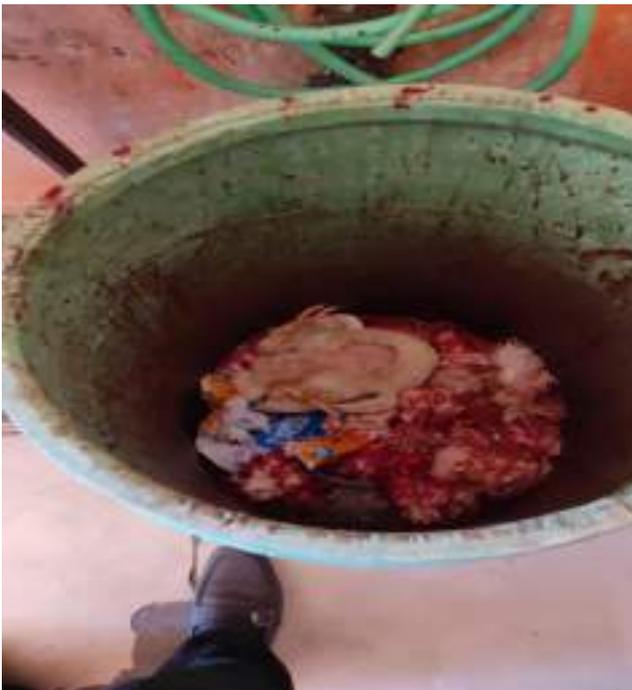
No adequate solid waste handling which leads to choking of sewers

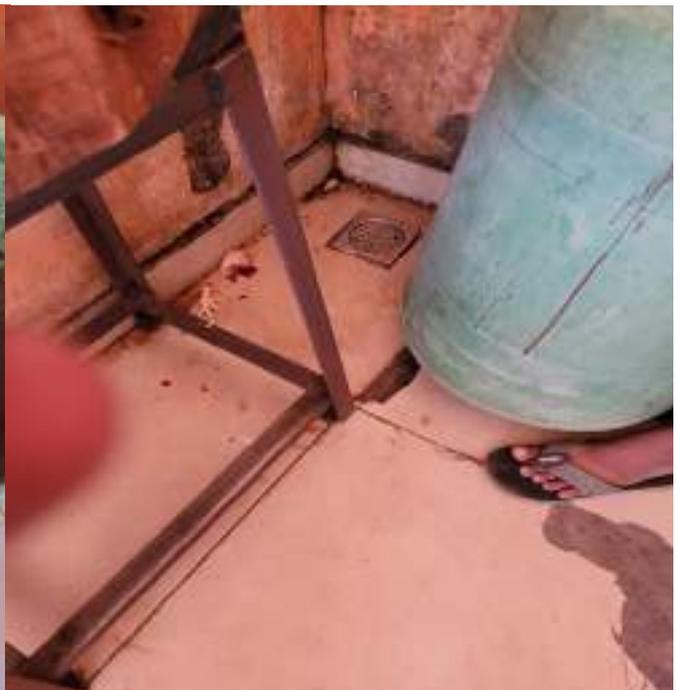
Illegal Outlet for discharge of high organic load directly into sewer .

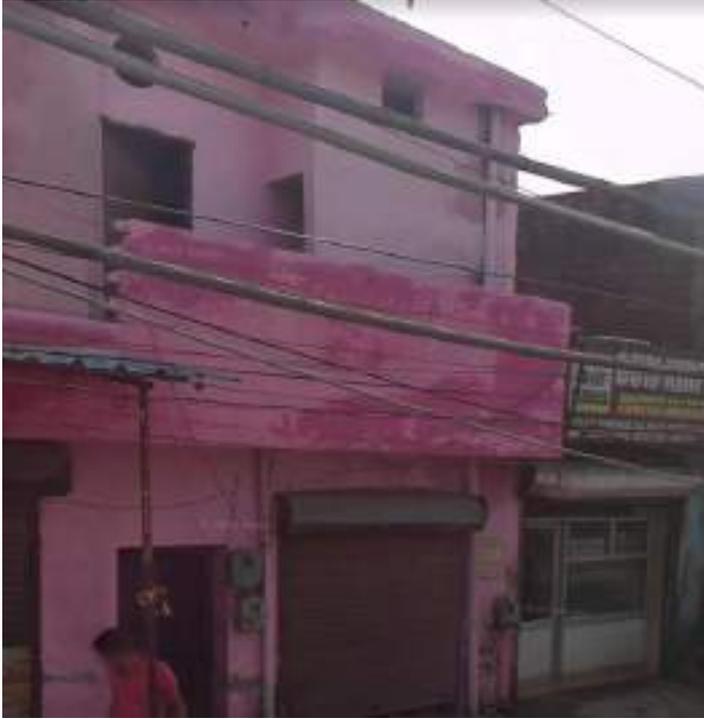
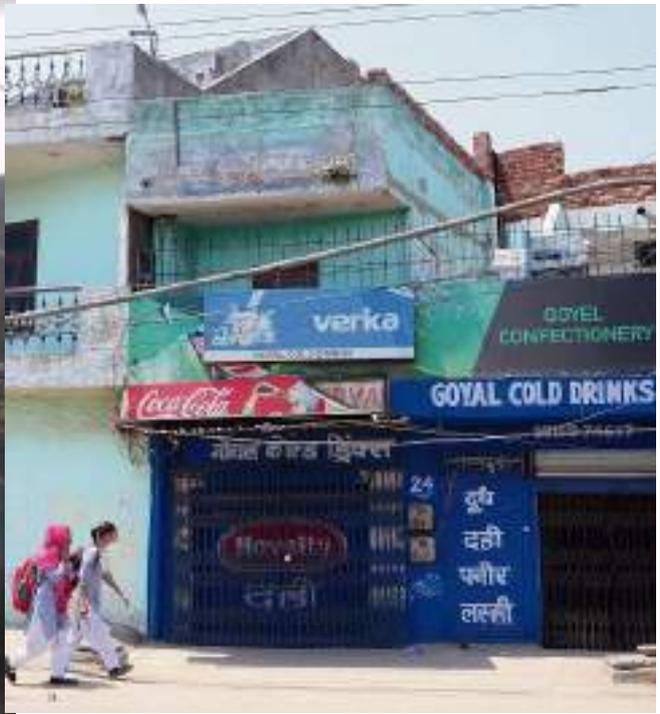
NO OR POOR VENTILATION IN THE HOUSES OF THE DECEASED

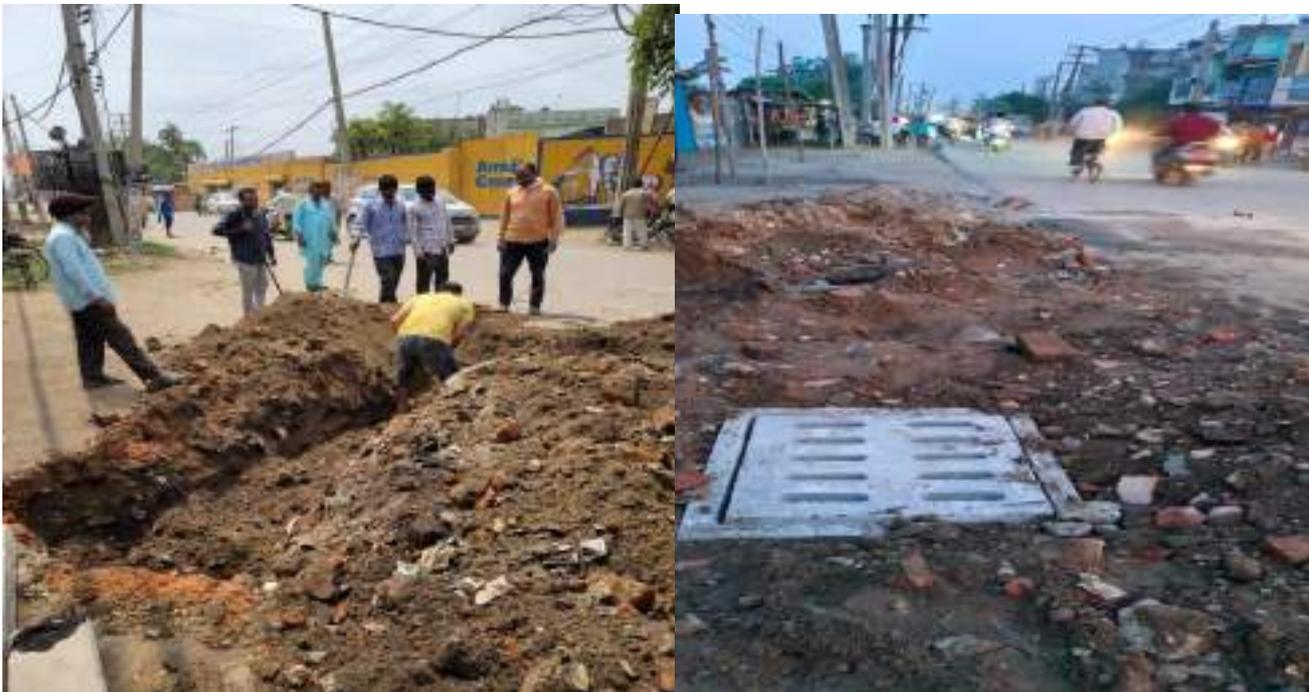
CONSTRUCTION OF ROAD GULLIES AND PROVISION OF VENTILATION JALIS 2 DAYS AFTER INCIDENT

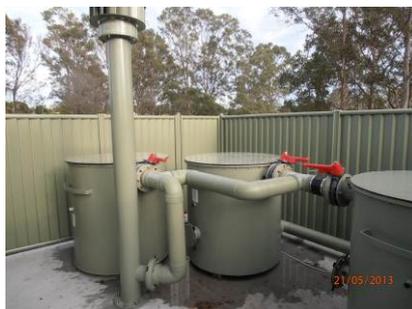
Figure 2: *Typical AC filter & vent*

In practice even retic gravity sewers or small diameter rising mains have the potential to generate high H₂S gas concentrations, usually due to long detention times. But how can we vent sewers near houses and businesses without adversely affecting customers? Some form of treatment combined with dispersion is usually required. Figures 2 and 3 show some relatively low cost treatment and dispersion options.

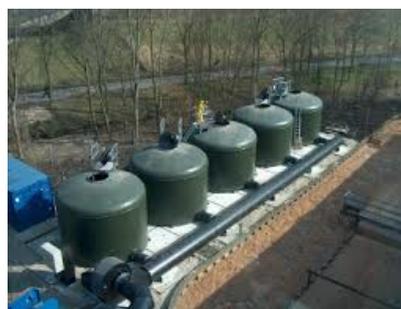
Figure 3: *Biotrickling filter*

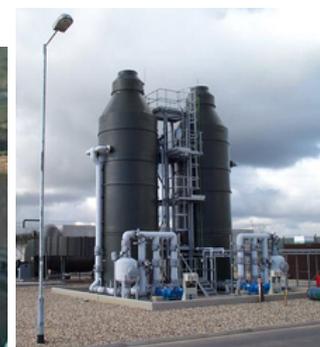
Figure 4: *Chemical scrubber*

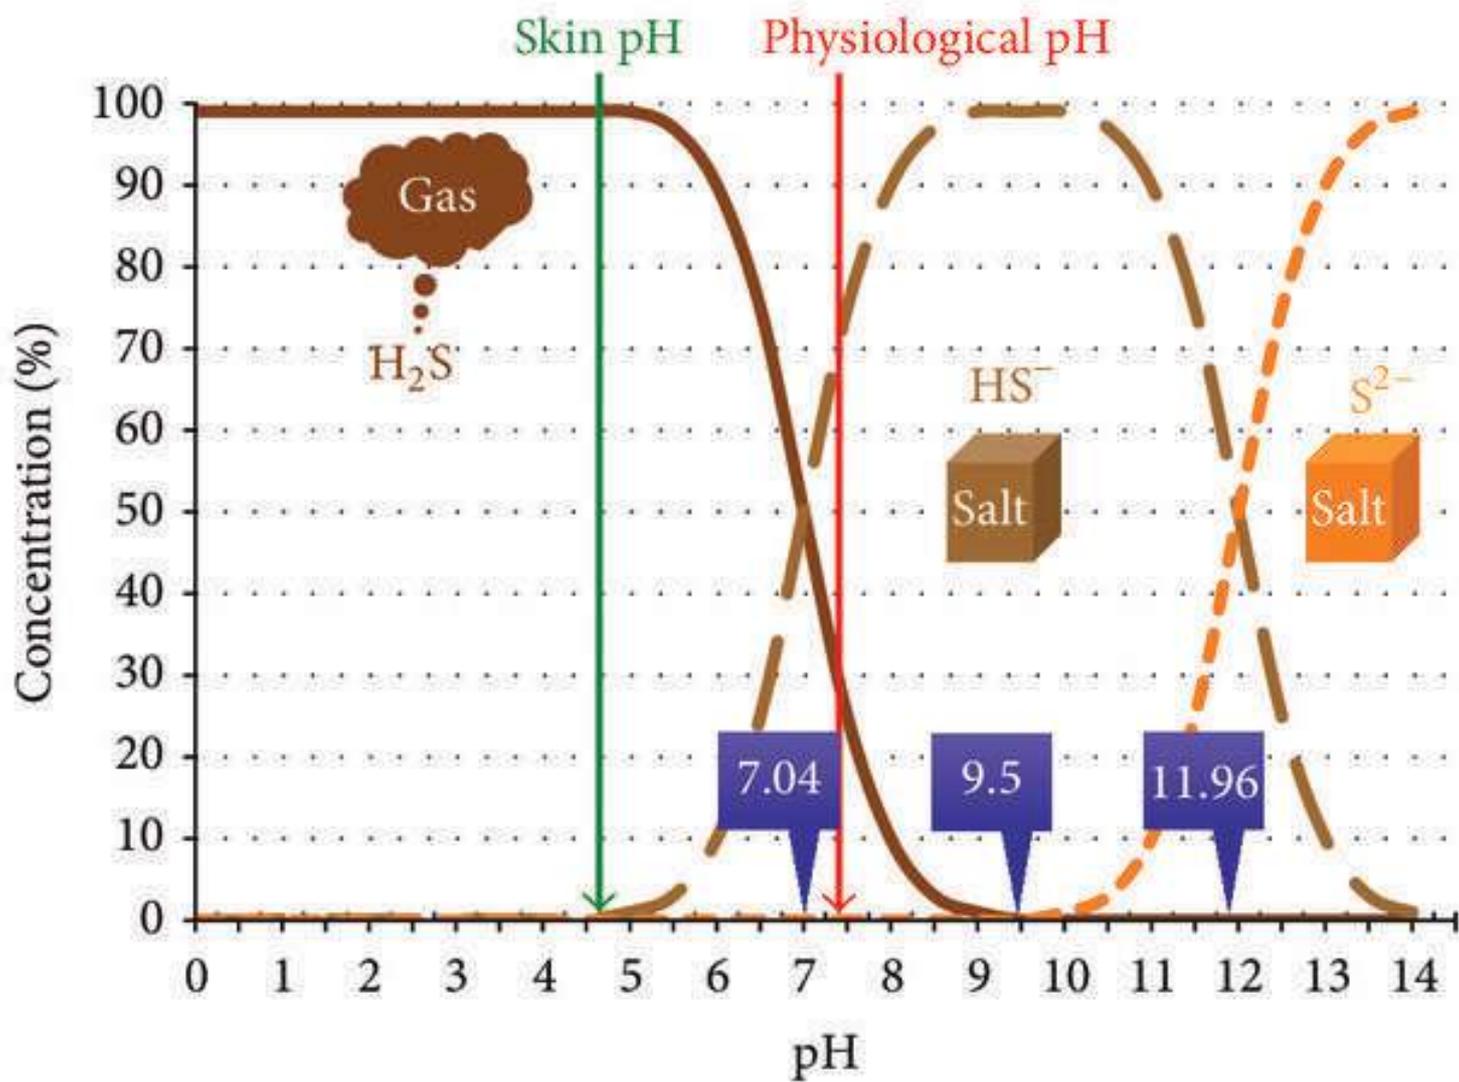
BIOGENIC SULPHURIC ACID ATTACK ON CONCRETE PIPE

In concrete pipes carrying aged sewage, in warm climates, the interior surface above the effluent level is subject to attack by sulfuric acid generated by bacterial action at the pipe wall, making use of hydrogen sulfide gas in the sewer atmosphere. The production of hydrogen sulphide and the consequential deterioration of concrete sewer pipes is first and foremost a function of sewer design and environmental factors. This process, known as "H₂S attack", can lead to very rapid deterioration.

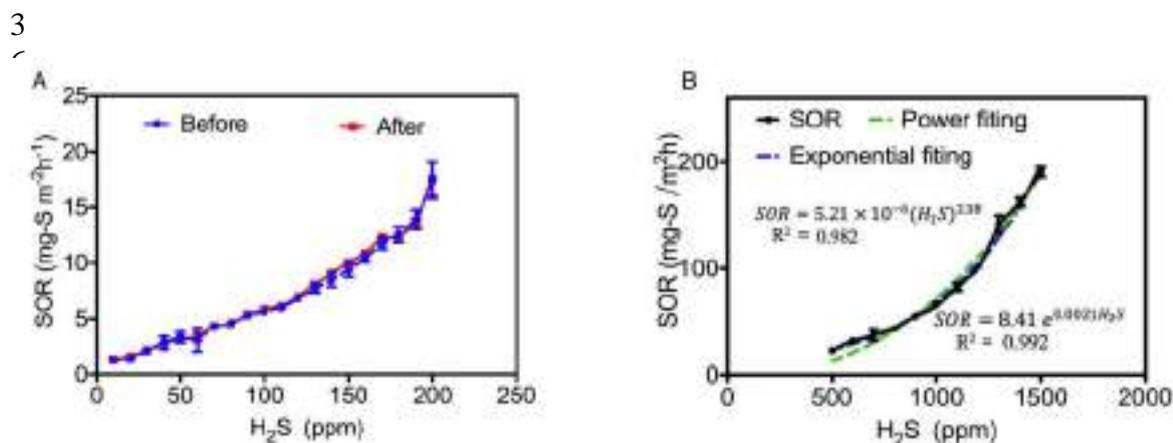
109 The SOR of the coupons prior to and after sterilization were quite similar for H₂S
 110 concentrations up to 200 ppm (Figure 6). It shows clearly that sterilization of the concrete did
 111 not have any impact on the SOR and it confirms that the microbes on the concrete had
 112 negligible role in H₂S oxidation. Together with the absence of sulfide oxidizing microbes in
 113 the corrosion layer (Section 3.2), it clearly suggests that biological sulfide oxidation is not the
 114 cause of the concrete corrosion and thus the SOR observed were mainly due to chemical
 115 oxidation of sulfide.

117 **Figure 6.** Sulfide oxidation rates of concrete coupons before and after sterilization under 10-200 ppm
 118 H₂S (A), and the sulfide oxidation rates of concrete coupons under 500-1500 ppm H₂S (B).
