Sub: Report of the High-Level Committee set up by the Hon'ble National Green Tribunal (Principal Bench) vide order dated 19.02.2021 in OA No. 43/20202(EZ), in the matter of Bonani Kakkar Vs. Oil India Limited

Re: Baghjan Blow out incident in Assam

Enclosed : Report of the High Level Committee

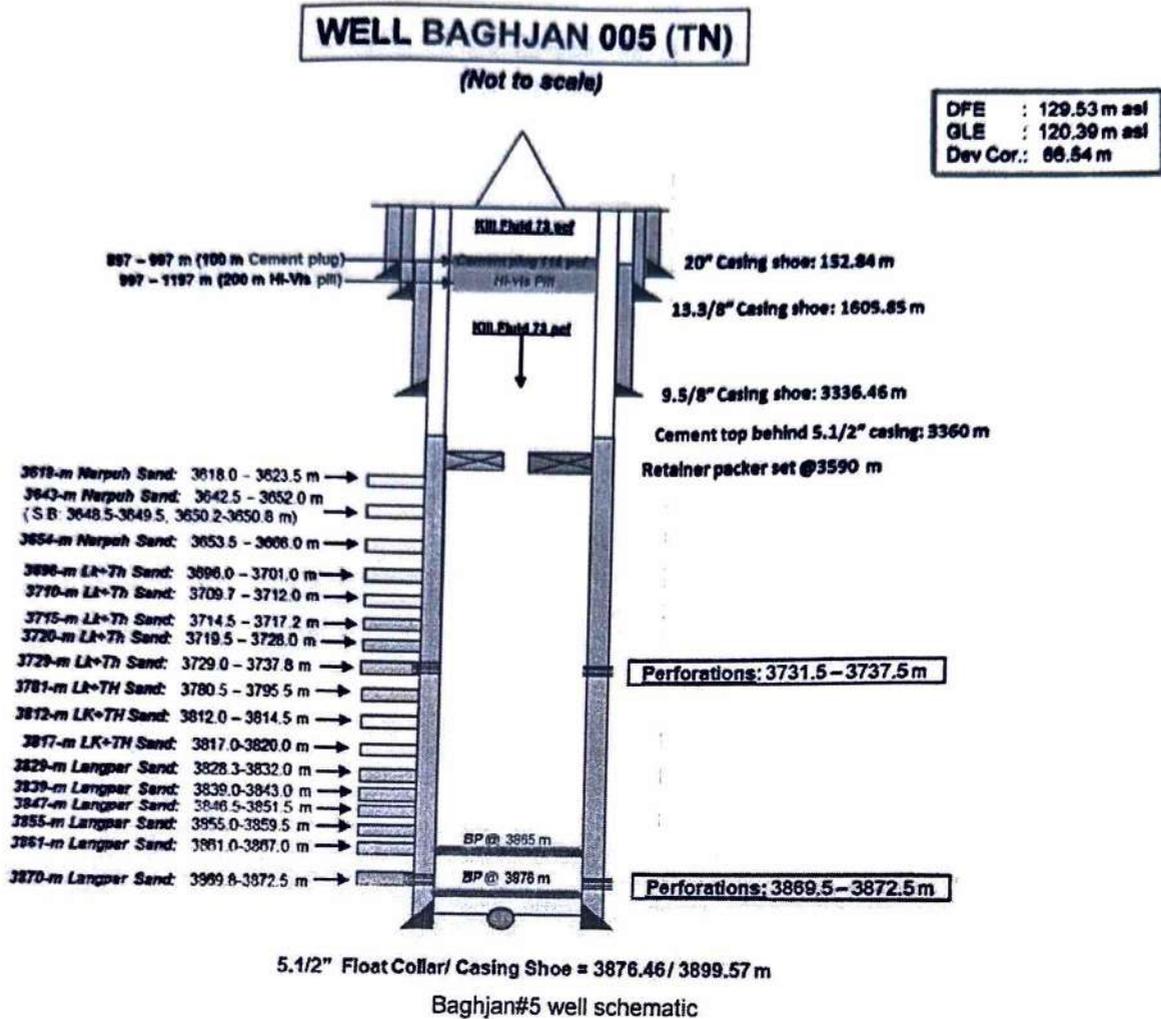
Arrangement was made to nipple down the tubing spool. During the process, little amount of displacement was observed from the well. The crew attempted to run in 2^{7/8}" tubing and tried to install tubing hanger cone. Flow increased and tubing hanger cone could not be placed due to increased flow rate from the well. After that the flow rapidly became uncontrolled, leading to blowout.
