BEFORE THE NATIONAL GREEN TRIBUNAL**PRINCIPAL BENCH NEW DELHI**

ORIGINAL APPLICATION NO. 6 /2012

**FACTUAL STATUS REPORT BY THE COURT COMMISSIONER
IN COMPLIANCE OF ORDER DATED 09.04.2025**

Quick Glance of drain with help of google earth image and photos taken on 9th and 11th April, 2025:

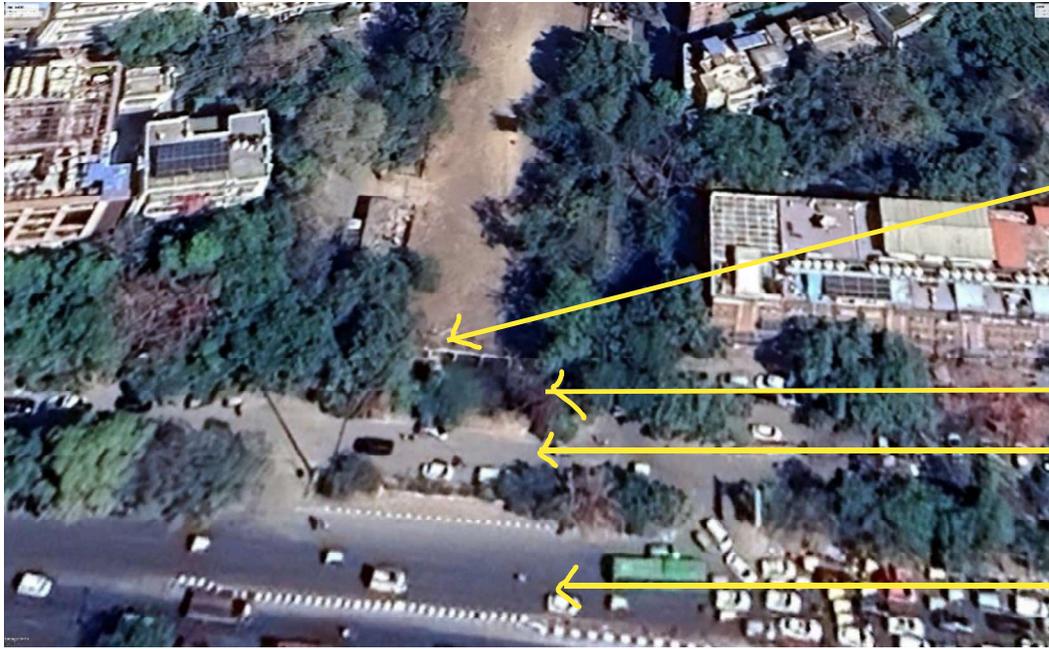
Point 'A' enlarged view

covered portion starts and goes upwards

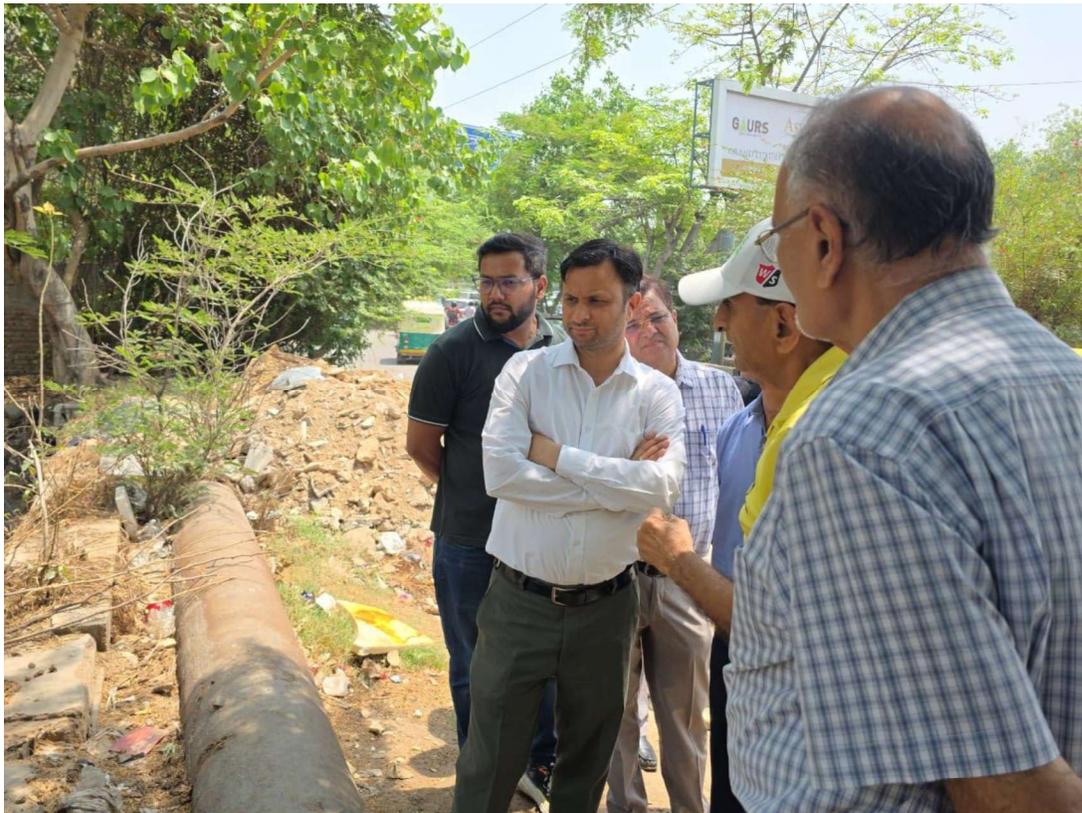
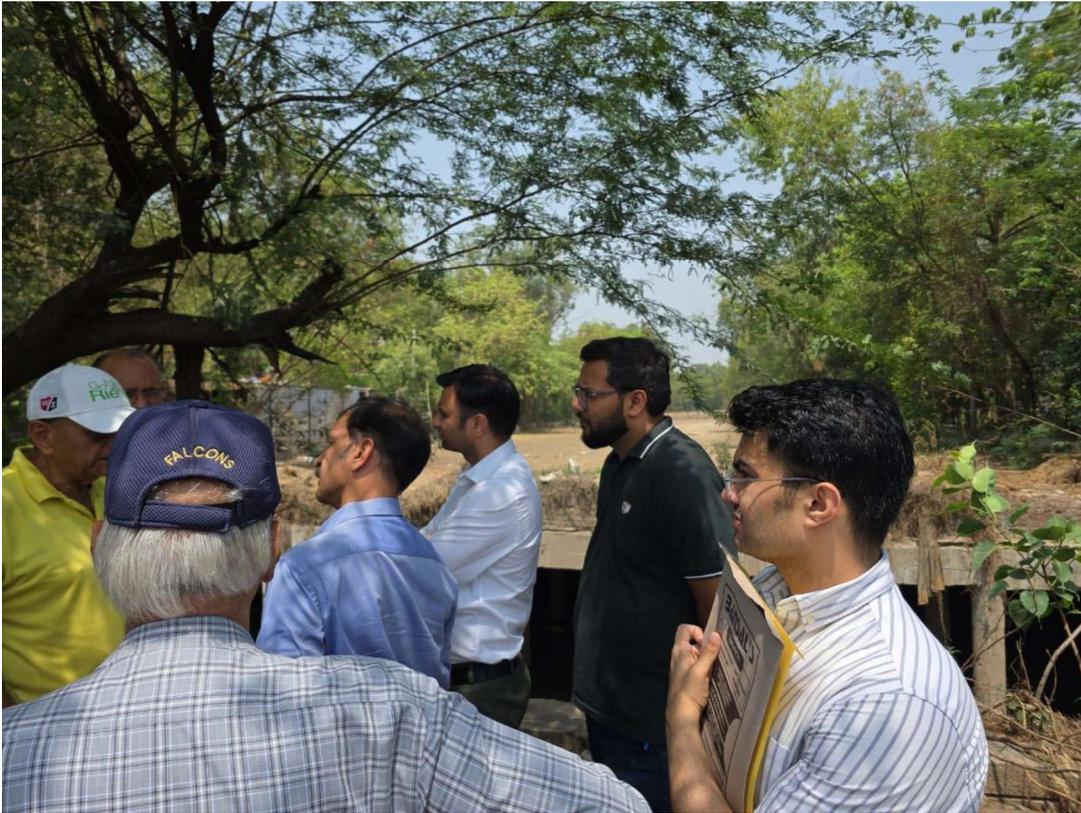
6. At service road/Ring Road. ↓

Muck/debris lying on service road

4. Point "A" was full of debris on both side of drain underneath the Ring Road culvert. And just below the starting point of concrete cover, huge amount of all type of waste including plastic waste (varying from small to large pieces) was found majorly on west side. The flow was found stagnant.

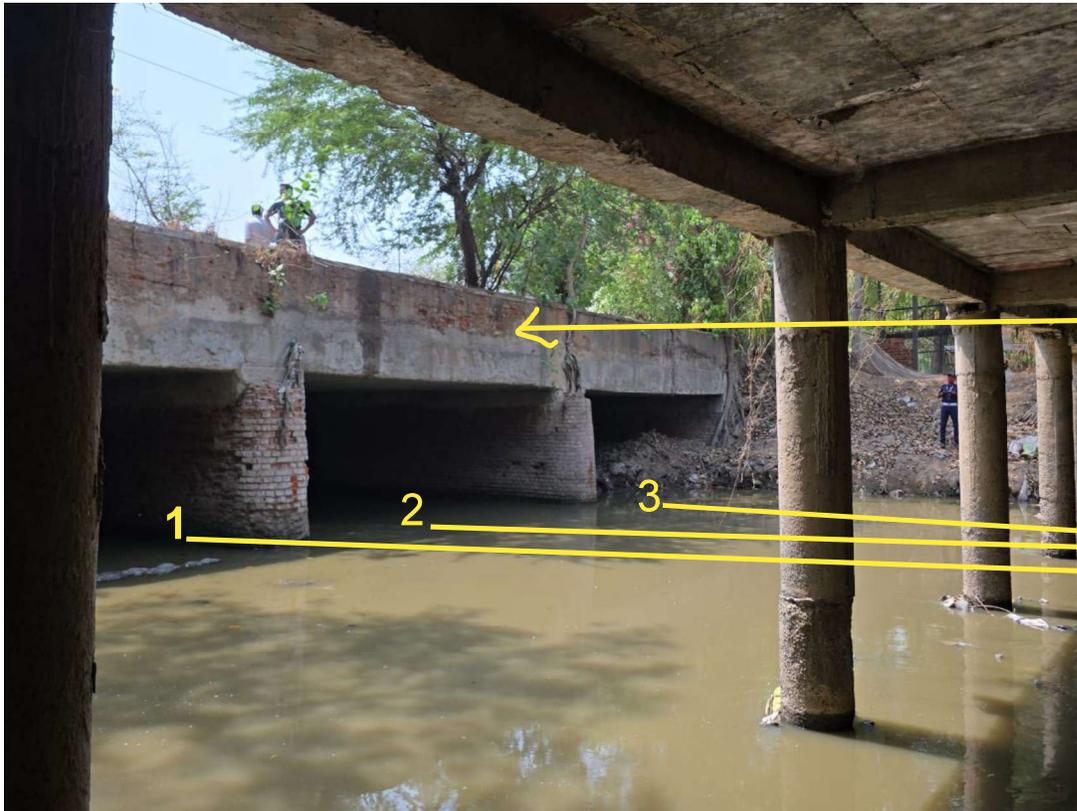
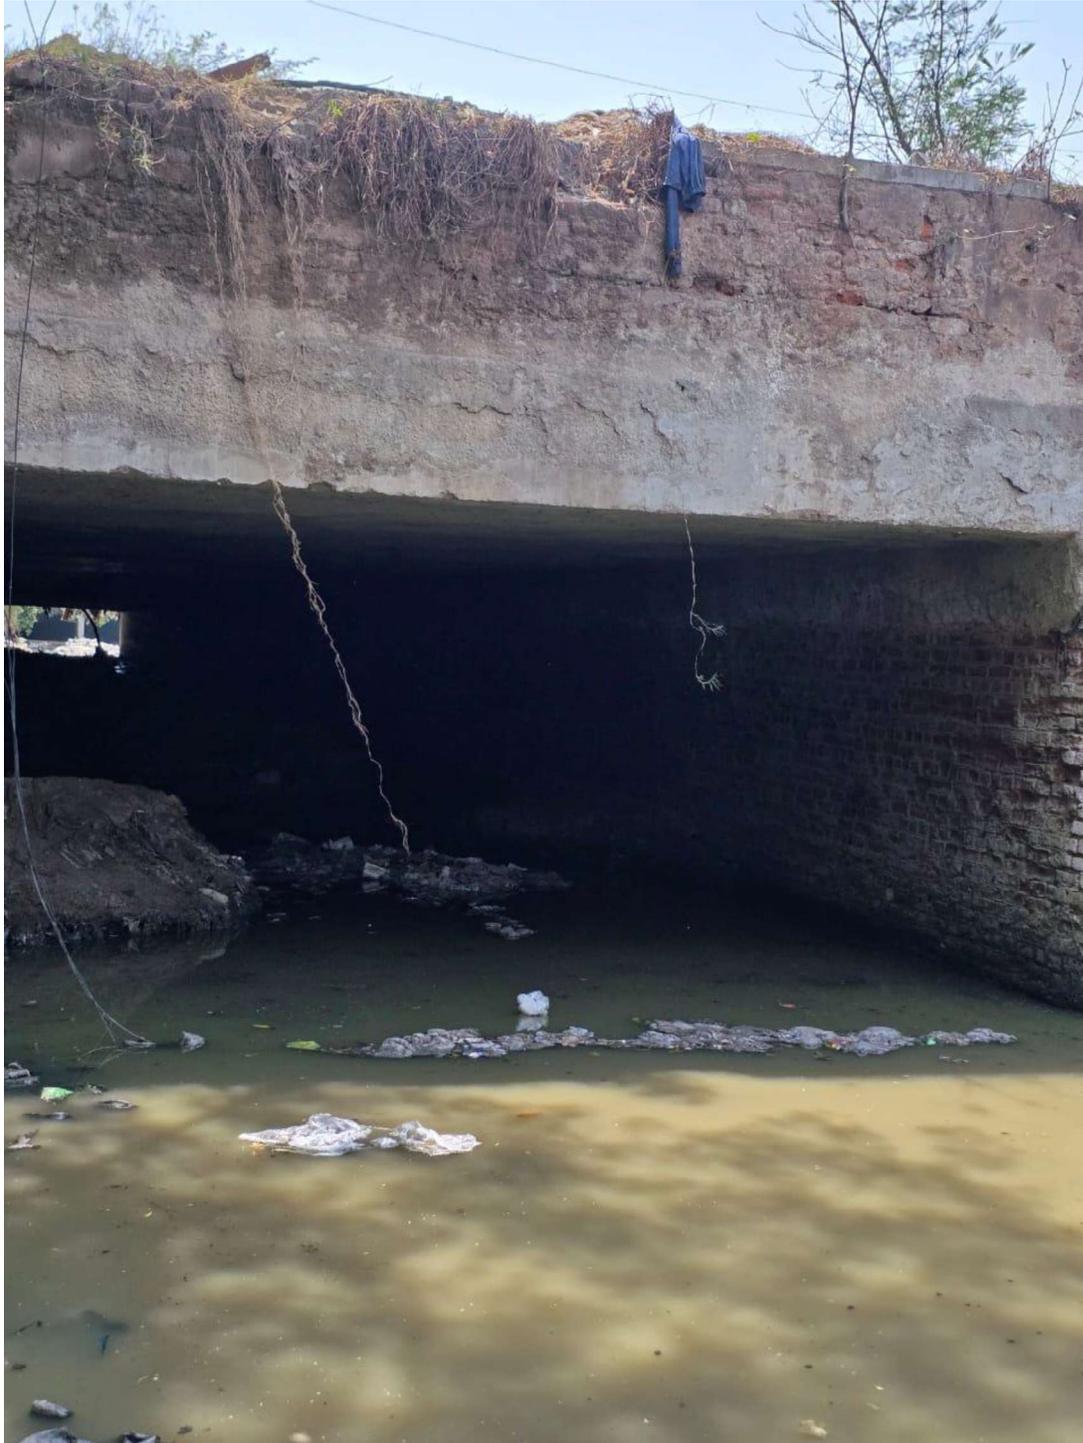
7. Photos of Drain at the point of entering Defence Colony (taken from east side of drain)

**Culvert/
service
road/ring road**

**3 channels
entering drain**

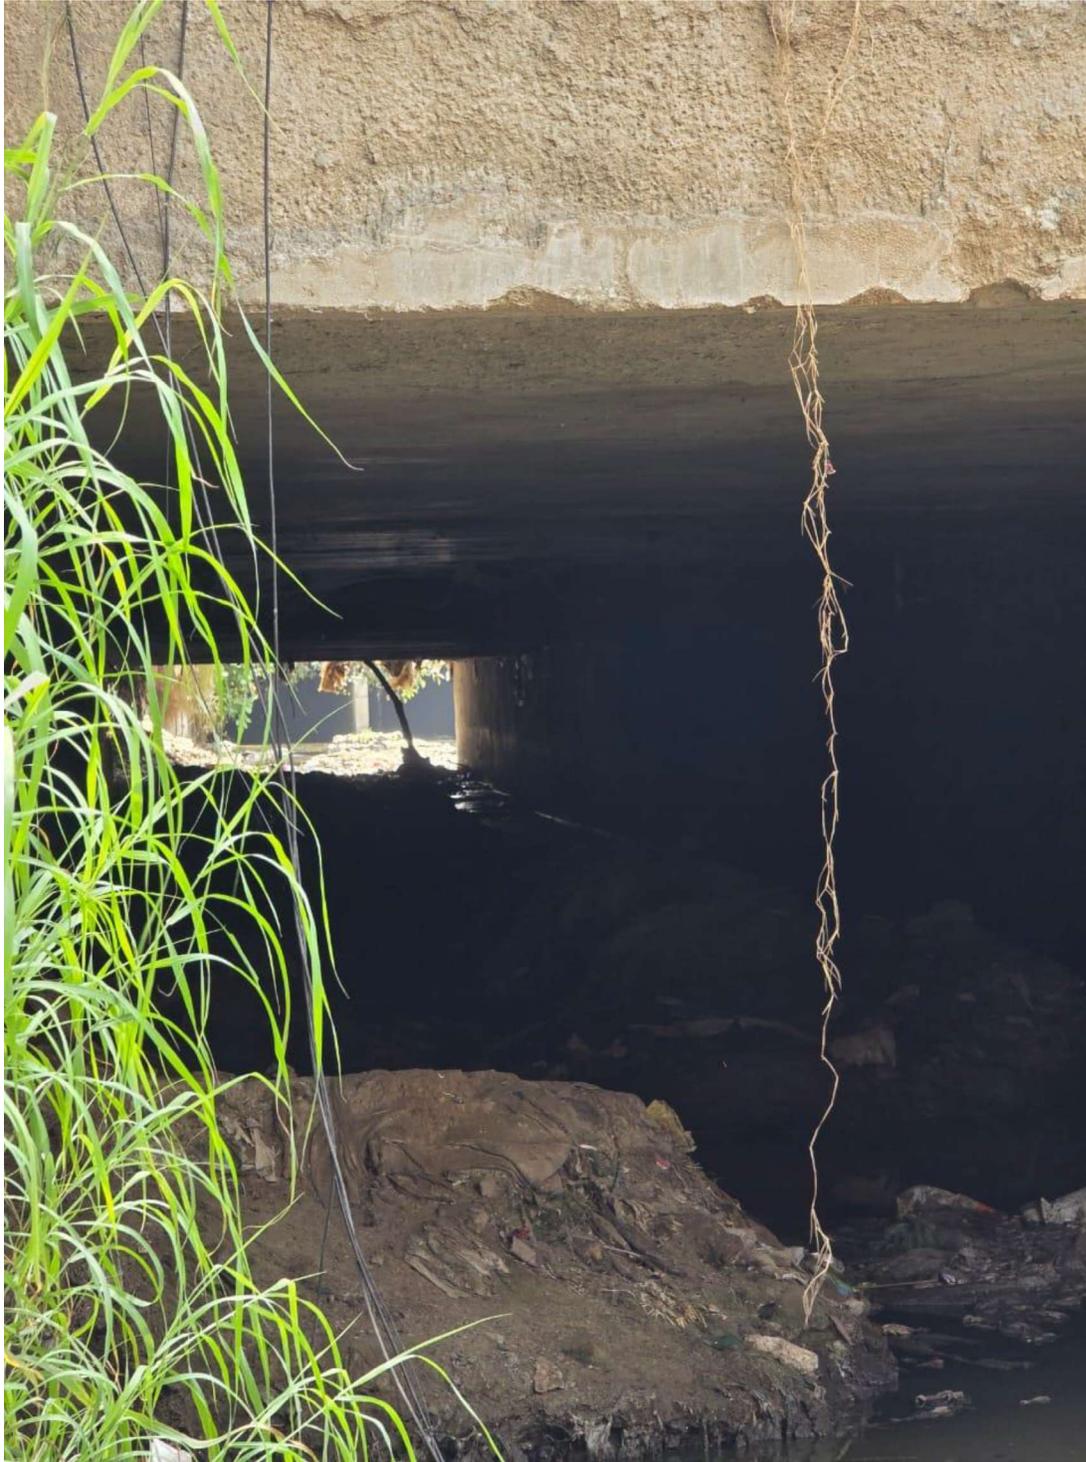
Channel coming towards the Defence Colony drain (below the Ring Road)
filled with debris (on eastern side)

1st channel
filled/choked
with debris

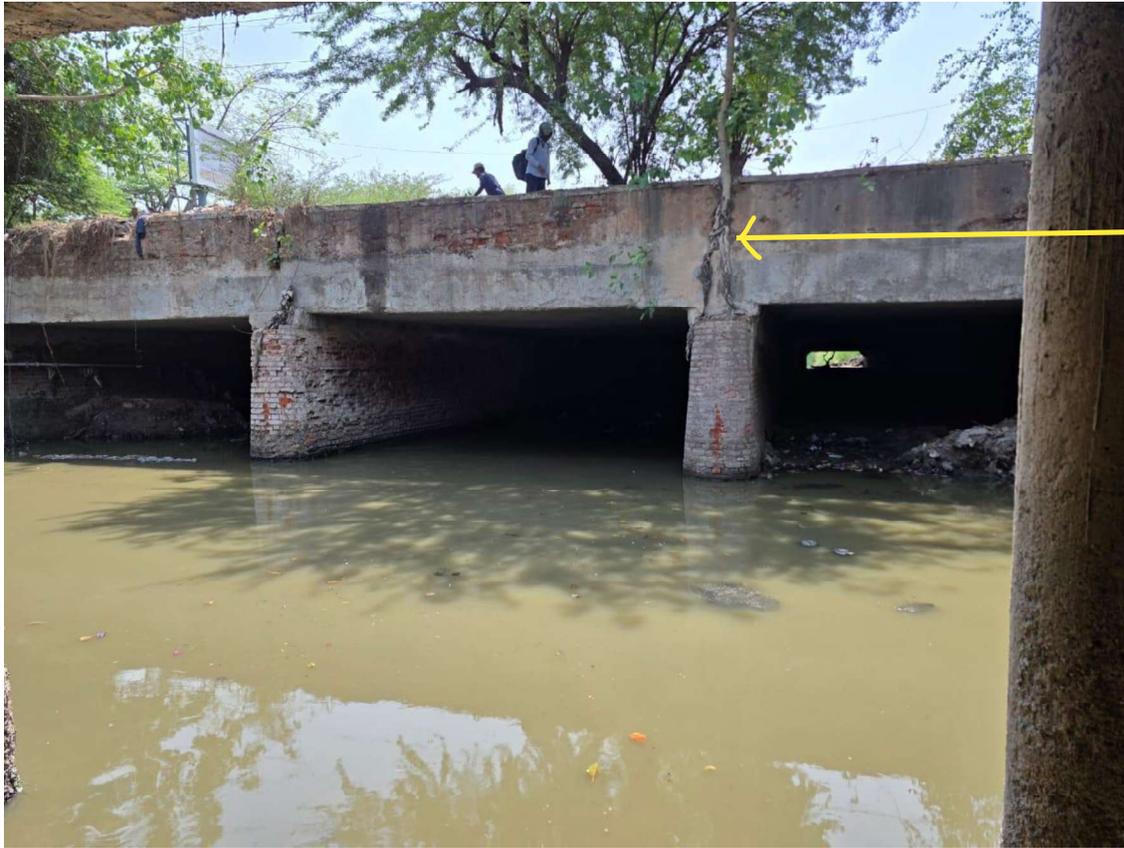
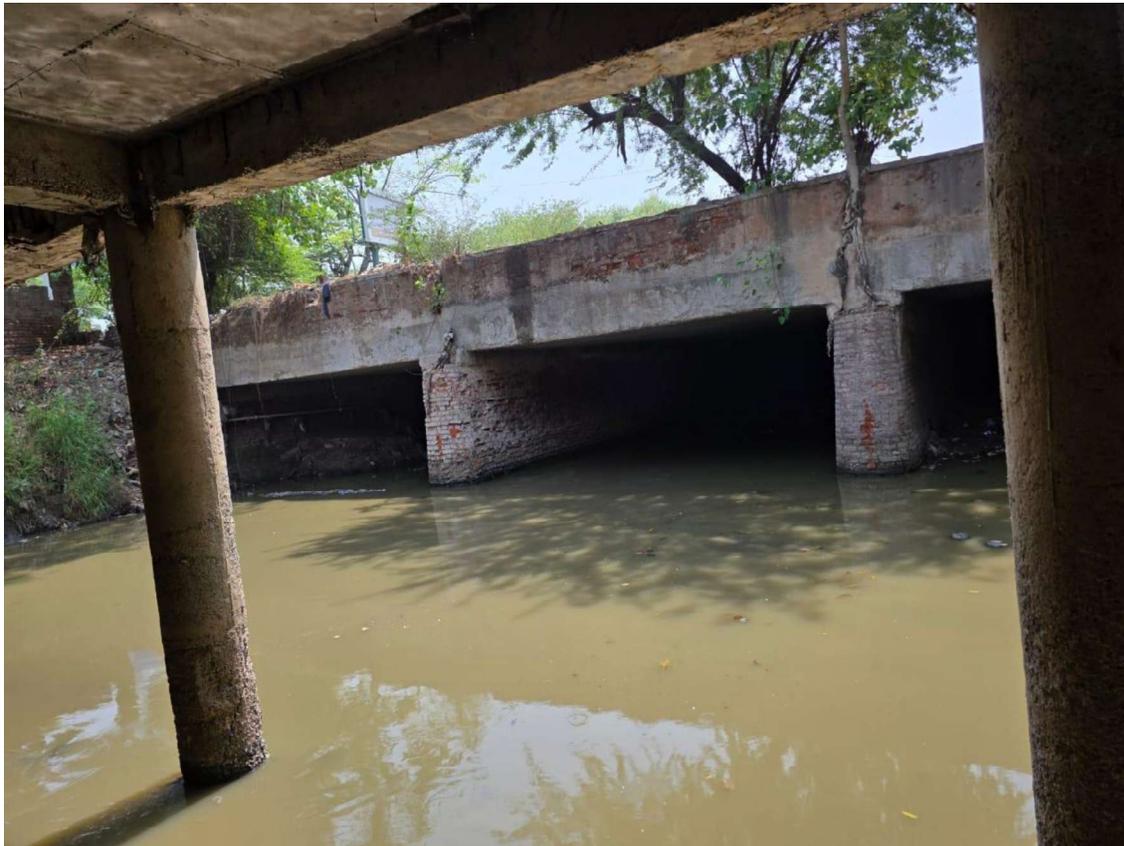
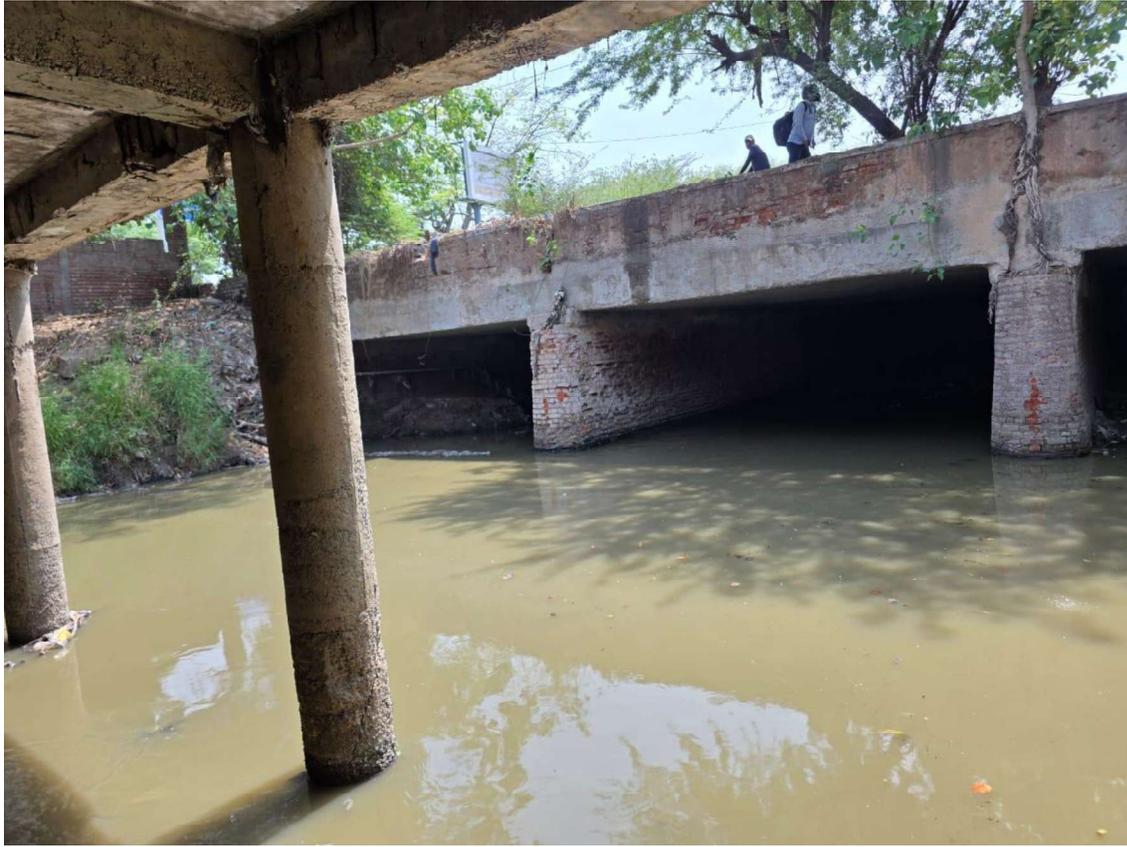
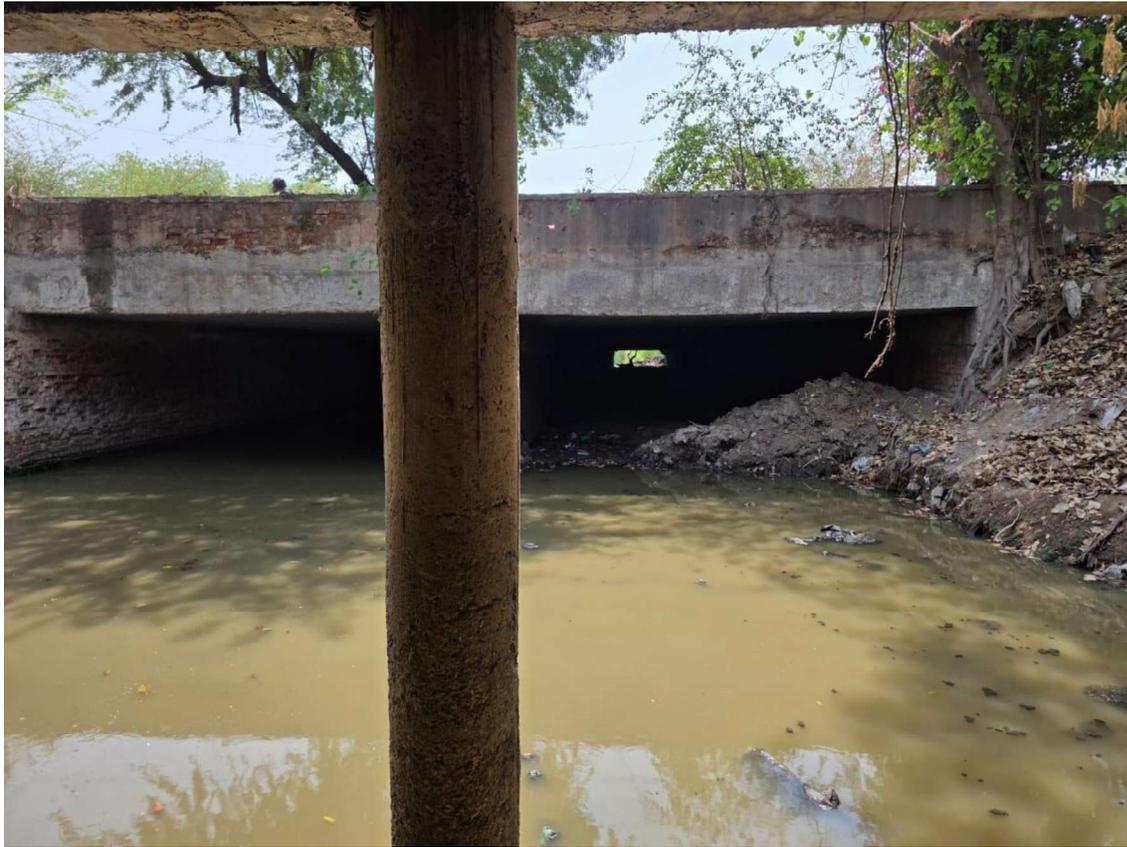
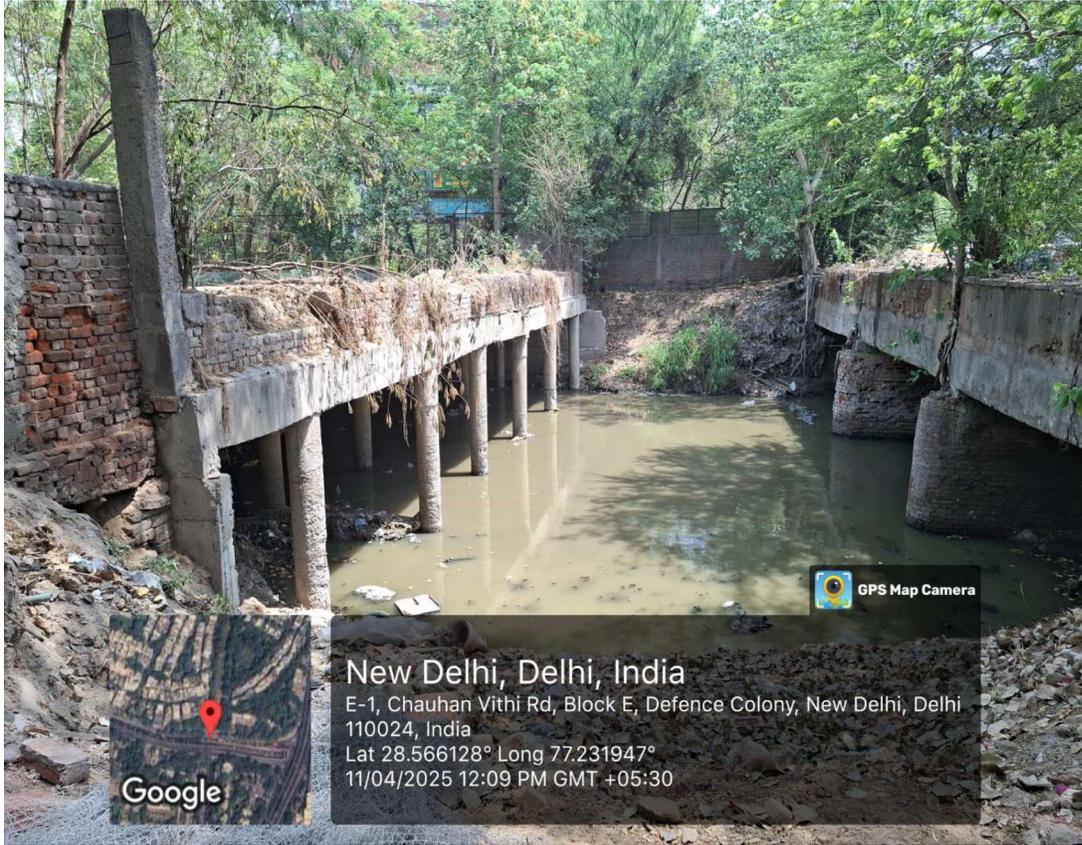
8. Photos of Drain entering Defence Colony (taken from west side of drain) ↓

3rd channel

Channel coming towards the Defence Colony drain (below the Ring Road) filled with debris on Western side.

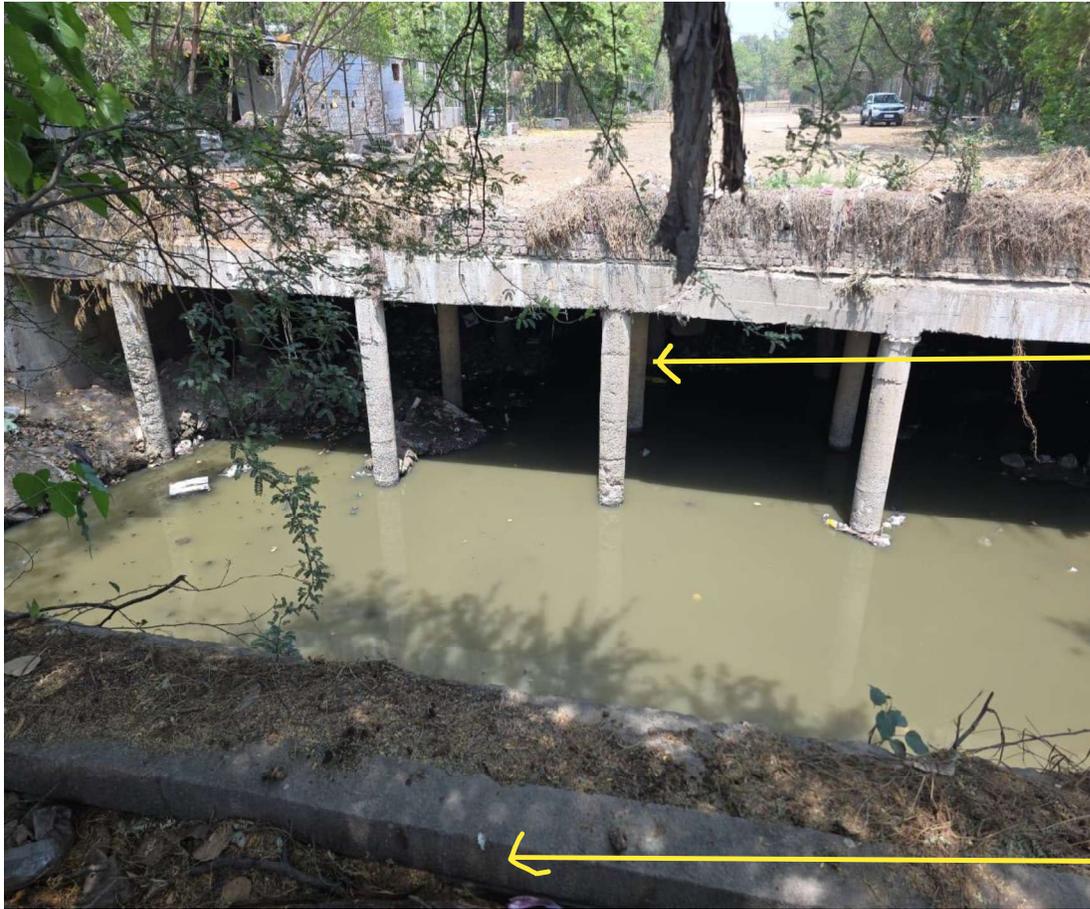
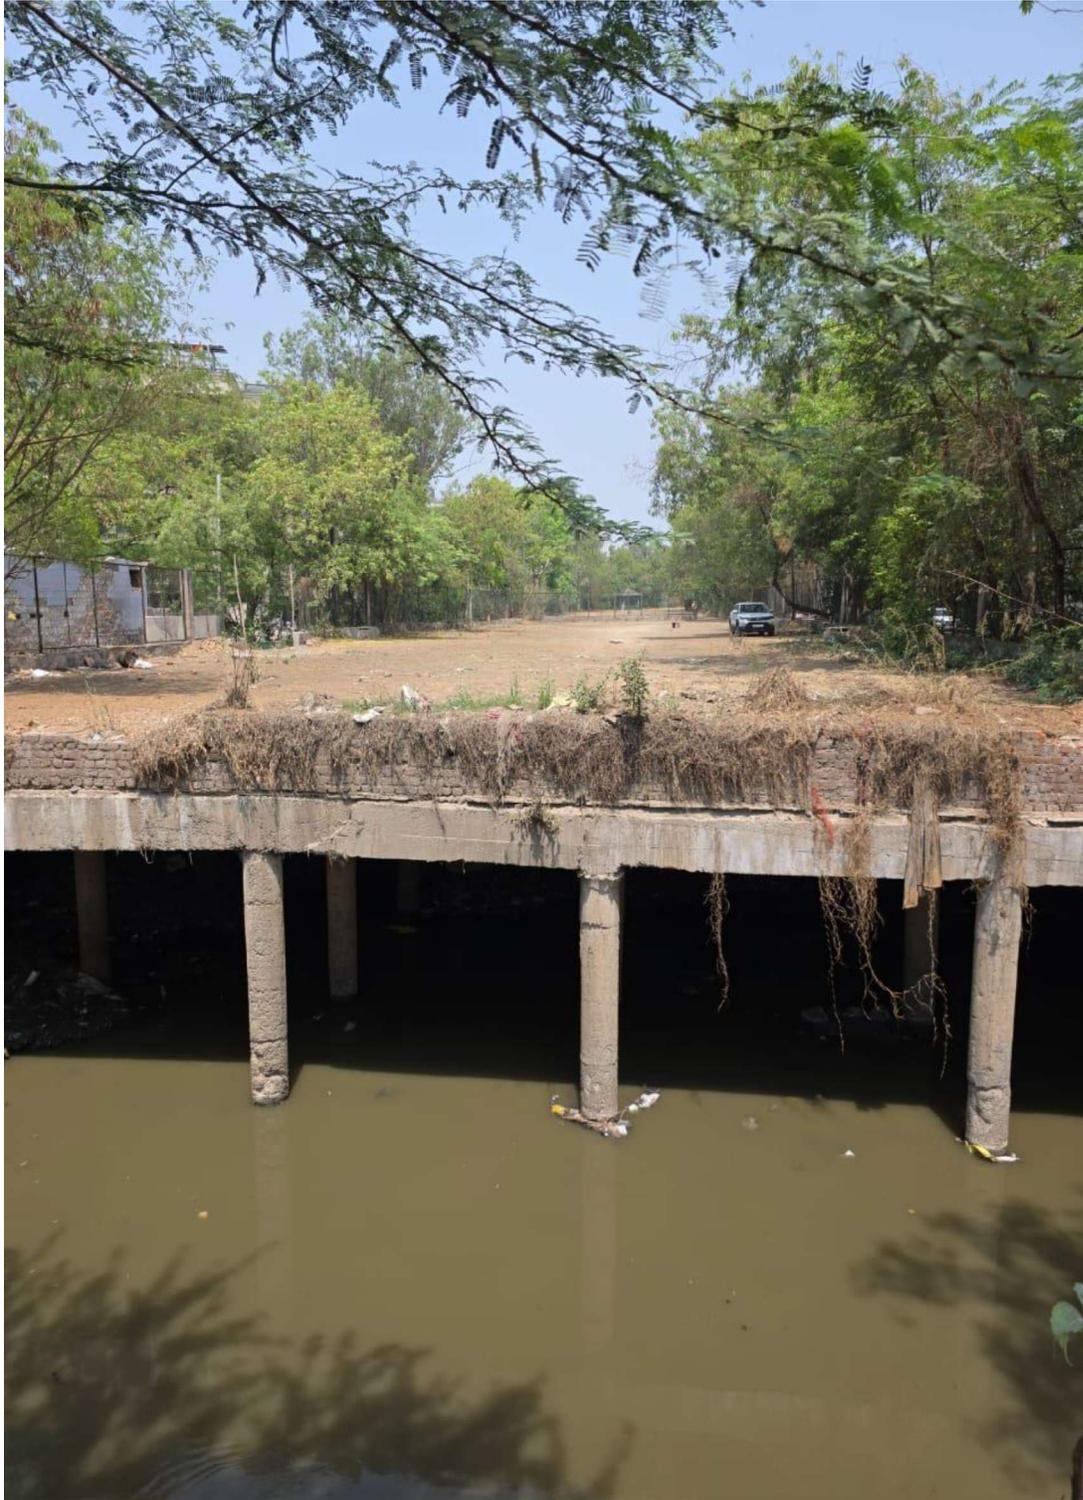
9. Photos of Drain towards Defence Colony (taken from service road/ring road) towards the North side.

concrete
portion
starts

on top of
culvert/service
road/ring road

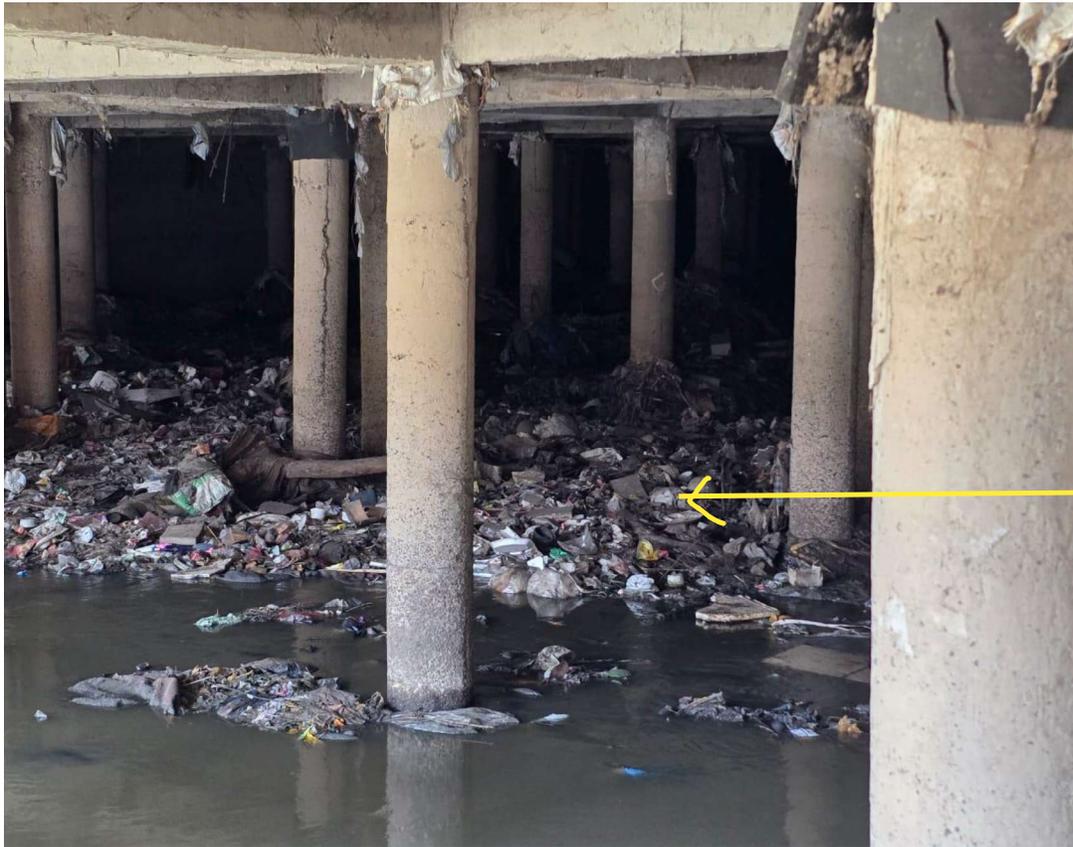
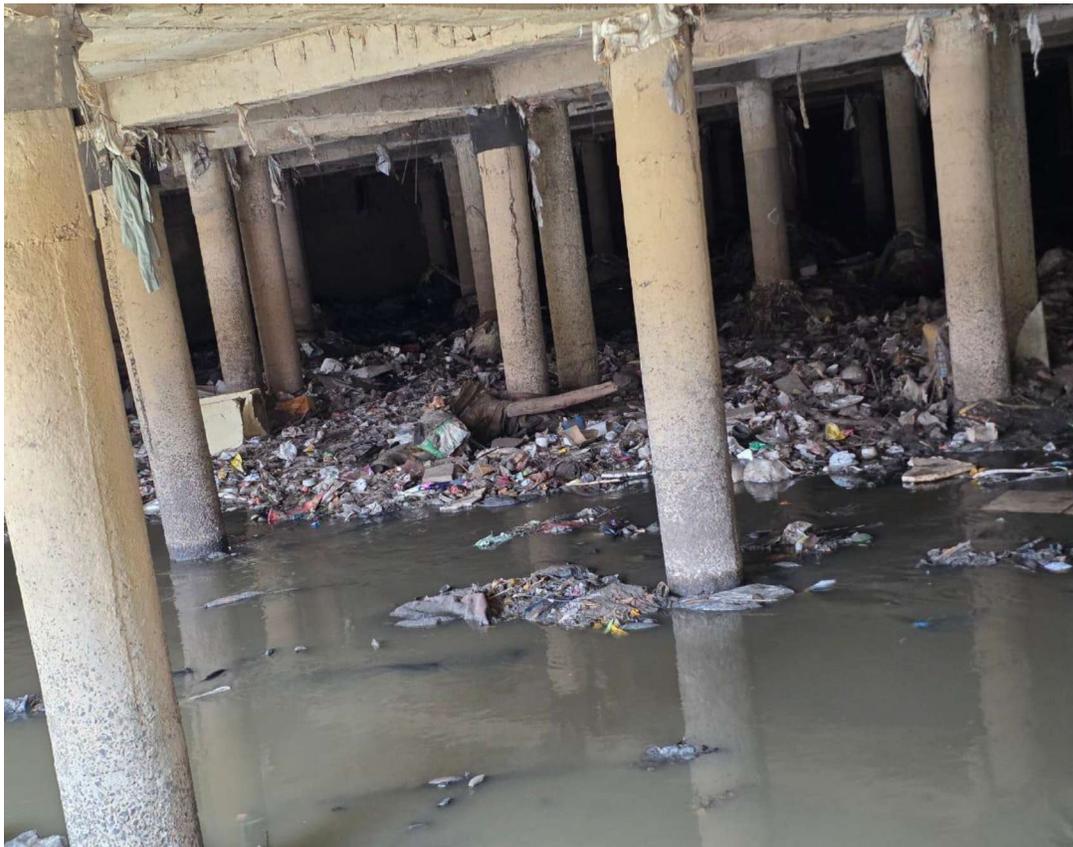
just below the
concrete
portion

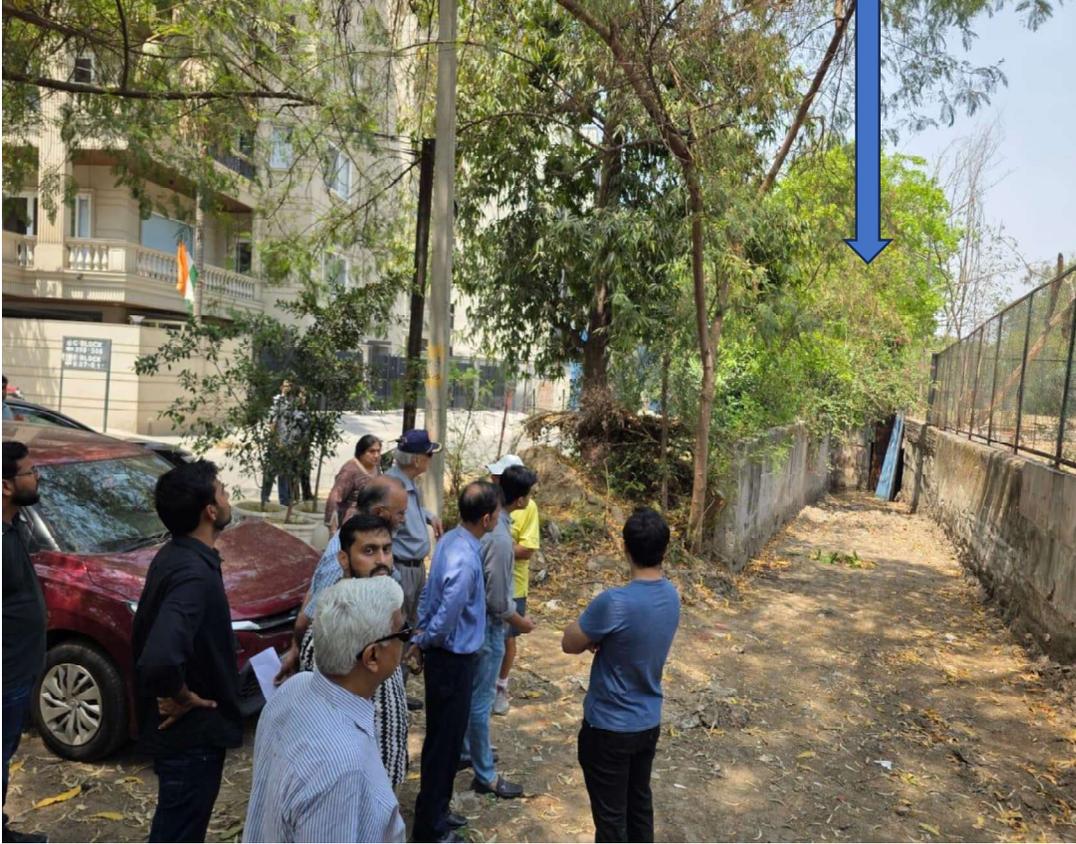
10. Towards the North Direction from Point A, there is First ramp to approach the drain somewhere at point B in front of House no.C-558.

← dried sludge/
mud

**stagnated
drain water**

covered with tin sheet.

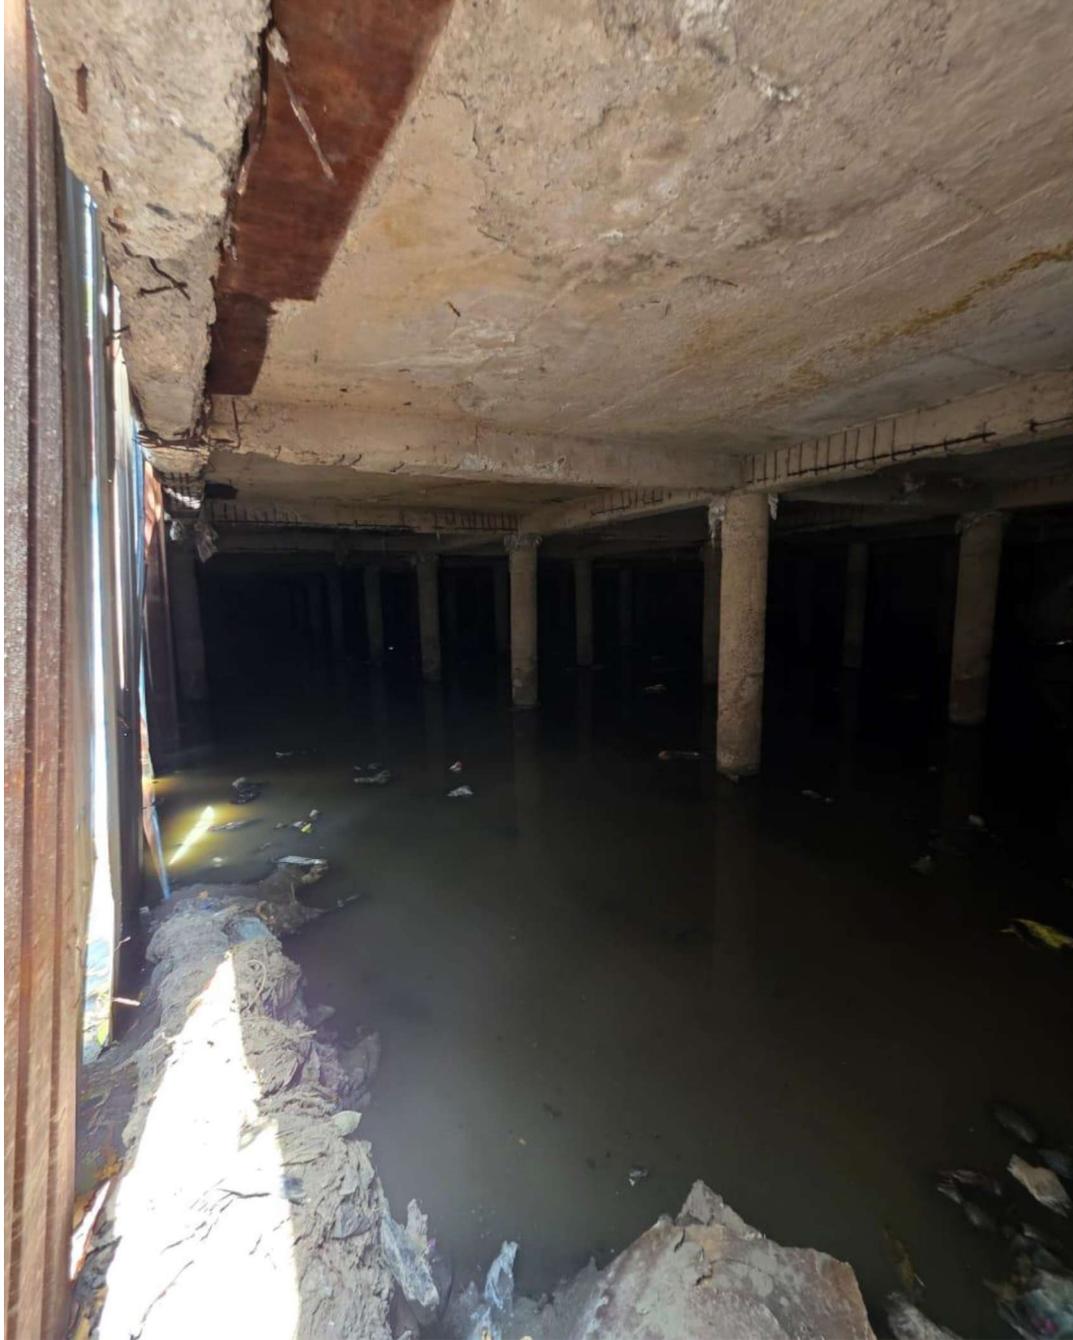
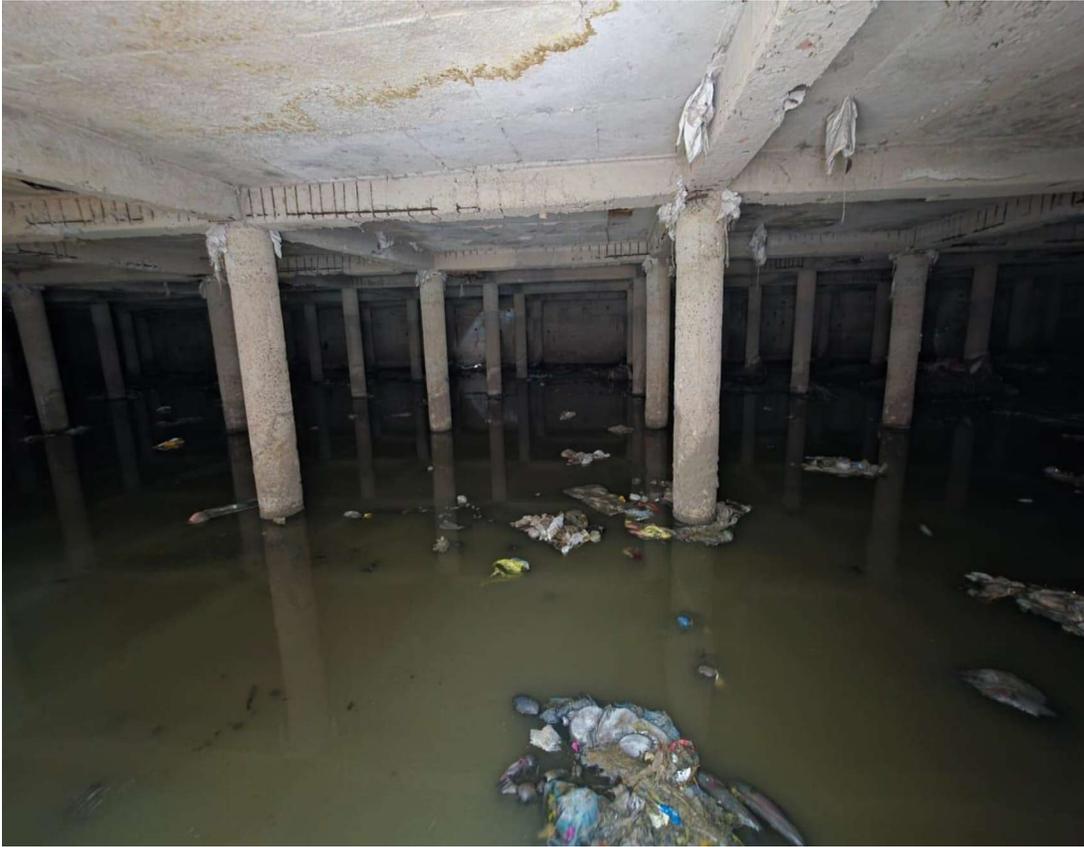
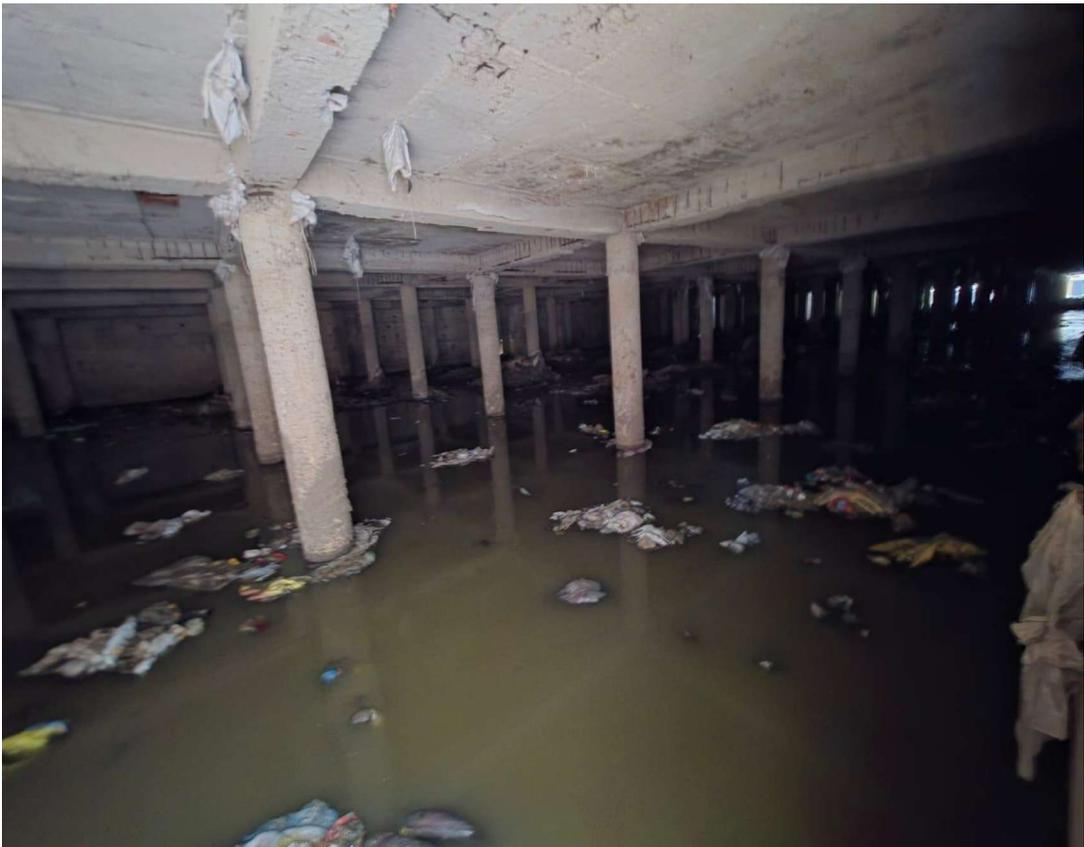
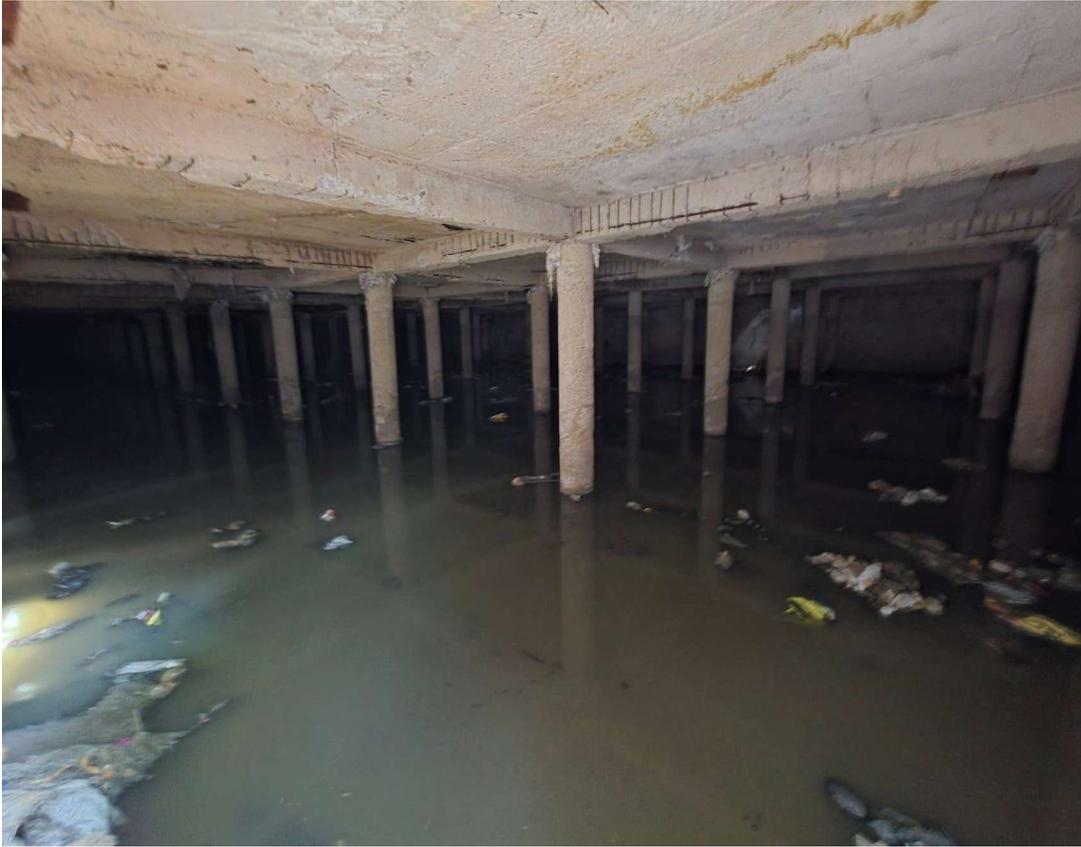
Photographs of Drain from the said approach point ↓

Stagnated drain with garbage.

1. Along the entire drain there are only three entry points through ramp from adjoining road to approach the drain. These entry points are stated to be meant for cleaning the drain through JCB machine etc. First entry at point "B" was found to be inadequately covered with tin sheet. Second entry at point "C" was found to be covered with Tarpoline and at the Third entry at point "F" one JCB was found cleaning the drain on 11.04.2025. At First and Second entry points/ramps as shown/detailed in above placed photos, the drain/polluted water was found stagnated.

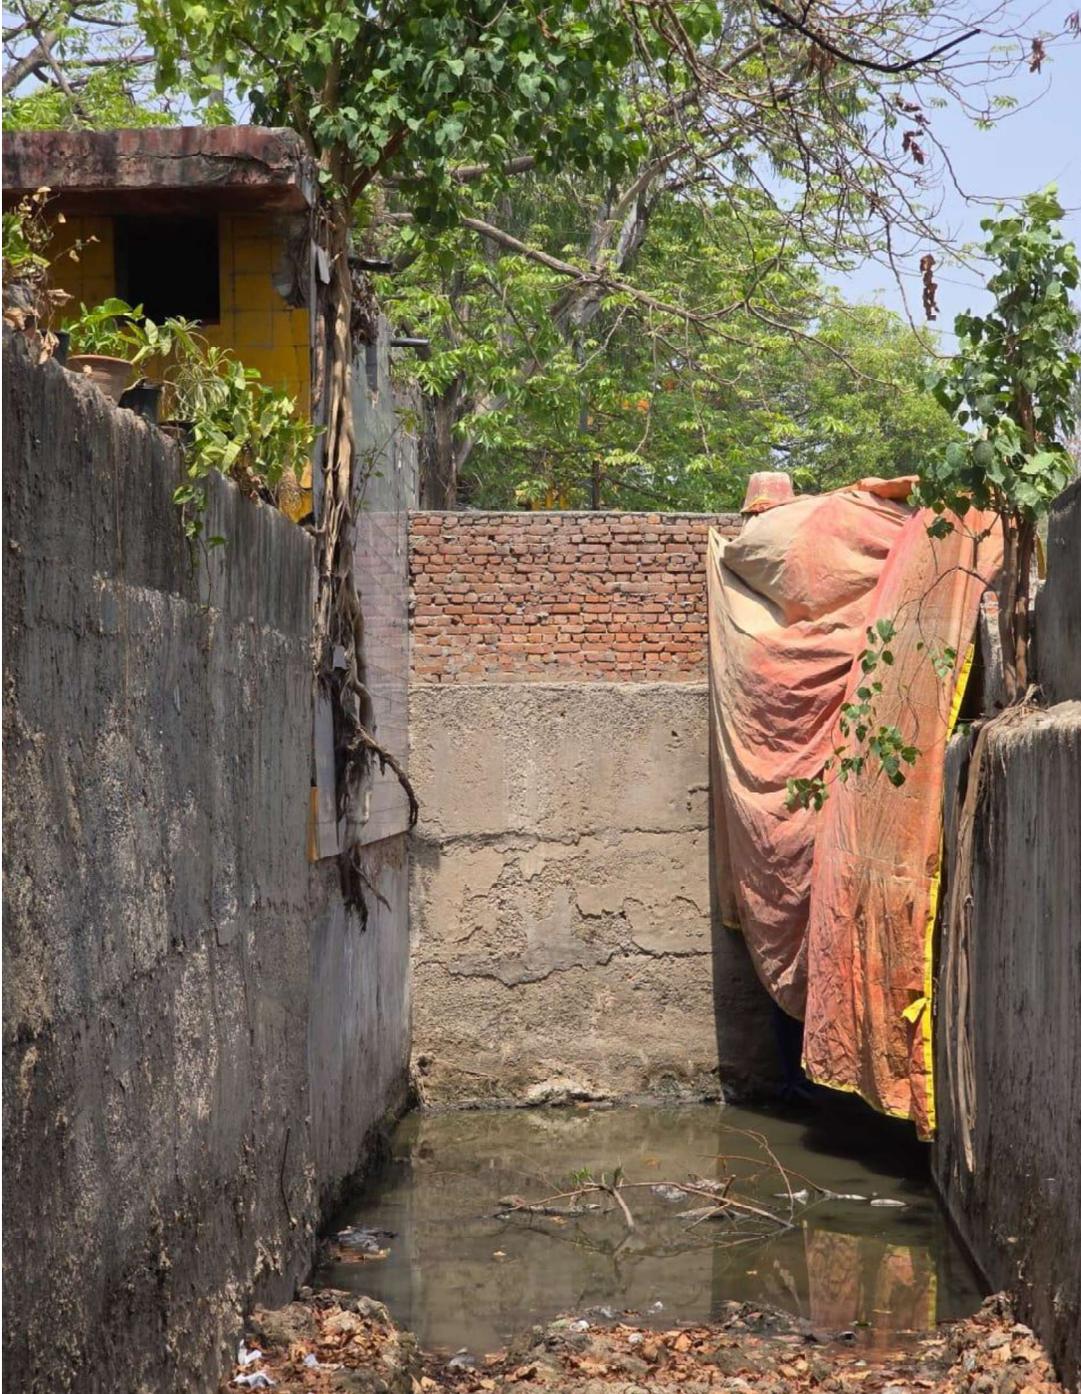
11. After walking further, there is Second ramp to approach (Infront of House No.C-159) the drain which was covered with tarpaulin sheet. Since sewage was stagnated, therefore it was not possible to approach the drain and take inside photographs. (Point 'C')
