BEFORE THE NATIONAL GREEN TRIBUNAL**PRINCIPAL BENCH NEW DELHI**

ORIGINAL APPLICATION NO. 6 /2012

**FACTUAL STATUS REPORT BY THE COURT COMMISSIONER
IN COMPLIANCE OF ORDER DATED 09.04.2025**

Quick Glance of drain with help of google earth image and photos taken on 9th and 11th April, 2025:

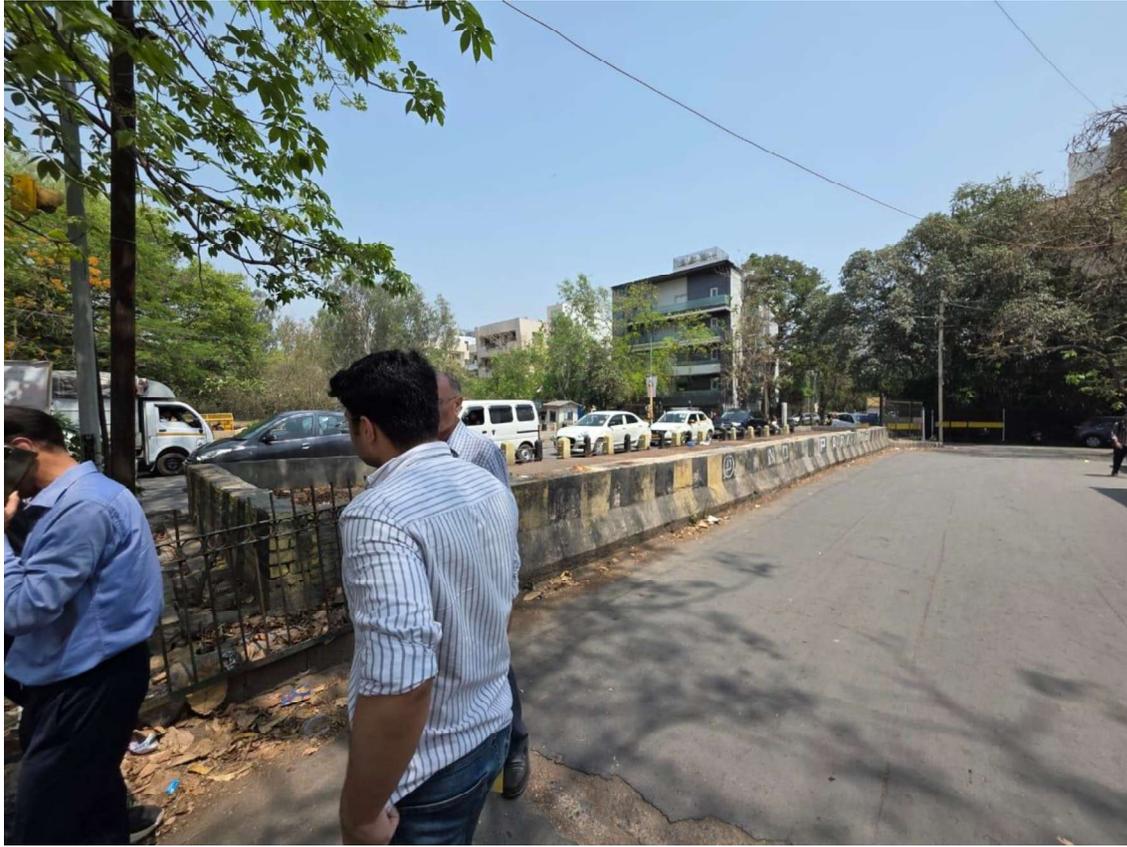
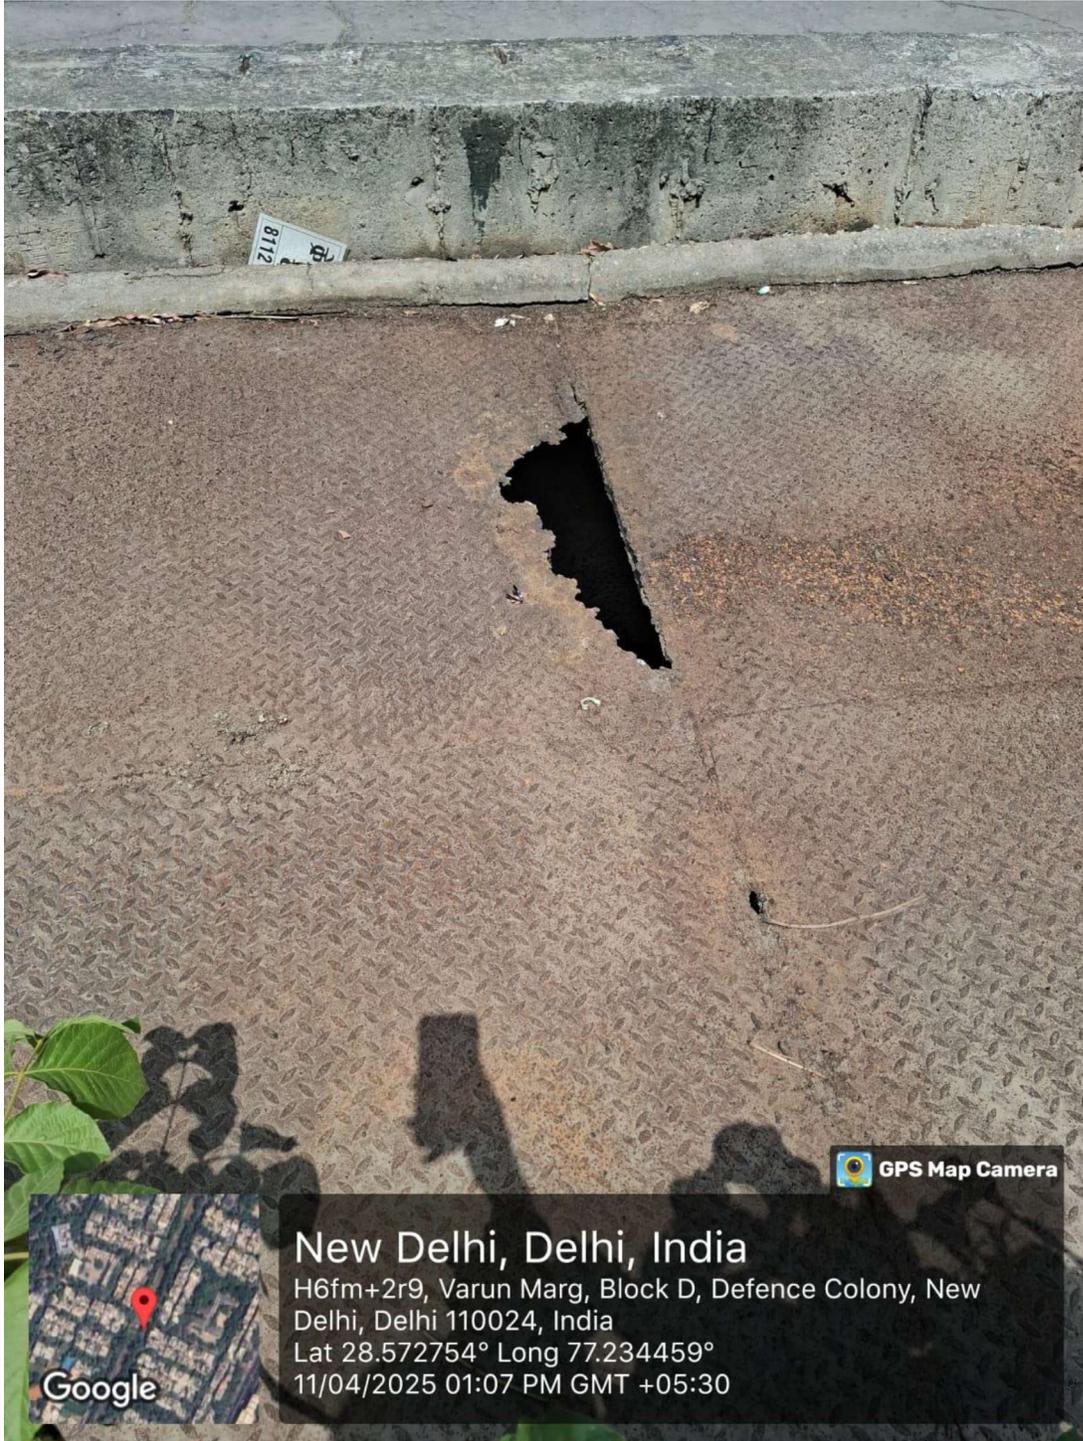
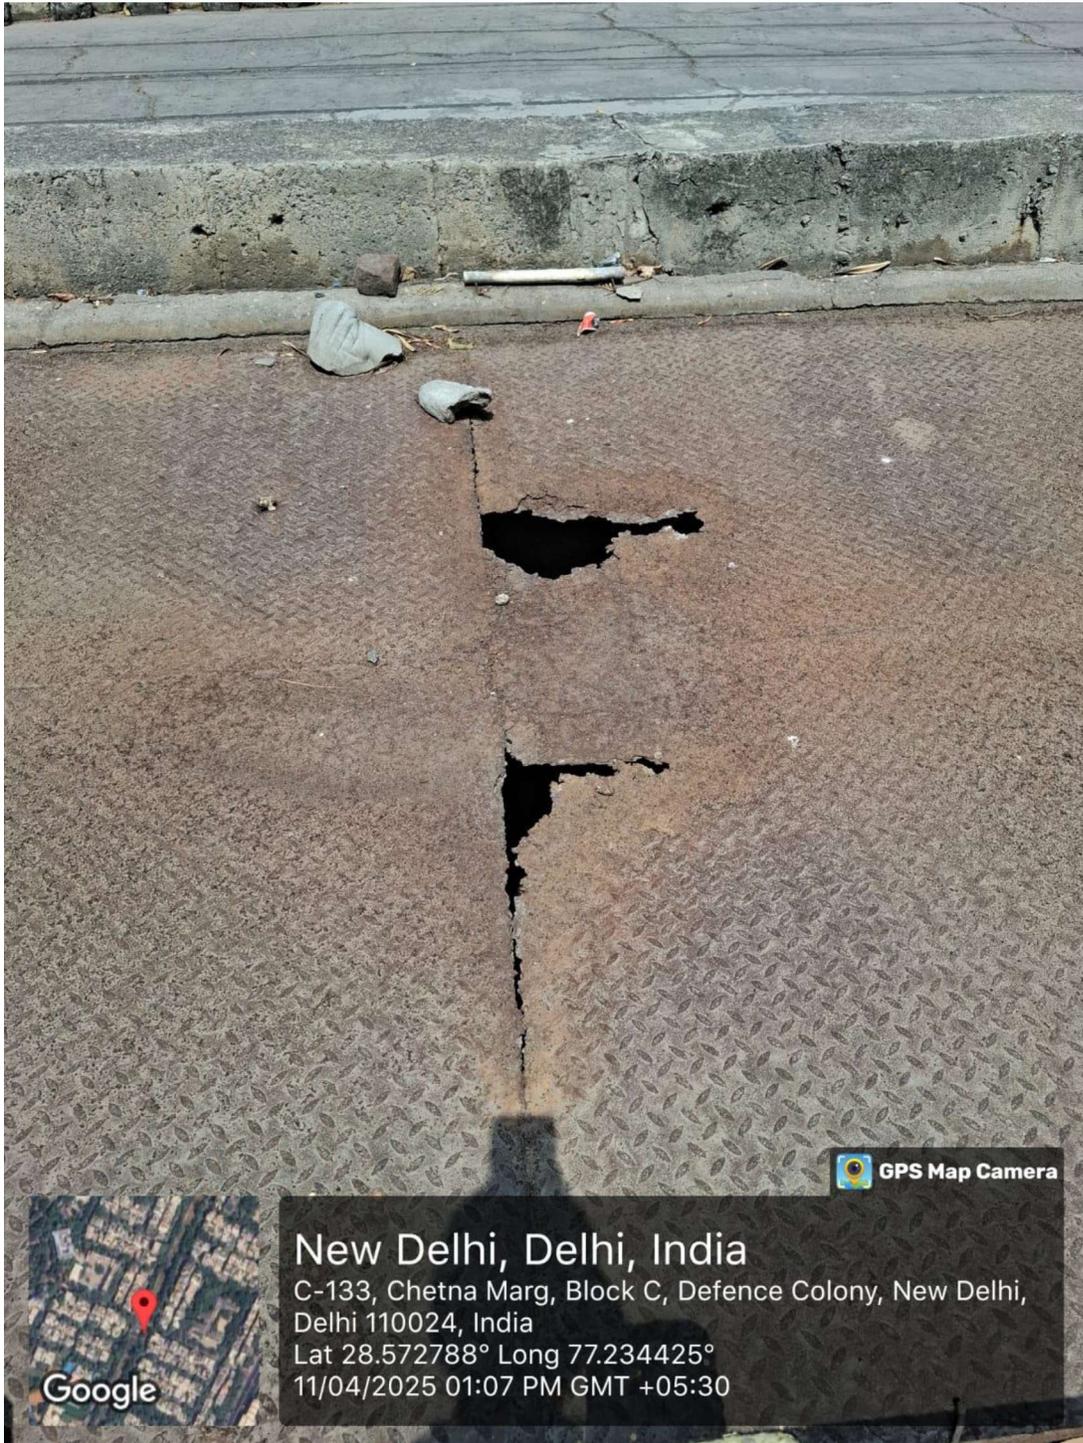
Point D
enlarged view

14. After reaching the mid point of drain at point D where the internal roads intersect, the drain was found covered with 2 big iron sheets (one each on 2 sides of intersecting road). The iron sheet has gained significant rust and developed holes. These holes were tried to be covered loosely with makeshift material.

cracks

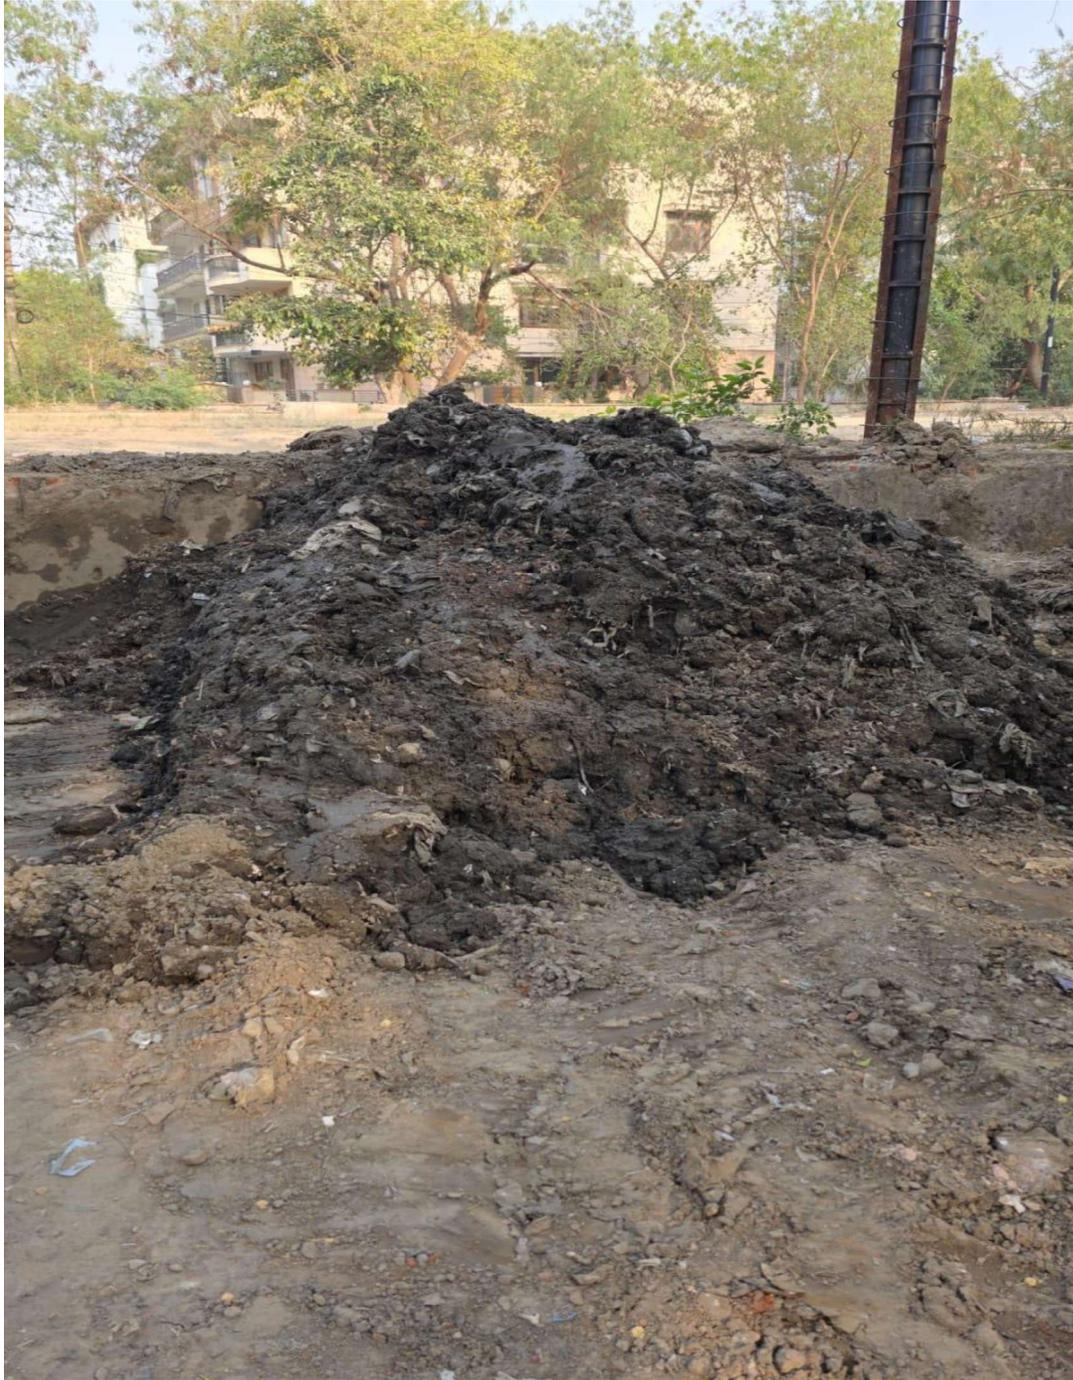
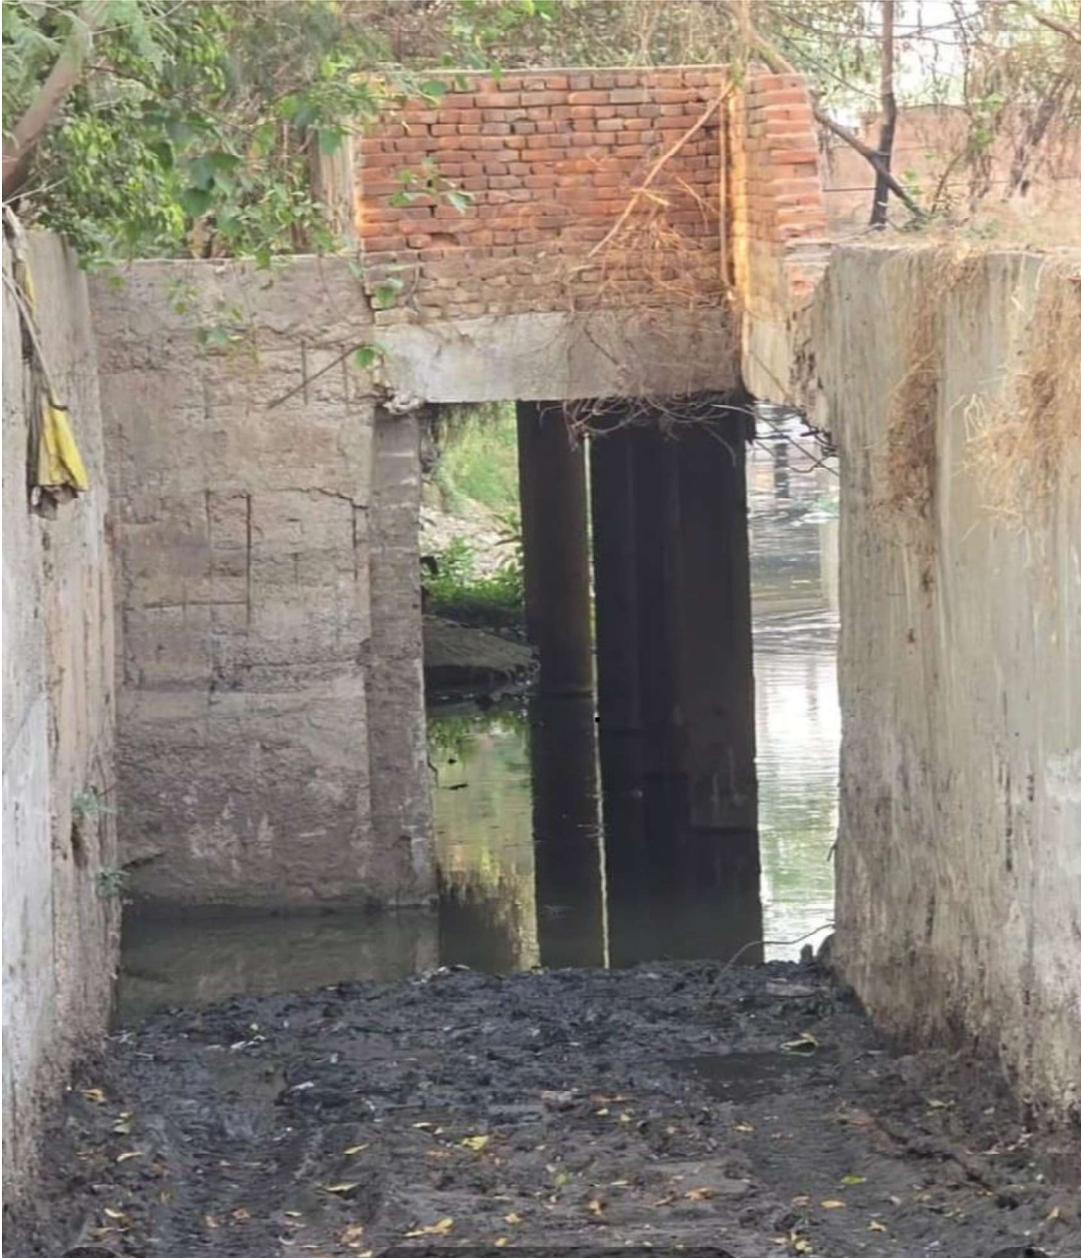
Photos of 3rd ramp taken on 09.04.2025

16. After reaching point F almost near to the end of drain, in front of Chetak Vithi signboard, there was 3rd ramp to approach the drain and on 11.04.2025 one JCB machine was found removing the silt through it. On observation it appeared to be black stinking sludge.

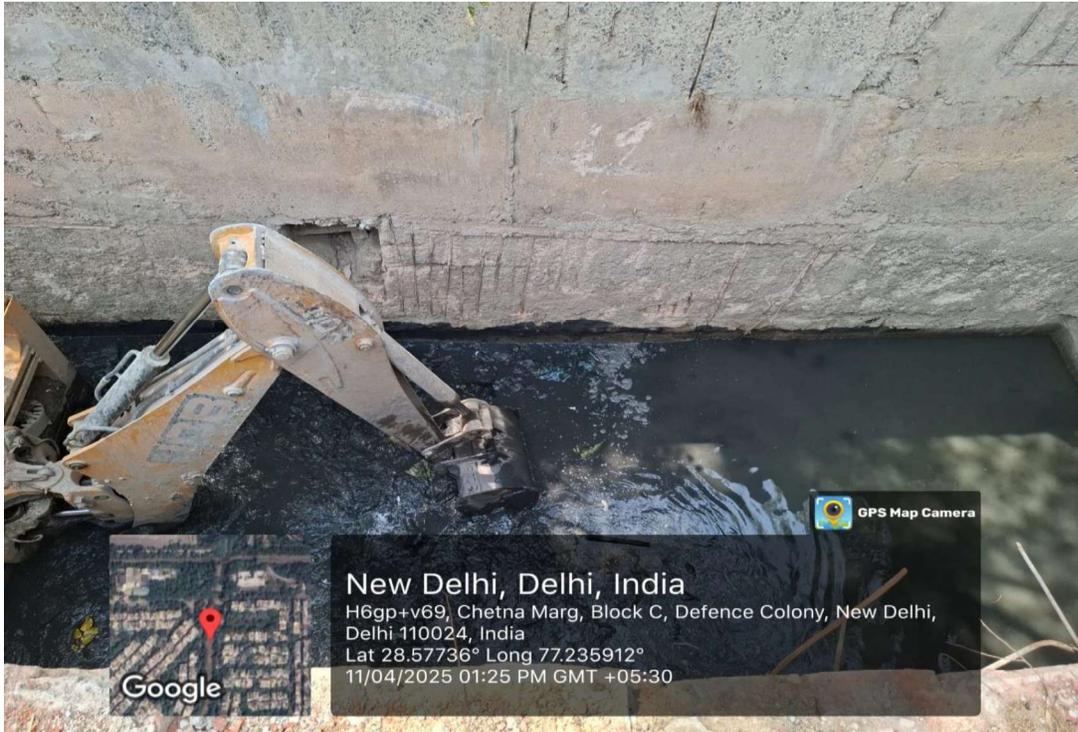
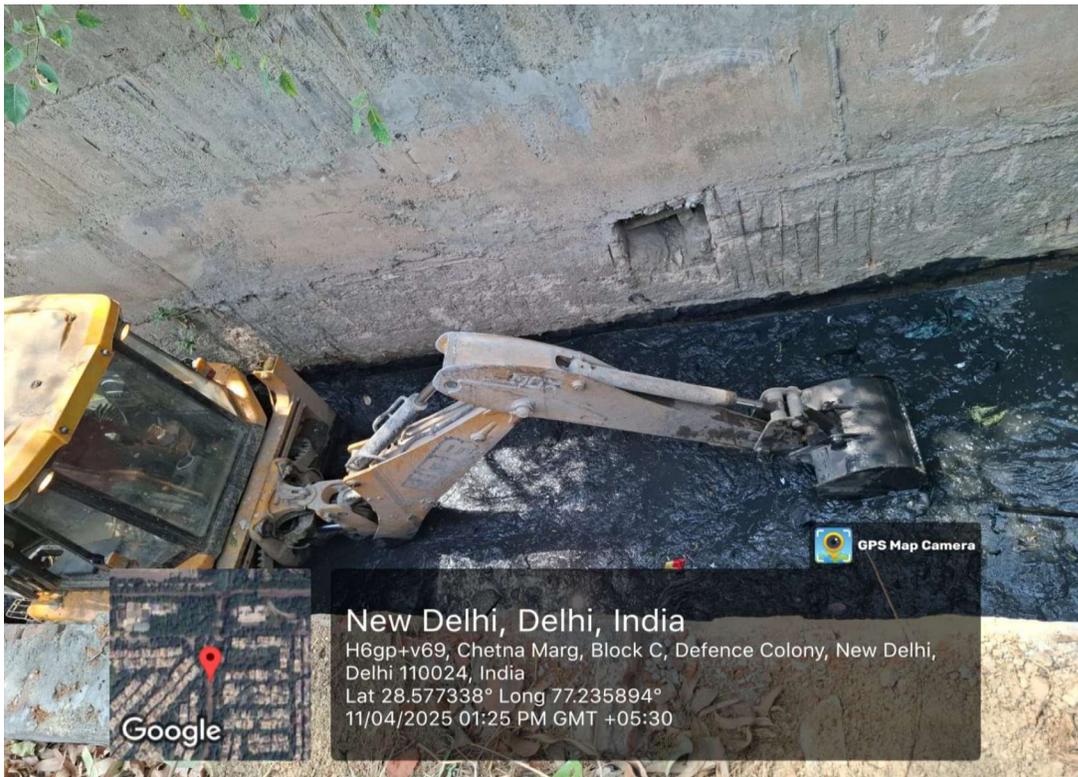
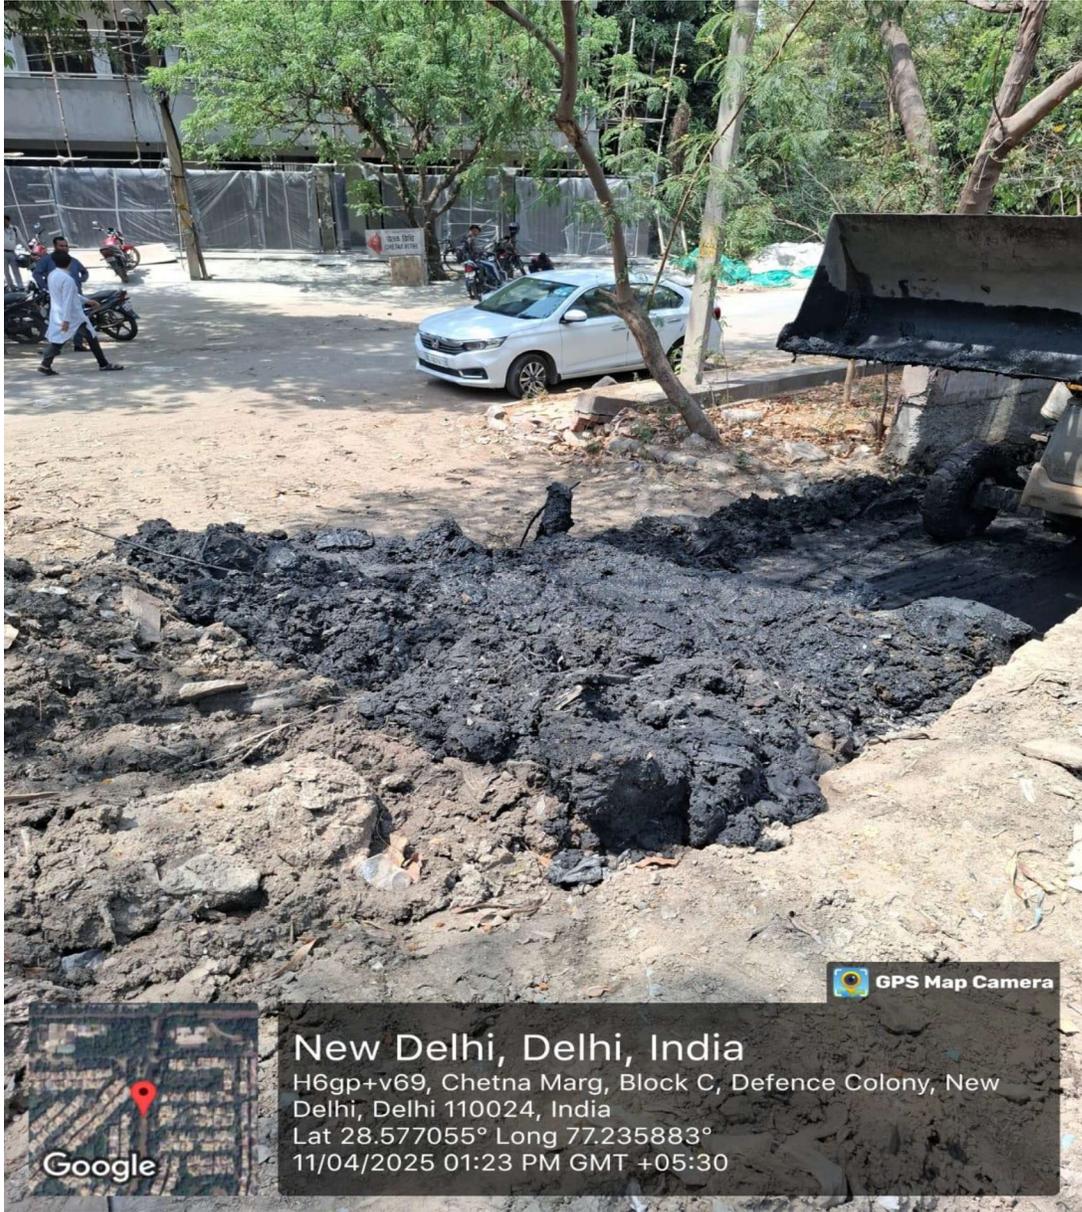
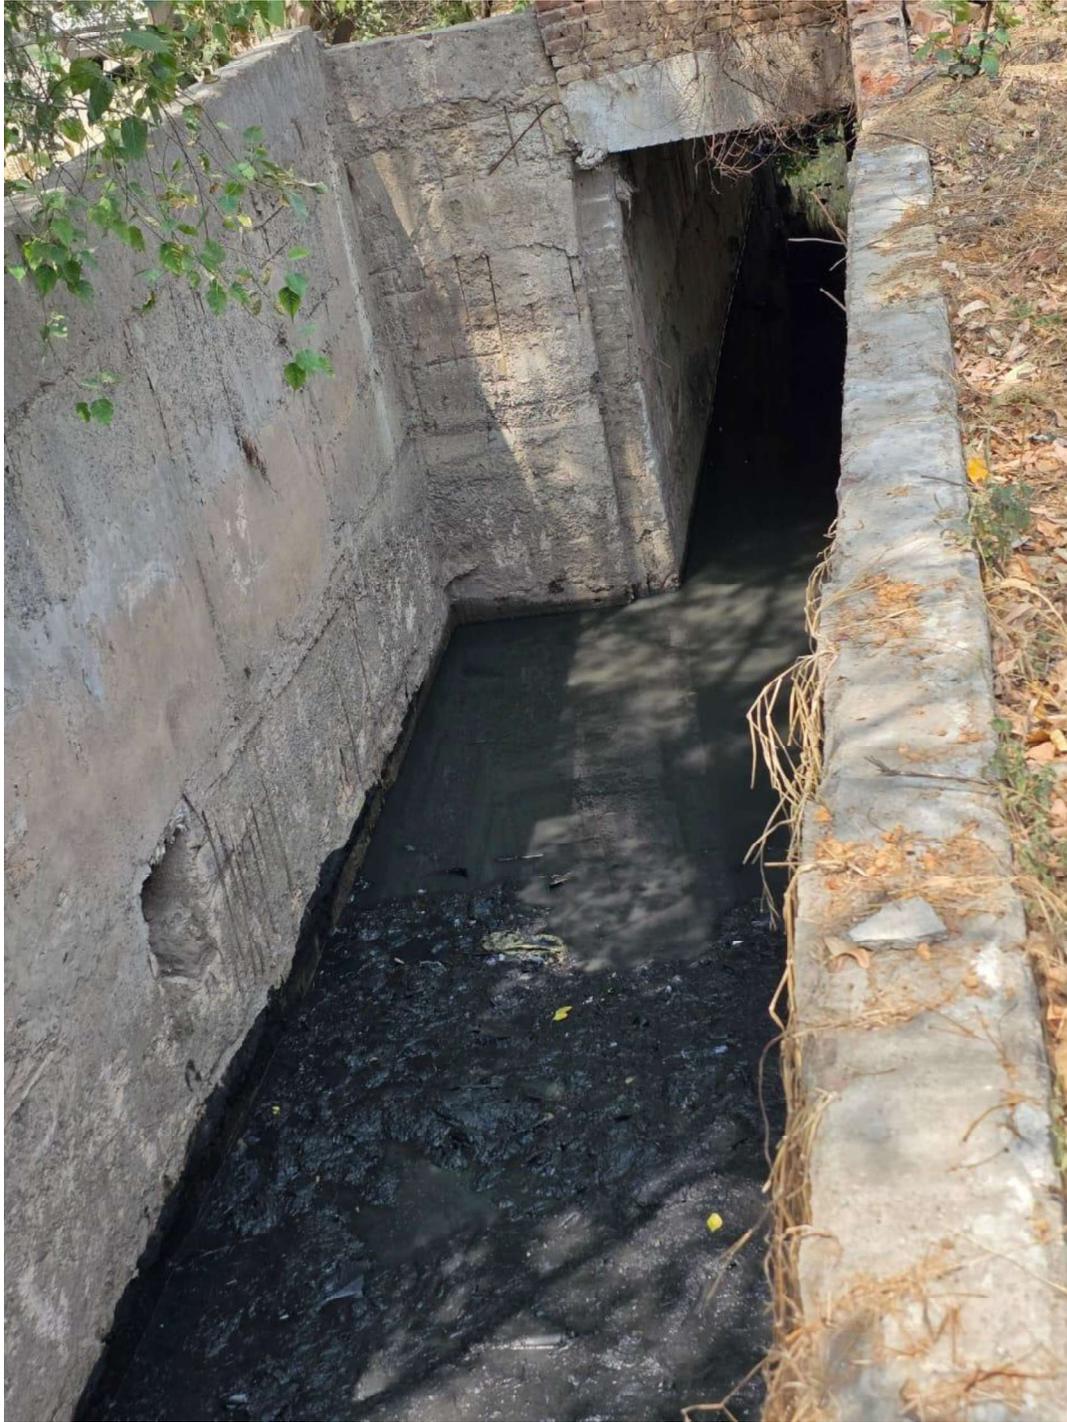
Photos of 3rd ramp taken on 11.04.2025

2. At the Third ramp made to approach the drain, the JCB machine was working on 11.04.2025, and it was observed that when the water was stable/stagnant then the colour was dark green and when the JCB arm scooped it then the underlying bottom layer of sludge got mixed with upper layer and turned into black sludge.

3. Except at point "F" (Third ramp), no de-siltation work was going on. And in near past also no such major work seems to be carried out except at Point "F". That might be the reason some flow in drain was observed beyond Point "F" where the concrete portion ends and near to filtration system. No traces of recent de-siltation work at any other point found.

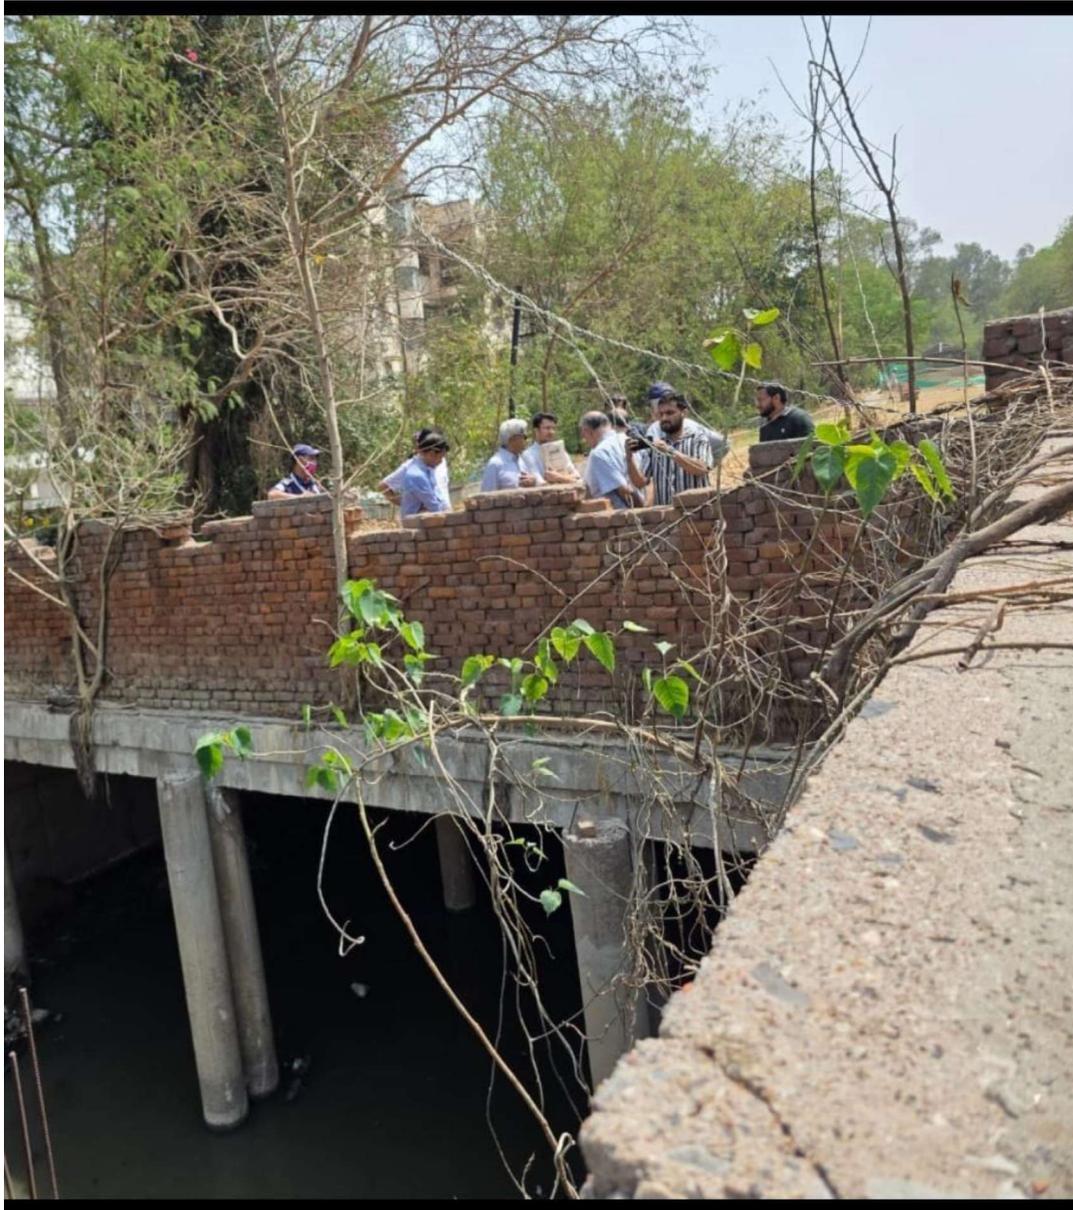
17. At end point of covered structure of Drain at point G only half portion along the width is covered. In other half portion pillars were there. After this point the drain is open except at culvert/road from Defence Colony towards Lajpat Nagar II.

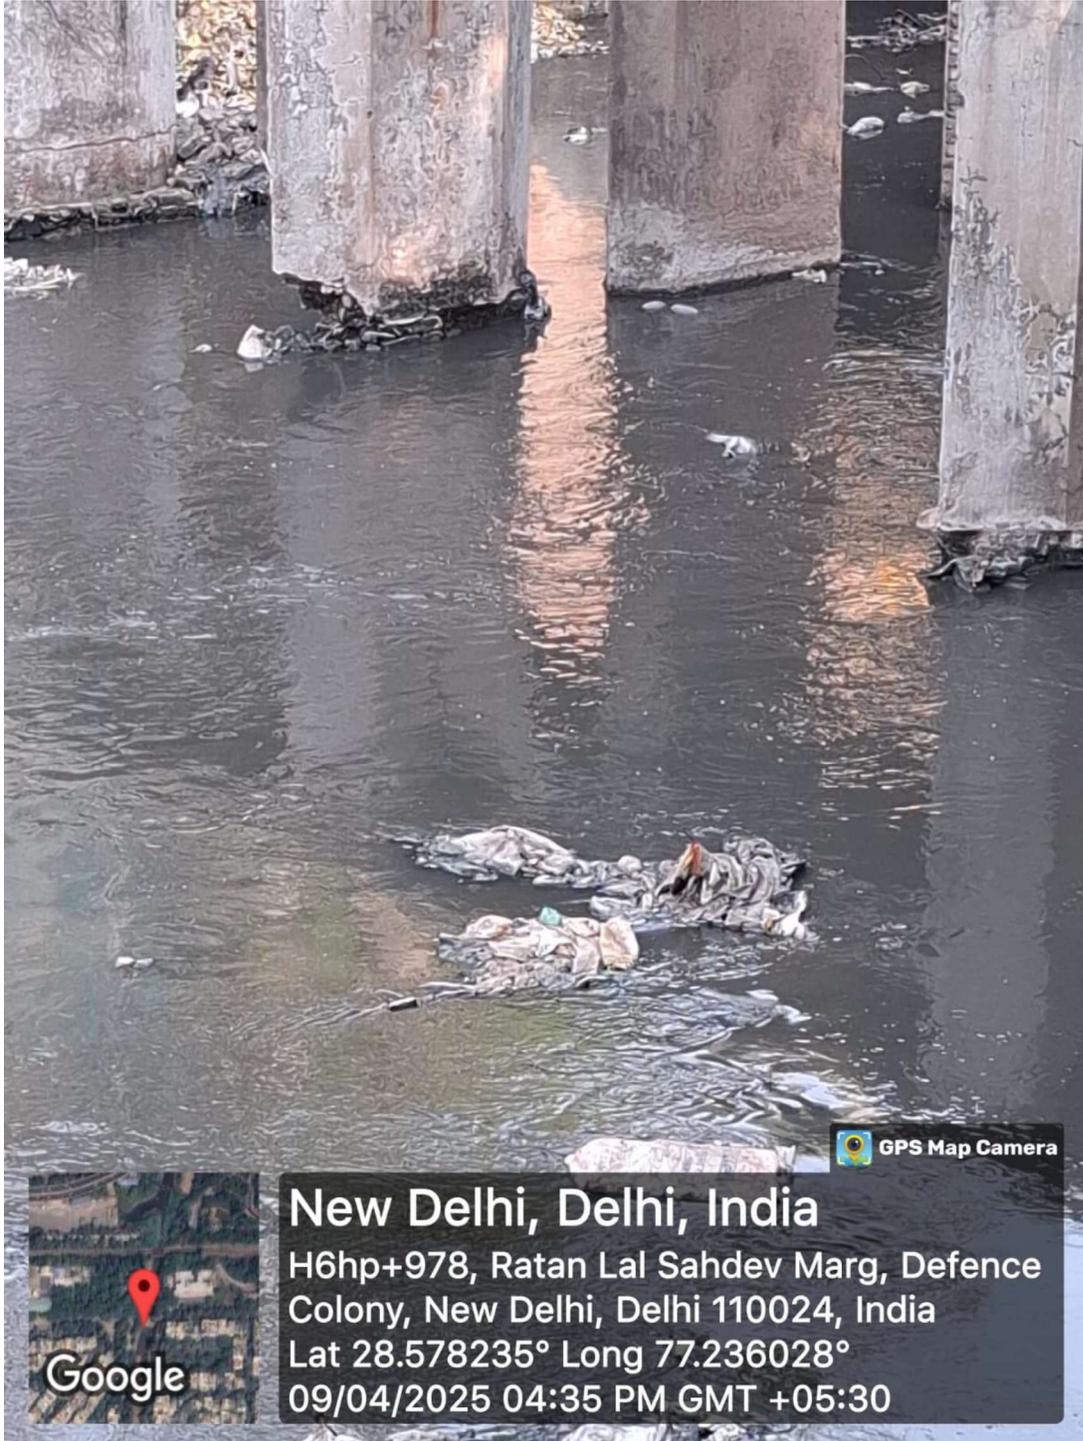
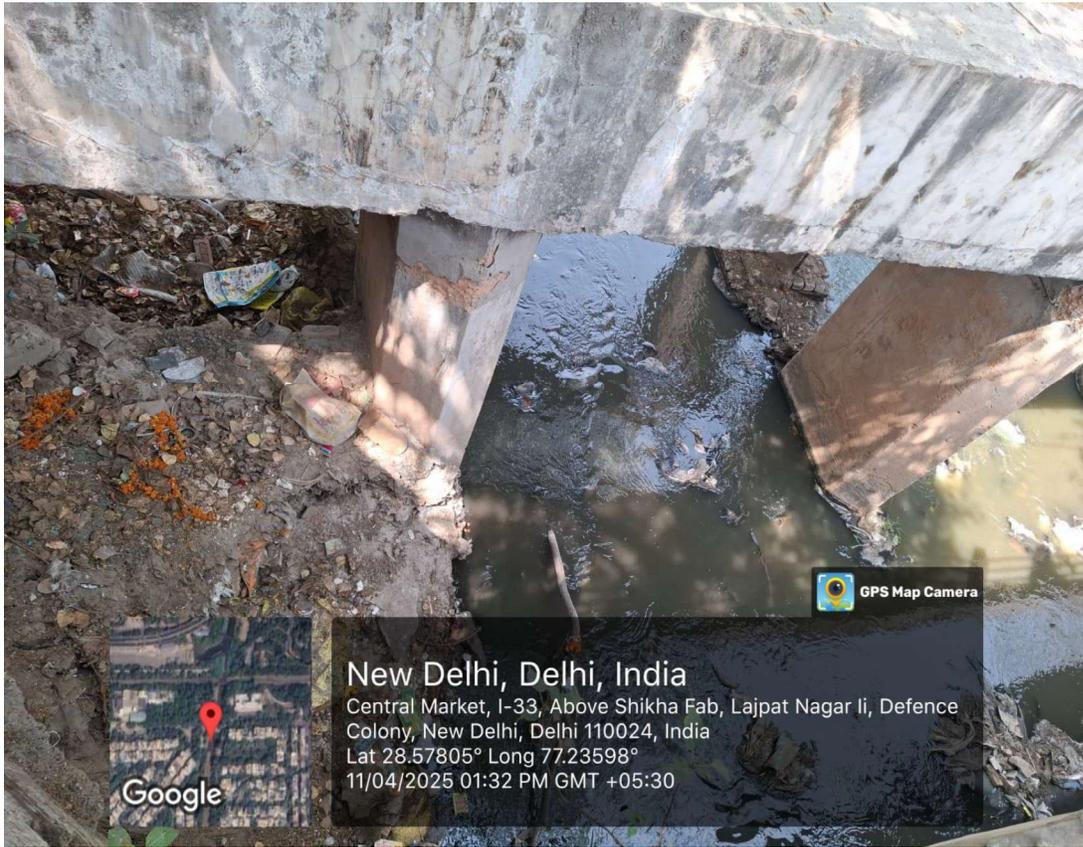
19. Under the filtration plant, the solid garbage was found in the drain.

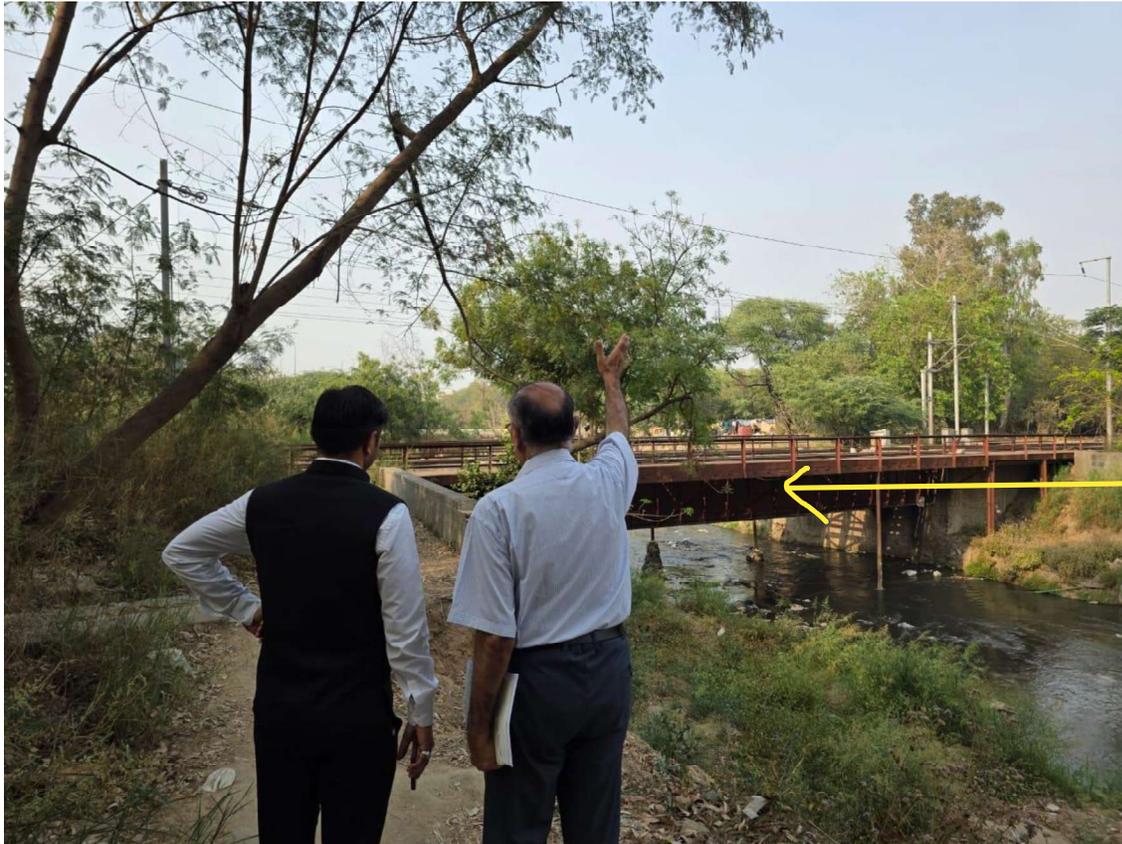
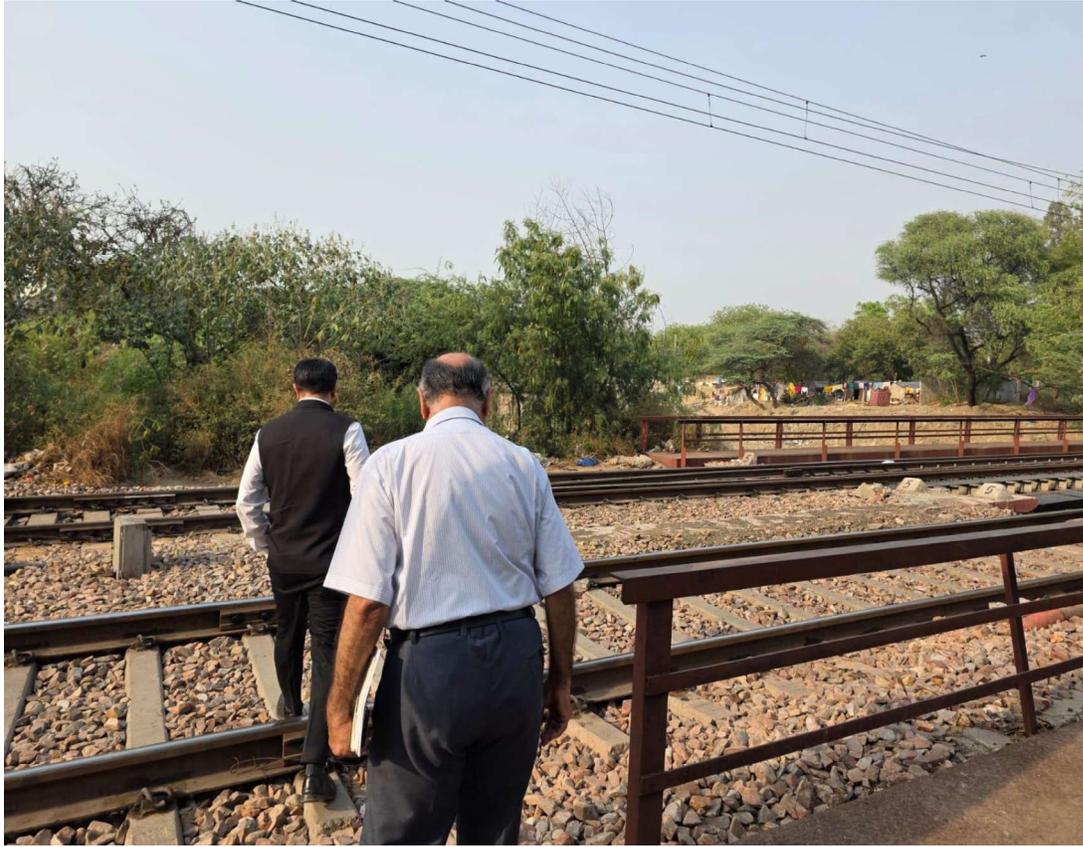
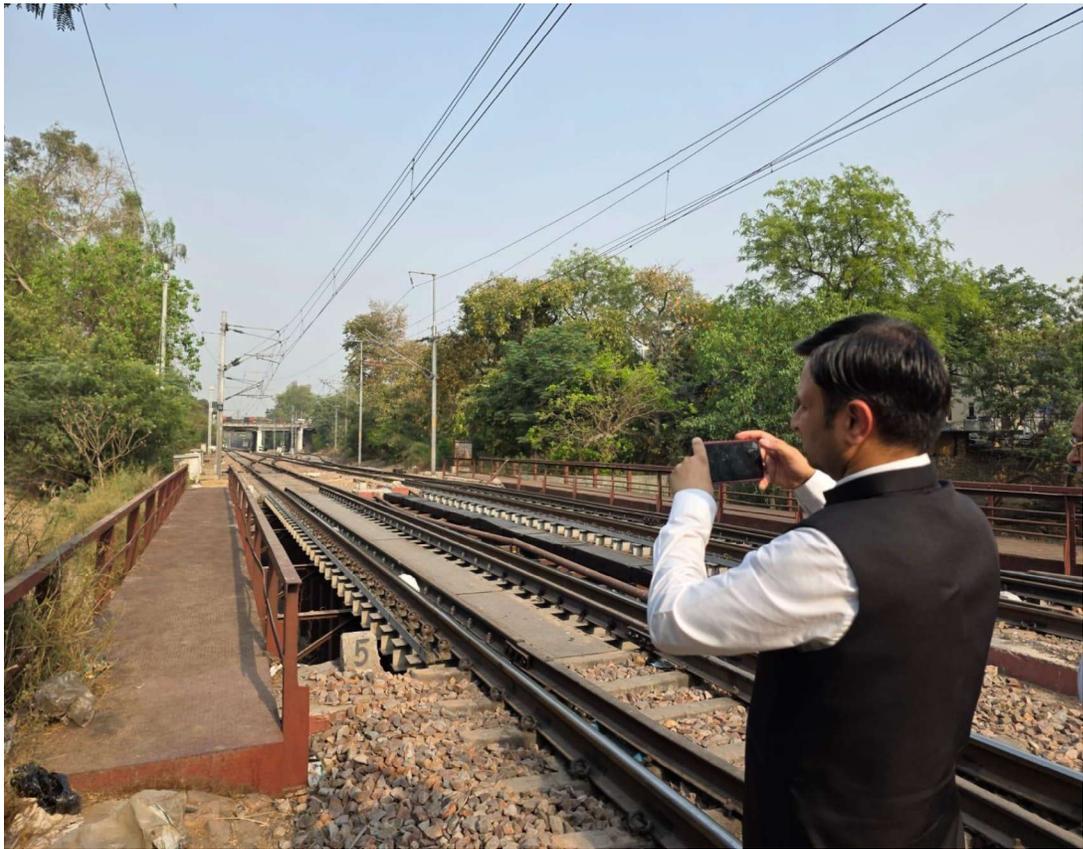
Point 'H'

21. The drain ends after railway track where it meets Sunheri drain. On 11.04.2025, it was not possible to cross the railway track due to dumping of soil at Kachcha path which was not dumped on 09.04.2025 (**Point 'H'**)
