BEFORE THE NATIONAL GREEN TRIBUNAL**PRINCIPAL BENCH NEW DELHI**

ORIGINAL APPLICATION NO. 6 /2012

**FACTUAL STATUS REPORT BY THE COURT COMMISSIONER
IN COMPLIANCE OF ORDER DATED 09.04.2025**

Quick Glance of drain with help of google earth image and photos taken on 9th and 11th April, 2025:

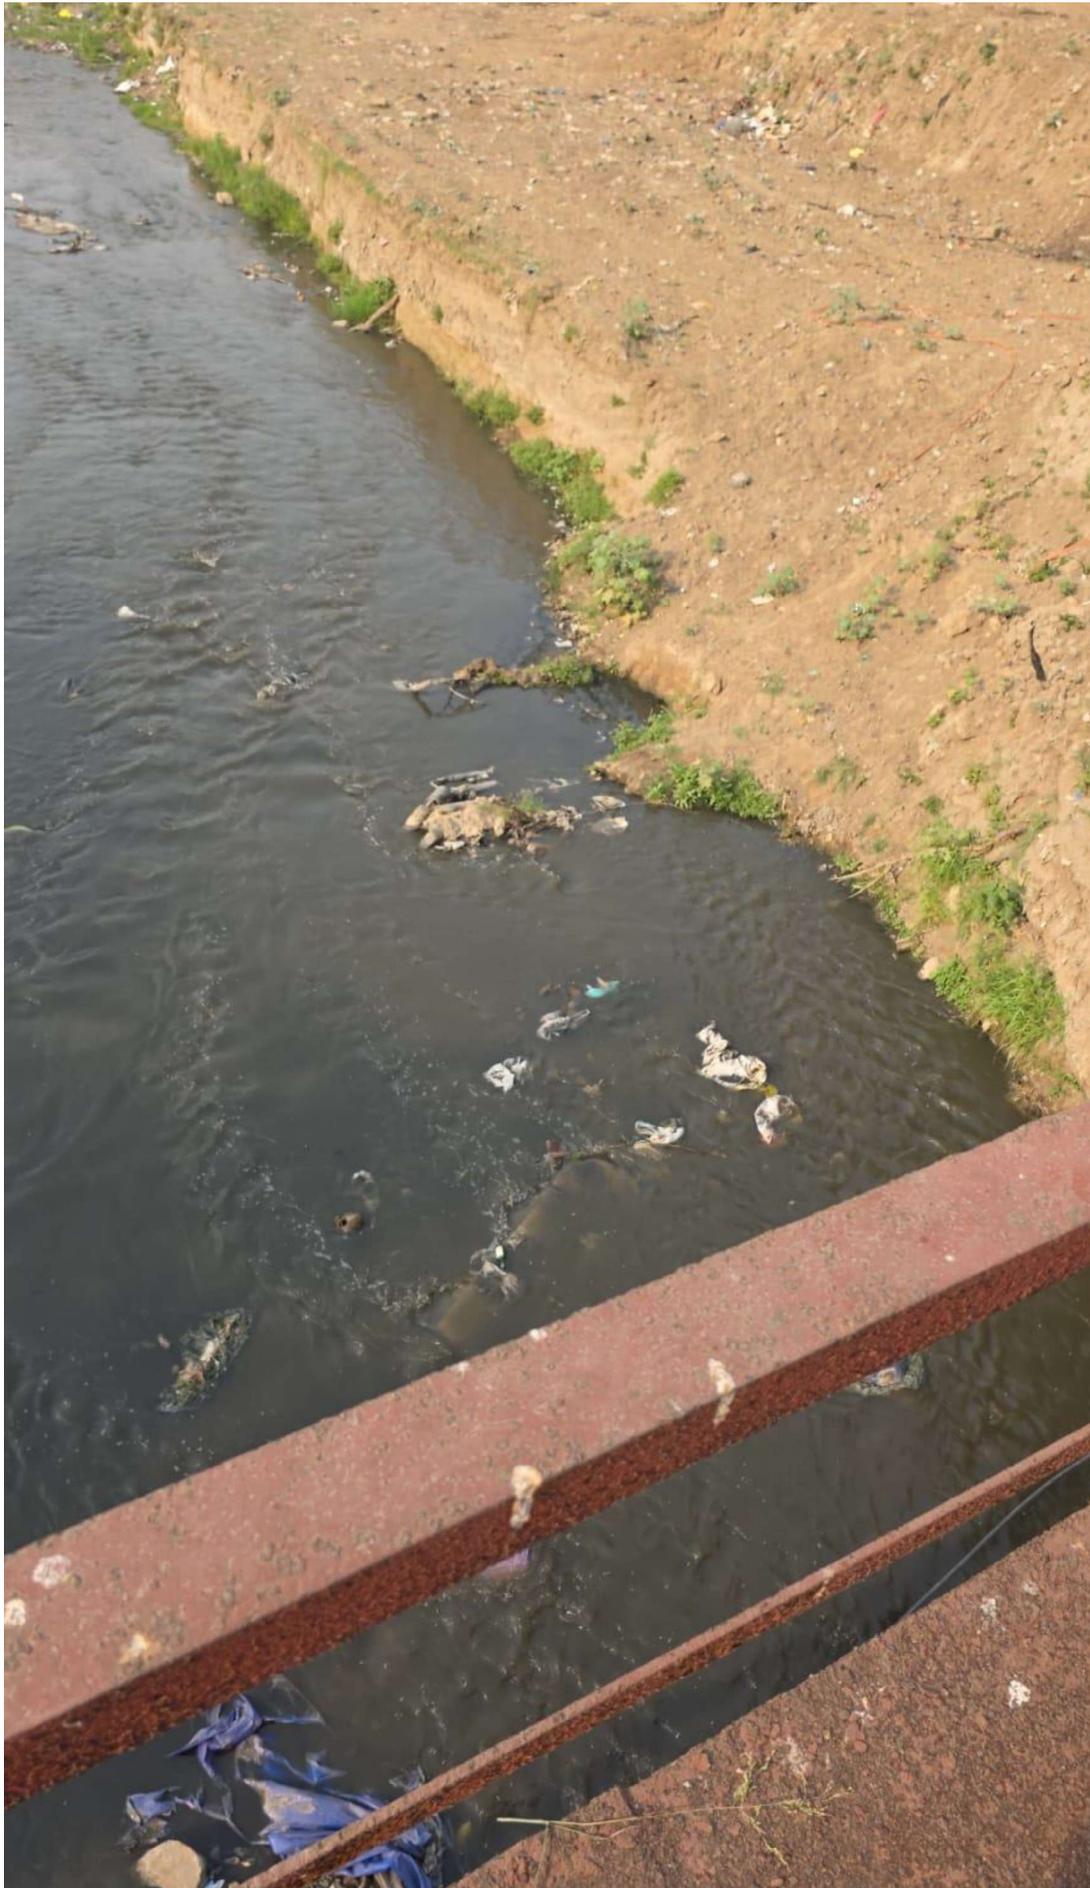
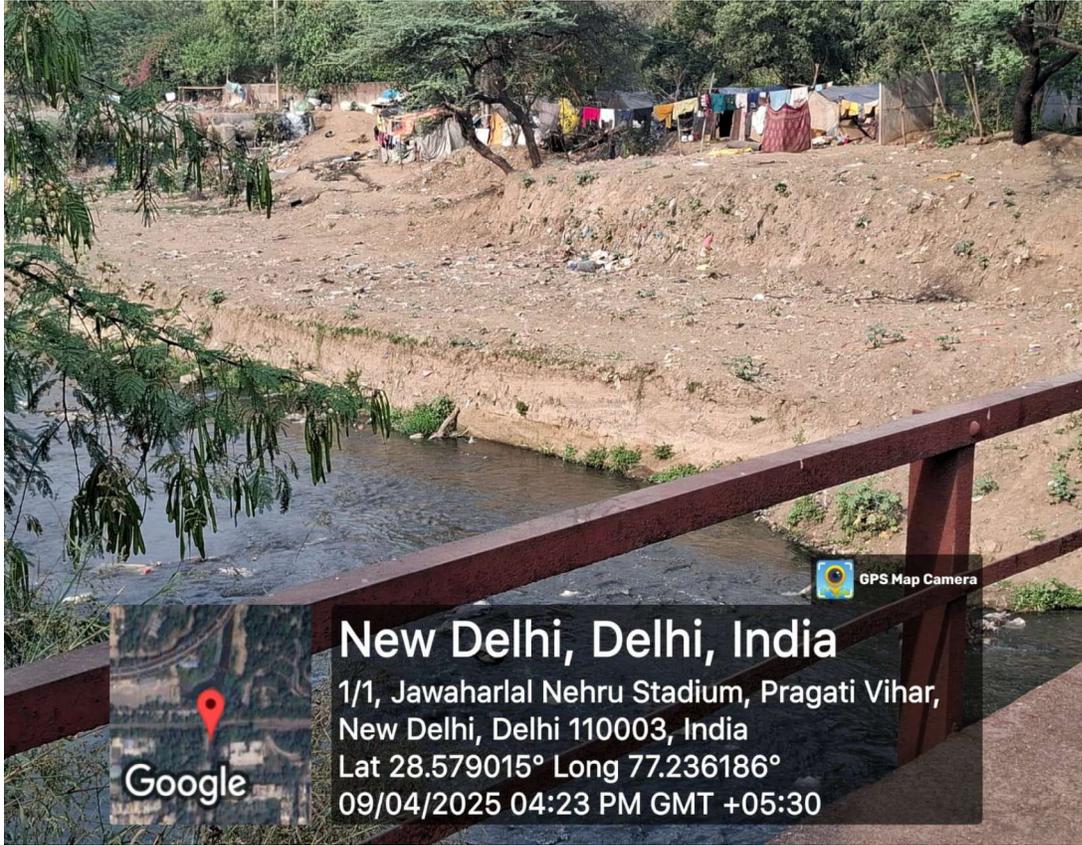
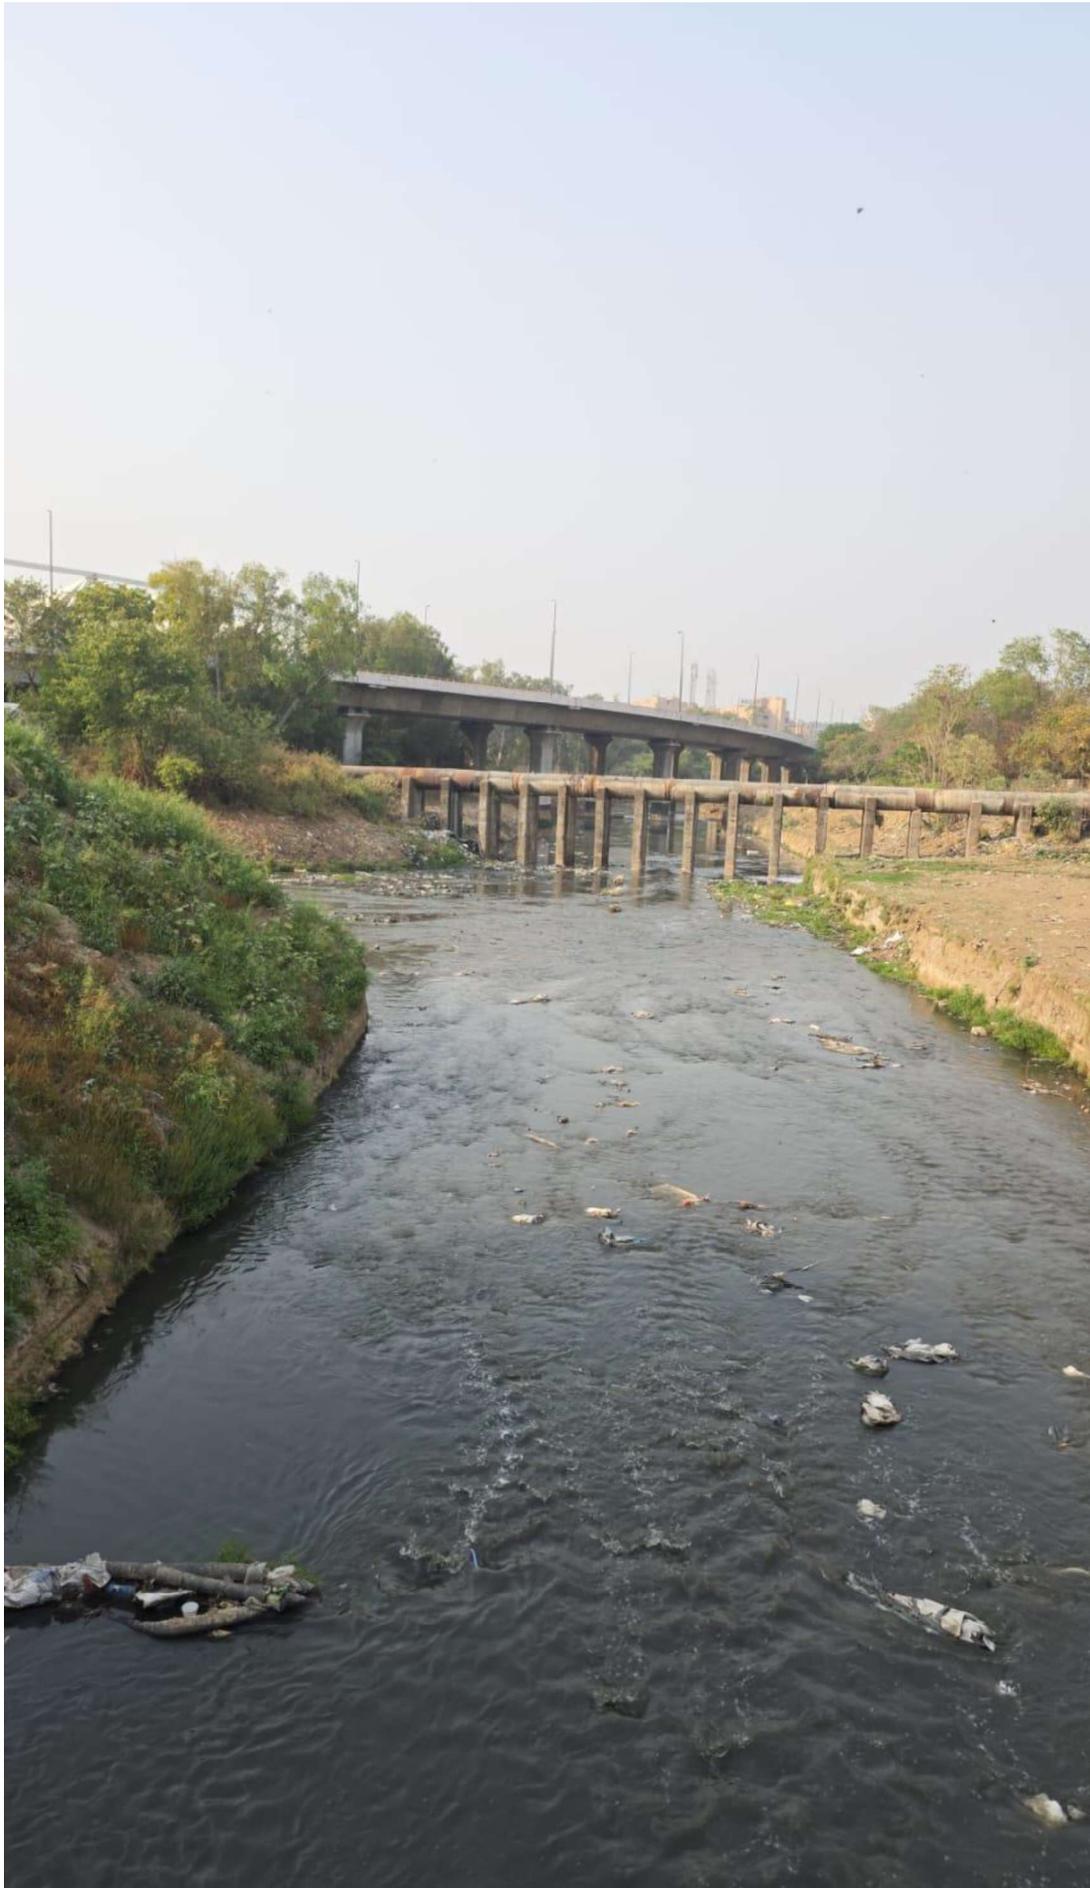
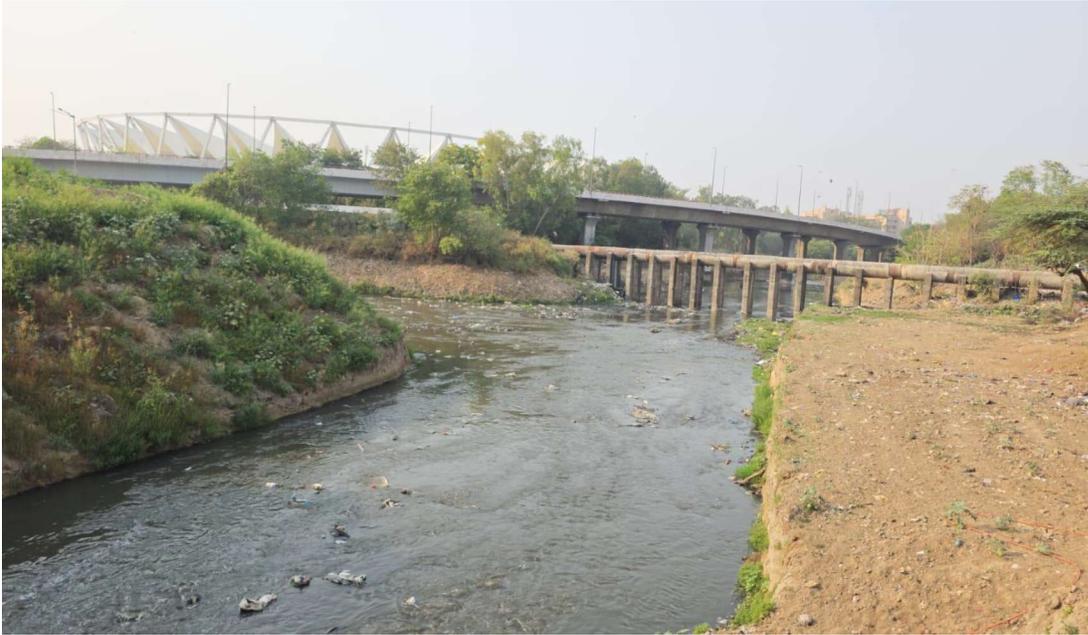
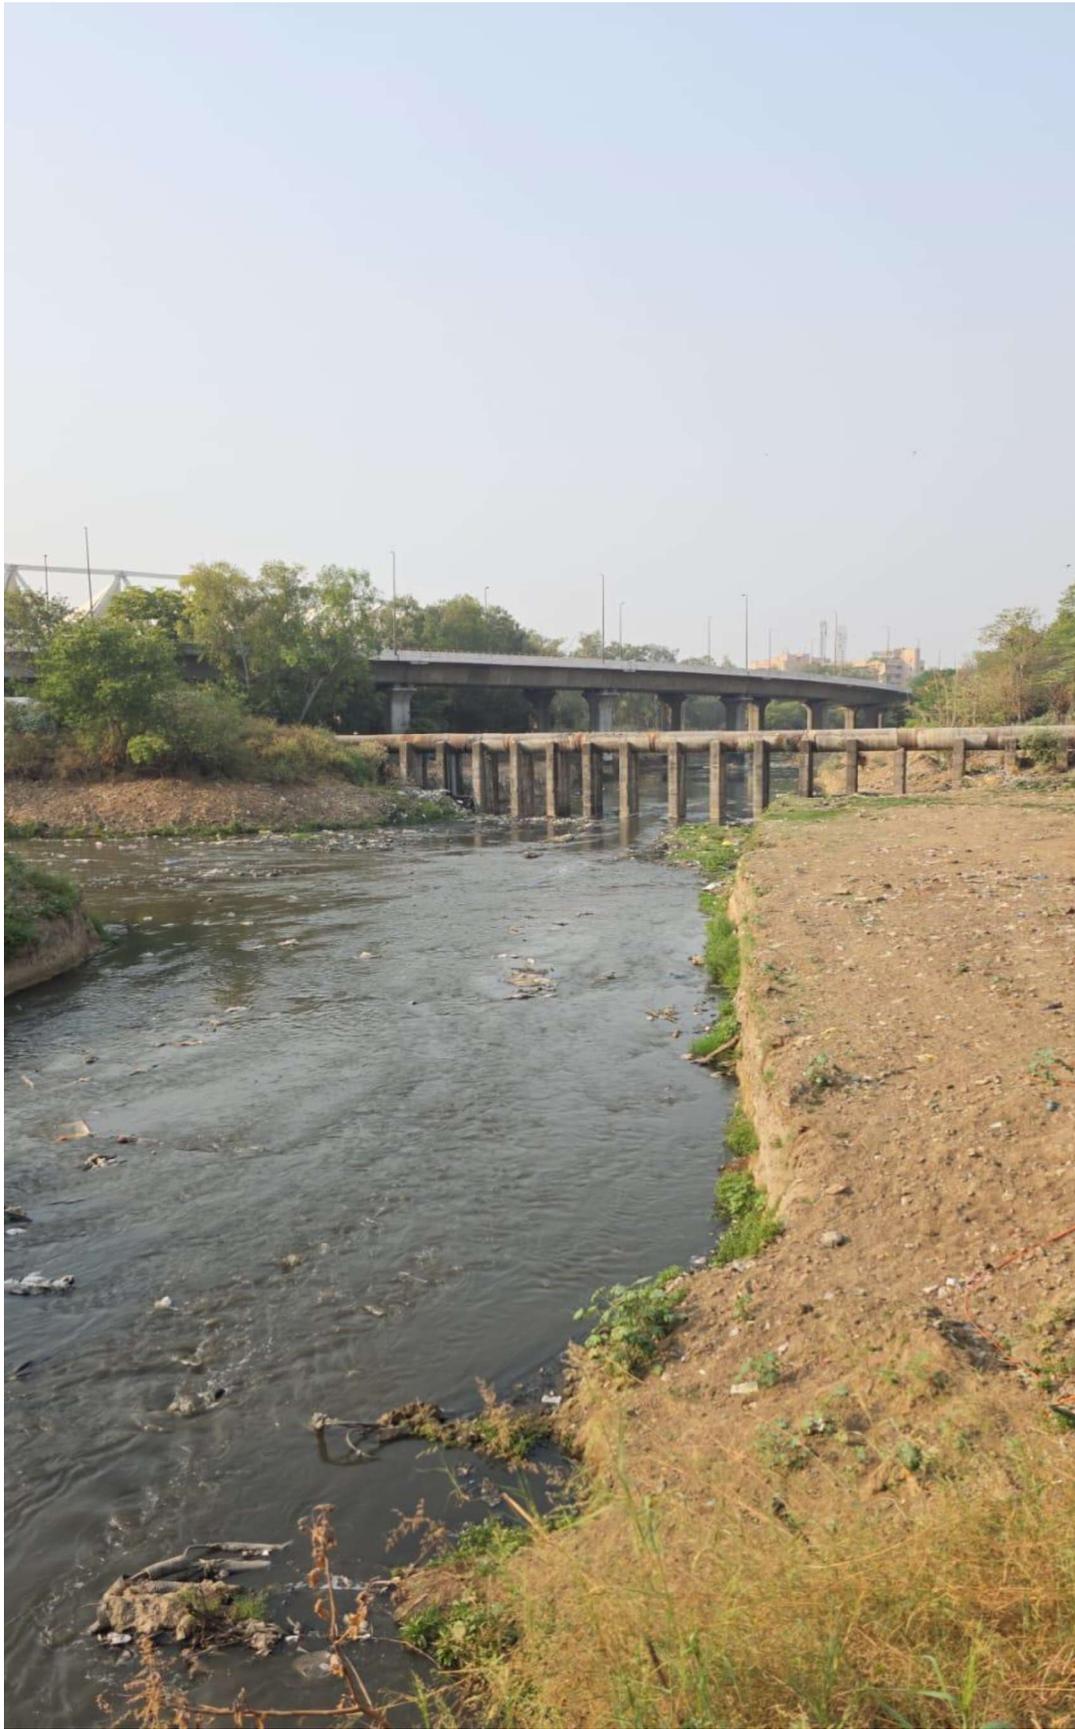
21. The drain ends after railway track where it meets Sunheri drain. On 11.04.2025, it was not possible to cross the railway track due to dumping of soil at Kachcha path which was not dumped on 09.04.2025 (**Point 'H'**)

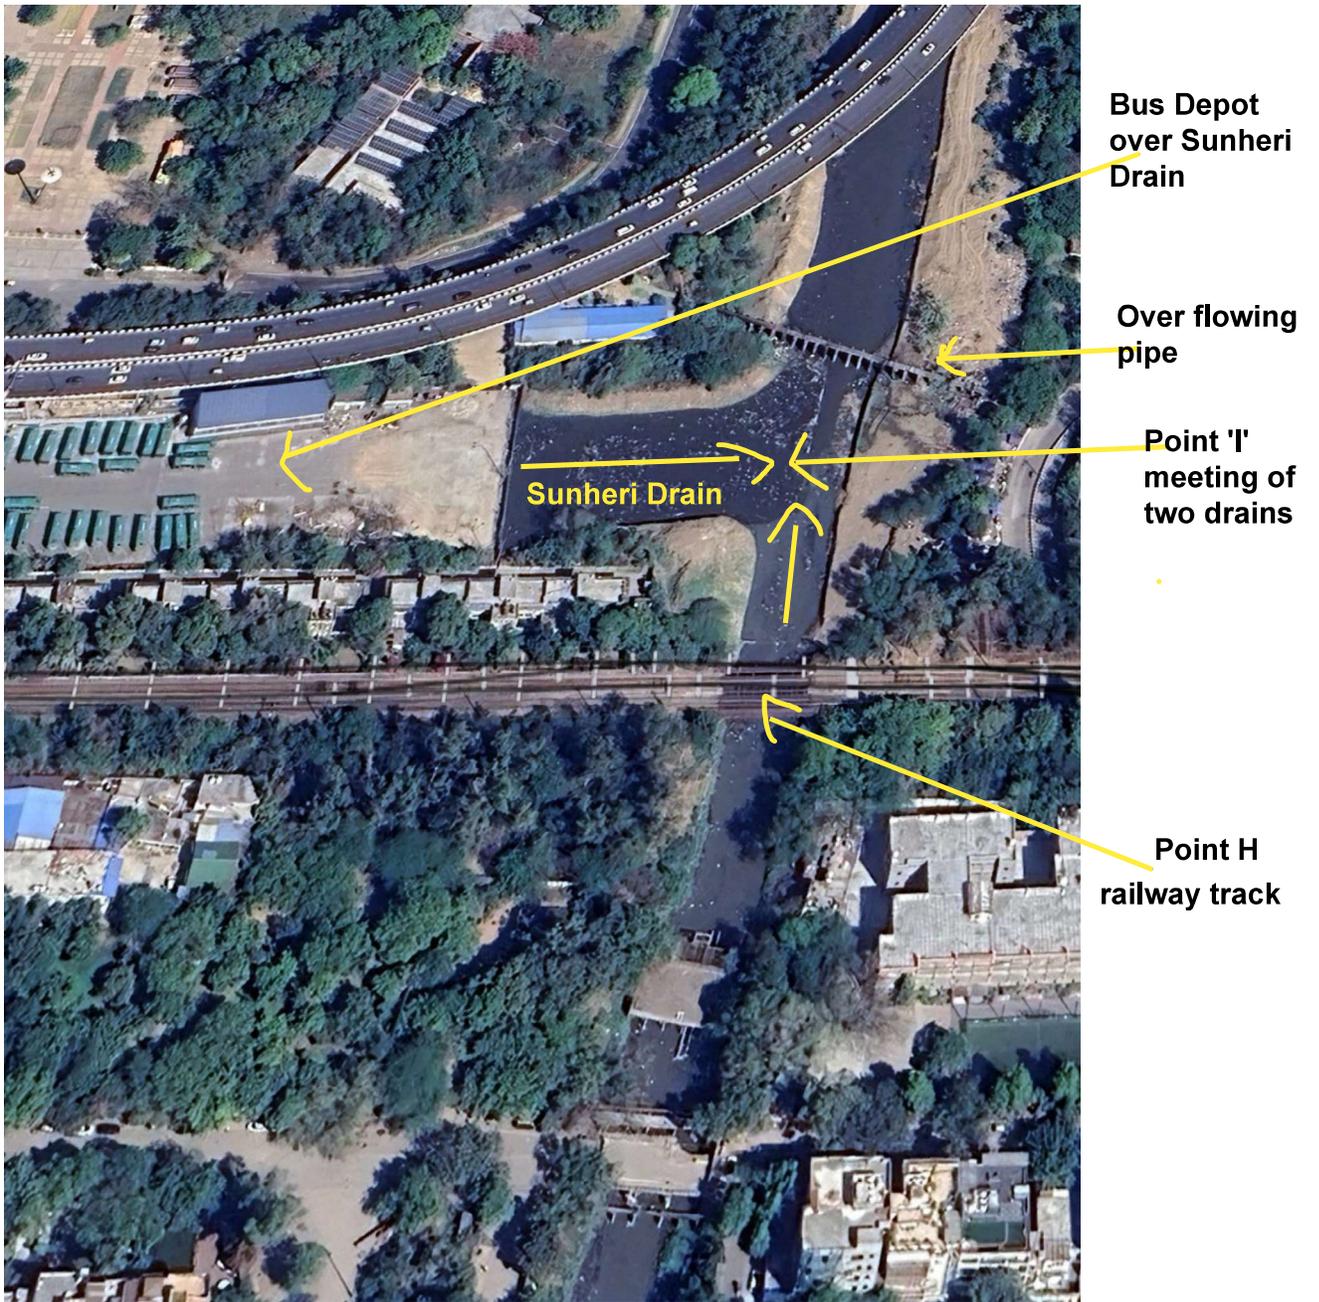
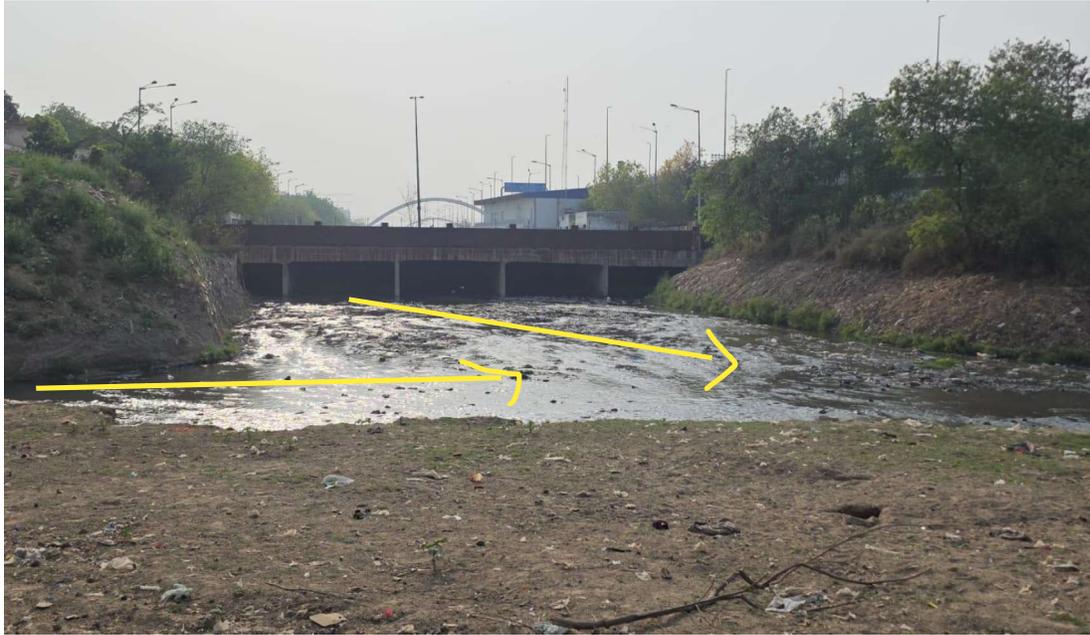
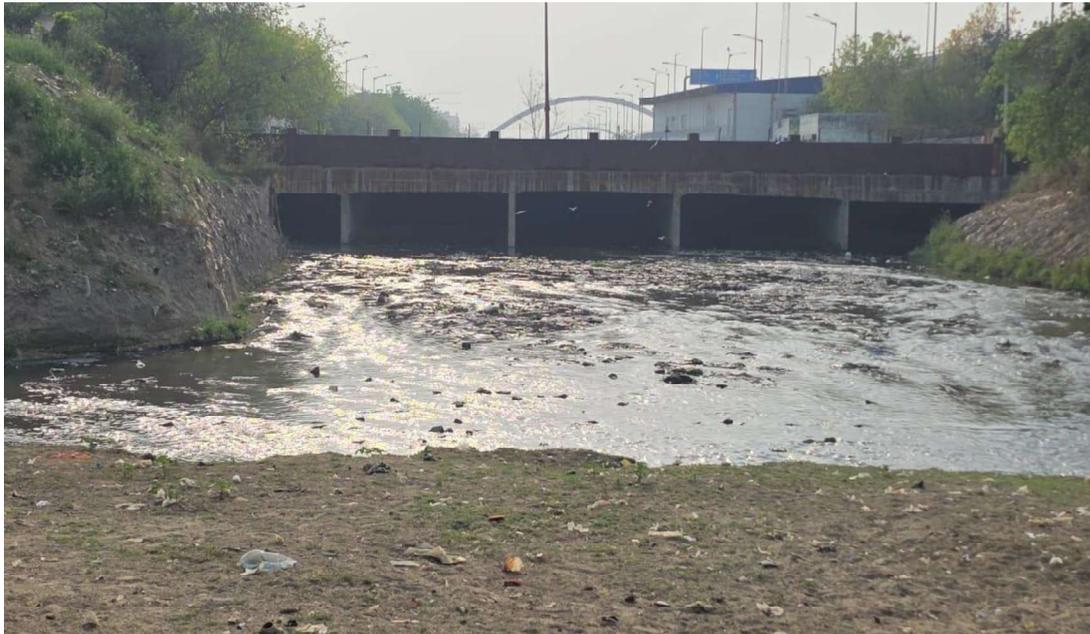
Meeting of Sunheri drain and Kushak drain at Point 'I'

At the end point and beyond the railway track, the Drain meets the Sunheri drain.
