Sub: Report of the joint site inspection held on 20/12/2024 from 11:15 am onwards at the property bearing survey no.16/7 of Sernabatim, Salcete, Goa.

REPORT OF THE JOINT SITE INSPECTION HELD ON 20/12/2024 FROM 11:15 AM ONWARDS AT THE PROPERTY BEARING SURVEY NO.16/7 OF SERNABATIM, SALCETE, GOA.

Site address: Survey No.16/7 of Sernabatim, Salcete, Goa

Date of inspection: 20/12/2024

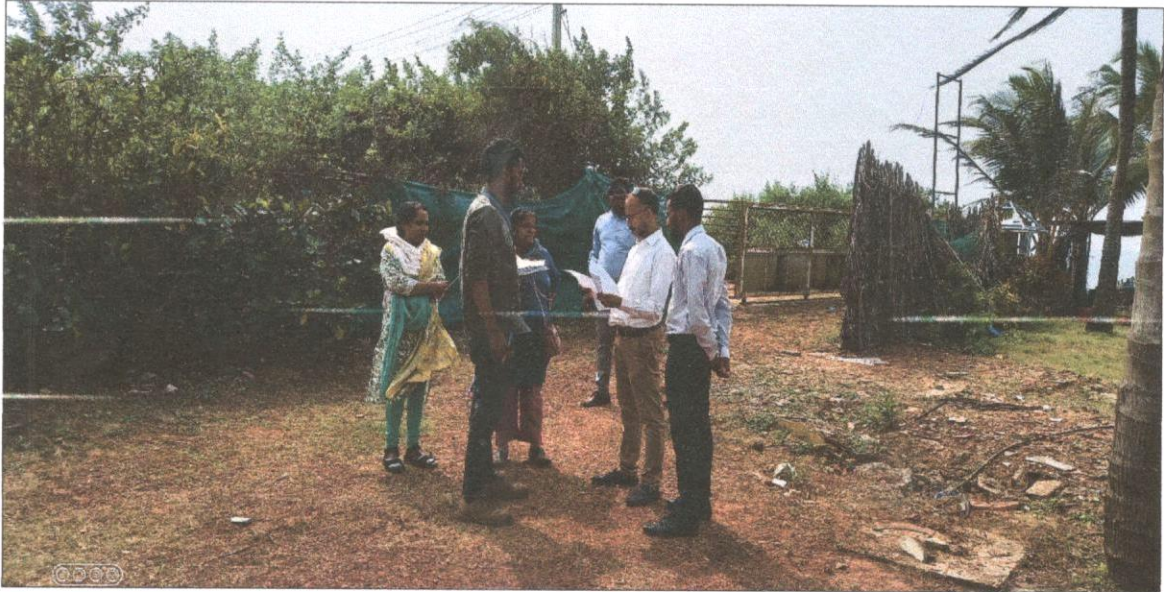
Pic 1: Officials from GSBB, GCZMA inspecting the site along with the respondent and representative of the applicant.
