Sub:- Regarding status report of field work done by Expert Committee formed on 22.07.2019 by District Magistrate, Bhilwara in reference to OA No. 288/2019, Bal Kishan Vyas Vs State of Rajasthan.

**Sub: Work Status Report on Investigations of Cracks in the Pur village, Distt. Bhilwara, Rajasthan**

1	Name of work	<b>Studies to investigate the reasons of cracks development in buildings of Pur village, Bhilwara, Rajasthan</b>
2	Institute	<b>CSIR-Central Building Research Institute, Roorkee</b>
3	Site	Pur Village, Bhilwara, Rajasthan
4	Date of visit	28 <sup>th</sup> January 2020 to 3 <sup>rd</sup> February 2020
5	Type of work	Condition assessment of various buildings and monitoring of cracks in building
6	Status of work	<ul style="list-style-type: none"> <li>• Condition assessment of 55 buildings of Pur Village, Bhilwara has been carried out in respect to typology of buildings, structural systems, construction materials, mapping of structural and non-structural cracks, other observations. The identified buildings were marked for monitoring at different locations in Pur village.</li> <li>• During studies, the cracks and other distresses in buildings were properly marked. The plan drawi

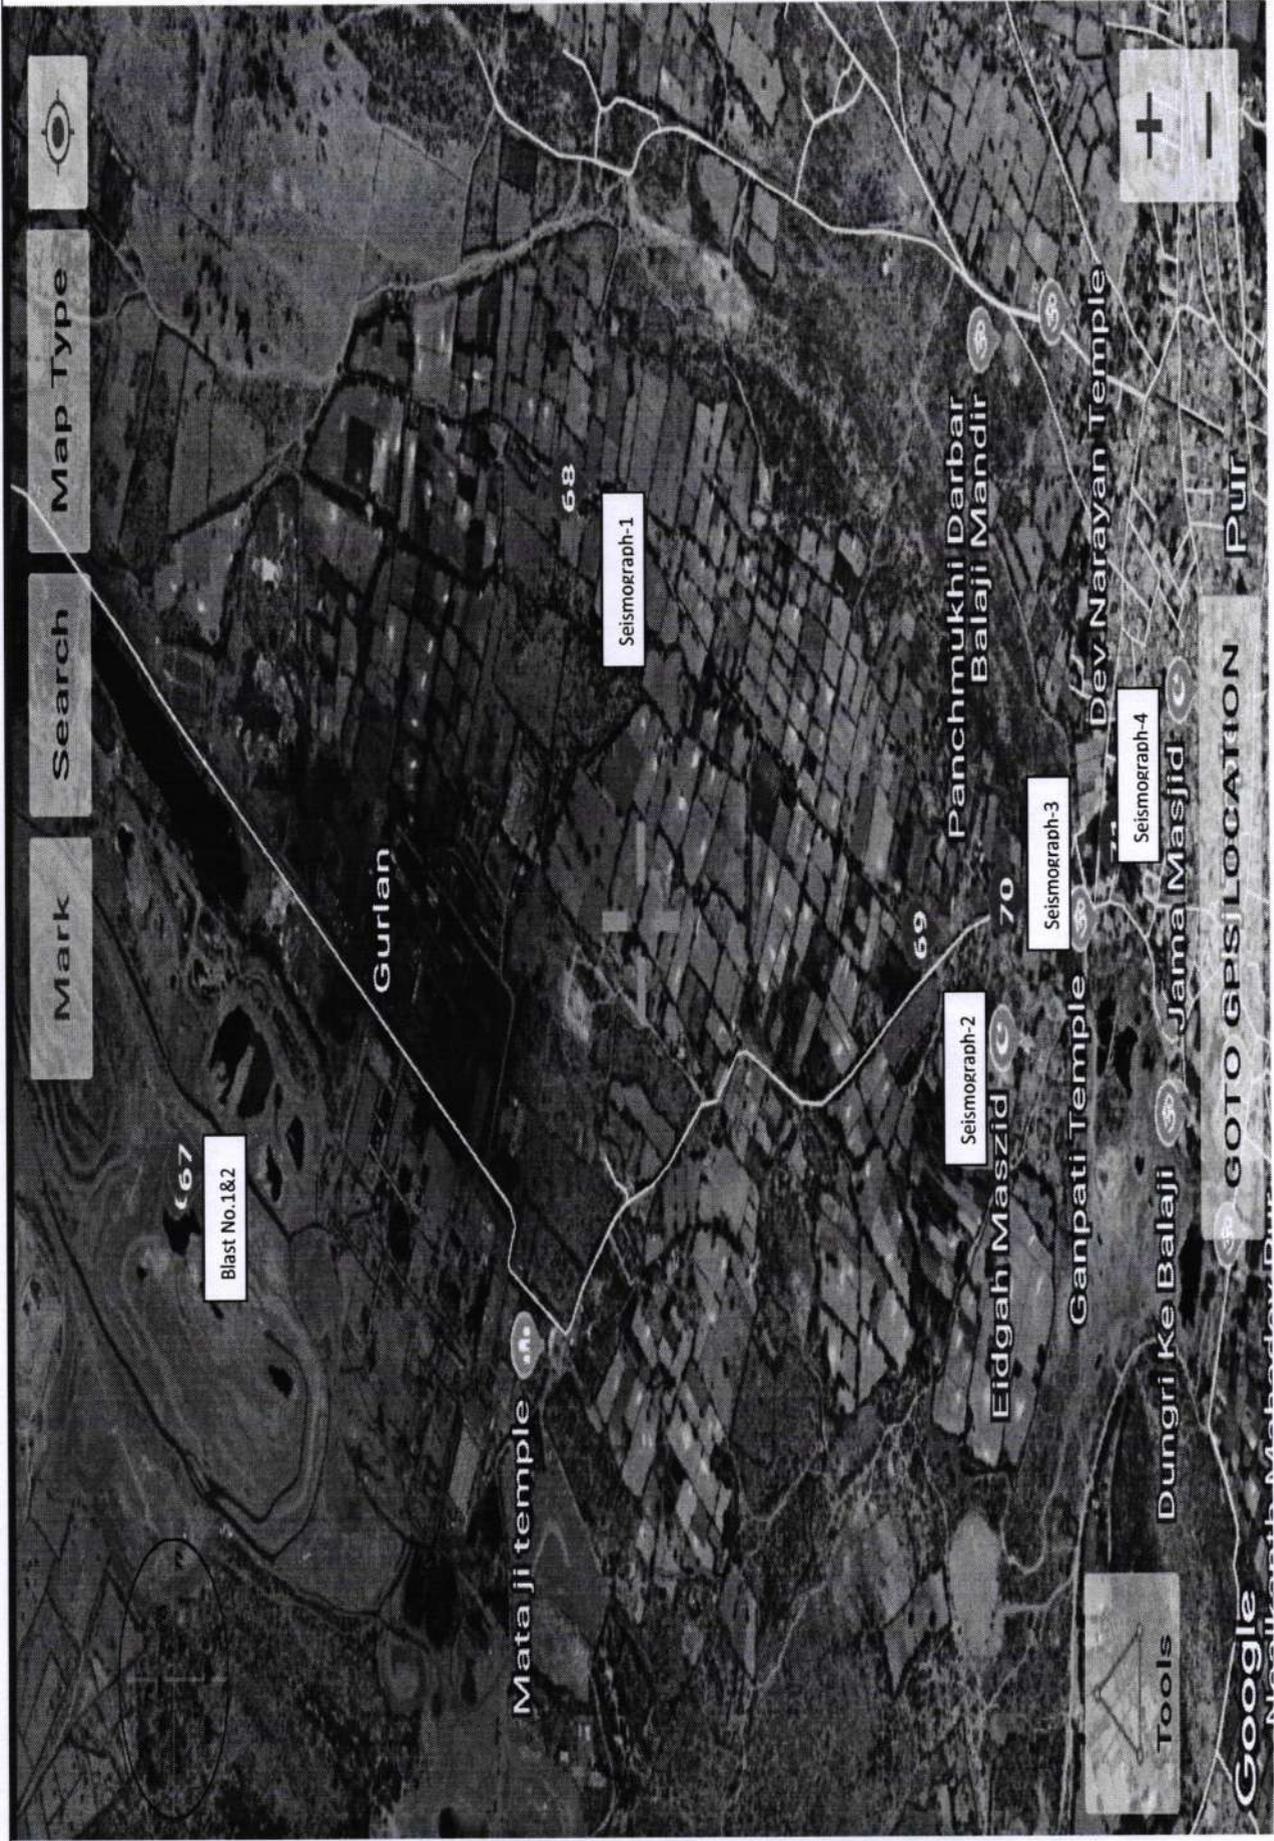
**Blast Location: 66-Blast 1; 67-Blast 2**  
**Vibration Monitoring Location: 68- ; 69- ; 70-Hanuman Temple, 71-Inside Village, Infront of House no.4949 & 4950**

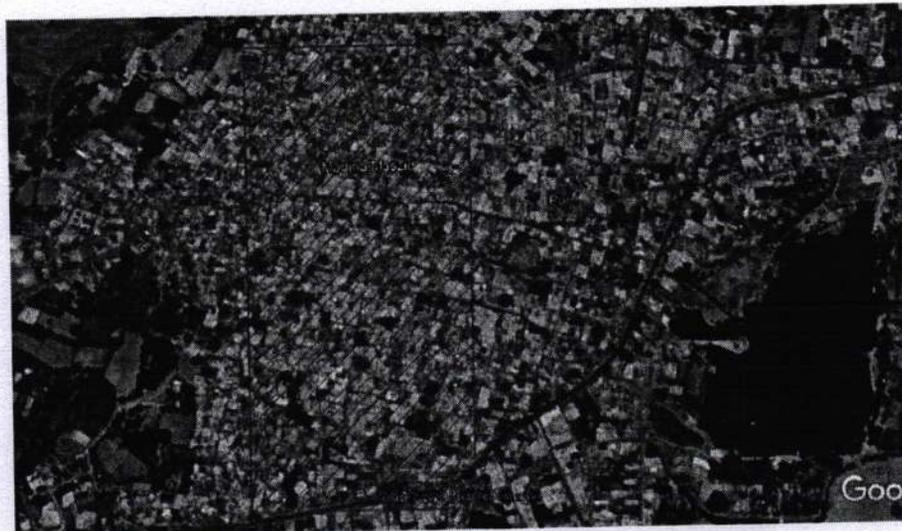
Fig 1. Sattellite image of Pur village and hashed red colour showing area covered in this phase
