ORIGINAL APPLICATION NO 662 OF 2024

In re: In the matter of developing cracks in the houses, fertile land of poor villagers and drying up of drinking water sources due to land subsidence in some villages of District Bageshwar.

7	Annexure CCR-5 (COLLY) (A) copy of the still images of various mining sites where non-adherence to the norms is leading to slope failure.	
8	Annexure CCR-6 (COLLY) (A) copy of the still images of various mining sites with visual non-adherence to the norms relating to the dumps of burden.	
9	Annexure CCR-7 (COLLY) (A) copy of the still images of various mining sites with visual non-adherence to the norms relating to the preservation of topsoil.	
10	Annexure CCR-8 (COLLY) (A) copy of the still images and Google Earth Images of various mining sites with visual non-adherence to the norms relating to drainage and water management, forest land usage, cutting of trees for firewood, and damage to forest land.	
11	Annexure CCR-9 (COLLY) (A) copy of the still images of various mining sites using heavy earth moving equipment.	
12	Annexure CCR-10 (COLLY) (A) copy of photographs displaying the poor living conditions of Labour.

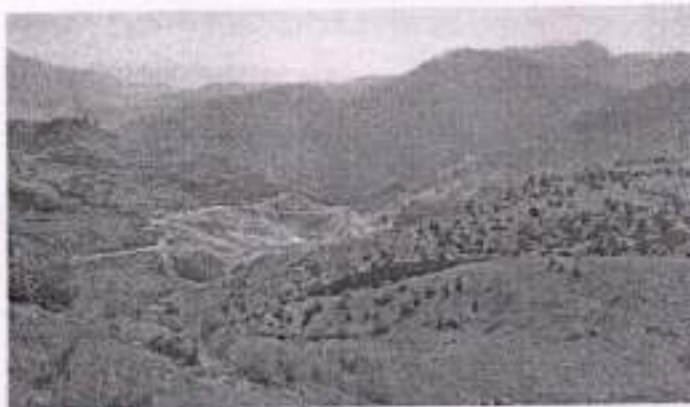
Photo 1: Open Cast Soap Stone Mining at Kanda Tehsil, Bageshwar

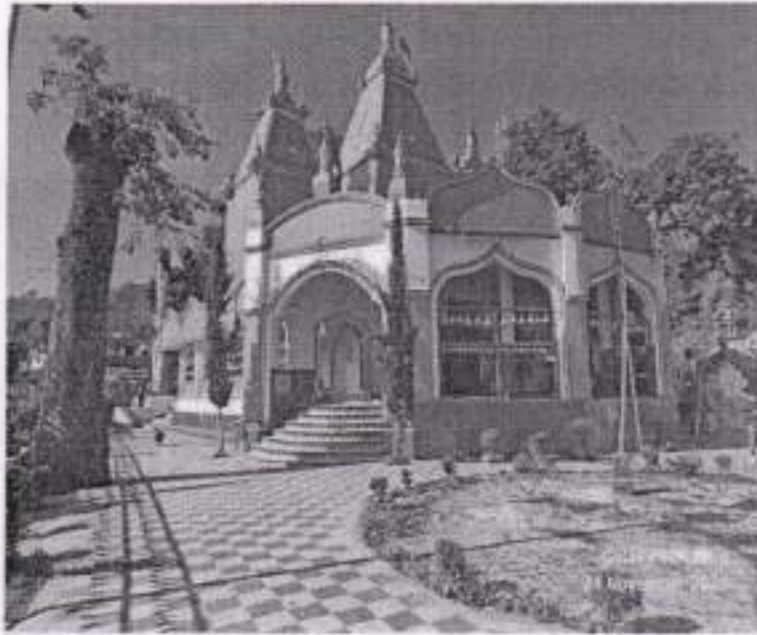
The Hon'ble NGT, while quoting the aforesaid news item, has further mentioned that a 1,000-year-old Kalika temple is also at risk due to nearby mining activities as the cracks have appeared in the temple premises, with locals attributing the damage to a open cast soapstone (Talc or Khadiaya) mine just 50 meters away. The article further claims that there has been no visible government effort to address the situation or help those affected. Hon'ble NGT in its order dated 30.08.2024 has correctly mentioned that the villagers initially supported talc mining for the jobs it provided. However, now they are worried for the safety of their homes and Kalika temple due to adjacent open cast soapstone (talc or khadiya) mine. It may however be noted that the District Administration vide order dated 01.06.2023 has closed the operations in all the mines within 50 m of existing CNG Godown, Aabadi Area and Motor Road including this particular mine. This open cast soapstone mine lease was allocated to Shri Kuldeep Singh Bisht.

Photo 2: Kalika Temple in Kanda Tehsil

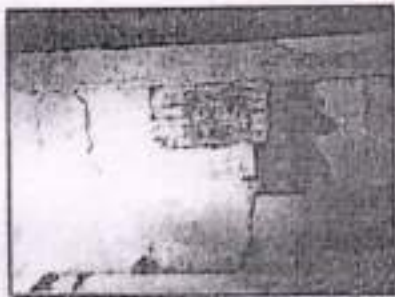
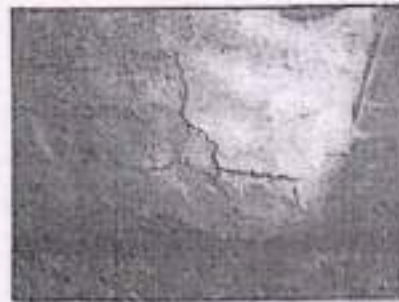
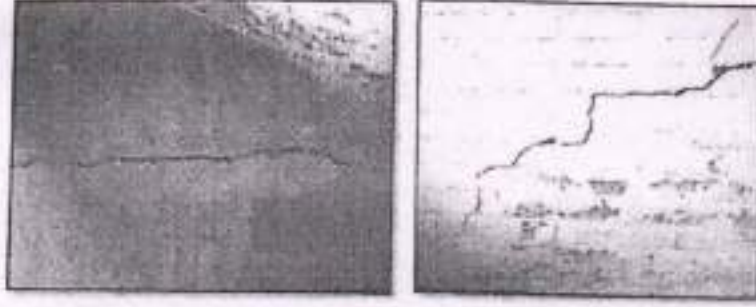
स्थल 01-हेम चन्द्र काण्डपाल पुत्र श्री प्रयाग दत्त-आवासीय भवन की बाहर की दीवार पर दरारें हैं, भवन के अन्दर कमरे में लगभग 01 सेमी० चौड़ी तथा 06 मी० लम्बी दरार है, जो फर्श से दीवार तक जा रही है। किचन के फर्श पर दरारें व गीली अवस्था में है। भवन के दूसरे कमरेके दरवाजे खोलने-बन्द करने में अटकरहे है। फर्श तथा दीवारों पर हल्की दरारें हैं। आंगन में बाहर दीवारी की ओर हल्का धंसाव है। परिवार भवन में निवास कर रहा है। निरीक्षण के दौरान भवन स्वामी द्वारा अवगत कराया गया की भवन लगभग 95 वर्ष पुराना है जिसमें वर्ष 2016 से दरारें आना शुरू हो गयी थी।

1. स्थल 01,02,03,04 पर स्थित आवासीय भवन के आँगन के नीचे सीढ़ीनुमा खेतों में निर्धारित स्तरों पर उपयुक्त रूप से डिजाईन की गयी सुरक्षा दीवार/गैबियन दीवार का निर्माण किया जाना होगा।
2. स्थल 05 पर स्थित भवन/दुकान के पीछे उत्तर-पूरव दिशा में उपयुक्त निर्धारित स्तरों पर उपयुक्त रूप से डिजाईन की गयी सुरक्षा दीवार/गैबियन दीवार का निर्माण किया जाना होगा।
3. भवनों की दरारों को उपयुक्त फिलिंग मटीरियल द्वारा भर कर मरम्मत की जानी होगी।
4. उपरोक्त प्रश्नगत स्थलों पर जल निकासी हेतु उचित व्यवस्था की जानी होगी।
5. उपरोक्त प्रश्नगत स्थलों पर भूस्खलन को रोकने वाली घास/पौधों का रोपड़ किया जाना होगा।

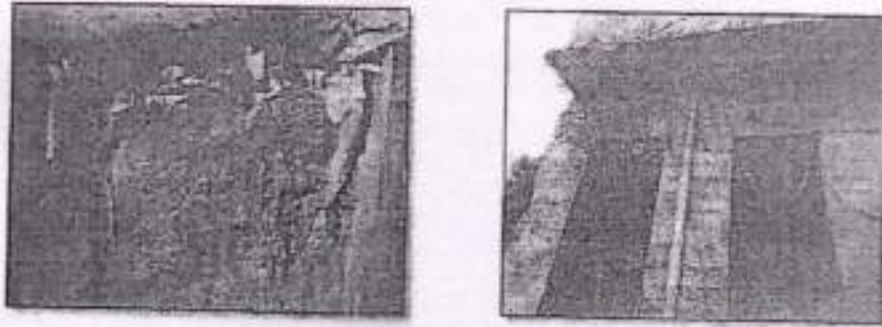
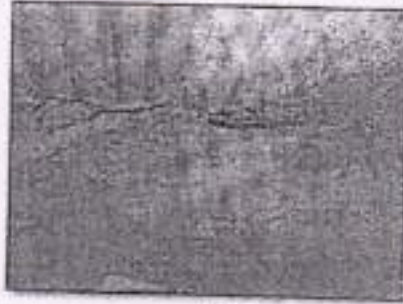
महेश चन्द्र काण्डपाल पुत्र श्री हरीश चन्द्र काण्डपाल—आवासीय भवन की बाहर तथा अन्दर की दीवारों पर अनवस्त दरारें हैं, कमरों के दरवाजे तिरछे हो गये हैं। परिवार अन्यत्र निवास कर रहा है। आंगन में बायी ओर हल्का धंसाव है। निरीक्षण के दौरान हेम चन्द्र काण्डपाल द्वारा अवगत कराया गया कि भवन लगभग 05 वर्ष पुराना है।

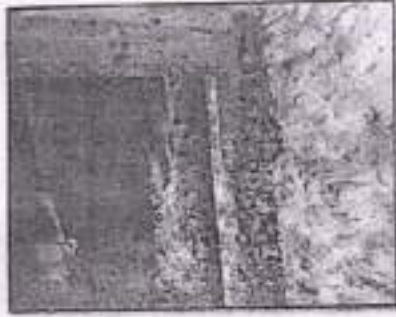
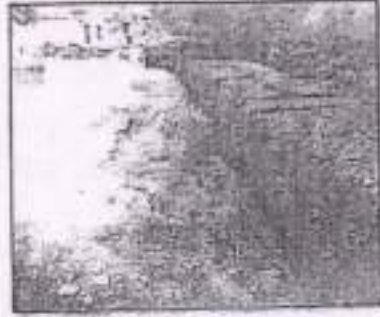
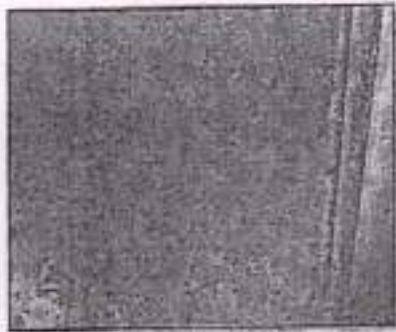
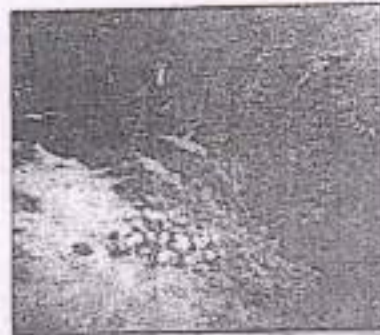
स्थल 02—साधू राम पुत्र श्री विल राम—आवासीय भवन की बाहर व अन्दर की दीवार पर हल्की दरारें हैं जिनकी मरम्मत की गई है। आंगन के फर्श में बाहर दीवारीकी ओर दरारें हैं तथा हल्का धंसाव है। परिवार भवन में निवास कर रहा है। निरीक्षण के दौरान भवन स्वामी द्वारा अवगत कराया गया कि भवन लगभग 12 वर्ष पुराना है। शौचालय में हल्की दरारें हैं। अवगत कराया गया है कि 08/08/2024 को अतिवृष्टि से आंगन से लगभग 15 मी० की दूरी पर नीचे की ओर खेत धंस गये हैं, वर्तमान में यह पीछी तथा घास से ढका है। स्थल से खनन क्षेत्र की दूरी लगभग 30 मी० है।

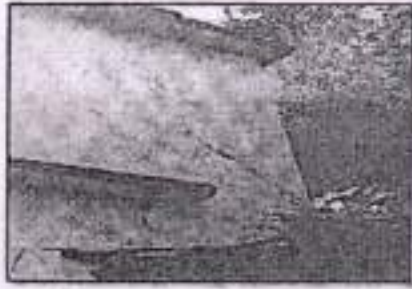
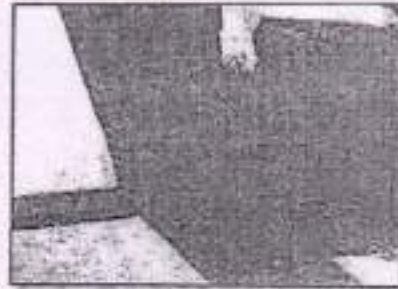
स्थल 04—हरीश राम पुत्र श्री कुंवर राम—आवासीय भवन के बाहर किनारे की दीवार पर हल्की दरार है। परिवार भवन में निवास कर रहा है। निरीक्षण के दौरान भवन स्वामी द्वारा अवगत कराया गया कि भवन लगभग 30 वर्ष पुराना है। स्थल से खनन क्षेत्र की दूरी लगभग 45 मी० है।

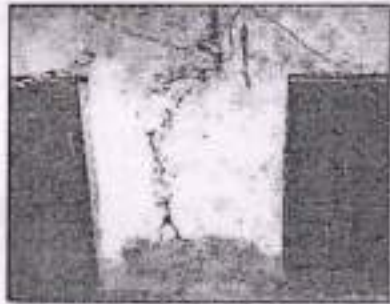
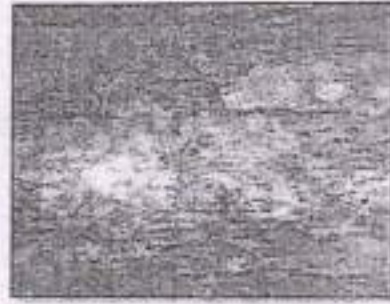
स्थल 06-जोगा राम पुत्र श्री लछम राम-निरीक्षण के दौरान भवन स्वामी द्वारा अवगत कराया गया की भवन के अन्दर कमरे में दरार थी जिनकी मरम्मत की गई है। भवन के किचन में सीलन है। शौचालय में हल्की दरारें हैं। गीसाला की बाहर तथा अन्दर की दीवारों पर दरारें हैं। परिवार भवन में निवास कर रहा है। निरीक्षण के दौरान भवन स्वामी द्वारा अवगत कराया गया की भवन लगभग 12 वर्ष पुराना है। आवास से लगभग 20-25 मी० दूरी पर दक्षिण-पूरब दिशा में प्राकृतिक जल स्रोत तथा मोटर मार्ग है। अवगत कराया गया है कि जल स्रोत में वर्ष भर पानी रहता है। स्थल से खनन क्षेत्र की दूरी लगभग 50-60 मी० है।

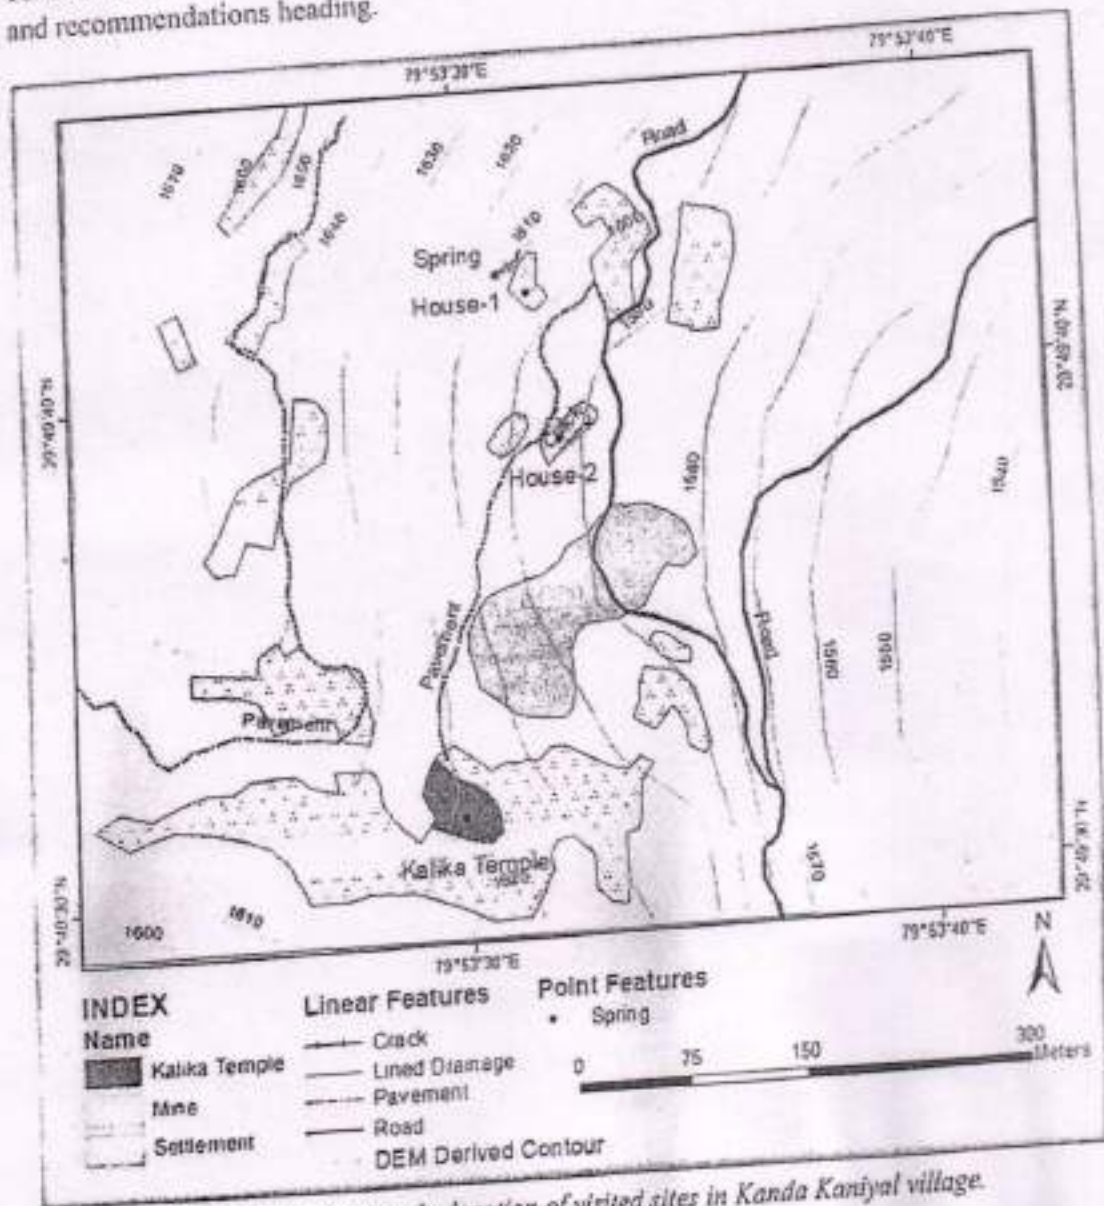
Fig. 2: Map showing the location of visited sites in Kanda Kaniyal village.

a) **Kanda Kanlyal Village:** The GSI team, accompanied by Sh. Anurag Arya, SDM, Smt. Ritu Goswami, Naib Tehsildar, and other local authorities, visited Kanda Kanlyal village. The Tehsil administration prioritized the investigation of cracks in two residential houses and the Kalika Temple. The location of these investigated sites in Kanda Kanlyal village is shown in Fig. 2. The observations and suggestions for individual site are discussed below:

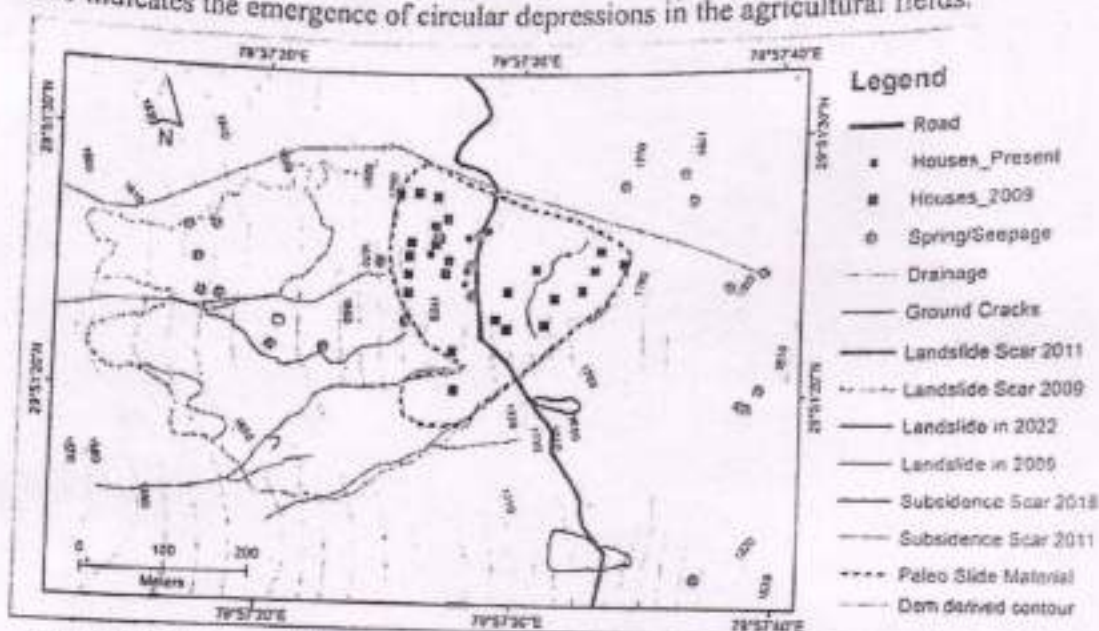
Analysis of Google Earth imagery indicates that Seri village is situated on a cone-shaped paleo slide material, sloping to the west (Fig. 6). This material is deposited over Augan Gneiss from the Proterozoic Baijnath Formation. The overburden is unsorted and contains large granite gneiss boulders embedded in a fine-grained matrix. The northern edge of the cone is defined by an unlined first-order nala fed by a spring located upslope to the east.

Over time, new springs have formed, feeding the cone's crown and causing water to seep down its slopes (Fig. 6). This subsurface water percolation through the overburden material washes away finer particles, leading to sinkholes near the crown and subsidence in the mid-section. The spring-fed nala has also contributed to the slow undercutting of the slide material, causing instability along its flank, evident from the tilted trees.

Multi-temporal Google Earth Imagery shows that houses previously built near the crown, periphery, and toe of the paleo slide were repeatedly constructed but could not withstand the ground instability. The majority of rehabilitated houses were also in these areas as evident from the comparison of houses in 2009 and houses present today (Fig. 6). Recently, cracks have started to appear in homes located in the middle part of the village. Numerous

Fig. 6: Map showing different ground deformation and hydrological features of Seri Village.

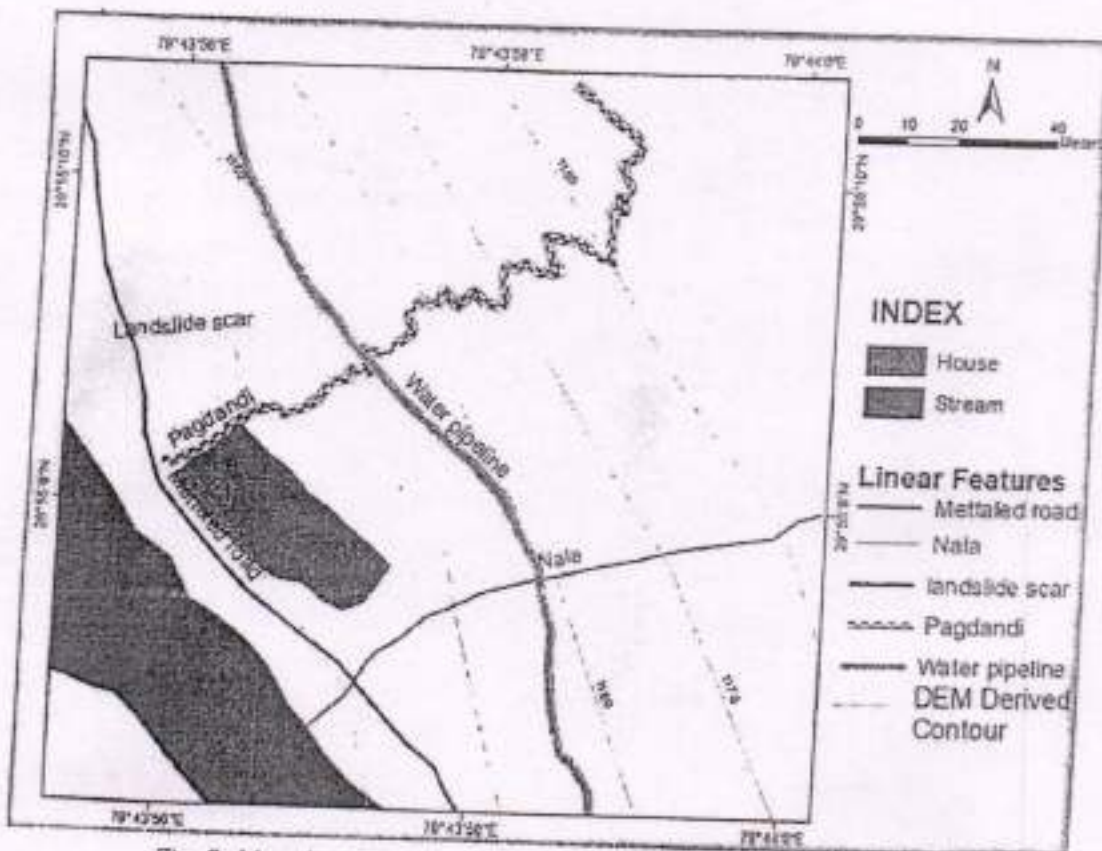
a) **Jakh village:** The Jakh village falls in SOI Toposheet no. 530/09, with the rehabilitated homes situated at coordinates N 29°55'8.01", E 79°43'56.59". During the field visit, GSI team was accompanied by Sh. Yuvraj Goswami, Revenue Sub Inspector. He informed that an issue began in September 2020 when a water pipeline above the homes of Sh. Rajendar Singh and Surinder Singh (Narain Singh's son) ruptured in night on a rainy day. This led to a sudden flow of water that saturated the slope, causing cracks to develop in the north side of the above mentioned houses. The location of houses and water pipeline are shown in Fig. 7.

Fig. 7: Map showing ground features of affected area in Jakh village.

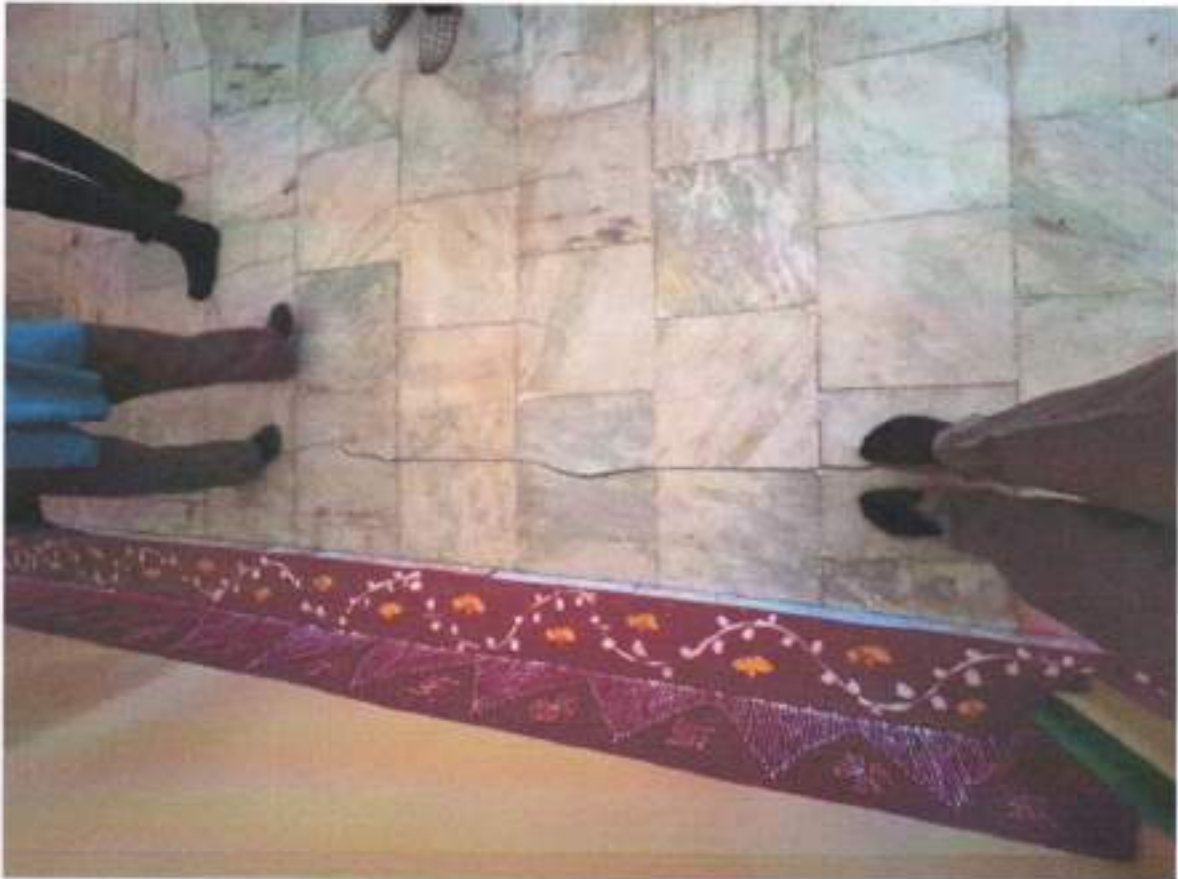
Land subsidence has led to the sinking of roof which is now resting on the wall. (UP)
Cracks on the Floor (DOWN)

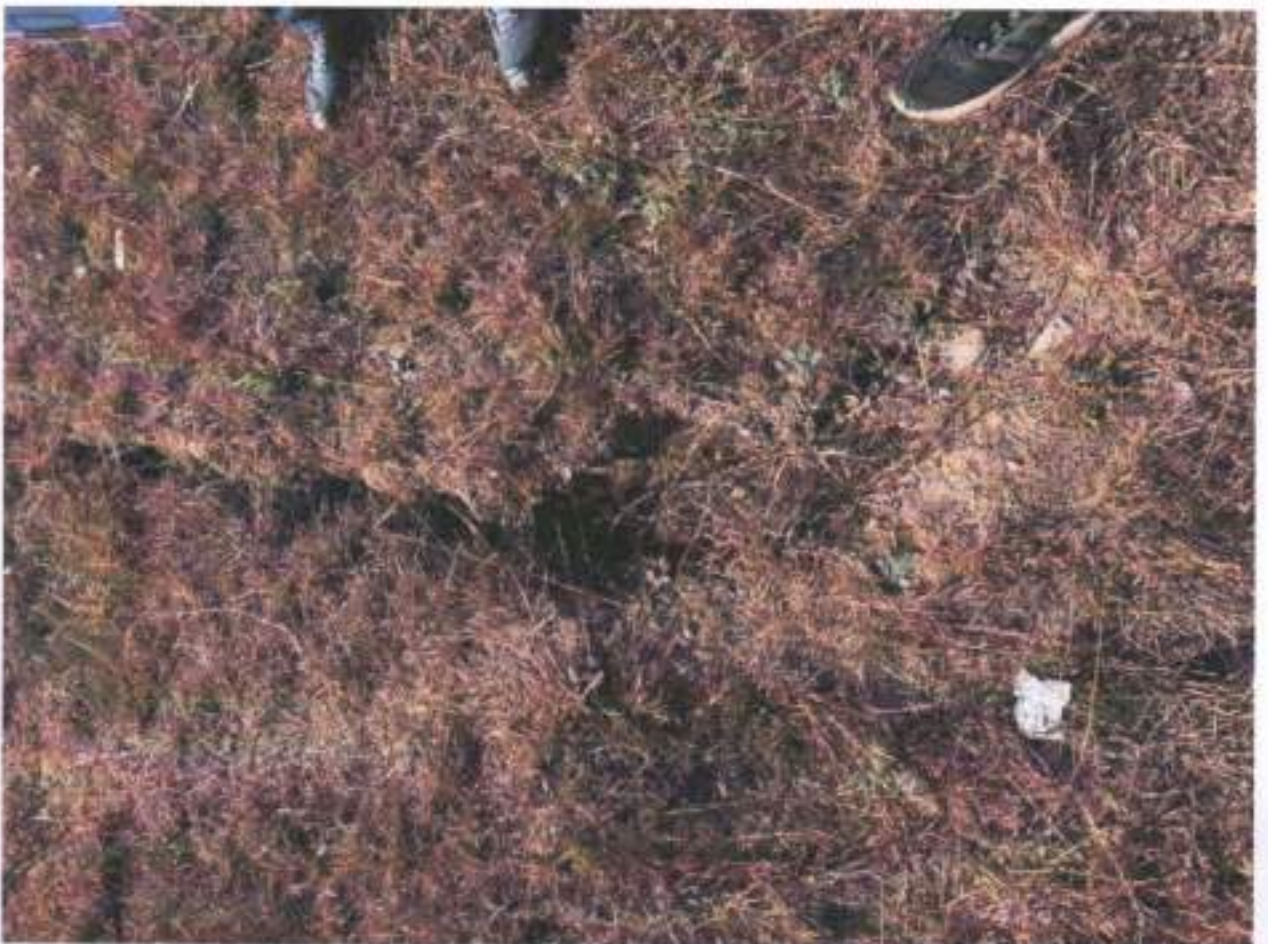
Cracks in Agricultural Fields

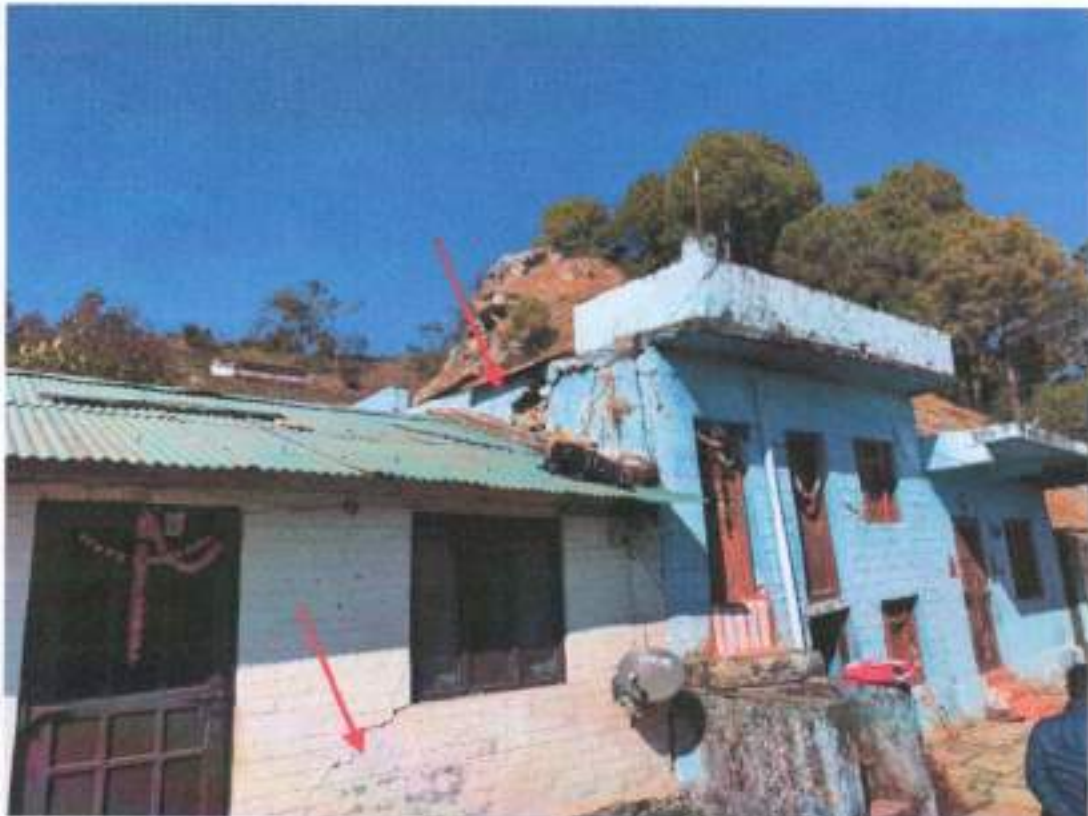
**Cracked and Exposed roof of Bakhli
Cracked Walled and Floor of the Bakhli**

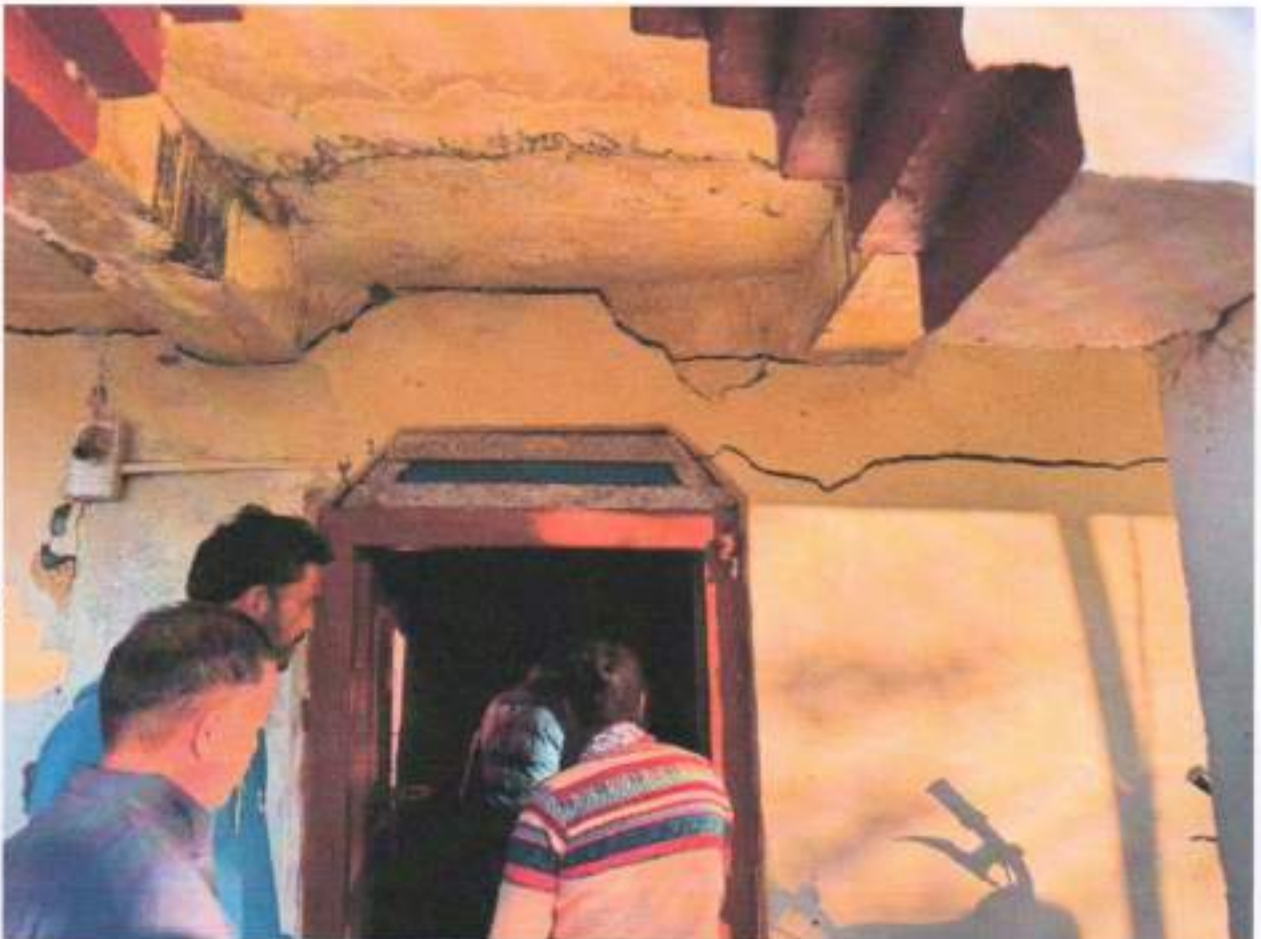
**Settling of Front Porch of the Bakhli of Sri. Kandpal
Failure of Beam/Lintel**

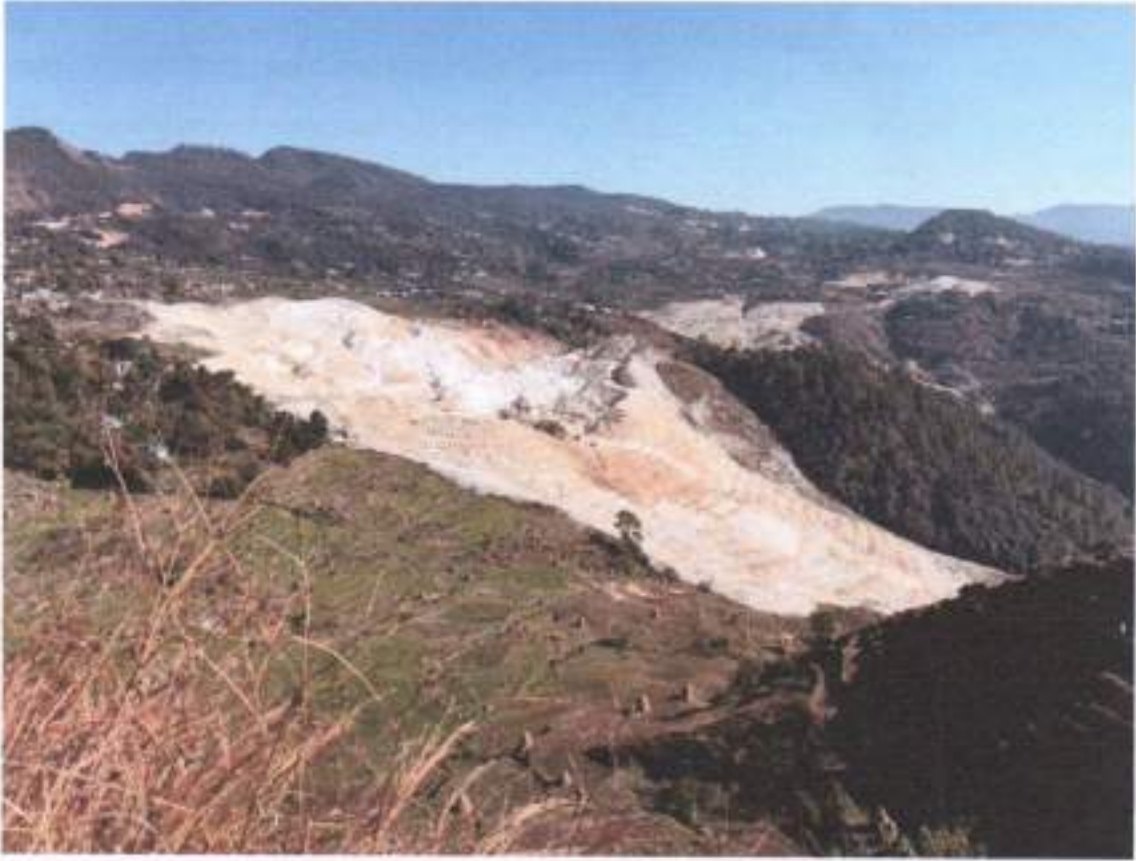
Mine operated by N.S. Corporation (Surkali, Reema)

Still images of various mining sites with non-existent Green Belts and Retaining Walls

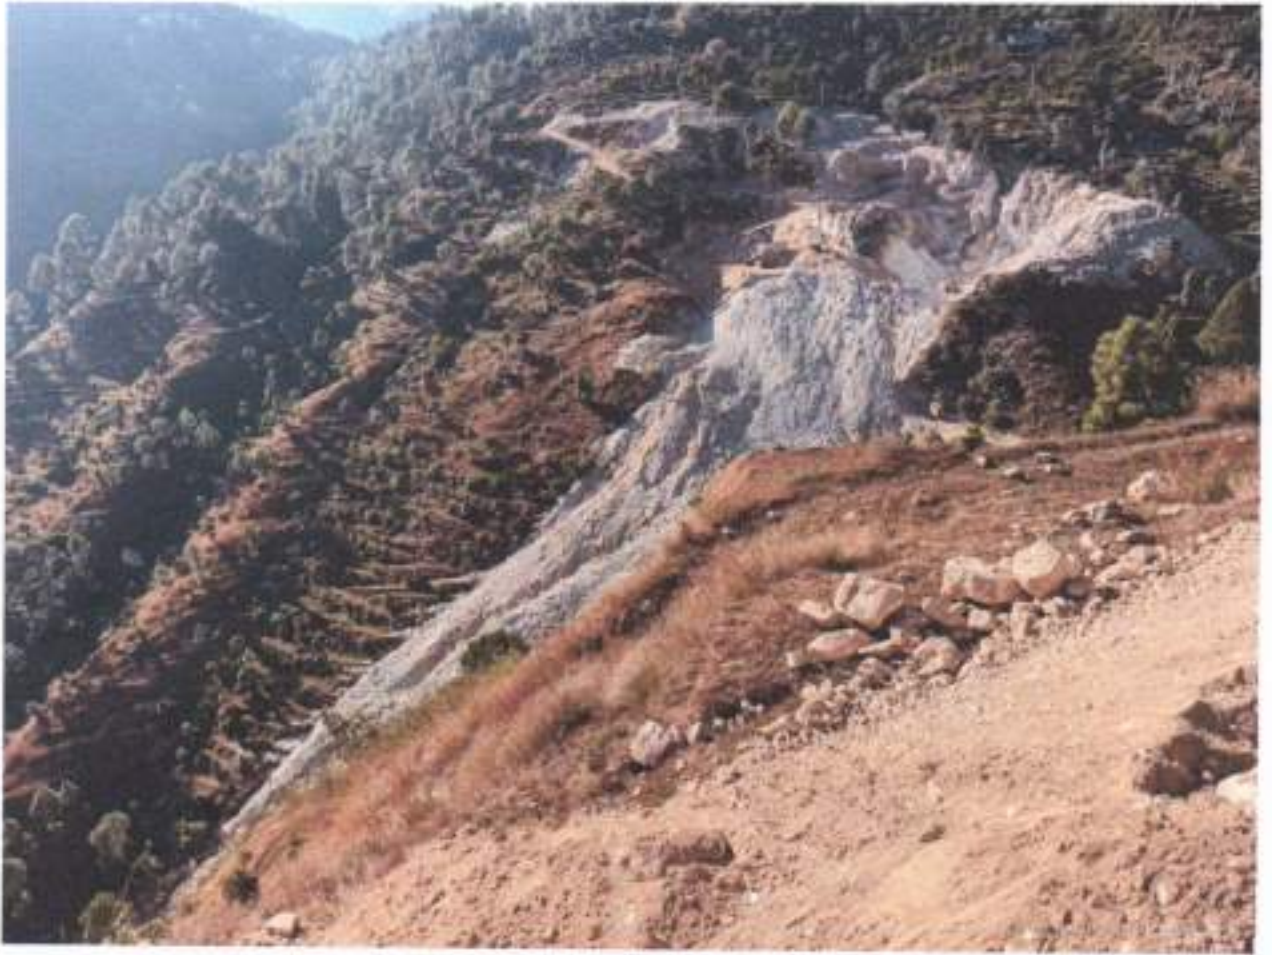
Absence of Retaining wall & green belts
Mine in front of Nandita Tiwari's Mine (UP)
Abandoned Mine in Village Kande Kanyal (DOWN)

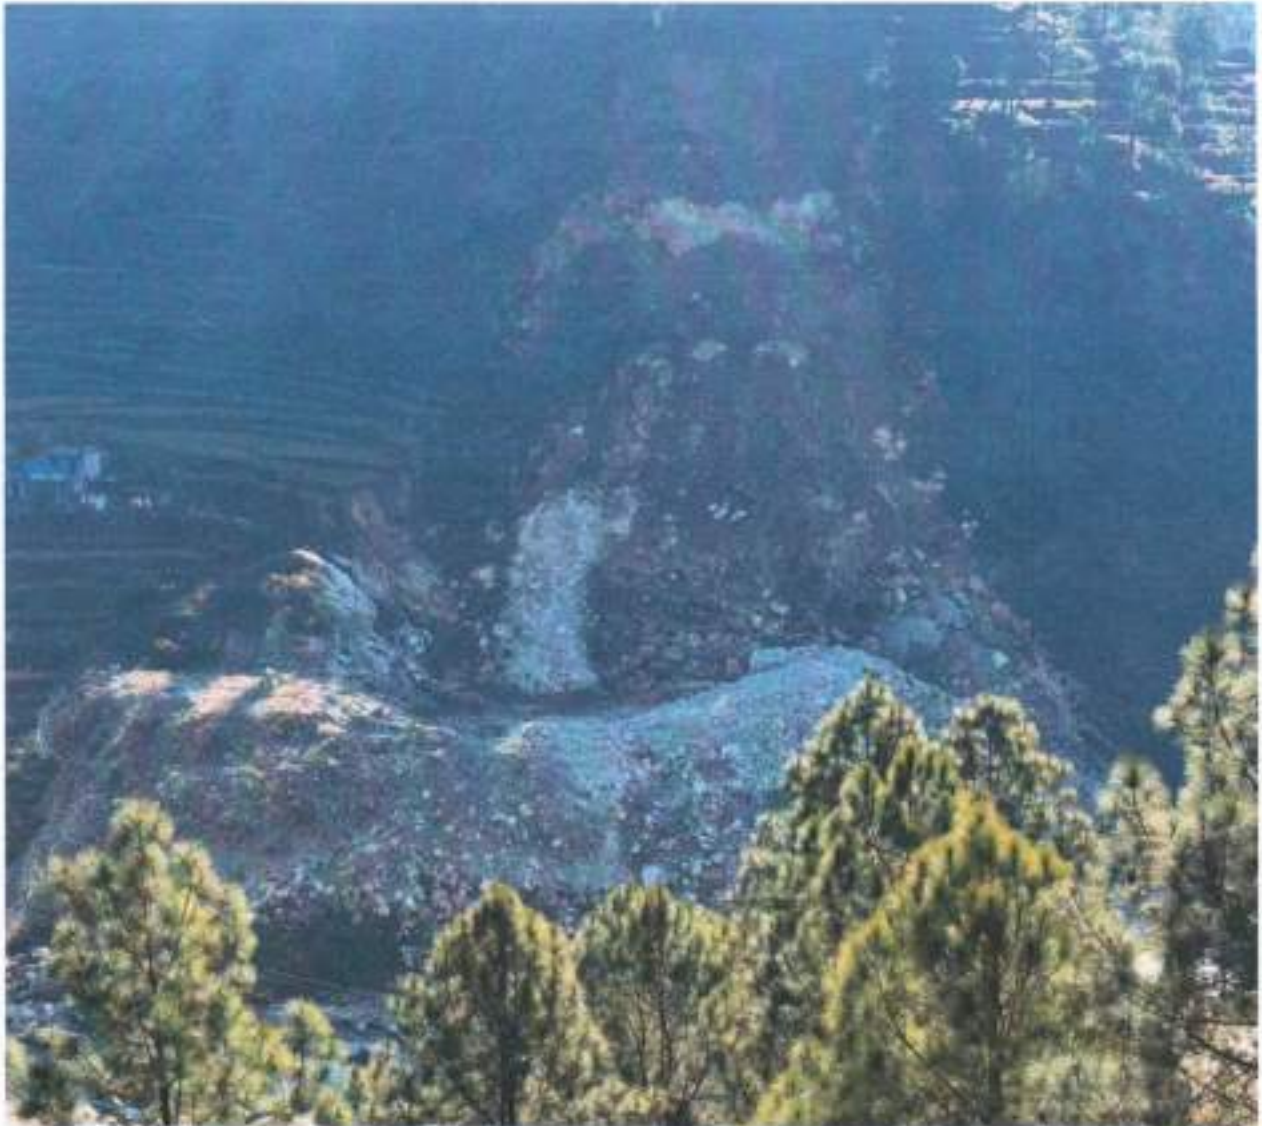
Mine at Village Bang Dungariya Across the Bageshwar Dofar Dharamghar Road
Clicked from

still images of various mining sites with visually vertical pit slopes and non-adherence to the norms.

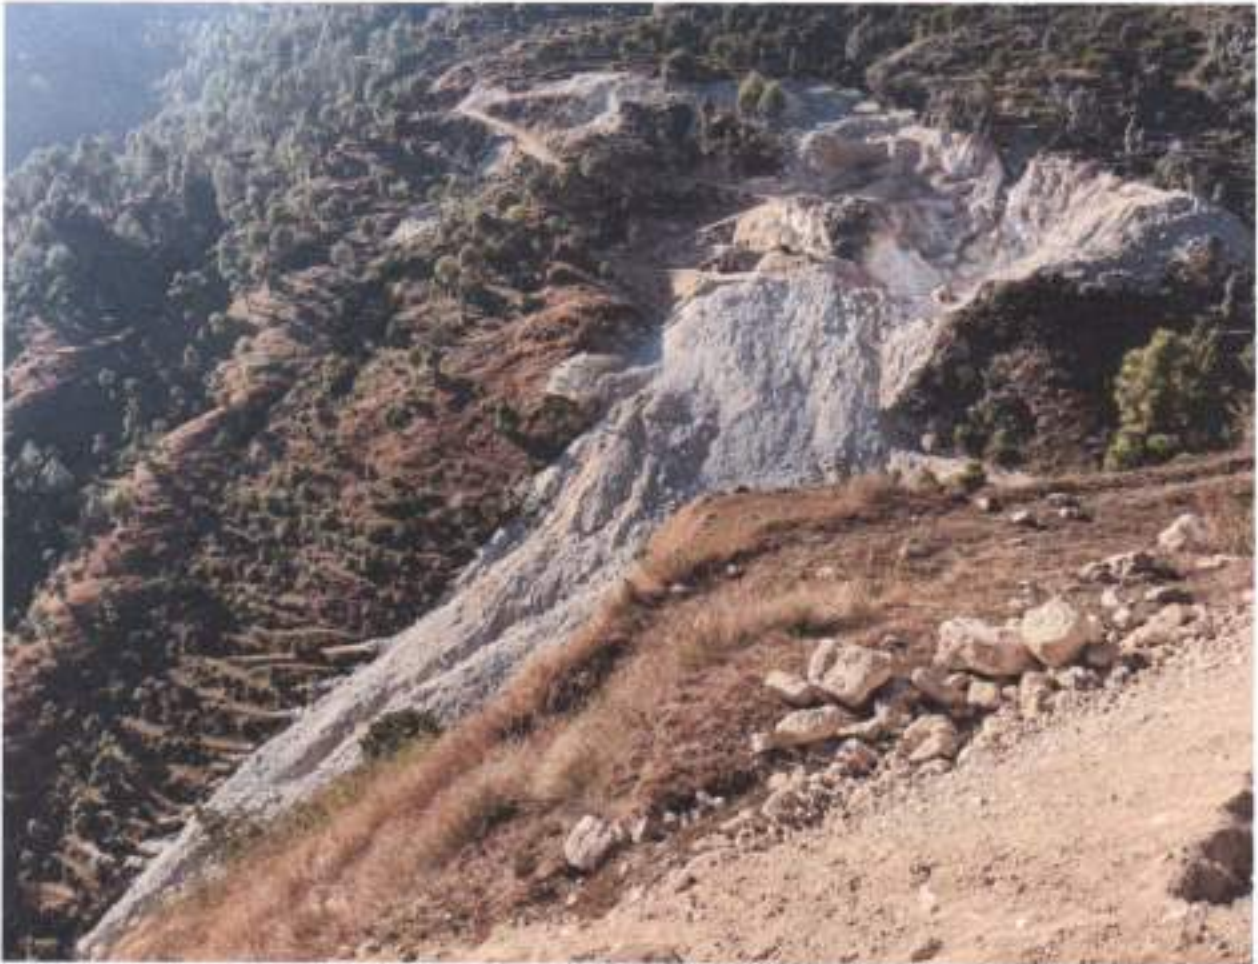
Mine in front of Nandita Tiwari's Mine

still images of various mining sites with visual non-adherence to the norms relating to the dumps of burden.

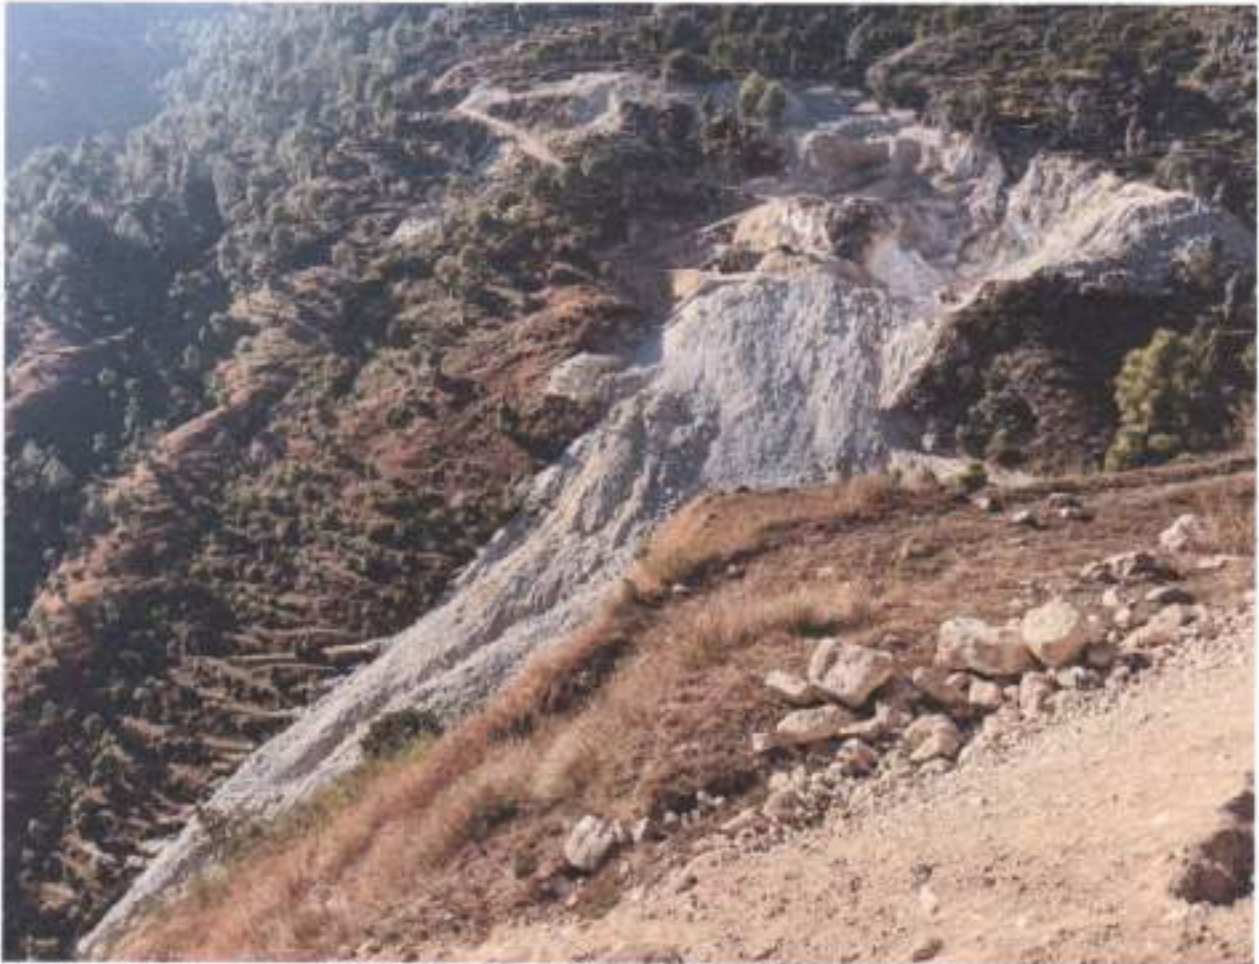
Mine in front of Nandita Tiwari's Mine
Clicked from
 $29^{\circ} 49' 7.578''$ N $79^{\circ} 52' 45.63''$ E

still images of various mining sites with visual non-adherence to the norms relating to the preservation of topsoil.

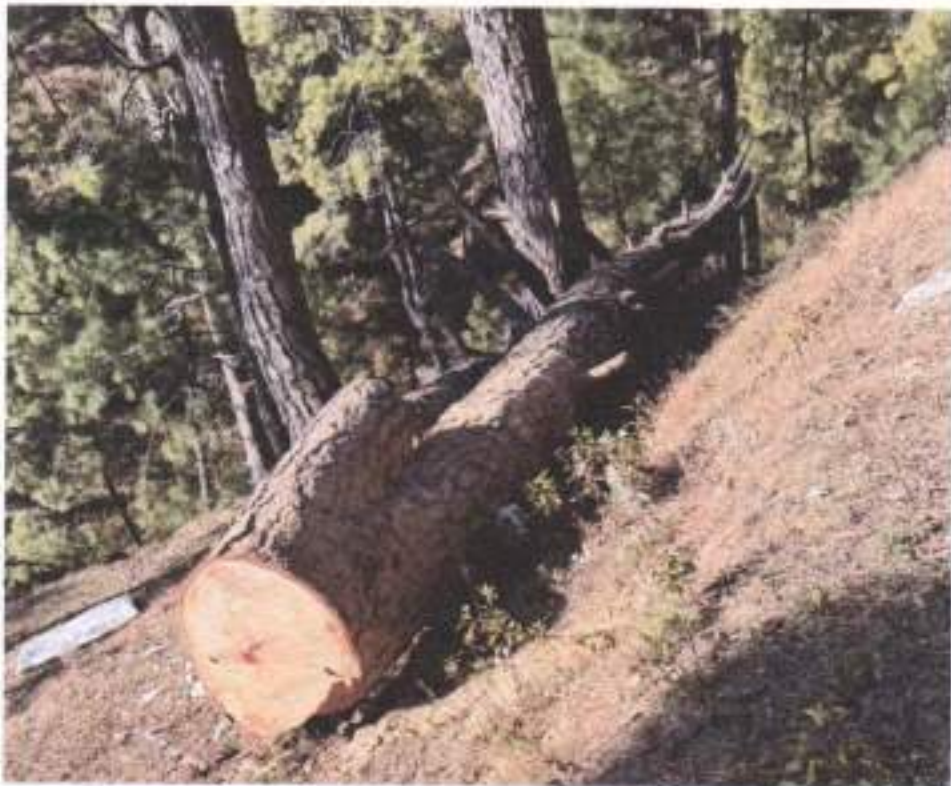
A large pine tree was found in the
Mine at Village Maholi Owned by Surendra Singh Bhauriyal
Clicked from
29° 53' 47.172" N 79° 58' 28.59" E

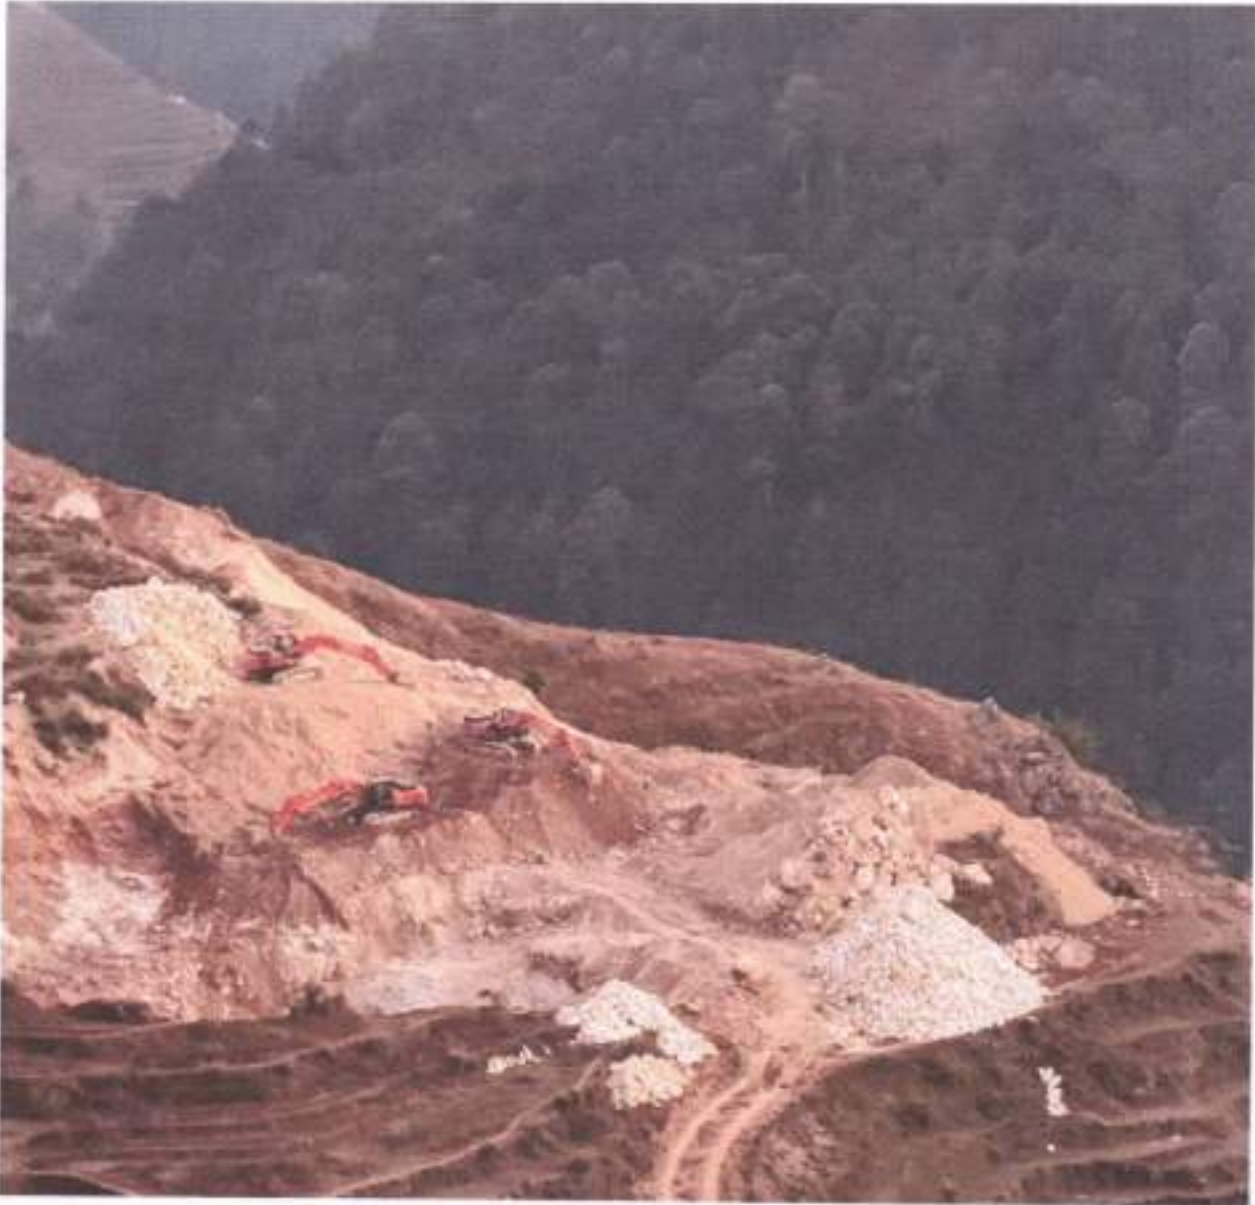
At Mrs. Nandita Tiwari's Mine in Kanda Tharp

Usage of Heavy Earth Moving Machinery

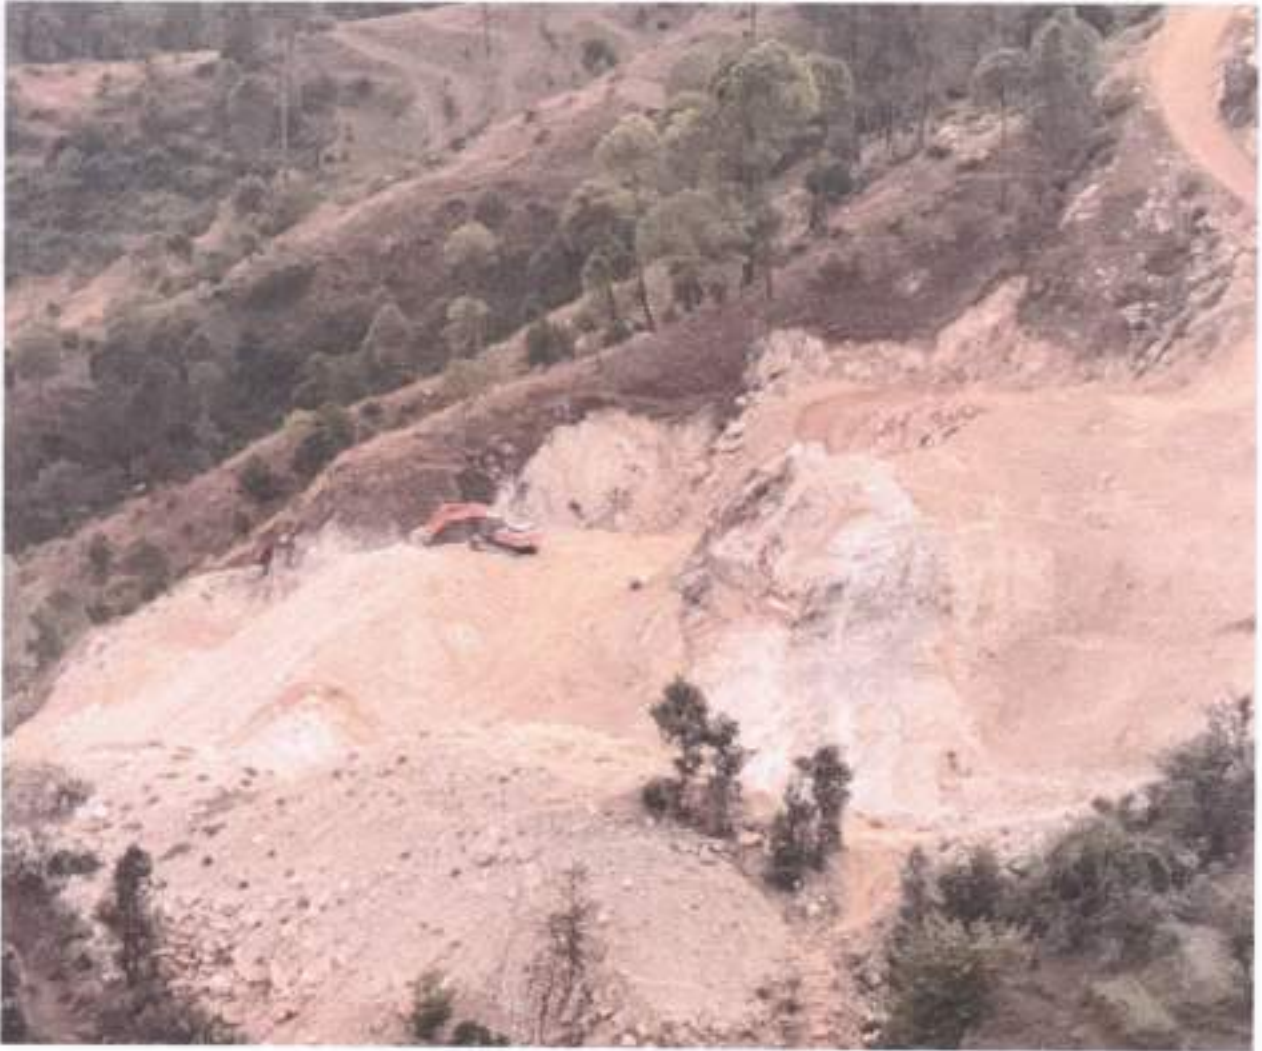
Excavator at a mine in front of Ms. Nandita Tiwari's Mine.

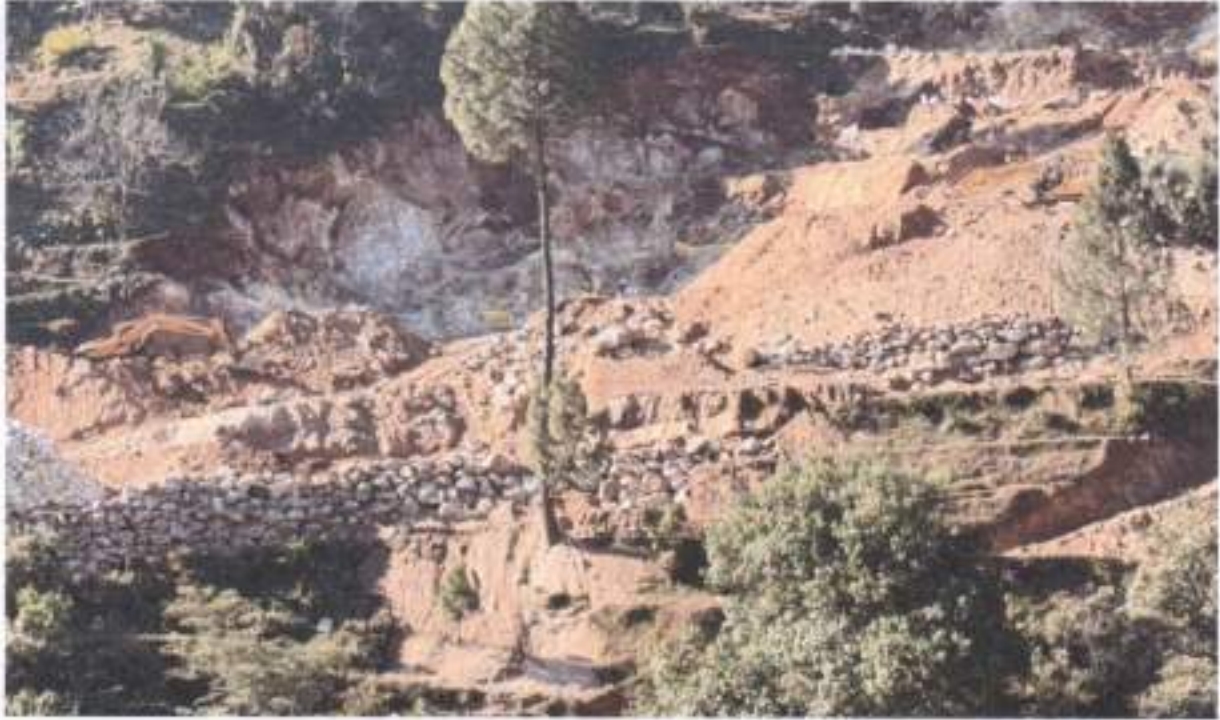
Earth Moving Equipment at Work in front of Road at GPS Coordinates
79° 47' 51.39" E
29° 52' 7.848" N

Mine probably at Village Kunara
