ORIGINAL APPLICATION NO 662 OF 2024

In re: In the matter of developing cracks in the houses, fertile land of poor villagers and drying up of drinking water sources due to land subsidence in some villages of District Bageshwar.

7	Annexure CCR-5 (COLLY) (A) copy of the still images of various mining sites where non-adherence to the norms is leading to slope failure.	
8	Annexure CCR-6 (COLLY) (A) copy of the still images of various mining sites with visual non-adherence to the norms relating to the dumps of burden.	
9	Annexure CCR-7 (COLLY) (A) copy of the still images of various mining sites with visual non-adherence to the norms relating to the preservation of topsoil.	
10	Annexure CCR-8 (COLLY) (A) copy of the still images and Google Earth Images of various mining sites with visual non-adherence to the norms relating to drainage and water management, forest land usage, cutting of trees for firewood, and damage to forest land.	
11	Annexure CCR-9 (COLLY) (A) copy of the still images of various mining sites using heavy earth moving equipment.	
12	Annexure CCR-10 (COLLY) (A) copy of photographs displaying the poor living conditions of Labour.

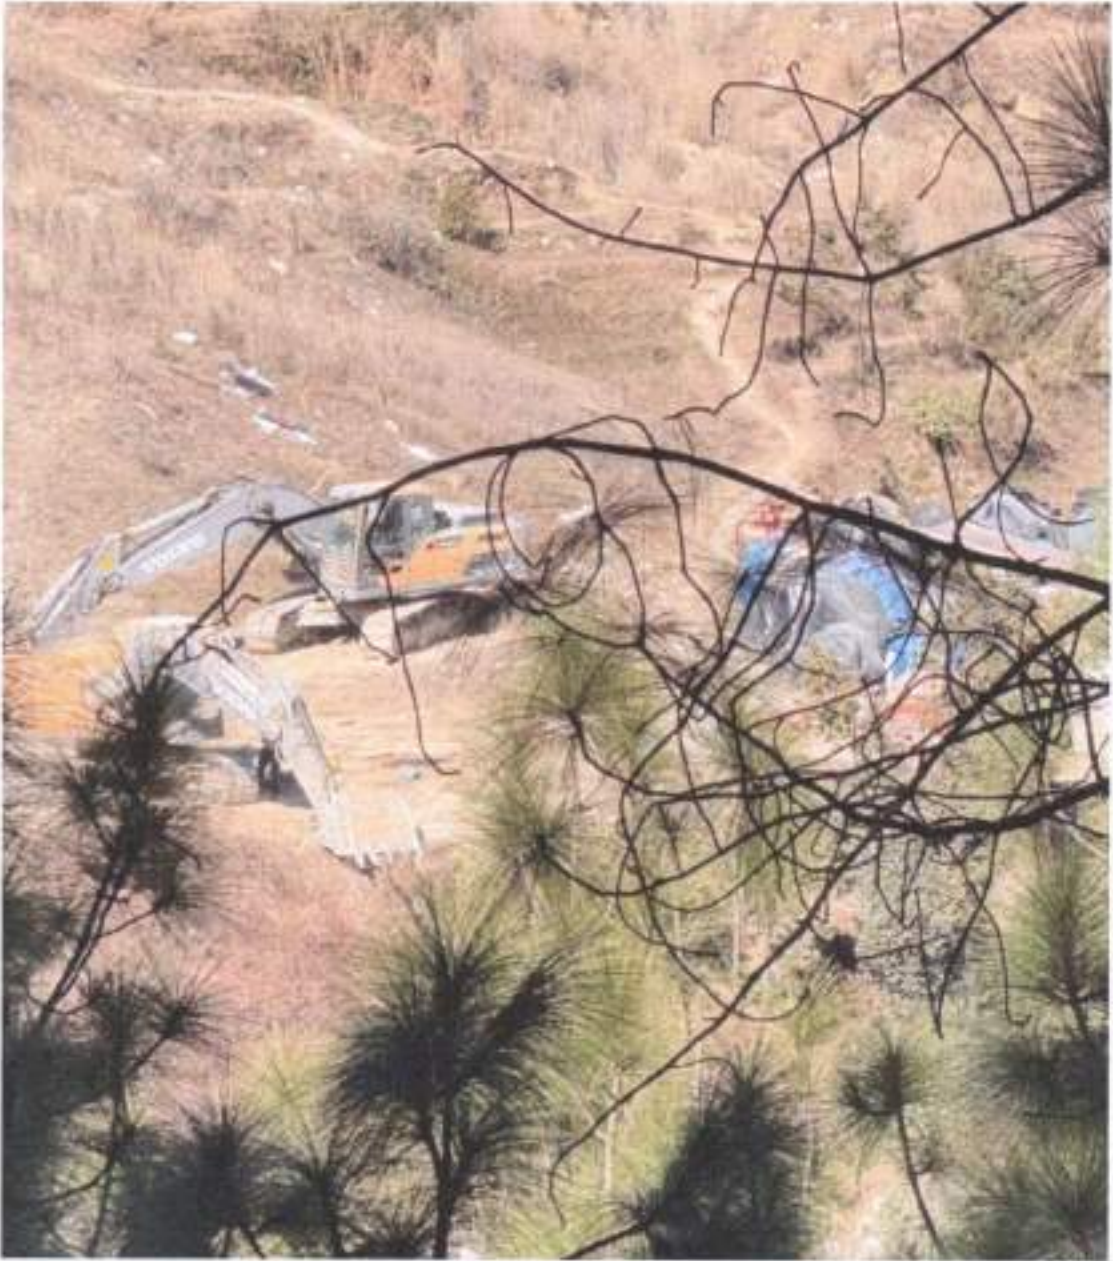
Heavy Earth Moving equipment at Jagthali Bajeena Mines, Kanda

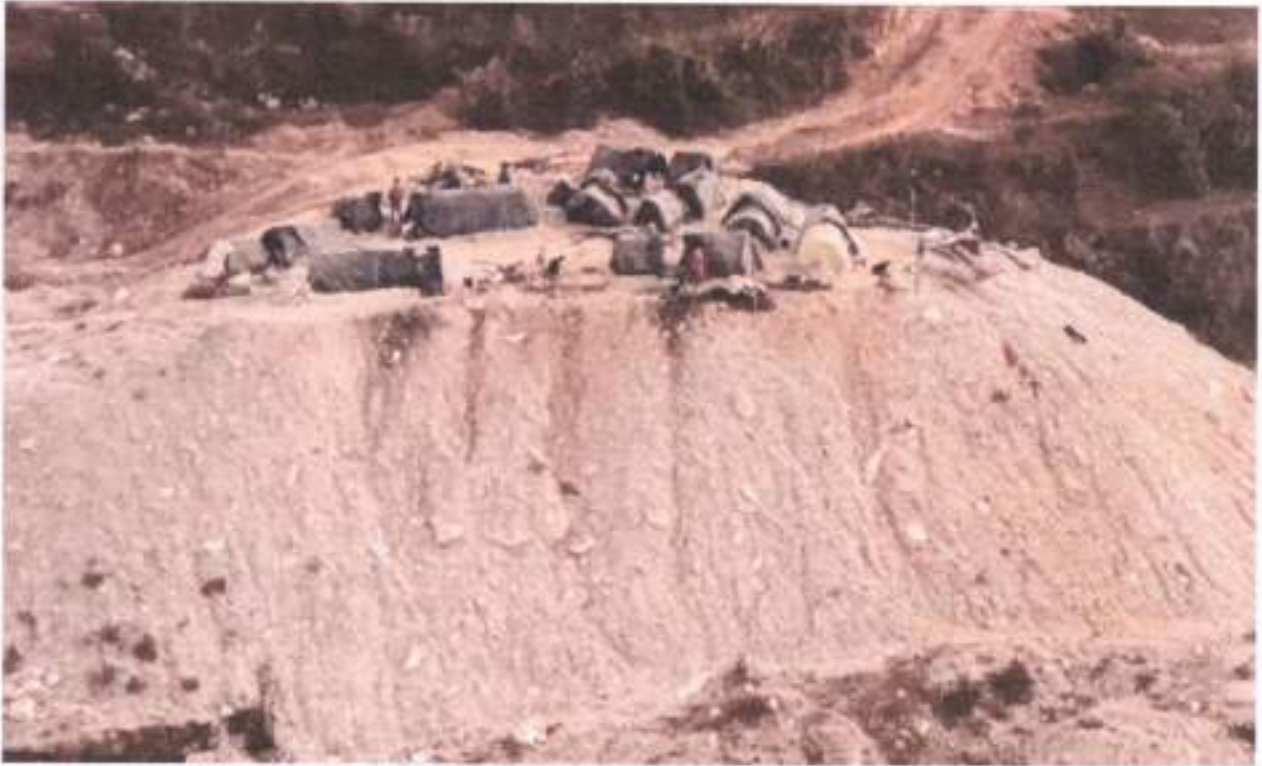
At Mrs. Nandita Tiwari's Mine in Kanda Tharp

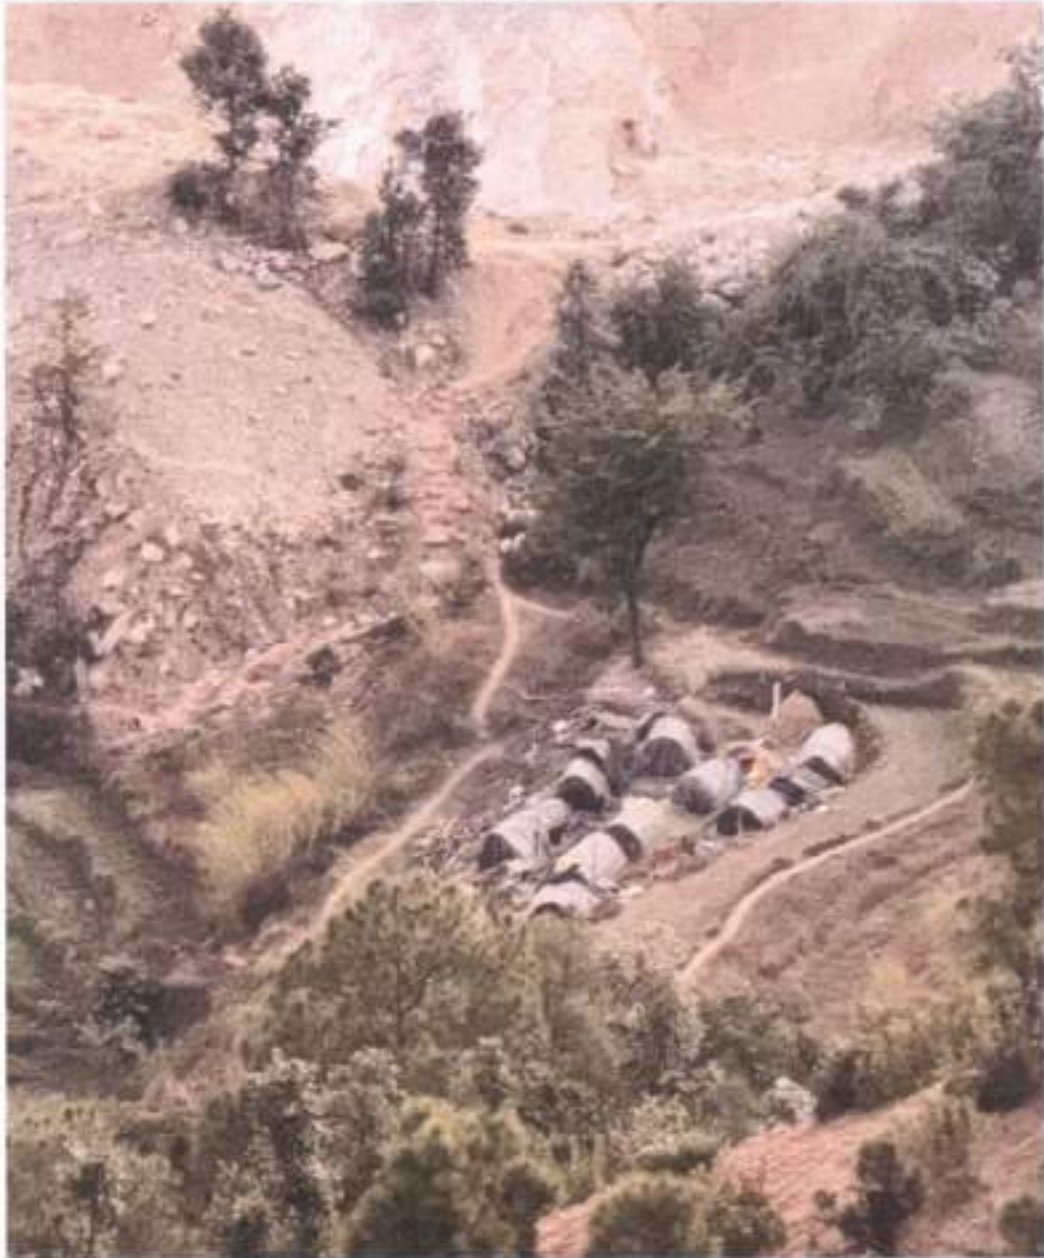
Labourer Tents at a mine in front of Ms. Nandita Tiwari's Mine.

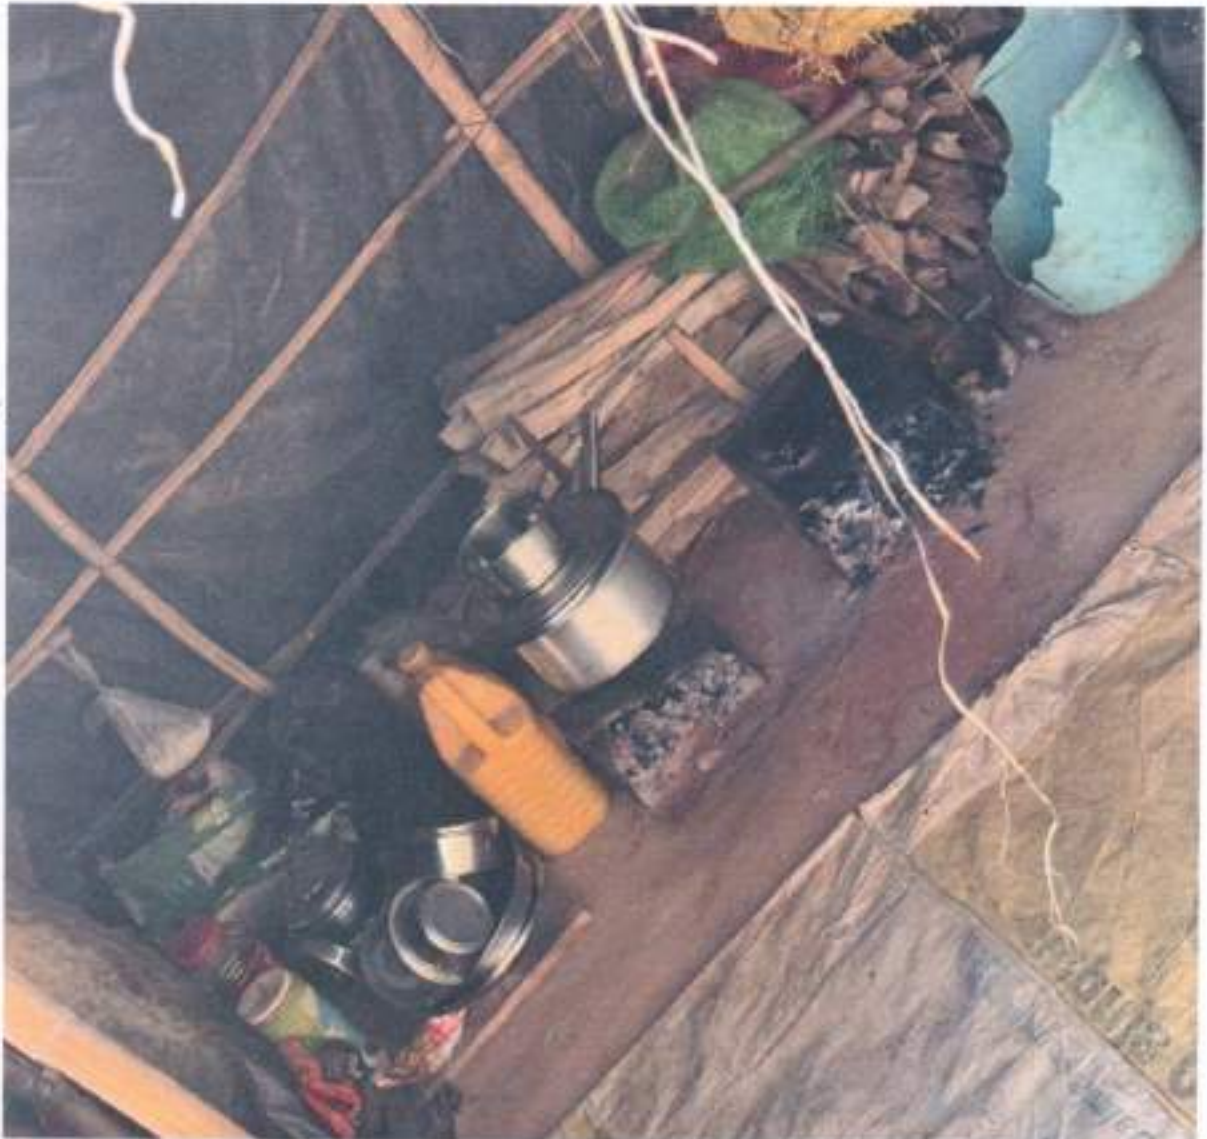
Surendra Singh Bhauriyal's Mine, Maholi, Reema
Living condition of Labourers
