**BEFORE THE NATIONAL GREEN TRIBUNAL
WESTERN ZONE BENCH AT PUNE
ORIGINAL APPLICATION NO. 41 OF 2022 (WZ)**

AFFIDAVIT – IN – REPLY OF RESPONDENT NO. 6

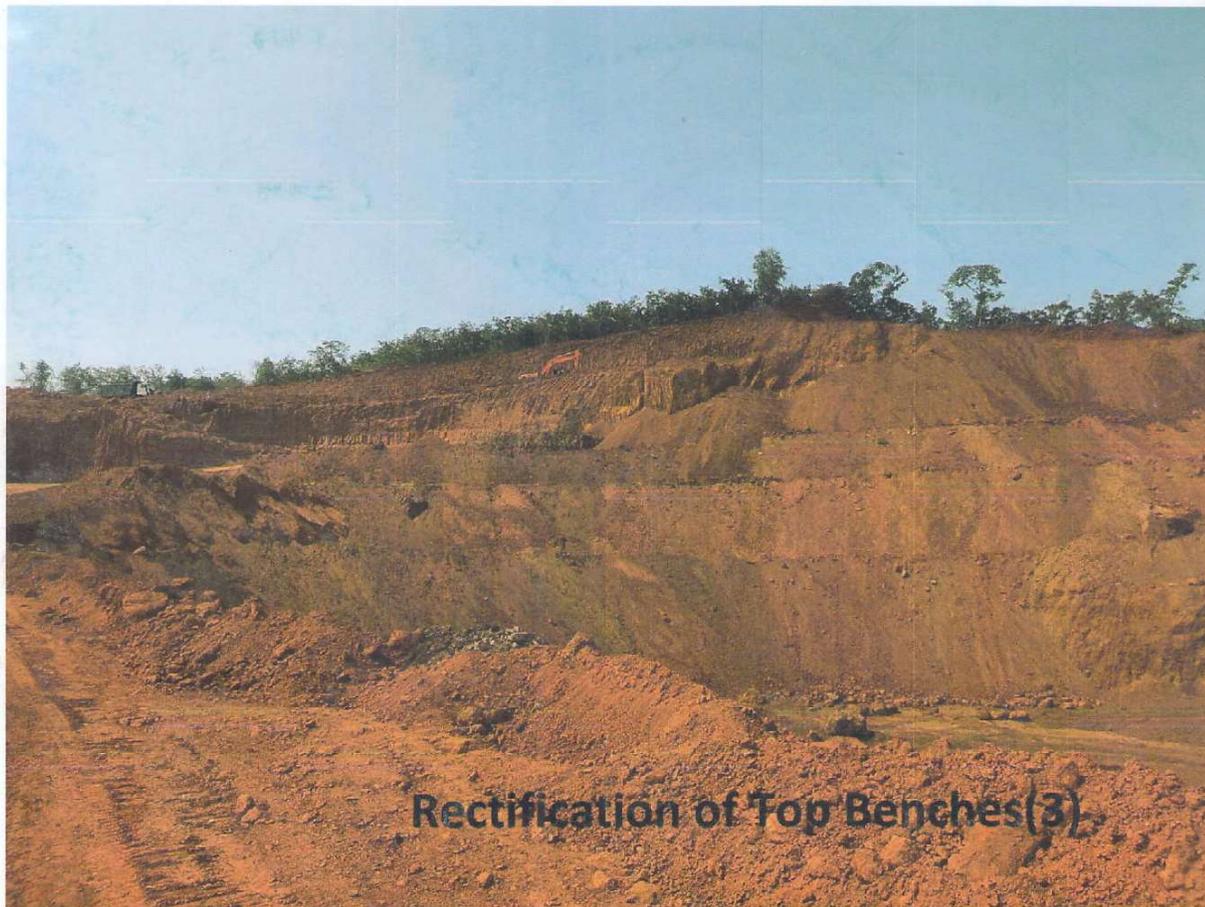
Rectification of Top Benches(3)

REPLY:-We have taken development of the top benches around 20 meter towards North between BP -2 to BP -4 section K - K² to section R - R² & started developing benches as per mining plan. Presently we have maintained the benches in proportion of height & width with proper pit slope. Collapsed Benches and pit slope failure is due to heavy rainfall in the season & its rectification is under process and it will get completed very soon. After that we will report to your good office. (photographs of rectified benches enclosed)

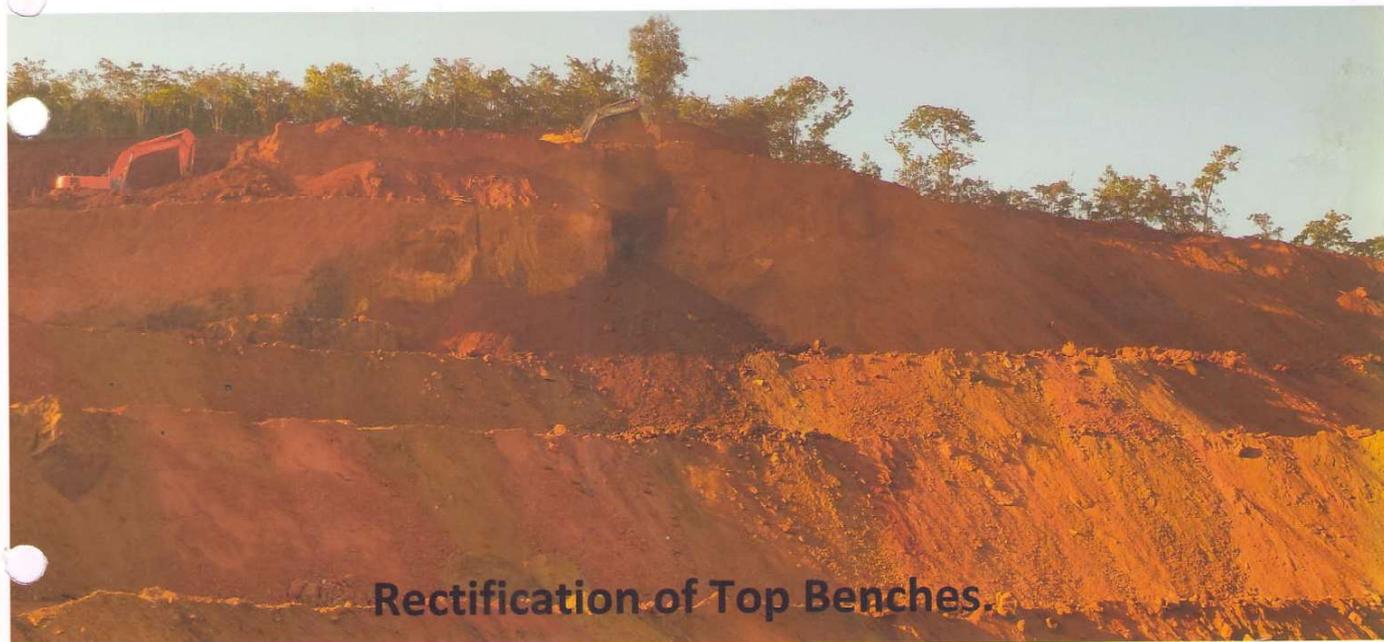
Rectification of Top Benches.

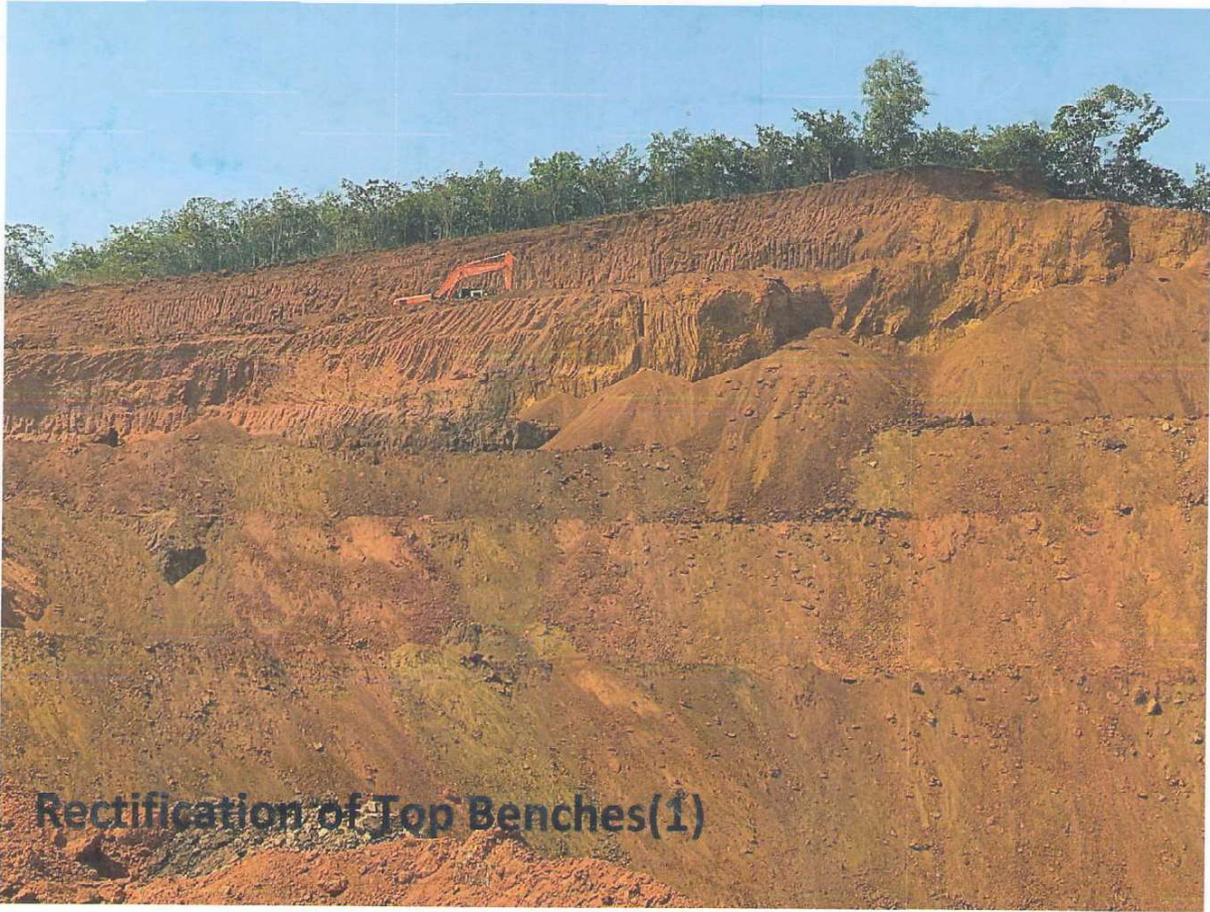
Rectification of Top Benches(1)

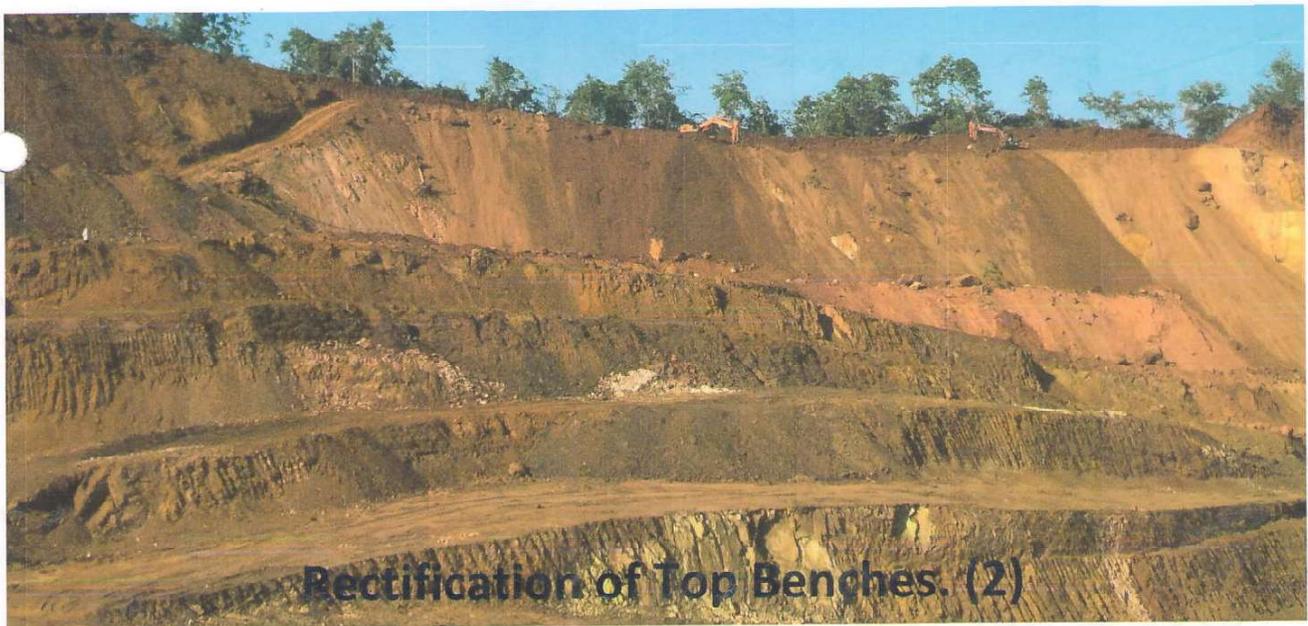
Rectification of Top Benches. (2)

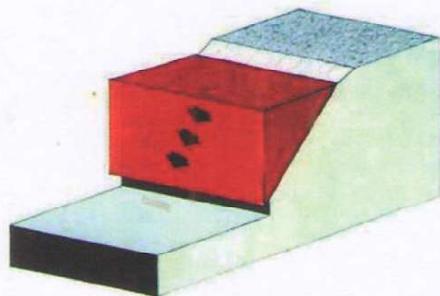
Plane Failure

Fig. 1 Different types of failure of rock slopes

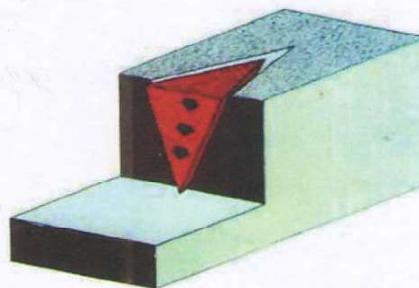
Wedge Failure

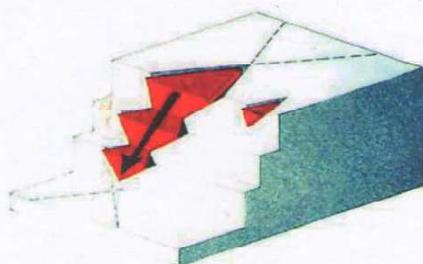
Multiple Bench Wedge failure

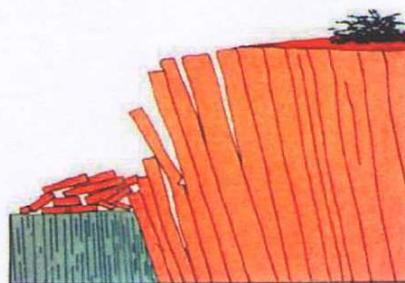
Flexural Toppling in Hard Rock Slopes

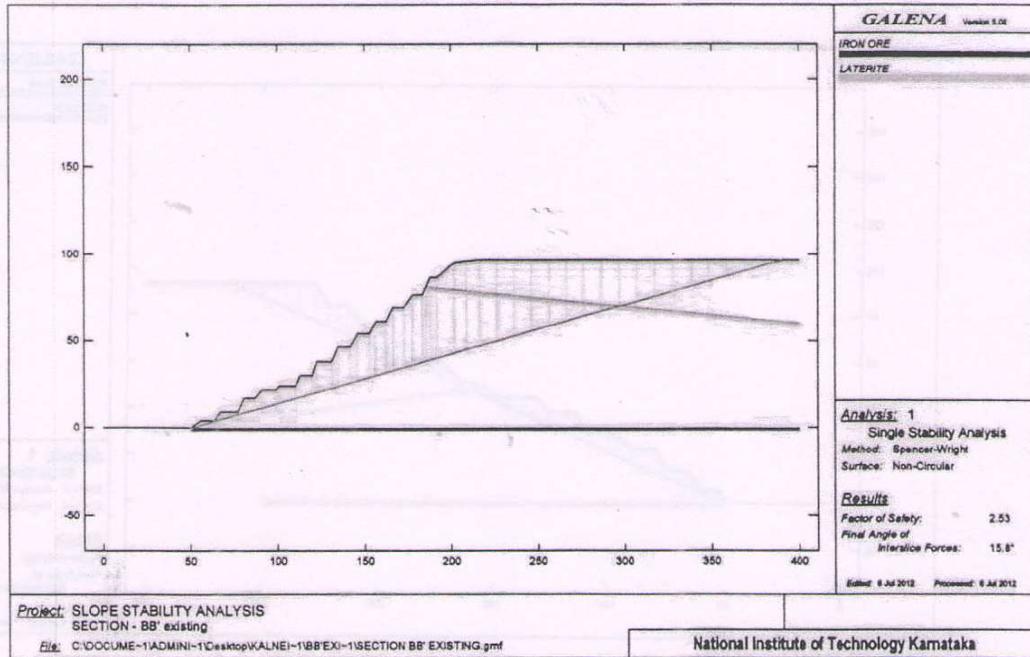
Fig.2.1 – Analysis of slope along Section-BB' for existing pit configuration

The result of slope stability analysis of Section-BB' for the existing pit configuration is shown in Fig. 2.1. As per the mine plan, the slope starts at 58.5 m RL and ends at 155 m RL. The ultimate pit slope indicated in the mine plan is 33°. Analysis using GALENA software shows that the tension crack angle (i.e., final angle of inter-slices force) with horizontal is 15.8°. As can be seen in the Fig. 2.1, the x-axis ranges from 0 - 400 m where as y-axis ranges from -50 to 200 m. In this figure, each material is shown by different color strips on the window of the software. Analysis of this section shows that the average bench height varies from 1.5 m to 10 m. The tension crack starts at 50 m on x-axis and ends at 400 m horizontally on the same axis. In this section, the approximate minimum bench slope angle is 6° and maximum is 72° (Table 2). The analysis indicates a FOS of 2.53 which is above the safe limit of 1.3.

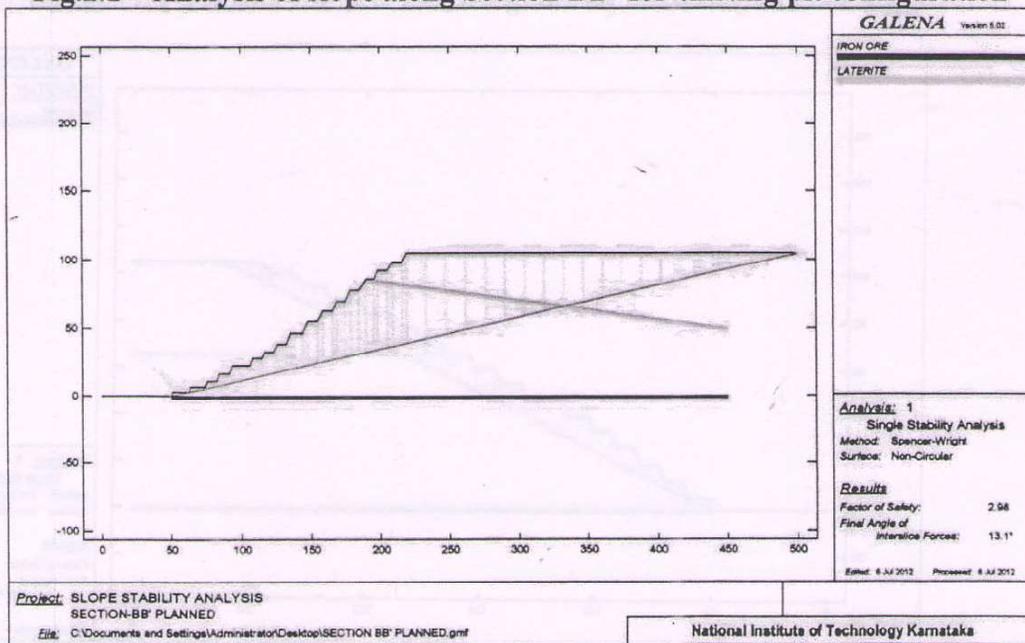
Fig. 2.2 – Analysis of slope along Section-BB' for planned pit configuration

The result of slope stability analysis of Section-BB' for the planned pit configuration is shown in Fig. 2.2. In this section, the minimum bench height is 3.0 m and maximum is 8.5 m (Table 2). As per the mine plan, the slope starts at 50 m RL and ends at 155 m RL. The ultimate pit slope indicated in the mine plan is 32°. For Section-BB' shown in Fig. 2.2, the x-axis ranges from 0 - 500 m where as y-axis ranges from -100 to 250 m. The tension crack starts at 50 m on x-axis and ends at 500 m horizontally on the same axis. In this section, the approximate minimum slope angle is 58° and maximum is 74° (Table 2). Analysis using GALENA software shows that the tension crack angle with horizontal is 13.1°. The analysis indicates a FOS of 2.98 which is above the safe limit.

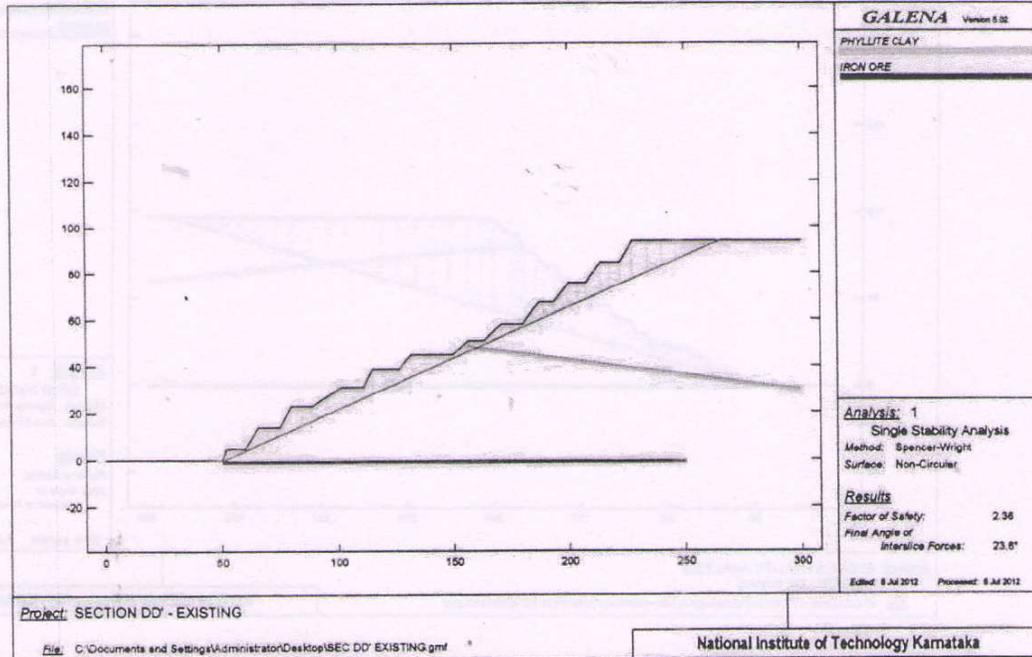
Fig.2.3 – Analysis of slope along Section-DD’ for existing pit configuration

The result of slope stability analysis of Section-DD' for the existing pit configuration is shown in Fig. 2.3. In this section, the minimum bench height is 5 m and maximum is 9.5 m (Table 3). As per the mine plan, the slope starts at 72 m RL and ends at 166 m RL. The ultimate pit slope indicated in the mine plan is 28°. For Section-DD' shown in Fig. 2.3, the x-axis ranges from 0 – 300 m where as y-axis ranges from -20 to 160 m. The tension crack starts at 50 m on x-axis and ends at 300 m horizontally on the same axis. In this section, the approximate minimum bench slope angle is 32° and maximum is 69° (Table 3). Analysis using GALENA software shows that the tension crack angle (i.e., final angle of inter-slices force) with horizontal is 23.6°. The analysis indicates a FOS of 2.36 which is considered as safe.

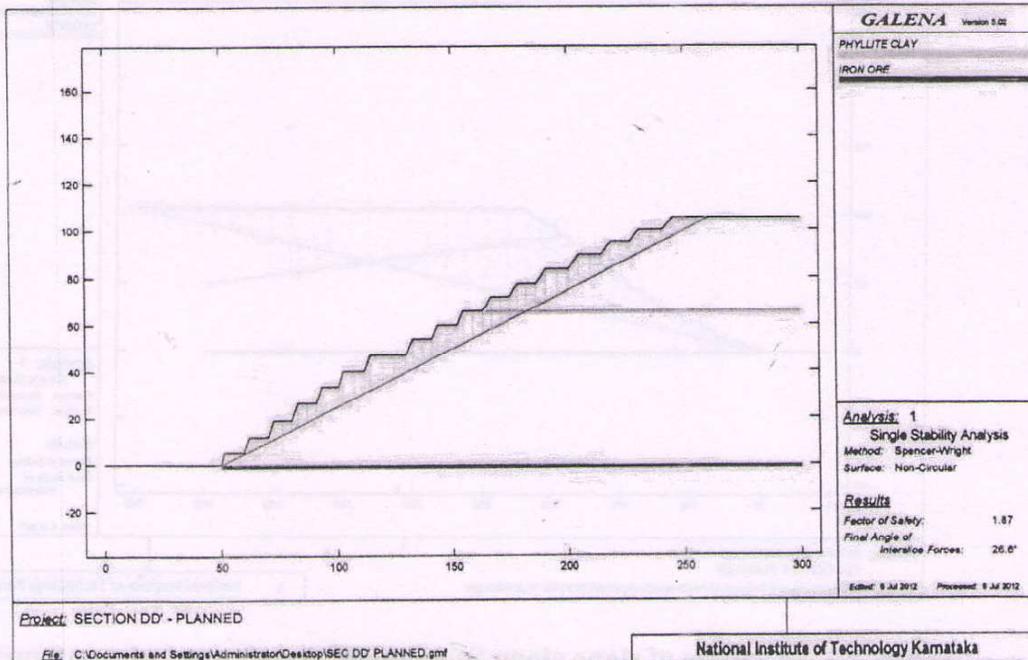
Fig. 2.4 – Analysis of slope along Section-DD’ for planned pit configuration

The result of slope stability analysis of Section-DD' for the planned pit configuration is shown in Fig. 2.4. In this section, the approximate minimum slope angle is 50° and maximum is 77° (Table 3). The analysis indicates a FOS of 1.87 which is above the safe limit. As per the mine plan, the slope starts at 50 m RL and ends at 155 m RL. The ultimate pit slope indicated in the mine plan is 28°. The x-axis ranges from 0 - 300 m where as y-axis ranges from -20 to 160 m. In this Section, the minimum bench height is 5 m and maximum is 7.5 m (Table 3). The tension crack starts at 50 m on x-axis and ends at 300 m horizontally on the same axis. Analysis using GALENA software shows that the tension crack angle with horizontal is 26.6°.

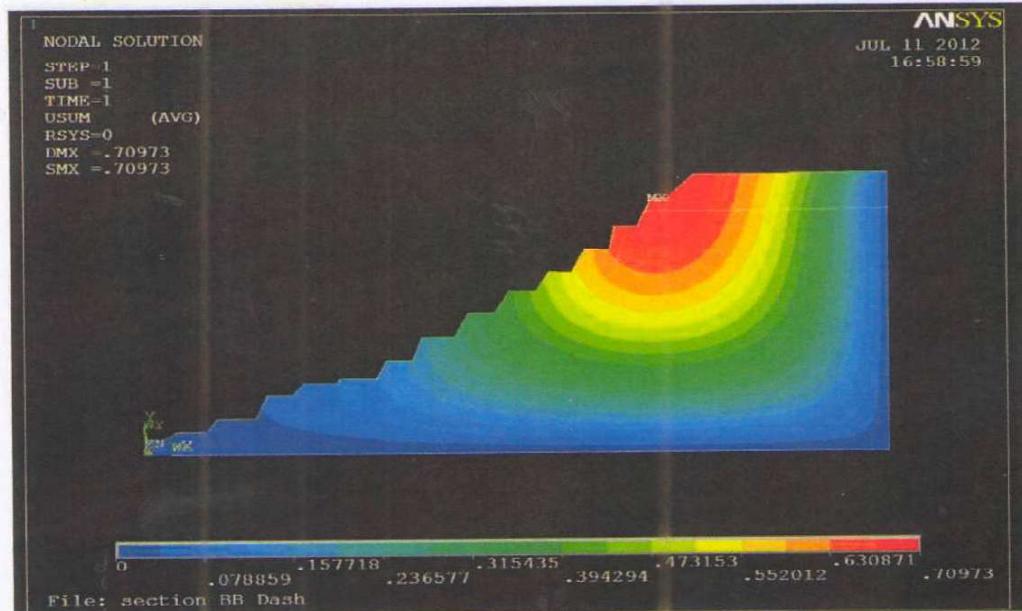
Fig. 3.1(a) – Vertical displacement analysis of slope along Section-BB’ for existing pit configuration

Fig 3.1(a) and Fig. 3.1(b) shows the vertical displacement and stress distribution analysis along Section-BB' for the existing pit configuration. The maximum displacement of 709 mm is associated with upper laterite bed in 1st and 2nd slope from top. The benches are also very stable with sufficient width as shown in Fig. 3.1(a). Displacement of rock mass is maximum in top two benches only and remaining benches have negligible displacement. There is no further displacement in bottom three benches.

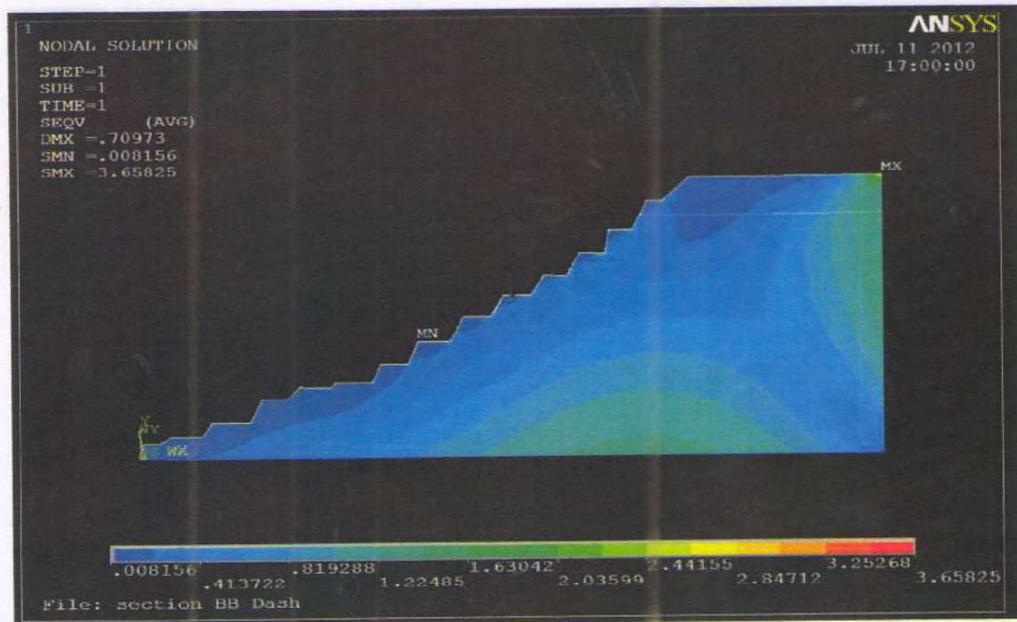
Fig. 3.1(b) - Stress distribution analysis of slope along Section-BB’ for existing pit configuration

The details of the stress acting are given in Table 5 and stress profile is shown in Figure 3.1(b) along Section-BB' for existing pit configuration. The widths of the benches are much higher compared to its height and the slope angles of individual benches are properly maintained. Hence there is a uniform stress distribution within the rock mass.

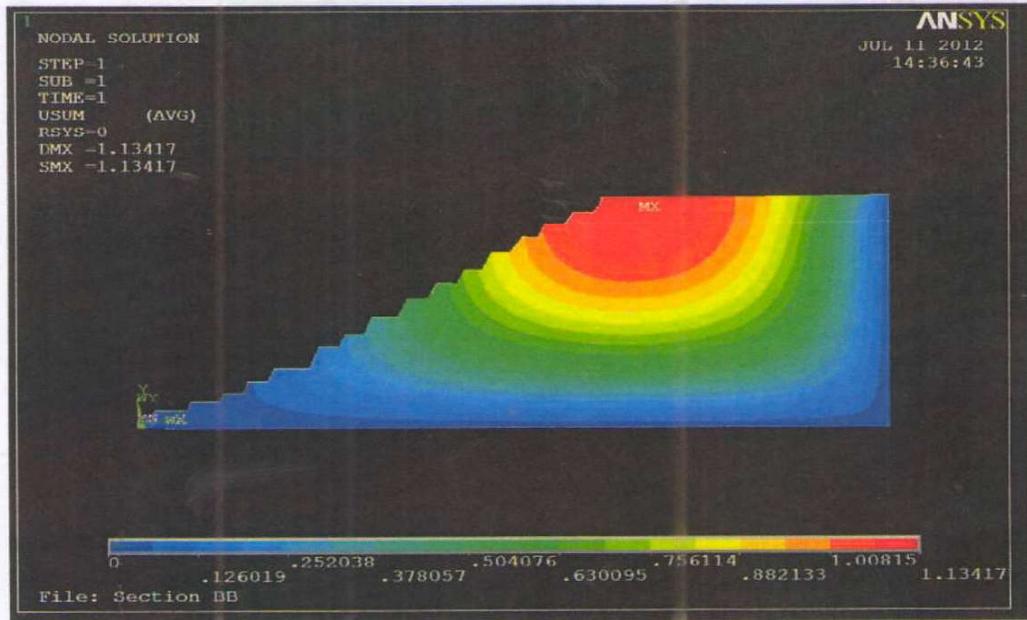
Fig. 3.2(a) – Vertical displacement analysis of slope along Section-BB’ for planned pit configuration

Fig. 3.2(a) and Fig. 3.2(b) show the vertical displacement and stress distribution along Section-BB' for the planned pit configuration. The maximum displacement is associated with upper laterite bed and partially with adjacent clay deposit. It is very clear from the figure that the amount of displacement is decreasing rapidly with depth and becomes negligible at bottom most central region. The maximum displacement associated with 1st and 2nd slope from the top is 1134 mm. There is no sign of any displacement in bottom most four benches.

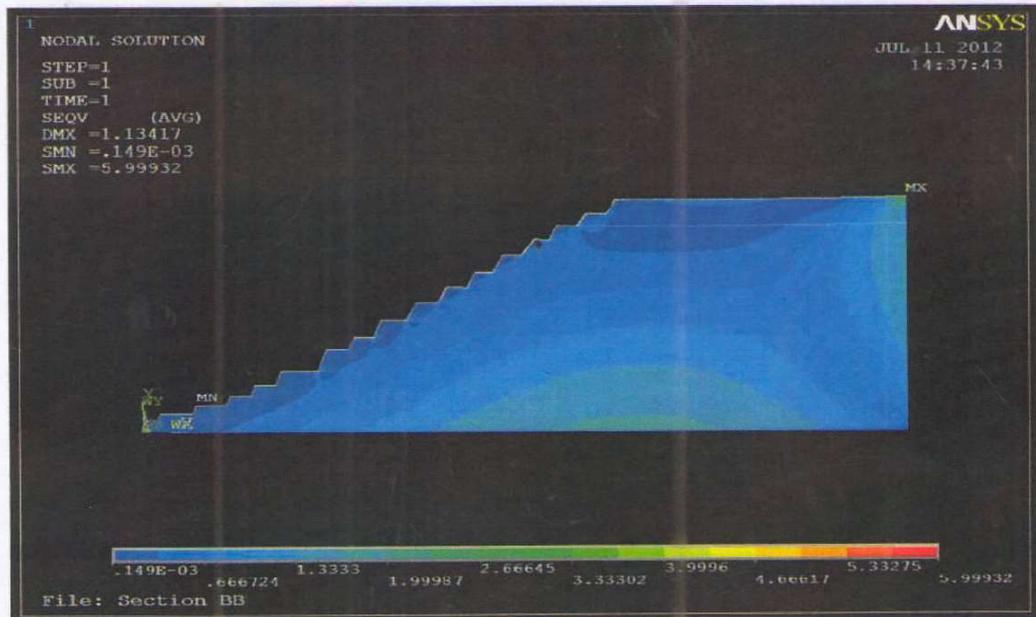
Fig. 3.2(b) - Stress distribution analysis of slope along Section-BB’ for planned pit configuration

The details of the stress acting are given in Table 6 and stress profile is shown in Figure 3.2(b) along Section-BB' for planned pit configuration. The stress along the slope is much lesser than the shear strength of encountered materials. Therefore, the slopes are quite stable. The maximum stress generated is along the bedded deposit which of course doesn't affect the stability. The stress concentration is also minimum near the faces, which favours the stability of slopes [as shown in Fig. 3.2(b)].

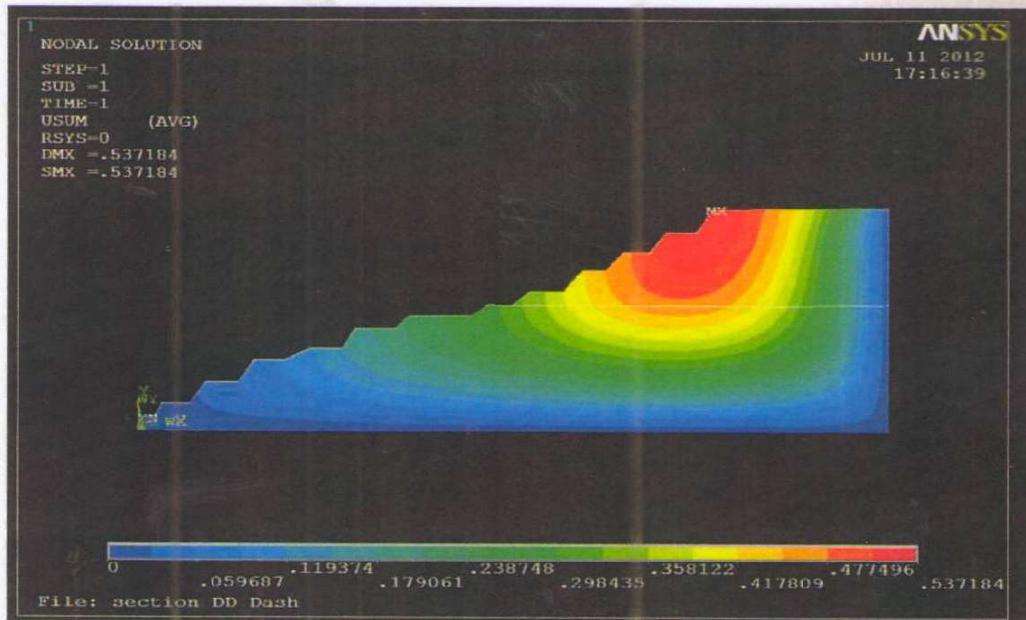
Fig. 3.3(a) – Vertical displacement analysis of slope along Section-DD' for existing pit configuration

Fig. 3.3(a) and Fig. 3.3(b) shows the vertical displacement and stress distribution along Section-DD' for the existing pit configuration. The maximum displacement is associated with the top two benches from top which is 537 mm Fig. 3.3(a) shows that the degree of displacement is gradually decreasing with depth and becomes negligible at bottom most region. Due to well developed benches with sufficient widths, the slope is very stable without any sign of lateral movements.

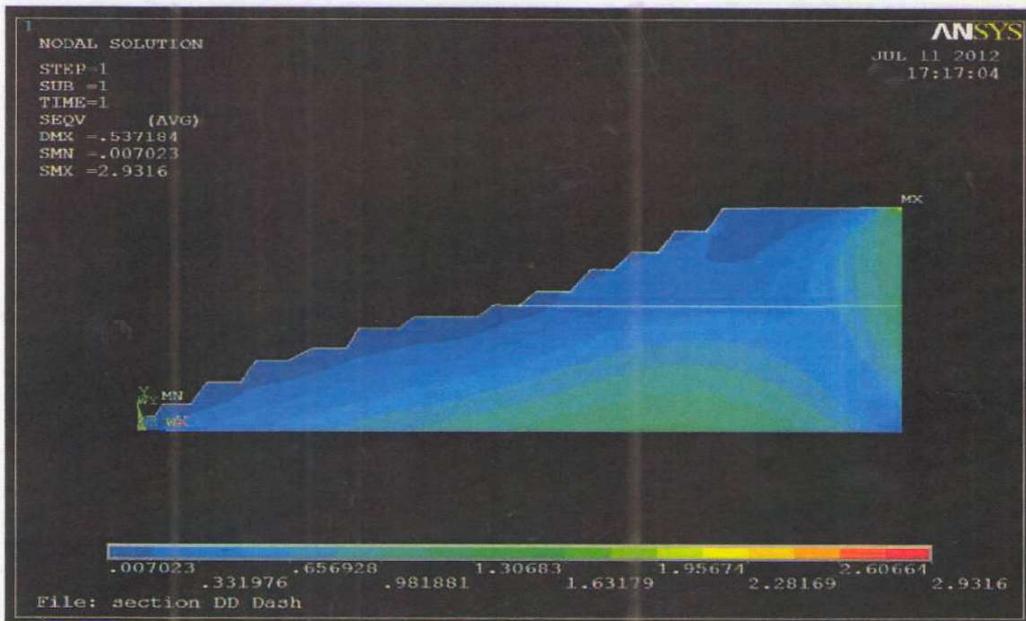
Fig. 3.3(b) - Stress distribution analysis of slope along Section-DD' for existing pit configuration

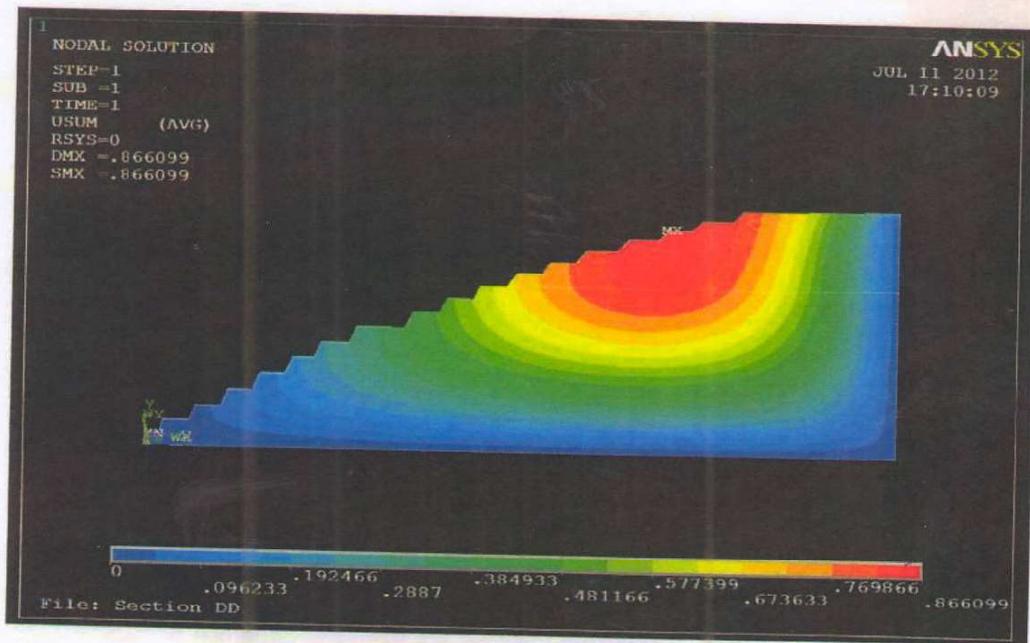
Fig. 3.4(a) – Vertical displacement analysis of slope along Section-DD’ for planned pit configuration

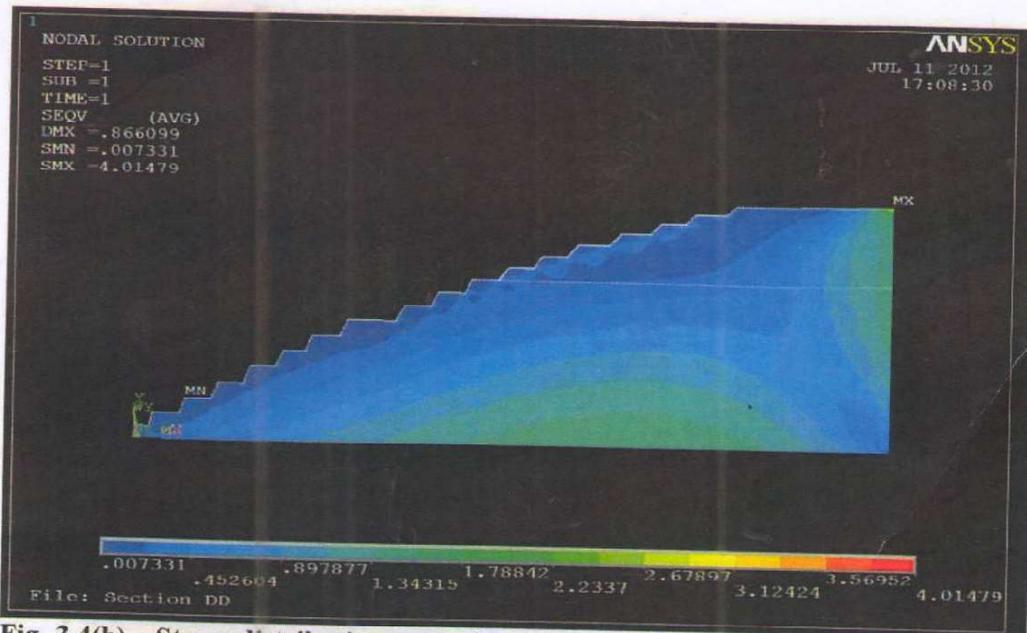
Fig. 3.4(b) - Stress distribution analysis of slope along Section-DD’ for planned pit configuration

There is no sign of any stress along the faces. The slopes are quite stable as stress along the slope is much lesser than the rock (Laterite and Manganiferous clay) shear strength. The details of the stress acting are given in Table 8 and stress profile is shown in Figure 3.4(b) along Section-DD' for planned pit configuration.

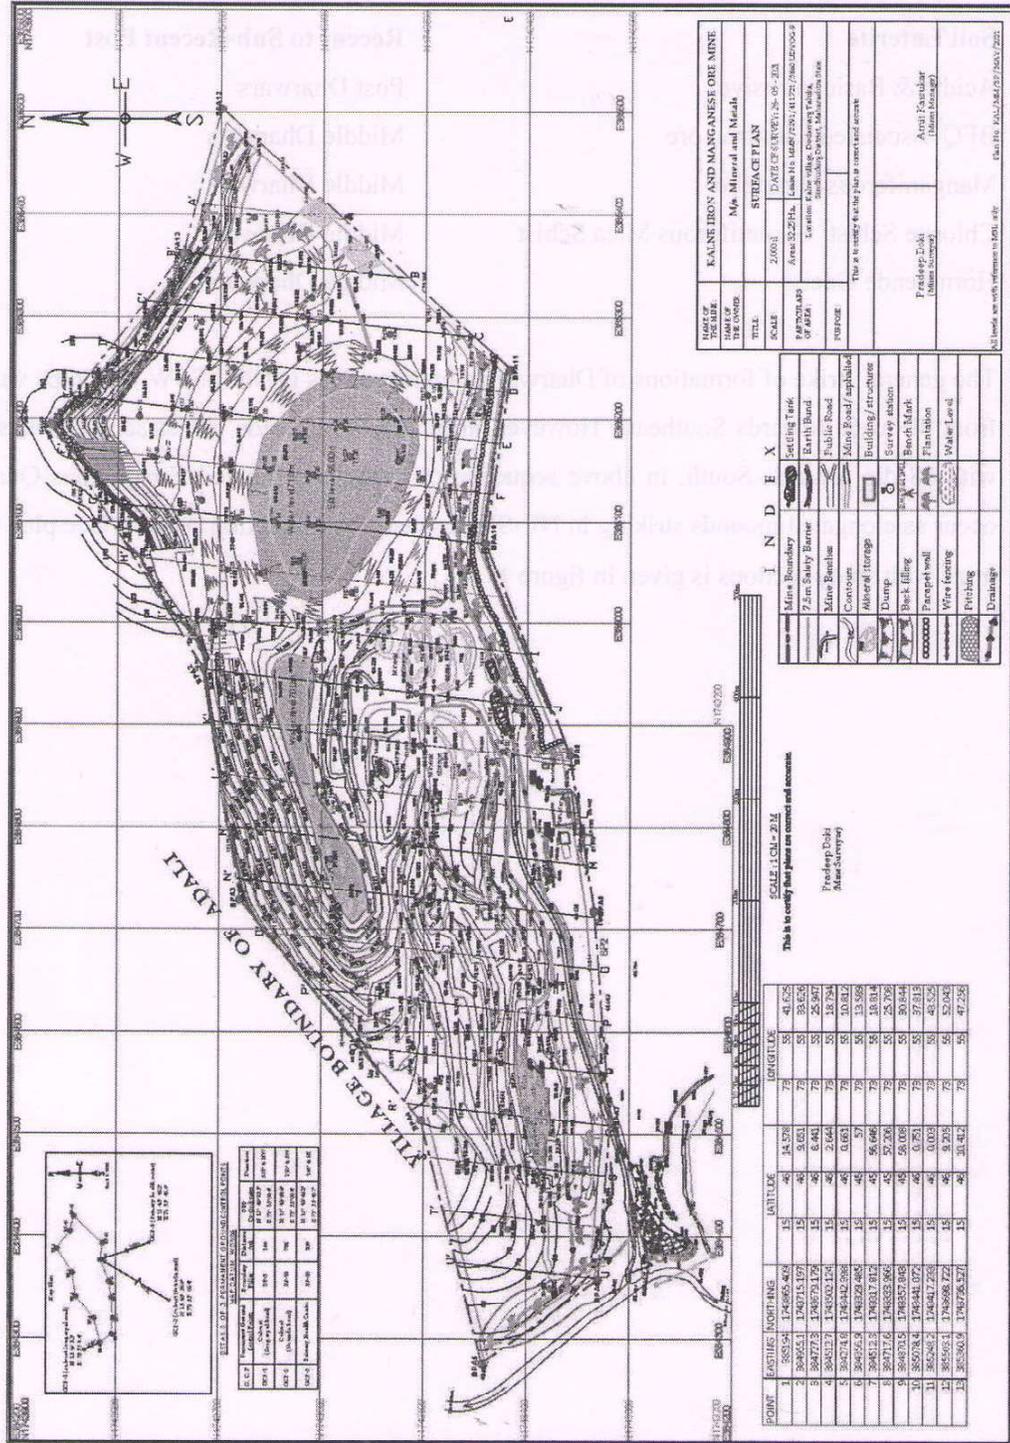
Figure 1: Surface plan of the mine with study sections

The general strike of formations of Dharwarian metacyclines is NNE-SSW with dips varying from 40 to 60 towards Southeast. However, at places, hornblende gneiss/schist strikes E-W with 58 dip towards South. In above sequence of rocks, the Banded Ferruginous Quartzite occur as elongated mounds striking in NE-SW to East-West direction. The surface plan of the mine with study sections is given in figure 1.

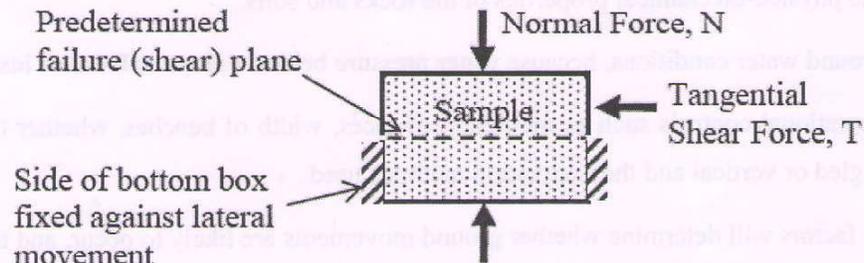
Figure 2. Schematic of Direct shear testing in the laboratory

The oldest form of shear test upon soil is the direct shear test, first used by Coulomb (1776). The soil is held in a box that is split across its middle; the bottom portion of the box is usually fixed against lateral movement (Figure 2). A confining normal force, N , is applied, and then a tangential shear force, T , is applied so as to cause relative displacement between the two parts of the box. The magnitude of the shear force is recorded as a function of the shear displacement, and usually, the change in thickness of the soil sample is also recorded.

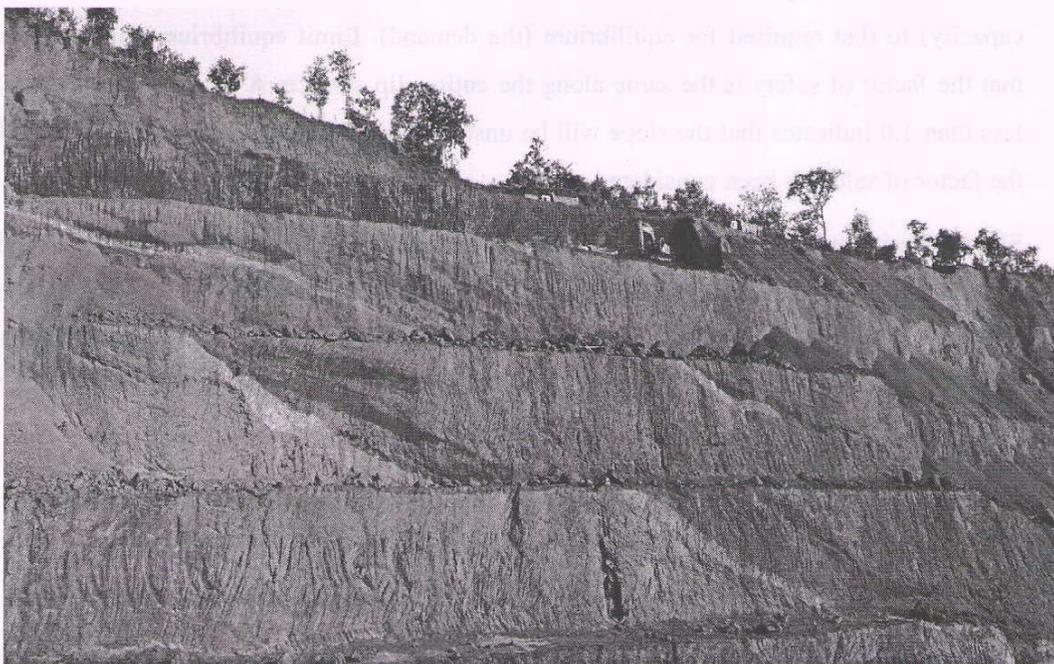
Figure 3: A view of the existing benches

The existing bench parameters in practice at the mine are given in table 3 and a typical section in the study area is shown in figure 3. To safely exploit the remaining resources of the mine, it is proposed to scientifically study and design safe and stable slopes for the benches and also for the overall pit slope. Accordingly, a few typical sections were selected initially to design slopes and study their stability. The selected sections are namely LL', MM', NN', OO' and PP'.

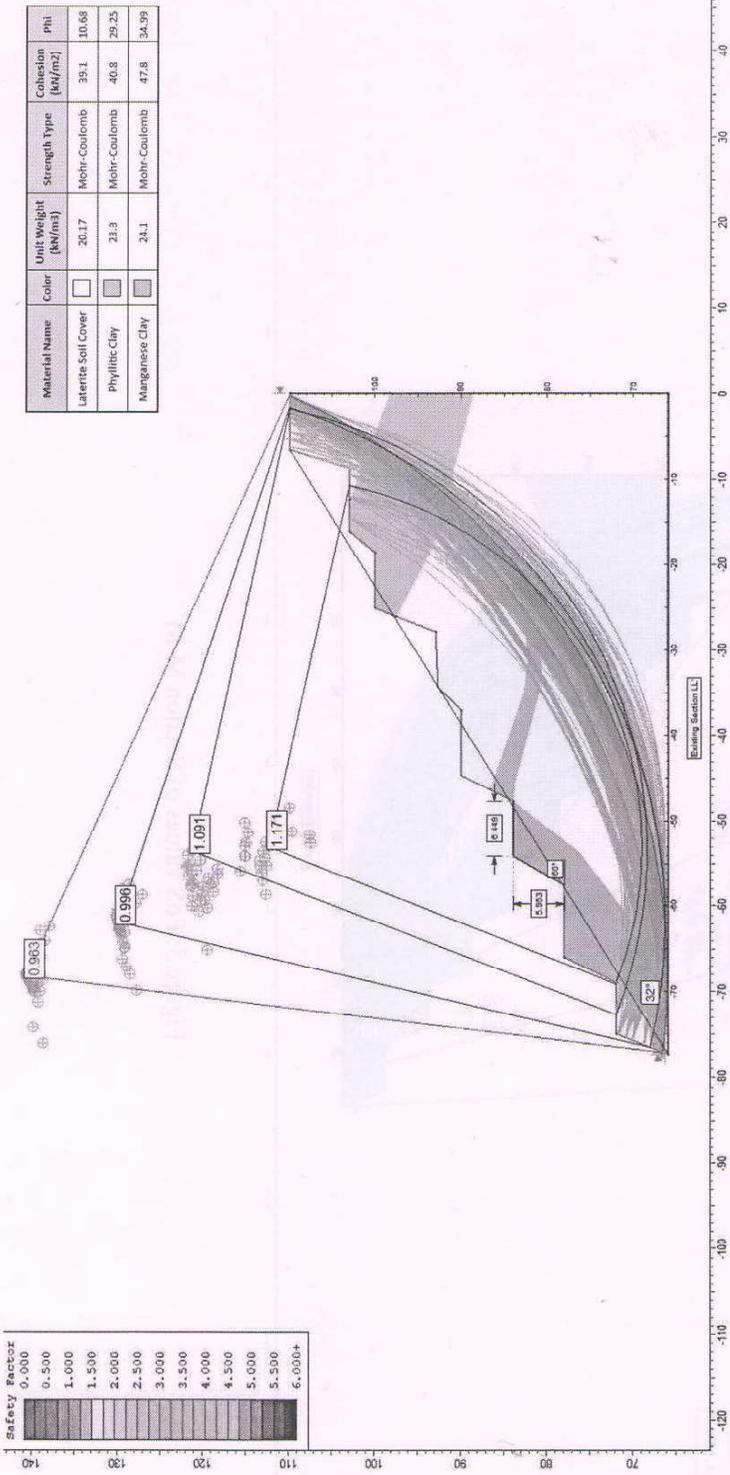
Figure 4: FoS values of Section L-L'

The analysis is carried out for the existing slope parameters of the mine benches and the corrected slope parameters is also been analyzed later in this report. The factor of safety for the existing sections is shown in figures 4 to 8. The factor of safety for these sections has been tabulated in table 3.

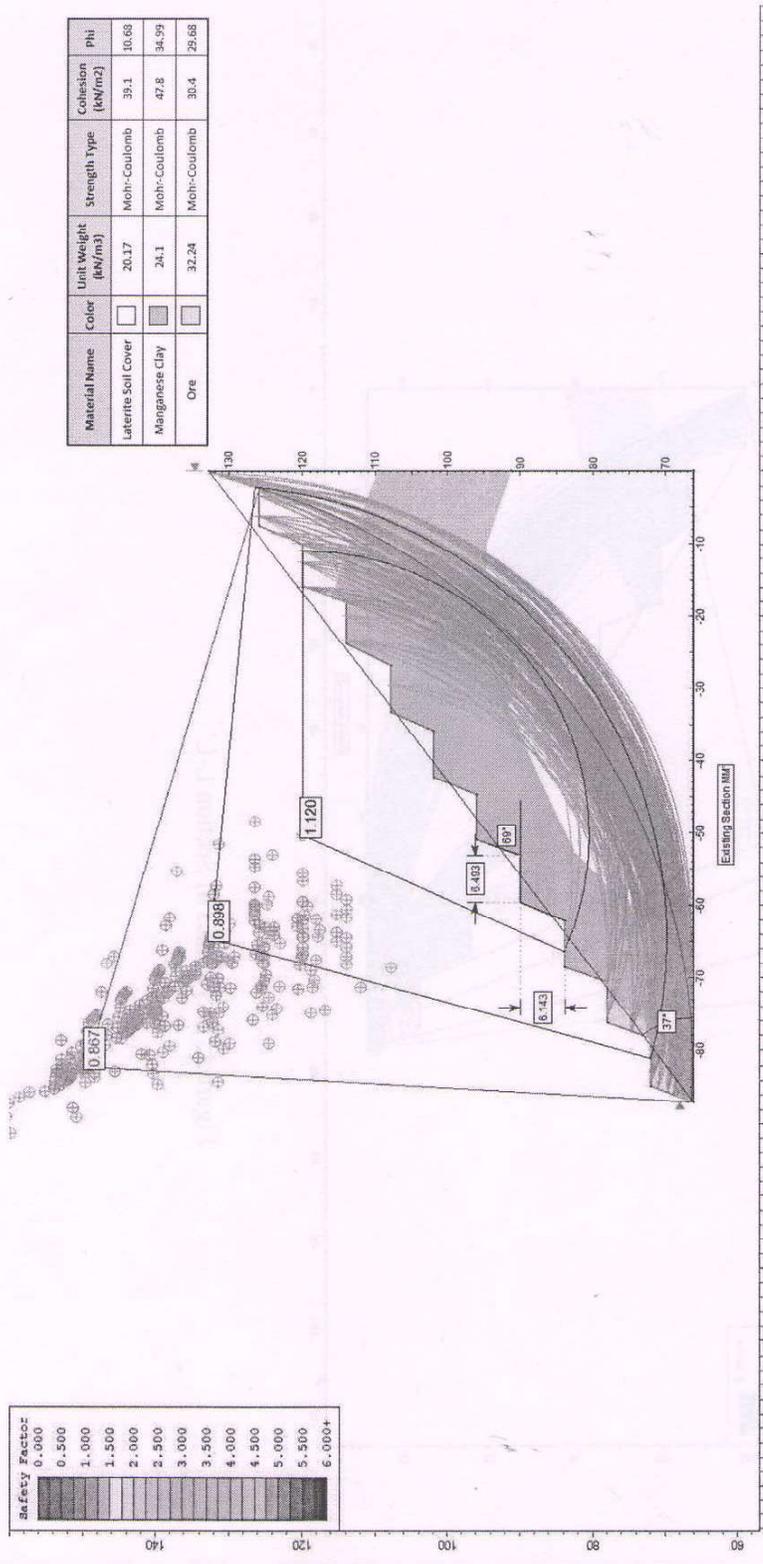
Figure 5: FoS values of Section M-M

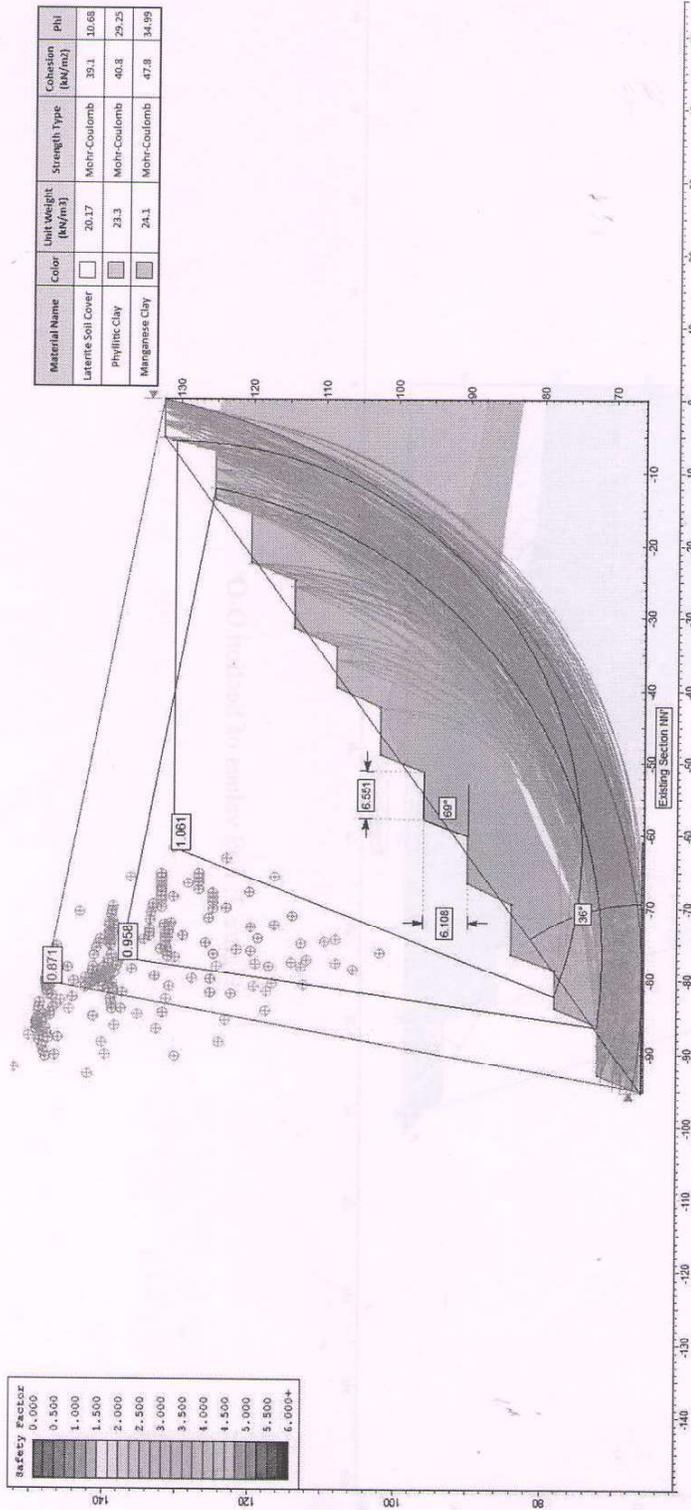
Figure 6: FoS values of Section N-N

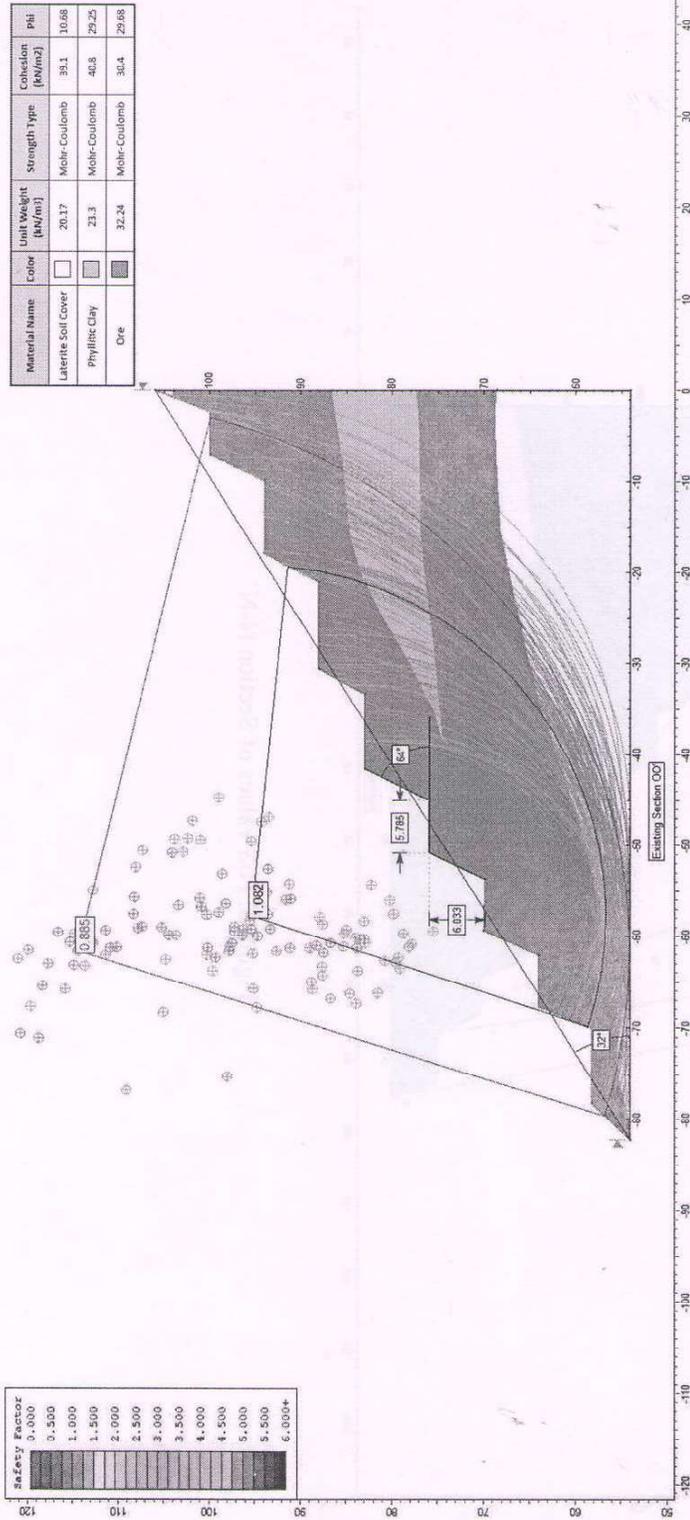
Figure 7: FoS values of Section O-O'

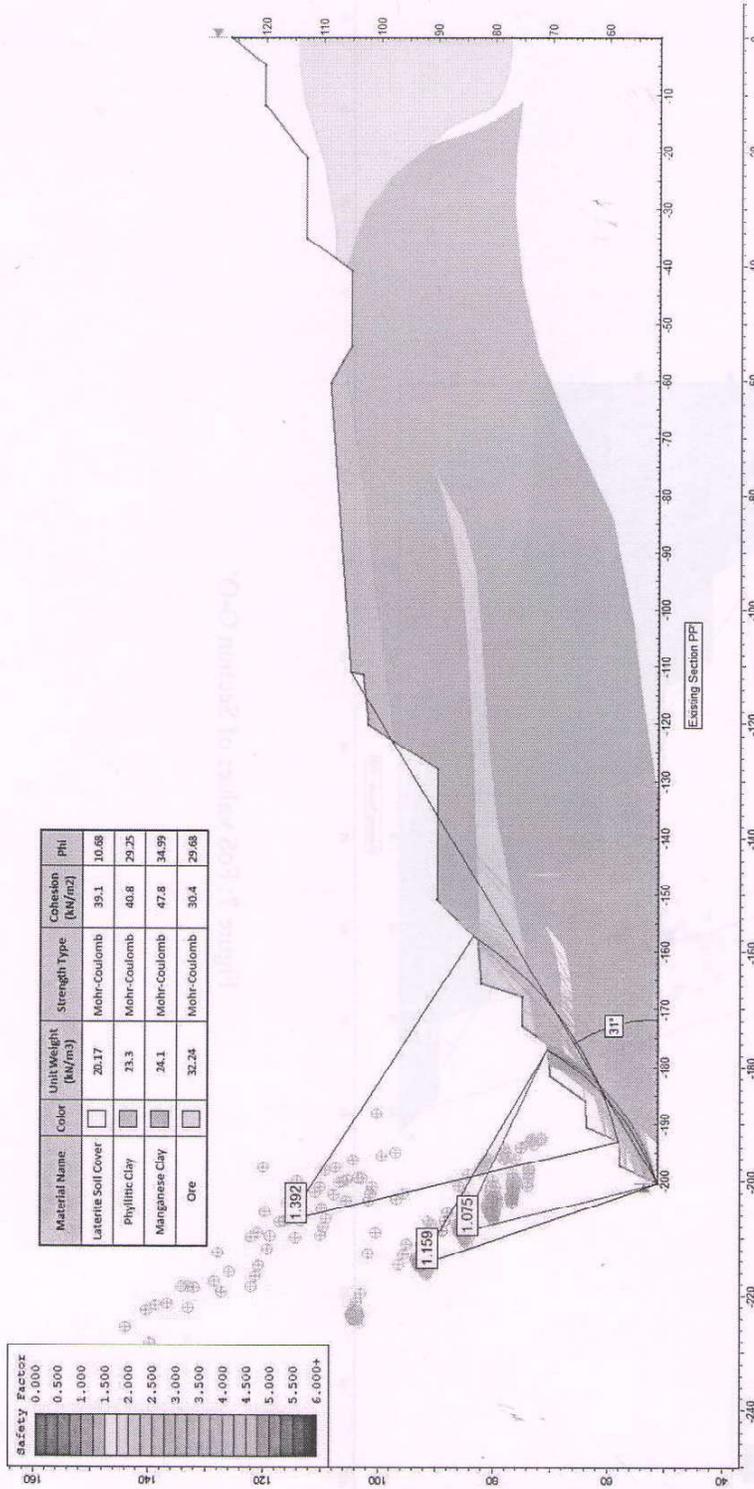
Figure 8: FoS values of Section P-P'
