**BEFORE THE NATIONAL GREEN TRIBUNAL
WESTERN ZONE BENCH AT PUNE
ORIGINAL APPLICATION NO. 41 OF 2022 (WZ)**

AFFIDAVIT – IN – REPLY OF RESPONDENT NO. 6

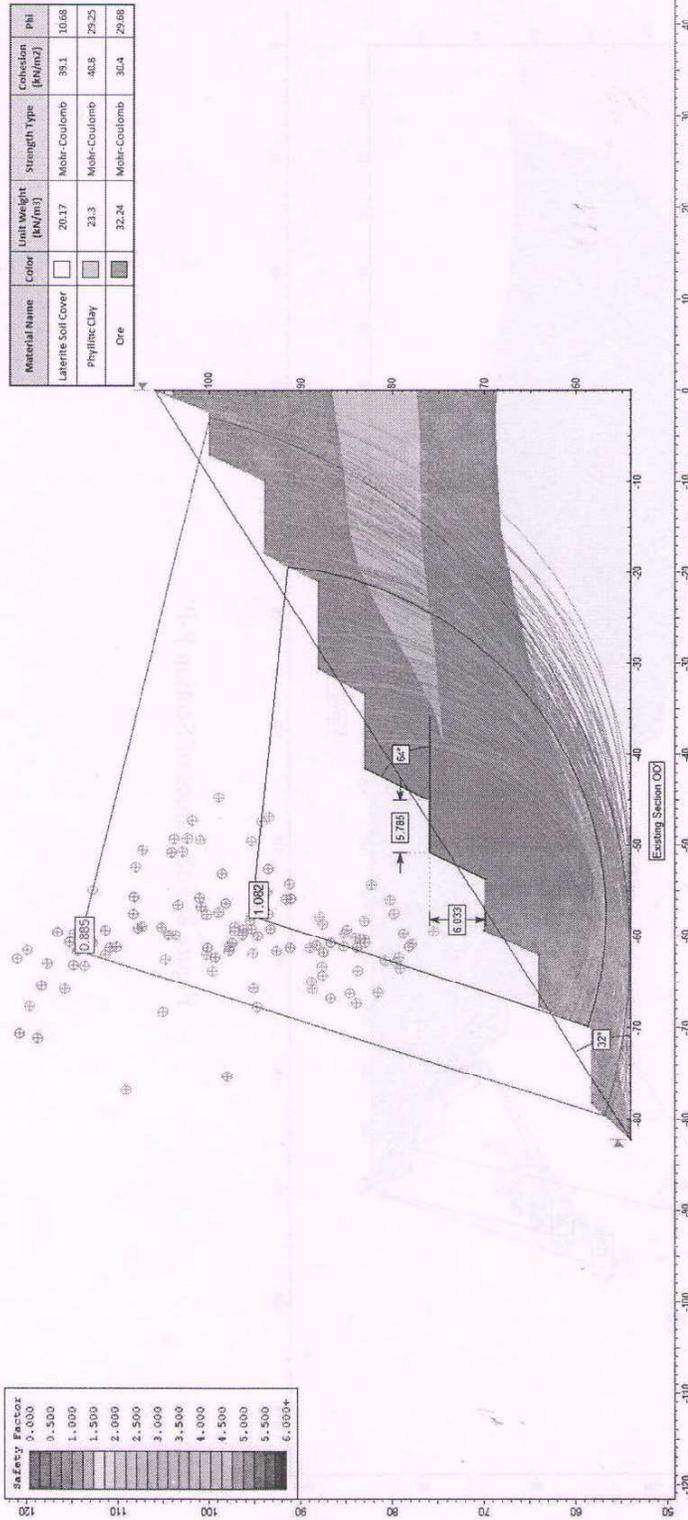
Figure 7: FoS values of Section O-O'

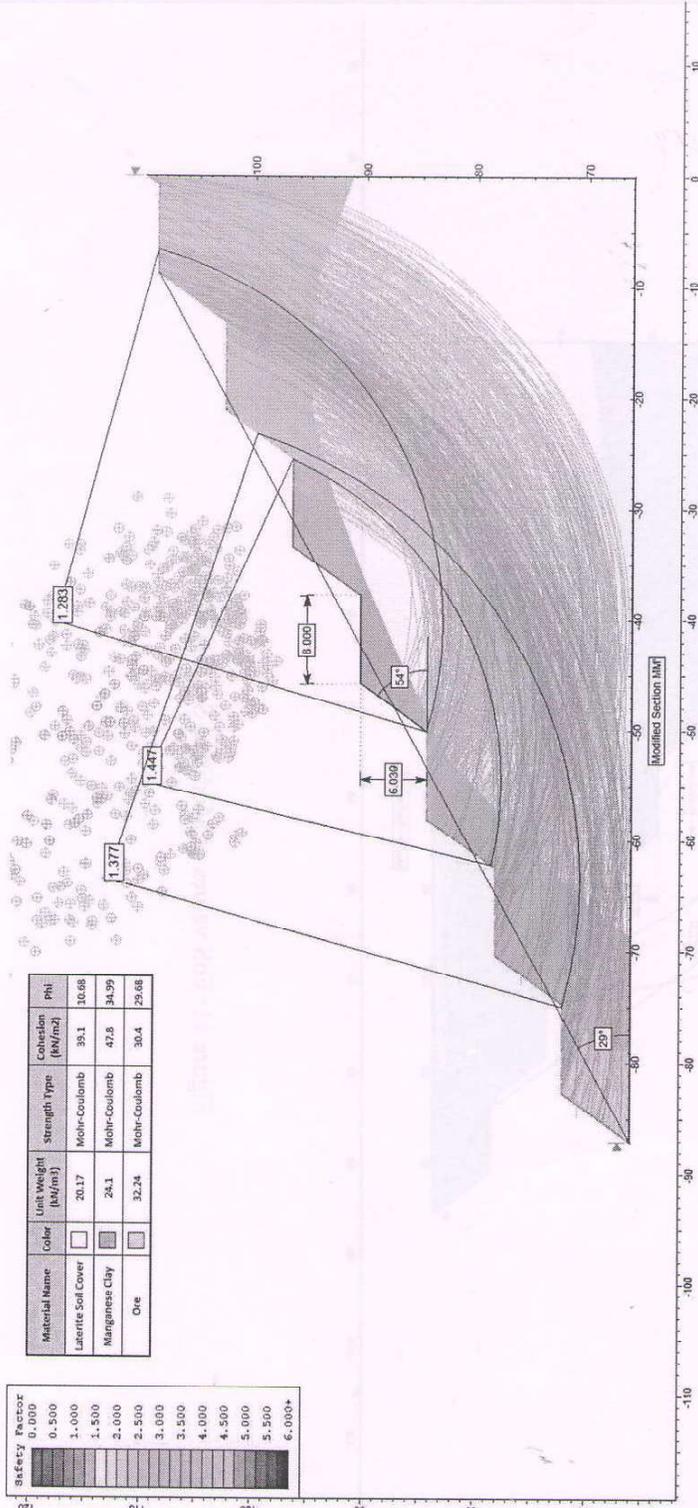
Figure 10: FoS values of Modified Section M-M'

Slope stability analysis of the modified bench parameters with bench height of 6m, bench width of 8m, individual bench angle of 54° and overall angle of 27° has been carried out using limit equilibrium analysis by means of Slide 10.0 software. The factor of safety for the modified bench parameters of various sections shown in table 4.

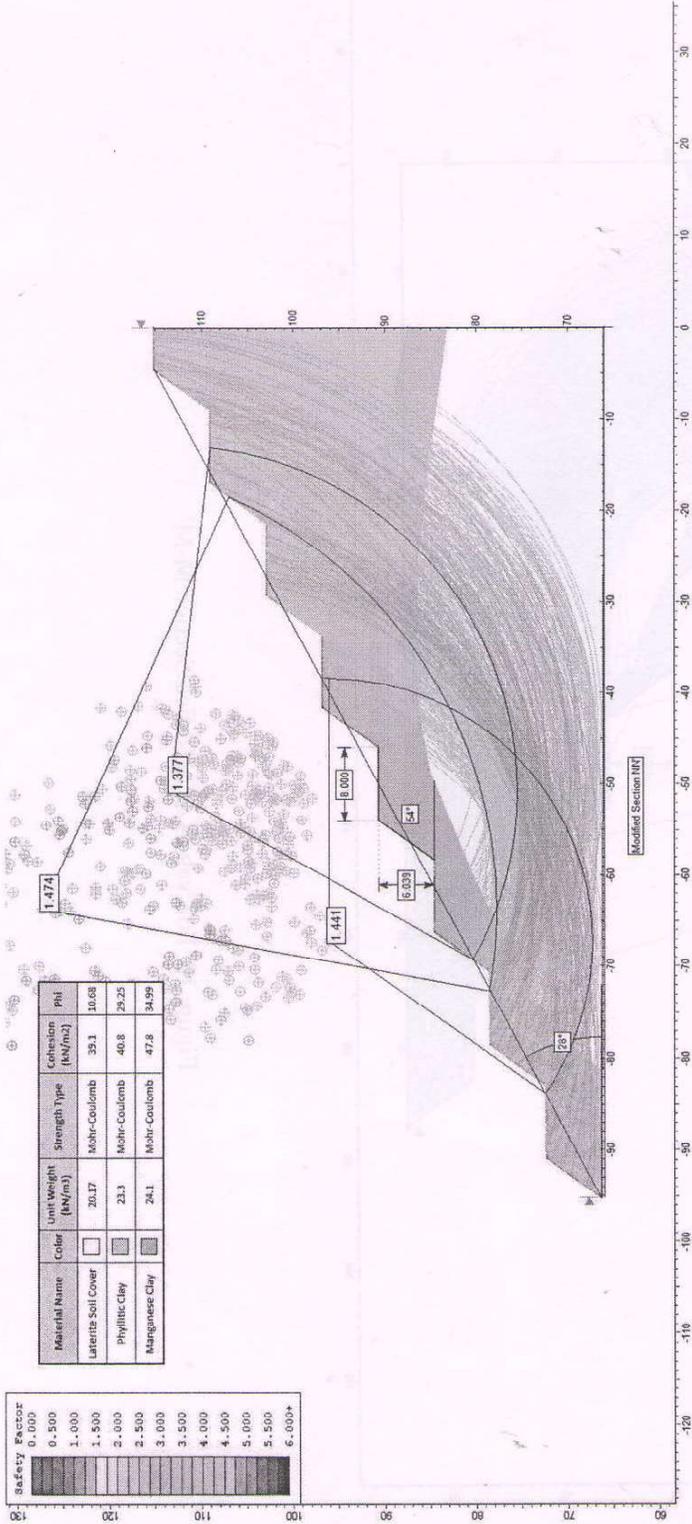
Figure 11: FoS values of Modified Section N-N'

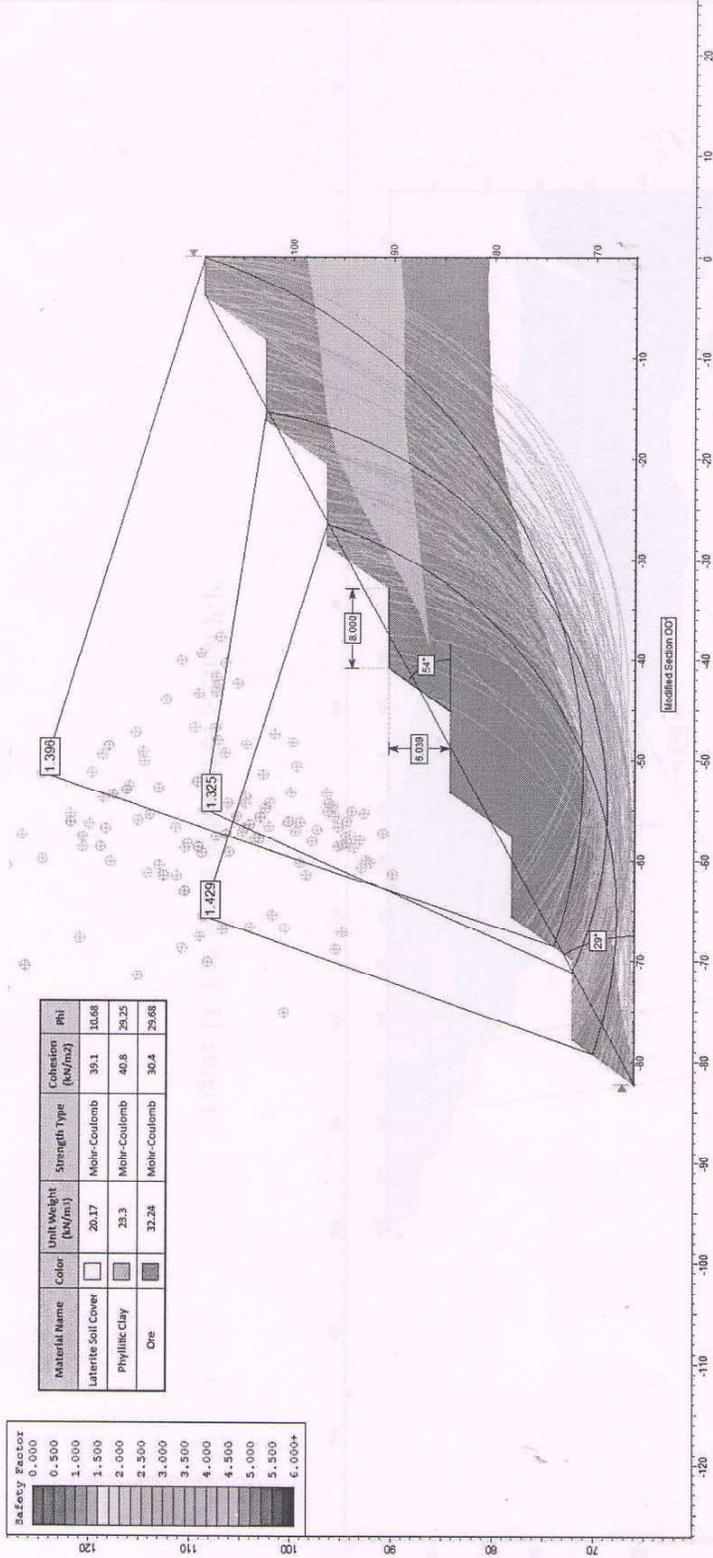
Figure 12: FoS values of Modified Section O-O*

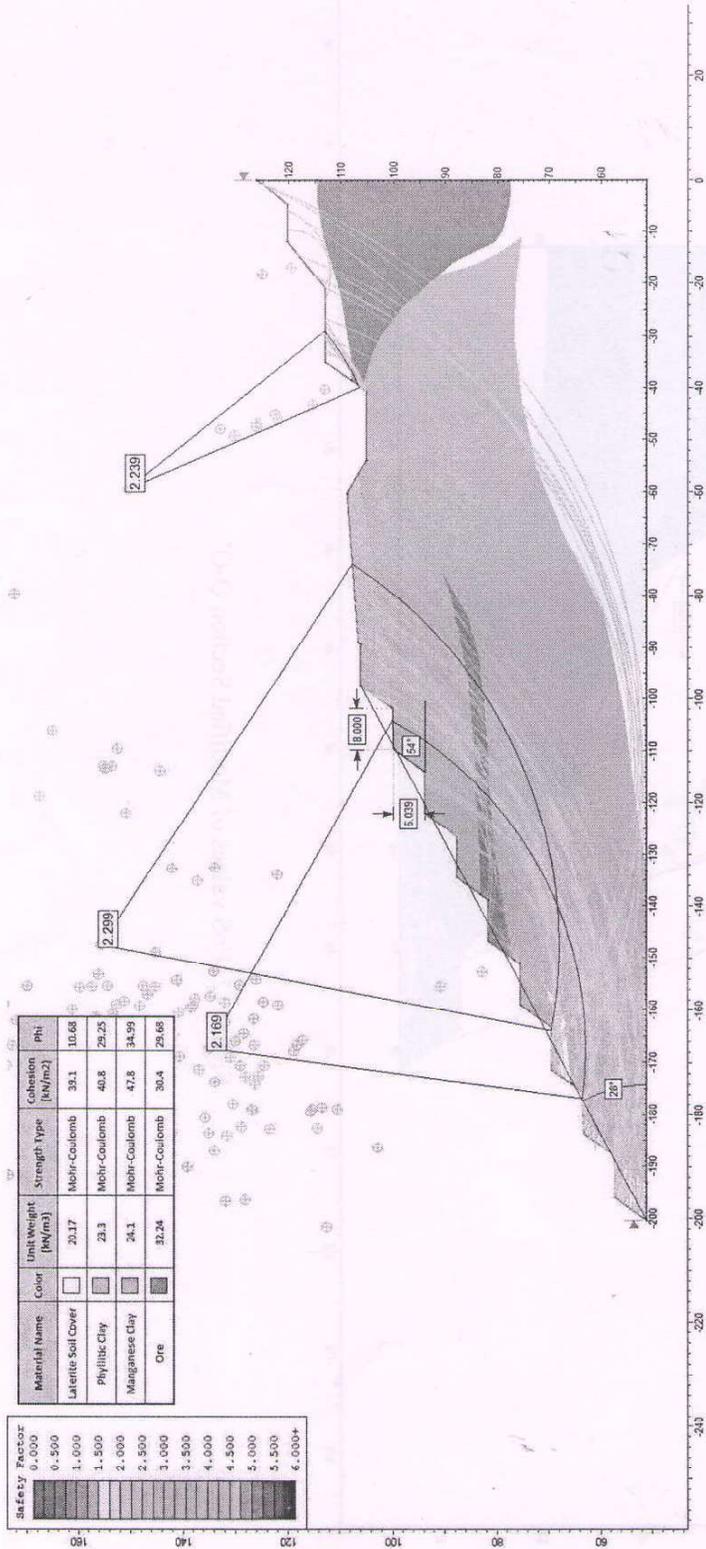
Figure 13: FoS values of Modified Section P-P'

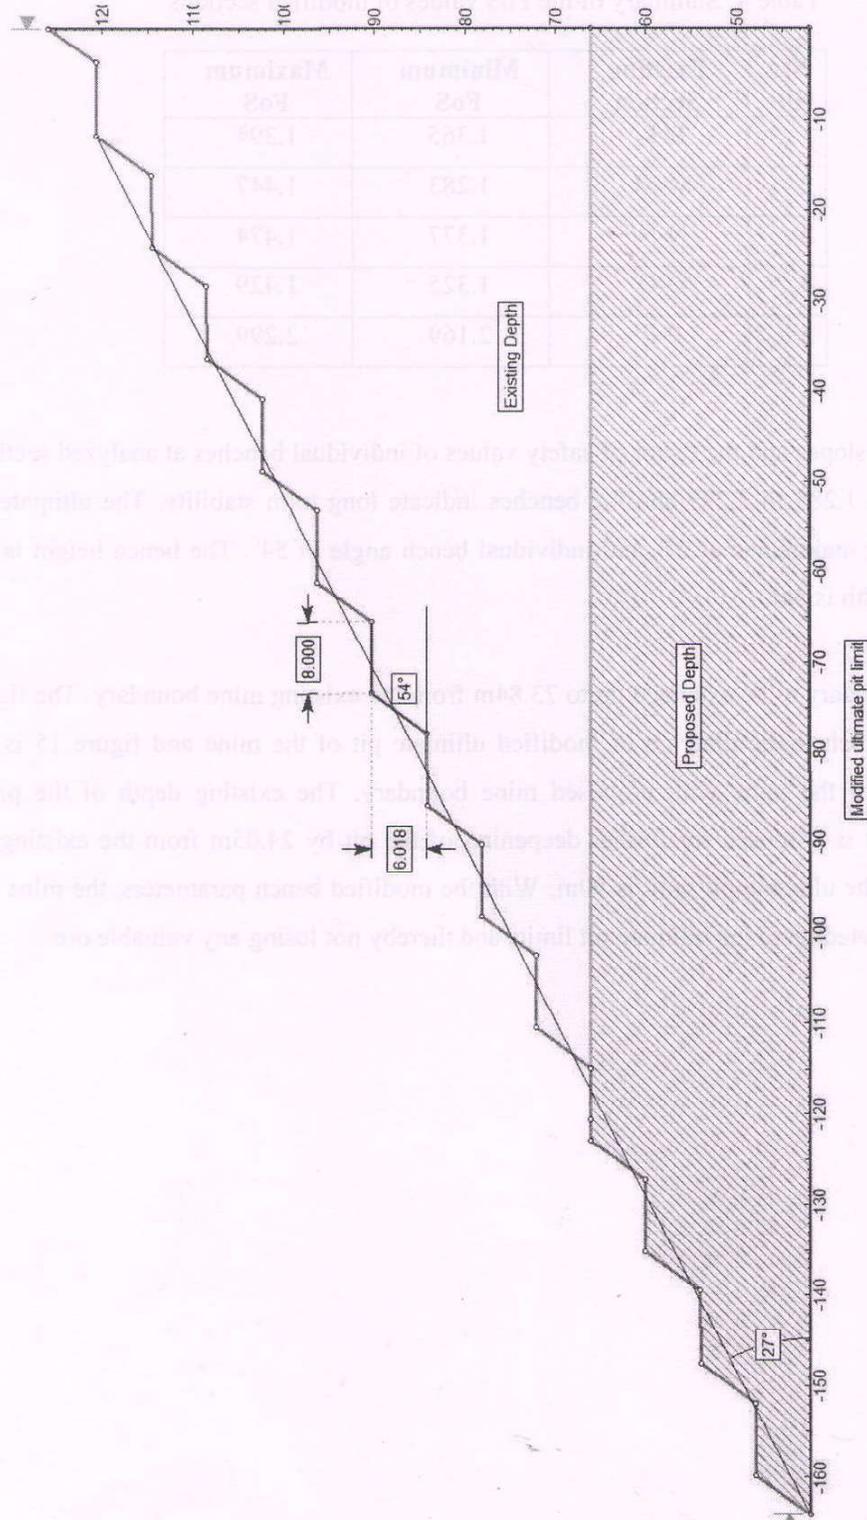
Figure 14: Schematic diagram of the modified ultimate pit

The mine boundary to be extended up to 73.84m from the existing mine boundary. The figure 14 shows the schematic diagram of modified ultimate pit of the mine and figure 15 is the surface plan of the mine with proposed mine boundary. The existing depth of the pit is 65.98m and it is proposed for further deepening of the pit by 24.05m from the existing pit limit. Thus, the ultimate pit limit is 90m. With the modified bench parameters, the mine can be safely operated up to the ultimate pit limits and thereby not losing any valuable ore.

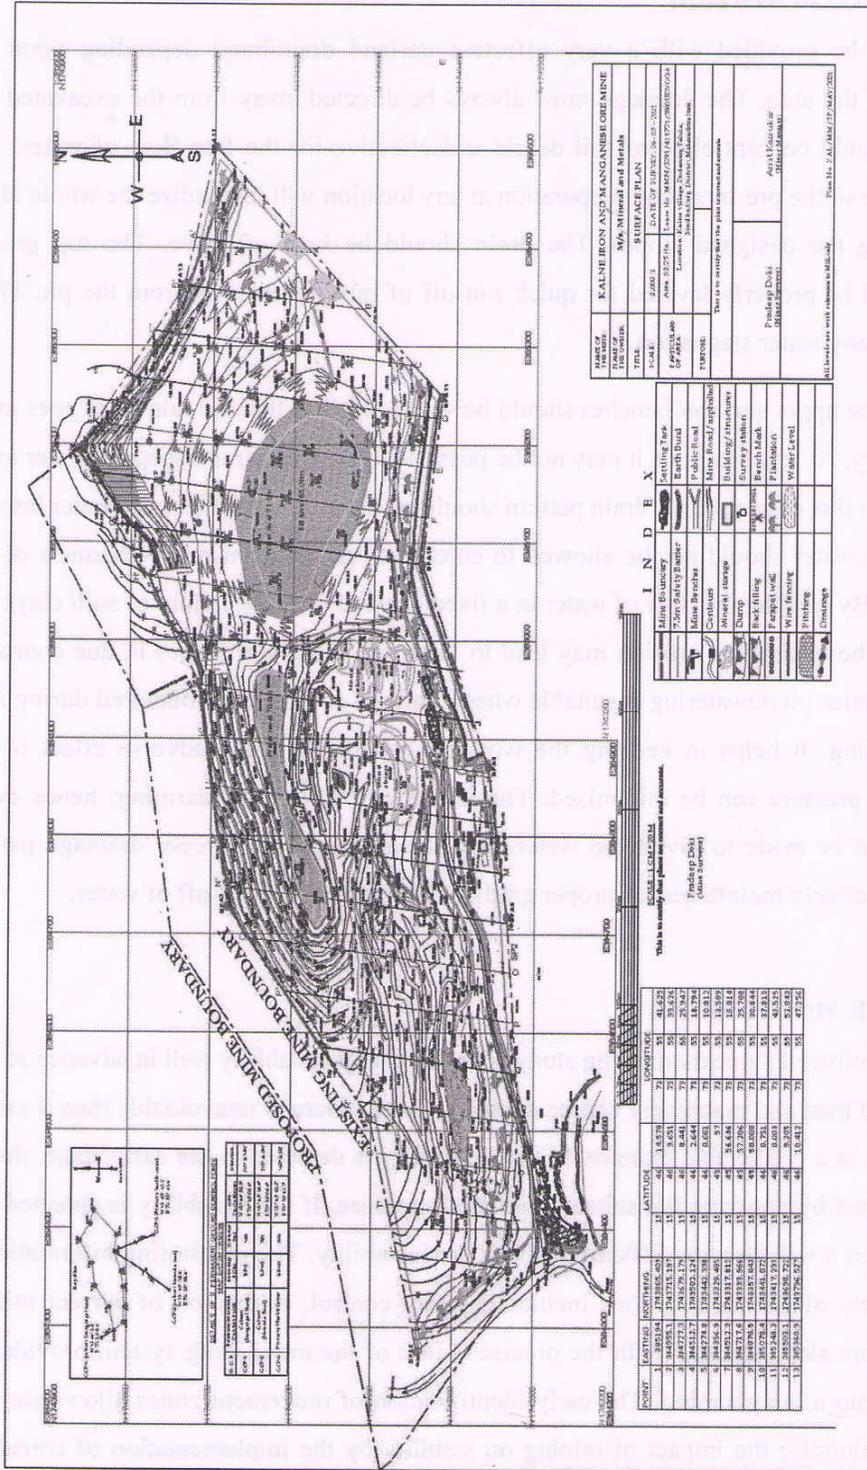
Figure 15: Surface plan of the mine with proposed mine boundary
