**Appeal No. 11 of 2024 (SZ)**

**REPLY STATEMENT FILED BY THE THIRD RESPONDENT**

**REPORT OF COMMITTEE IN THE MATTER OF  
ORIGINAL APPLICATION NO. 20 OF 2016, SRI. SANTO P.  
L. & OTHERS Vs STATE OF KERALA AND OTHERS  
SUBMITTED BEFORE THE HON'BLE NATIONAL GREEN  
TRIBUNAL SOUTHERN ZONE, CHENNAI CIRCUIT  
BENCH, AS PER THE ORDER DATED 20.04.2022**

### **3.0 Field visit and Observations**

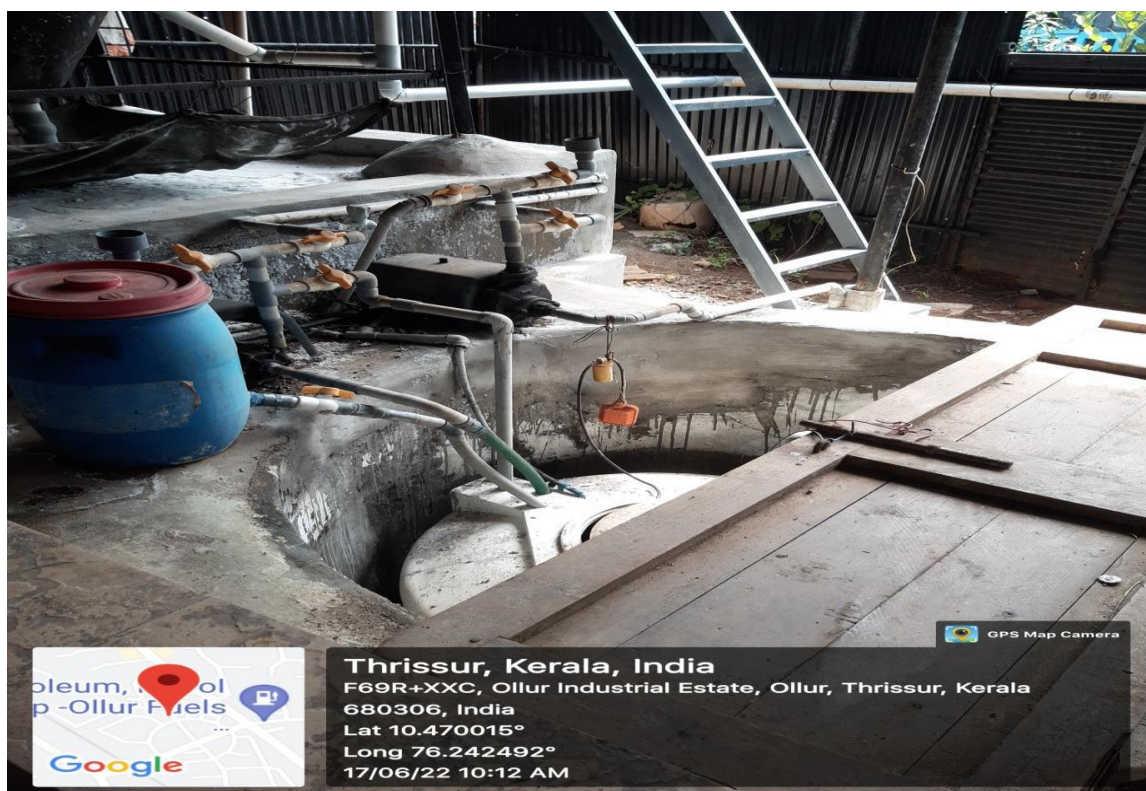
The settling tank consists of a conical shaped tank where in the sludge is drawn from the bottom and overflow goes to the filter feed tank. Below the settling tank is a sludge drying bed which consists of graded coarse and fine aggregate, and the sludge from the settling tank is allowed to dry here. The dried sludge is then transported to the common hazardous waste storage and disposal facility at Ambalamedu, Ernakulam. In all the units it is claimed that the treated water is reused.

**Figure 4 - Collection tank and chemical addition installations in ETP**

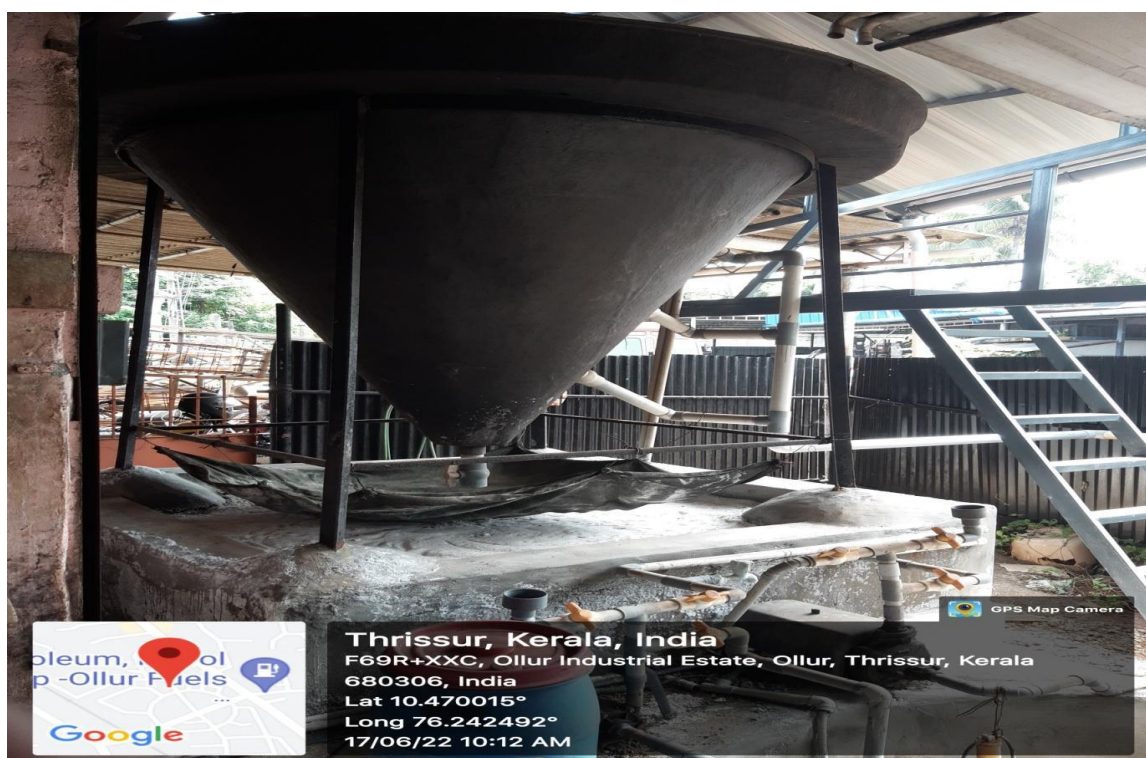
**Figure 5 - Hopper bottom settling tank and sludge drying bed**

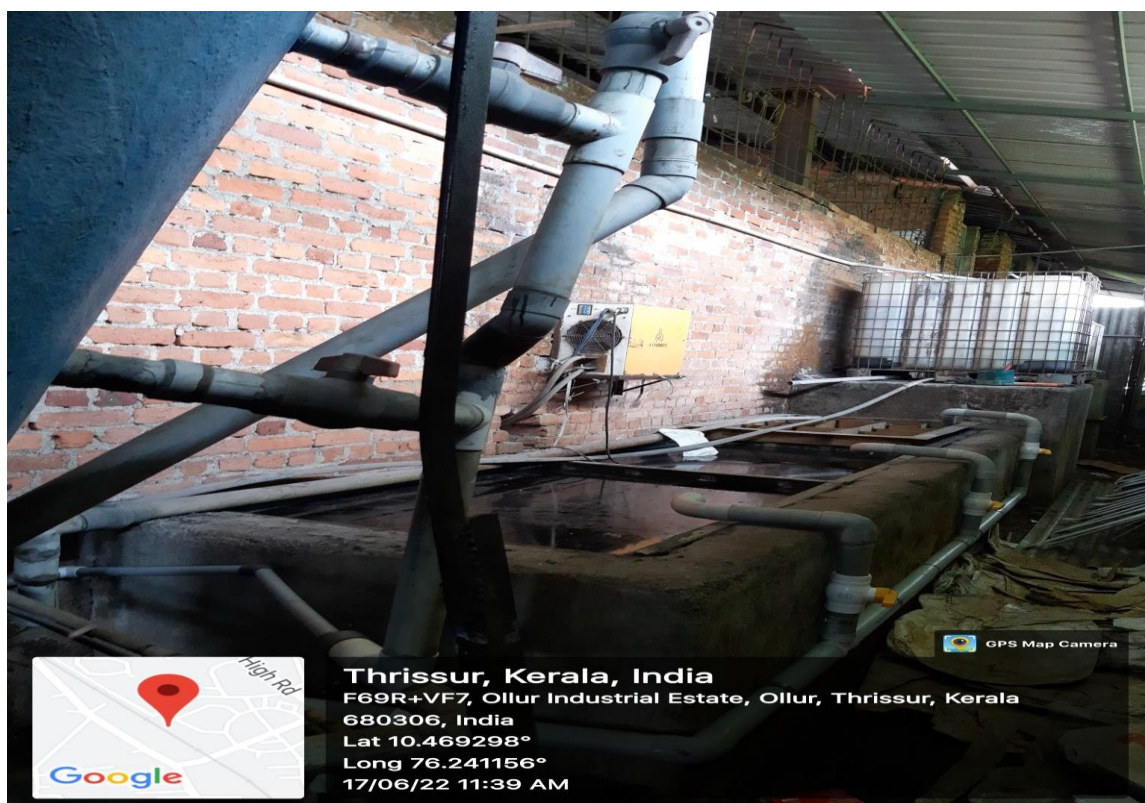
During inspection it was observed that ETP provided in the units were in operational condition (batch mode) except in the unit named Bright Precured Systems II, which is an electro colouring unit. The wastewater from the unit was discharged into the premises of the unit. The compliance of other units with regard to reuse provisions, sludge storage and manifest submission and other statutory records are being duly submitted.

**Figure 7 - Defunct effluent treatment plant at Bright Precured Systems 2**

- VI. However, in Bright Precured System 2, it was observed during the visit of this committee on 17.06.2022 that wastewater was discharged outside without any treatment and ETP was not in operation. Hence the unit is liable to pay compensation for violating the conditions in Consent No. PCB/DO/TSR/R2/ICO/2871/2018 issued to the unit. Copy of the consent to operate submitted as **Annexure 14**. Also the results of open well water sample from the unit shows a pH of 4.3 as well as there are exceedances with respect to Copper, Manganese and Nickel above the limits prescribed in the drinking water standards IS 10500:2012. It was also observed from the file of the State Pollution Control Board that the unit has replied
