INSPECTION REPORT OF THE JOINT COMMITTEE CONSTITUTED BY THE HON'BLE NATIONAL GREEN TRIBUNAL (SOUTHERN ZONE) IN RESPECT OF O.A NO. 124 OF 2020 (SZ) SUOMOTU ON THE BASIS OF THE NEWS PAPER REPORT PUBLISHED IN DINAMALAR CHENNAI CITY SUPPLEMENT EDITION DATED, 15.07.2020, UNDER THE CAPTION "CAN ANYONE ENTER INTO TO SET RIGHT? THE TROUBLE THAT HAS COME FOR SUNNAMBU KOLATHUR LAKE"

5. JOINT INSPECTION OF THE COMMITTEE

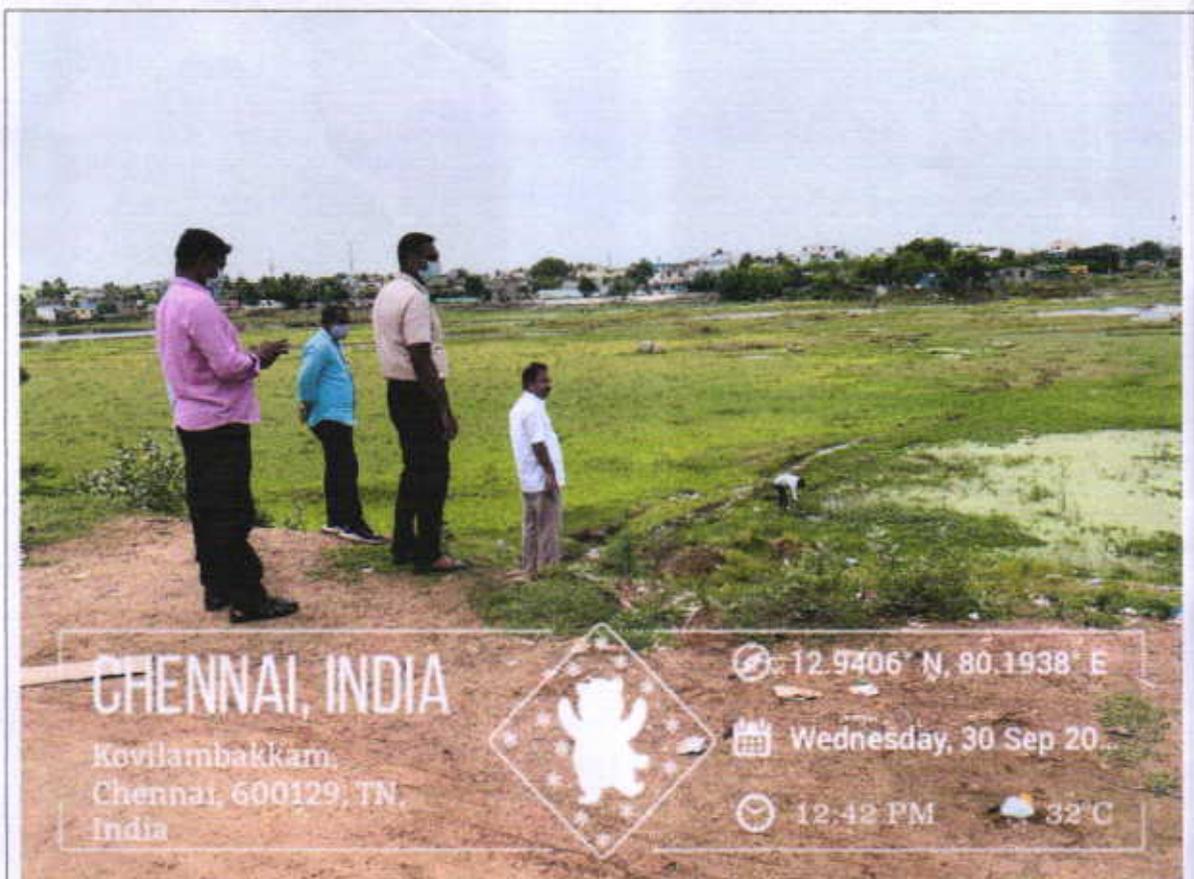
In due compliance of the orders of the Hon'ble National Green Tribunal, water samples were collected by the officials of Tamil Nadu Pollution Control Board from the Sunnambu Kolathur Lake in Kovilambakkam Village Panchayat on 30/09/2020.

Collection of water sample to ascertain the quality of water in the Sunnambu Kolathur Lake

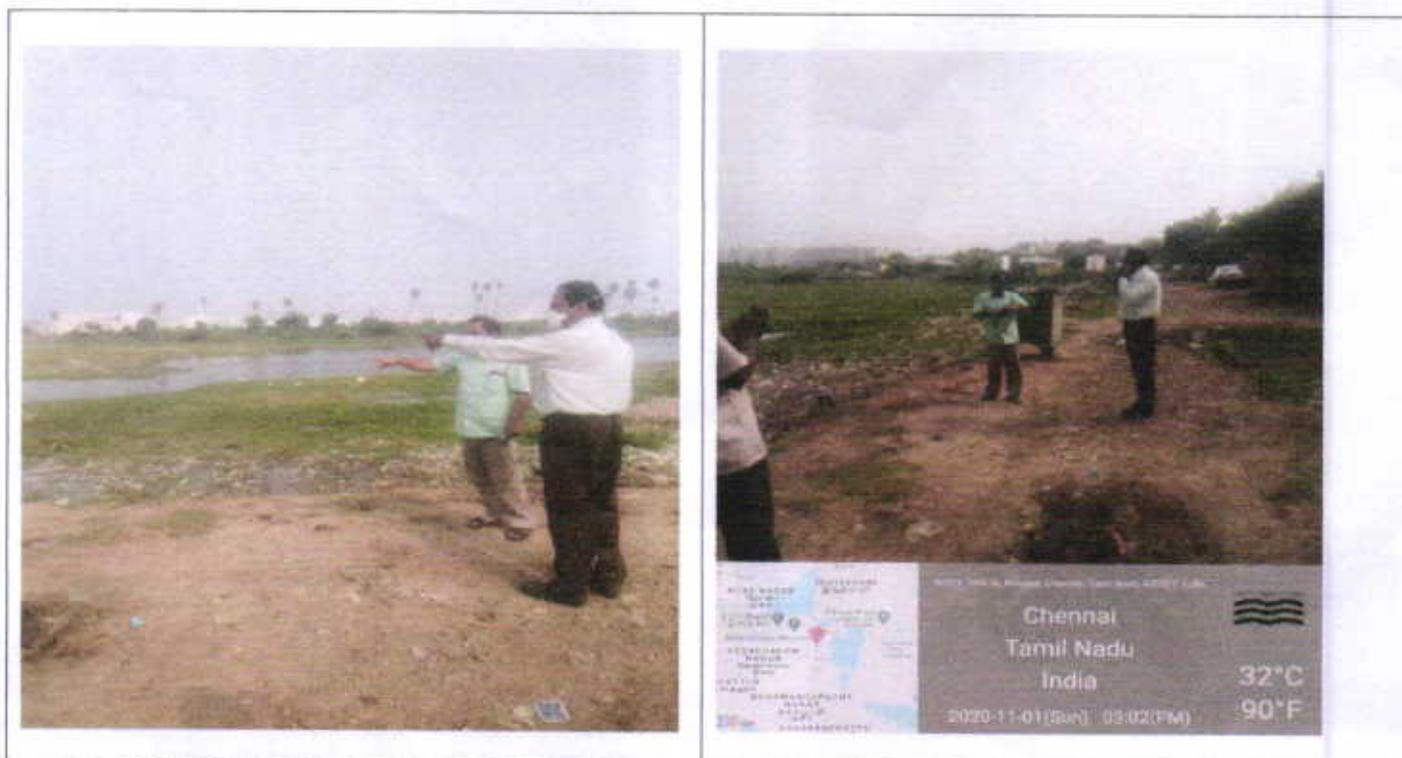
The joint committee as constituted by the Hon'ble National Green Tribunal (SZ) inspected the area in question on 30.09.2020 and 01.11.2020.

1. The Village panchayat is not having solid waste processing facility and the solid waste generated from the Village panchayat area is dumped in a dumping yard in an extent of 2.5 acres located adjacent to S Kolathur main road in Suvery no.432 of Kovilambakkam Village.
2. The Village panchayat has taken action to clear the solid waste dumped by the nearby residents in the fringe of the said water body and provided garbage collection bins to prevent the throwing of solid waste into the water body. Further provided warning boards "not to dump the solid waste in the water body, failure to comply with, action to be initiated".
3. One storm water drain carrying sullage/sewage generated from the village panchayat area was found discharging the same into the water body in the western side.
4. Encroachment was noticed in the water spread area of the water body.

01. The Village Panchayat shall ensure 100% collection of solid waste being generated within its jurisdiction with proper segregation, door to door collection, processing and disposal by complying with the provisions of the Solid Waste Management Rules 2016 within three months time.
02. The Village Panchayat shall not dump solid waste under any circumstances in the said area in question i.e. at Sunnambu Kulathur Lake of Kovilambakkam Village.
03. The Village Panchayat shall establish Micro composting centre within three months within the village panchayat area to compost the segregated Biodegradable wastes and to take steps to dispose the non degradable waste including plastic waste to the recycling facility complying with the provisions of the Solid Waste Management Rules, 2016.

05. The Village panchayat shall provide a treatment system to intercept sewage entering the lake and to treat the same within three months.
06. The Revenue Authorities shall make fresh survey to identify the exact no of encroachments and their extent in the impugned tank and furnish the details thereof to the WRD to issue Form III notice to the encroachers for taking eviction proceedings under the Tamil Nadu Lake Protection Act, 2007 within three months.
