INSPECTION REPORT OF THE JOINT COMMITTEE CONSTITUTED BY THE HON'BLE NATIONAL GREEN TRIBUNAL (SOUTHERN ZONE) IN RESPECT OF O.A NO. 124 OF 2020 (SZ) SUOMOTU ON THE BASIS OF THE NEWS PAPER REPORT PUBLISHED IN DINAMALAR CHENNAI CITY SUPPLEMENT EDITION DATED, 15.07.2020, UNDER THE CAPTION "CAN ANYONE ENTER INTO TO SET RIGHT? THE TROUBLE THAT HAS COME FOR SUNNAMBU KOLATHUR LAKE"

#### **5. JOINT INSPECTION OF THE COMMITTEE**

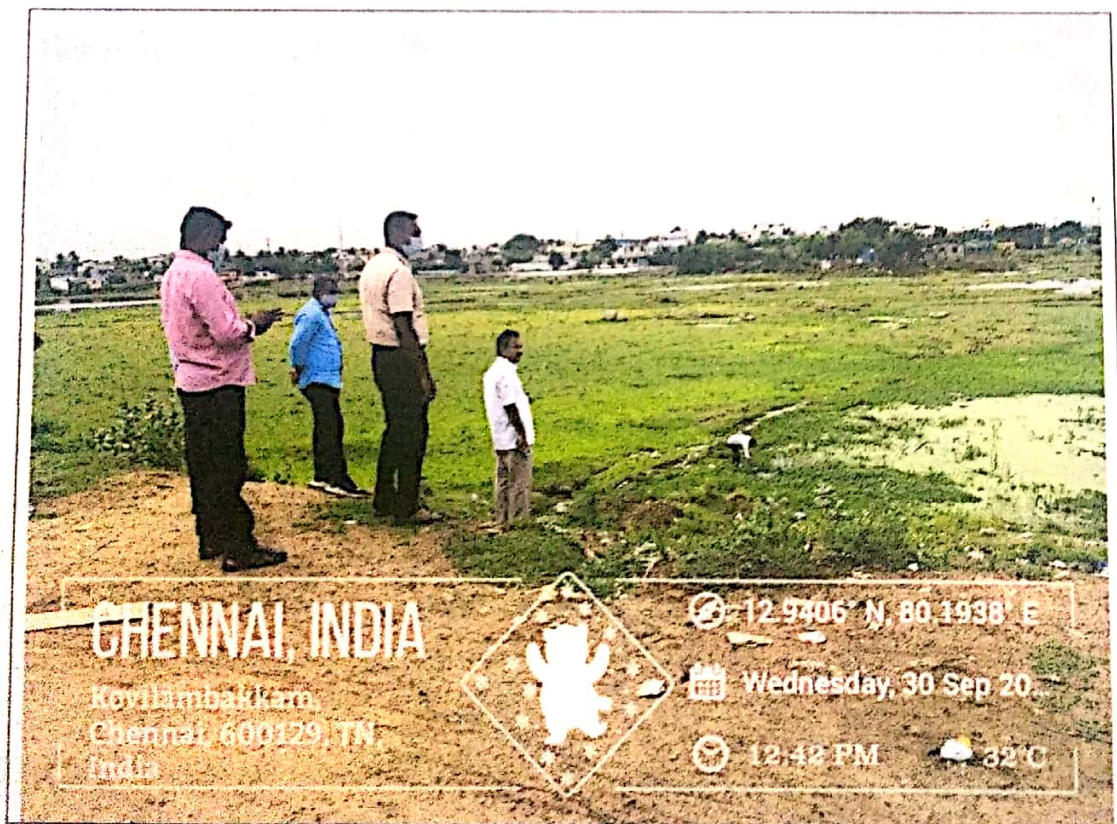
**Collection of water sample to ascertain the quality of water in the Sunnambu Kolathur Lake**

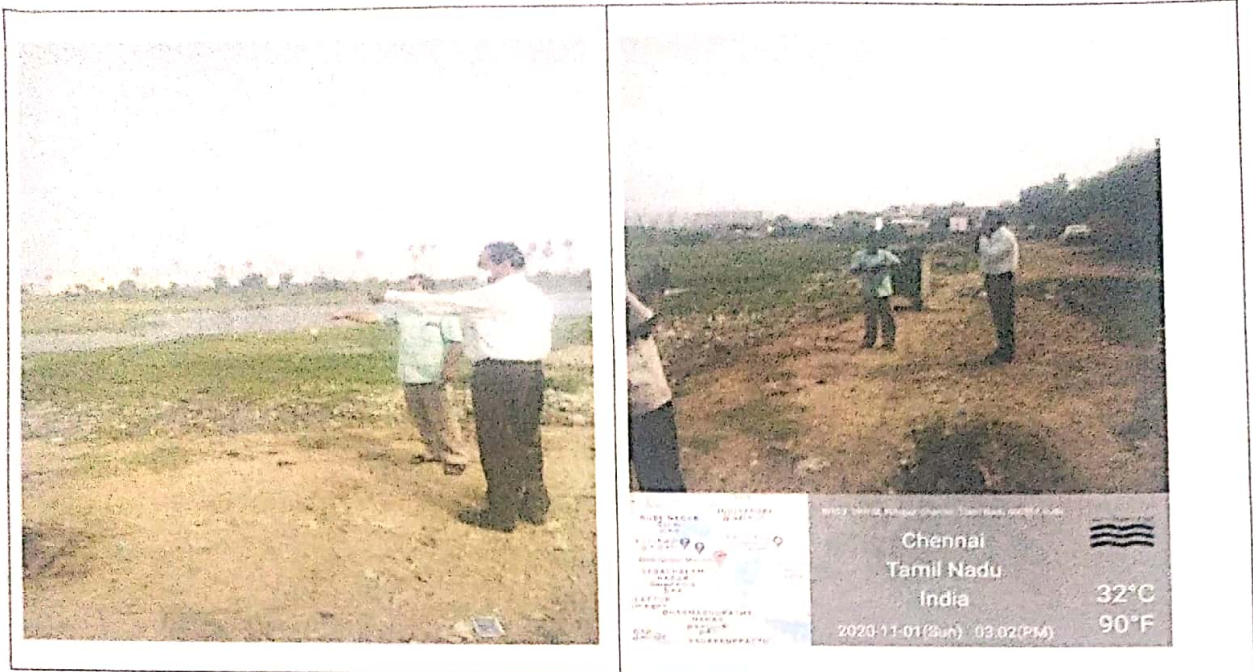
The joint committee as constituted by the Hon'ble National Green Tribunal (SZ) inspected the area in question on 30.09.2020 and 01.11.2020.

1. The Village panchayat is not having solid waste processing facility and the solid waste generated from the Village panchayat area is dumped in a dumping yard in an extent of 2.5 acres located adjacent to S Kolathur main road in Suvery no.432 of Kovilambakkam Village.
2. The Village panchayat has taken action to clear the solid waste dumped by the nearby residents in the fringe of the said water body and provided garbage collection bins to prevent the throwing of solid waste into the water body. Further provided warning boards "not to dump the solid waste in the water body, failure to comply with, action to be initiated".
3. One storm water drain carrying sullage/sewage generated from the village panchayat area was found discharging the same into the water body in the western side.
4. Encroachment was noticed in the water spread area of the water body.

01. The Village Panchayat shall ensure 100% collection of solid waste being generated within its jurisdiction with proper segregation, door to door collection, processing and disposal by complying with the provisions of the Solid Waste Management Rules 2016 within three months time.
02. The Village Panchayat shall not dump solid waste under any circumstances in the said area in question i.e. at Sunnambu Kulathur Lake of Kovilambakkam Village.
03. The Village Panchayat shall establish Micro composting centre within three months within the village panchayat area to compost the segregated Biodegradable wastes and to take steps to dispose the non degradable waste including plastic waste to the recycling facility complying with the provisions of the Solid Waste Management Rules, 2016.

05. The Village panchayat shall provide a treatment system to intercept sewage entering the lake and to treat the same within three months.
06. The Revenue Authorities shall make fresh survey to identify the exact no of encroachments and their extent in the impugned tank and furnish the details thereof to the WRD to issue Form III notice to the encroachers for taking eviction proceedings under the Tamil Nadu Lake Protection Act, 2007 within three months.
