**BEFORE THE NATIONAL GREEN TRIBUNAL
SOUTHERN ZONE, CHENNAI.**

**M.A.No.13 OF 2022
In
O.A.No. 195 OF 2021(SZ)**

Action Taken Report of Karnataka State Pollution Control Board (KSPCB) with respect to Hon'ble NGT MA No.13 of 2022 (SZ) in OA No.195 of 2021 (SZ) in respect of Yele Mallappa Shetty Lake/Tank located at Basavanapura Village, K.R.Puram Hobli, Bengaluru East Taluk, Bengaluru Urban District

Photographs taken during inspection of Yelemallappachetty Lake on 08.12.2022.

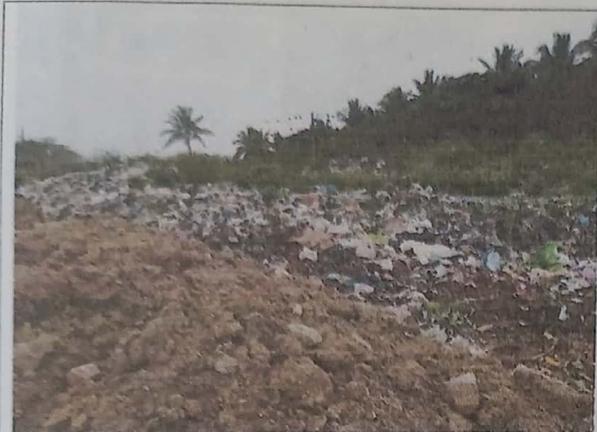
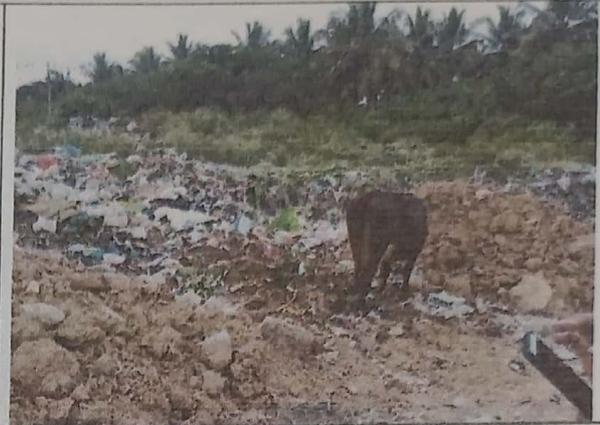
9. The photographs are taken during inspection with regard to the plastic waste burnt and dumped in the lake bed towards Hirandahalli village are enclosed for kind reference.

Plastic waste has dumped in the lake bed

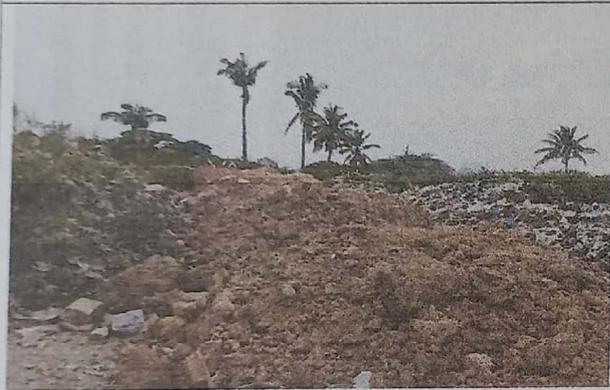
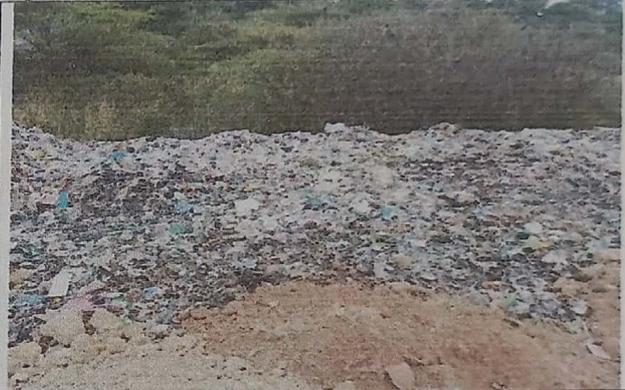
Fresh soil/mud has being dumping over the plastic waste dumped in the lake bed

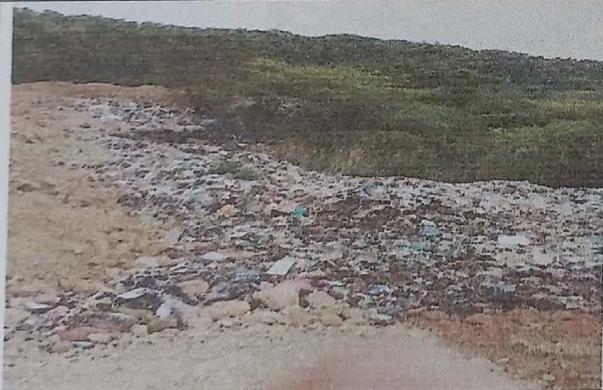
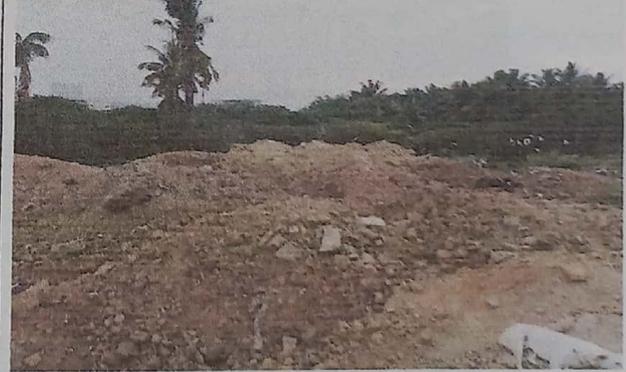
Fresh soil/mud has being dumping over the plastic waste dumped in the lake bed

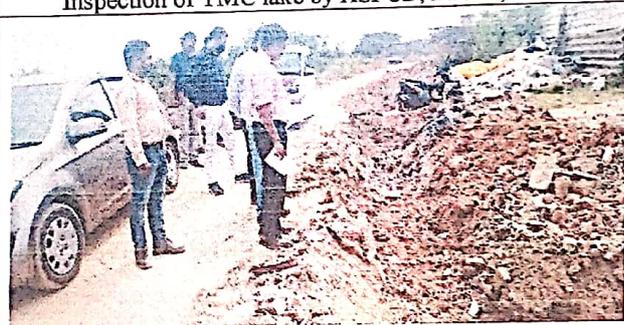
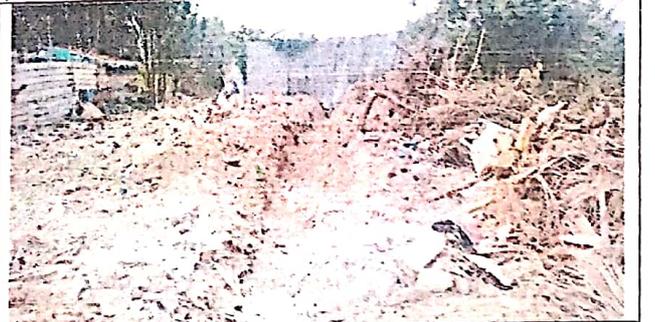
Trenches have been digged by MIE authority after earmarked the boundary of lake by Revenue authorities

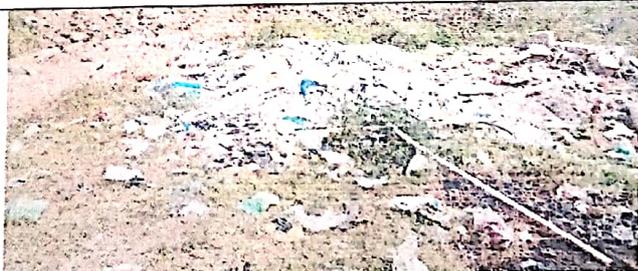
Plastic and other solid waste dumped in the lake bed area

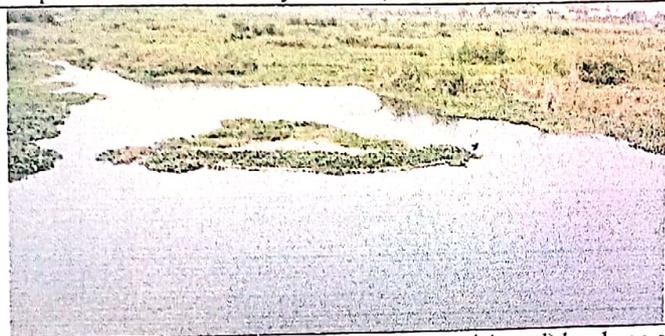
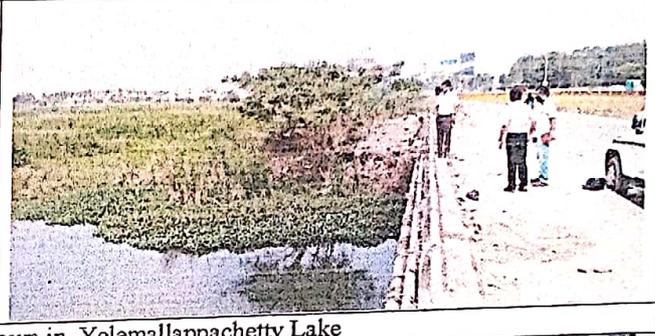
Water Hyacinth (weed) has been grown in Yelemallappachetty Lake

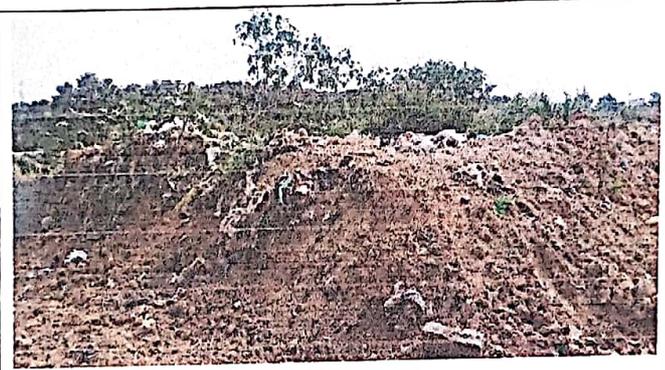
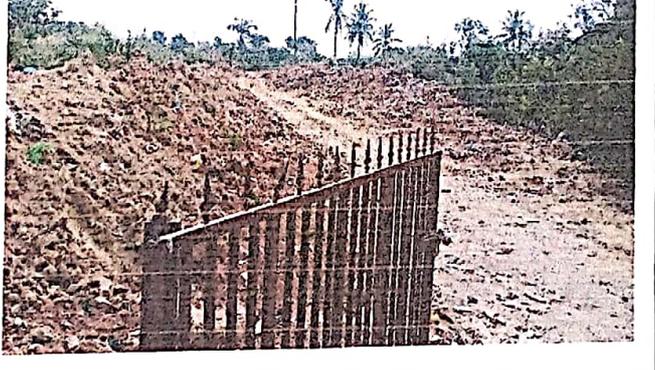
Soil has been dumped in lake bed towards Hiranahalli main road and fence with steel gate has been erected to avoid entry of illegal vehicles for dumping of waste.

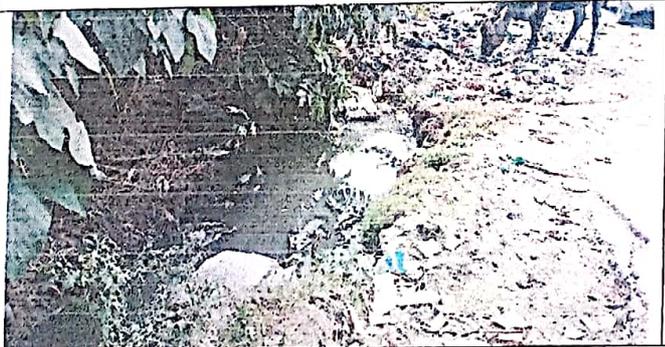
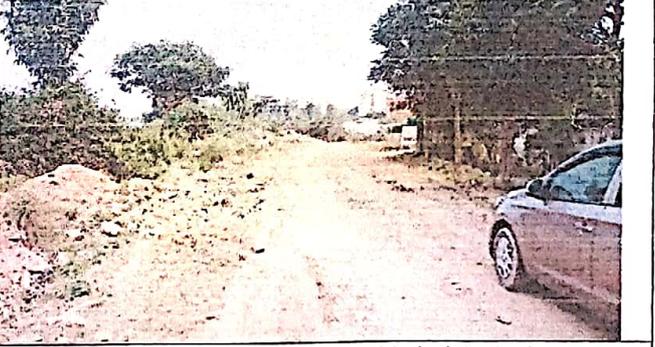
Plastic waste has been dumped near Avalahalli side and road has been made towards Kithaganur side in lake bed area

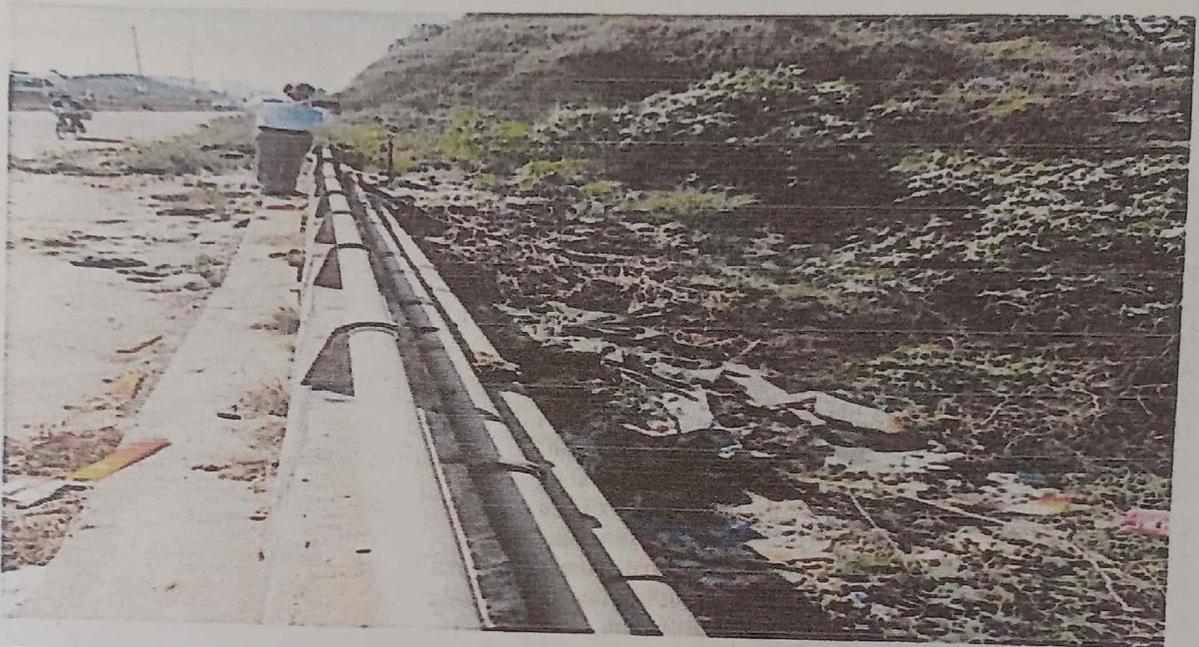
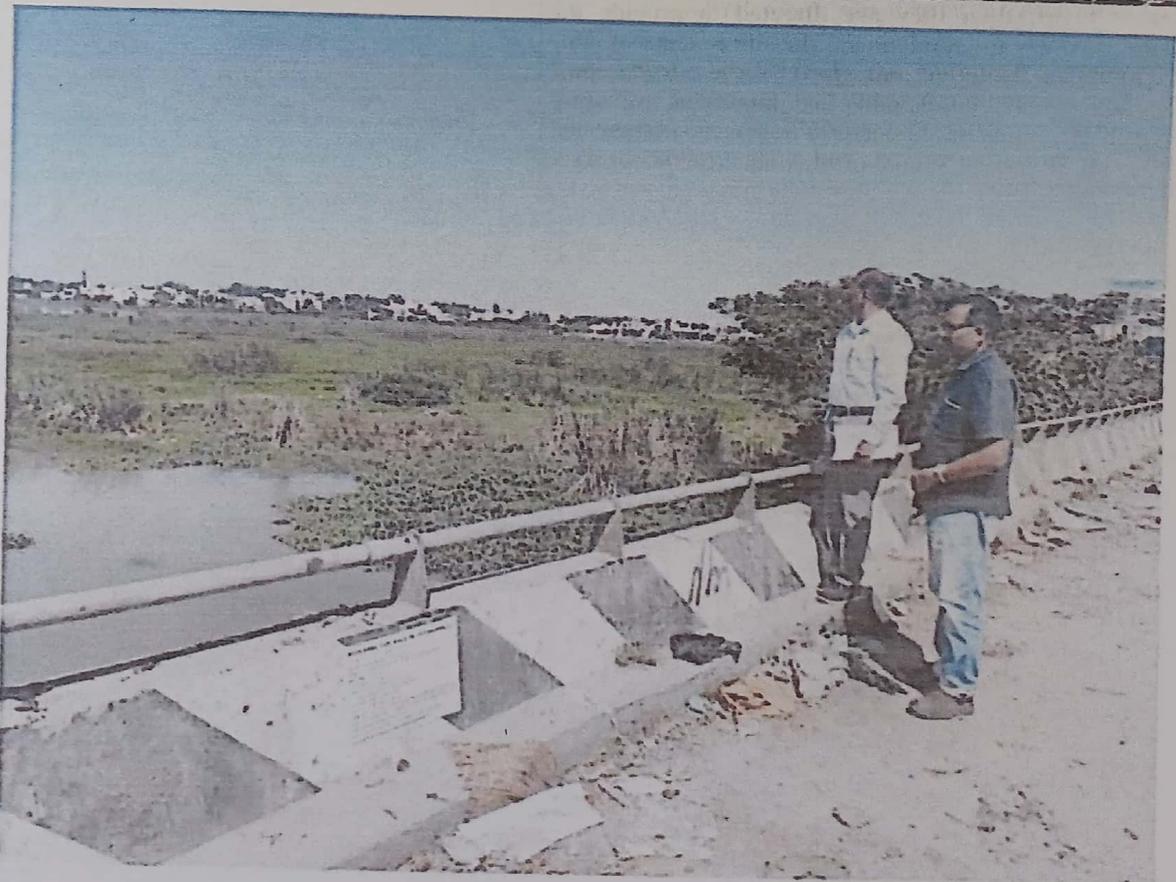
ANNEXTURE 'A'

Photograph of dumped Solid Wastes/debris, Weeds and other sediments obstructing free flow of water at the Vent.

As mentioned in para 3, there is no obstruction at inlet and outlet for flow of water from upstream to downstream. The obstruction caused by dumped solid waste/debris, weeds and other sediments are now cleared periodically. And to avoid dumping of dumped solid waste/debris, weeds and other sediments, a proposal has been submitted for Fencing arrangements at both sides of road. The proposal is in the Finance Department of Karnataka state government. We persuade for approval for this proposal by referring Hon'ble National Green Tribunal directions. We are awaiting approval from Finance Department of Karnataka Government.

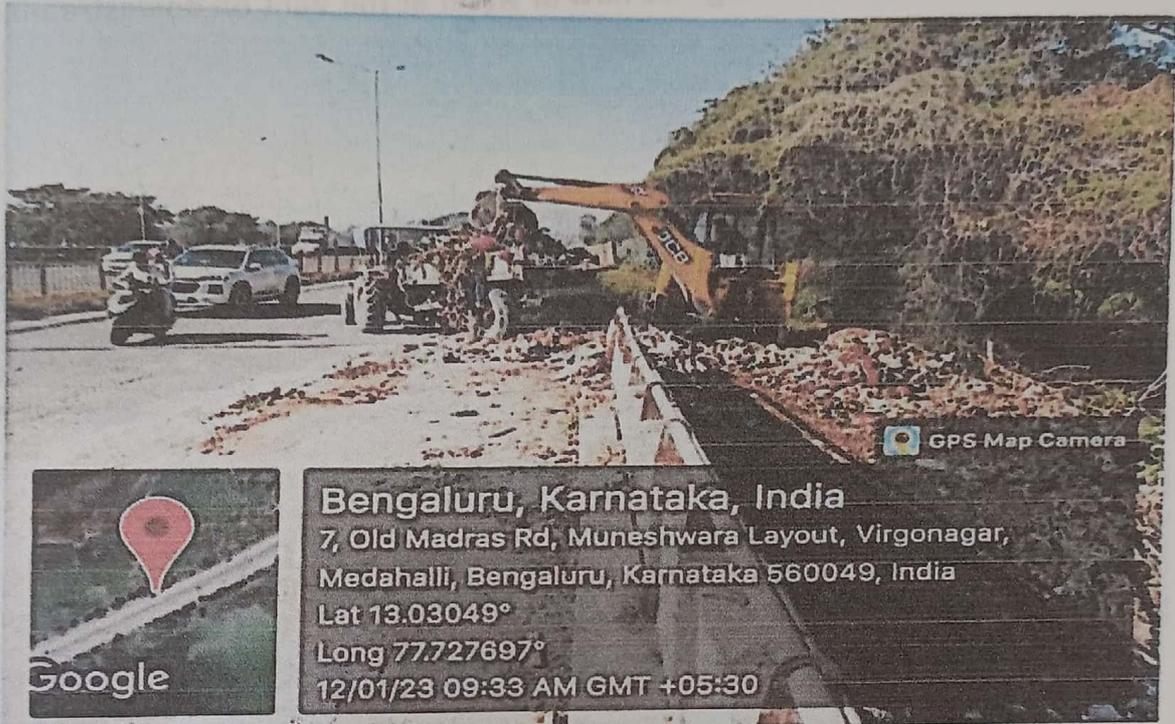
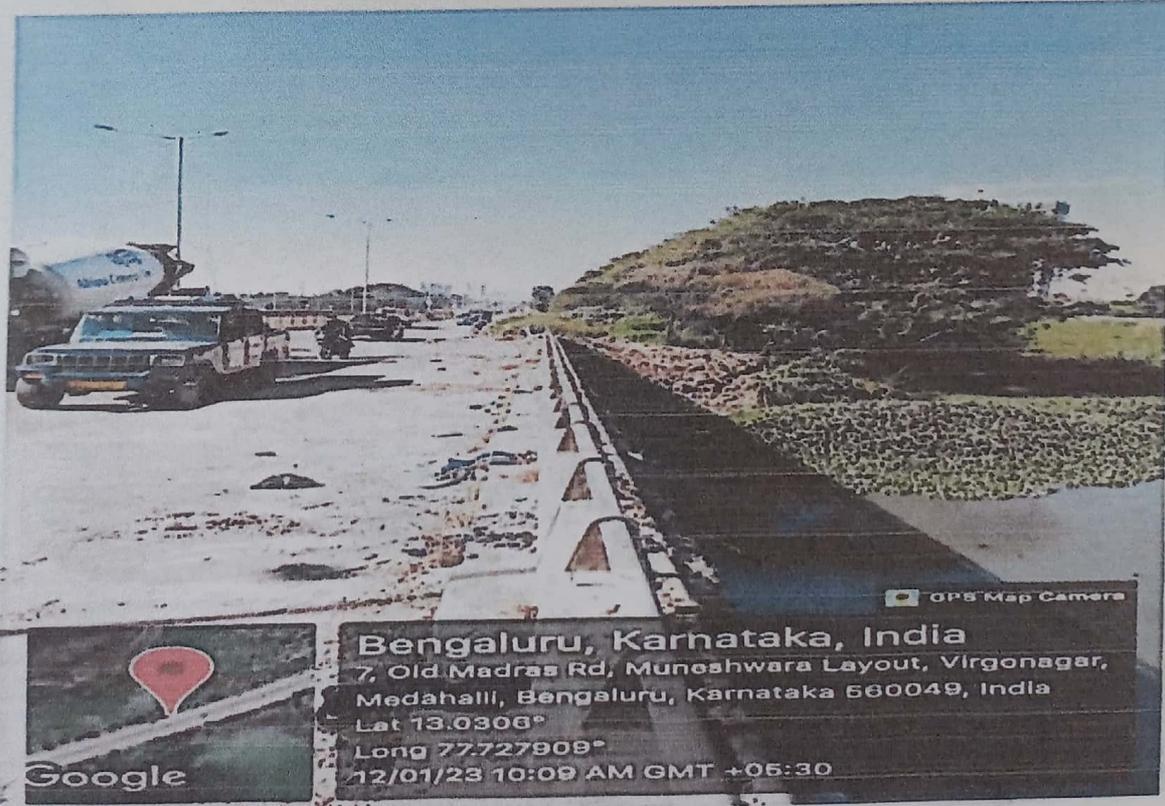
ANNEXTURE 'A1'

Photograph of Clearing Process of dumped Solid Wastes/debris, Weeds and other sediments obstructing free flow of water at the Vent on upstream.

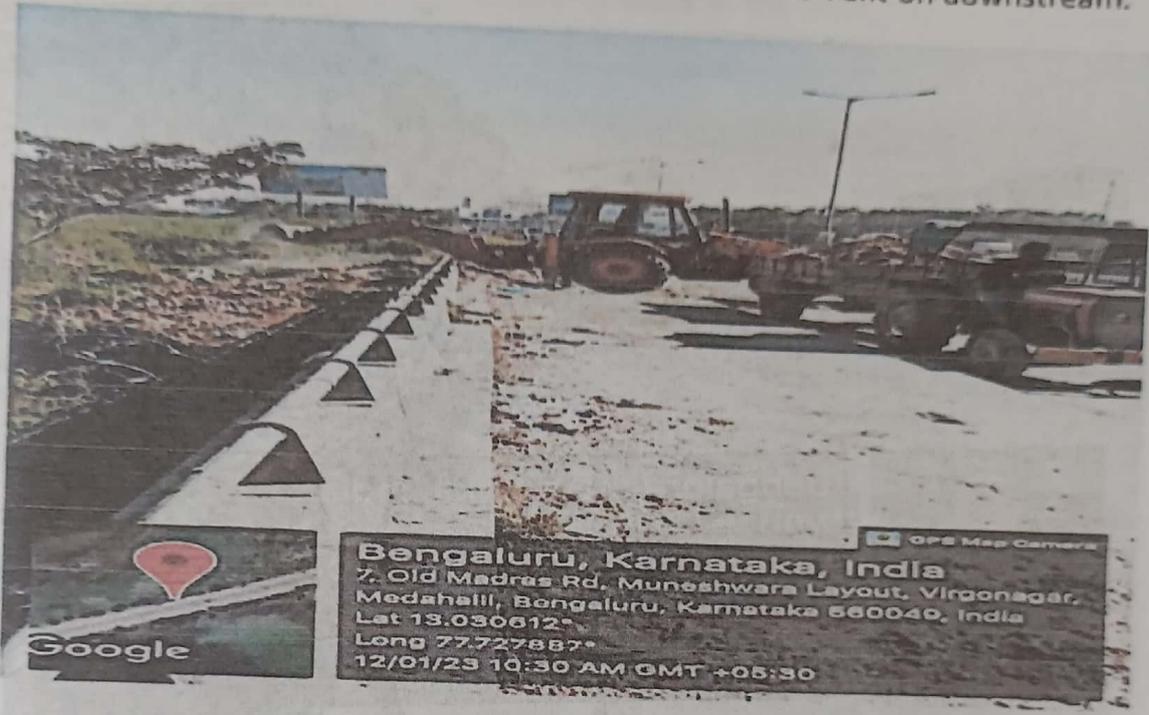
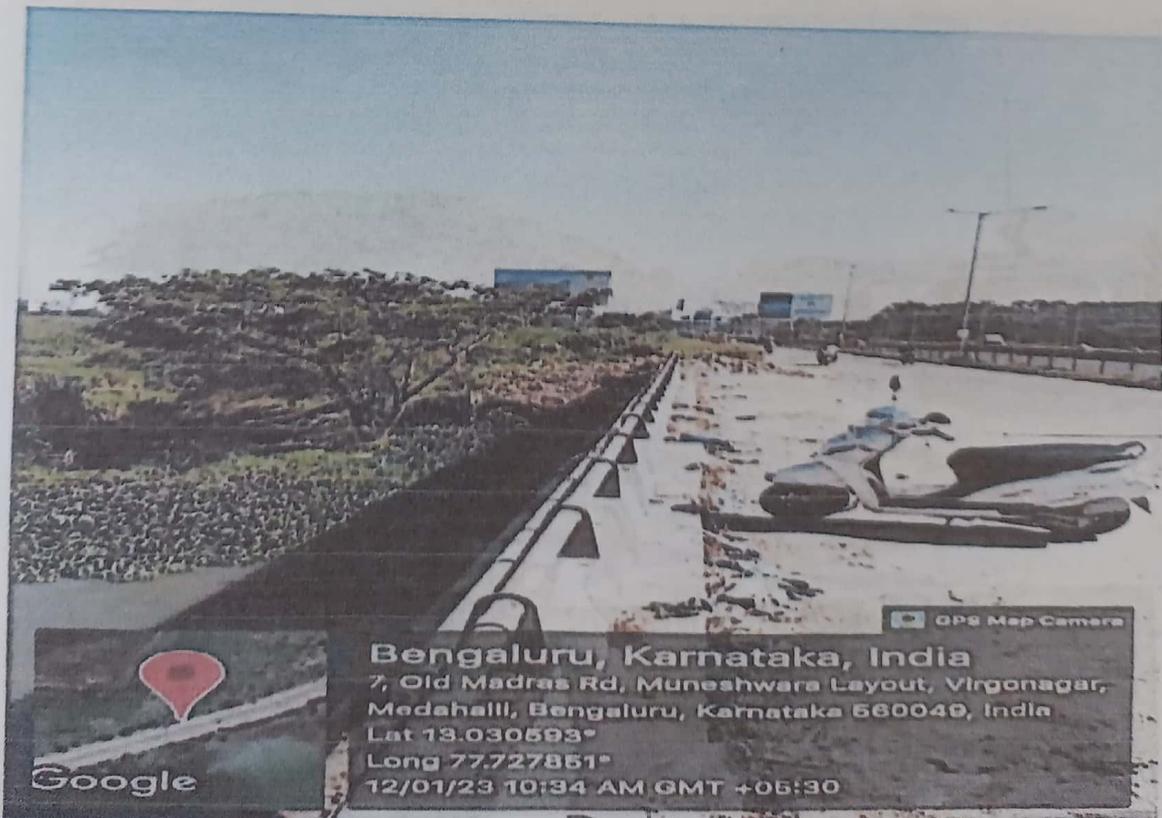
ANNEXTURE 'A2'

Photograph of Clearing Process of dumped Solid Wastes/debris, Weeds and other sediments obstructing free flow of water at the Vent on downstream.

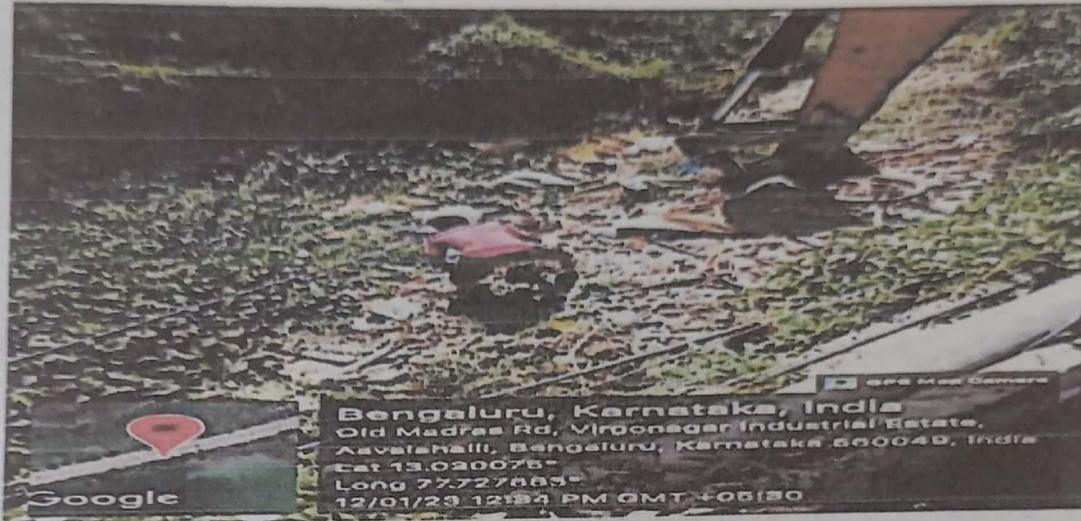
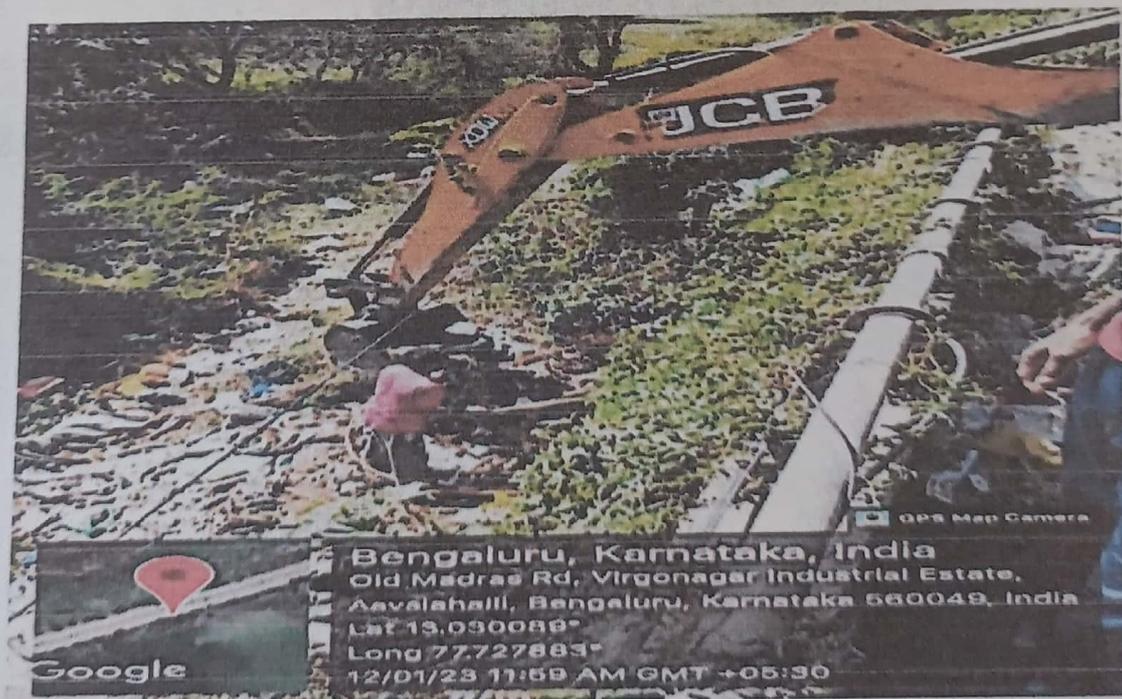
ANNEXTURE 'A3'

Photograph of Clearing Process dumped Solid Wastes/debris, Weeds and other sediments obstructing free flow of water at the Vent.

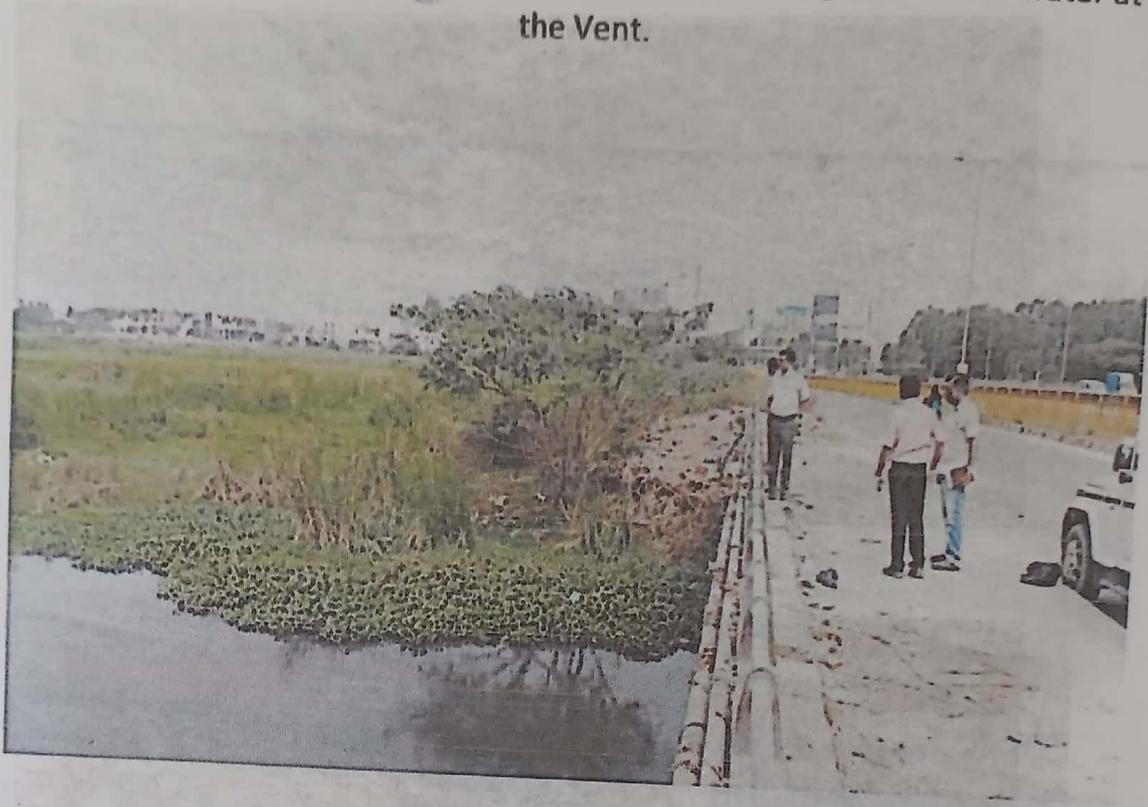
ANNEXTURE 'A4'

Photograph of Pollution Control Board Officers visit to spot at dumped Solid Wastes/debris, Weeds and other sediments obstructing free flow of water at the Vent.

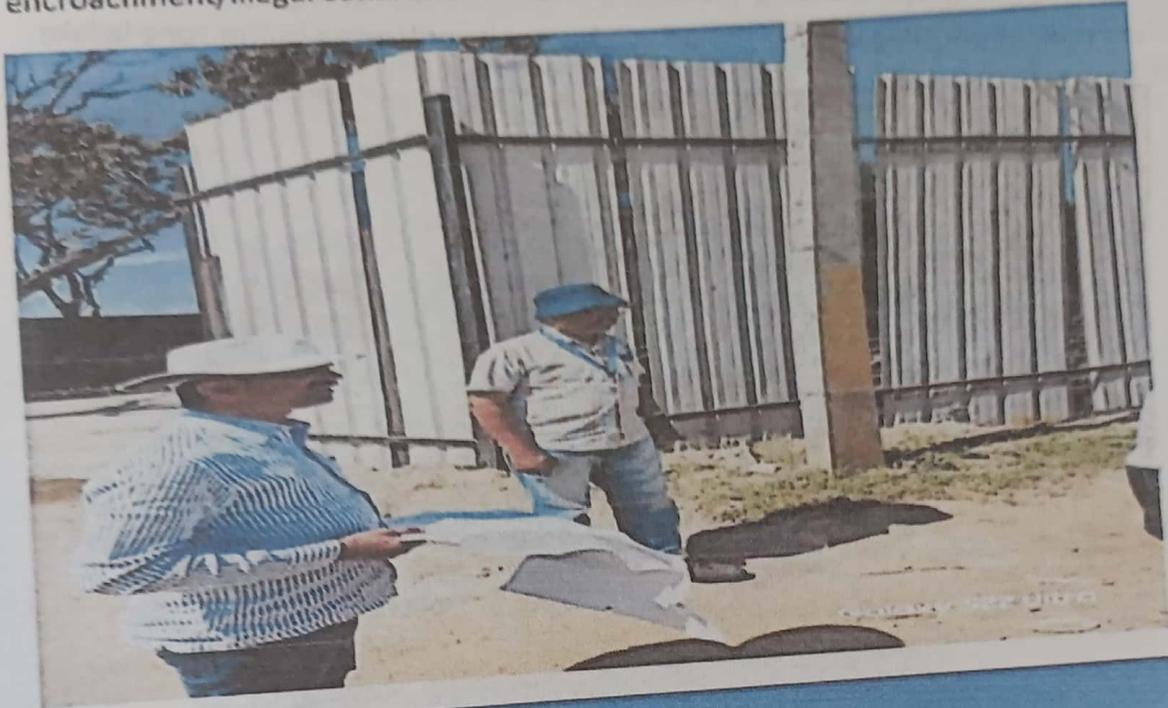
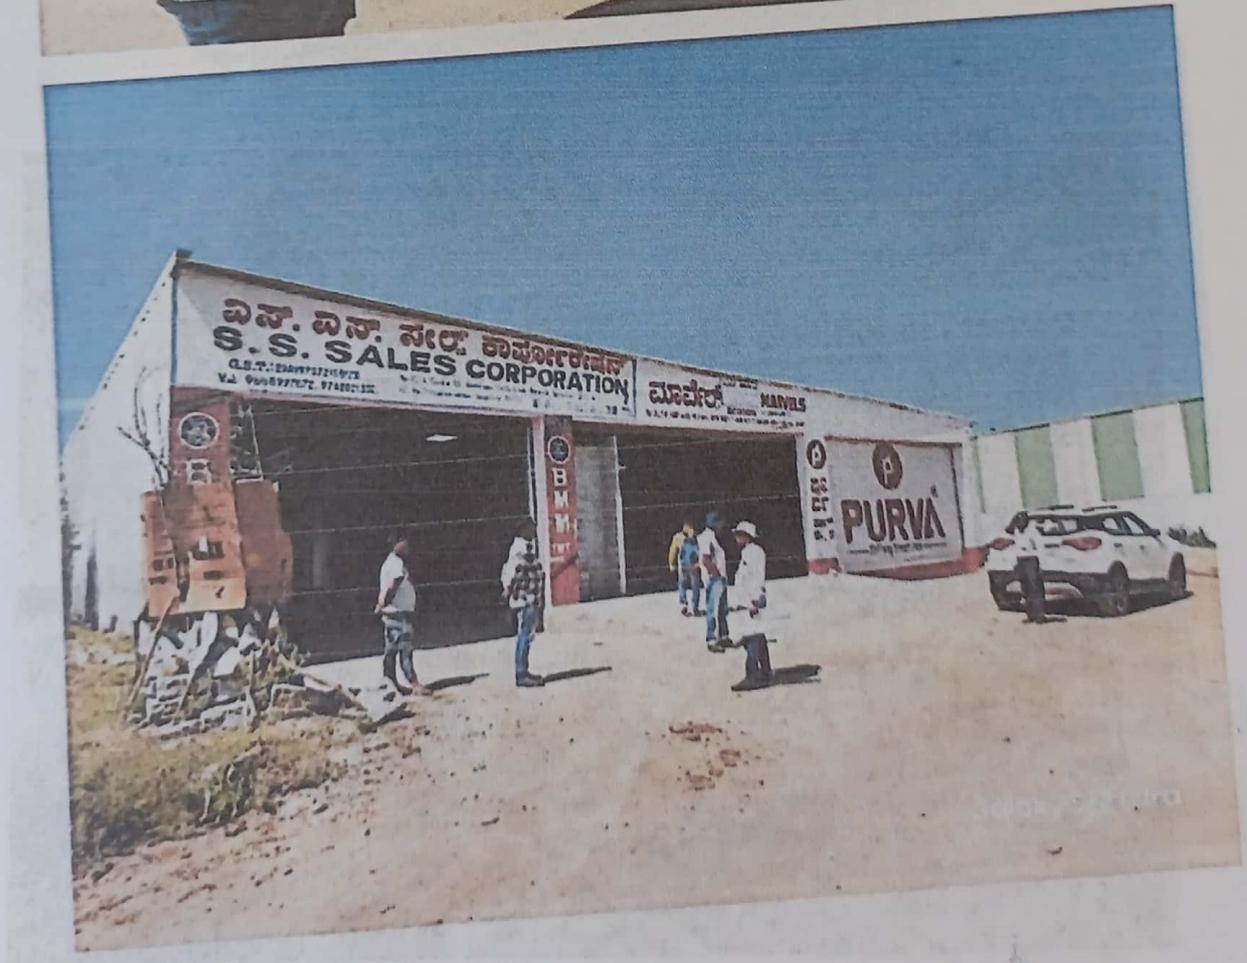
ANNEXTURE 'B'

Photograph showing marking process of Survey Department of encroachment/illegal construction in lake and its protected buffer zone in lake.

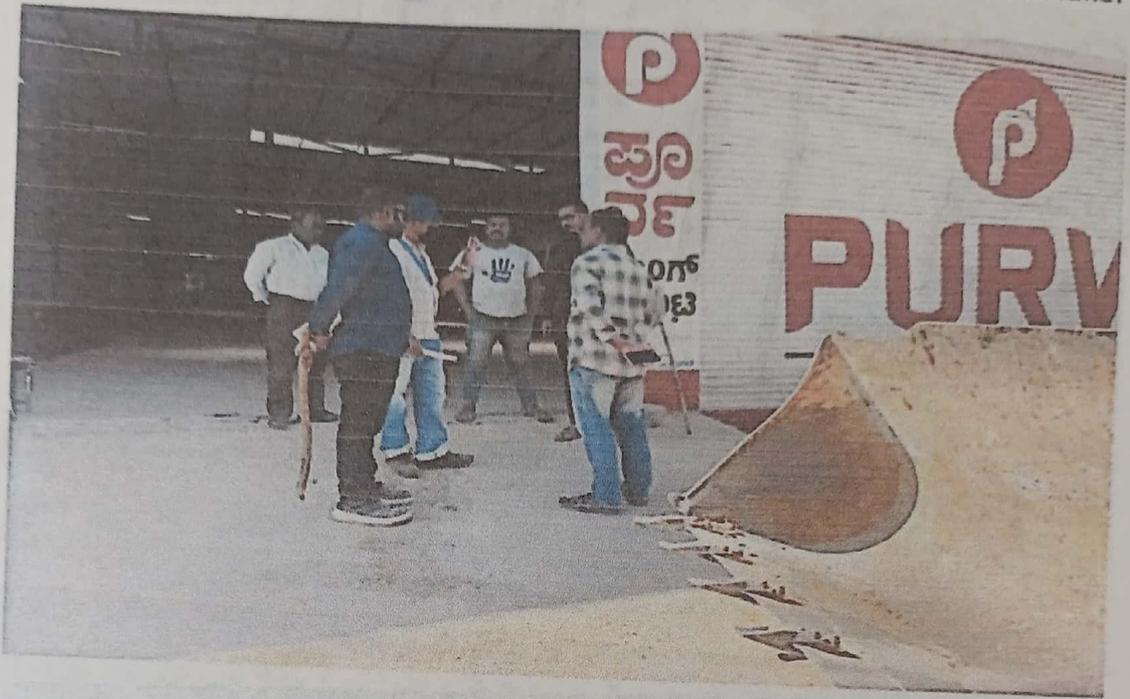
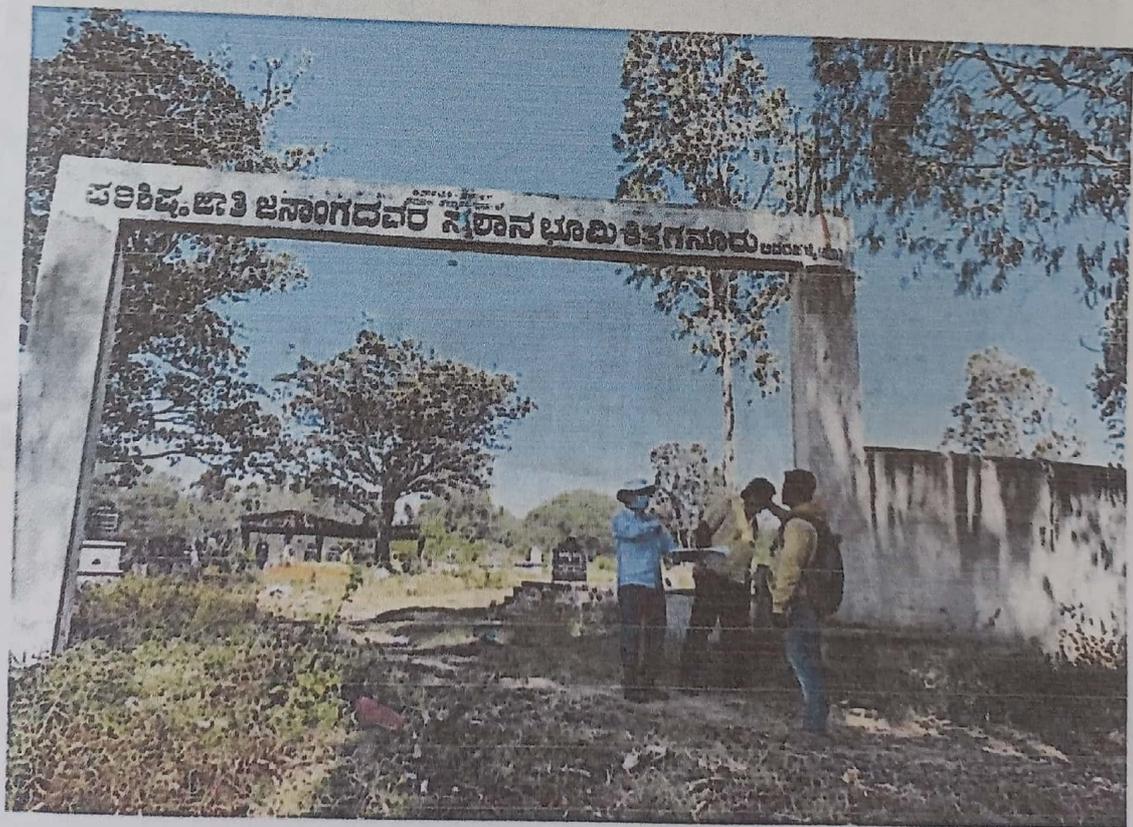
ANNEXTURE 'B1'

Photograph showing marking process of Survey Department of encroachment/illegal construction in lake and its protected buffer zone in lake.

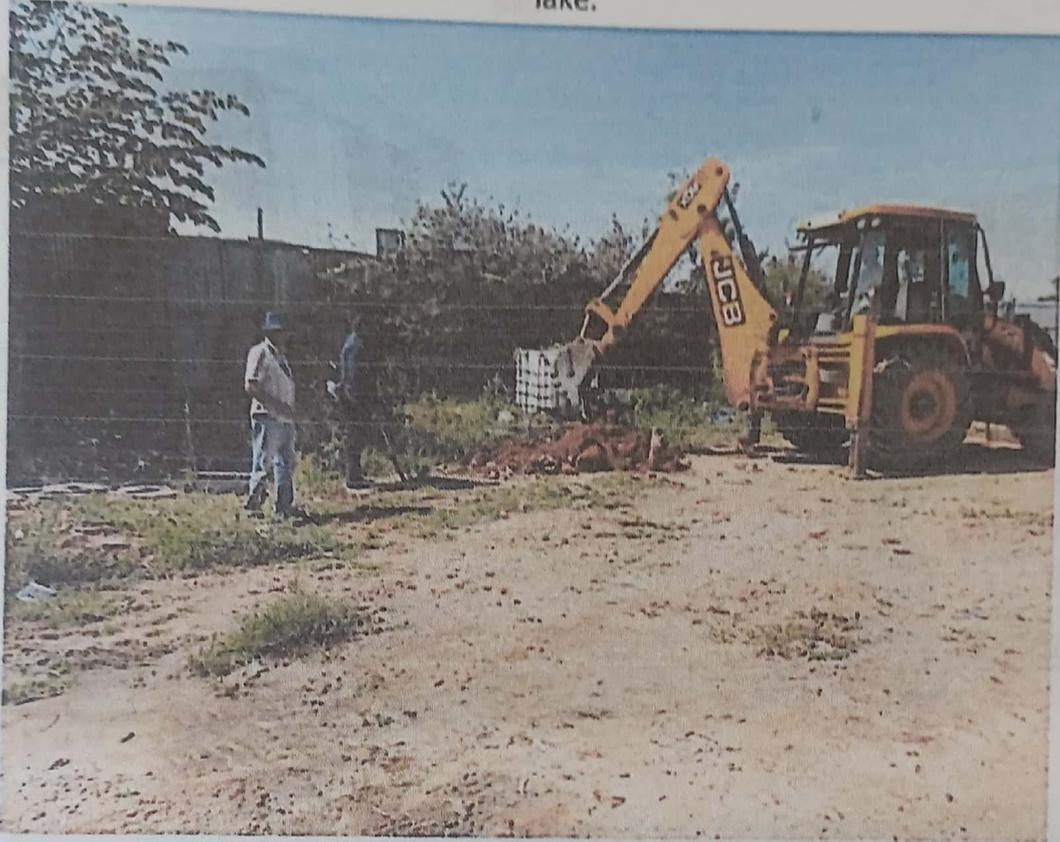
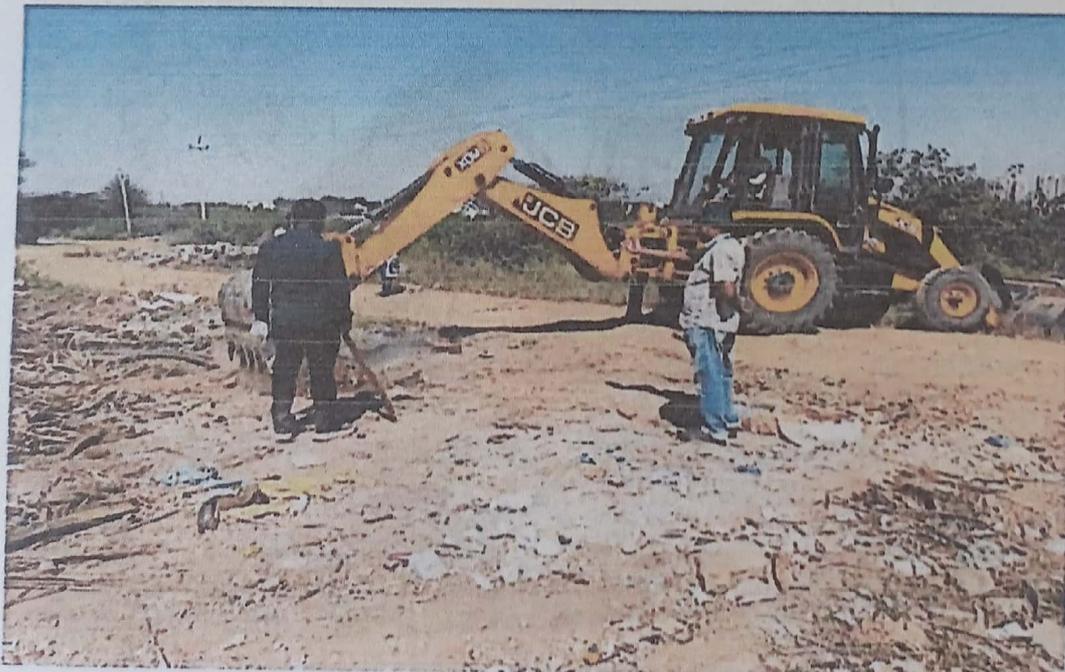
ANNEXTURE 'B2'

Photograph showing clearing process of marking given by Survey Department at encroachment/illegal construction in lake and its protected buffer zone in lake.

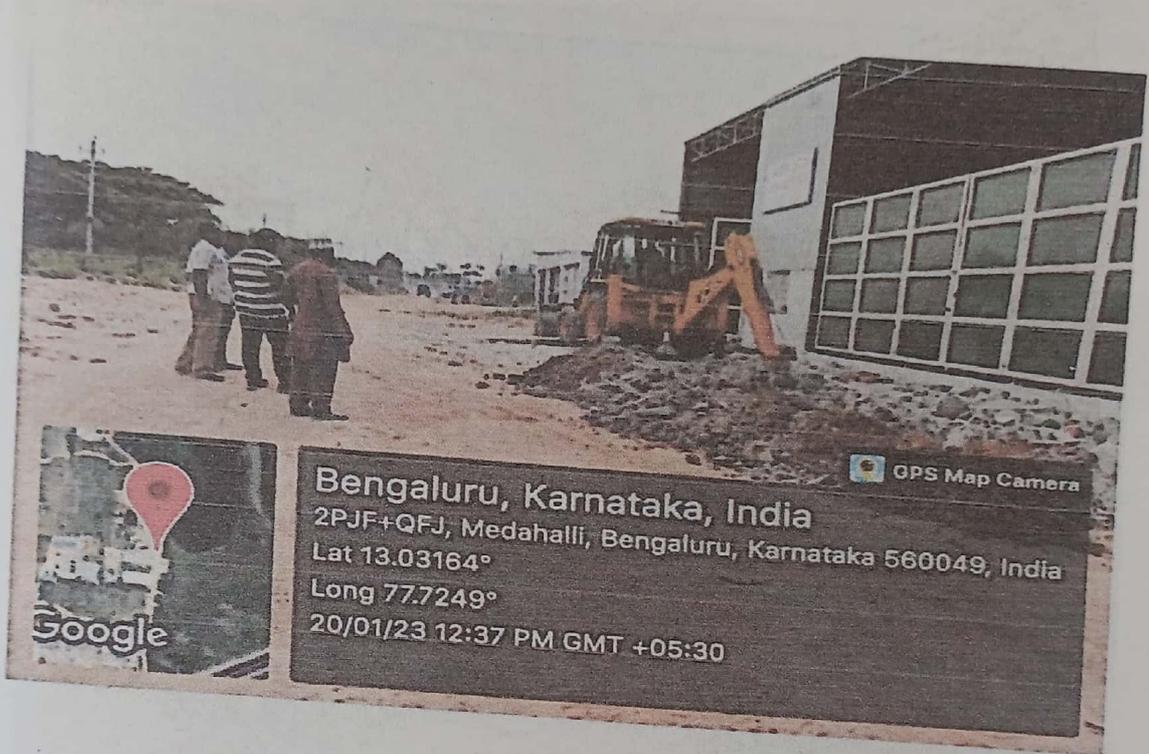
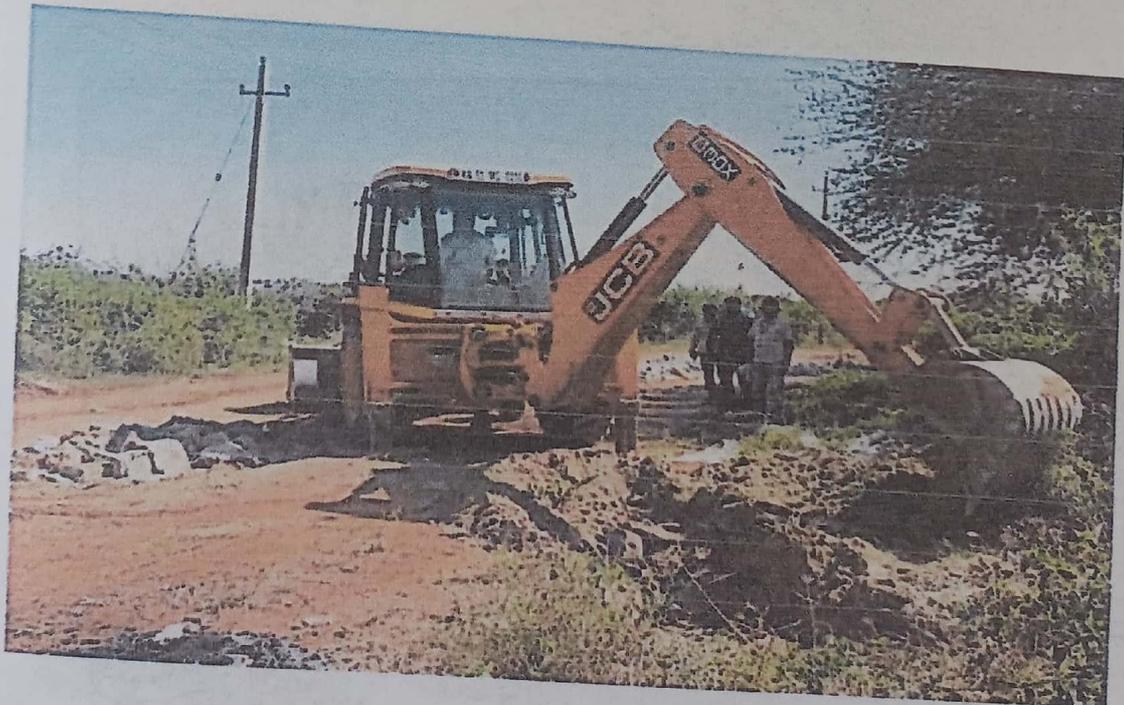
ANNEXTURE 'B3'

Photograph showing clearing process of marking given by Survey Department at encroachment/illegal construction in lake and its protected buffer zone in lake .
